Monthly Site Environmental Audit

Glanmire Flood Relief Scheme

29/07/24 To 26/08/24

ENVIRONMENTAL AUDIT

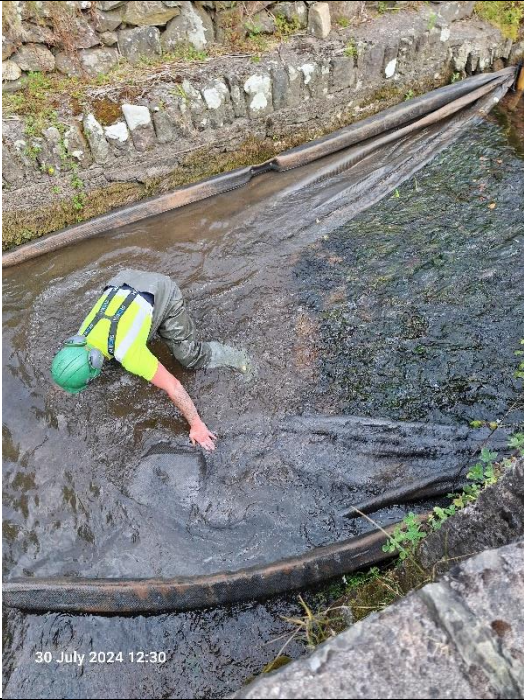
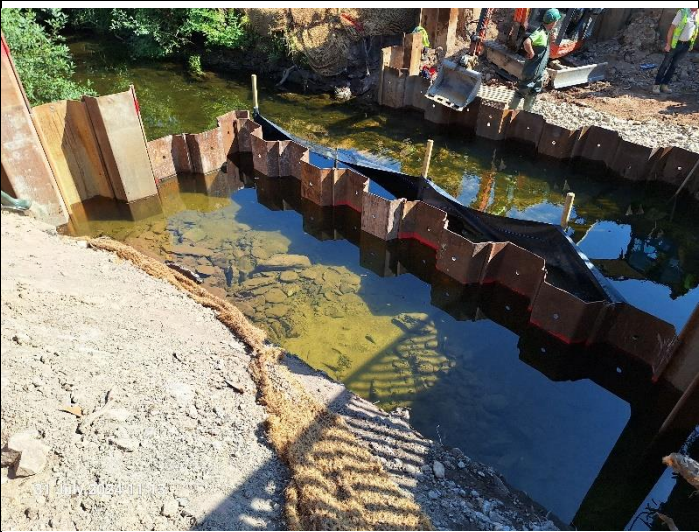
Figure 1			Figure 2

Caption 1			Caption 2		
Silt curtain installation at Brooklodge.			Western cofferdam at Hazelwood bridge with silt fencing placed prior to sheet pile installation.

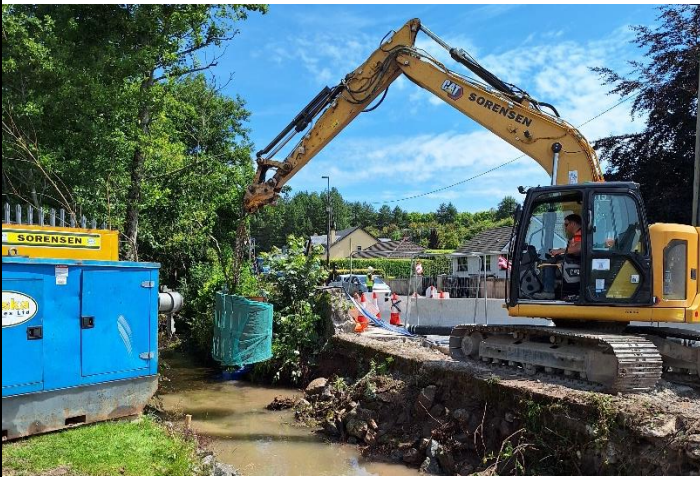
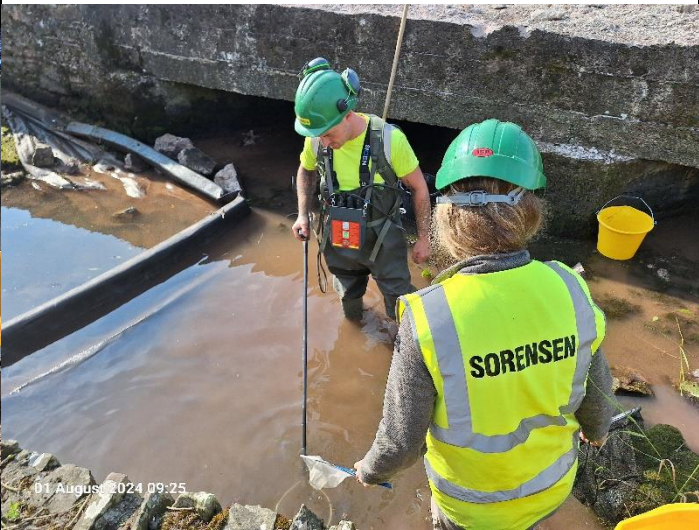
Figure 3			Figure 4

Caption 3			Caption 4		
Placing of sump at Brooklodge. Sump wrapped with green mesh to prevent fish accessing the intake hose.			Electrofishing completed by the Env Team at Brooklodge.

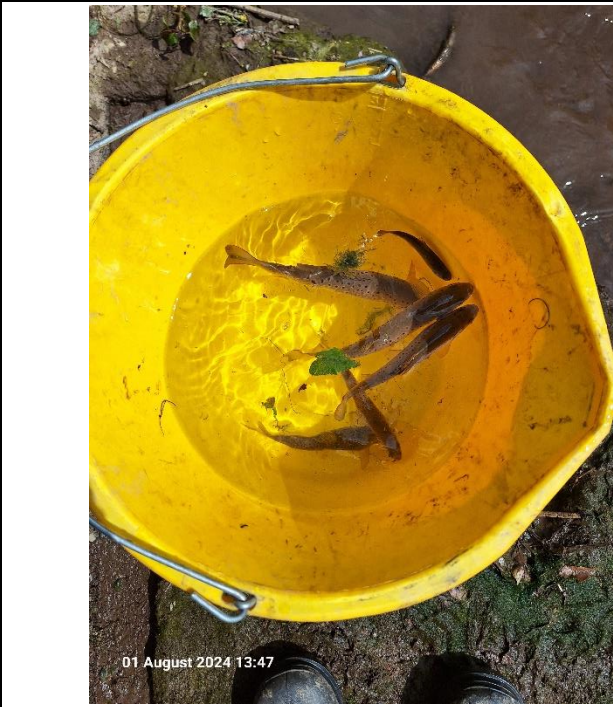
Caption 5

Juvenile Brown Trout recovered during efishing operations at Brooklodge.

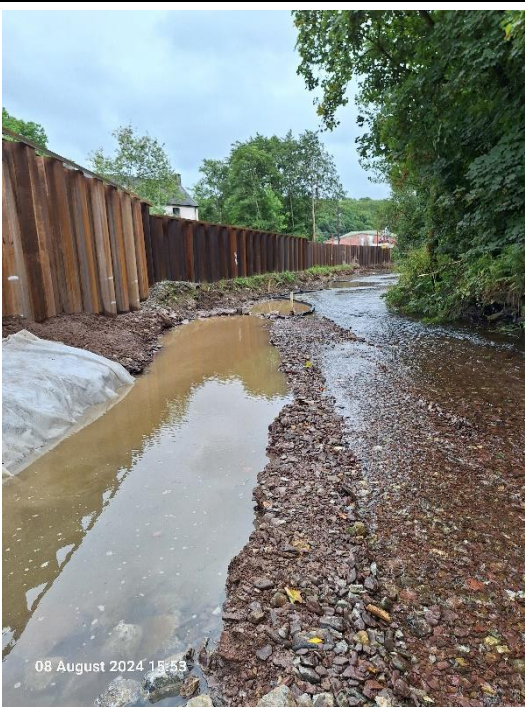
Caption 6

Rock armour works in Area 1

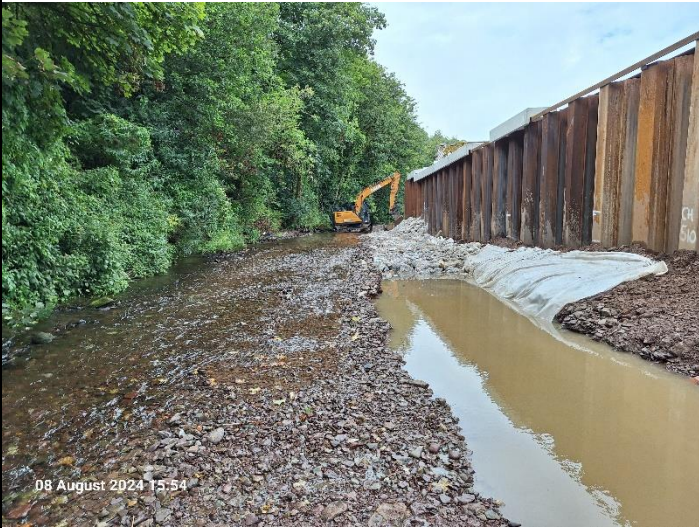
Caption 7

Rock armour works in Area 1

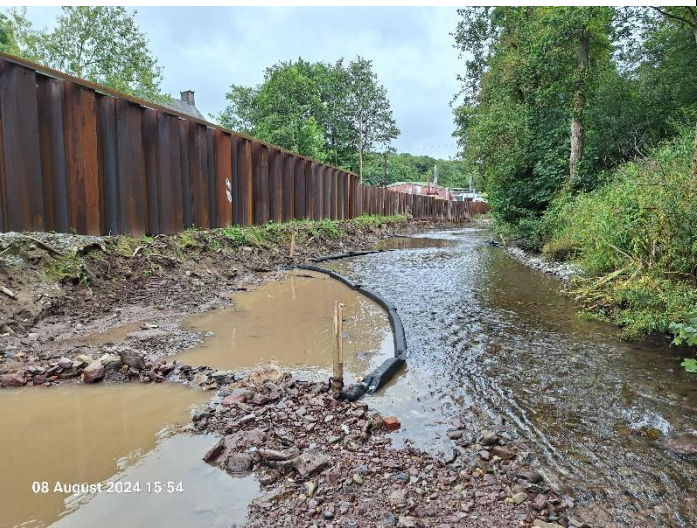
Caption 8

Silt curtain effectively containing silt generated during rock armour works at Area 1.

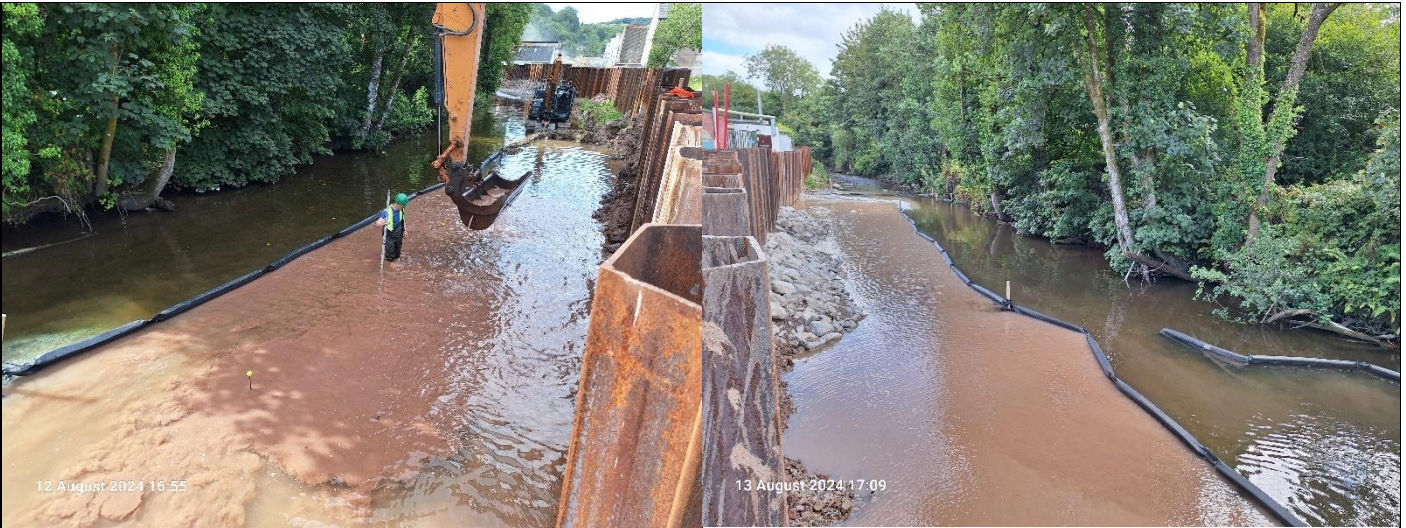
Caption 9			Caption 10		
Rock armour works in Area 1, silt curtains installed parallel to works as well as diagonally downstream of works.			Gravel checkdam installed at the lower extent of works to aid in the containment of silt.

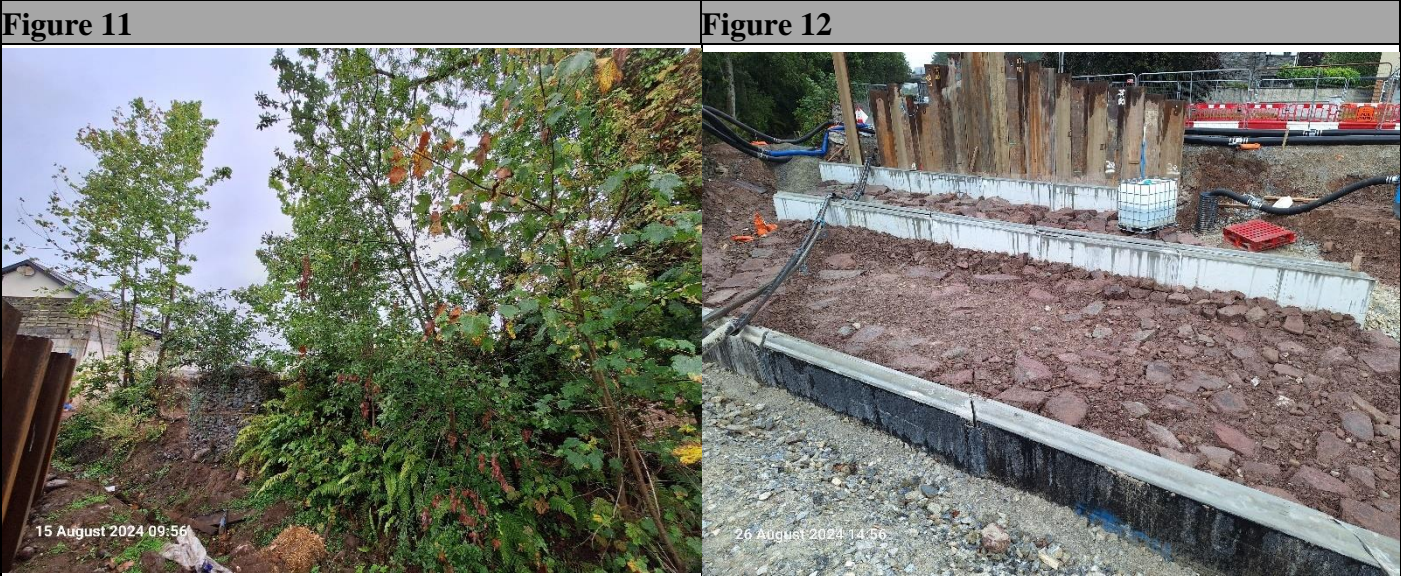
Caption 11			Caption 12		
Trees surveyed prior to removal at Springmount.			Flagstones placed in Brooklodge culvert and seeded with gravels.

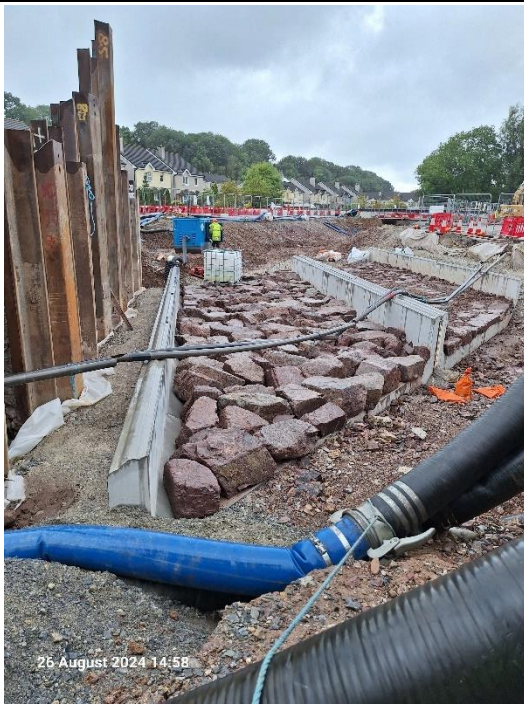
Caption 13

Flagstones placed at Brooklodge culvert.

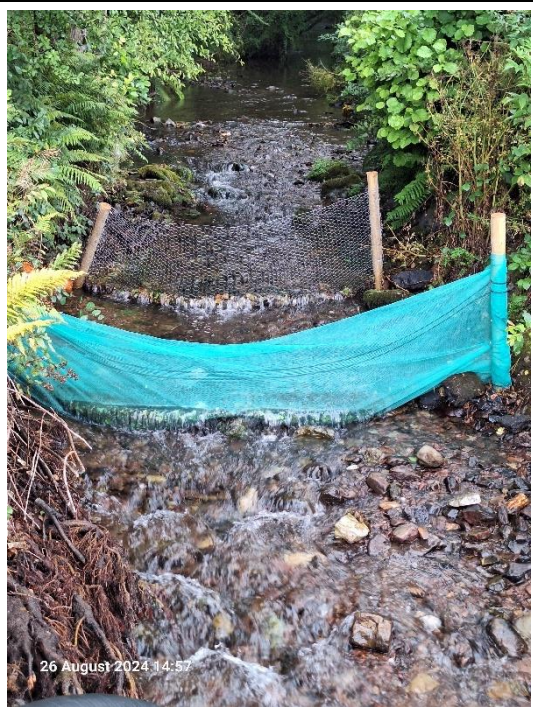
Caption 14

Fish guard with wire mesh to prevent debris damaging the guard at Brooklodge.
