JBA
consulting

Hydromorphic audit of the River Glashaboy

Final

November 2016

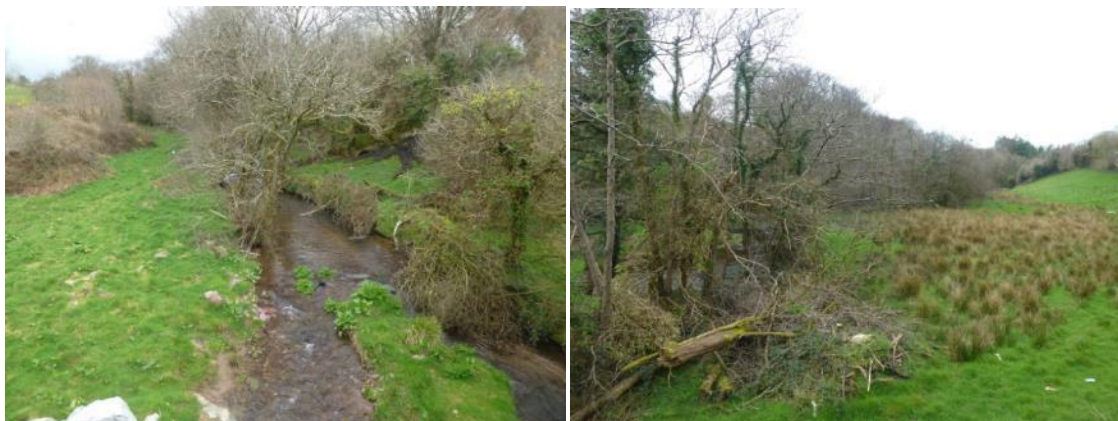
Figure 3-5 Upstream of Ballyskerdane Bridge (Point 4)

Stable vegetated bars were common throughout the reach (Figure 3-5) along with small pockets of fine sediment deposition along the lateral edges of the channel, mainly from localised bank erosion. Small areas of deposition like this are often an indication of the channel naturally attempting to narrow as a result of historic intervention, such as over widening. Several low weirs exist (see example in Figure 3-2), which cause limited upstream impoundment, but act to cause increased fine sediment deposition within their impoundment zones. Limited evidence was noted of weirs restricting movement of gravels.

Opportunities exist to improve connection through embankment removal and re-grading (Figure 3-5). This should act to improve floodplain storage in these upper reaches and act to reduce downstream flood risk.

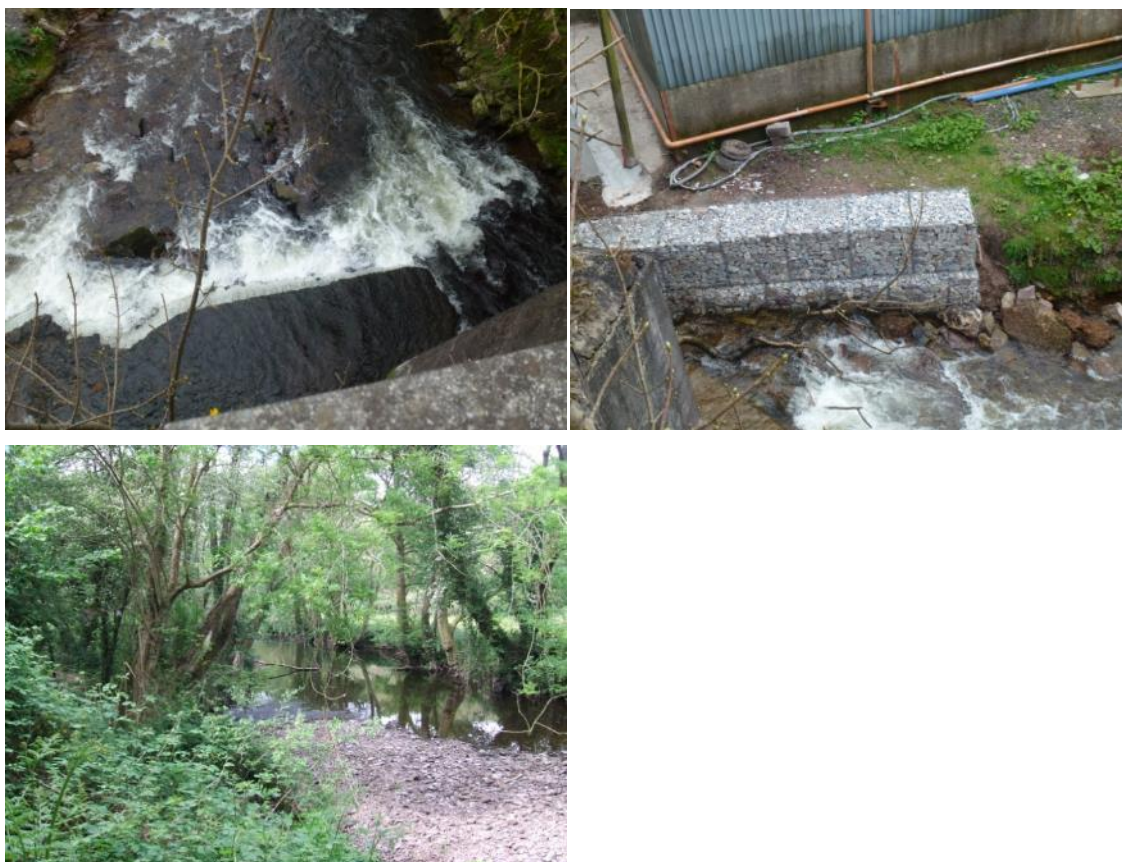
Figure 3-6 Upper Glanmire Bridge (Point 5)

In the reach between Upper Glanmire Bridge and Knocknahorgan the river valley narrows which results in a confined floodplain. At Upper Glanmire Bridge a weir is leading to local bank erosion (Figure 3-6), due to the direction of flows passing under the bridge. Banks have been reinforced using gabion baskets, however, in the long term the river may undercut these baskets.

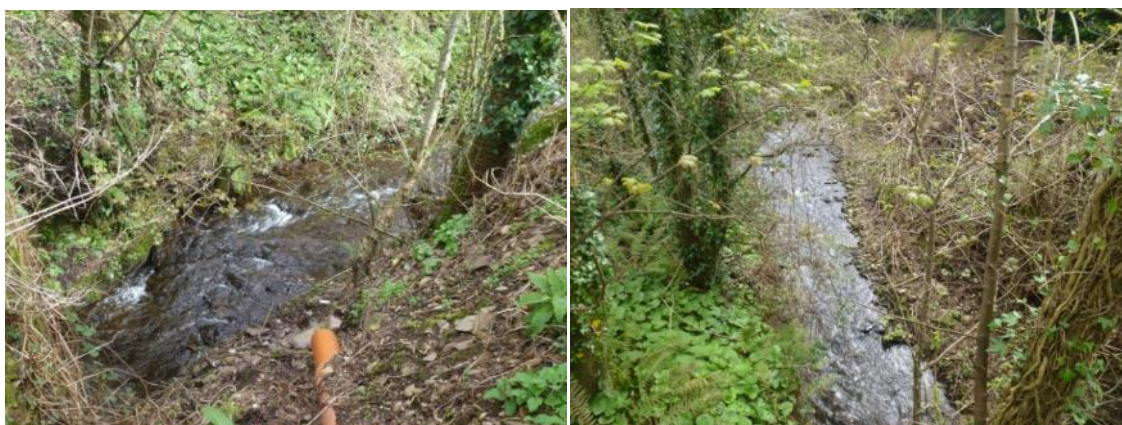
Figure 3-7 Knocknahorgan tributary (Point 6)

Downstream of Upper Glanmire Bridge, flow energy in the channel reduces and areas of gravel and small cobble deposition occur (sizes of gravels range from 4cm to 40cm). Gravel splays occur at tributary confluence points (Figure 3-6) along this section, suggesting an active supply of gravels is present from the steep tributaries joining the river (Figure 3-7).

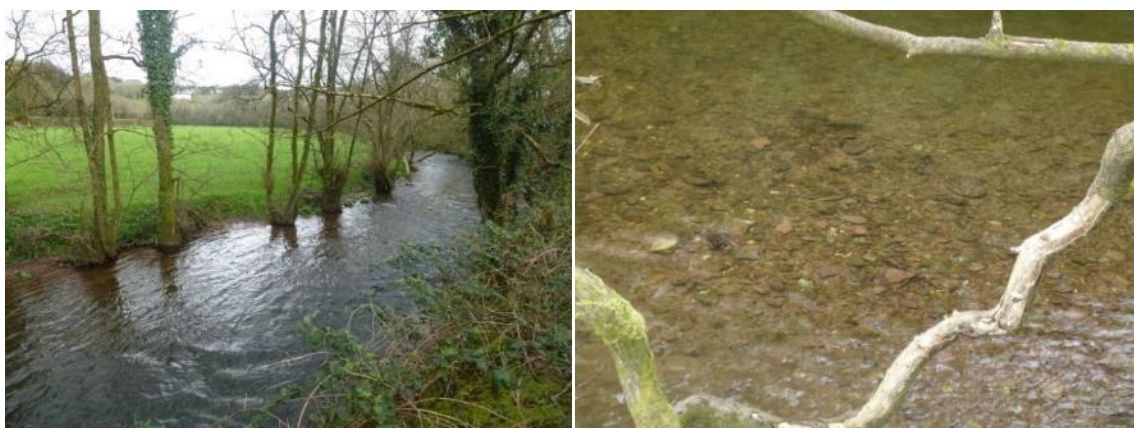
Figure 3-8 Knocknahorgan (Point 7)

The channel bed throughout this reach is again dominated by gravels and cobbles, in a plane bed and pool riffle morphology. Less algae was seen on the more gravelly sections on the bed which suggests a more active supply and movement of gravels through this reach (Figure 3-8).

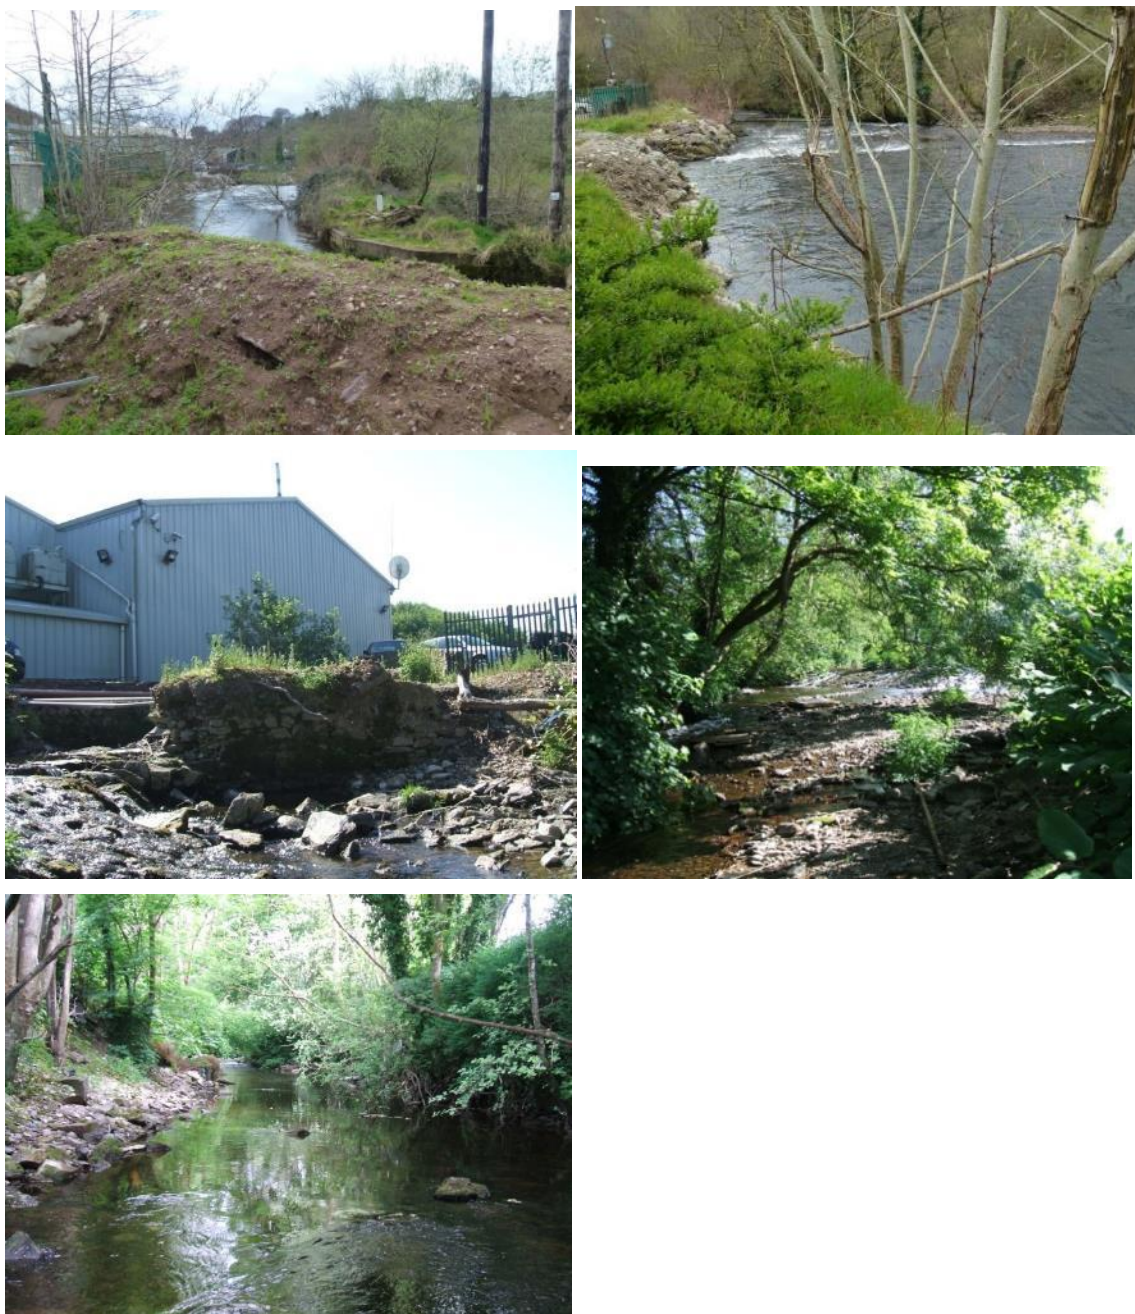
Figure 3-10 Channel upstream of Sallybrook (Point 8)

As the channel approaches Sallybrook the valley widens and becomes less confined. The wider floodplain along this reach has been developed / built upon which acts to constrict the channel. In some areas informal flood embankments have been constructed. In other areas active bank erosion is occurring as the channel attempts to naturally adjust within its confined channel. This is exacerbated by the higher energies during flood conditions as a result of the channel constriction. Hard measures, such as walls have been constructed to reduce the erosional impact of the river (particularly on the outside of bends) and some of these are now failing (such as adjacent to the petrol station). The erosion of banks acts as a strong sediment supply of gravels and fine materials. Deposition is also common through this reach, with several gravel bars (which are unvegetated, signalling frequent movement) being present. However, in the lower portions of the reach the channel becomes incised as a result of the influence of old mill leats and weirs (some existing and some now removed). As a result of these structures the channel is disconnected by over 1m from the floodplain (due to the channel eroding downwards in an attempt to adjust its bed gradient) and deposition is minimal, due to floodplain disconnection and high in channel energy levels. The channel in this lower section is dominated by coarser cobbles.

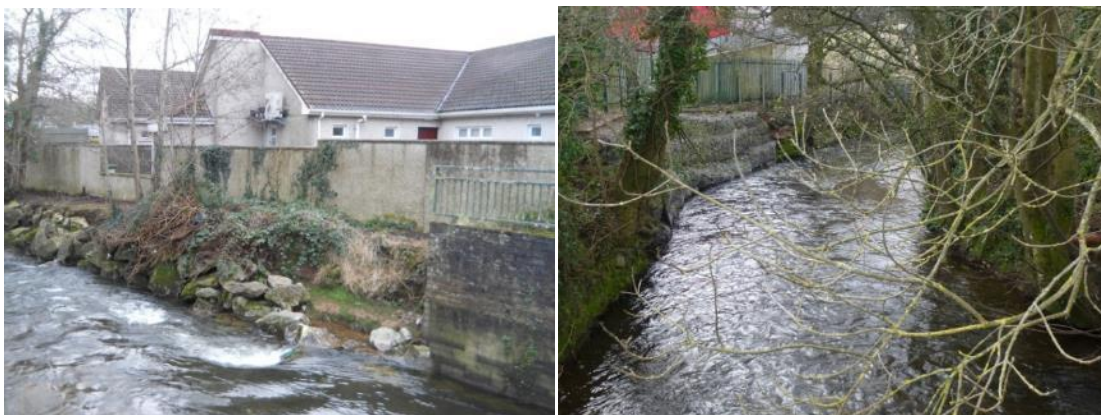
Figure 3-13 Adjacent to the Glanmire shopping centre (Point 10a)

At the Glanmire shopping centre several areas of bank instability exist (Figure 3-13 and Figure 3-14). The channel at this point is confined and relatively narrow compared to reaches upstream. There is limited deposition due to the steepness in some sections and disruption from upstream to the sediment transport process. The channel banks are high in most locations due to land raising and embankments. As a result, during flood conditions all energy is concentrated within the channel which is leading to bank erosion and instability. In many places existing bank protection has been undermined and has collapsed into the river. This section appears to be starved of sediment, suggesting upstream structures, such as the old weirs are influencing in-channel processes. As a result, the channel has excess stream power leading to the erosion processes along the beds and bank. In order to reduce the flood impact and erosion within this section various options could be investigated including flood storage options upstream and also improving the in-channel morphology which is currently degraded, to manage the existing high energy conditions.

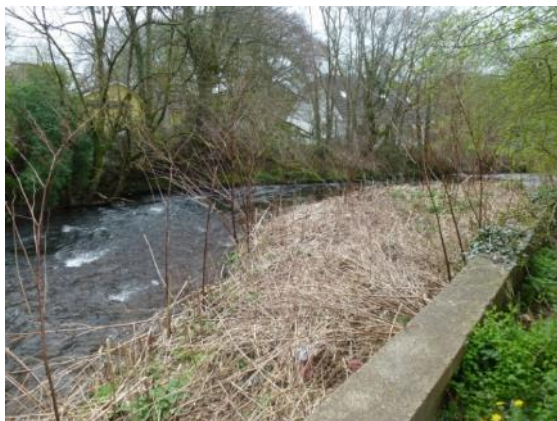
Figure 3-15 Defences downstream of the Glanmire shopping centre, adjacent to the housing estate (Point 11)

Downstream of the shopping centre the channel widens slightly. Flood defences exist, which protect an adjacent housing estate. The defences act as a constraint to the channel in terms of its floodplain connection. The wider nature (Figure 3-15) of the channel here has allowed for the

deposition of some sediment (dominated by fines). In the majority of cases the depositional features are vegetated which suggests that the channel has reacted following past intervention (i.e. it has adjusted to a more natural narrow channel), probably as a result of the construction of the flood defences. This indicates that if any future maintenance of this section occurs (such as sediment removal or flood defence improvements) deposition of this nature will continue to occur.

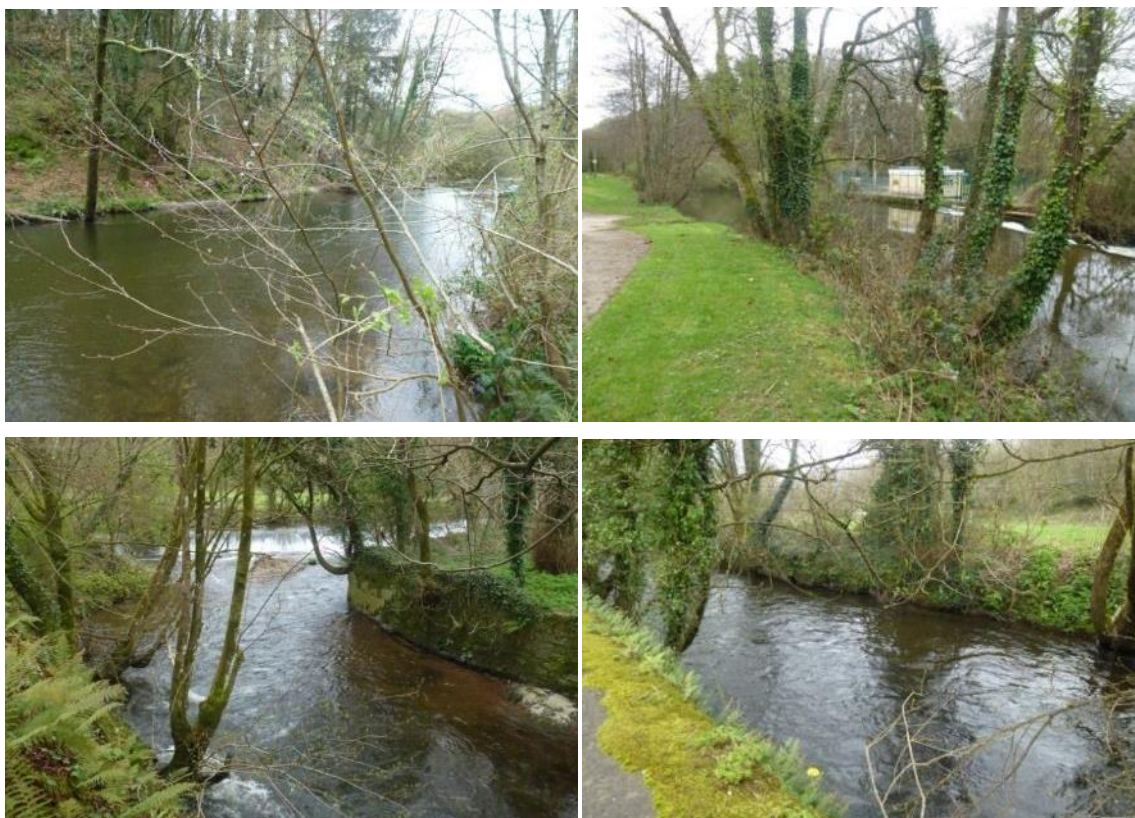
Figure 3-18 Impoundment (Point 14)

In the downstream section of the park a weir exists, which historically was used to feed a mill leat (which is still active). This causes upstream impoundment through the park increasing fine sediment deposition (Figure 3-18). Downstream of the weir some minor scour has occurred along

with a small area of gravel deposition, in a classic weir pool morphology. The channel then enters a canalised section with steep walls on both banks which act to prevent any channel migration. As a result, flows within this section have the ability to transport gravels downstream resulting in little deposition apart from coarser sediment at the edges of the channel through this section.

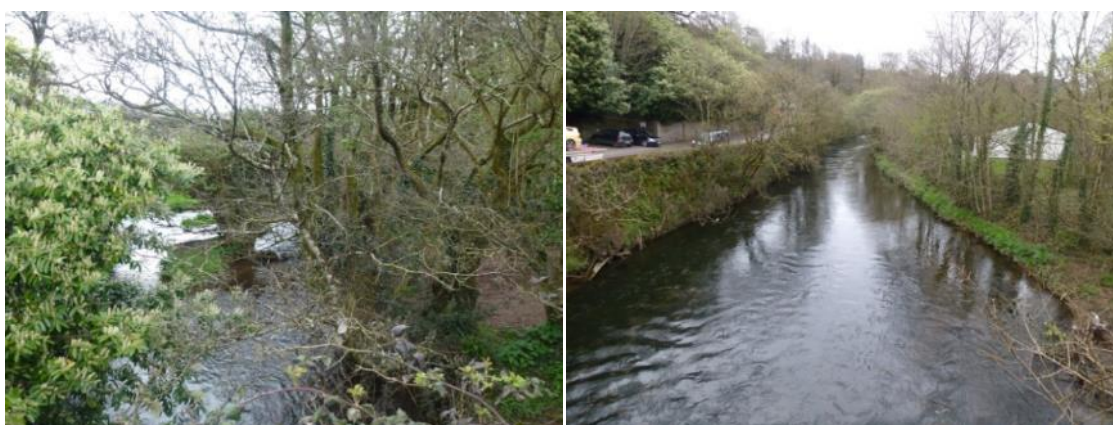
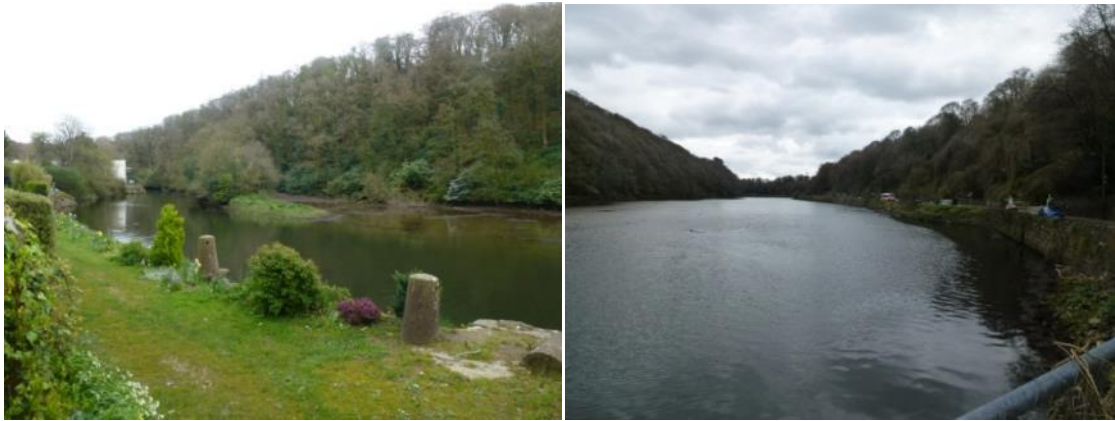
Figure 3-20 Sections downstream of Glanmire

At Glanmire bridge, deposition of gravels is occurring on the left bank (Figure 3-20). Downstream of the bridge the river gradually becomes wider and eventually is influenced by the tidal regime. This influences water levels and flow conditions downstream of Glanmire, resulting in some deposition of tidally derived muds and silts. The deposition of this sediment appears low therefore there is little risk of increased sedimentation in this section.

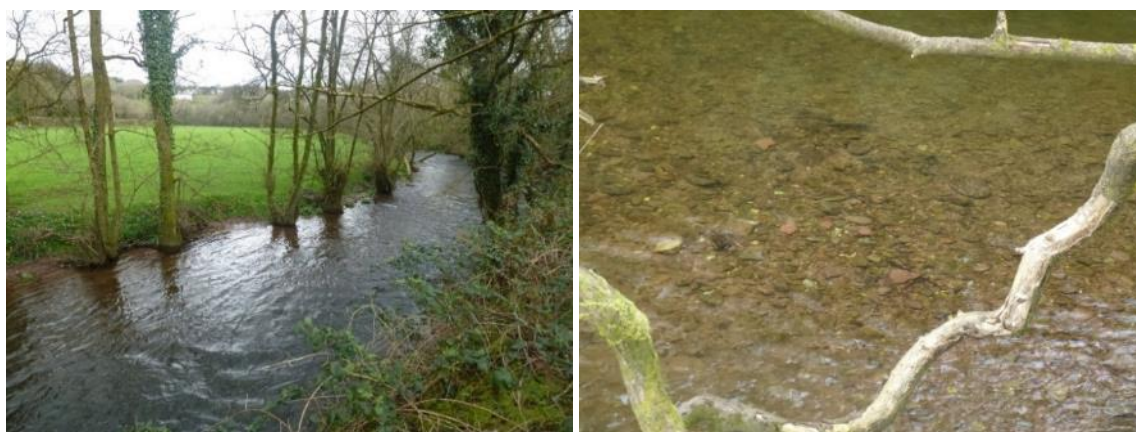
Figure 4-1 Typical conditions upstream of the industrial estate

This is a moderately active section of the channel upstream of the mill leat with a gravel / cobble bed that is partly mobilised during higher flows. The river is disconnected from its floodplain in several locations through this reach as a result of informal flood defences. This elevates in-channel energy levels during higher flows, preventing formation of significant gravel features. Under existing conditions, flow velocities vary between 1.0-2.4m/s for bankfull flows upstream of the mill leat, that are capable of moving medium to large gravels. Downstream of the old mill, the channel is moderately incised and the channel bed is dominated by cobbles. Bankfull flow velocities through this section range from 0.2-2.2m/s.

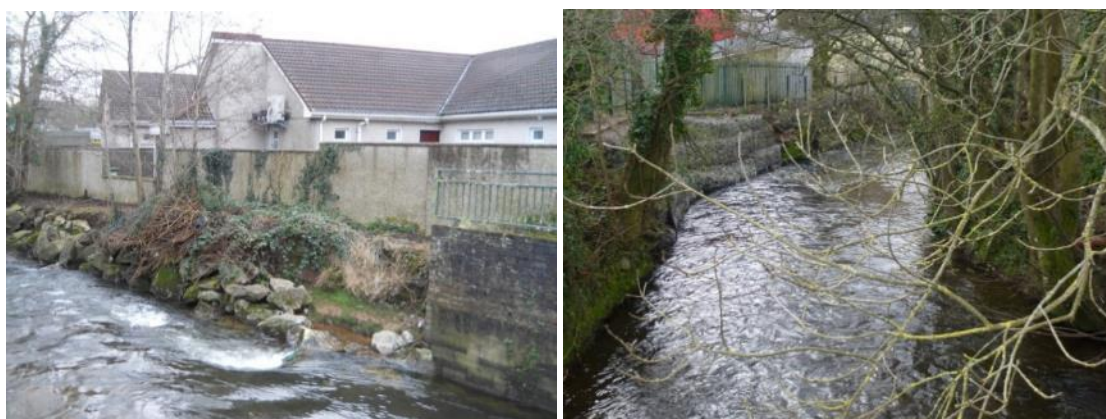
Figure 4-2 Typical conditions adjacent to the shopping centre

This reach is an active section of the river, with bank erosion common. Bank erosion is particularly occurring on the bend upstream of the confluence. There is a decent supply of sediment from upstream and adjoining steep tributaries. Historic straightening, possible dredging, informal flood embankments and bank protection works all act to increase energy levels during the channel during elevated flows as a result of the disconnected floodplain, loss of channel length through straightening and restriction of lateral processes. The channel is also relatively narrow through this section when compared to upstream reaches which again increases in-channel energy levels during elevated flows. This means there are few depositional features on the channel bed despite the strong supply of sediment to the reach.

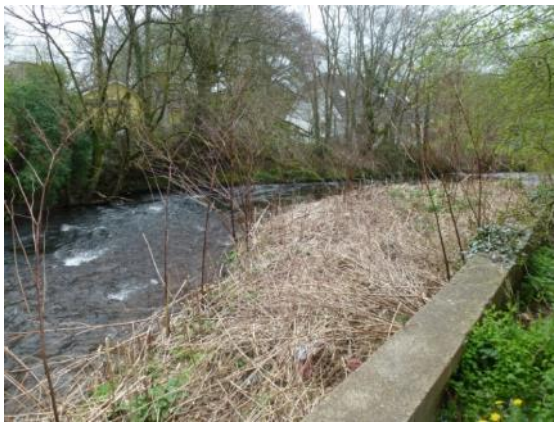
Figure 4-3 Typical conditions adjacent to Meadowbrook Housing Estate

In the section of the river downstream of the shopping centre the channel widens slightly. Flood defences exist on the right bank, which protect an adjacent housing estate. The defences act as a constraint to the channel in terms of its floodplain connection. The wider nature of the channel here has allowed for the deposition of some sediment (dominated by fines). In the majority of cases the depositional features are vegetated which suggests that the channel has reacted following past intervention (i.e. it has adjusted to a more natural narrow channel), probably as a result of the construction of the flood defences and disconnected floodplain over the right bank.

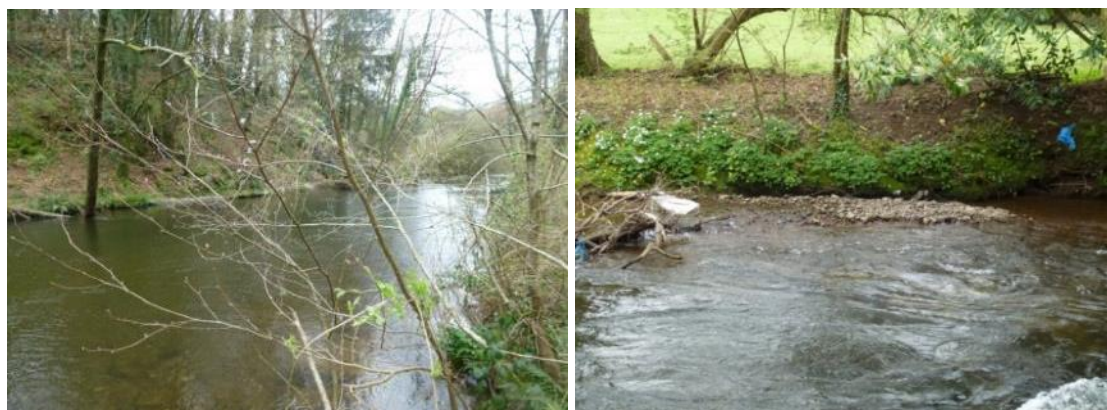
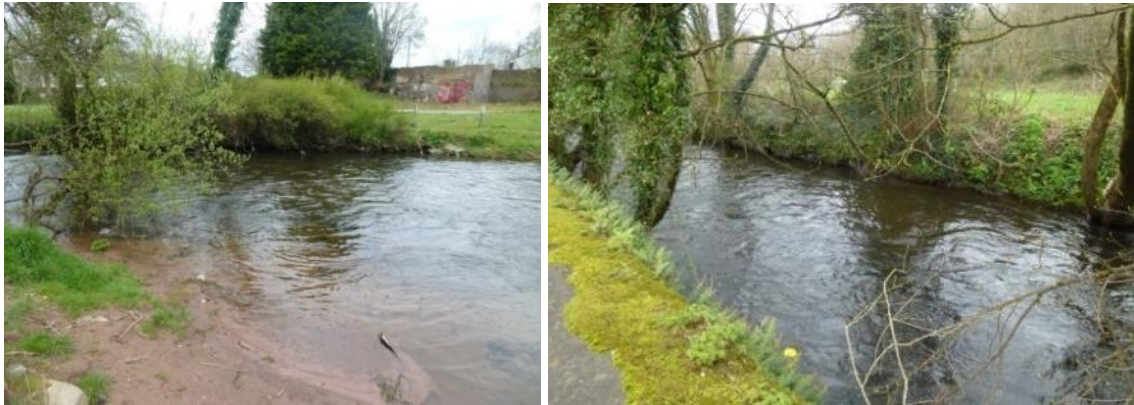
Figure 4-4 Typical conditions through O'Callaghan Park

This reach is characterised by a moderately active channel with some deposition of gravel and fines and some embryonic riffle pool sequencing. There is an impounded section of watercourse within this reach as a result of the large weir downstream, this creates elevated levels of fine sediment deposition on the channel bed. There is some evidence of bank erosion outside of the impounded area.

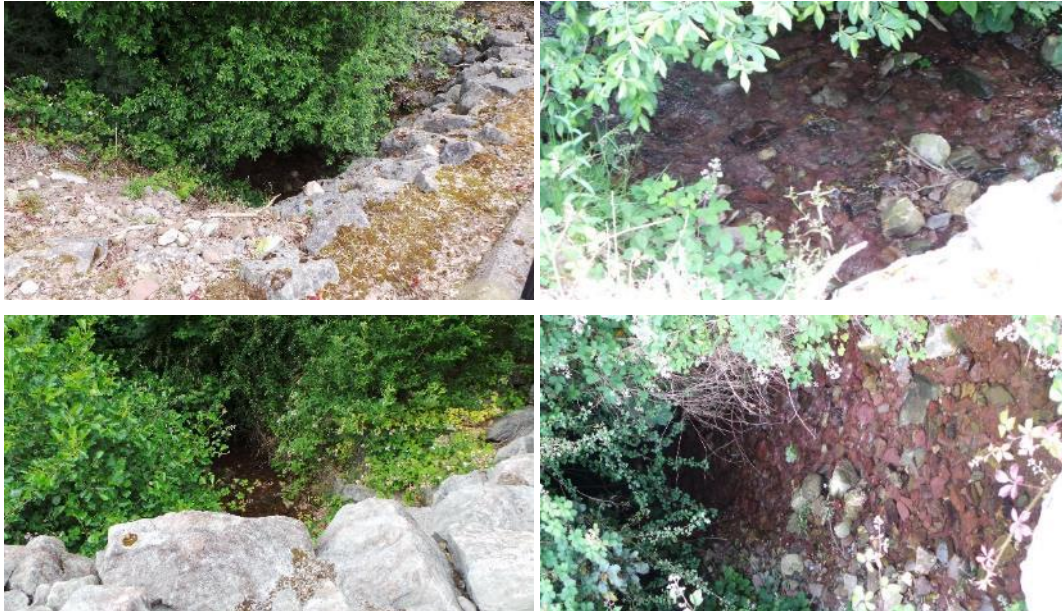
A.1 C09_B01: Replace existing twin 0.9m dia. culverts with new 1.6m by 1.2m high rect. culvert

Bleach Hill Stream at this location is entrenched (overly deep). As a result there is little floodplain connectivity except when flood water backs up behind the structure. The stream is dominated by a gravel and cobble bed which appears partially mobile (i.e. limited evidence of armouring). During flood conditions it is likely that this sediment will be mobilised and transported downstream, whilst new sediment will be delivered from upstream reaches. Due to the existing small culverts some sediment has accumulated upstream of the bridge. Whilst the existing culverts appear to be capable of allowing sediment to move downstream, it is likely that the culverts frequently become blocked with trash and debris which will hinder sediment continuity to downstream reaches.

The proposed larger culvert will improve sediment continuity through the system. The existing bed material should be maintained and matched where possible, however, any disturbance to the bed will quickly be rectified during subsequent high flow events. High flows event will be capable of transporting sediment to the structure from upstream reaches and the bed will quickly re stabilise.

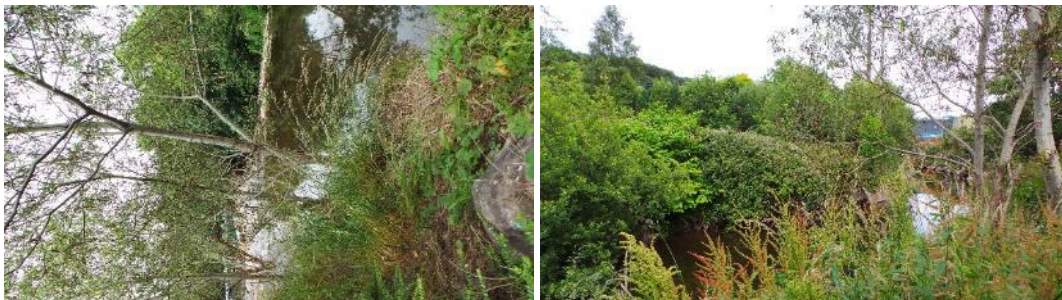
A.2 C01_L01: Concrete flood defence (Old weir at Petrol Stn North of Sallybrook)

There is an impounded reach upstream of an old weir adjacent to the petrol station. The weir is partially collapsed and appears unmaintained. The reach upstream of the weir exhibits low velocities due to the impoundment impacts. The weir has also, over time acted to trap sediment upstream which in turn has elevated the upstream channel bed level.

The main flow route over the weir is towards the left bank (outside bed) at the weir site. The steep gradient of the weir acts to elevate velocities and this has caused outer bank erosion problems.

In the long term there is a risk that the existing bank protection measures could fail due to their ad-hoc nature and the old weir structure could fail. If this occurs the existing river bed upstream of the weir will naturally lower as the trapped sediment is released. There may be a case for further investigation to determine the impact of the failure of this old weir structure on both the bed and bank upstream. Works are planned on the left hand bank, and this will stabilise this bank.

Any future failure would release trapped sediment downstream (which may impact structures) and cause upstream bank instability (which may impact the existing and future flood defences and erosion protection measures depending on foundation depth). This issue should be monitored and action taken if conditions deteriorate.

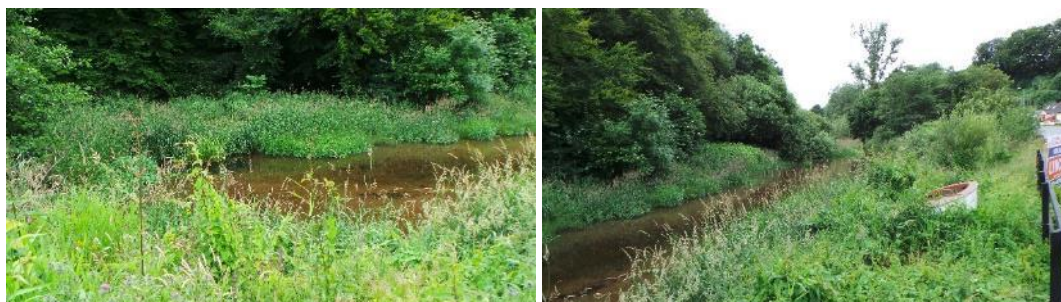
A.3 C08_700: Silted mill race

The redundant weir (noted above) feeds into the mill race shown in the photographs above. This is heavily silted due to the low velocities and limited variation in flow. Limited change is expected in this area following the construction of the new flood defences.

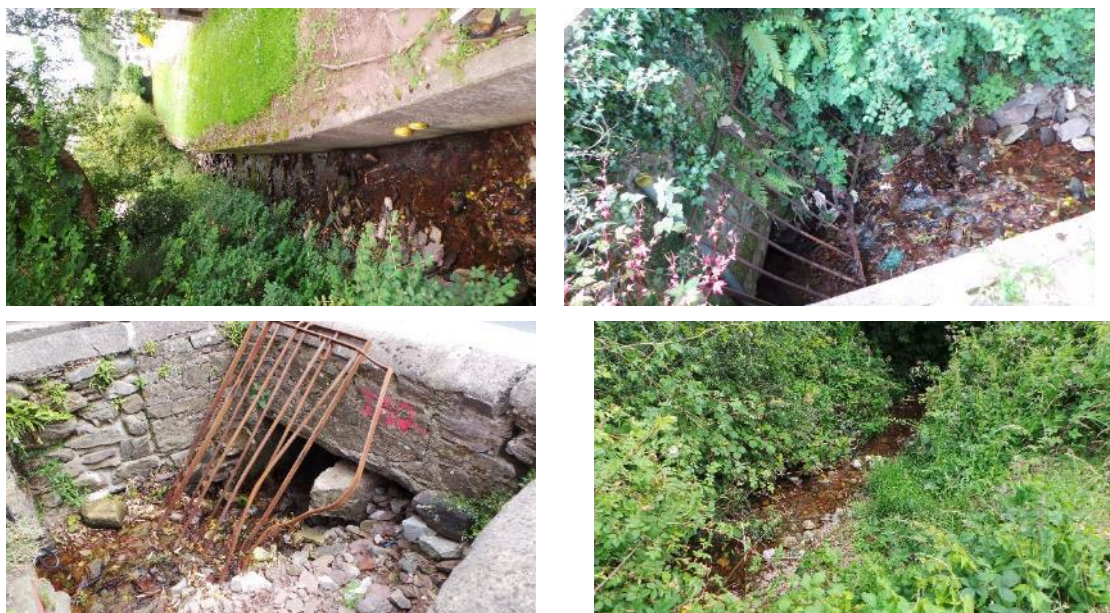
A.4 Cols na Gleann Stream: Replace existing culvert with a new 2m wide by 0.9m high rectangular culvert

The Cols na Gleann Stream is a small steep channel dominated by cobbles and gravels, which appear to readily transported downstream. The channel is very narrow and it is likely that it has been straightened historically. Such modifications act to elevate in channel velocities. Sediment has accumulated upstream of the culvert. Downstream of the culvert the channel gradient reduces and smaller gravels have been deposited (due to the reduced velocities associated with the reduced gradient). Within this area gravels dominate the channel bed and less cobbles are present. The existing culvert appears to disrupt the downstream continuity of sediment due to blockages at the small trash screen and the undersized nature of the bridge.

The proposals at this location should improve sediment continuity downstream. Care will be required to ensure large cobbles do not become trapped against the upstream trash screen (if one is to be constructed) as the high energy conditions will still be present.

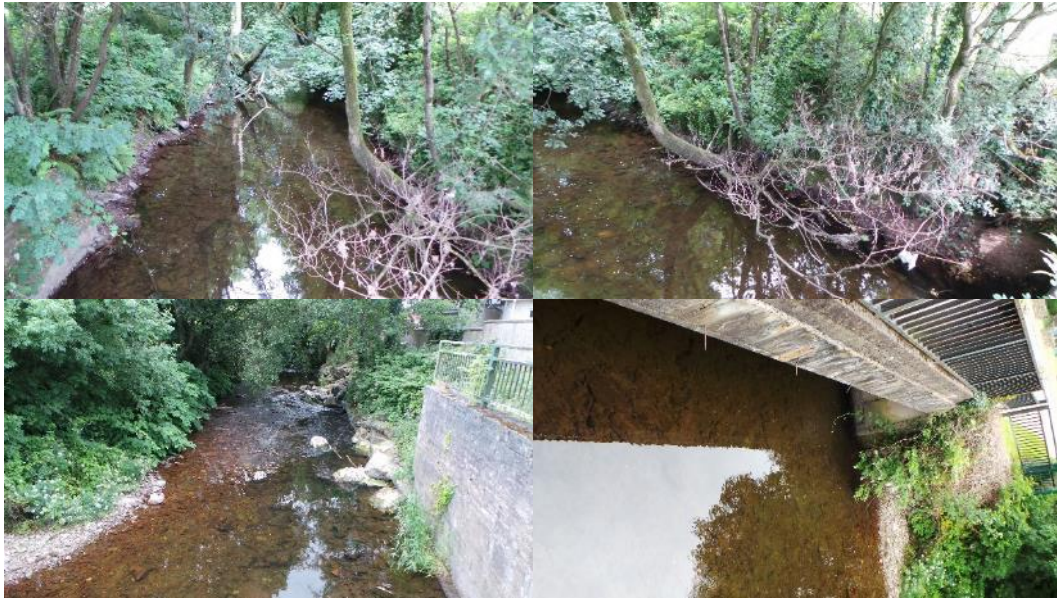
A.5 C01_C01, B02, C02: Proposed flood relief channel and culvert

The existing channel at this location is dominated by cobbles and gravels. The bed is partially armoured (evidenced by the moss over some of the larger cobbles) which suggests limited large sediment delivery. However, site conditions suggest higher velocity flows frequently transport smaller gravels through this reach. The construction of a flood relief channel is unlikely to significantly alter existing morphological conditions. However, the invert of the flood relief channel should be set at a point as to not decrease velocity as this could lead to an increase in deposition if in channel velocities are reduced significantly.

The existing bed material should be maintained and matched where possible. High flows event will be capable of transporting sediment; however several flood events may need to pass through the system before the bed restabilises.

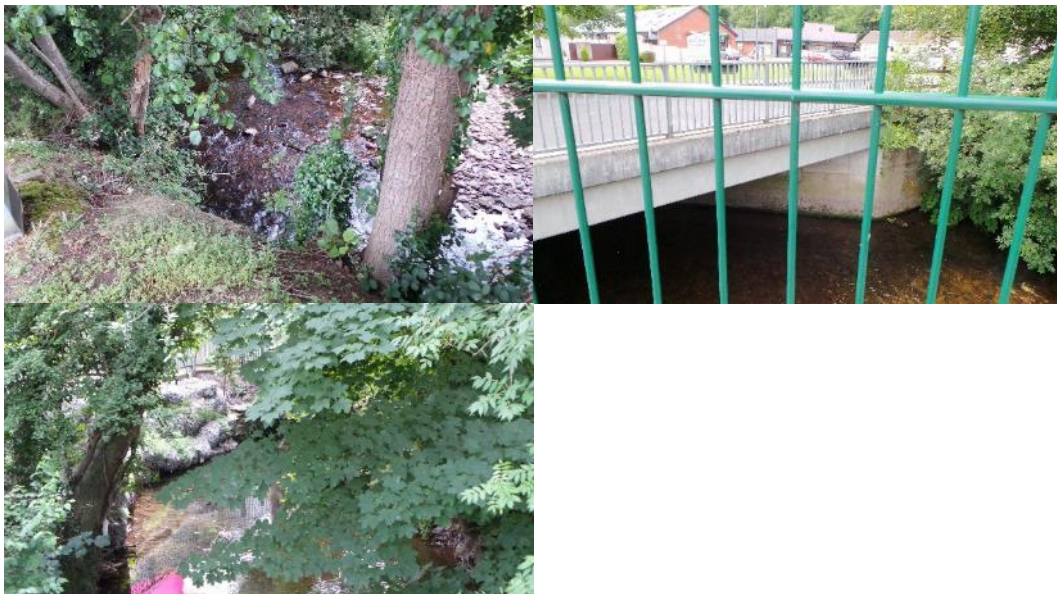
A.6 C01_B03: Replace bridge

The channel at this location is currently over wide which acts to influence morphological processes. As a consequence, depositional zones are noted within this reach. (i.e. the over wide nature of the channel may lead to lower velocities which in turn may encourage deposition). The proposed new

Upstream and downstream of this bridge some channel erosion is evident. In particular, downstream of the bridge, existing gabion basket protection has begun to fail on the outside of the bend. An alternative solution to bank protection is recommended at this location.

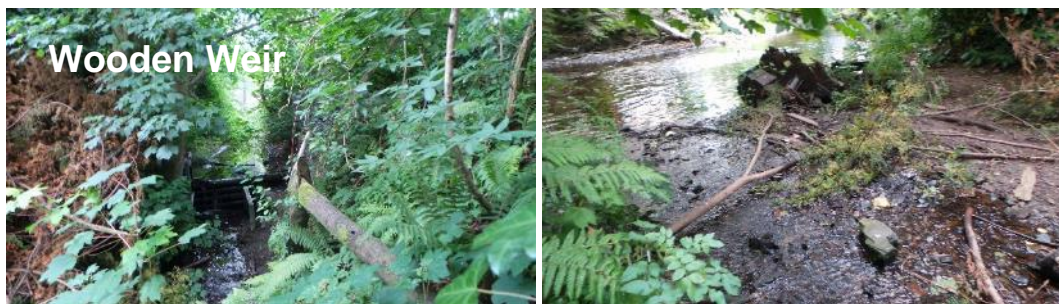
A.7 C06_B01: Replace existing twin 0.4m dia culverts with a new 1.8m wide by 0.9m high rect culvert

No safe access could be sought to see this culvert on the Springmount stream. However, extensive gravels and sands were present downstream. A wooden weir structure is also in place downstream which acts to impound water upstream for an unspecified distance. This appears to have collected a substantial amount of sediment. If this weir fails it could impact the stability of the channel upstream in the short term. Further investigation should be sought to see if this weir influences flow conditions at the upstream culvert.

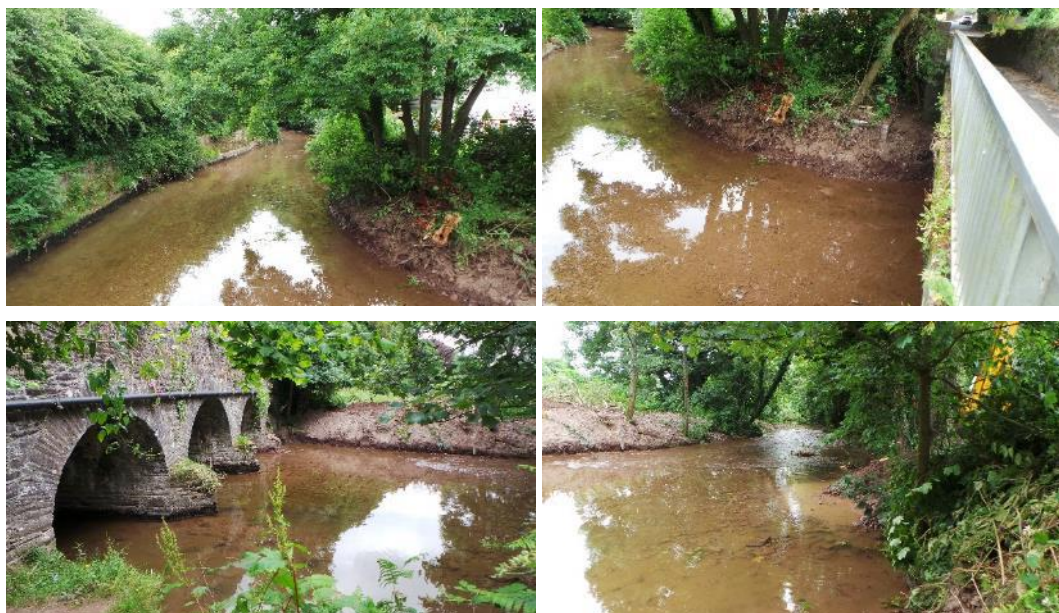
A.8 C01_C03: Bridge arch to be cleared by removing vegetation

Sediment was in the process of being removed from the channel during the site visit on the 03/07/16. Sediment was being removed several hundred metres upstream and downstream of the bridge. Some banks remain steeply profiled and could be subject to erosion until vegetation re-establishes.

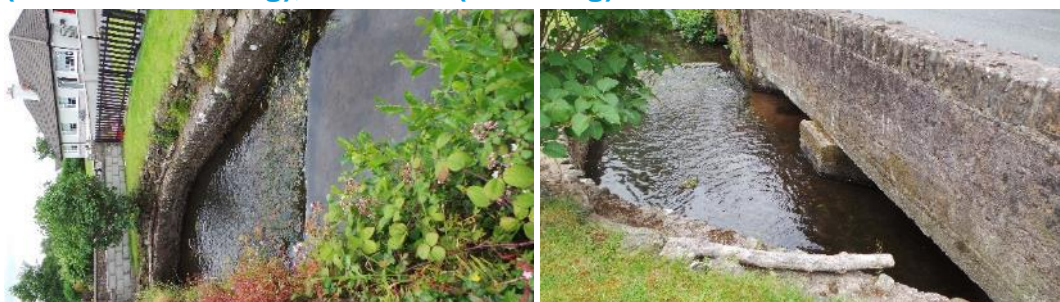
A.9 C09_C01 (channel deepening), C05_B01 (replace culverts), C05_C02 (channel widening), C05_C03 (widening)

Deepening and increasing the culvert size will increase conveyance through the bridge. There will be limited impact on the channel morphology. The weir downstream of the bridge acts to trap some sediment.

The delivery of sediment within this reach appears to be lower than over reaches. This means that the channel may take longer to recover following any in channel works.
