Project Number:	6075	Document Number:	Appendix 7.1	Revision:	09
Project Name:	GLASHABOY FRS	Document Title:	PHOTOMONTAGES	Date:	07 March 2018

- 1.1 The Office of Public Works are undertaking the Glashaboy Flood Relief Scheme. The scheme will include works at a number of locations along the Glashaboy River and its tributaries including Bleach Hill Stream, Cois na Gleann Stream, Springmount Stream, Butlerstown Stream and Glenmore Stream (Figs. 1 and 2). An Environmental Impact Assessment (EIA) is currently being prepared on the scheme. As part of this EIA, the Underwater Archaeological Unit at the Department of Arts Heritage and the Gaeltacht were consulted and they recommended archaeological wading and metal detector surveys at a number of locations where works are proposed for the scheme in order to assess the archaeological potential of the watercourses and their environs.

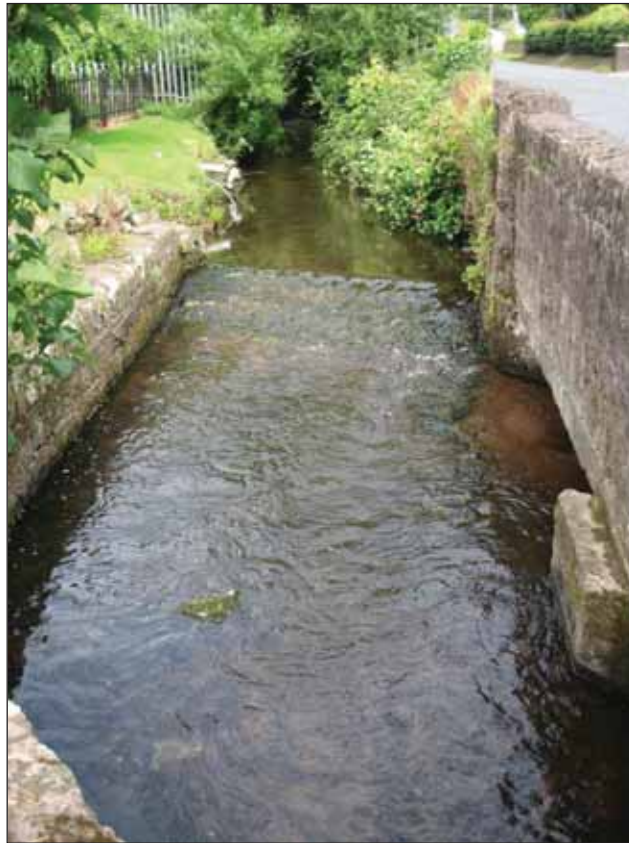
The eastern section of the stream was very clean with some modern pipes along the northern bank. The western section contained some modern rubbish including metal pipes and plastic rubbish. No archaeological features or finds were noted.

**Plate 5:** Glenmore Stream eastern section with garden to north (left) and Brooklodge Grove Road to south (right). Opening to the rectangular culverted channels are visible at bottom right, looking east

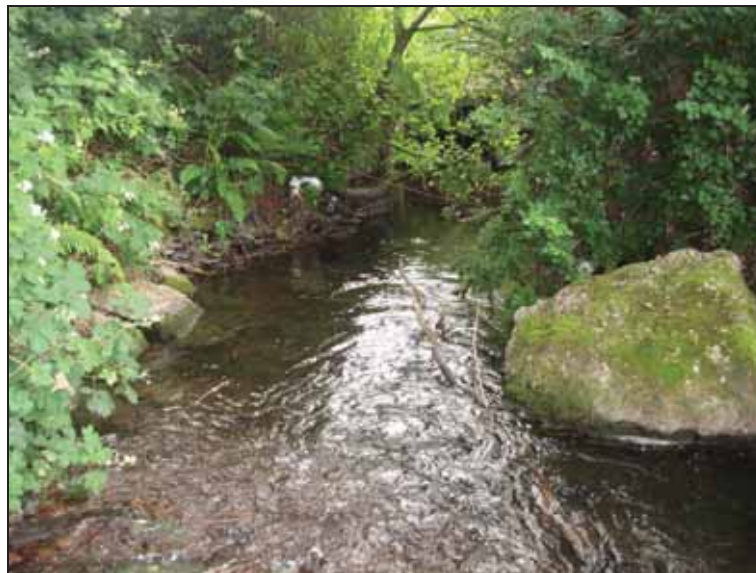
**Plate 10:** Glenmore Stream western section, looking west

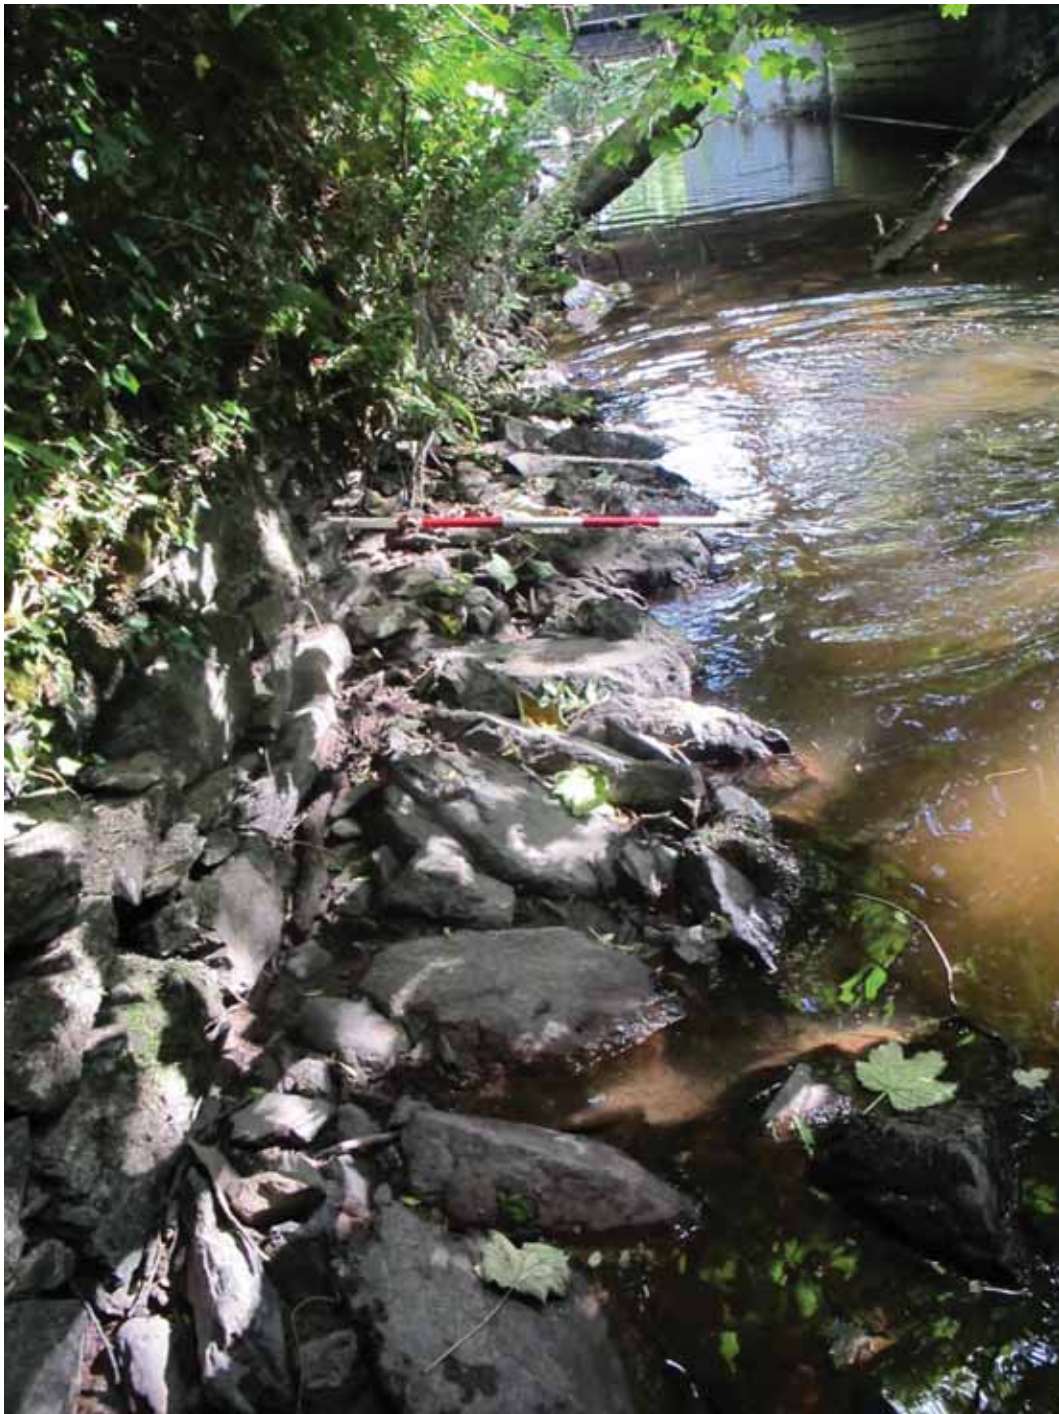
A riverbank revetment wall extends along most of Survey Area 3 (Fig. 9) albeit with sections missing in places exposing an earthen bank. In other sections it is replaced in an *ad hoc* fashion with various modern wall types including gabion walls, concrete walls or simply revetted with railway sleepers. It is of random rubble construction. An average height of 1.7m was recorded. At the northern limits of the survey a section of stone paving measuring 7.4m x 1.0m is present at the base of the wall (Plate 24 & 25).

**Plate 24:** View of CHS 08, revetment wall taken from north.

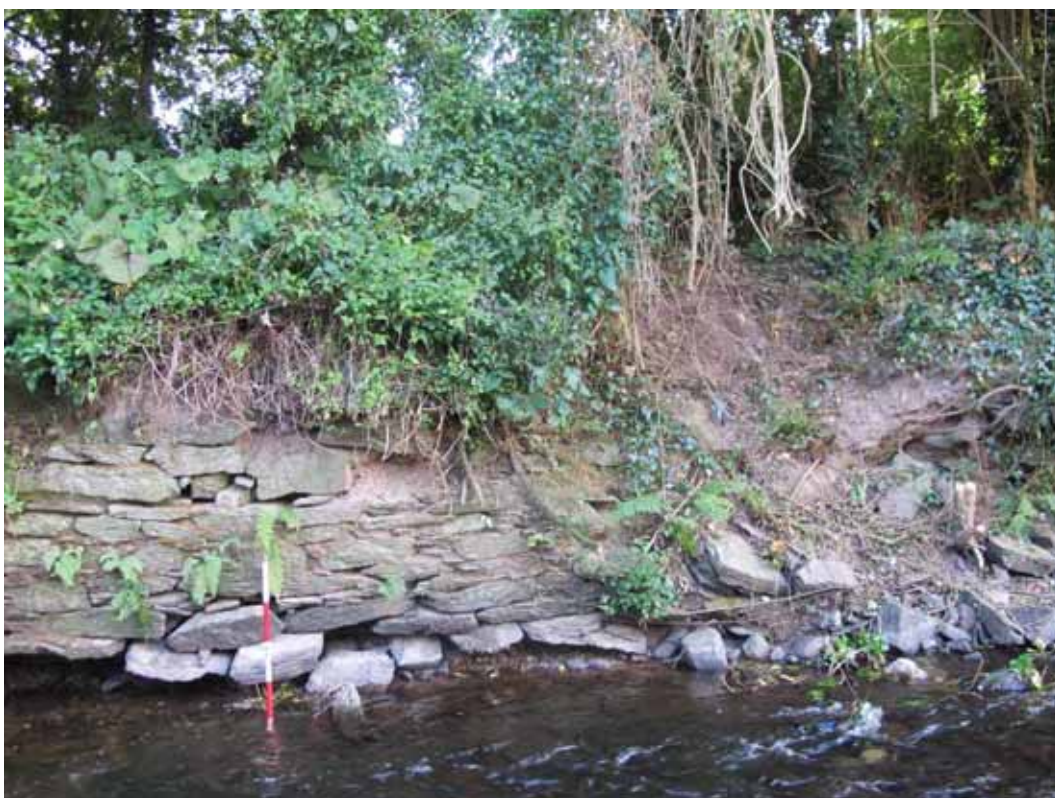
Three sections of the revetment wall on the western bank survive within the study area. The wall is constructed of uncoursed rubble sandstone (Plate 29). It has a max. height of 1.5m. It is in a poor state of preservation with outward bulging and a scour of up to 0.4m noted beneath the wall.

**Plate 29:** View of CHS 09, taken from north.

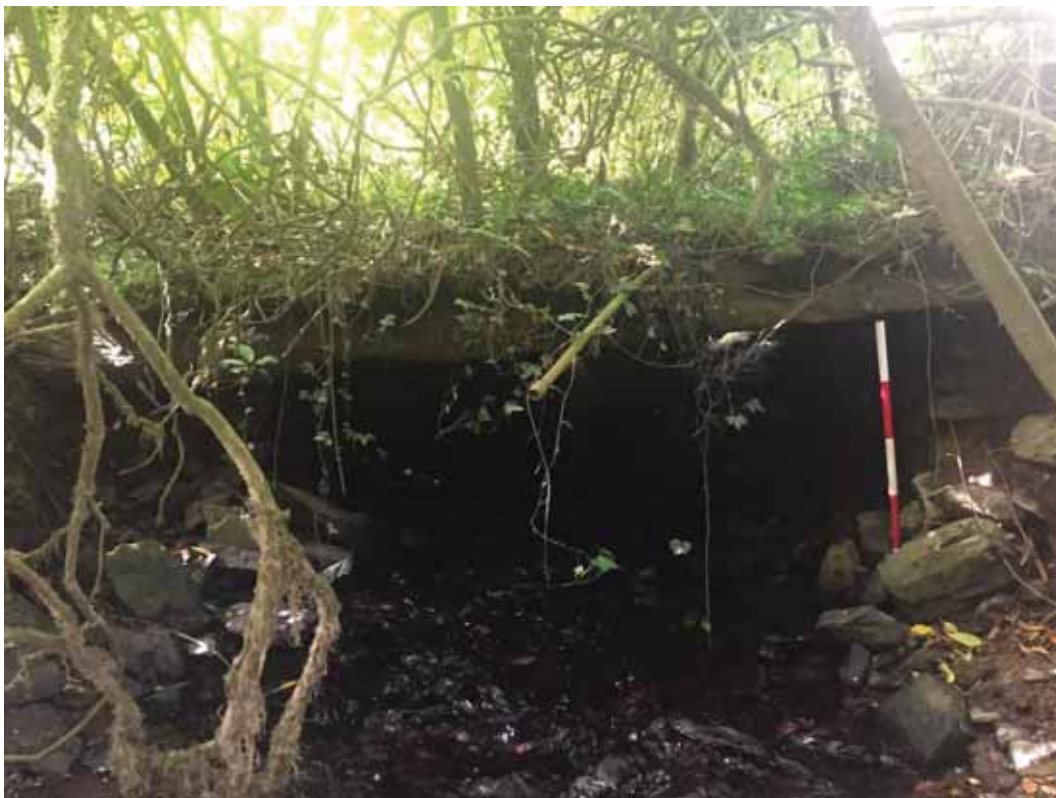
arch of twenty-six voussoirs (Plate 40). To the west of this is a crudely constructed wooden bridge spanning the second race (Plate 41). This is a twin culvert constructed of random rubble stone capped with large stone lintels (plates 42 & 43). Modern repairs comprising concrete support propping have been inserted at the exit, and the eastern channel of the twin culvert has collapsed.

**Plate 41:** View of CHS 13, from south.

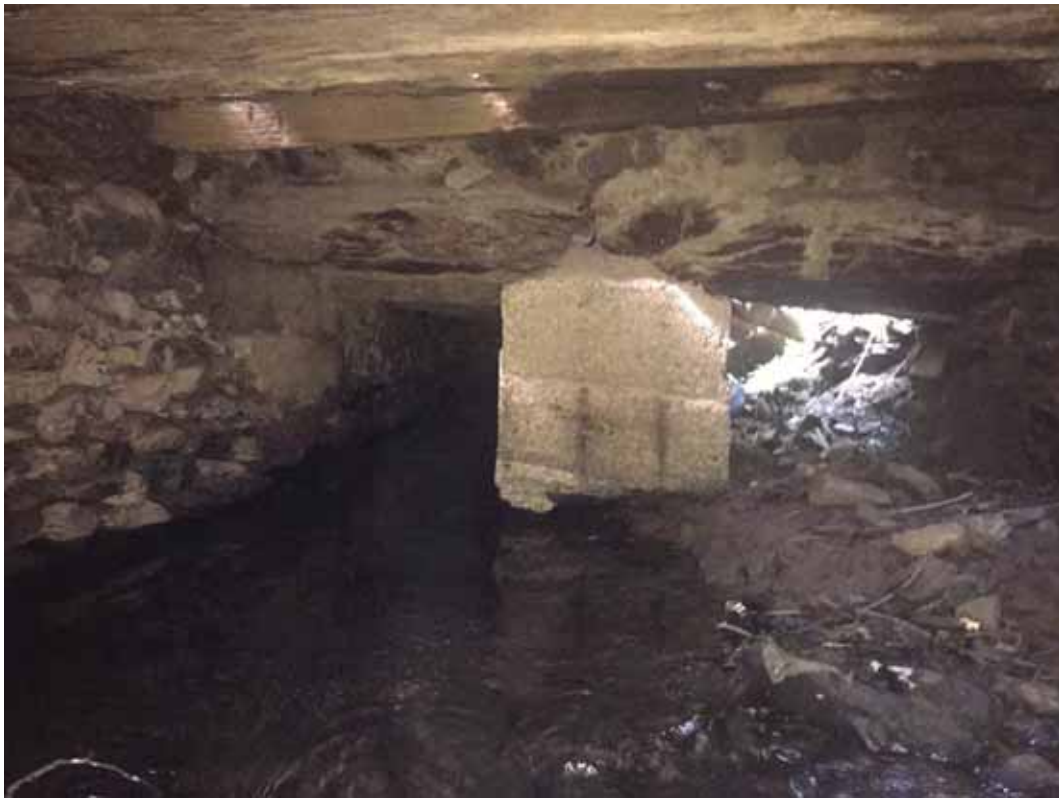
**Plate 42:** View of CHS 13, from south.

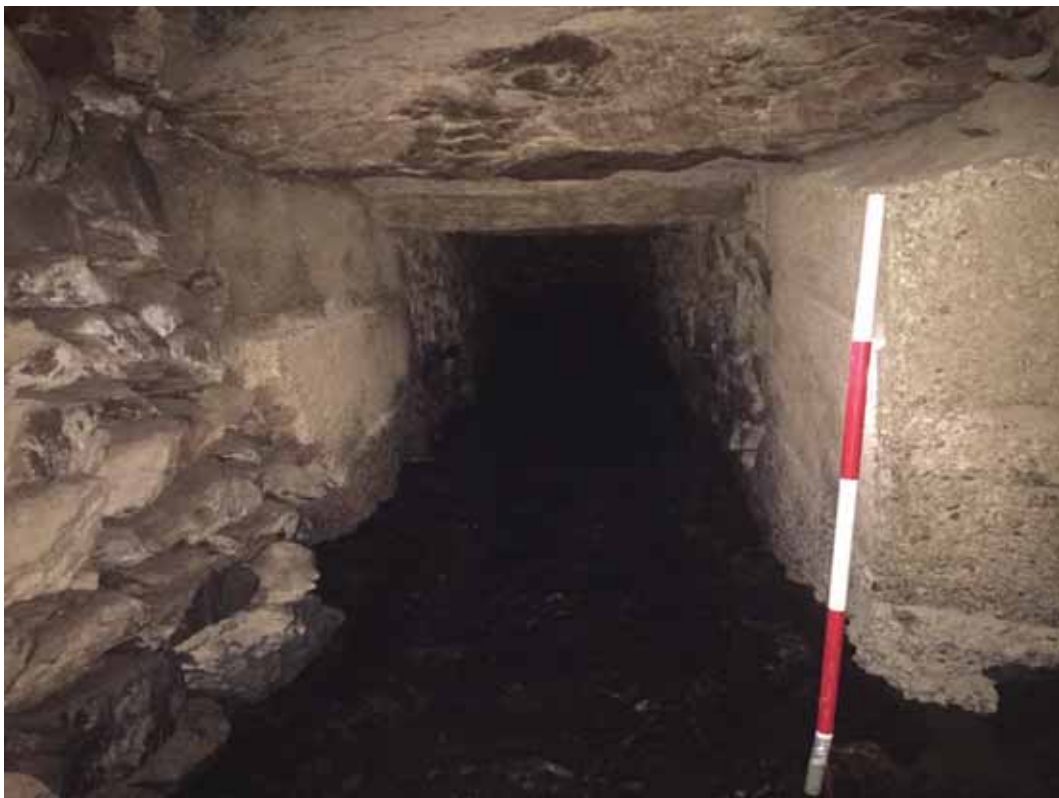
**Plate 43:** View of CHS 13, from south.

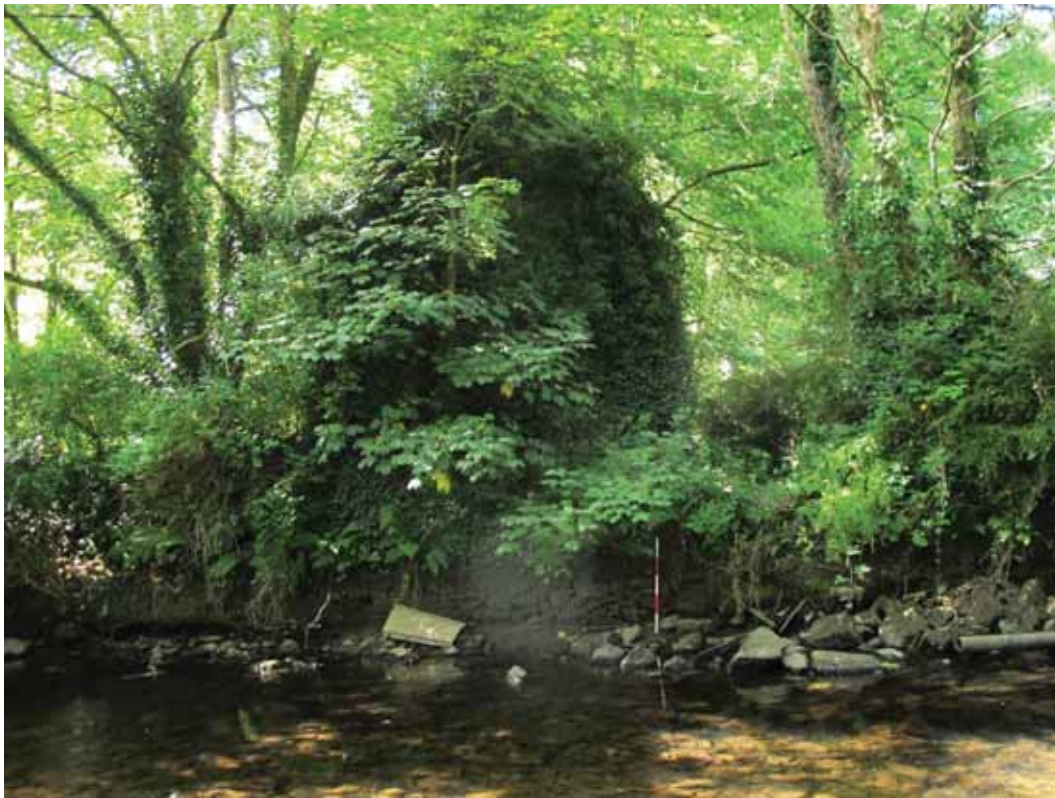
The intra-riverine survey noted a revetment wall manifest on the east bank of the river at the northern limits of Survey Area 5 (Fig.15). It is constructed of generally small uncoursed rubble sandstone that vary in size between 0.2m x 0.2m to 0.3m x 0.4. The revetment wall survives to a height of 1.3m and appears to have originally extended along the entire length of the survey area but has collapsed towards the southern limits.

**Plate 44:** View of CHS 15, revetment wall, taken from southeast.

Licensed archaeological monitoring should be undertaken by an experienced underwater archaeologist with regard to the proposed construction works C01\_L08 & C01-P02.

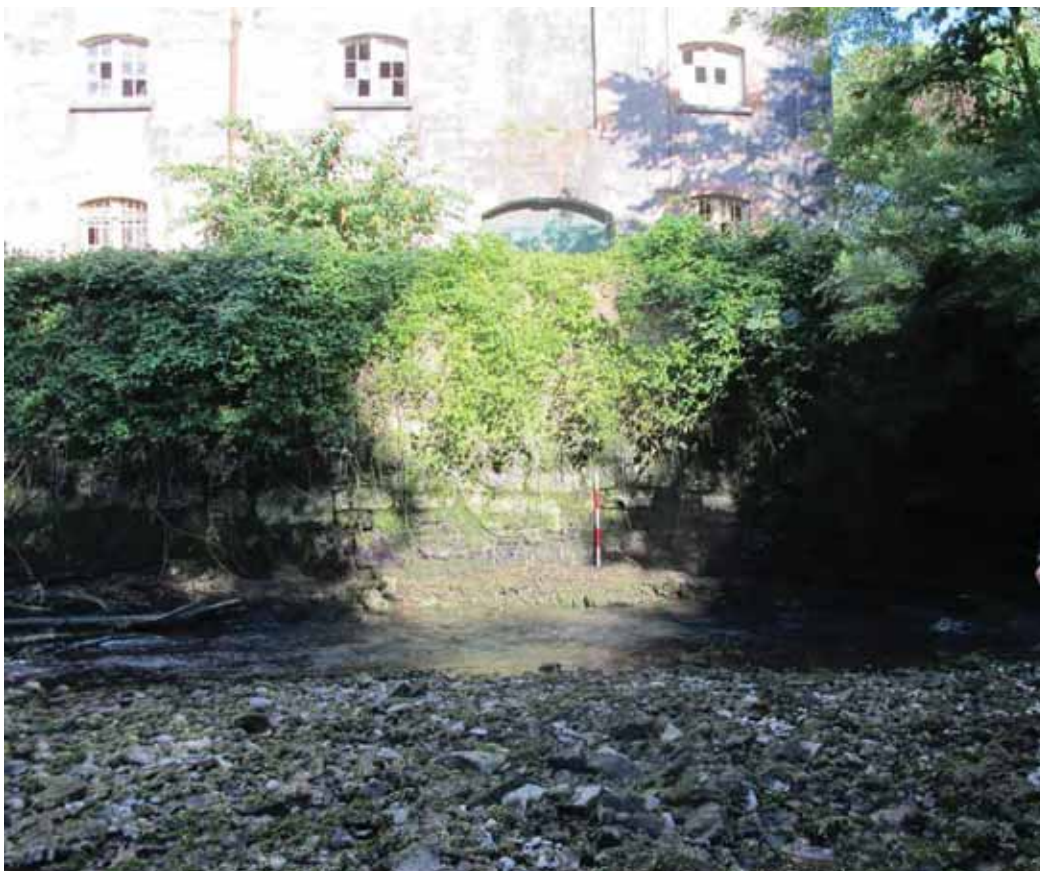
A revetment wall is visible on the east bank between the mill building and the tail race (Fig. 18, Plate 46). Due to an accumulation of sediment and dense vegetation it was not possible to examine the northern limits of this wall. It is possible that the wall continues further upstream concealed behind collapsed bank material. The wall is a substantial structure measuring up to 3.0m in height. It is constructed of dressed limestone blocks measuring from 0.30m x 0.30m up to 1m x 0.6m. Mortar bonding is visible in places. Tree root damage is particularly noticeable resulting in portions of the wall having completely collapsed as a result (plate 47 & 48). Three sections of the wall, measuring between 3.8 and 4.5m in width have been repaired with concrete.

**Plate 46:** View of CHS 17, revetment wall, taken from west.

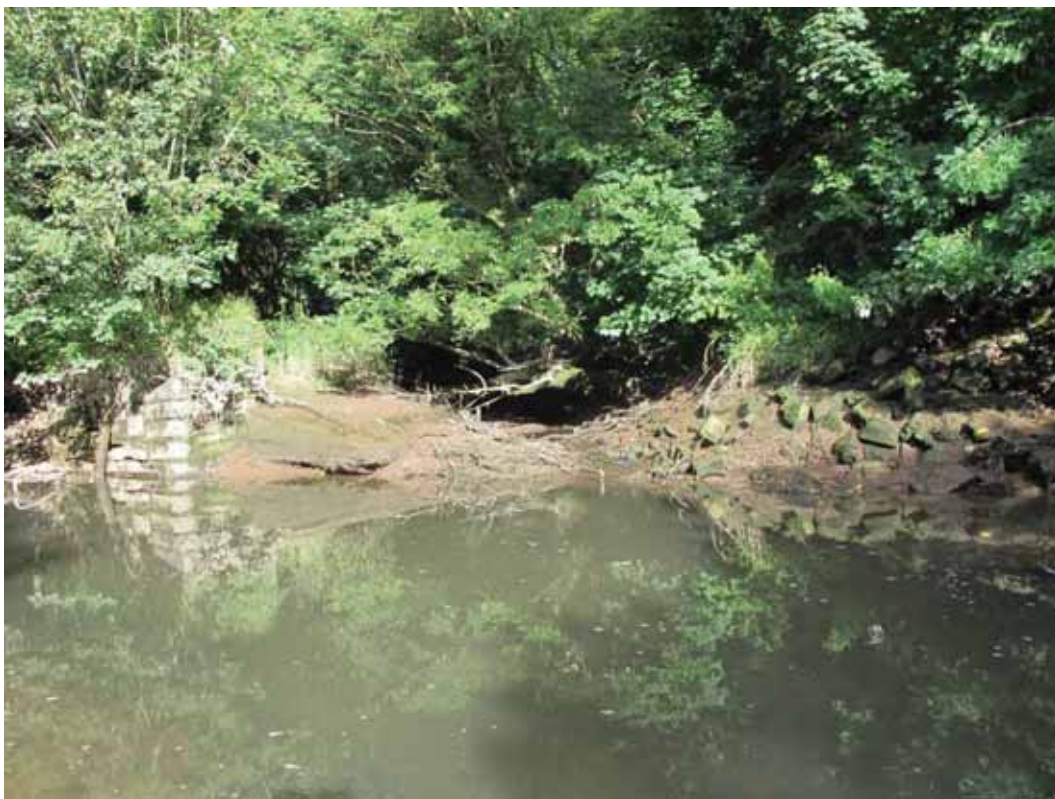
The tailrace for the Fountains Mill discharges into the river on a bend at the end of revetment wall CHS 17 (plate 49). The original exit point for the tailrace has been modified. A concrete slip supports /abuts the end of the revetment wall. The current concrete slip structure is most likely a replacement of an earlier 19<sup>th</sup> century slip. A Boat House shown on the 2<sup>nd</sup> Edition OS map, may have served the mill and indeed a nearby recorded Limekiln, CO075-002002. The south-eastern bank of the race has collapsed and now consists of mud with a large quantity of tumbled stone of which some are dressed limestone (Plate 50).

**Plate 49:** View of CHS 18, tailrace, taken from west.

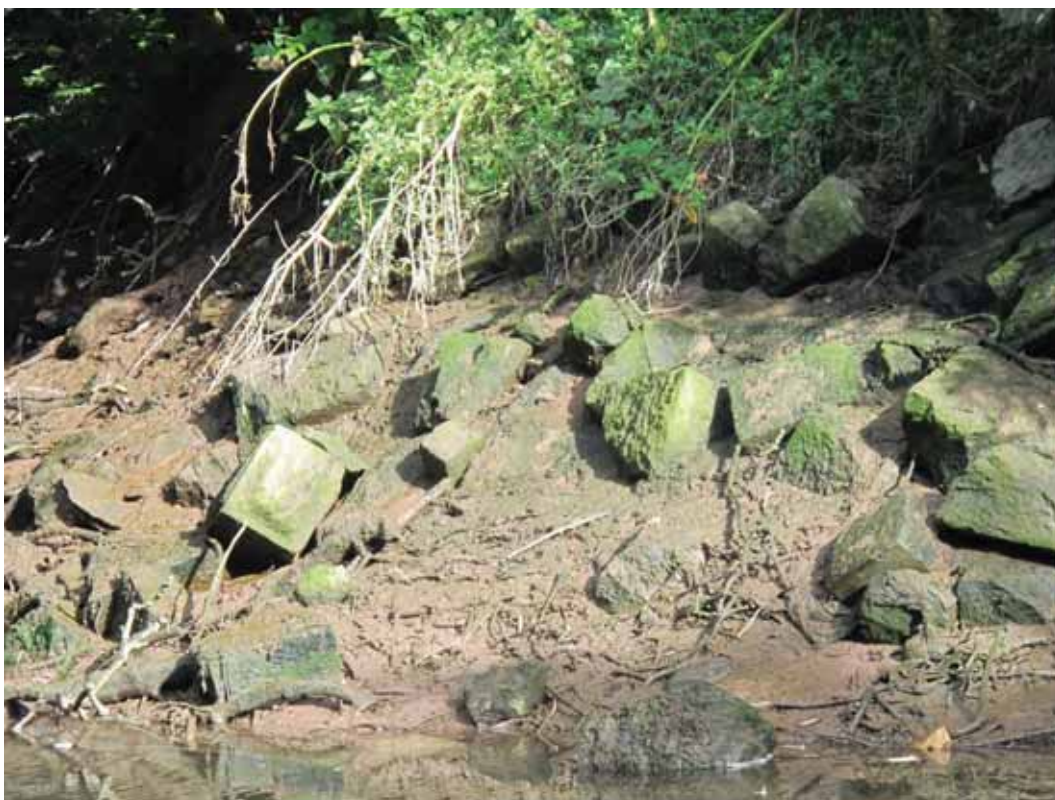
**Plate 50:** View of CHS 18, tailrace taken from southwest.

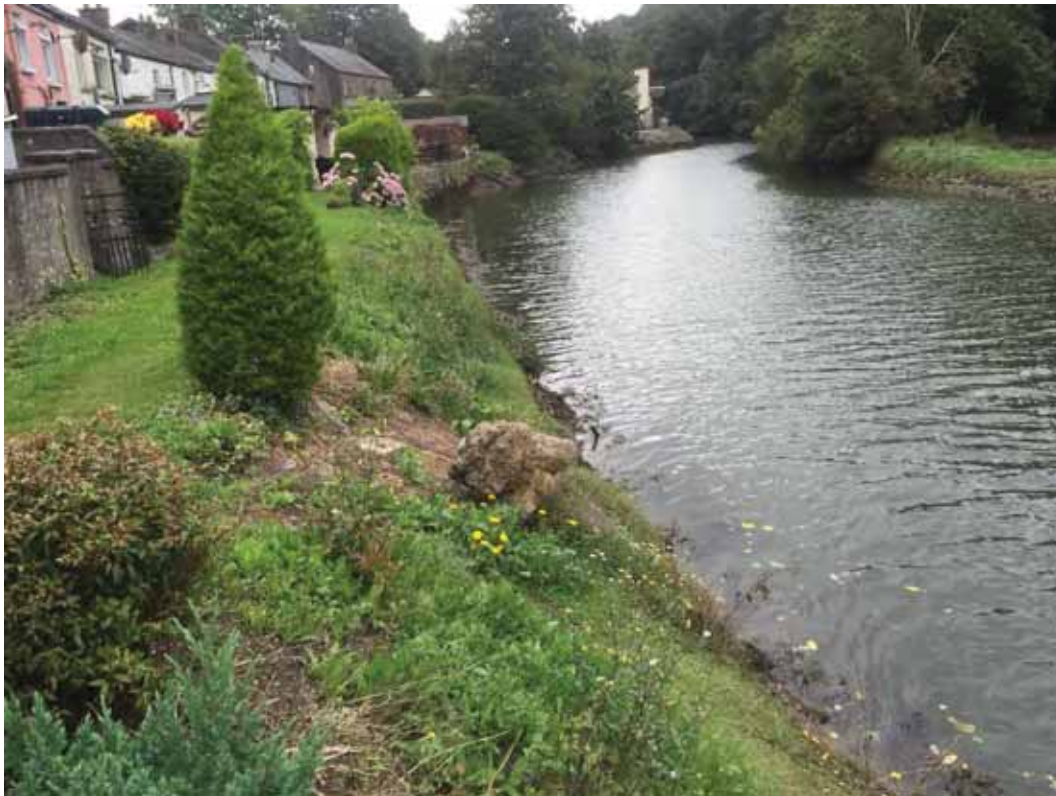
**Plate 53:** View of CHS 20 , Sand Quay.

Licensed archaeological testing should be undertaken at Sand Quay. Further mitigation may be required based on the results of this archaeological testing.
