Appendix 6.2

Geomorphology Report

Hydromorphic audit of the River Glashaboy

November 2016

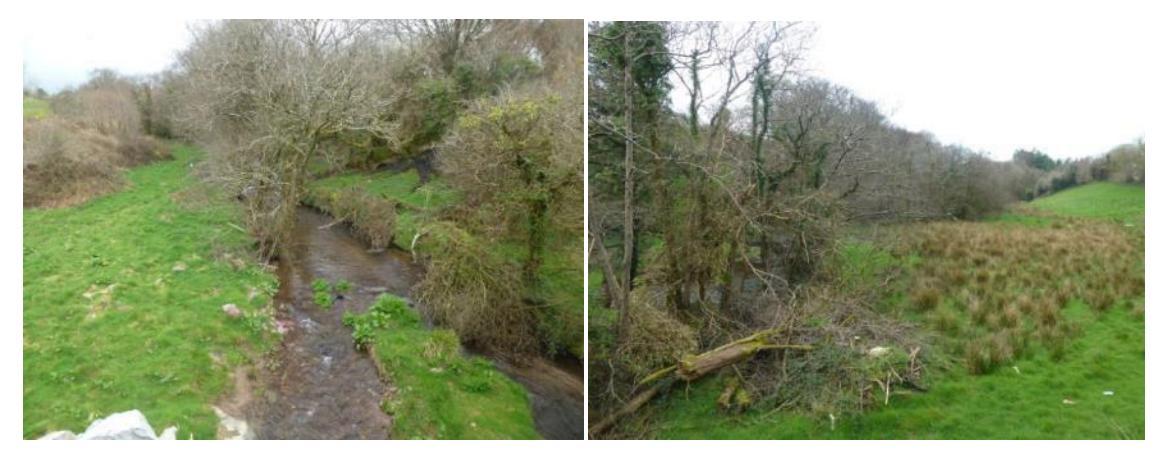
Figure 3-5 Upstream of Ballyskerdane Bridge (Point 4)

Stable vegetated bars were common throughout the reach (Figure 3-5) along with small pockets of fine sediment deposition along the lateral edges of the channel, mainly from localised bank erosion. Small areas of deposition like this are often an indication of the channel naturally attempting to narrow as a result of historic intervention, such as over widening. Several low weirs exist (see example in Figure 3-2), which cause limited upstream impoundment, but act to cause increased fine sediment deposition within their impoundment zones. Limited evidence was noted of weirs restricting movement of gravels.

Opportunities exist to improve connection through embankment removal and re-grading (Figure 3-5). This should act to improve floodplain storage in these upper reaches and act to reduce downstream flood risk.

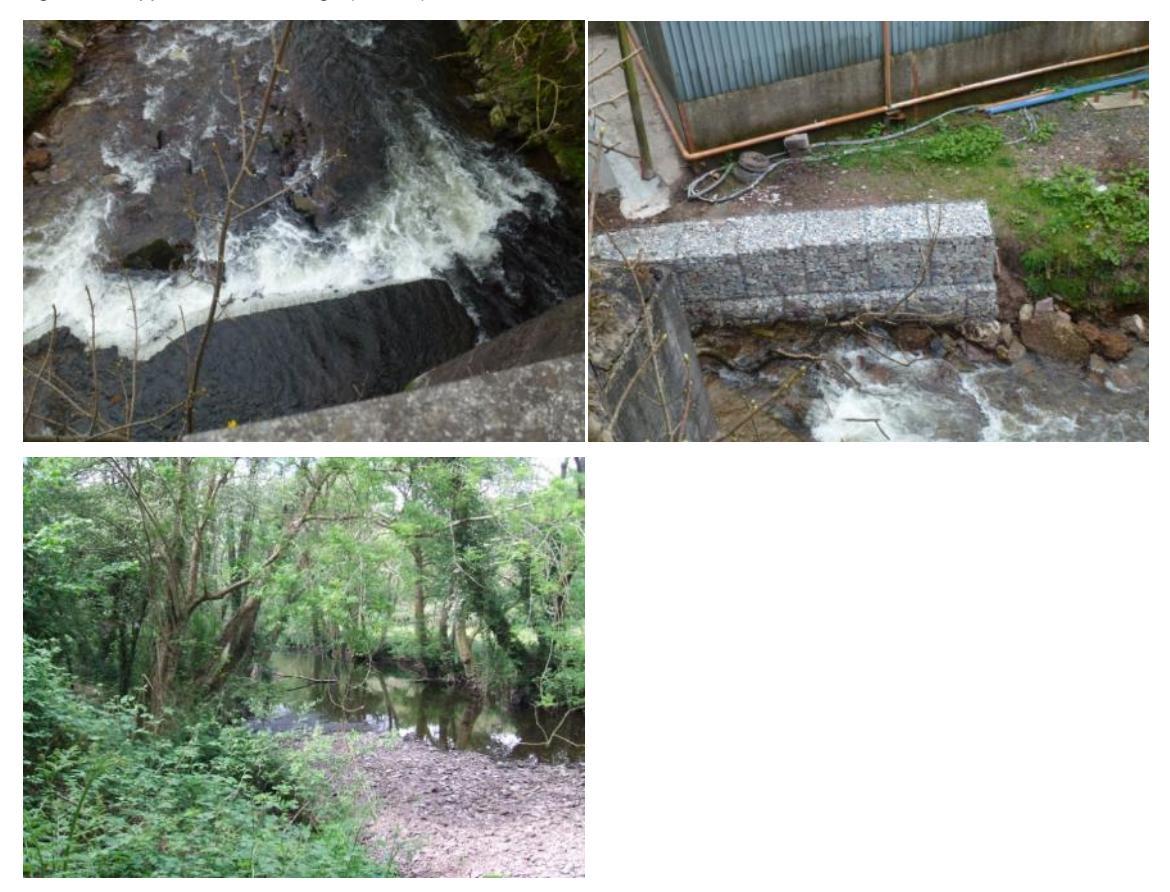
Figure 3-6 Upper Glanmire Bridge (Point 5)

In the reach between Upper Glanmire Bridge and Knocknahorgan the river valley narrows which results in a confined floodplain. At Upper Glanmire Bridge a weir is leading to local bank erosion (Figure 3-6), due to the direction of flows passing under the bridge. Banks have been reinforced using gabion baskets, however, in the long term the river may undercut these baskets.

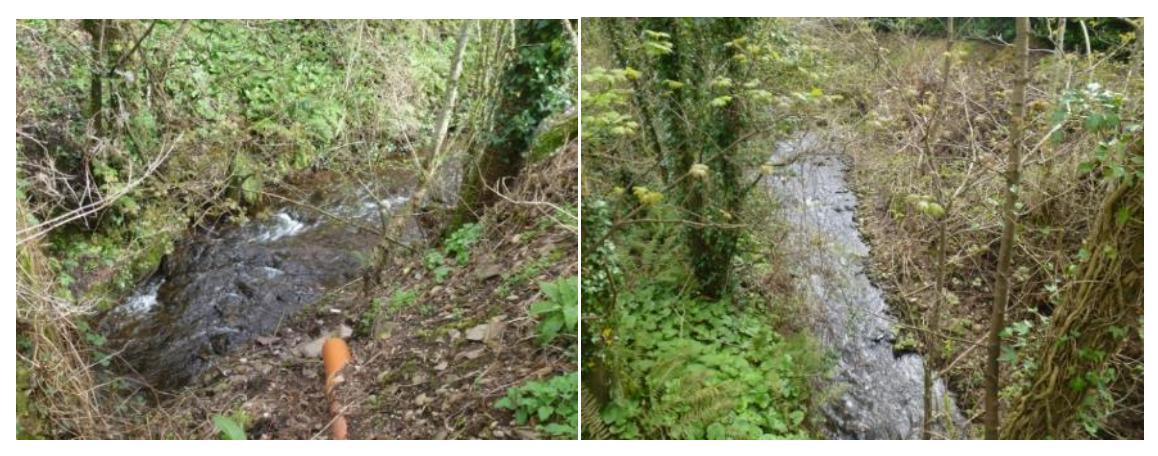
Figure 3-7 Knocknahorgan tributary (Point 6)

Downstream of Upper Glanmire Bridge, flow energy in the channel reduces and areas of gravel and small cobble deposition occur (sizes of gravels range from 4cm to 40cm). Gravel splays occur at tributary confluence points (Figure 3-6) along this section, suggesting an active supply of gravels is present from the steep tributaries joining the river (Figure 3-7).

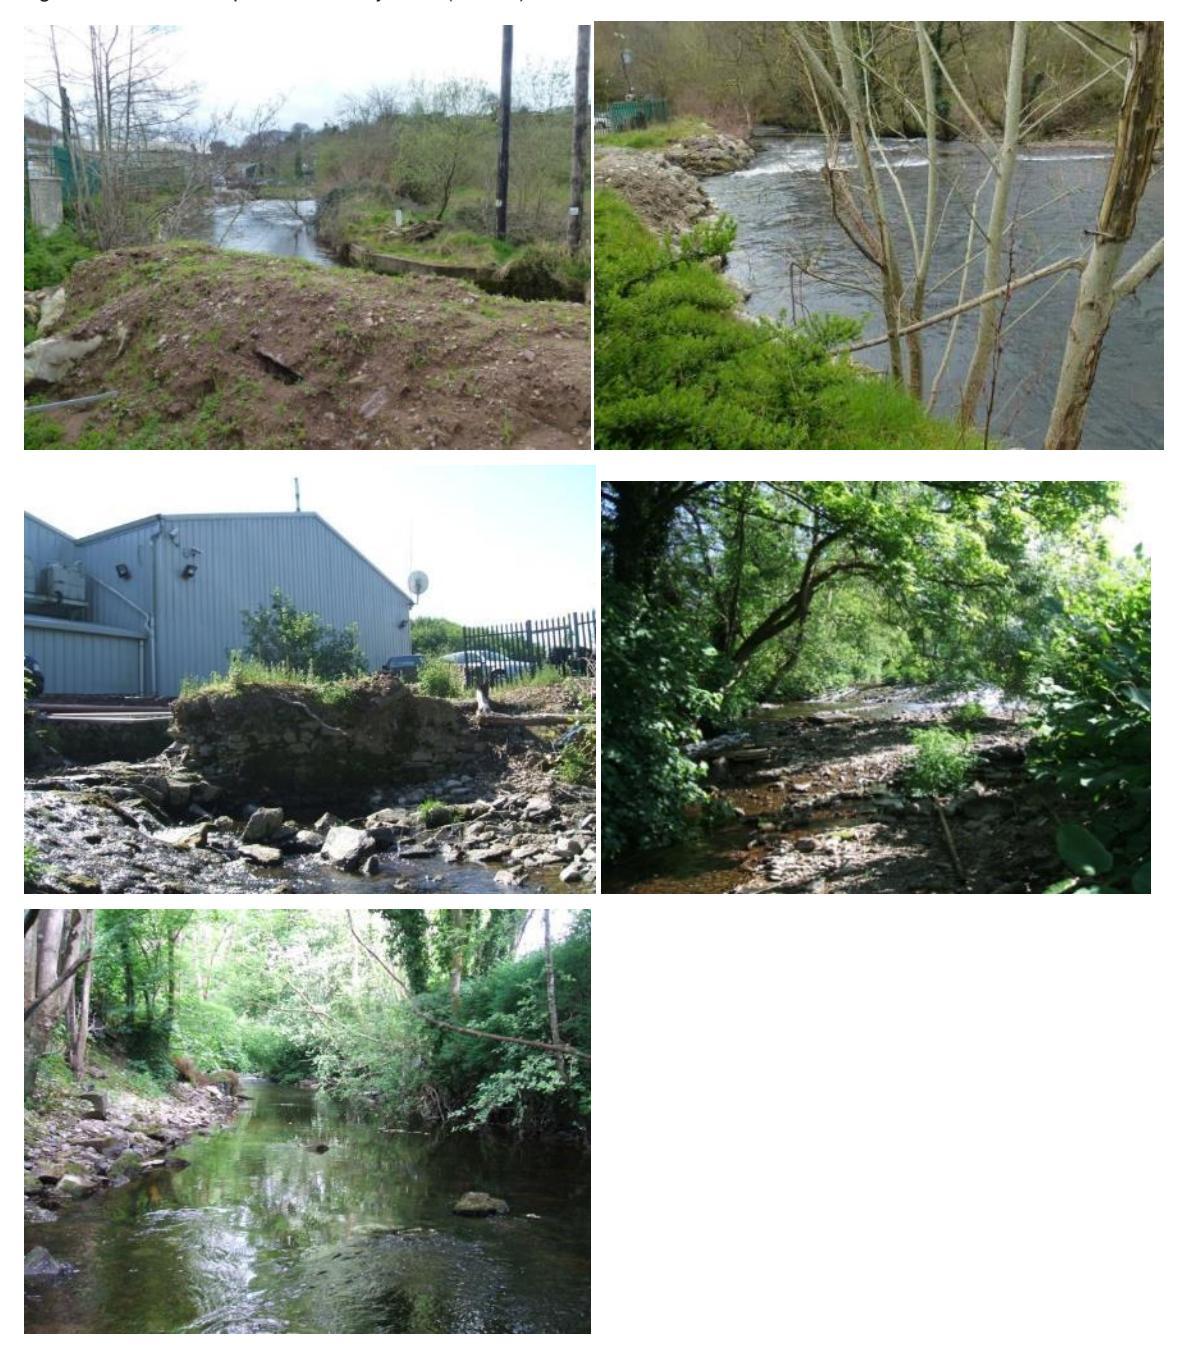
Figure 3-10 Channel upstream of Sallybrook (Point 8)

As the channel approaches Sallybrook the valley widens and becomes less confined. The wider floodplain along this reach has been developed / built upon which acts to constrict the channel. In some areas informal flood embankments have been constructed. In other areas active bank erosion is occurring as the channel attempts to naturally adjust within is confined channel. This is exacerbated by the higher energies during flood conditions as a result of the channel constriction. Hard measures, such as walls have been constructed to reduce the erosional impact of the river (particularly on the outside of bends) and some of these are now failing (such as adjacent to the petrol station). The erosion of banks acts as a strong sediment supply of gravels and fine materials. Deposition is also common through this reach, with several gravel bars (which are unvegetated, signalling frequent movement) being present. However, in the lower portions of the reach the channel becomes incised as a result of these structures the channel is disconnected by over 1m from the floodplain (due to the channel eroding downwards in an attempt to adjust its bed gradient) and deposition is minimal, due to floodplain disconnection and high in channel energy levels. The channel in this lower section is dominated by coarser cobbles.

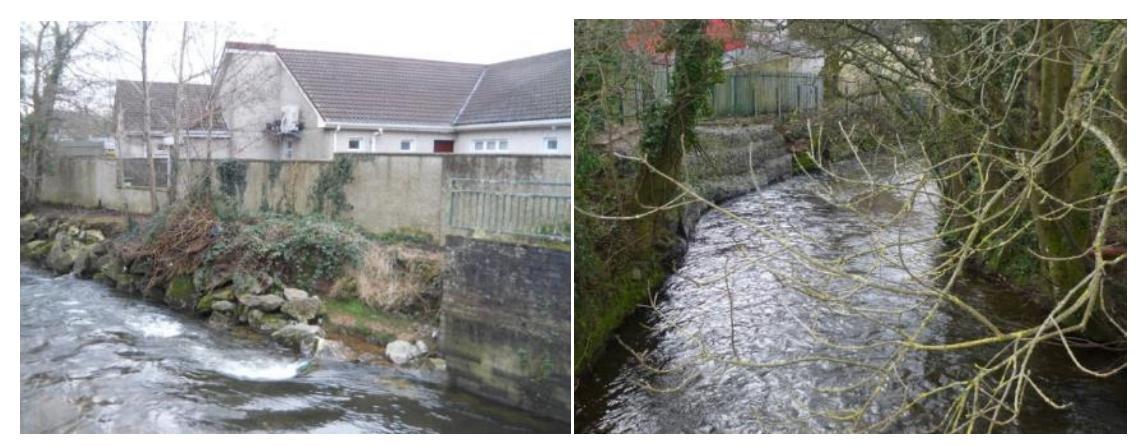
Figure 3-13 Adjacent to the Glanmire shopping centre (Point 10a)

At the Glanmire shopping centre several areas of bank instability exist (Figure 3-13 and Figure 3-14). The channel at this point is confined and relatively narrow compared to reaches upstream. There is limited deposition due to the steepness in some sections and disruption from upstream to the sediment transport process. The channel banks are high in most locations due to land raising and embankments. As a result, during flood conditions all energy is concentrated within the channel which is leading to bank erosion and instability. In many places existing bank protection has been undermined and has collapsed into the river. This section appears to be starved of sediment, suggesting upstream structures, such as the old weirs are influencing inchannel processes. As a result, the channel has excess stream power leading to the erosion processes along the beds and bank. In order to reduce the flood impact and erosion within this section various options could be investigated including flood storage options upstream and also improving the in-channel morphology which is currently degraded, to manage the existing high energy conditions.

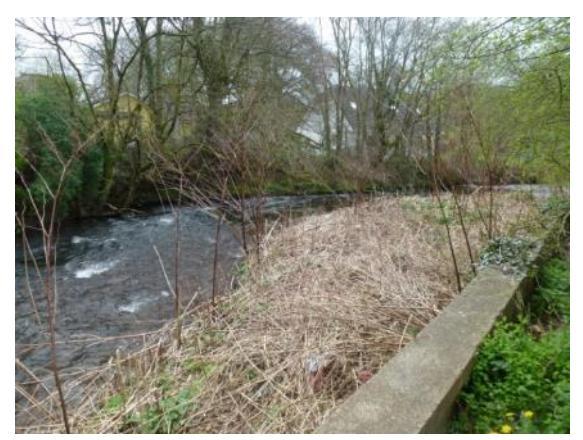
Figure 3-15 Defences downstream of the Glanmire shopping centre, adjacent to the housing estate (Point 11)

Downstream of the shopping centre the channel widens slightly. Flood defences exist, which protect an adjacent housing estate. The defences act as a constraint to the channel in terms of its floodplain connection. The wider nature (Figure 3-15) of the channel here has allowed for the

deposition of some sediment (dominated by fines). In the majority of cases the depositional features are vegetated which suggests that the channel has reacted following past intervention (i.e. it has adjusted to a more natural narrow channel), probably as a result of the construction of the flood defences. This indicates that if any future maintenance of this section occurs (such as sediment removal or flood defence improvements) deposition of this nature will continue to occur.

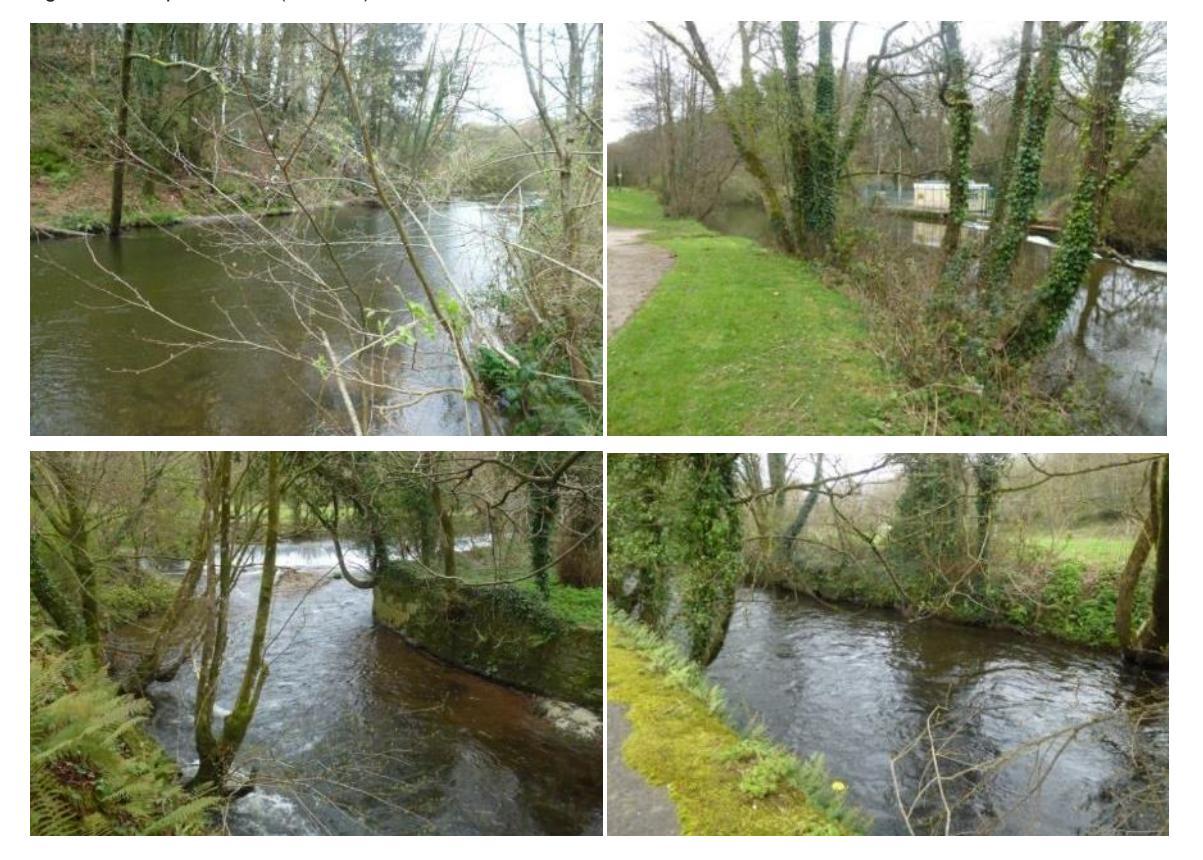
Figure 3-18 Impoundment (Point 14)

In the downstream section of the park a weir exists, which historically was used to feed a mill leat (which is still active). This causes upstream impoundment through the park increasing fine sediment deposition (Figure 3-18). Downstream of the weir some minor scour has occurred along

with a small area of gravel deposition, in a classic weir pool morphology. The channel then enters a canalised section with steep walls on both banks which act to prevent any channel migration. As a result, flows within this section have the ability to transport gravels downstream resulting in little deposition apart from coarser sediment at the edges of the channel through this section.

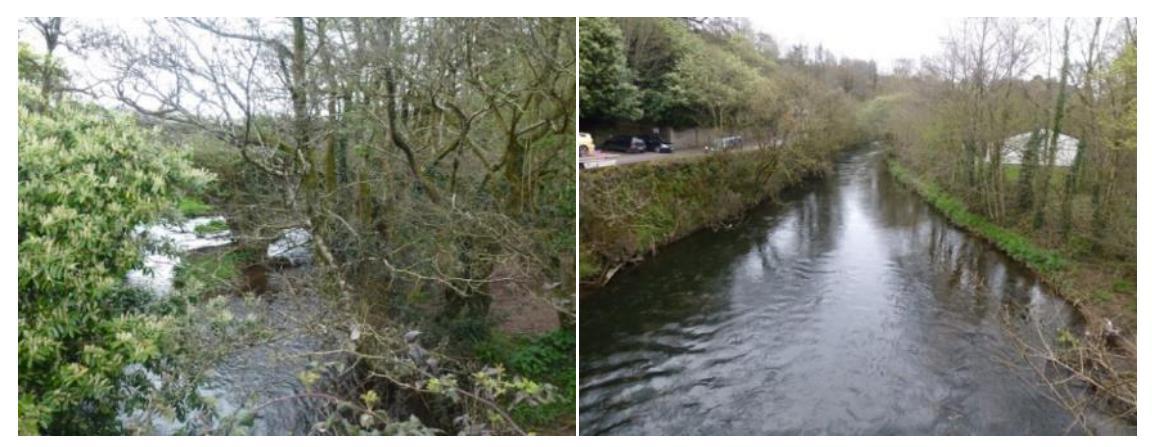
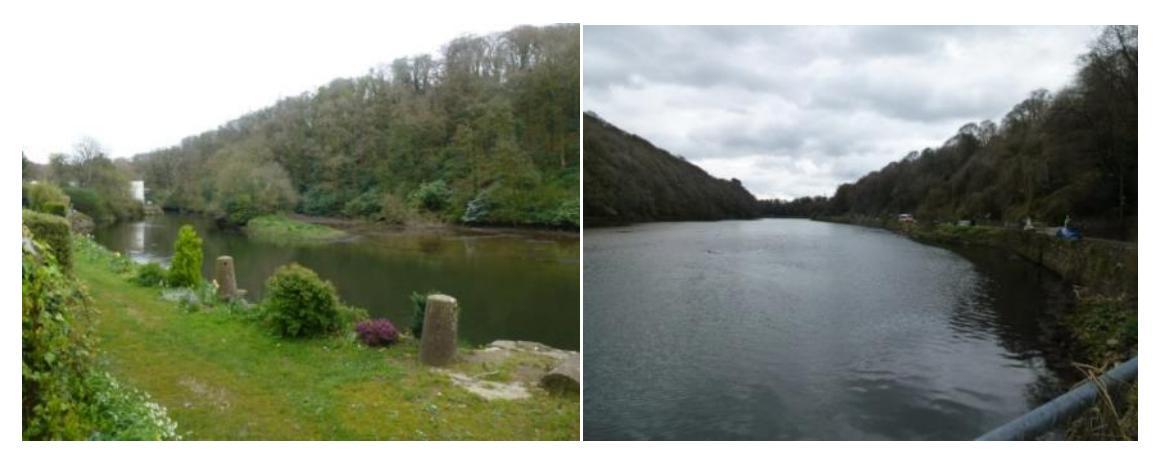
Figure 3-20 Sections downstream of Glanmire

At Glanmire bridge, deposition of gravels is occurring on the left bank (Figure 3-20). Downstream of the bridge the river gradually becomes wider and eventually is influenced by the tidal regime. This influences water levels and flow conditions downstream of Glanmire, resulting in some deposition of tidally derived muds and silts. The deposition of this sediment appears low therefore there is little risk of increased sedimentation in this section.

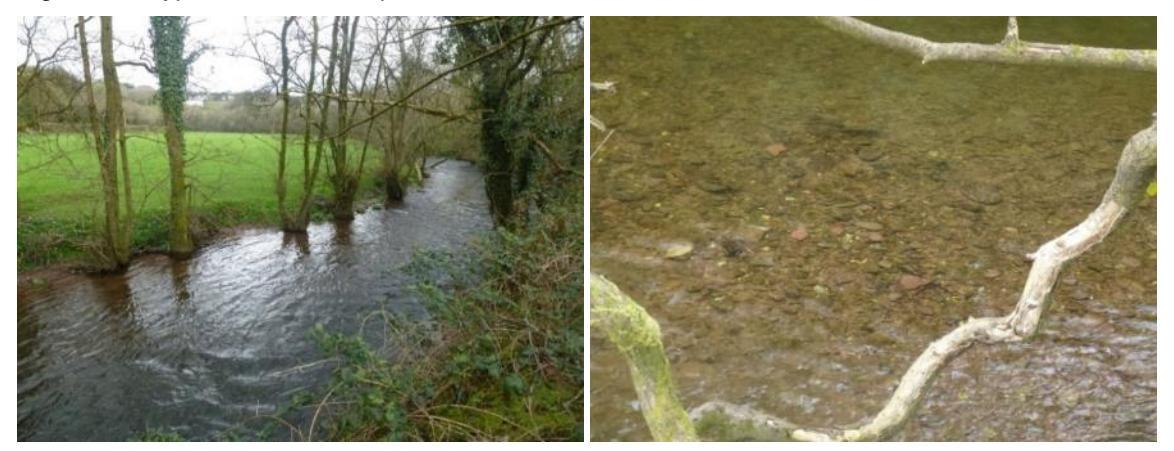
Figure 4-1 Typical conditions upstream of the industrial estate

This is a moderately active section of the channel upstream of the mill leat with a gravel / cobble bed that is partly mobilised during higher flows. The river is disconnected from its floodplain in several locations through this reach as a result of informal flood defences. This elevates inchannel energy levels during higher flows, preventing formation of significant gravel features. Under existing conditions, flow velocities vary between 1.0-2.4m/s for bankfull flows upstream of the mill leat, that are capable of moving medium to large gravels. Downstream of the old mill, the channel is moderately incised and the channel bed is dominated by cobbles. Bankfull flow velocities through this section range from 0.2-2.2m/s.

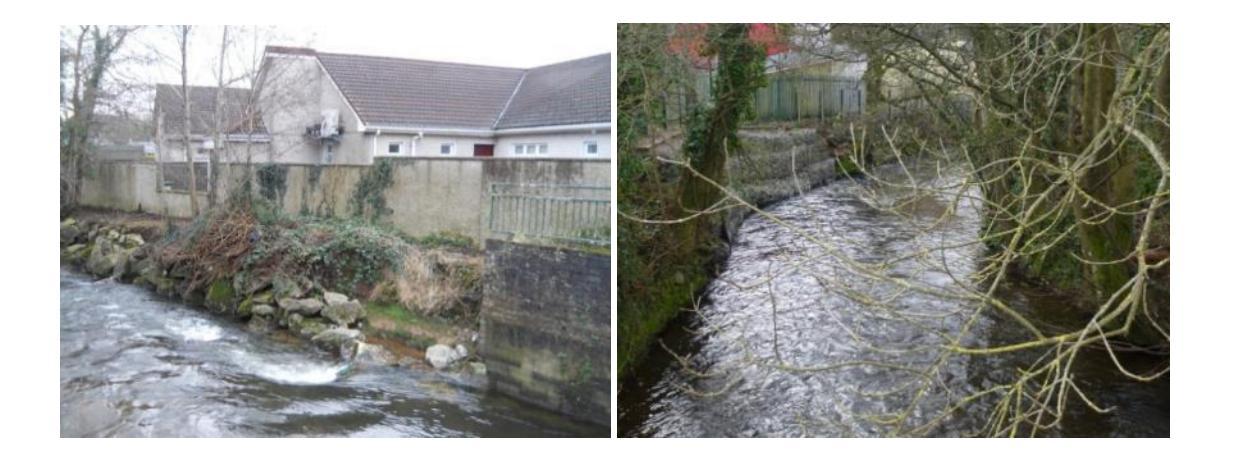
Figure 4-2 Typical conditions adjacent to the shopping centre

This reach is an active section of the river, with bank erosion common. Bank erosion is particularly occurring on the bend upstream of the confluence. There is a decent supply of sediment from upstream and adjoining steep tributaries. Historic straightening, possible dredging, informal flood embankments and bank protection works all act to increase energy levels during the channel during elevated flows as a result of the disconnected floodplain, loss of channel length through straightening and restriction of lateral processes. The channel is also relatively narrow through this section when compared to upstream reaches which again increases in-channel energy levels during elevated flows. This means there are few depositional features on the channel bed despite the strong supply of sediment to the reach.

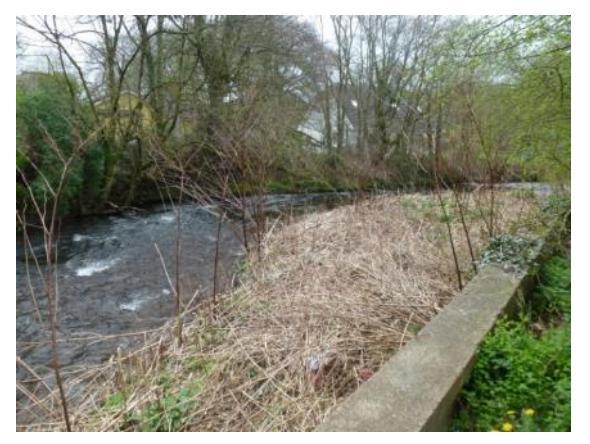
Figure 4-3 Typical conditions adjacent to Meadowbrook Housing Estate

In the section of the river downstream of the shopping centre the channel widens slightly. Flood defences exist on the right bank, which protect an adjacent housing estate. The defences act as a constraint to the channel in terms of its floodplain connection. The wider nature of the channel here has allowed for the deposition of some sediment (dominated by fines). In the majority of cases the depositional features are vegetated which suggests that the channel has reacted following past intervention (i.e. it has adjusted to a more natural narrow channel), probably as a result of the construction of the flood defences and disconnected floodplain over the right bank.

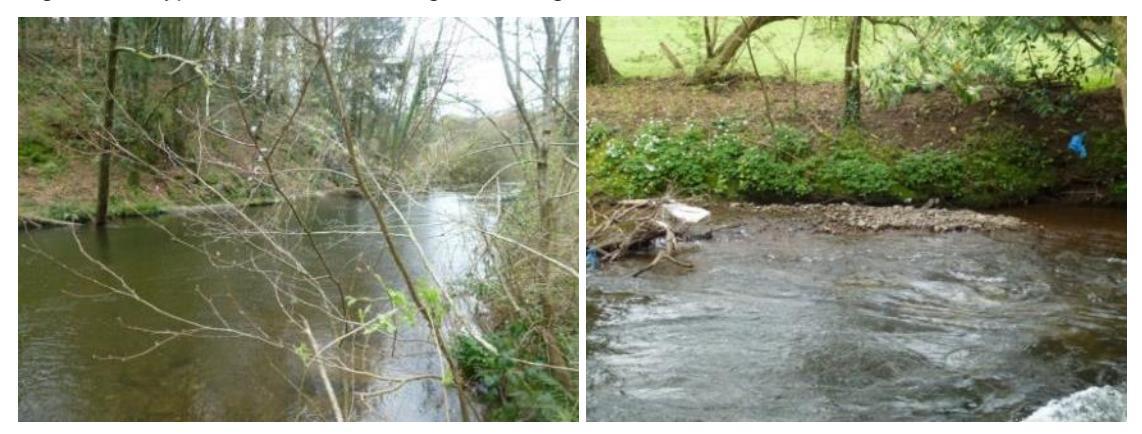
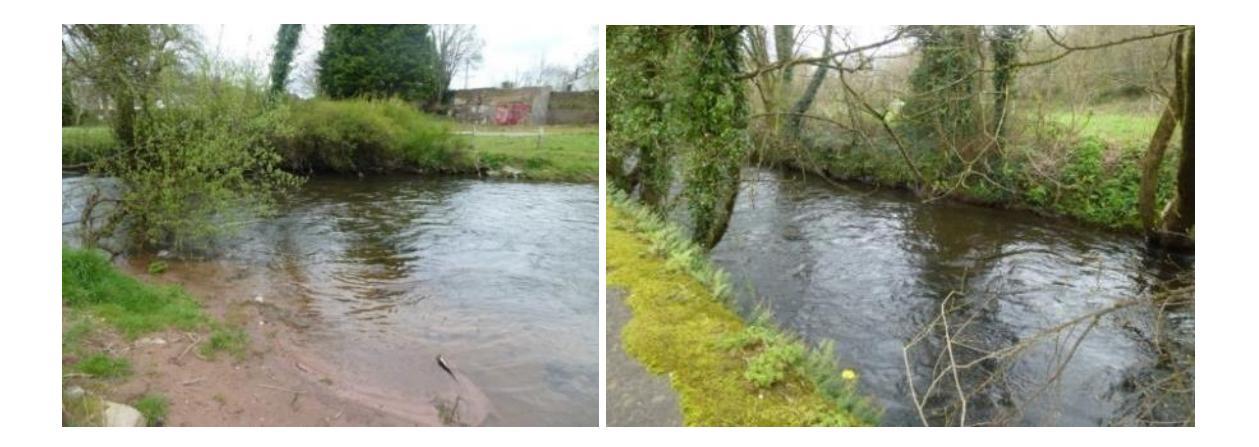
Figure 4-4 Typical conditions through O'Callaghan Park

This reach is characterised by a moderately active channel with some deposition of gravel and fines and some embryonic riffle pool sequencing. There is an impounded section of watercourse within this reach as a result of the large weir downstream, this creates elevated levels of fine sediment deposition on the channel bed. There is some evidence of bank erosion outside of the impounded area.
