Project Number:	6075	Document Number:	Appendix 7.1	Revision:	09
Project Name:	GLASHABOY FRS	Document Title:	PHOTOMONTAGES	Date:	07 March 2018

Appendix 7.2

Summary of relevant
observations and Planning
Objectives from Cork
Development Plan (2014) and
Cobh Municipal District Local
Area Plan (2017)

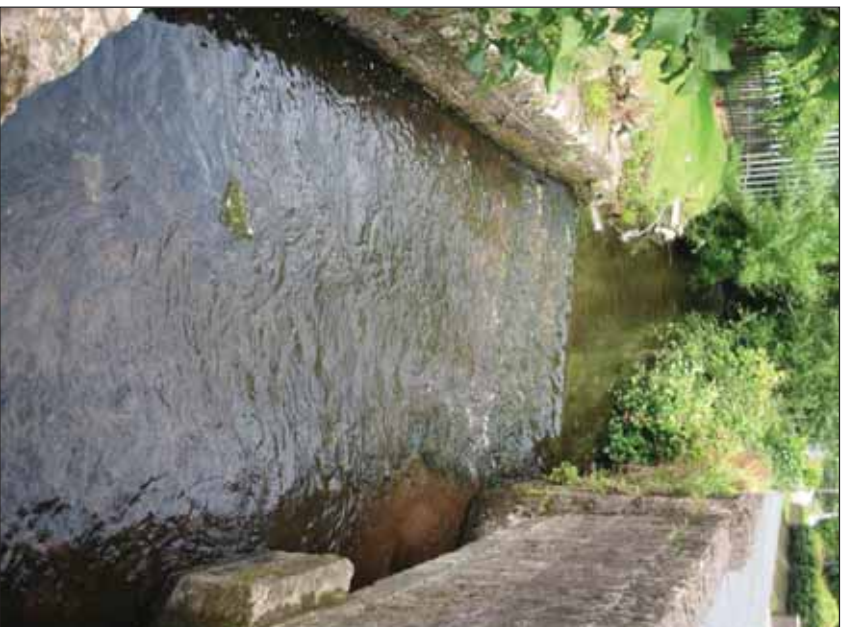
To the south of the road and culverts the stream was quite wide and shallow with a stoney bed. The southern bank was earthen and most of the northern one was concrete with an open metal barrier above defining the southern side of Brooklodge Grove Road. A small section of the northern bank was earthen, approaching the access road to Copper Valley Vue. Mature trees line the southern bank and the western section of the northern one.

The eastern section of the stream was very clean with some modern pipes along the northern bank. The western section contained some modern rubbish including metal pipes and plastic rubbish. No archaeological features or finds were noted.

Plate 5: Glenmore Stream eastern section with garden to north (left) and Brooklodge Grove Road to south (right). Opening to the rectangular culverted channels are visible at bottom right, looking east

- 5.4 Works to the Glenmore Stream will comprise the replacement of the three existing culverts (two of concrete and one of random rubble) and construction of a single new larger one. Work will comprise excavation, temporary diversion of the stream and road re-grading to tie the new road over the new culvert back into the existing road levels. These works will impact the weir which is located between the culverts. The weir and the random rubble culvert date, probably, to the construction of the adjoining Brooklodge Grove Road at the turn of the 20th century. It is recommended that the weir and random rubble culvert will be recorded prior to works commencing at this location.

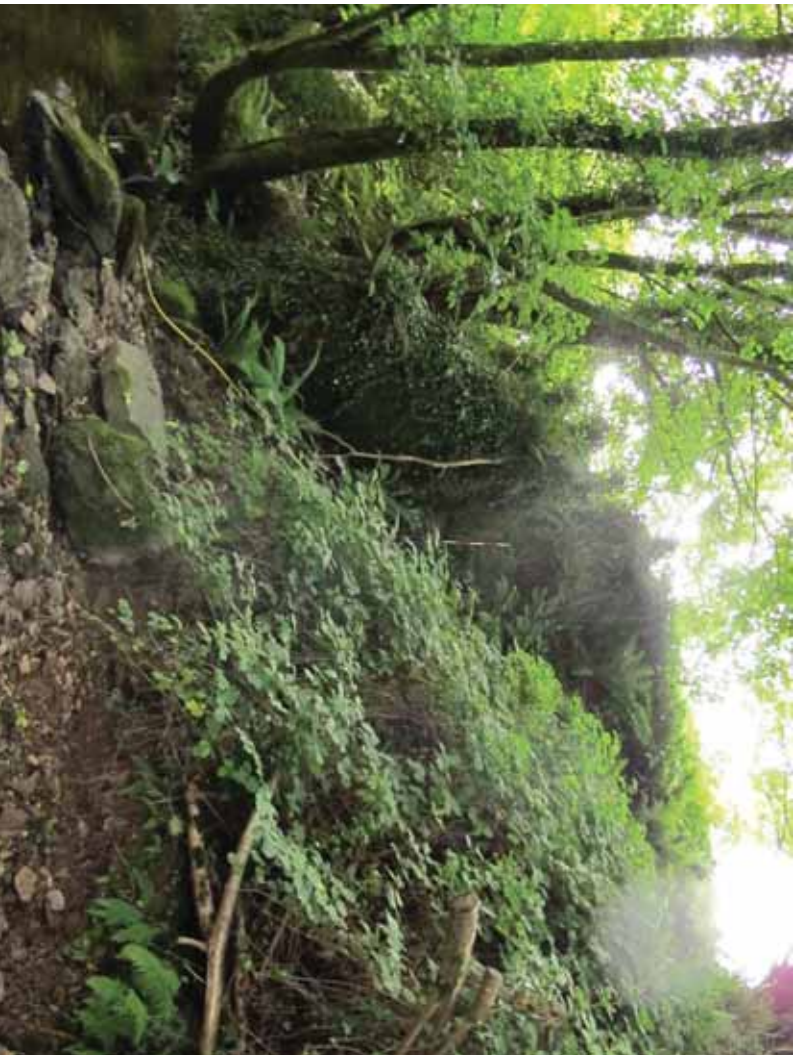
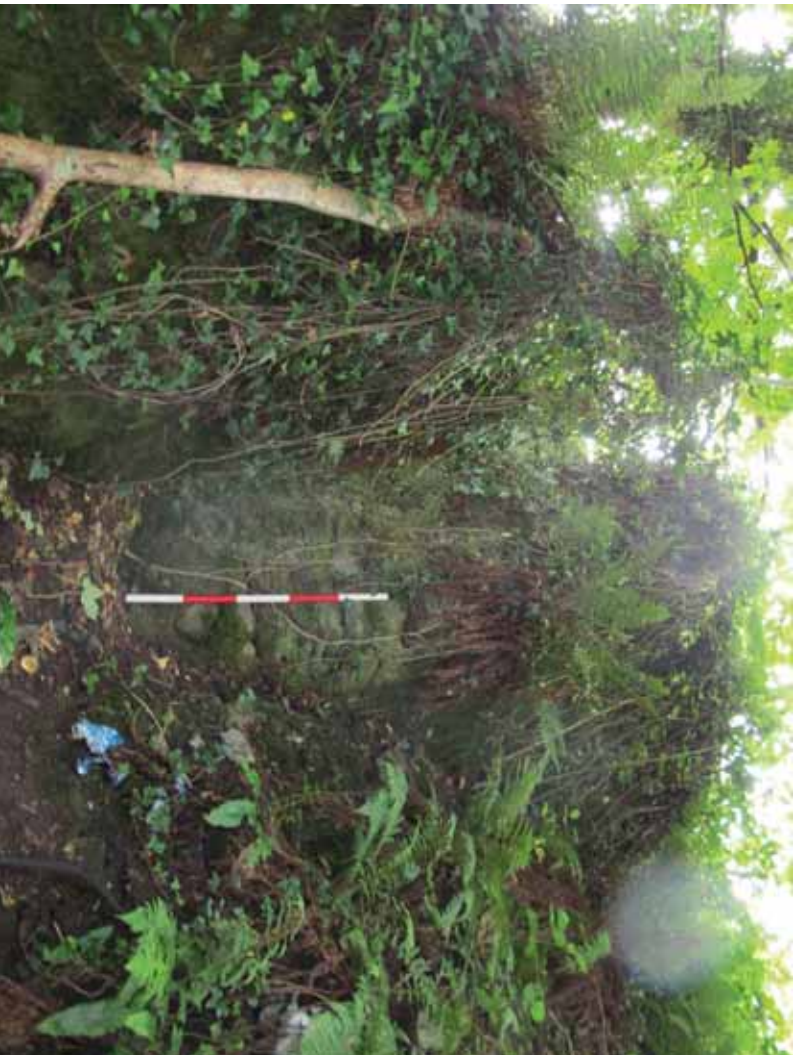
Plate 6: View of CHS 02 Boundary wall, taken from northeast.

Plate 7: View of CHS 02 Boundary wall, taken from northeast.

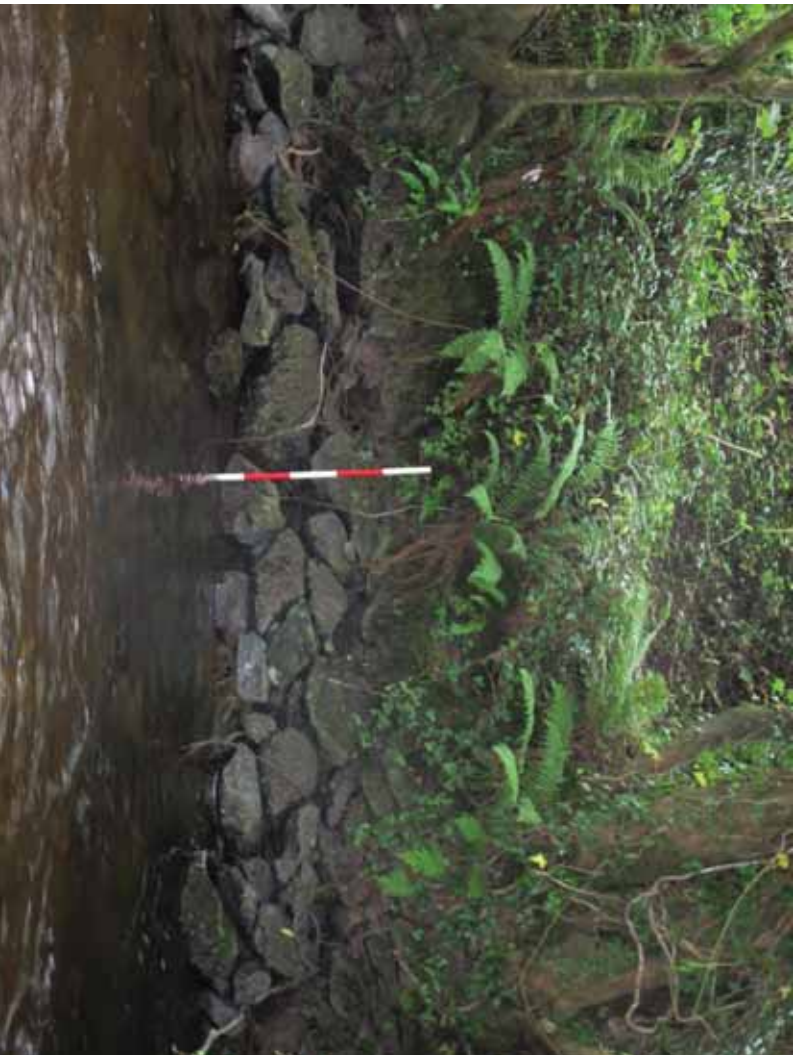
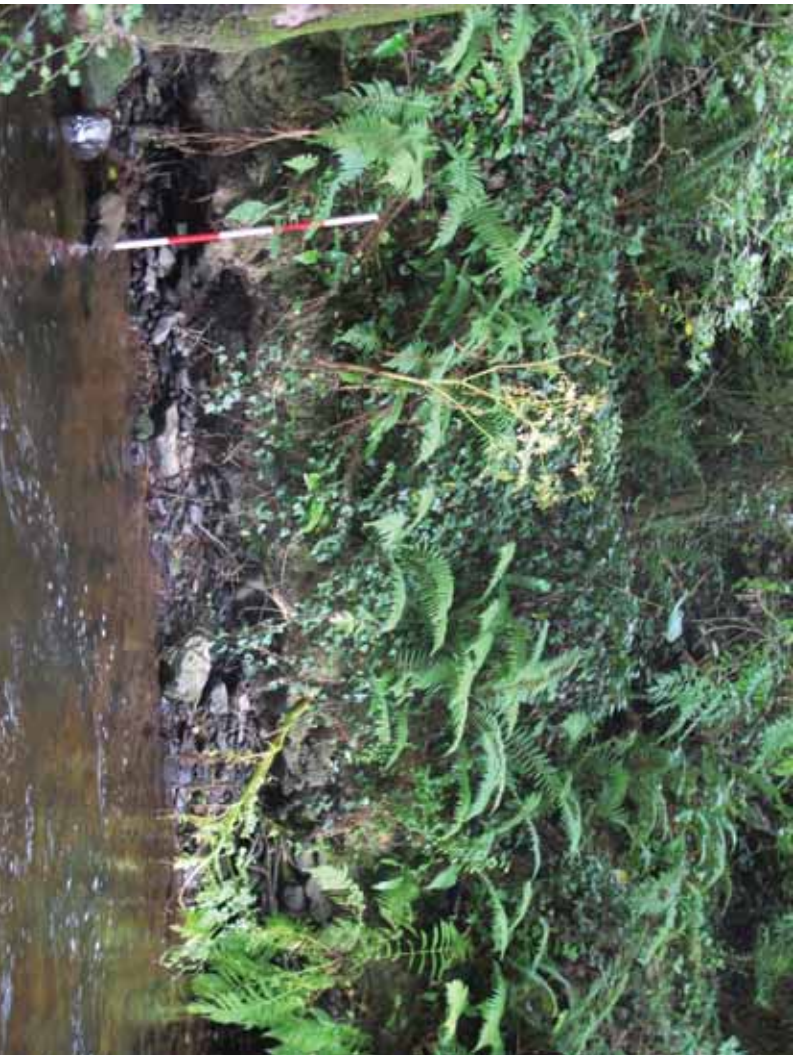
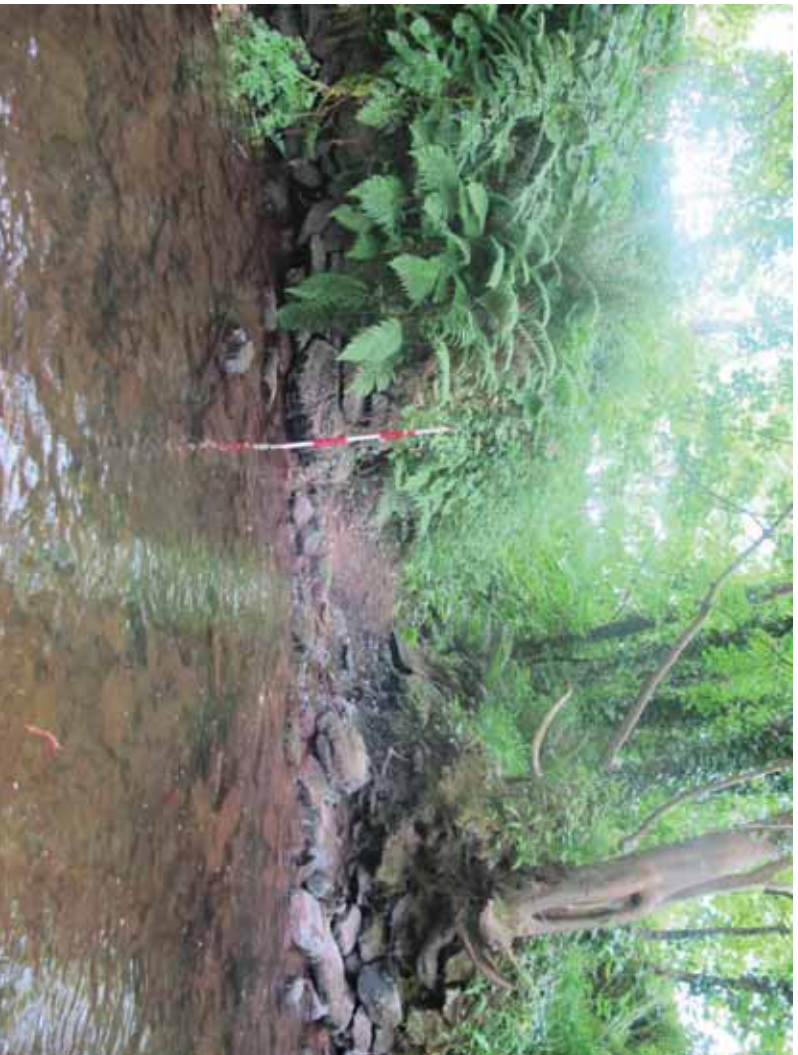
Plate 8: View of CHS 03, revetment wall, taken from west.

Plate 9: View of CHS 03, revetment wall, taken from west.

Plate 10: View of CHS 03, revetment wall, taken from west.

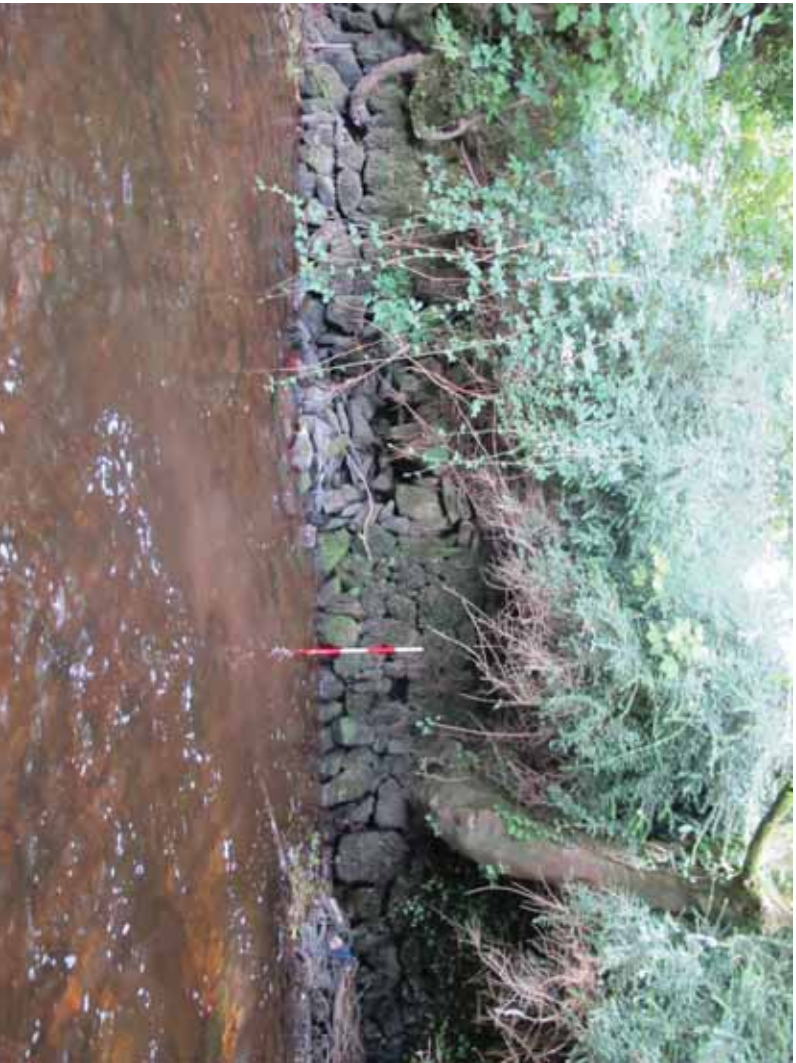
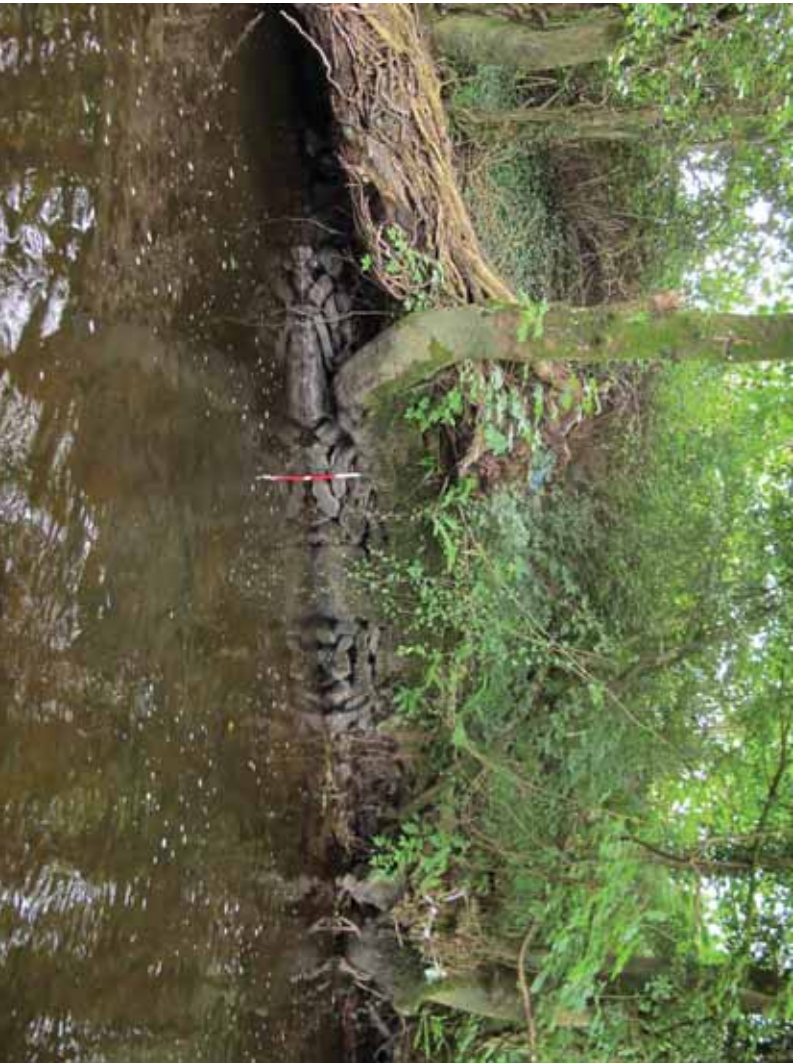
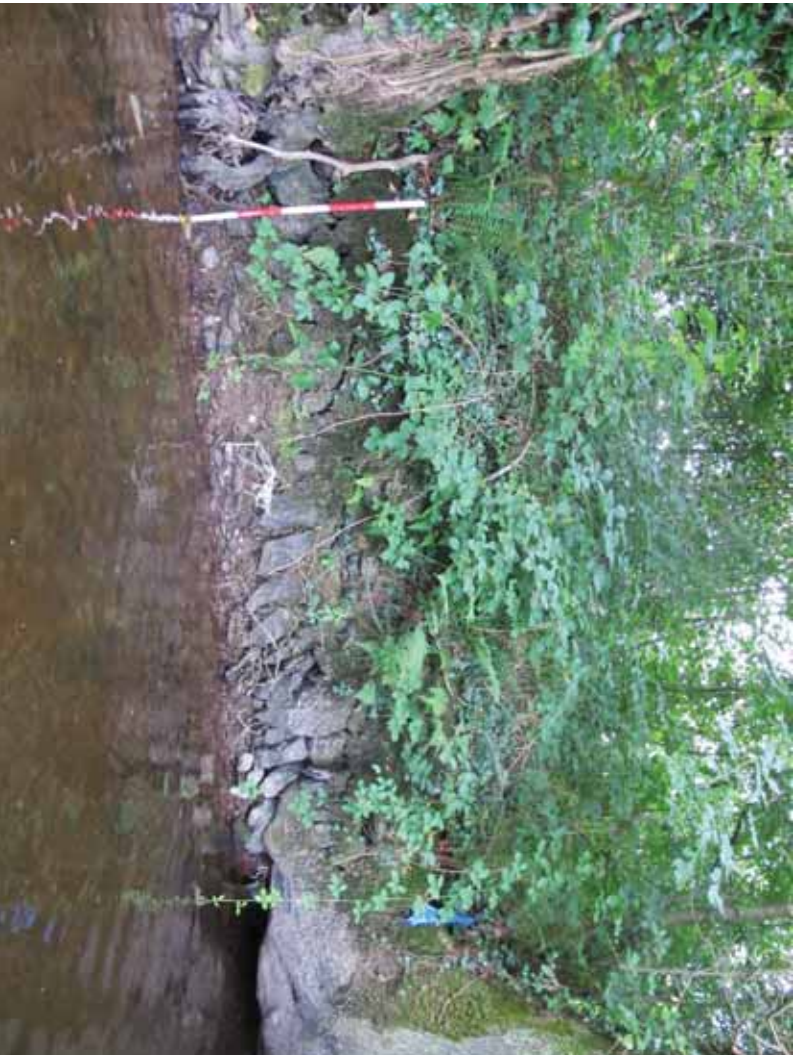
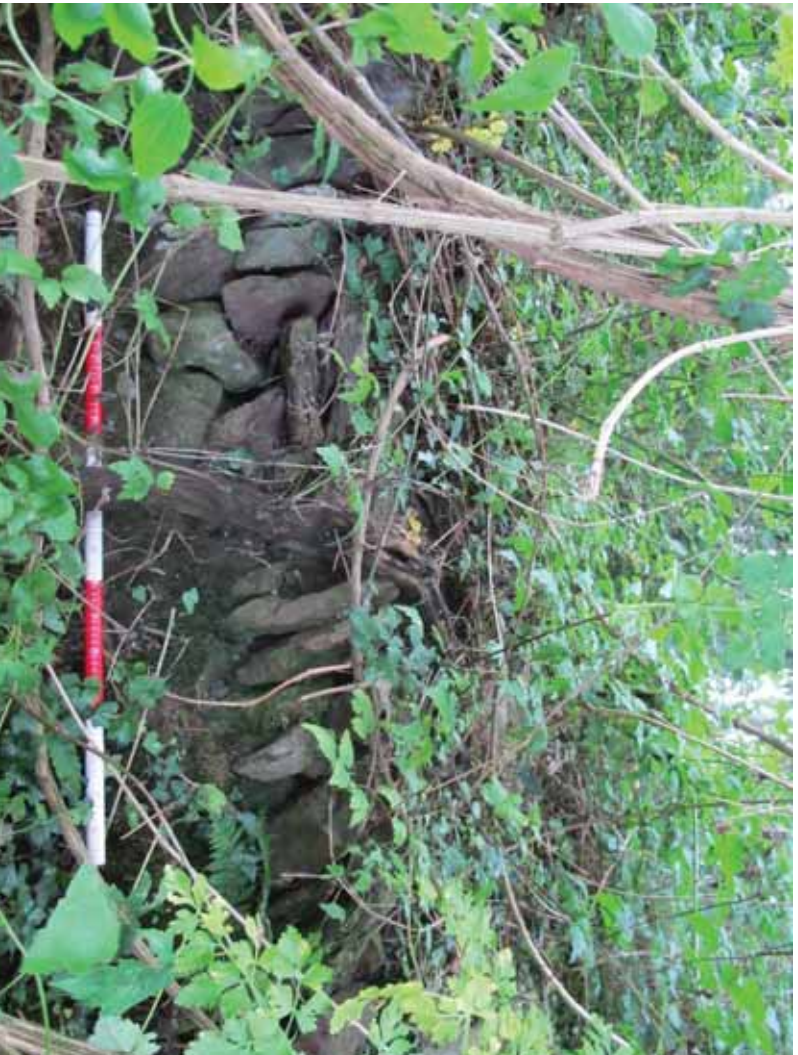
Plate 11: View of CHS 04 revetment wall, taken from northeast.

Plate 12: View of CHS 04 revetment wall, taken from northeast

Plate 13: View of CHS 04 revetment wall, taken from northeast.

Plate 14: View of CHS 04 revetment wall, taken from northeast

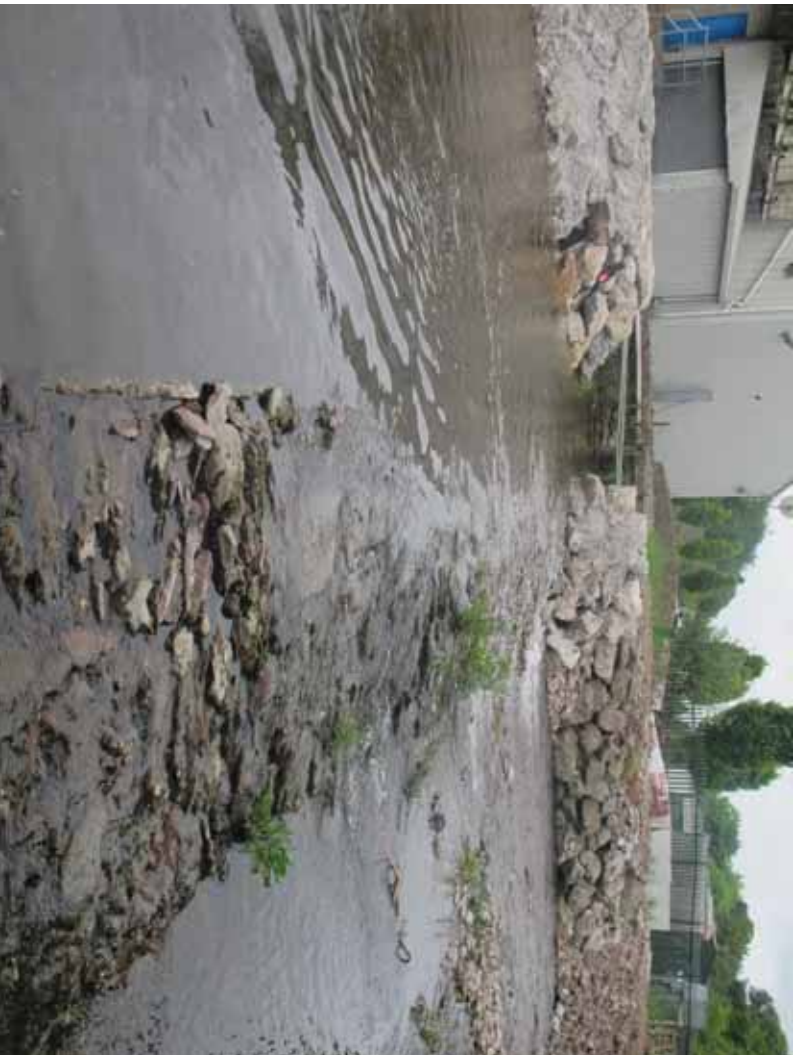
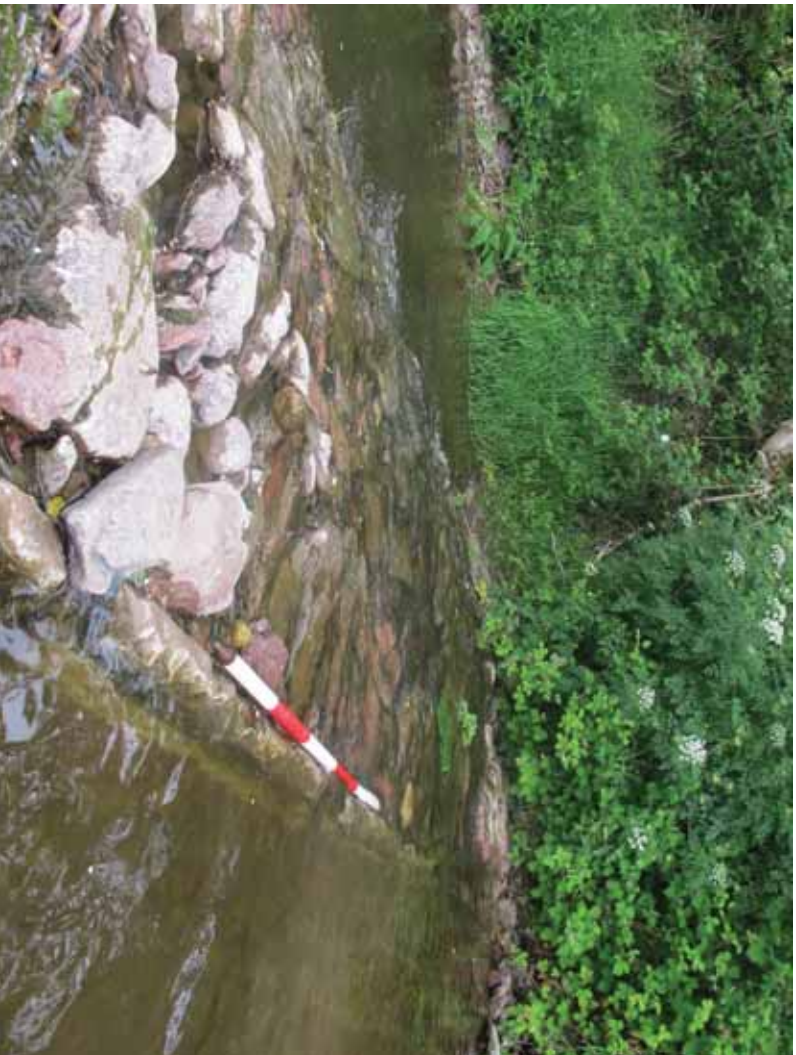
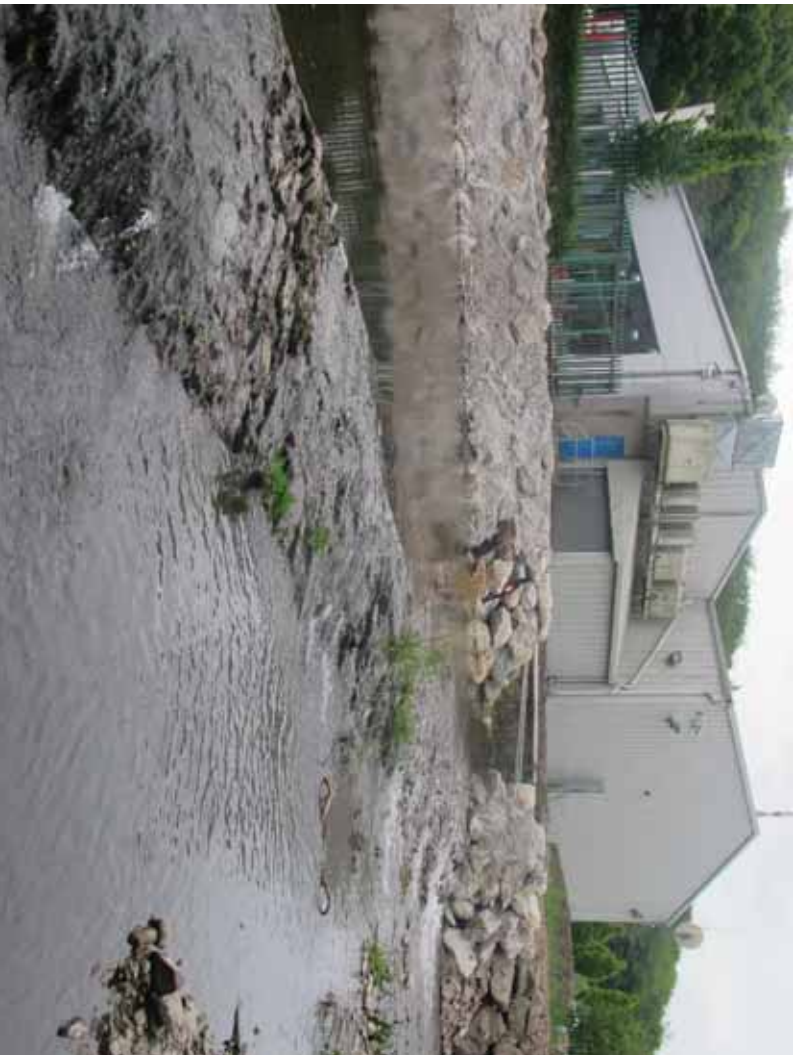
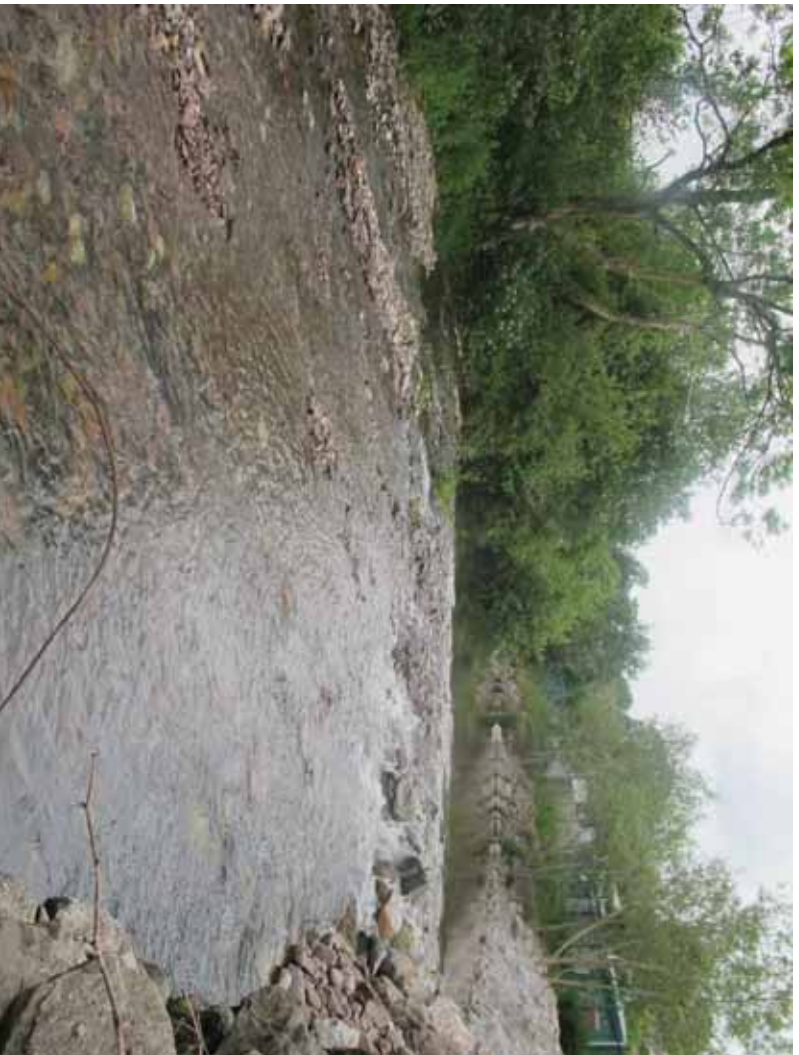
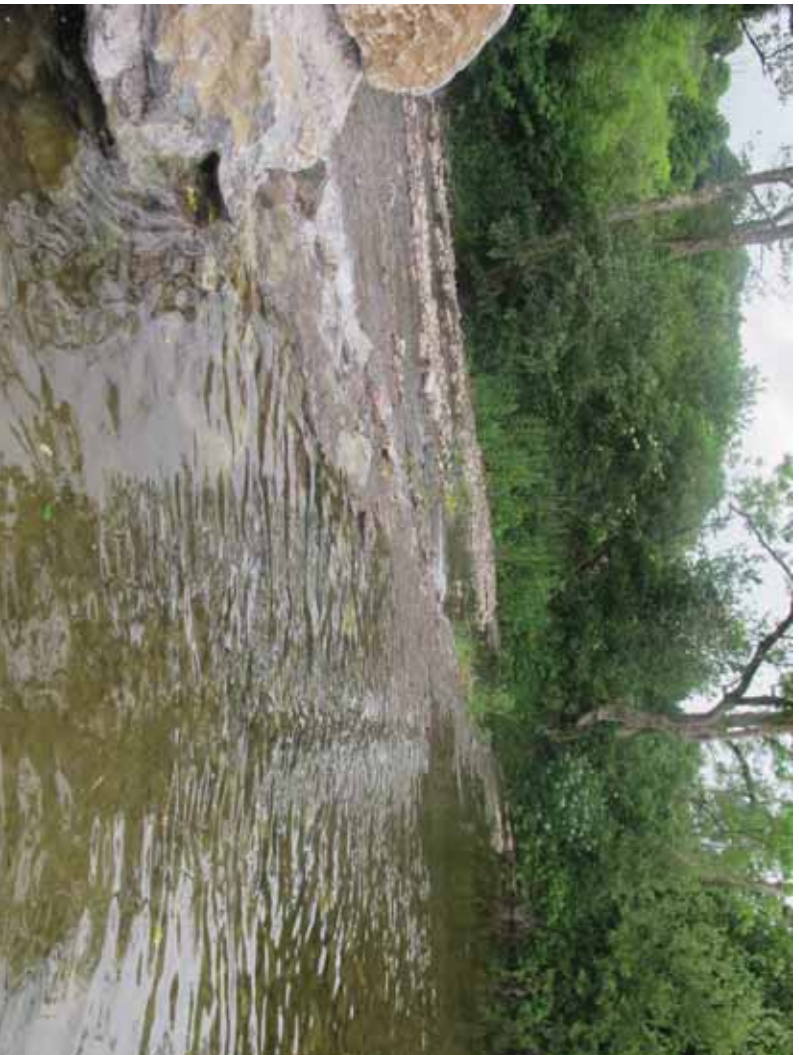
The main channel flows on the eastern side of the weir. The NW corner of the weir connects to the western riverbank which is concealed beneath dense vegetation that restricted close inspection. The SE limit of the weir abuts the sluice which serviced Pike Mill. The latter corner has been impacted by inappropriate modifications to the bank including the pouring of concrete onto the weir structure where it ties into the headrace. The consequential damage to the weir has negatively impacted the wider cultural aesthetics of the site.

Plate 16: View of CHS 06 weir, Pike Mill, taken from north-northwest.

Plate 17: View of CHS 06 weir, Pike Mill, taken from northeast.

Plate 18: View of CHS 06 weir, Pike Mill, taken from west-southwest

Plate 20: View of CHS 06 weir, Pike Mill, taken from south.

Plate 22: View of CHS 06 weir, Pike Mill, taken from south.

Mitigation by avoidance. Where possible, impact by the construction works on the existing sluice wall should be avoided. If unavoidable the proposed construction works should be faced with sympathetic material to minimise potential negative aesthetic visual impacts.

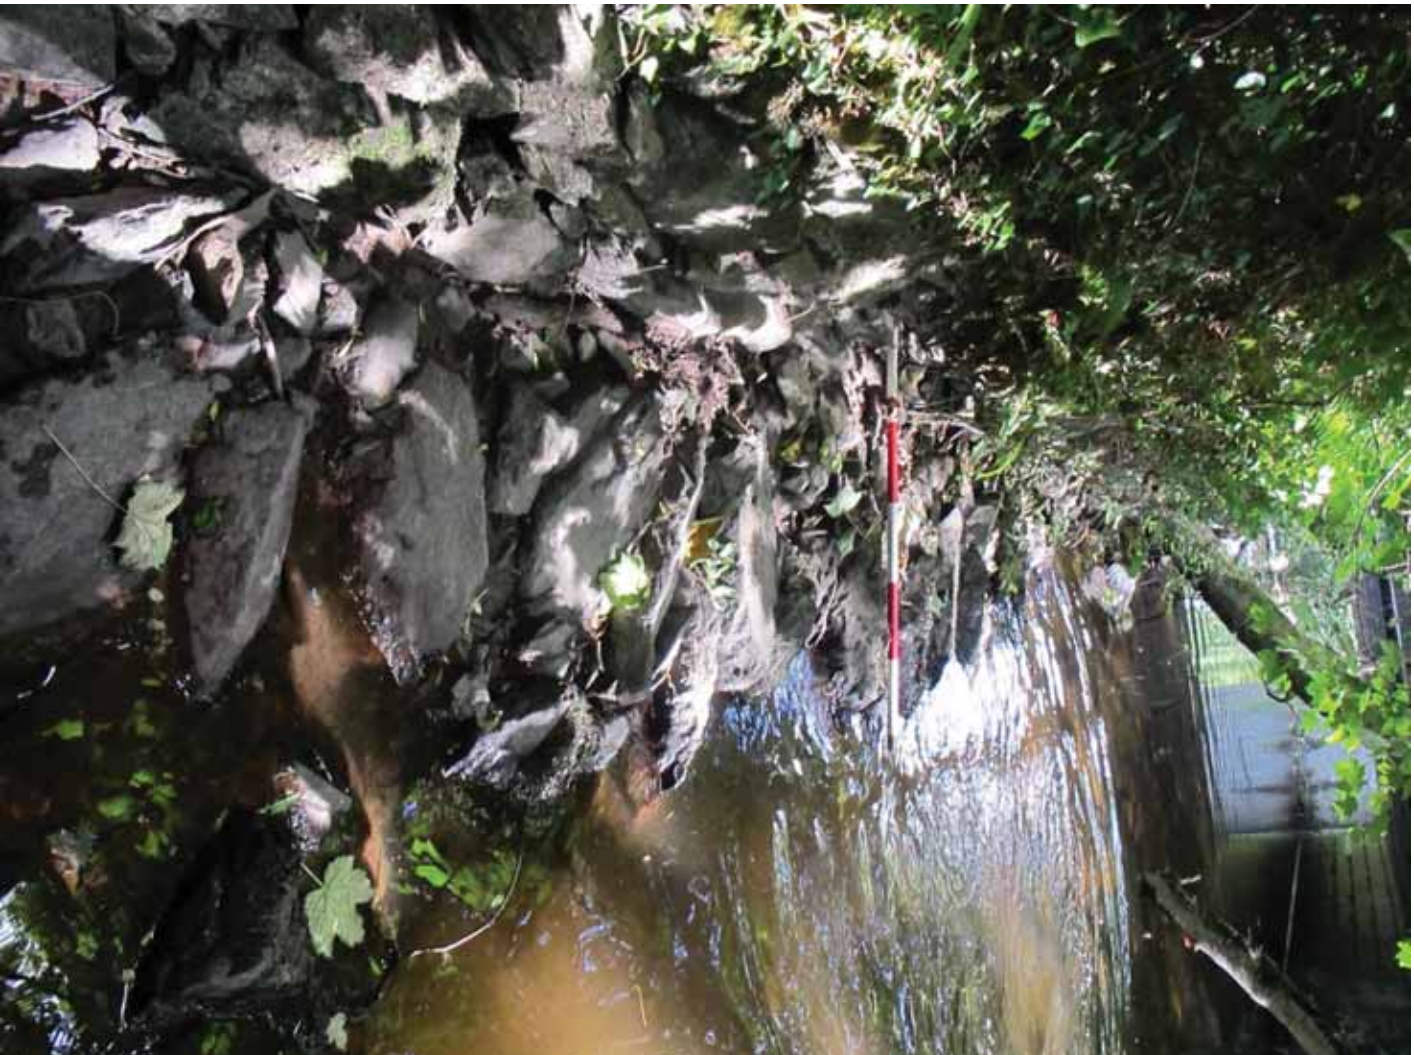
A riverbank revetment wall extends along most of Survey Area 3 (Fig. 9) albeit with sections missing in places exposing an earthen bank. In other sections it is replaced in an *ad hoc* fashion with various modern wall types including gabion walls, concrete walls or simply revetted with railway sleepers. It is of random rubble construction. An average height of 1.7m was recorded. At the northern limits of the survey a section of stone paving measuring 7.4m x 1.0m is present at the base of the wall (Plate 24 & 25).

Plate 24: View of CHS 08, revetment wall taken from north.

- Licensed archaeological monitoring should be undertaken by an experienced underwater archaeologist with regard to the proposed construction works C01-L05 & C01_L06.
- Mitigation by licensed archaeological testing in advance of construction should be undertaken with regard to all proposed works within the ZON associated with Riverstown Bridge a recorded monument and a recorded protected structure, including: - C0_L06; C01-L07; C01_P01; C01_R02; C01_C03 & C01_C04.
- The recorded protected structure Riverstown Bridge should be fully surveyed archaeologically in advance of construction works.

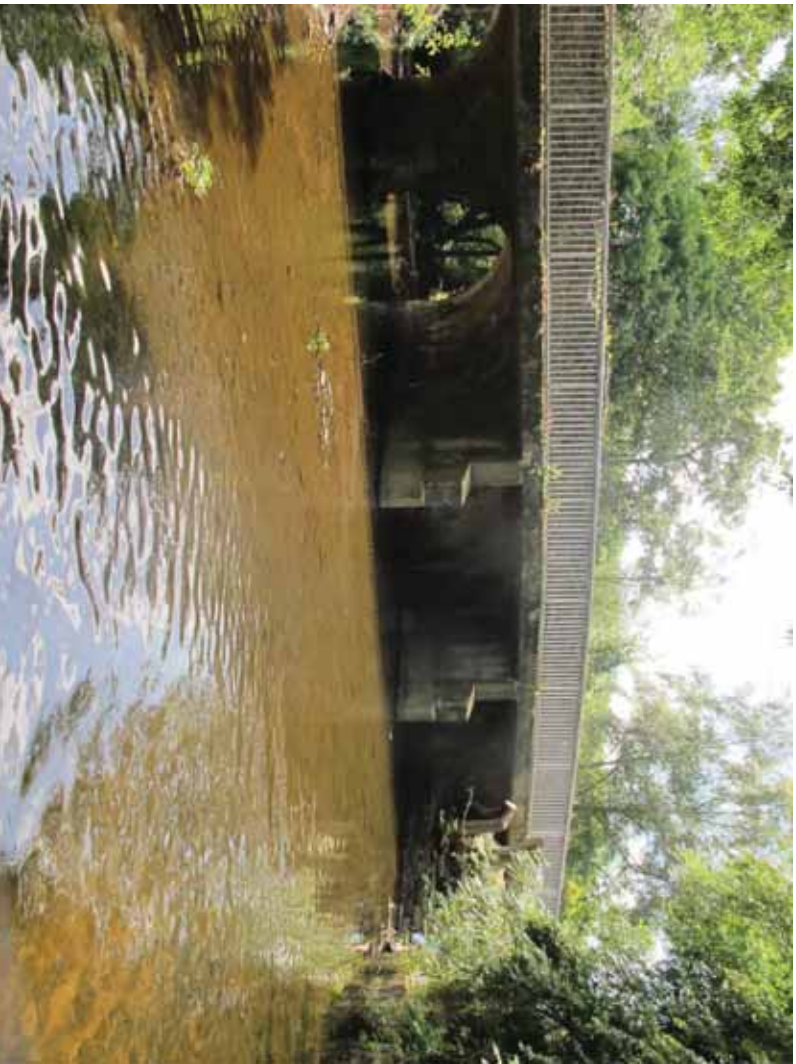
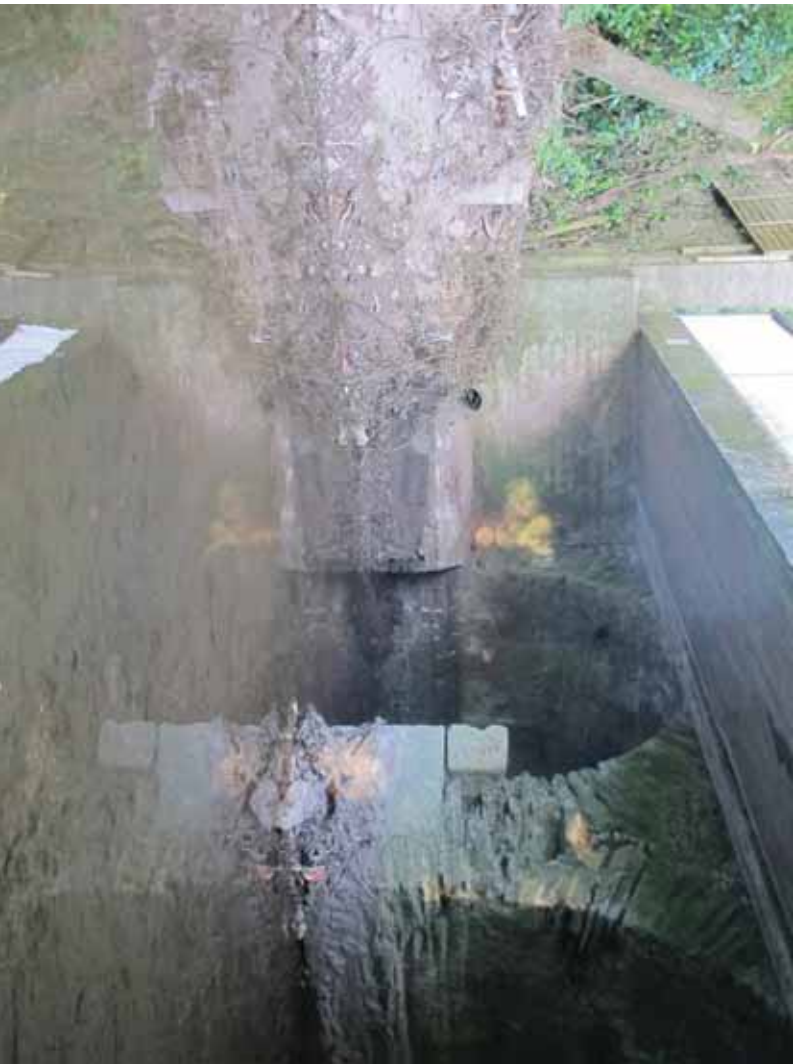
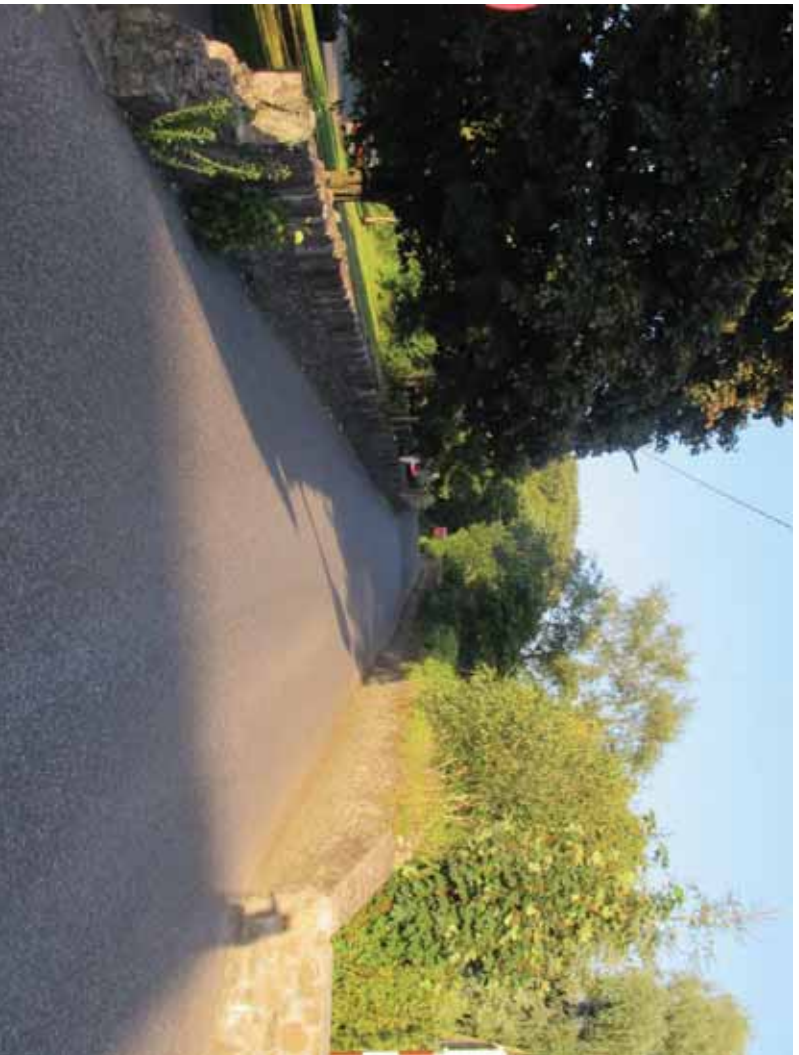
No foundations were visible at the base of the piers. The piers are protected on both elevations by rubble-stone pointed cutwaters projecting outwards by 0.9m, and 1.15m in height. The cutwaters are damaged as a result of erosion and vegetation. The modern concrete extension to facilitate a footpath has damaged the bridge and conceals much of the northern elevation. The parapet has vertically set coping.

Plate 33: View of CHS 12, bridge taken from northeast

Plate 34: View of CHS 12, bridge with pedestrian bridge extension and recent earthen embankment to northeast..

Plate 36: View of CHS 12, bridge, carriageway.

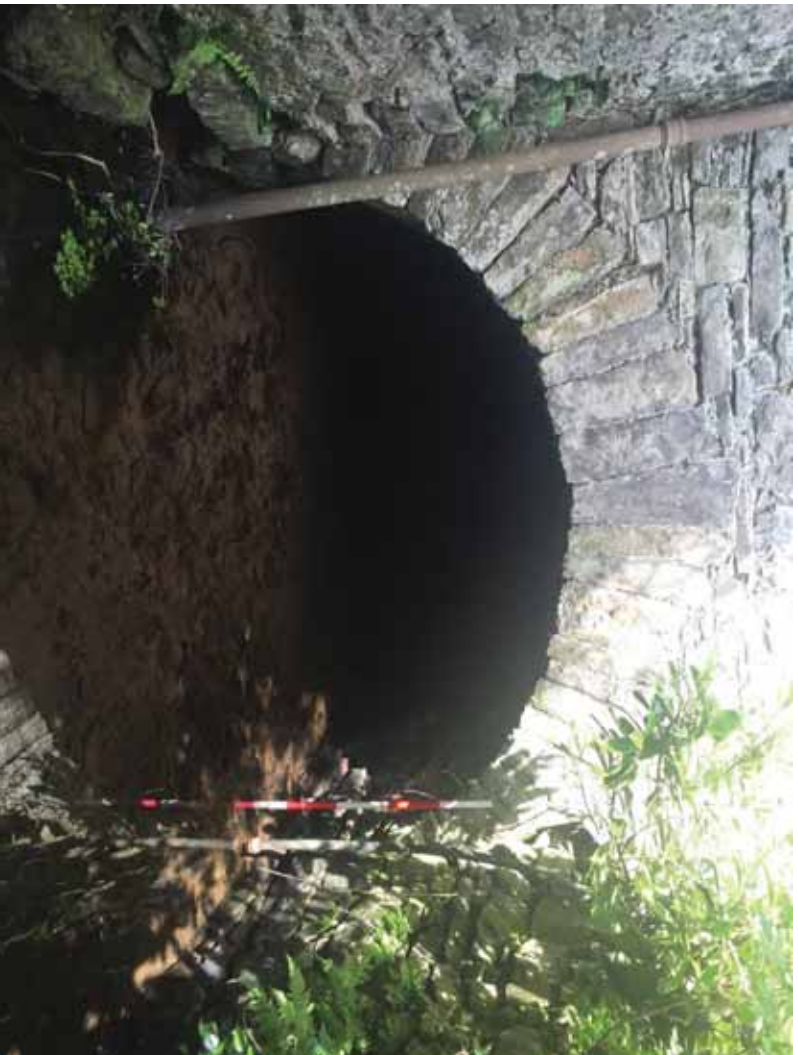
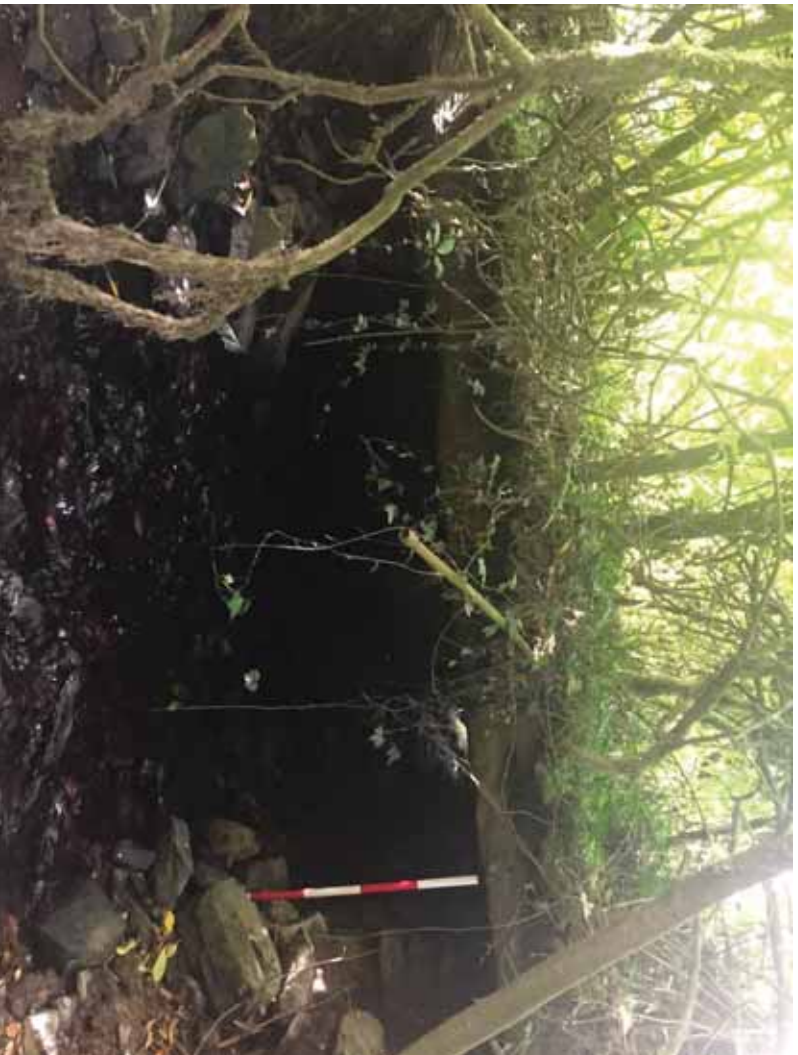
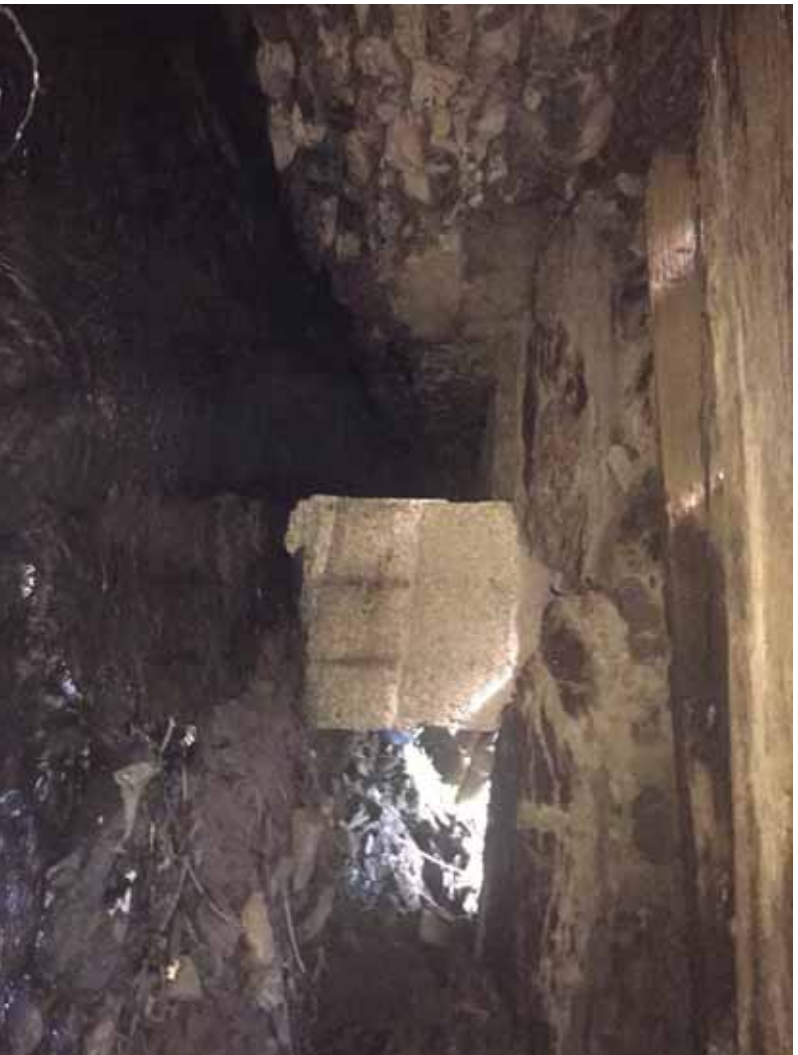
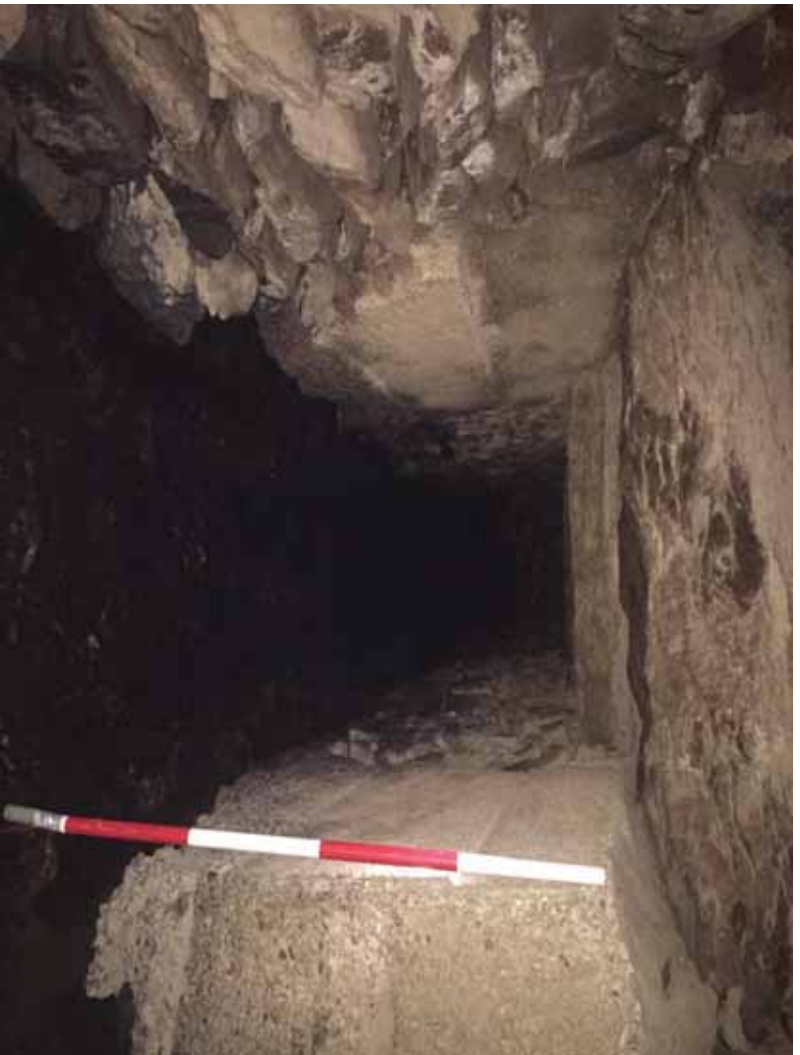
arch of twenty-six voussoirs (Plate 40). To the west of this is a crudely constructed wooden bridge spanning the second race (Plate 41). This is a twin culvert constructed of random rubble stone capped with large stone lintels (plates 42 & 43). Modern repairs comprising concrete support propping have been inserted at the exit, and the eastern channel of the twin culvert has collapsed.

Plate 40: View of CHS 13, from south.

Plate 41: View of CHS 13, from south.

Plate 42: View of CHS 13, from south.

Plate 43: View of CHS 13, from south.

No mitigation required.
