Project Number:	6075	Document Number:	Appendix 7.1	Revision:	09
Project Name:	GLASHABOY FRS	Document Title:	PHOTOMONTAGES	Date:	07 March 2018

Appendix 7.2

Summary of relevant
observations and Planning
Objectives from Cork
Development Plan (2014) and
Cobh Municipal District Local
Area Plan (2017)

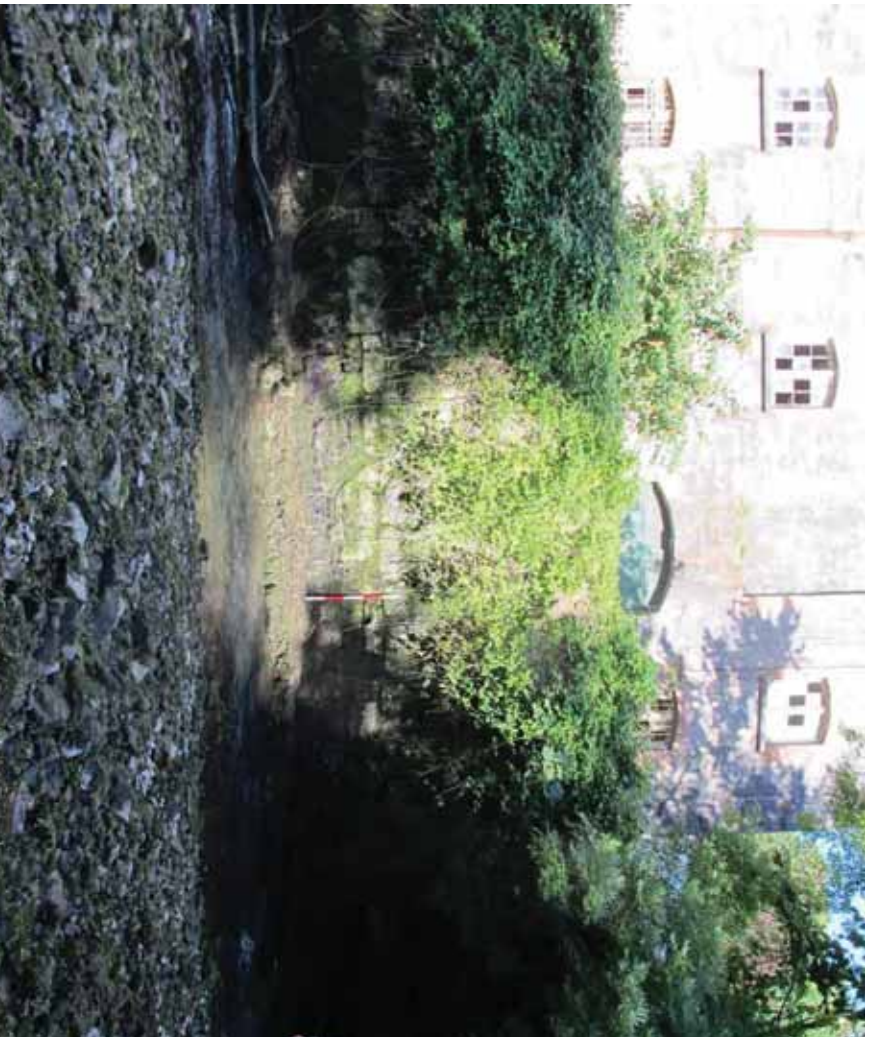
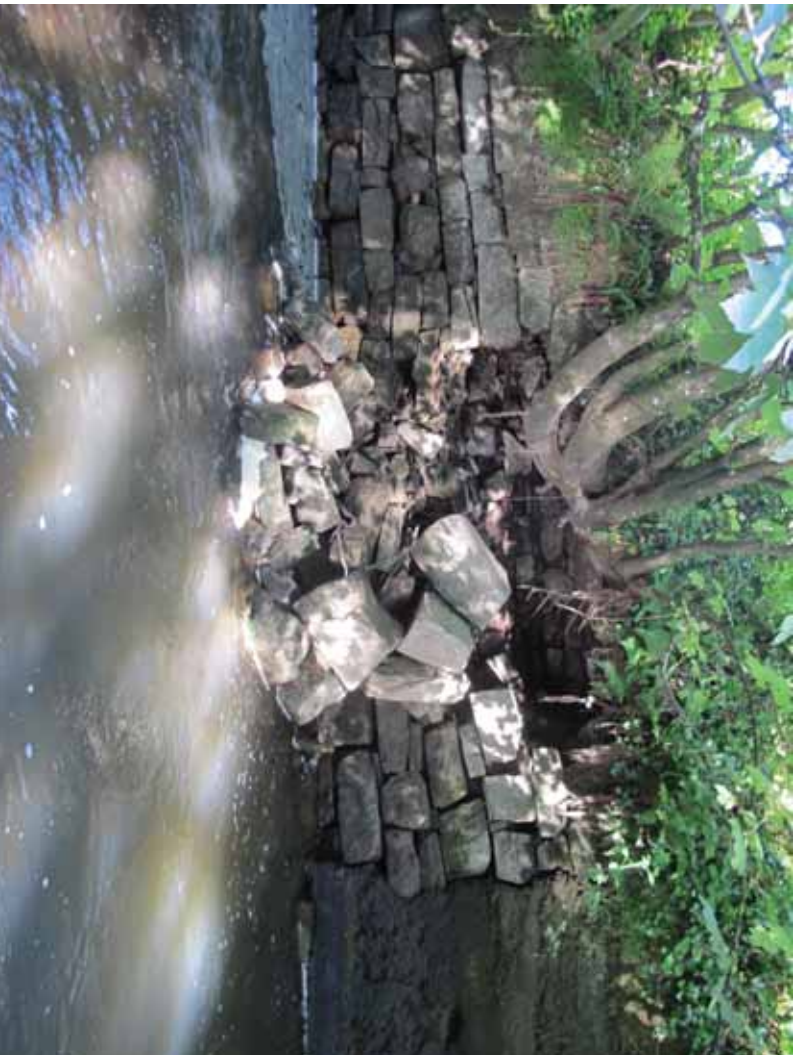
A revetment wall is visible on the east bank between the mill building and the tail race (Fig. 18, Plate 46). Due to an accumulation of sediment and dense vegetation it was not possible to examine the northern limits of this wall. It is possible that the wall continues further upstream concealed behind collapsed bank material. The wall is a substantial structure measuring up to 3.0m in height. It is constructed of dressed limestone blocks measuring from 0.30m x 0.30m up to 1m x 0.6m. Mortar bonding is visible in places. Tree root damage is particularly noticeable resulting in portions of the wall having completely collapsed as a result (plate 47 & 48). Three sections of the wall, measuring between 3.8 and 4.5m in width have been repaired with concrete.

Plate 46: View of CHS 17, revetment wall, taken from west.

Plate 48: View of CHS 17, revetment wall, taken from west.

No mitigation required.

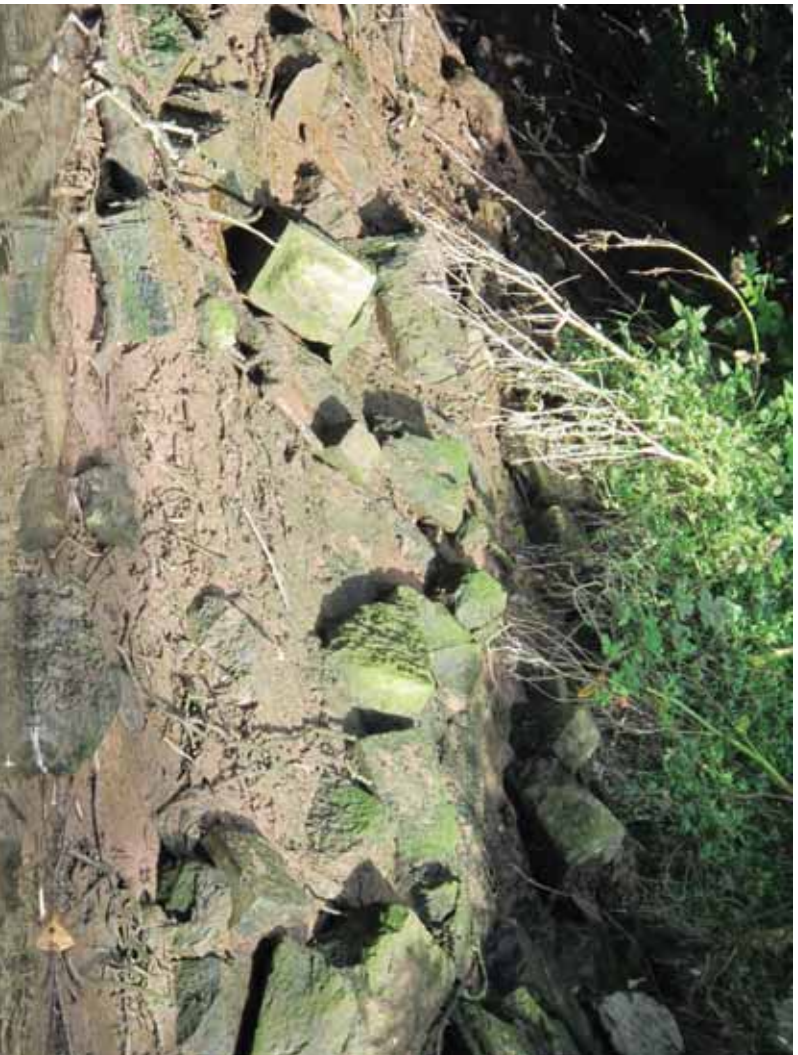
The tailrace for the Fountains Mill discharges into the river on a bend at the end of revetment wall CHS 17 (plate 49). The original exit point for the tailrace has been modified. A concrete slip supports /abouts the end of the revetment wall. The current concrete slip structure is most likely a replacement of an earlier 19th century slip. A Boat House shown on the 2nd Edition OS map, may have served the mill and indeed a nearby recorded Limekiln, CO075-002002. The south-eastern bank of the race has collapsed and now consists of mud with a large quantity of tumbled stone of which some are dressed limestone (Plate 50).

Plate 50: View of CHS 18, tailrace taken from southwest.

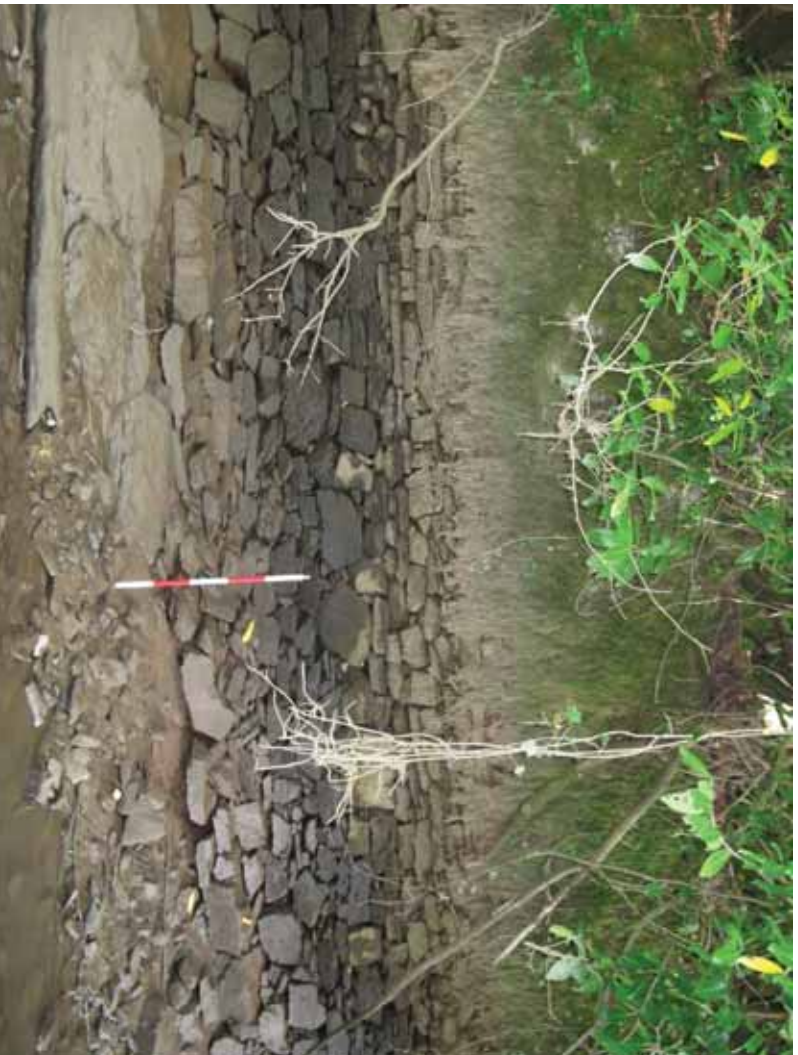
The heavily vegetated revetment wall on the west bank survives intermittently exposing the earthen bank (Figure 21,). Some sections have been replaced with boulders and concrete walling. The original stone revetment wall survives to a height of 1.8m. However, the basal courses are concealed beneath estuarine mud / silts (Plate 51). The west side of riverbed is also strewn by large quantities of debris and branches or trees deposited on the mud, largely by tidal action.

Plate 52: View of CHS 19, revetment wall, taken from north.

Licensed archaeological monitoring should be undertaken by an experienced underwater archaeologist with regard to the proposed construction works C01_L09. Licensed archaeological testing should be undertaken at Sand Quay. Further mitigation may be required based on the results of this archaeological testing.
