## 7A KARST HYDROGEOLOGY ASSESSMENT

## **7A.1** INTRODUCTION

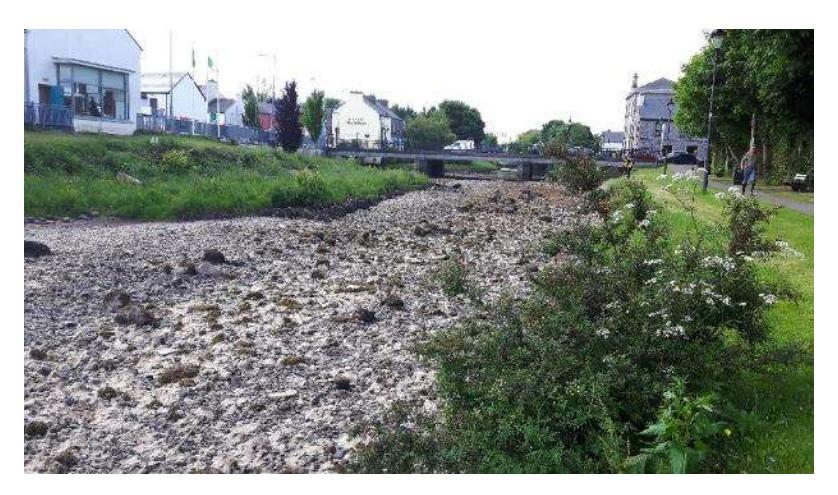
Plate 7A.2 Dry River Bed, Crossmolina Town, June 2016

There was limited photographic evidence available of the River Deel running dry in Crossmolina Town prior to this investigation. However, in June 2016, the river ran dry from a point just downstream of a pool in the river known colloquially as Pollgorm through Crossmolina Town, leaving just stagnant pools of water: Plate 7A.2 shows the dry river bed with Crossmolina Town in the background.

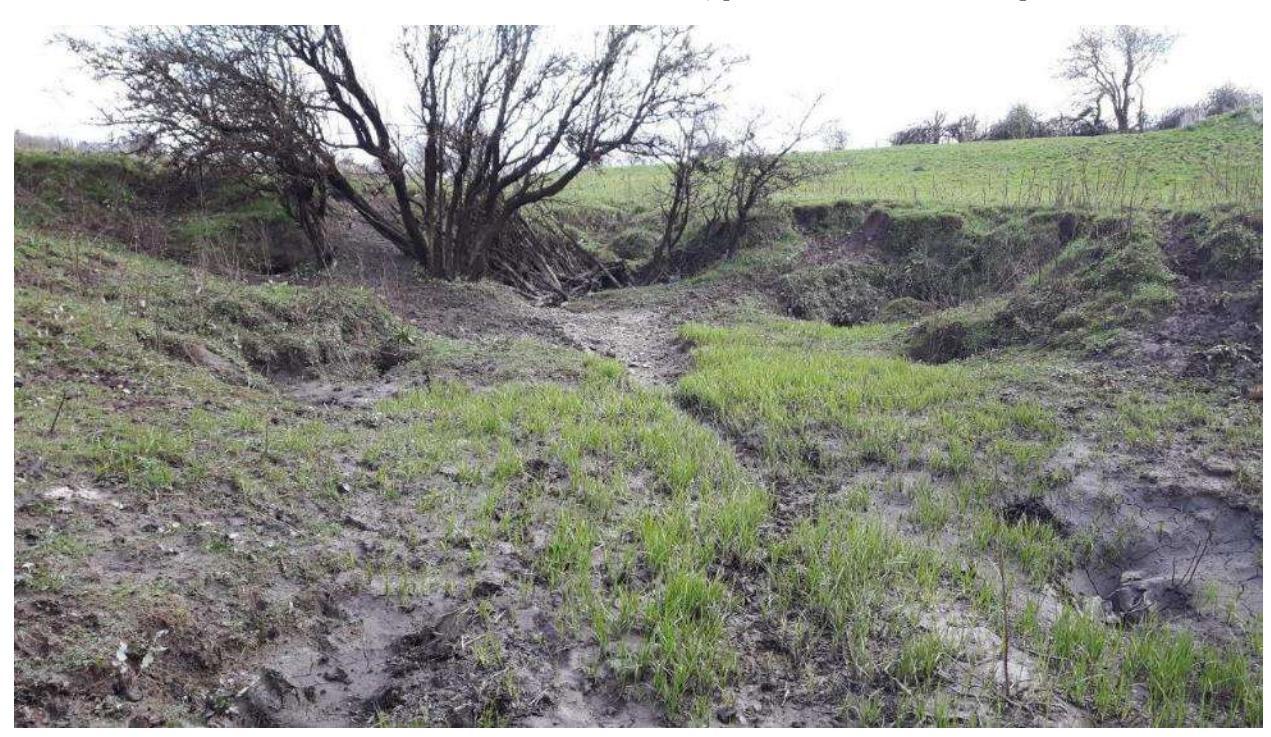
Plate 7A.4 Lough Agawna swallow holes

Apart from those in the Deel channel (which are described in more detail under the Stage 2 Assessment below), one significant swallow-hole was located within the study area during the Stage 1 Assessment on the outlet from Lough Agawna, with a discharge of <100 litres/sec and a conductivity of 260-400 µS/cm.

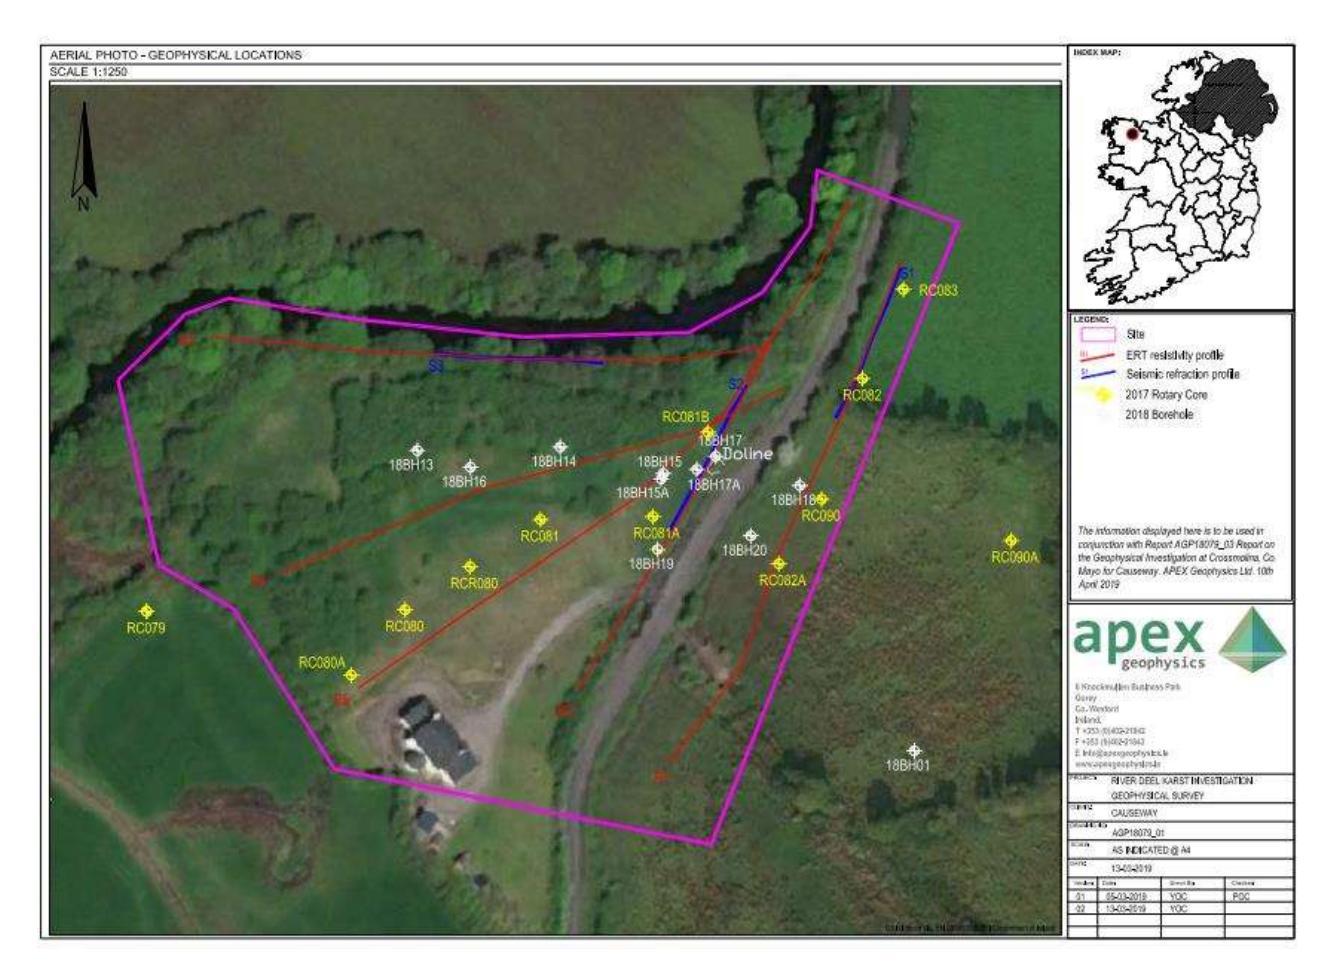
Figure 7A.10 Extent of Geophysical Investigations at Pollnacross (extract from Apex report)

In Q4 2018, a collapse doline formed at Pollnacross in close proximity to the River Deel. Apex Geophysics Ltd were subsequently commissioned to carry out a geophysical survey of the area surrounding the doline in order to investigate the cause of the drop out. The purpose of the investigation was:

The survey did not detect any significant karst features in the bedrock underlying the collapse doline. A probable karst feature was detected along the riverbank, and a depression in the bedrock was also detected in the vicinity of one of the geotechnical investigation points, RCR080. RCR080 had also detected this feature, and it is noted at this point that the output from geophysical surveys when it comes to karst limestone is indicative only and requires hard data from drilling, etc., to confirm or refute its conclusions.

Further geotechnical investigation was recommended by Apex and this was completed as part of the geotechnical investigation (described separately above). Two new boreholes (BHs 32 & 34) carried out on foot of this recommendation were used as part of the July 2019 dye tracer experiment.

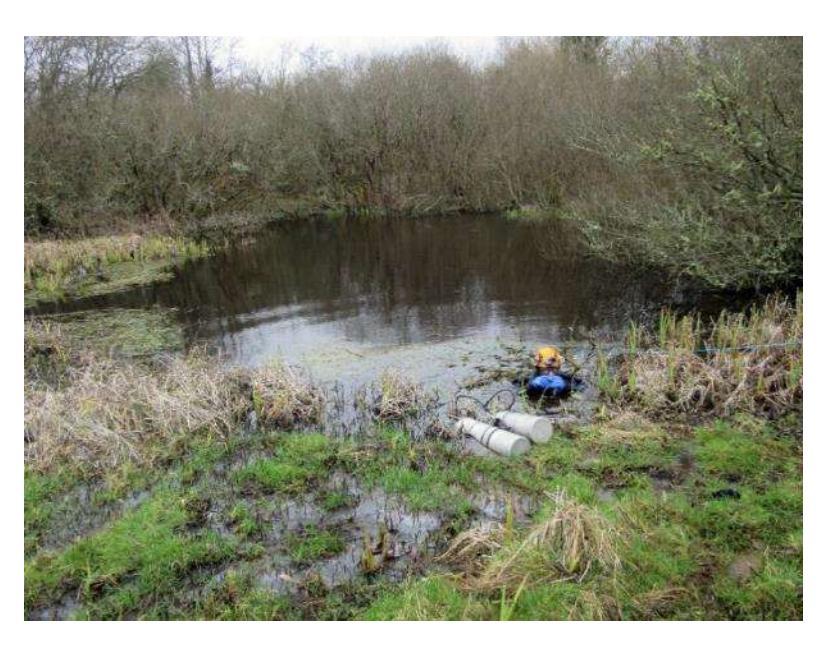
Plate 7A.5 Diving of South Spring, Mullenmore

The northern spring consists of two pools, the more upstream of which was surveyed bathymetrically last year by OPW Hydrometric. The diver confirmed the findings of the bathymetric survey that the northern pool is 8-9m deep with a deeper cleft in bedrock descending to 12.5m below water level.

The downstream pool, which was not covered by the bathymetric survey, was found to be 4.5m deep with no deeper zones. Water flow was not detected in neither pool and visibility was close to zero.

The diver also confirmed the findings of the bathymetric survey that the southern pool as 8-8.5m deep over almost all of its area with no obvious zones of groundwater inflow except possibly in the area where the stream flows out of the pool.

The inference from this work is that water enters the spring pools diffusely through the sands and gravels that overlie bedrock, possibly originating in a now partially blocked major karst conduit some distance to the west of the springs, as indicated by the preliminary geotechnical investigation.
