Appendix 6.2

Geomorphological Audit

Geomorphic audit of the Glashaboy River and assessment of the proposed Drainage Scheme

March 2018

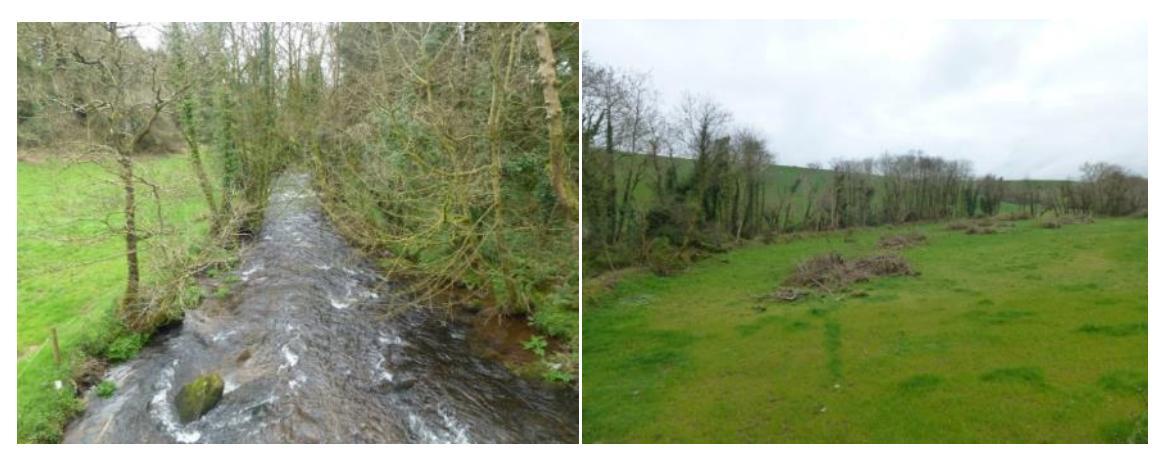
Figure 3-3 Dunbulloge Bridge (Point 2)

Evidence within the reach of historic channel management exists, including old dredging embankments (Figure 3-3) and channel straightening. Channel straightening and dredging has led to some disconnection of the channel from its floodplain in certain areas (although this is not excessive in the upper reaches). Modifications to the channel such as dredging and straightening

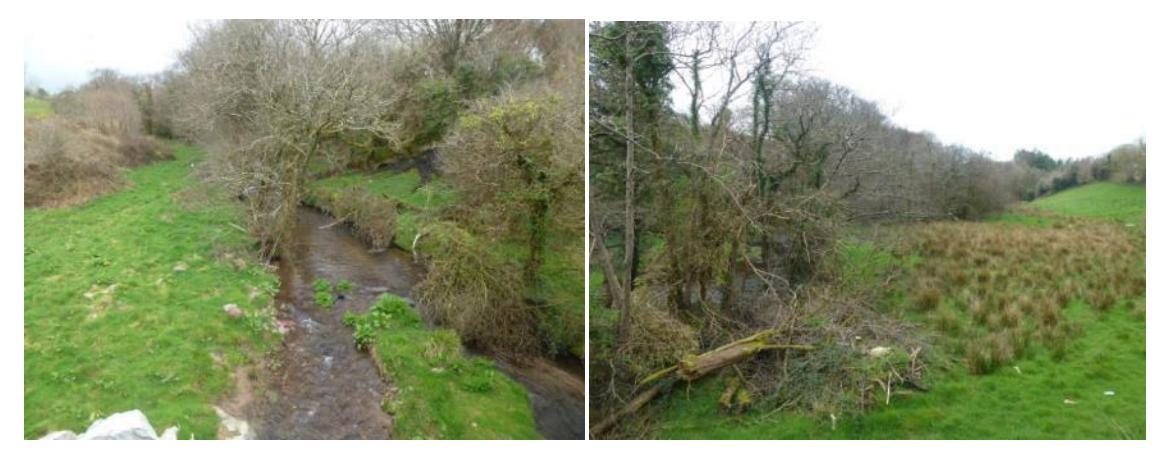
Figure 3-5 Upstream of Ballyskerdane Bridge (Point 4)

Stable vegetated bars were common throughout the reach (Figure 3-5) along with small pockets of fine sediment deposition along the lateral edges of the channel, mainly from localised bank erosion. Small areas of deposition like this are often an indication of the channel naturally attempting to narrow as a result of historic intervention, such as over widening. Several low weirs exist (see example in Figure 3-2), which cause limited upstream impoundment, but act to cause increased fine sediment deposition within their impoundment zones. Limited evidence was noted of weirs restricting movement of gravels.

Opportunities exist to improve connection through embankment removal and re-grading (Figure 3-5). This should act to improve floodplain storage in these upper reaches and act to reduce downstream flood risk.

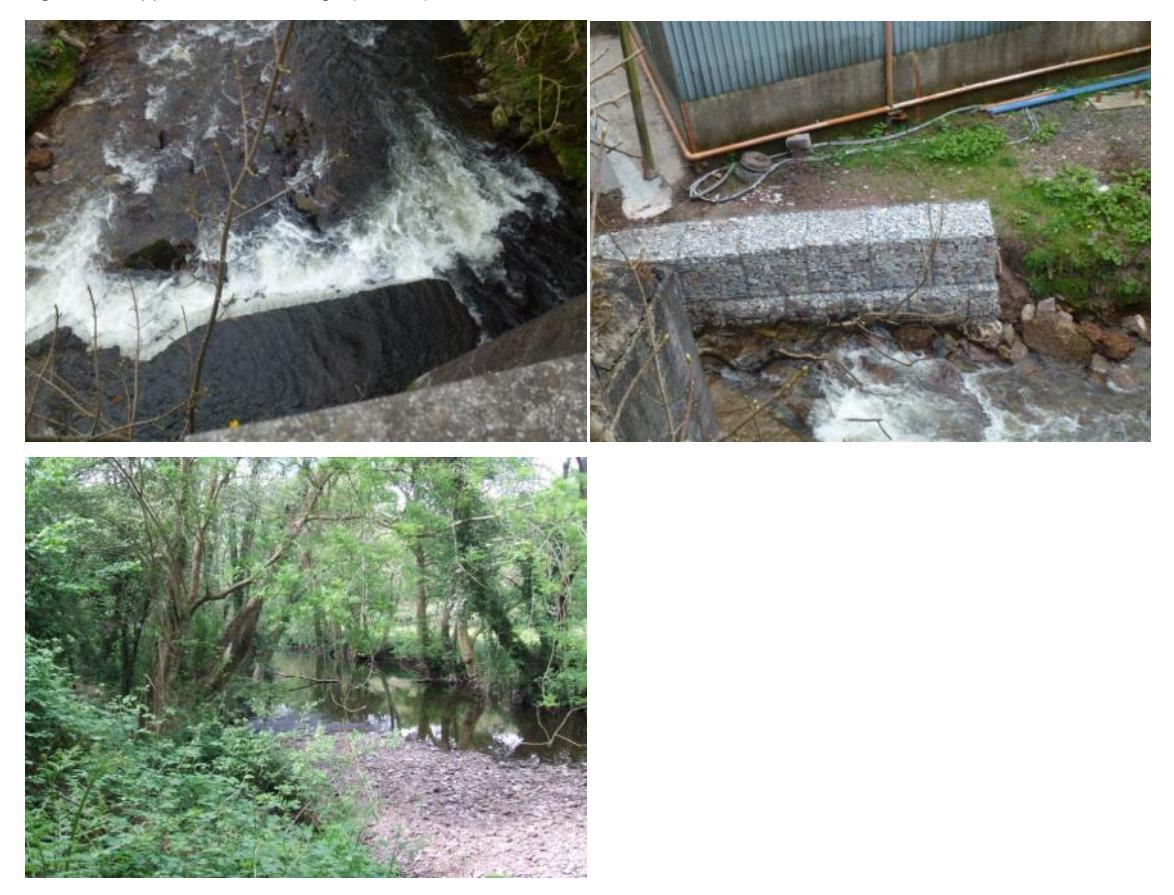
Figure 3-6 Upper Glanmire Bridge (Point 5)

In the reach between Upper Glanmire Bridge and Knocknahorgan the river valley narrows which results in a confined floodplain. At Upper Glanmire Bridge a weir is leading to local bank erosion (Figure 3-6), due to the direction of flows passing under the bridge. Banks have been reinforced using gabion baskets, however, in the long term the river may undercut these baskets.

Downstream of Upper Glanmire Bridge, flow energy in the channel reduces and areas of gravel and small cobble deposition occur (sizes of gravels range from 4cm to 40cm). Gravel splays occur at tributary confluence points (Figure 3-6) along this section, suggesting an active supply of gravels is present from the steep tributaries joining the river (Figure 3-7).

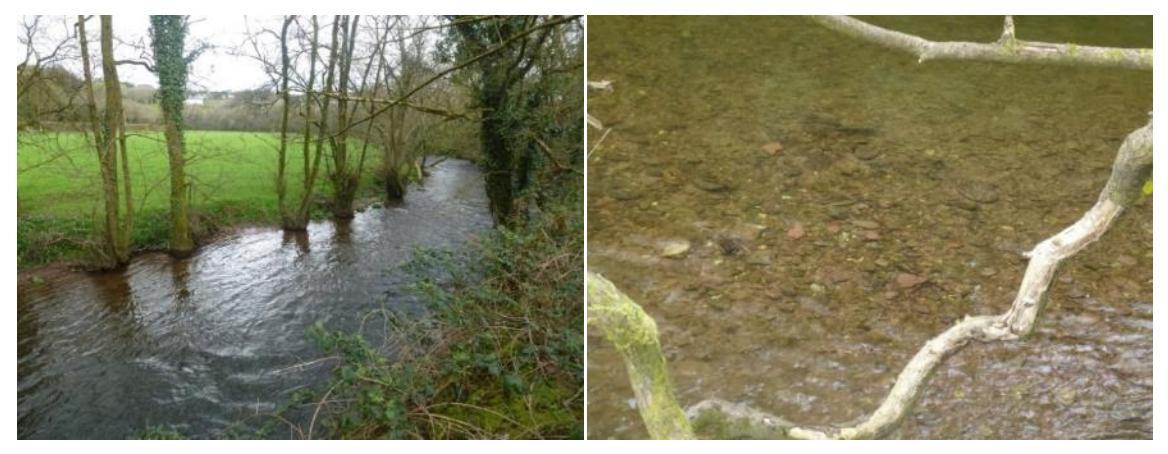
Figure 3-8 Knocknahorgan (Point 7)

The channel bed throughout this reach is again dominated by gravels and cobbles, in a plane bed and pool riffle morphology. Less algae was seen on the more gravelly sections on the bed which suggests a more active supply and movement of gravels through this reach (Figure 3-8).

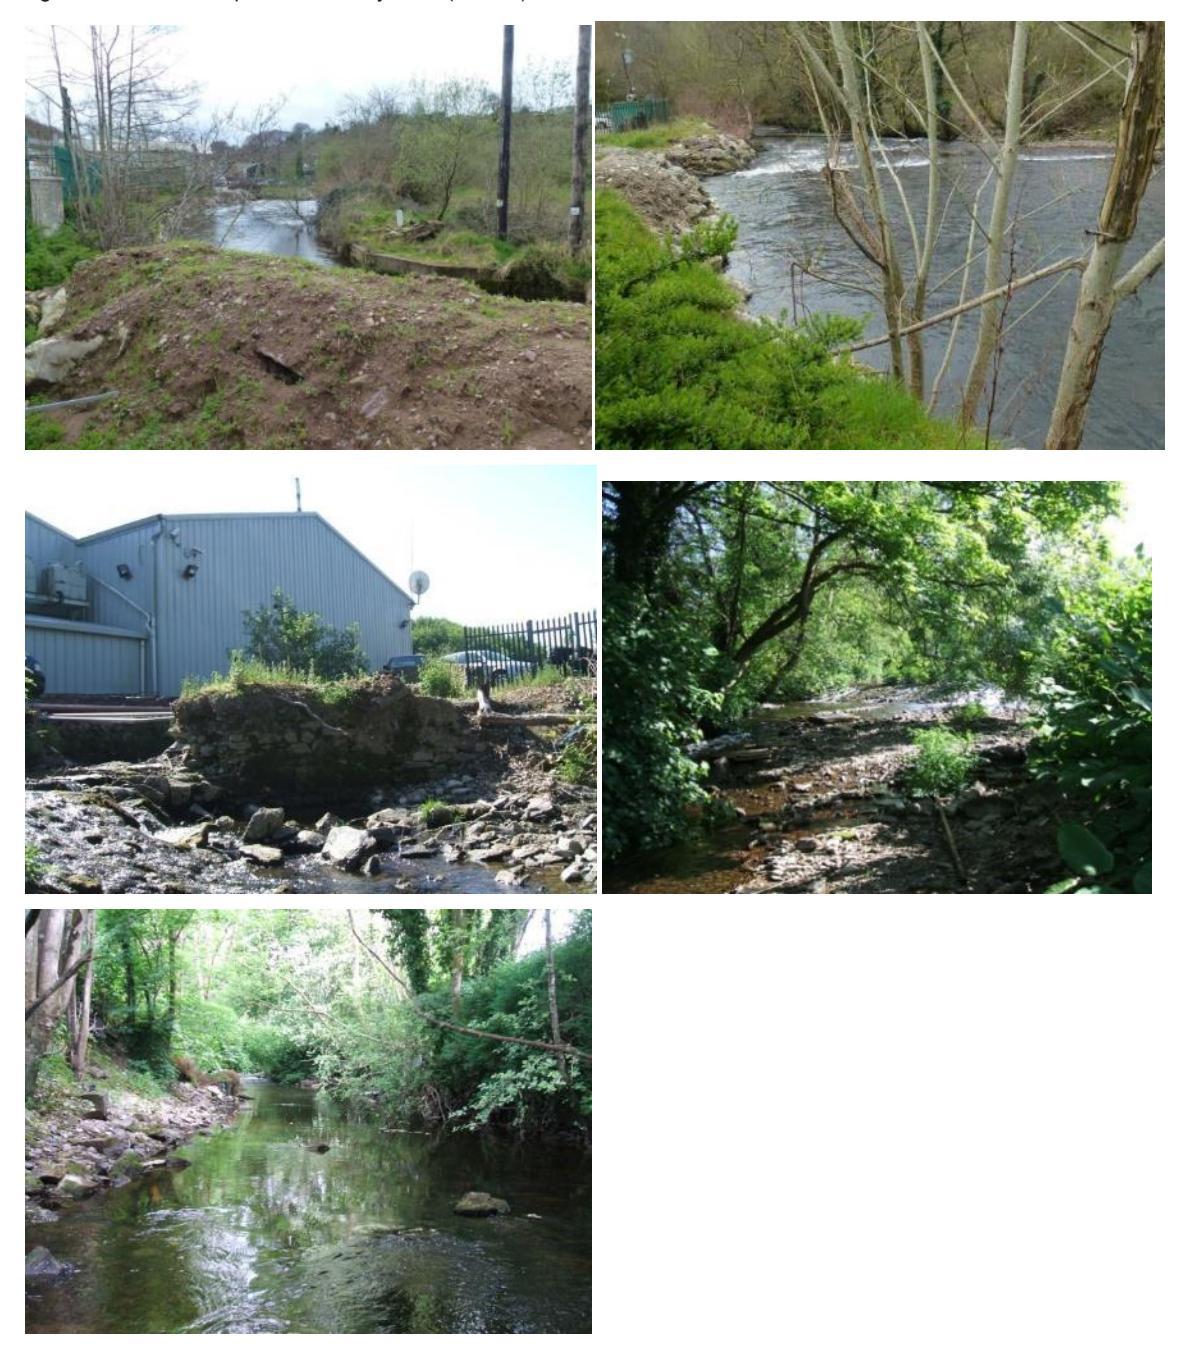
Figure 3-10 Channel upstream of Sallybrook (Point 8)

As the channel approaches Sallybrook the valley widens and becomes less confined. The wider floodplain along this reach has been developed / built upon which acts to constrict the channel. In some areas informal flood embankments have been constructed. In other areas active bank erosion is occurring as the channel attempts to naturally adjust within is confined channel. This is exacerbated by the higher energies during flood conditions as a result of the channel constriction. Hard measures, such as walls have been constructed to reduce the erosional impact of the river (particularly on the outside of bends) and some of these are now failing (such as adjacent to the petrol station). The erosion of banks acts as a strong sediment supply of gravels and fine materials. Deposition is also common through this reach, with several gravel bars (which are unvegetated, signalling frequent movement) being present. However, in the lower portions of the reach the channel becomes incised as a result of the structures the channel is disconnected by over 1m from the floodplain (due to the channel eroding downwards in an attempt to adjust its bed gradient) and deposition is minimal, due to floodplain disconnection and high in channel energy levels. The channel in this lower section is dominated by coarser cobbles.
