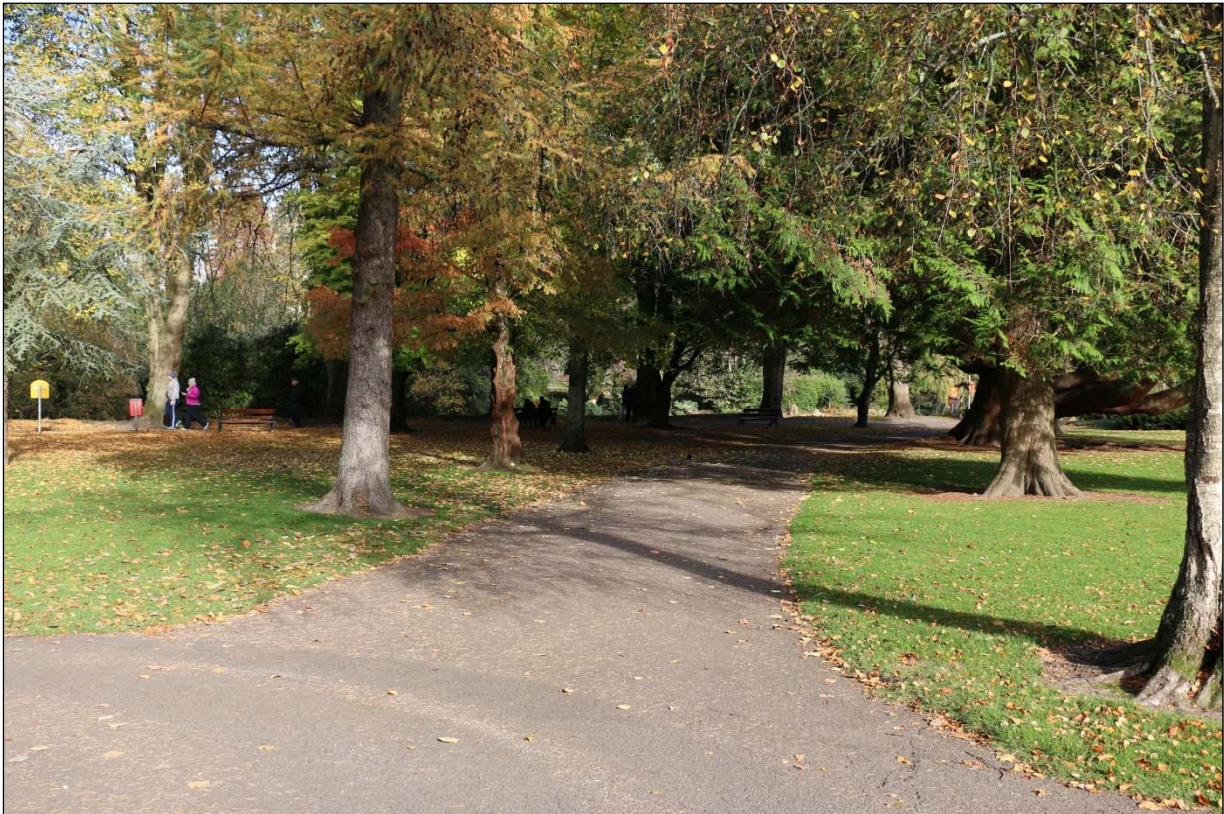
Plate 9.46: Photo Location 14 –Existing View from Fitzgerald's Park

The view is from a walkway at Fitzgerald's Park, over an area of grass and mature trees.

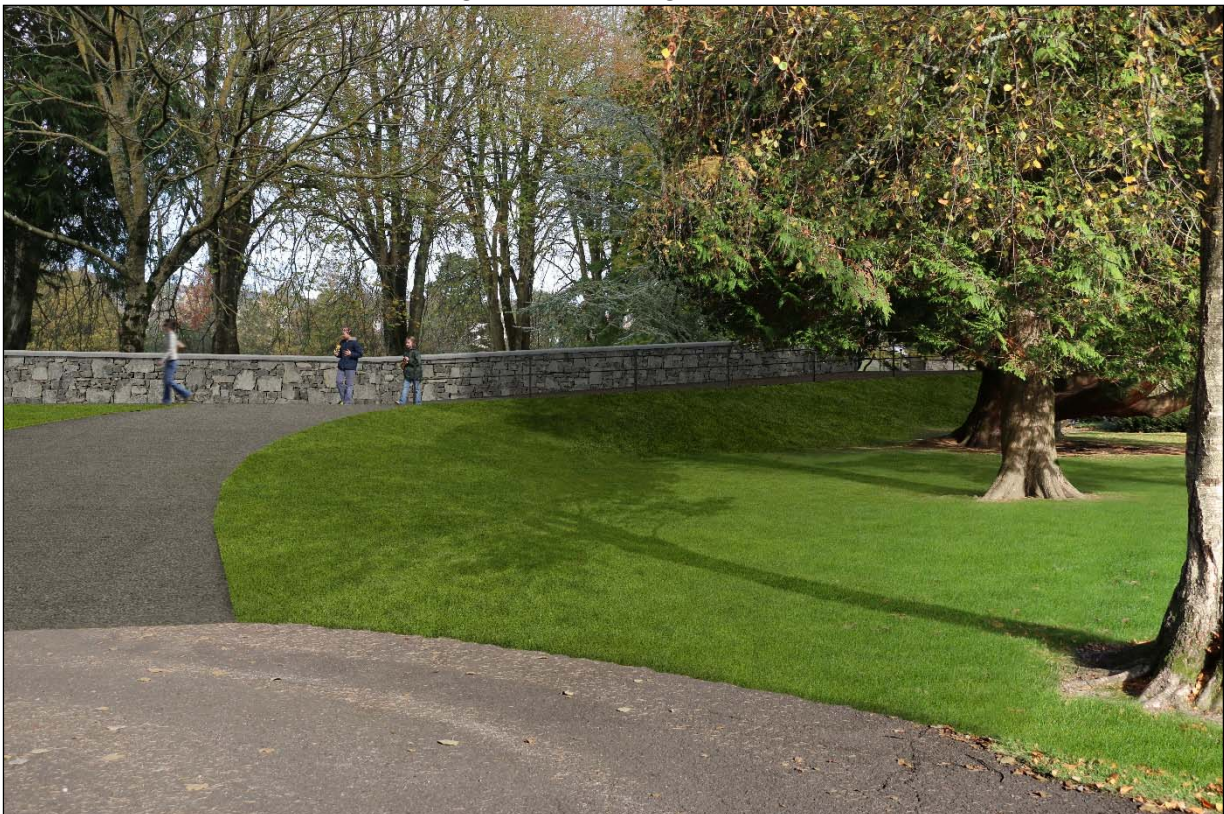
Plate 9.47: Photo Location 14 – Proposed View from Fitzgerald's Park

Visual receptors are considered of high sensitivity in this location, as they are viewers engaged in recreation and enjoyment of the surroundings. A grass embankment and glass wall are seen in the direction of the river bank, and some mature trees are removed. However the removal of trees also opens up some views while the majority are retained.

The change is considered to be of Slight magnitude. The visual impact is considered a Slight, negative visual impact.

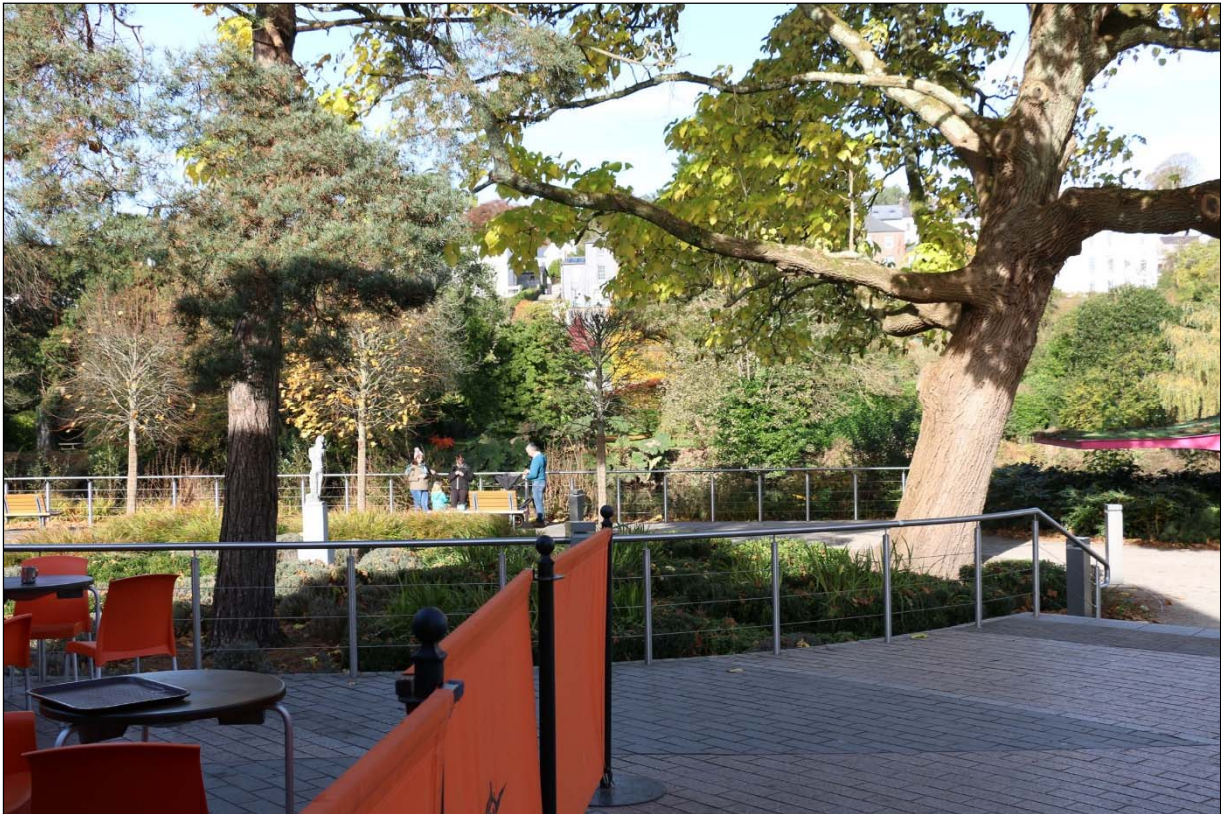
Plate 9.48: Photo Location 15 –Existing View from Fitzgerald's Park

The view is from the rear of the Museum at Fitzgerald's Park, over an area of paving, planting, grass and mature trees.

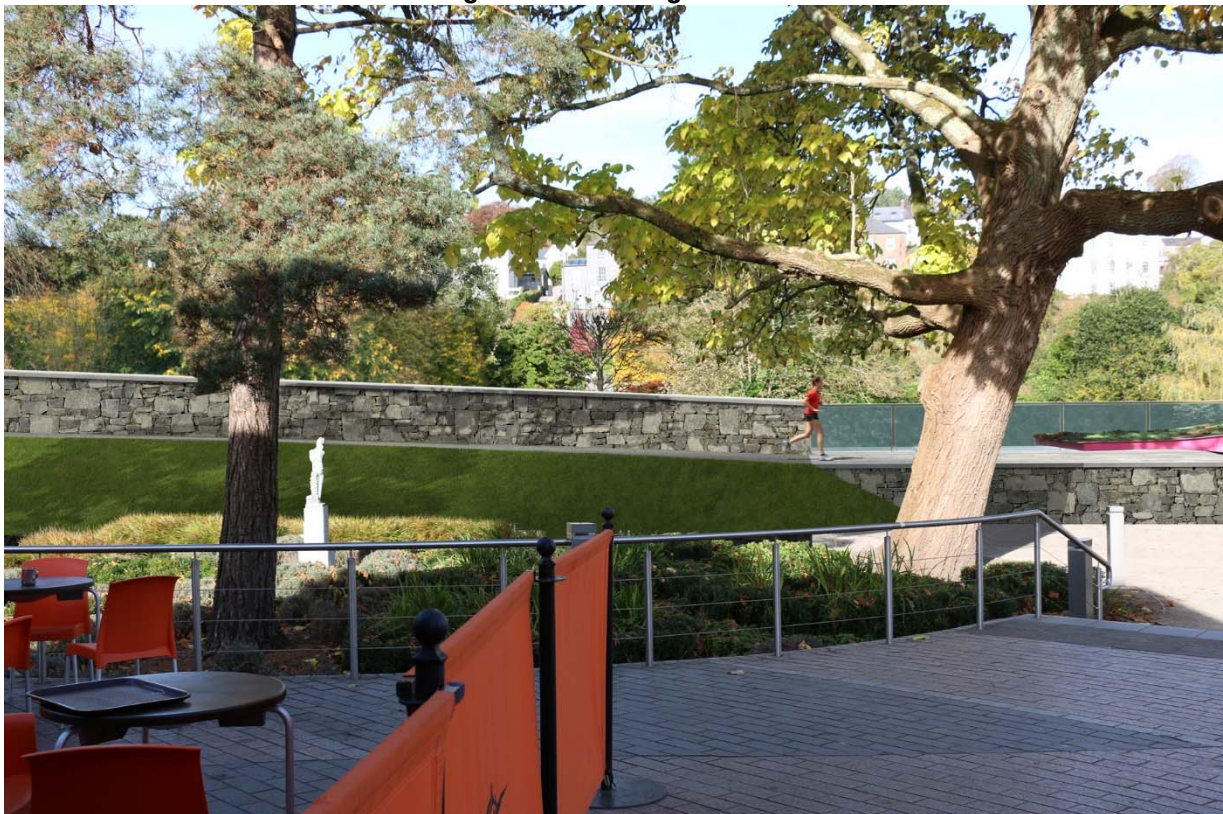
Plate 9.49: Photo Location 15 –Existing View from Fitzgerald's Park

Visual receptors are considered of high sensitivity in this location, as they are viewers engaged in recreation and enjoyment of the surroundings. A grass embankment and glass wall are seen in the direction of the river bank, and some trees are removed. The change is considered to be of Medium = magnitude. The visual impact is considered a Moderate, negative visual impact.

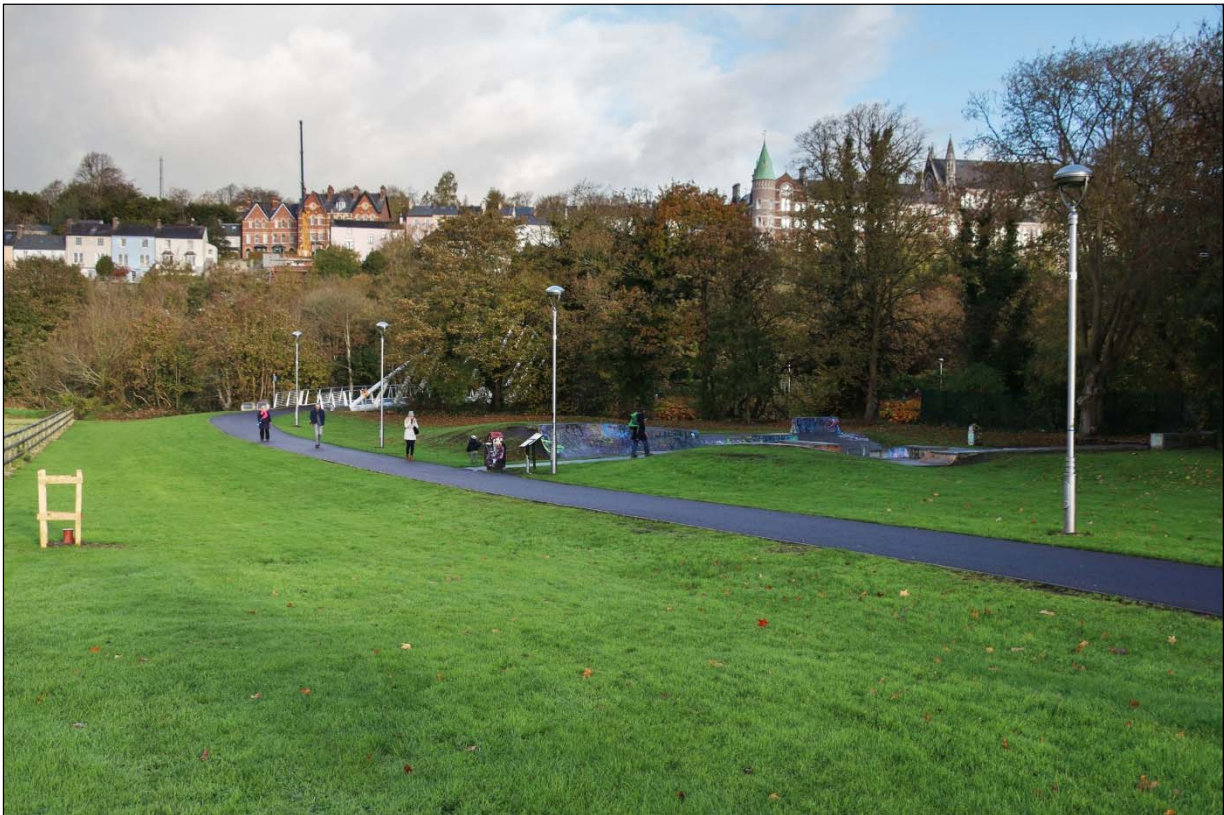
Plate 9.50: Photo Location 16 –Existing View to Mardyke Bridge

The view is from the amenity area and walkway looking towards the Mardyke Bridge.

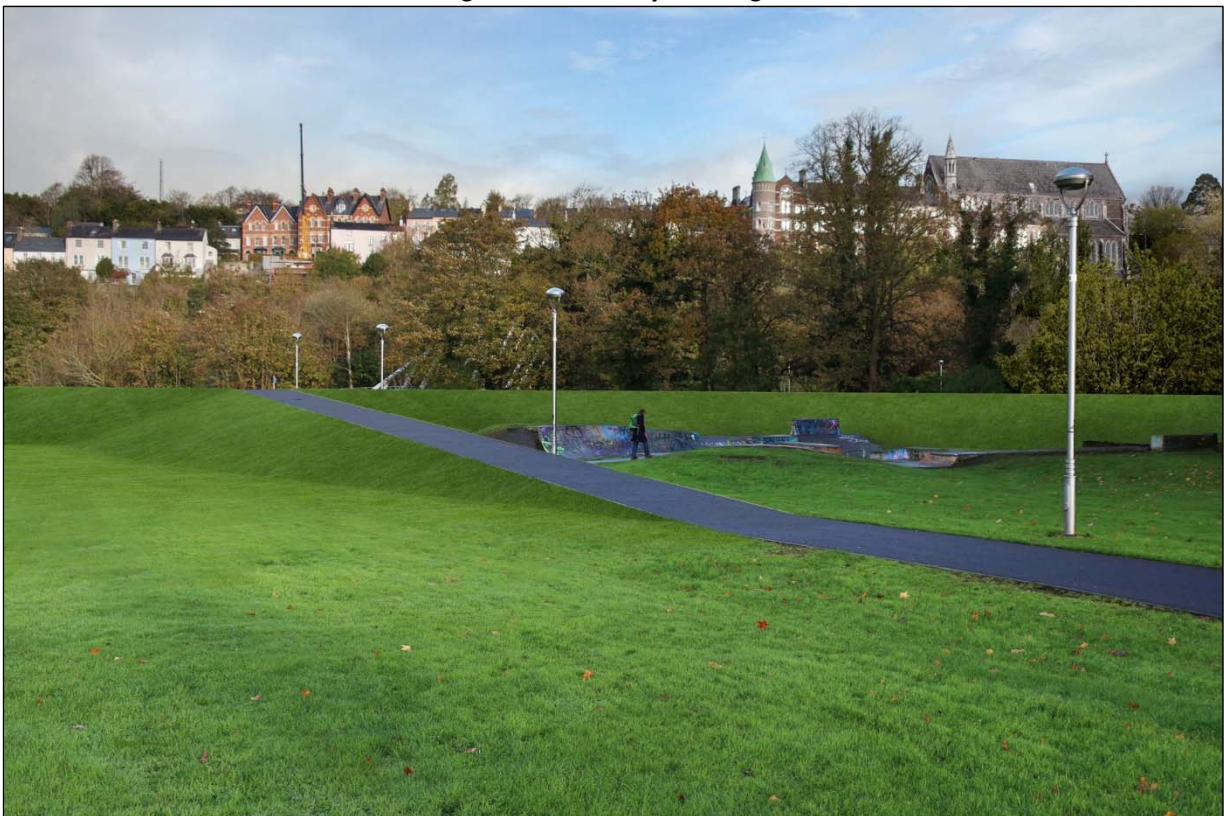
Plate 9.51: Photo Location 16 –Existing View to Mardyke Bridge

Visual receptors are considered of high sensitivity in this location, as they are viewers engaged in recreation and enjoyment of the surroundings. A grass embankment is located to the rear of the skate park, reduces visibility of the bridge, and there is some limited tree removal. The magnitude of change is considered Low and the visual impact is considered Slight negative impact.

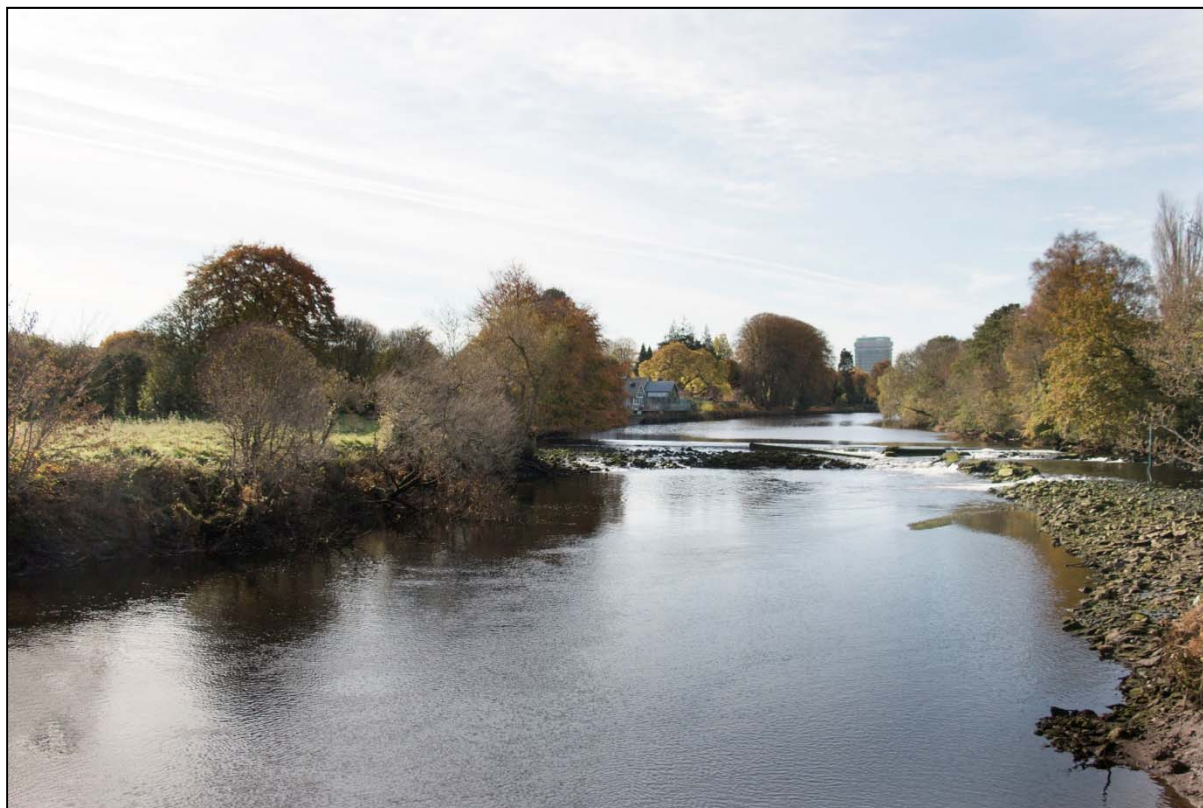
Plate 9.52: Photo Location 17 –Existing View from Mardyke Bridge

The existing view is taken from the Mardyke Bridge looking towards the Sunday's Well tennis club. Mature trees and the river itself are important features of the landscape, and County Hall is seen in the distance.

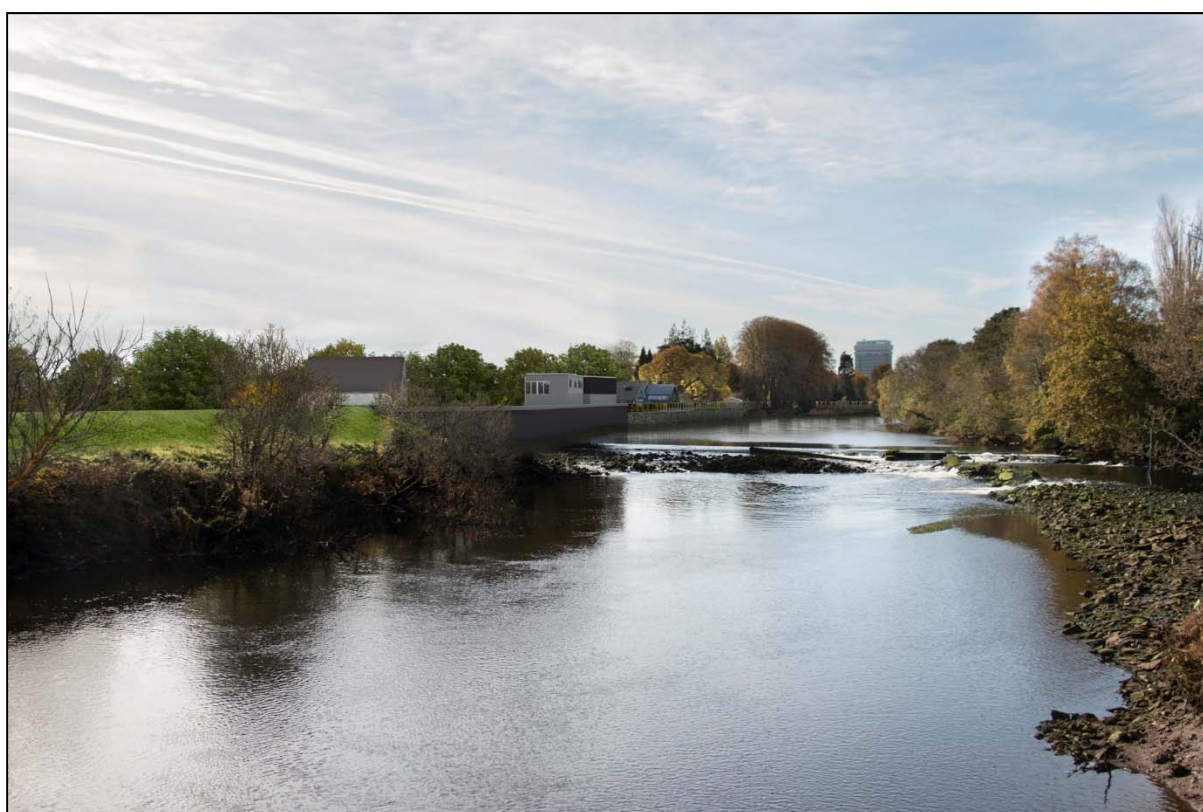
Plate 9.53: Photo Location 17 – Proposed View

The proposed view shows the sheet pile wall which runs downstream from the tennis club along the riverbank, and the embankment set behind the tree line. Some trees will be removed. The viewers at this location are considered to have high sensitivity to change. The magnitude of the change is considered Moderate, The visual impact is considered Moderate negative visual impact.

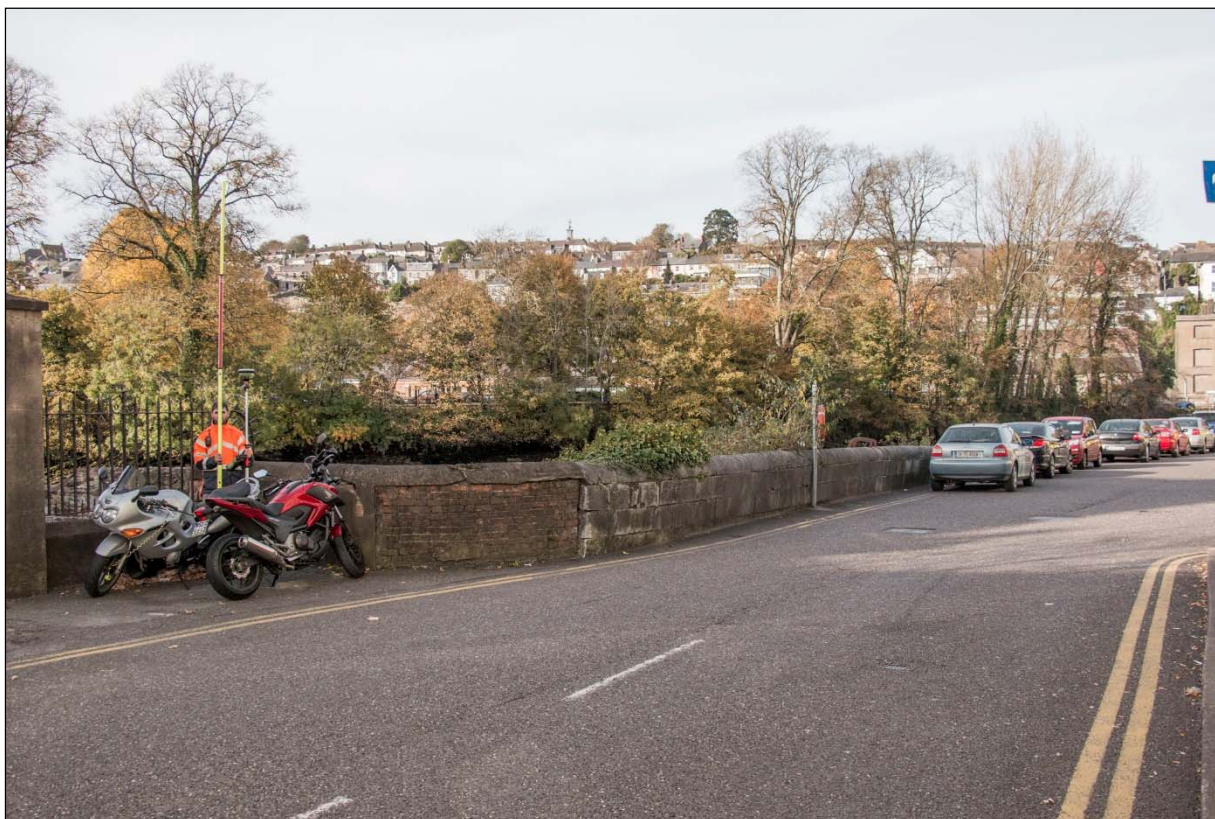
Plate 9.54: Photo Location 18 –Existing View

The existing view is taken from the Grenville Place looking across the river with the road in the foreground.

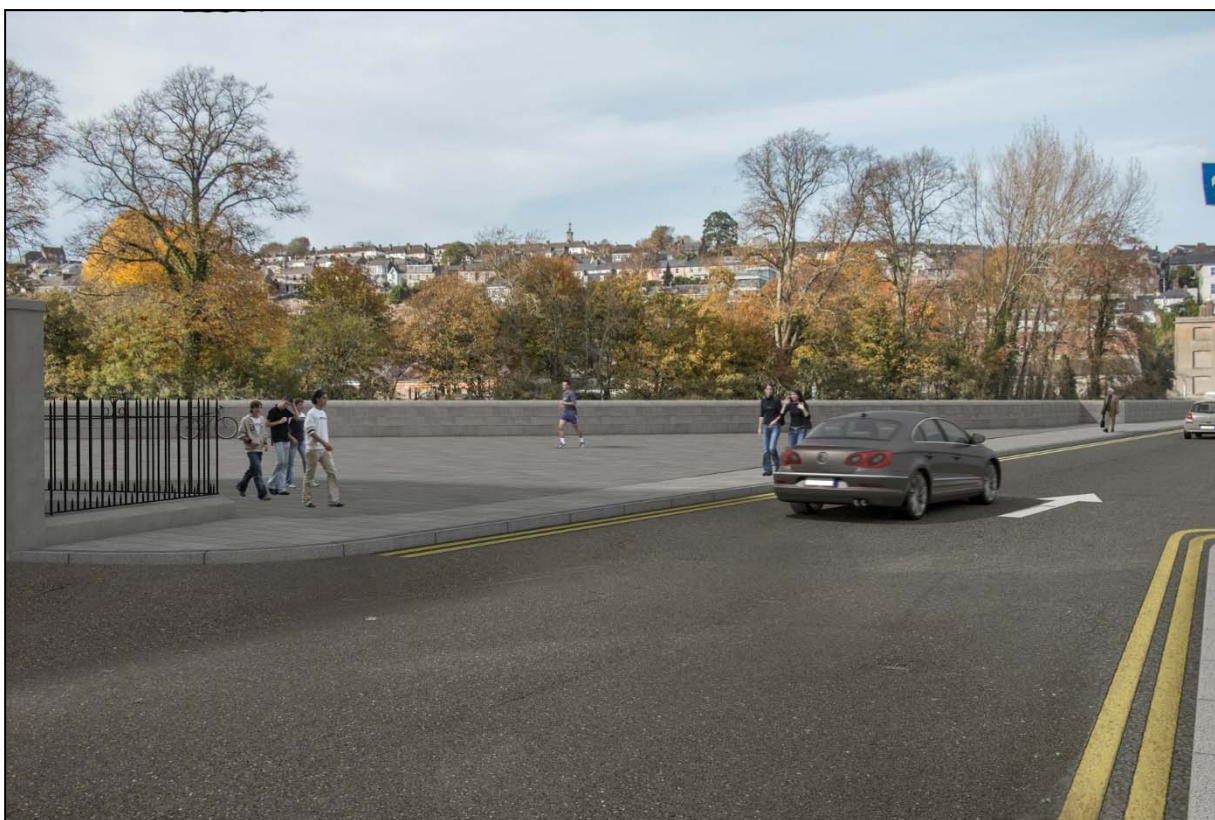
Plate 9.55: Photo Location 18 –Proposed View

The proposed view shows the reclaimed land which is hard surfaced as a public space, and the proposed flood defence wall. Views across the river to the trees on the Distillery Fields remain.

The magnitude of change is considered Medium and the visual receptor Medium, and the visual impact is considered Moderate negative impact.

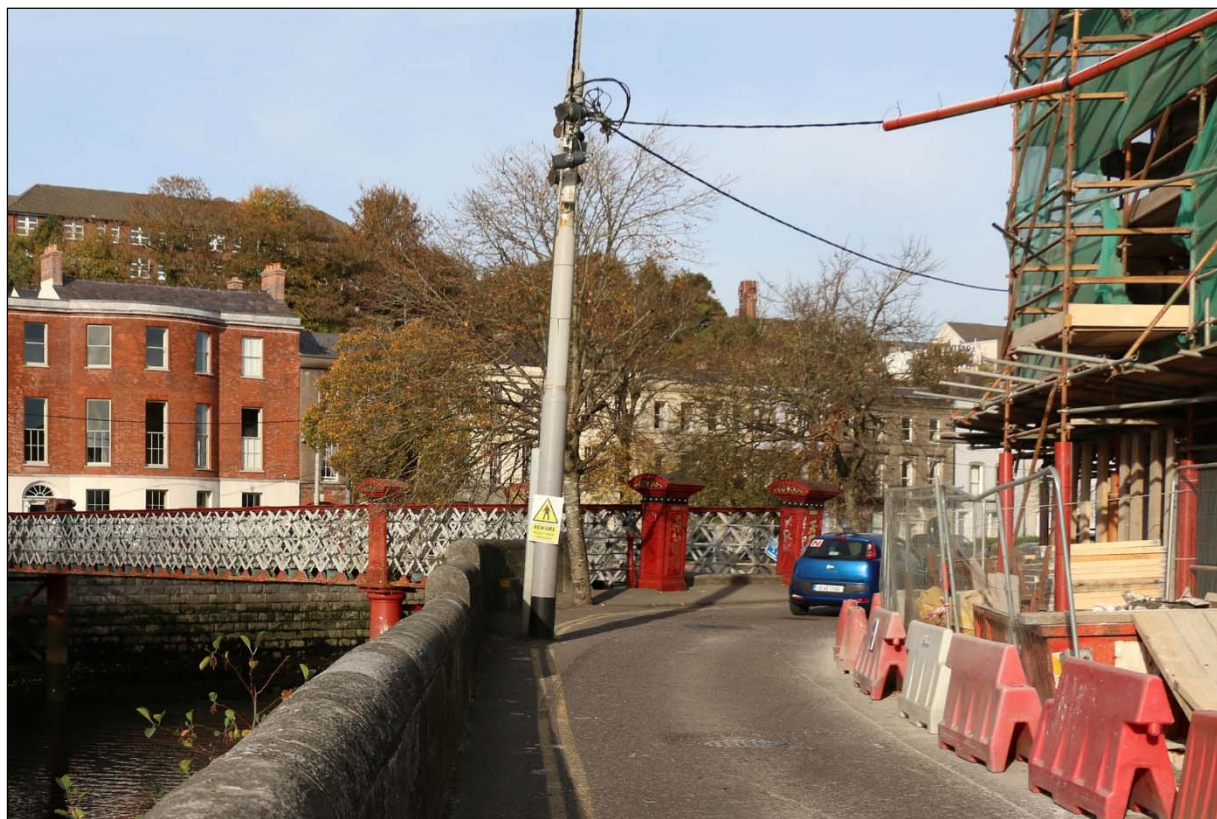
Plate 9.56: Photo Location 19 –Existing View

The existing view is taken from the Grenville Place looking across the river towards St Vincent's Bridge and North Mall, with the road in the foreground.

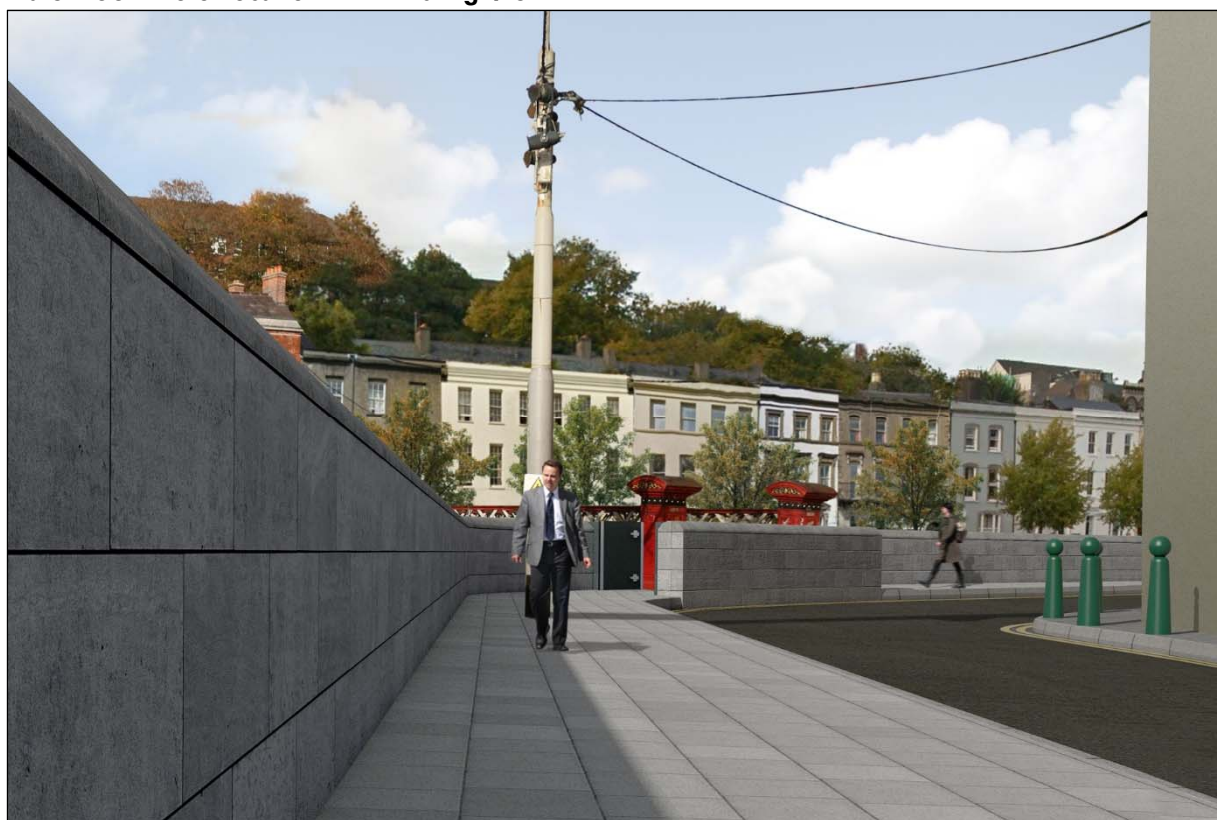
Plate 9.57: Photo Location 19 –Proposed View

The proposed view shows the flood defence walls and raised road level as well as flood gates to the bridge. Because of the raised road level, the camera height appears lower and therefore gives a view from a level lower than will be experienced by the viewer. The flood defence structure does impair views of the bridge.

The magnitude of change is considered Medium and the visual receptor Medium, and the visual impact is considered Moderate negative impact.

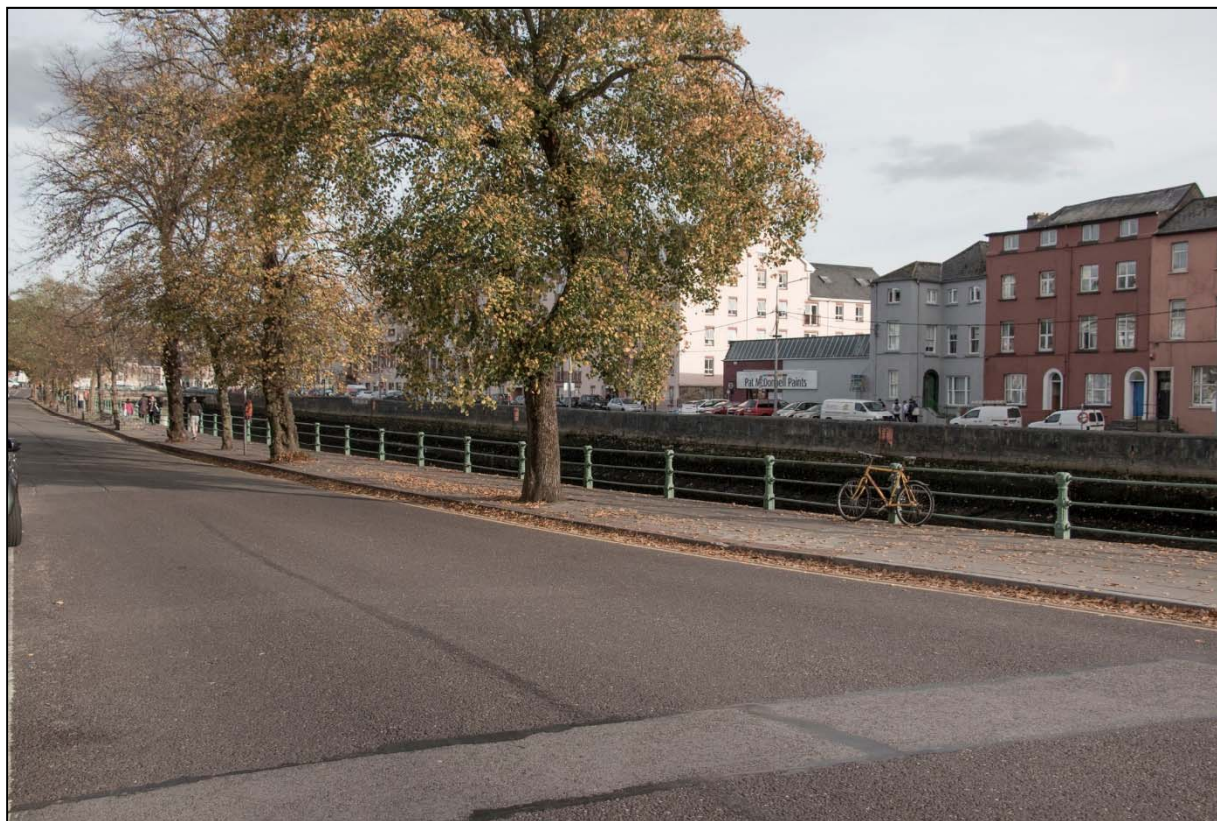
Plate 9.58: Photo Location 20 – Existing View

The existing view is taken from the North Mall. The view shows a street which borders the river, which is shown at low flow, and the railings allow open views both to the river and along the riverbank. In the foreground, along the riverbank, are railings and mature street trees. The quay walls on the opposite bank are visible, as are the buildings. It should be noted that at times of high tide, the river will appear as more of a feature in this view.

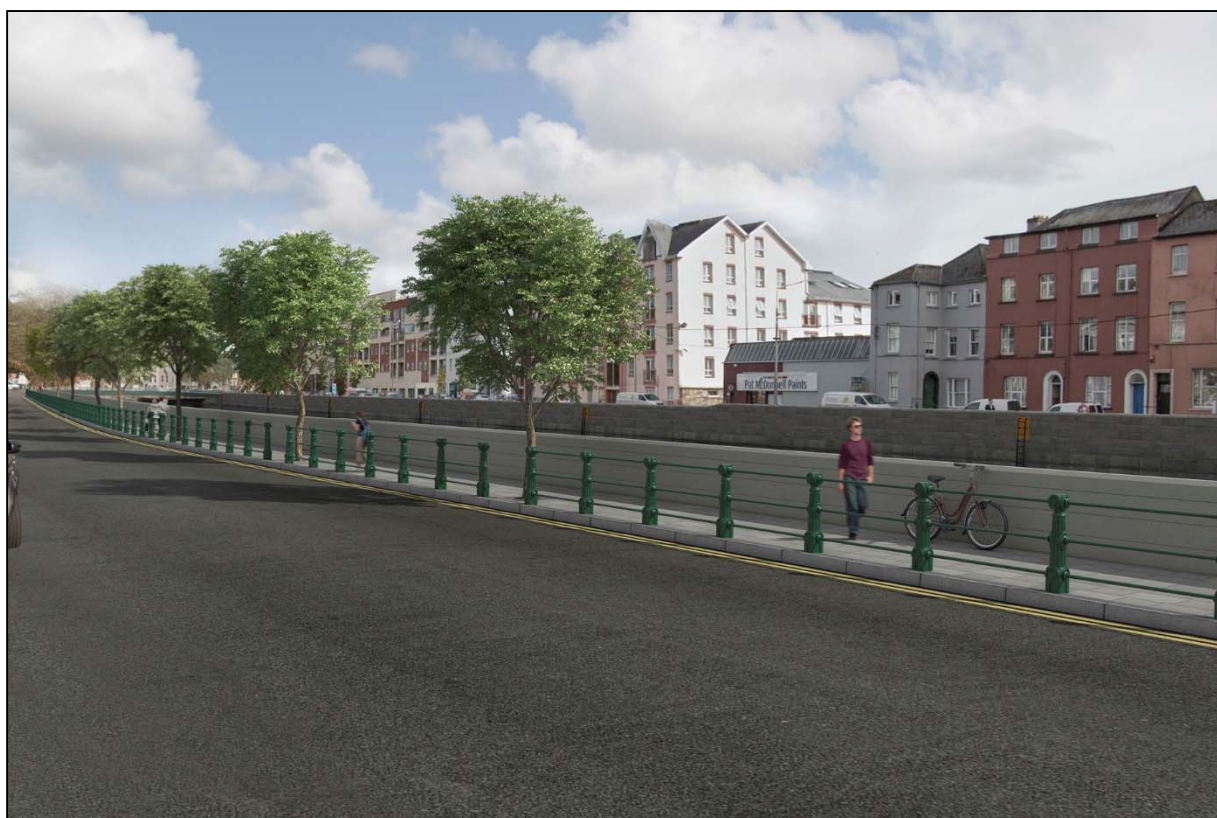
Plate 9.59: Photo Location 20–Proposed View

The proposed view illustrates the proposed works, which show the road in the foreground to be regraded, and existing railings to be moved to the roadside of the pavement. A concrete wall is shown which restricts the view of the river from this angle. The refurbished quay wall which has increased in height, is visible across the river and considerably restricts views to the street opposite as well as down the North Mall. The street trees are replaced. The visual receptor is considered to be of medium sensitivity in this location, while the magnitude of the change is considered to be high. The overall impact is considered Permanent, Significant negative visual impact.

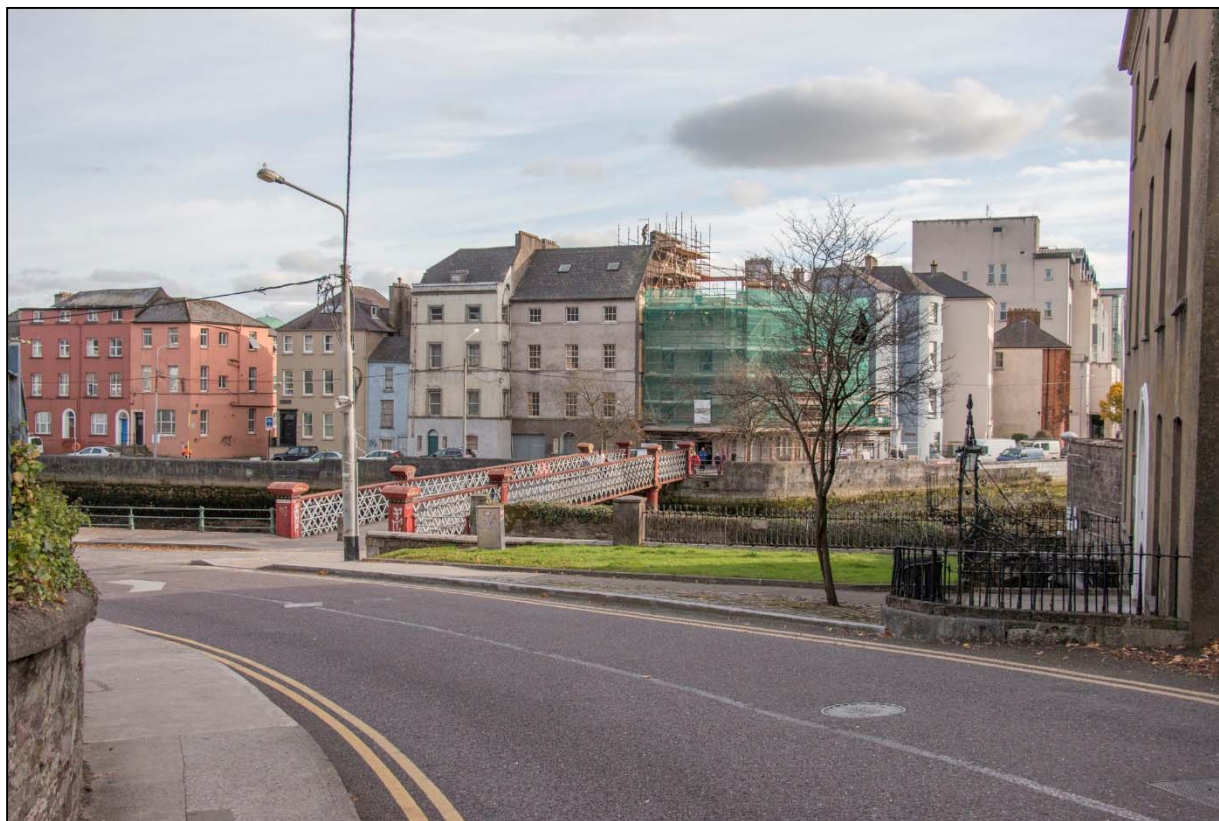
Plate 9.60: Photo Location 21– Existing View

The existing view is taken from the North Mall. The view shows a street which borders the river, which is shown at low flow, and the railings allow open views both to the river and along the riverbank. In the foreground, along the riverbank, are railings and mature street trees. The quay walls on the opposite bank are visible, as are the buildings. It should be noted that at times of high tide, the river will appear as more of a feature in this view.

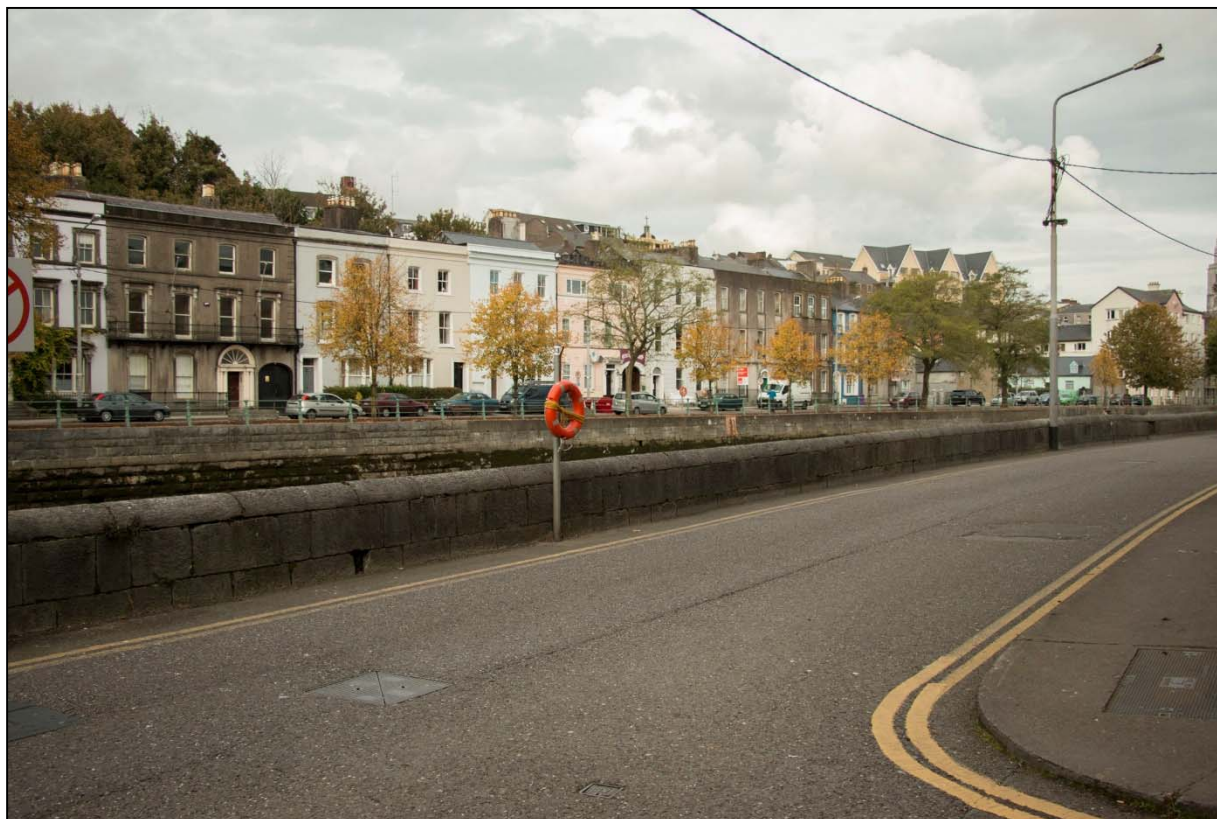
Plate 9.62: Photo Location 22 –Existing View

The existing view is taken from Bachelor's Quay looking towards the North Mall. The view is close to a protected view looking to the North Mall.

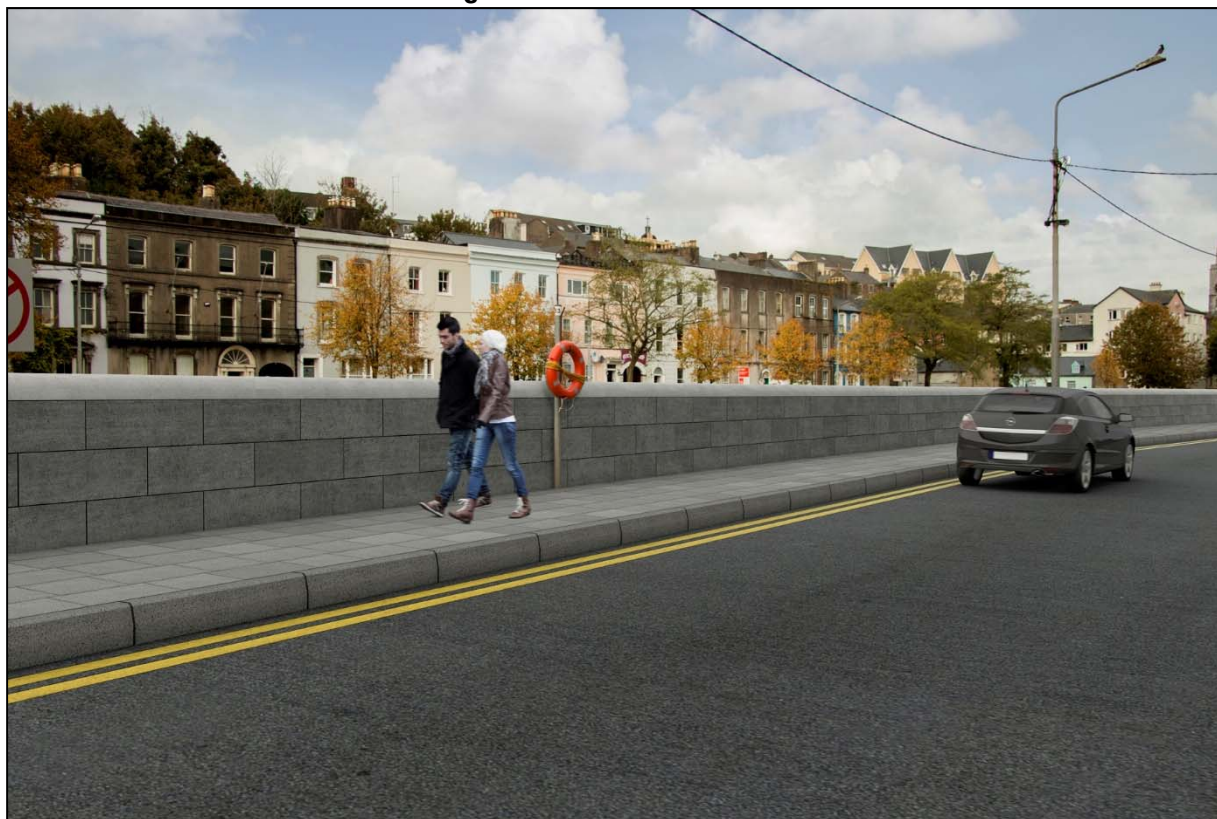
Plate 9.63: Photo Location 22 –Proposed View

The proposed view illustrates the proposed works, which show the road in the foreground to be regraded, and the existing wall to be raised in height which blocks some of the view across the river and to the river itself.

The visual receptor is considered to be of high sensitivity in this location, while the magnitude of the change is considered to be Medium. The overall impact is considered Moderate to Significant negative visual impact.

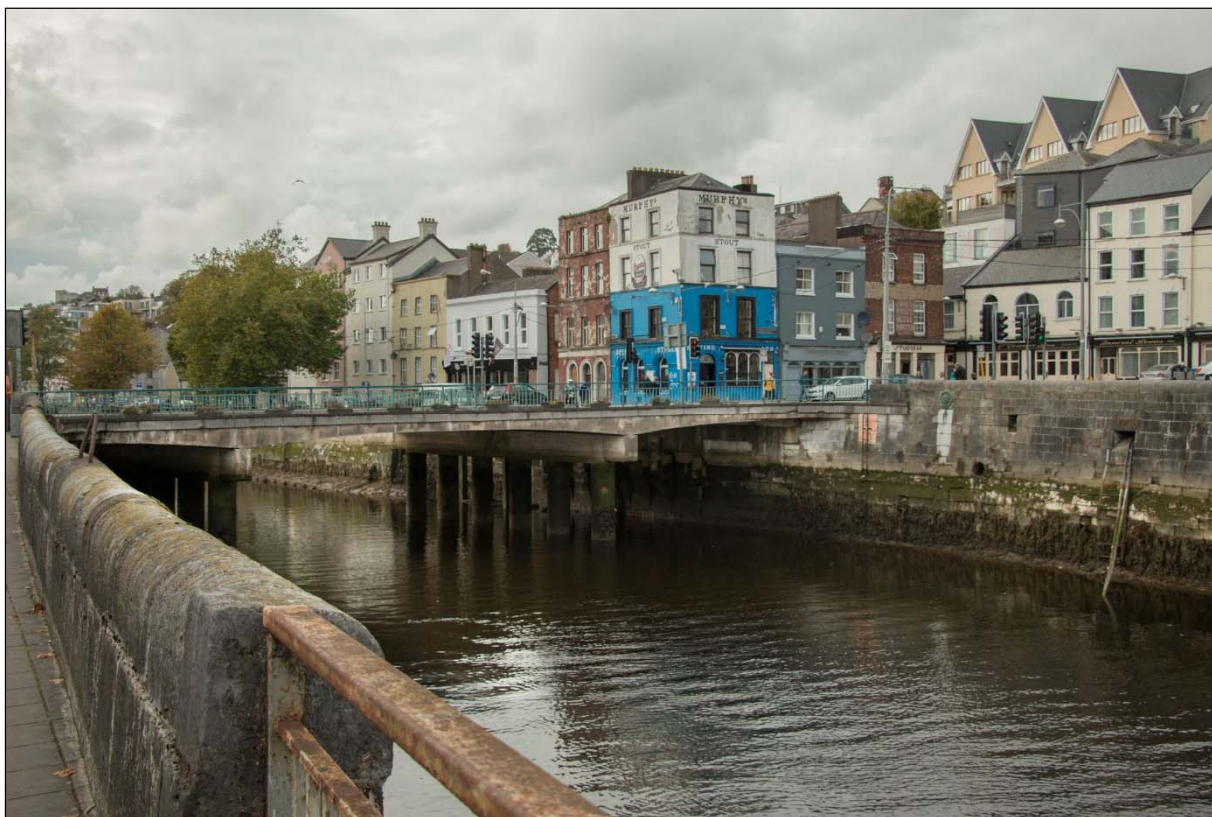
Plate 9.64: Photo Location 23 –Existing View

The existing view is taken from looking towards the North Gate Bridge.

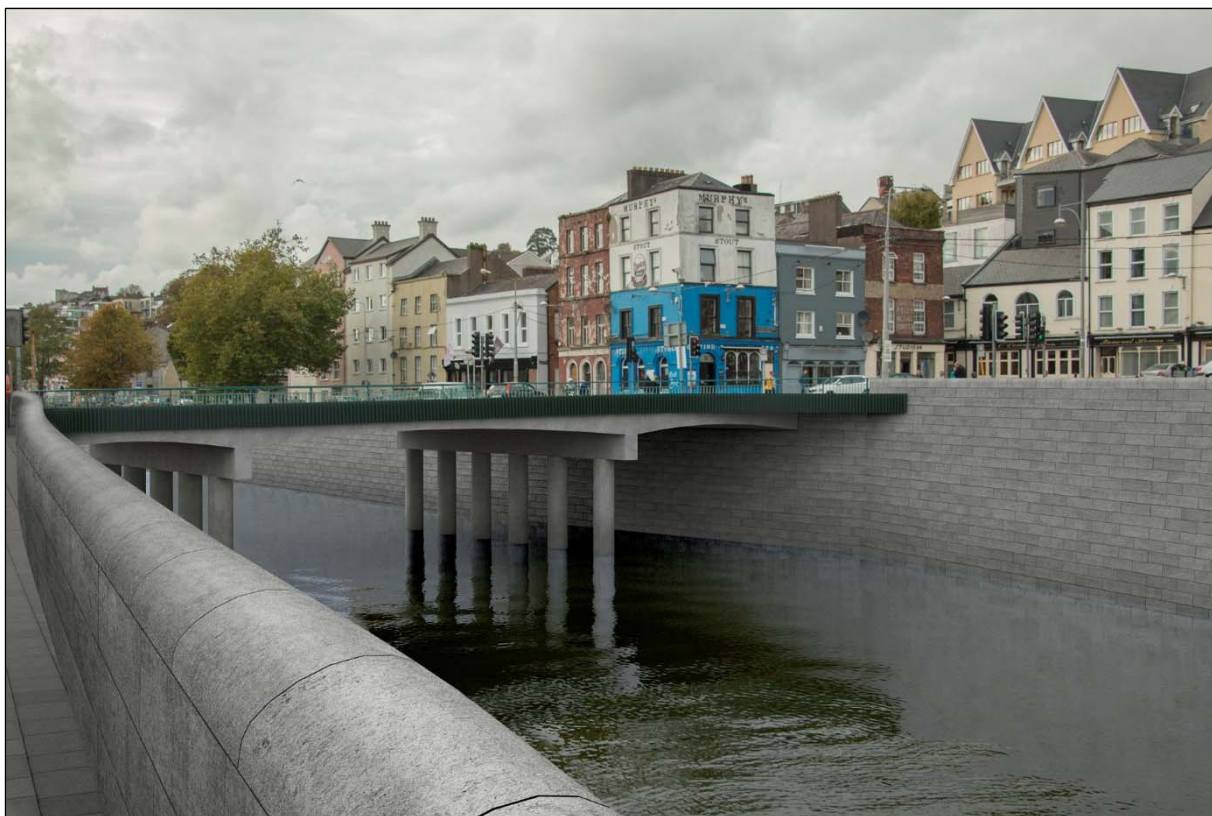
Plate 9.65: Photo Location 23 – Proposed View

The proposed view illustrates the proposed works to the quay walls and to the bridge.

The visual receptor is considered to be of low to medium in this location, while the magnitude of the change is considered to be Low. . The overall impact is considered Slight neutral to negative visual impact.

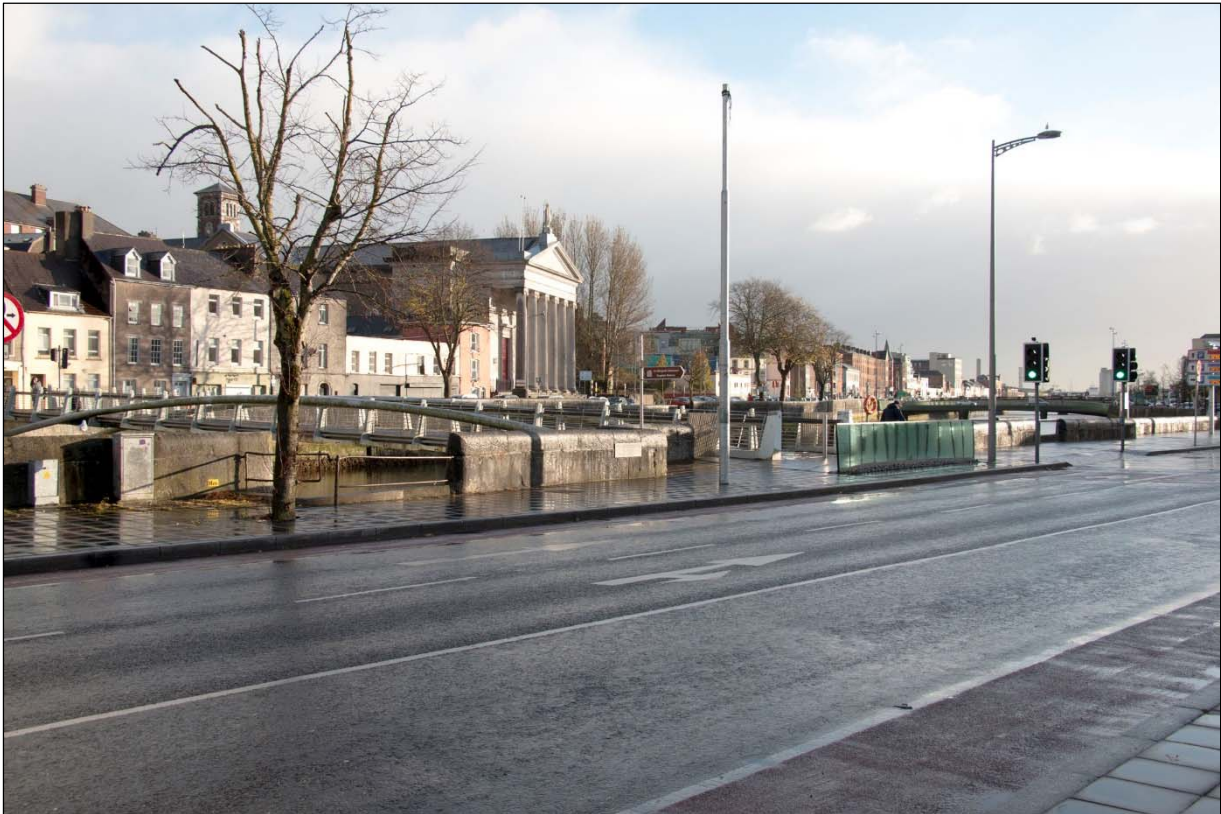
Plate 9.66: Photo Location 24 –Existing View

The existing view is taken from looking towards Popes Quay and the pedestrian bridge.

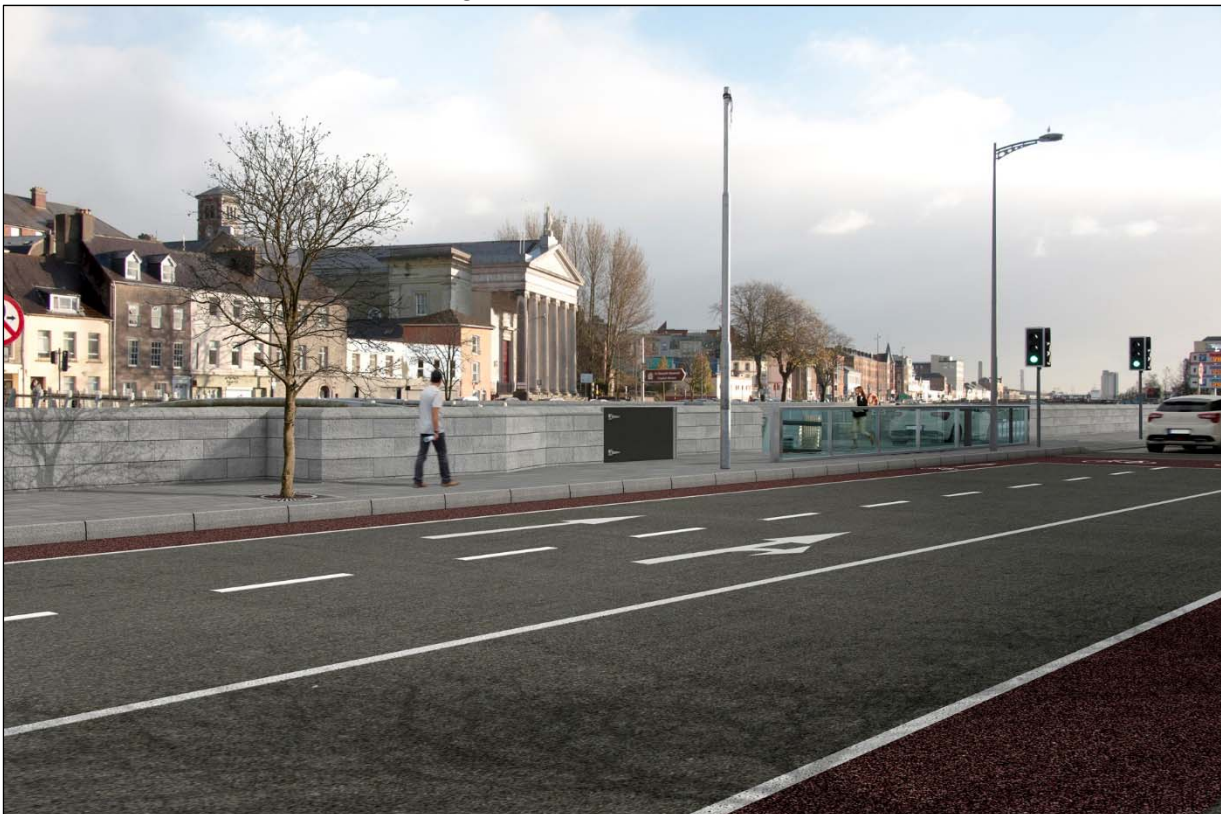
Plate 9.67 Photo Location 24 –Proposed View

The proposed view illustrates the proposed works to the quay walls, the removal of access to the river and the flood gates.

The visual receptor is considered to be of low to medium in this location, while the magnitude of the change is considered to be Low. The overall impact is considered Slight negative visual impact.
