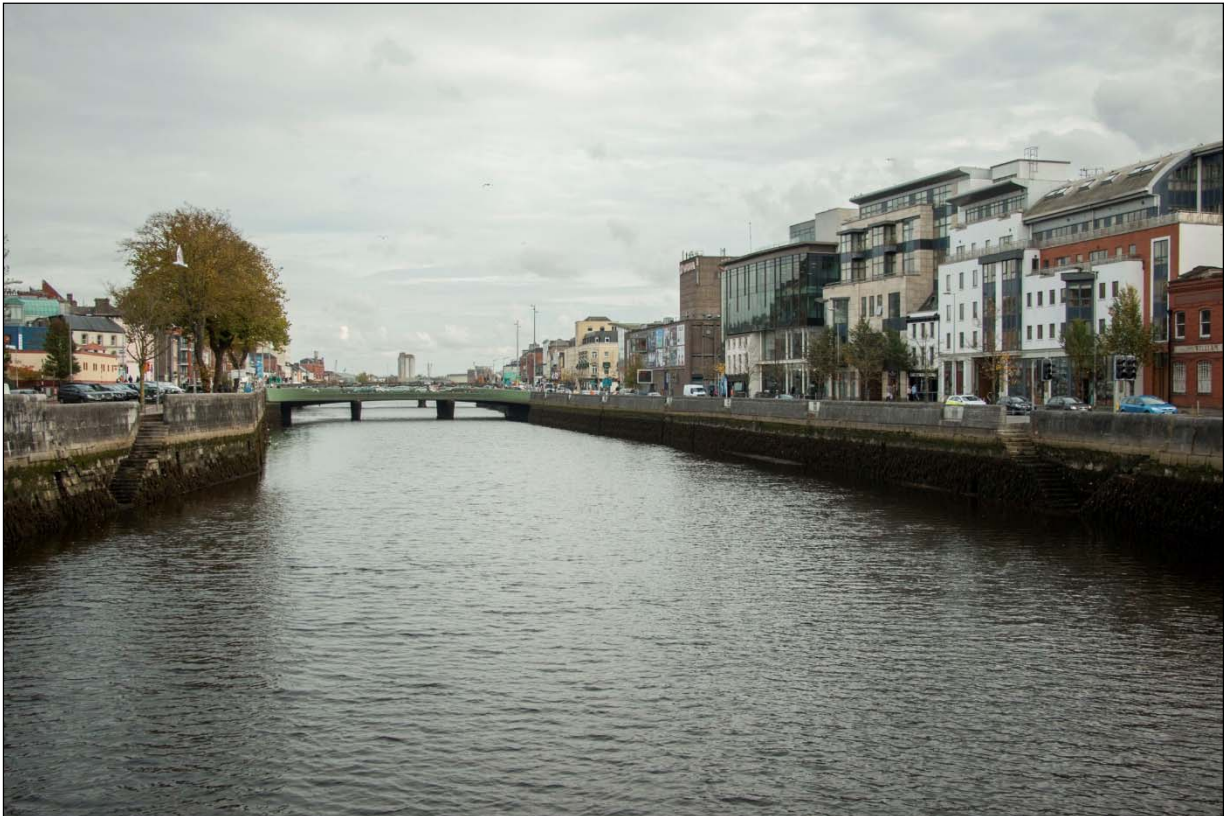
Plate 9.68 Photo Location 25 –Existing View

The existing view is taken from looking towards Lavitts Quay, looking downstream along the river and towards the Opera House Bridge.

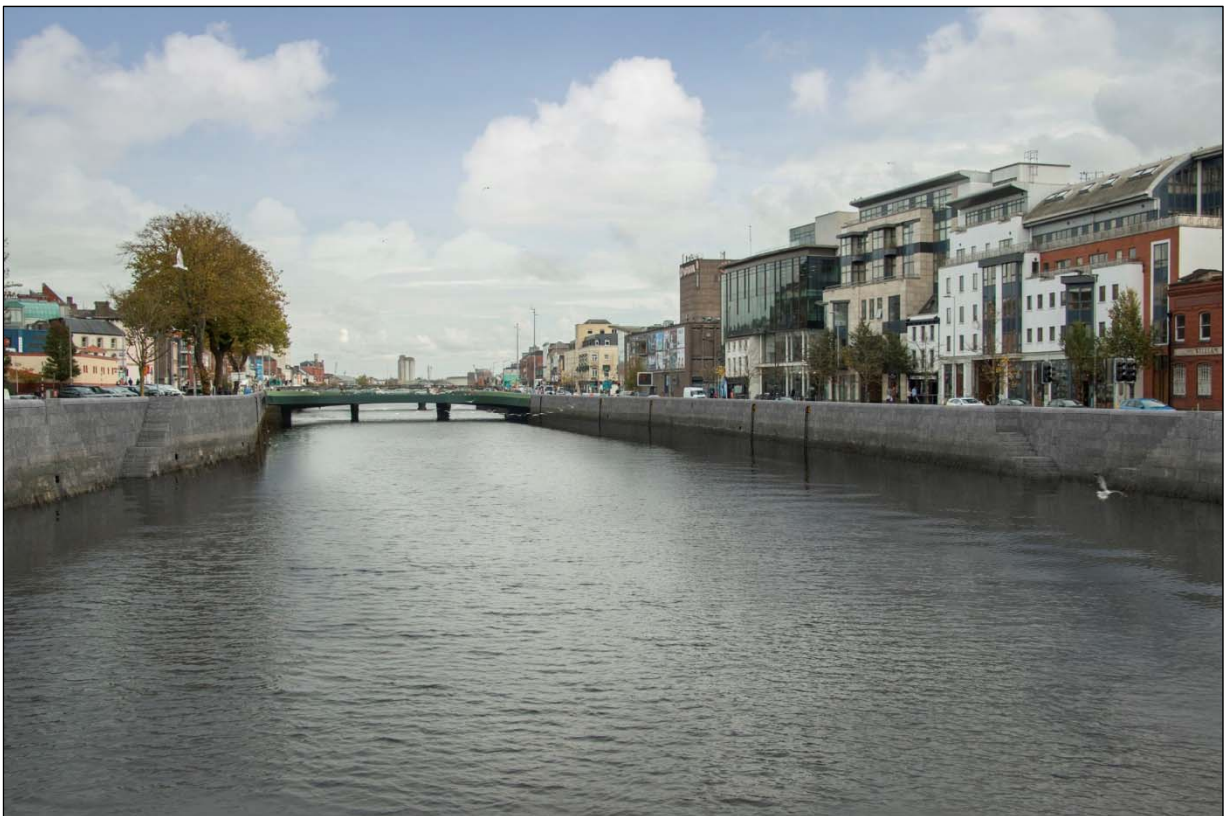
Plate 9.69 Photo Location 25 –Proposed View

The proposed view illustrates the proposed works to the quay walls, and extended steps which currently provide access to the river .

The visual receptor is considered to be of low to medium in this location, while the magnitude of the change is considered to be Low. The overall impact is considered Slight neutral visual impact.

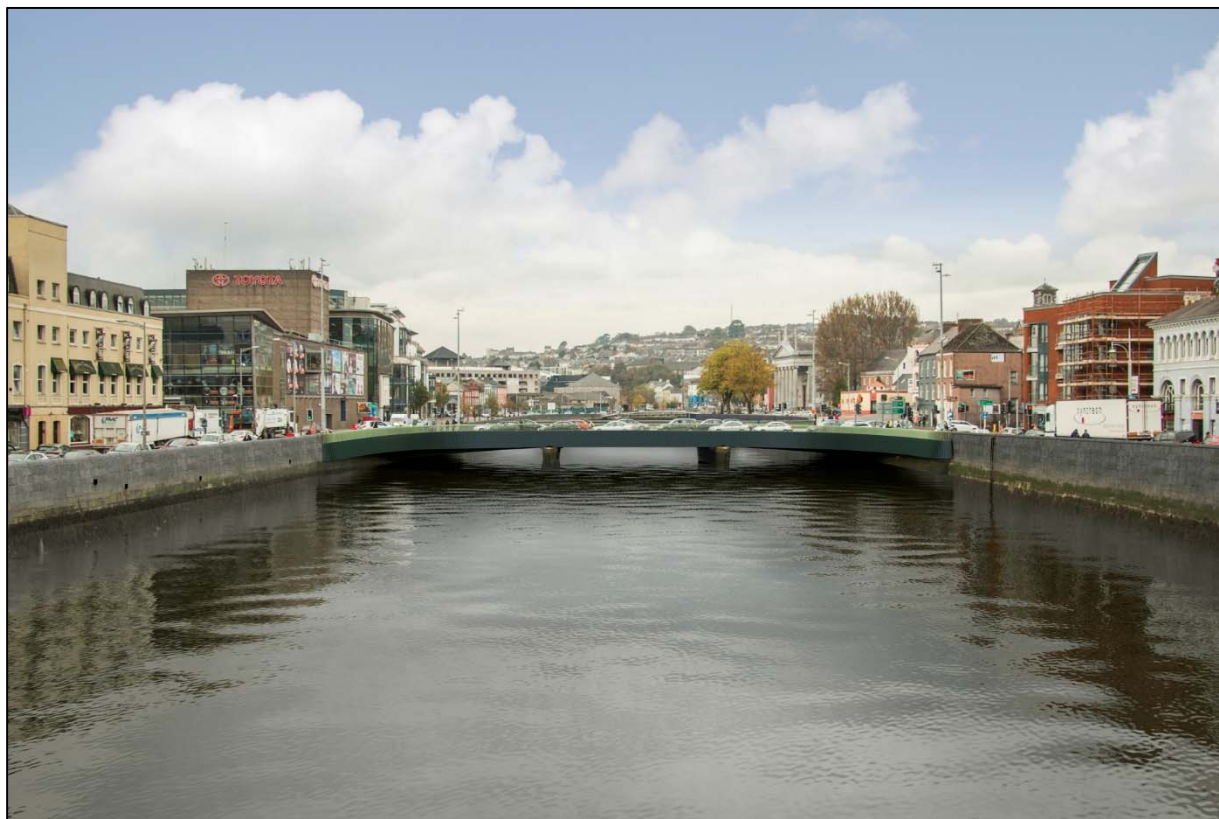
Plate 9.70 Photo Location 26 –Existing View

The existing view is taken from looking towards the Opera House on Lavitts Quay and Camden Quay, looking upstream along the river and towards the Opera House bridge.

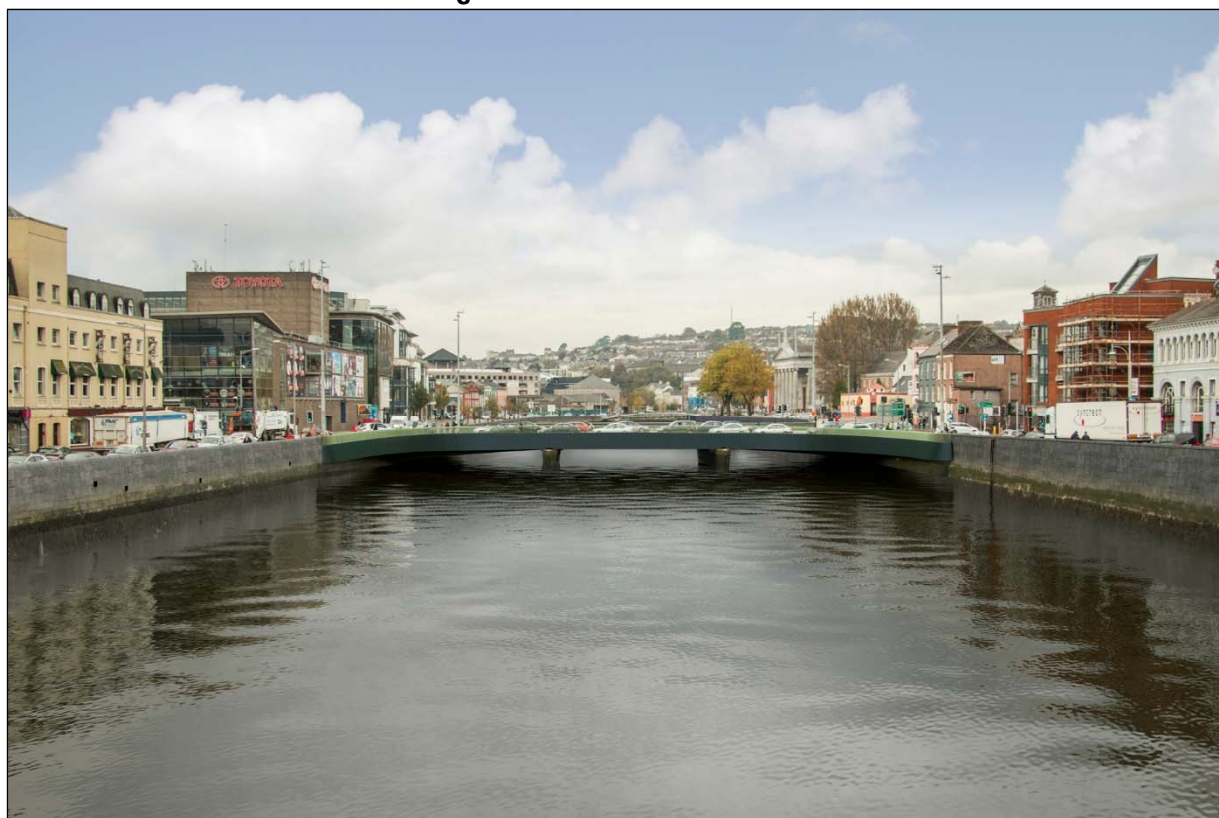
Plate 9.71 Photo Location 26 –Proposed View

The proposed view illustrates the proposed works to the quay walls, and some road regrading along the quays. The visual receptor is considered to be medium in this location, while the magnitude of the change is considered to be Low. The overall impact is considered Slight neutral visual impact.

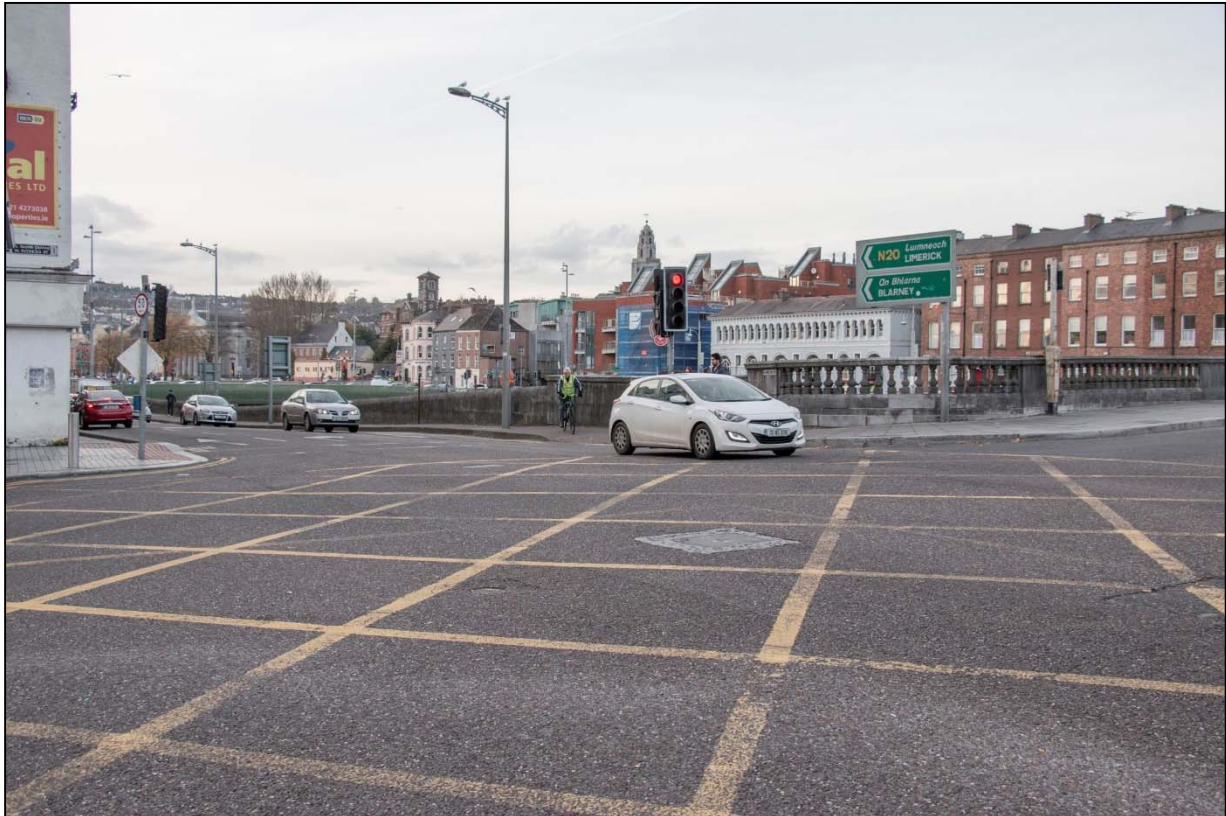
Plate 9.72 Photo Location 27 –Existing View

The existing view is taken from St Patrick's Street, looking towards Lavitt's Quay and Patrick's Bridge.

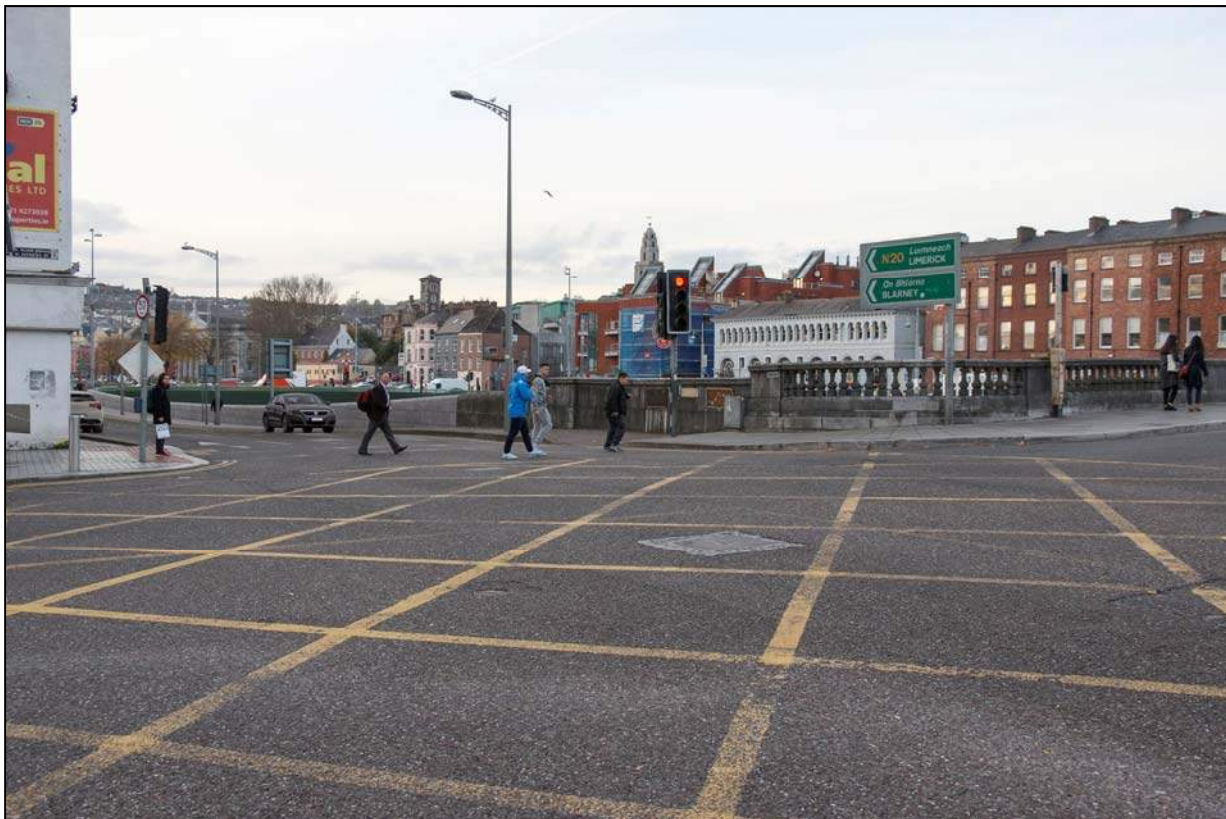
Plate 9.73 Photo Location 27 – Proposed View

The proposed view shows the railings of the bridge in the foreground along the river bank are retained. There are changes to the quay wall along Lavitt's Quay at some distance from the viewer. It is considered that the visual receptors in this location are of medium sensitivity, combining groups of people who are walking and driving in close proximity to the river, and may be engaged in travel, recreation, or enjoyment of the surrounds. The magnitude of change is considered to be Low. The visual impact is considered to be Imperceptible Negative visual impact.

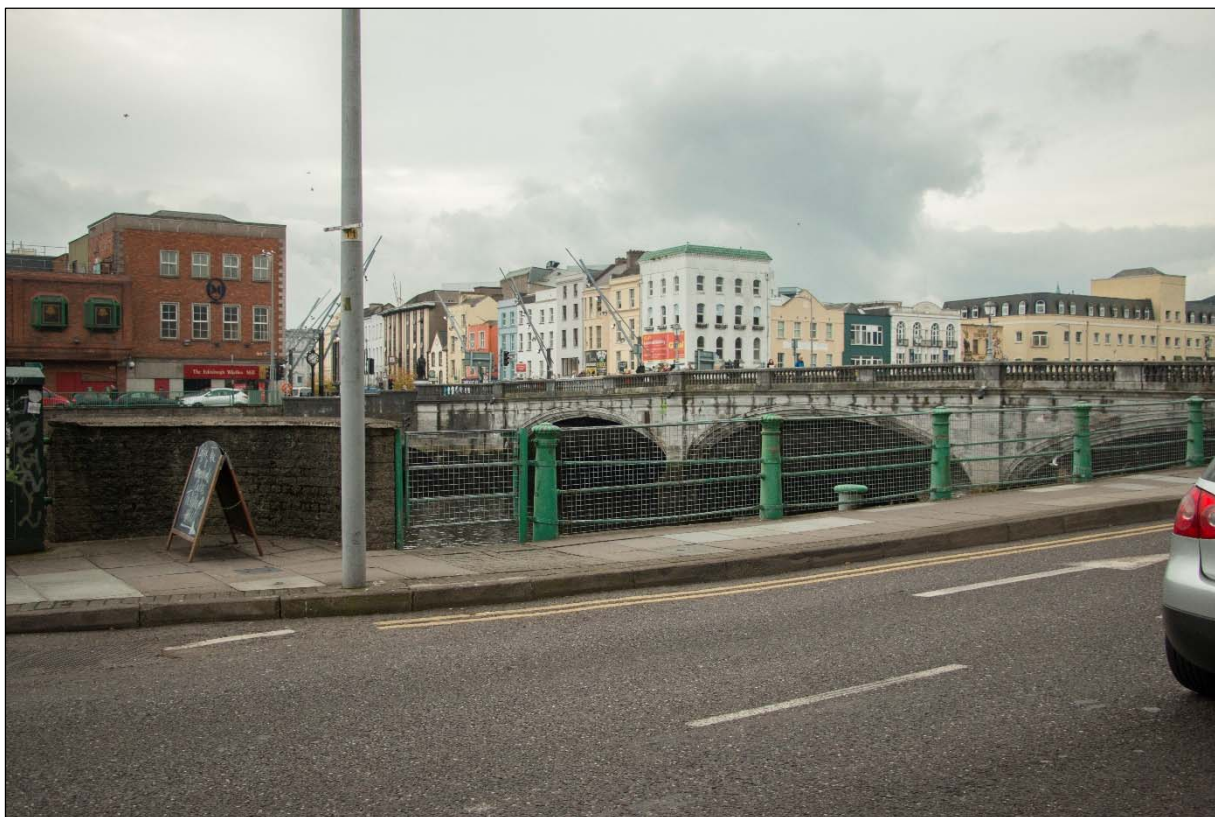
Plate 9.74 Photo Location 28 –Existing View

The existing view is taken from Patrick's Quay looking towards St Patrick's Bridge and Patrick St., with railings in the foreground allowing views of the river and streets.

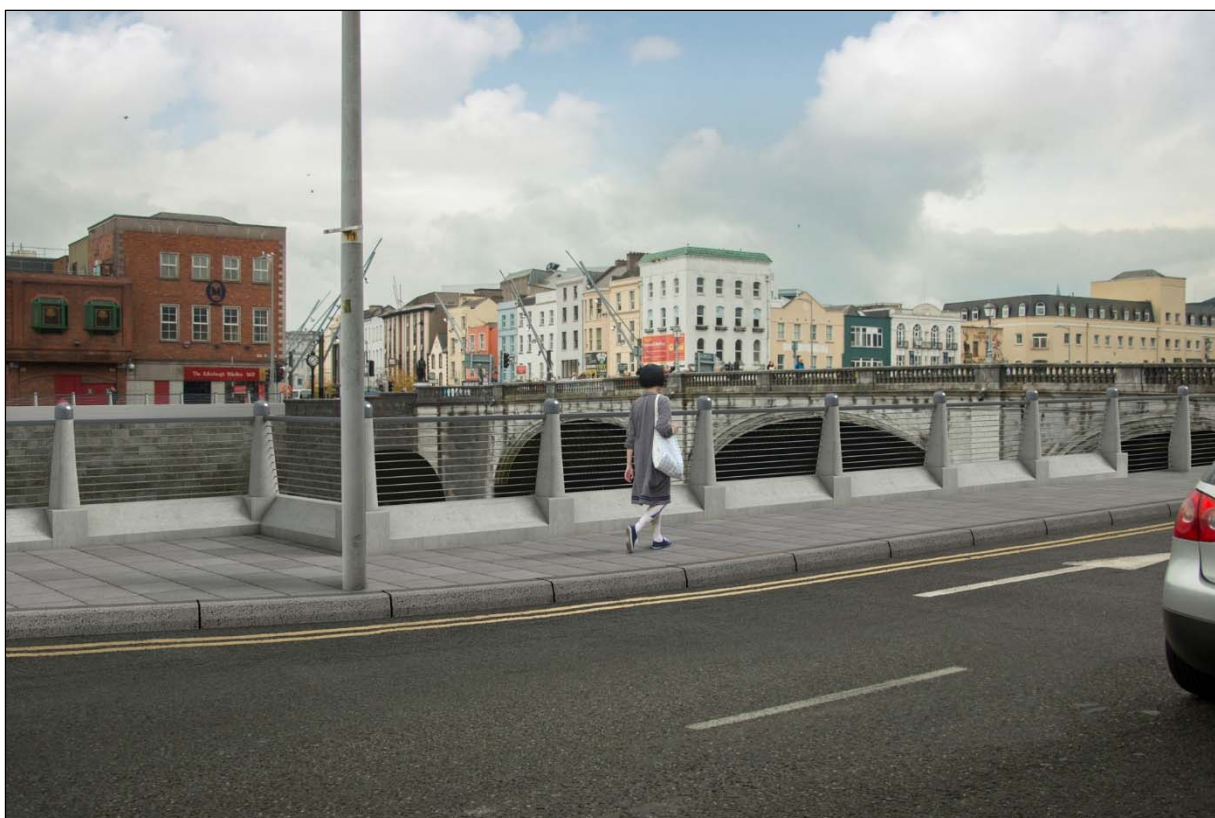
Plate 9.75 Photo Location 28 –Proposed View

The proposed view illustrates the proposed works to the railings which are to be replaced, while no works are proposed to Patrick's Bridge. The visual receptor is considered to be medium in this location, while the magnitude of the change is considered to be Low. The overall impact is considered Slight neutral visual impact.

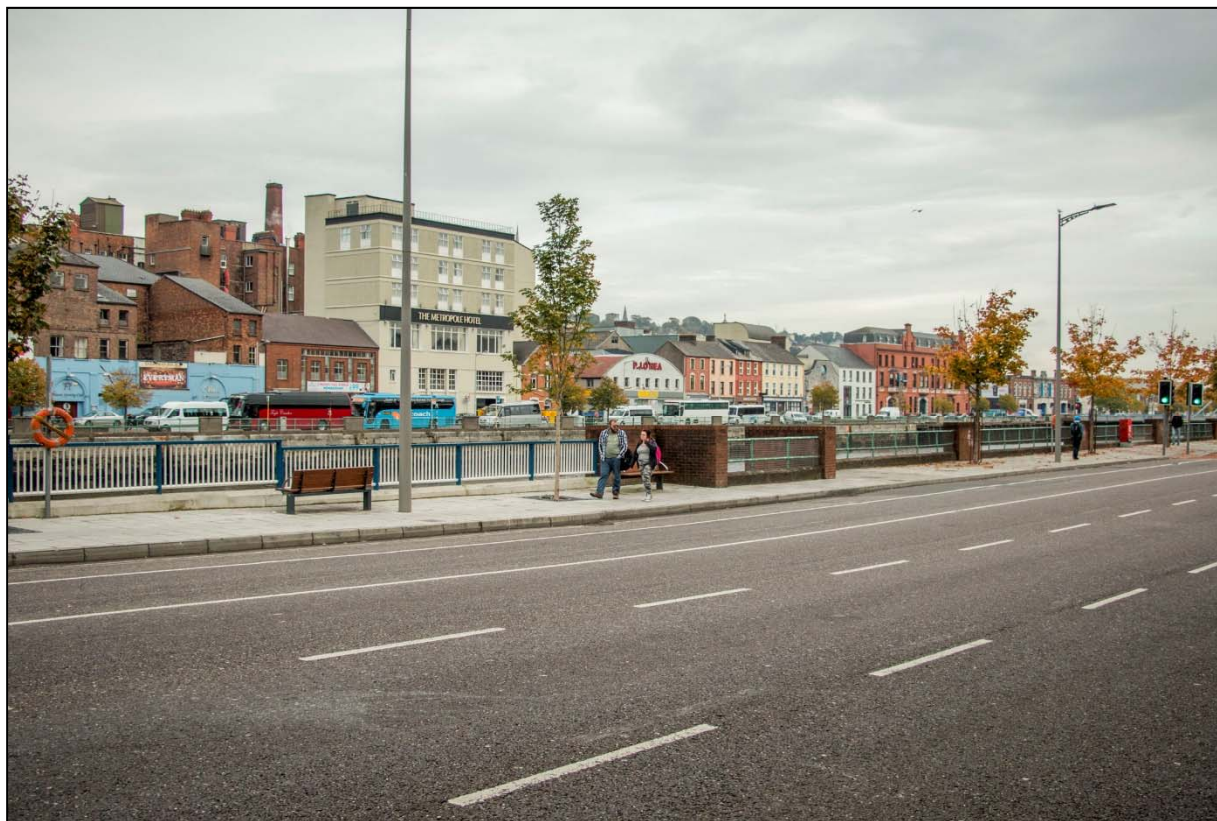
Plate 9.76: Photo Location 29 –Existing View looking from Merchant's Quay towards river

The existing view is taken from Merchant's Quay looking towards the river at St. Patrick's Quay. The view includes a partial view of the river, and the railings allow some visibility (this would be the case at high tide). Across the riverbank, railings are also evident and part of the limestone quay walls are visible, the buildings are clearly visible.

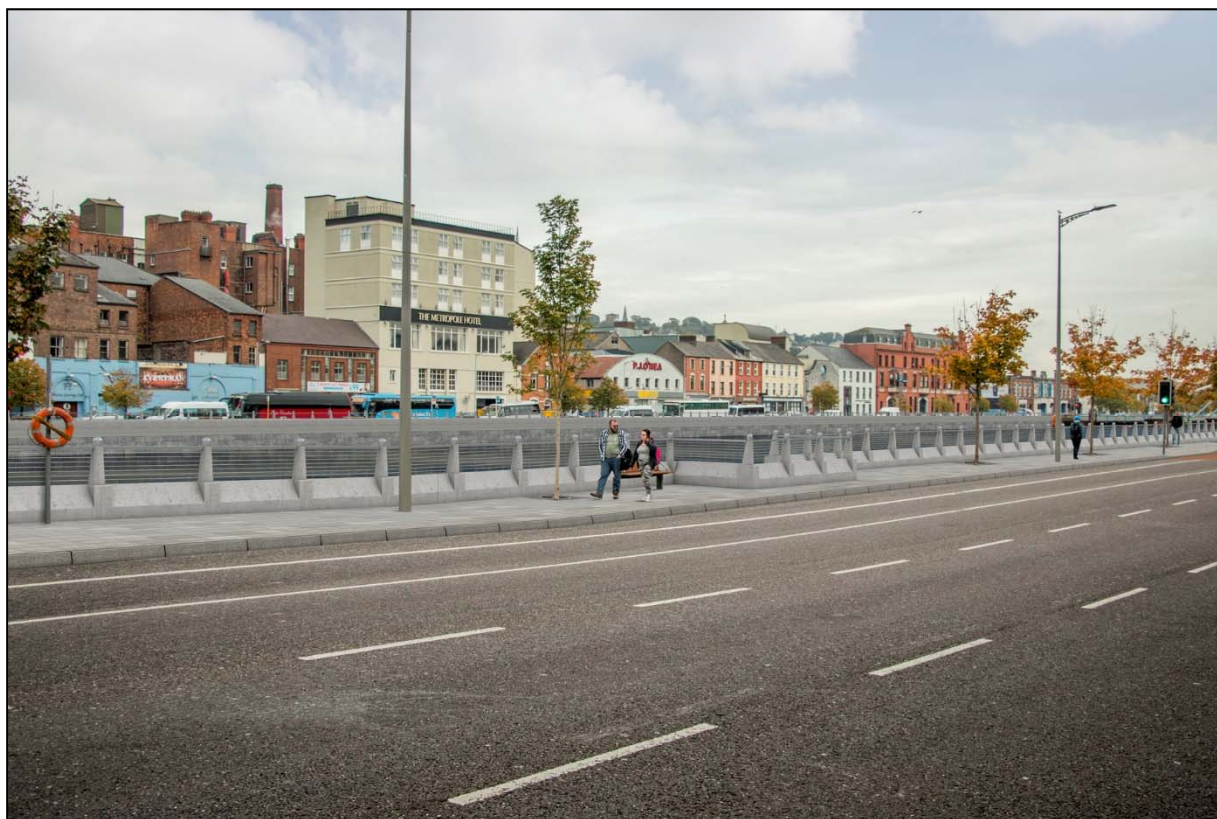
Plate 9.77: Photo Location 29– Proposed View

The proposed view shows the railings in the foreground along the river bank are removed and replaced with a concrete wall, which considerably reduces the visibility of the river and the opposite quay walls, and introduces a considerable area of new texture into the view. It is considered that the visual receptors in this location are of medium sensitivity, combining groups of people who are walking and driving in close proximity to the river, and may be engaged in travel, recreation, or enjoyment of the surrounds. The magnitude of change is considered to be Low. The visual impact is considered to be Slight Negative visual impact.
