Client
Project Title
**Glashaboy River
(Glanmire/Sallybrook)
Drainage Scheme**

Drawing Title
**Area 2
Site Clearance & Demolition
Sheet 5 of 7**

Scale at A1 1:250
Role Civil Structures
Suitability Tender
Anup Job No **234334-10** Rev **T2**
Name **2-040-05**

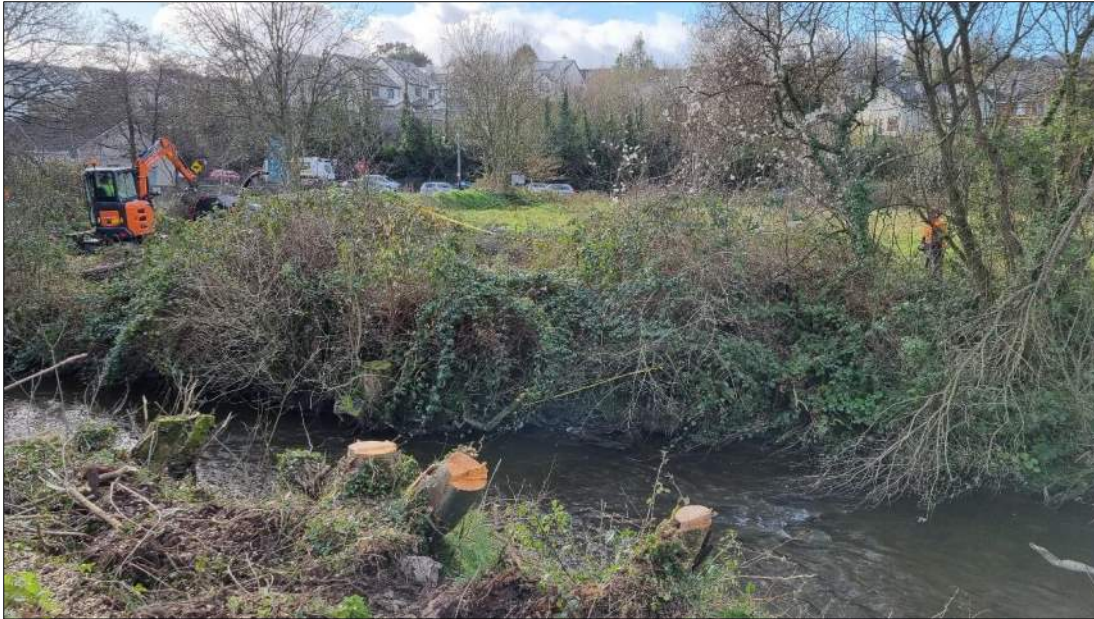
Plate 3.1 Tree felling in the 'Circus Field' at Meadowbrook showing the preservation of vegetation overhanging holt No. N6 on the Glashaboy River at Meadowbrook. Vegetation area that was preserved overhanging the holt was marked with yellow hazard tape from above to ensure drivers avoided inadvertent cutting

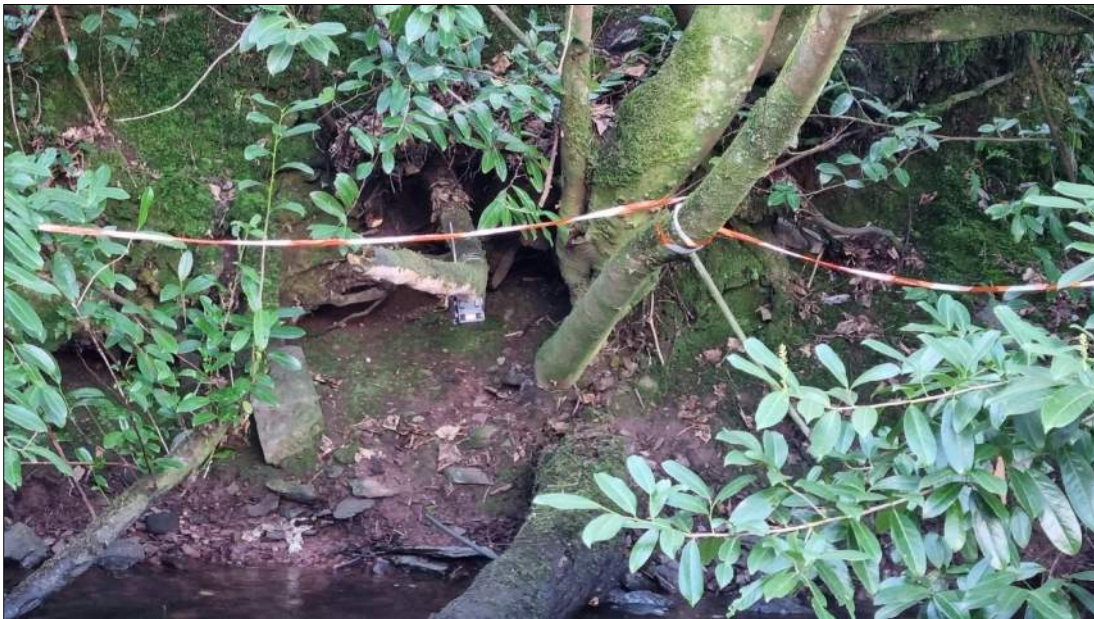
Plate 3.2 Tree felling did not occur on the west bank of the Glashaboy River at Sallybrook and the holt area was marked during cutting to ensure no inadvertent damage to vegetation

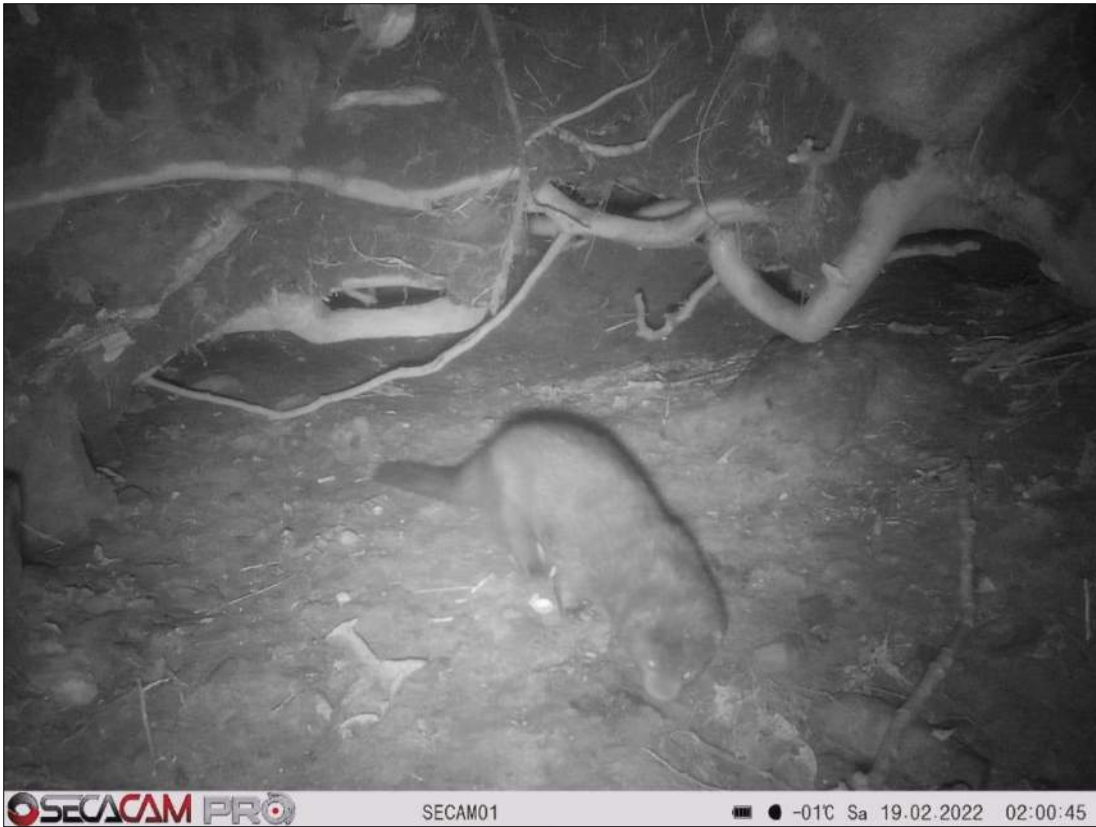
Plate 3.3 Otter activity before tree felling at Sallybrook holt No. N2

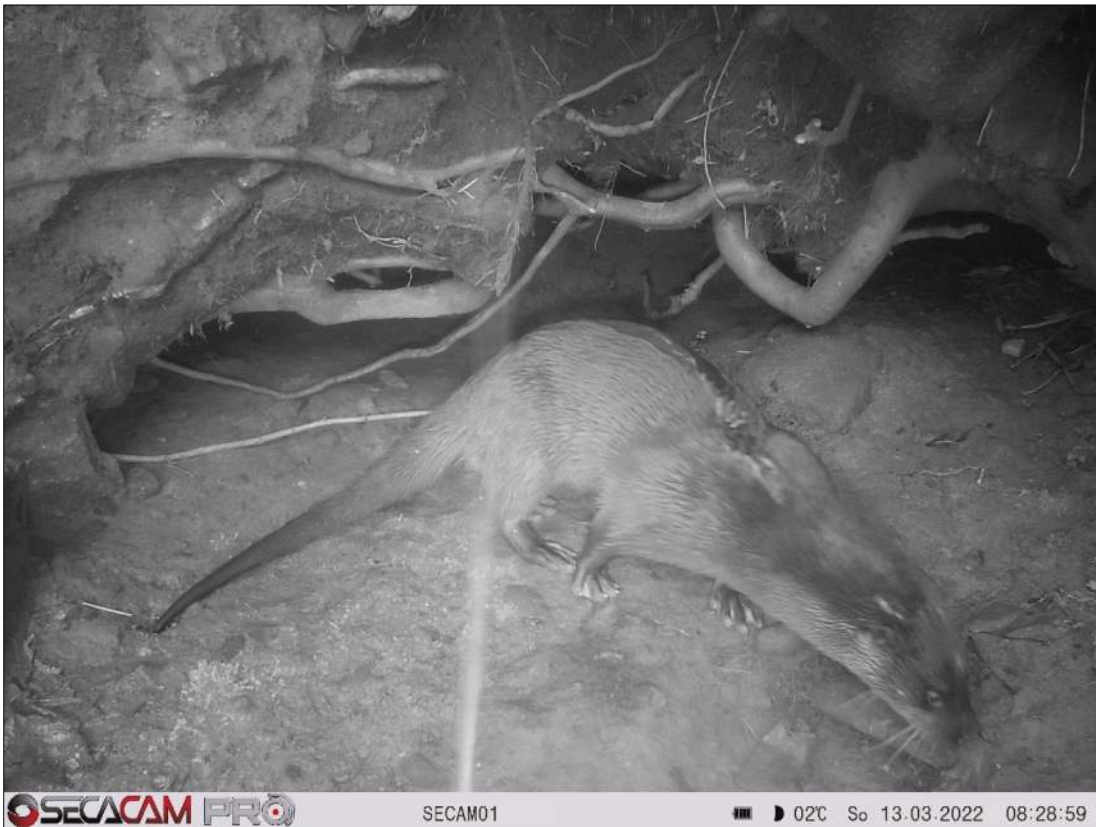
Plate 3.4 Otter activity after tree felling at Sallybrook holt No. N2

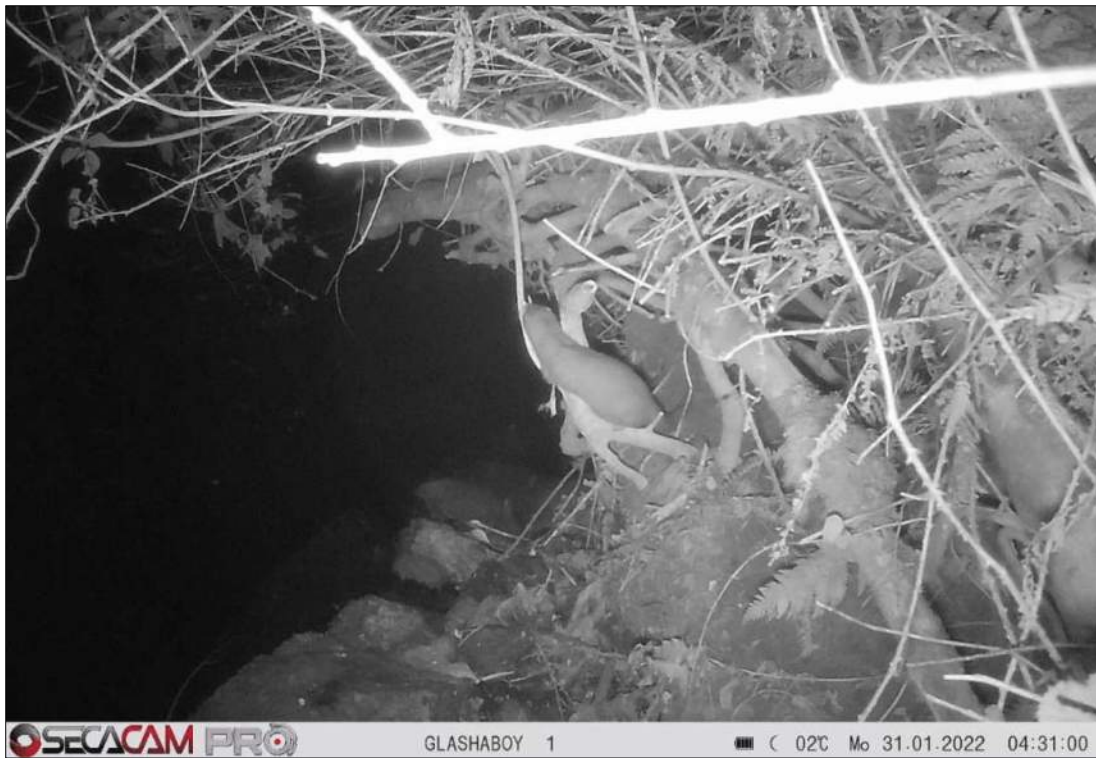
Plate 3.5 Otter activity before tree felling at Meadowbrook holt No. N6

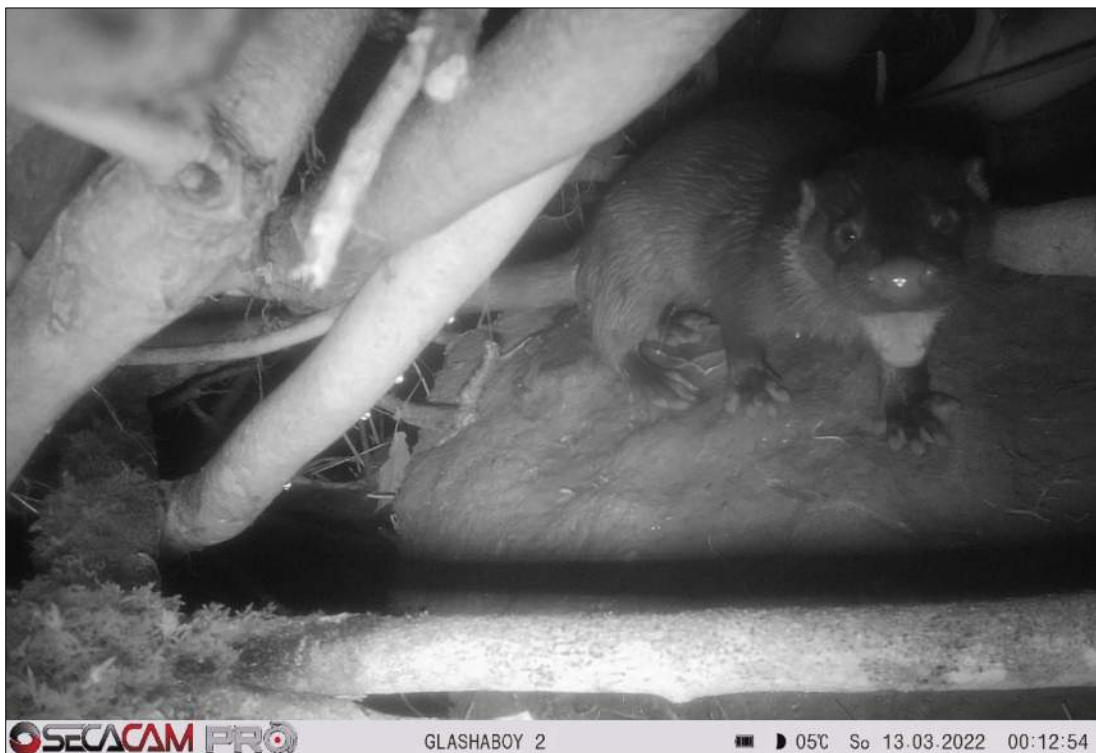
Plate 3.6 Otter activity after tree felling at Meadowbrook holt No. N6, camera angle changed due to vegetation growth
