**Re: Pre-planning consultation regarding the proposal by Limerick City and County Council to construct a Flood Relief Scheme for King's Island.**

**SECTION 21 APPLICATION**  
*Groenlandia densa*

**METHODS STATEMENT**

**March 2019**

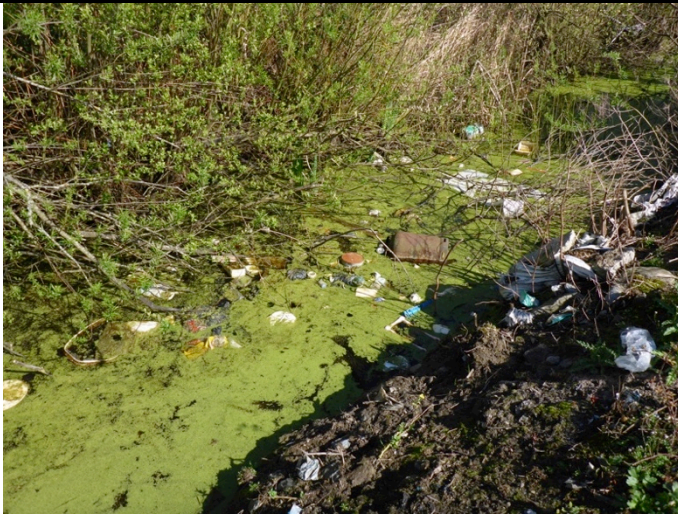
Photograph 5. Ditch to north of *Groenlandia densa*, showing overhanging scrub, litter and dense *Lemna* spp. on water surface.

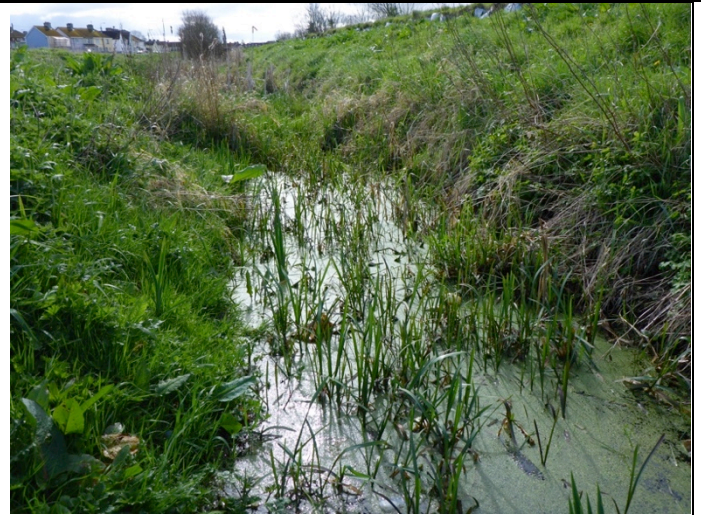
Photograph 6. Ditch to south of *Groenlandia densa*, showing channel dominated by tall monocots with dense *Lemna* spp. on water surface.

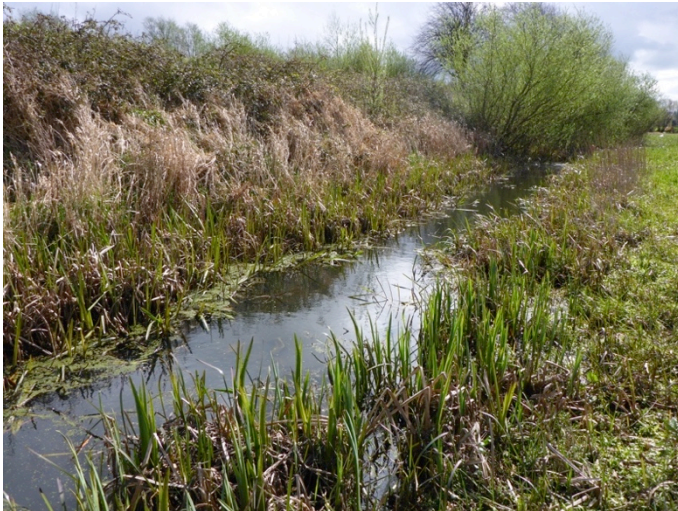
Photograph 7. Ditch section with open water (view to S)

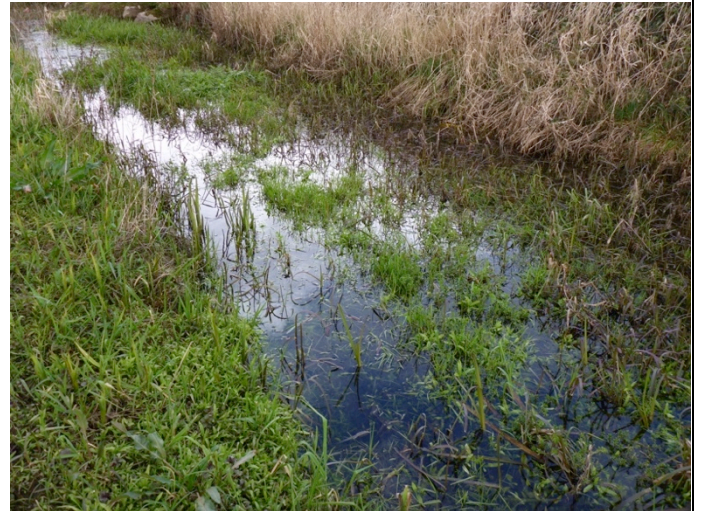
Photograph 8. Channel dominated by wetland species (e.g. monocots and *Veronica* spp.) but no true aquatic macrophytes seen.

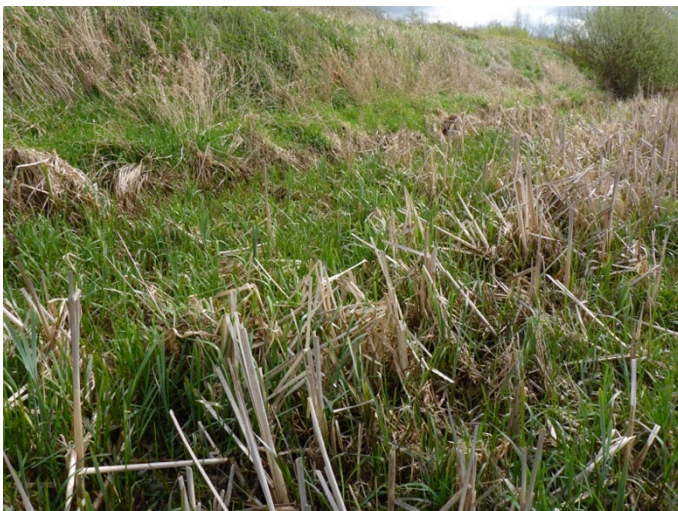
Photograph 9. Ditch channel overgrown with monocots (view to S)

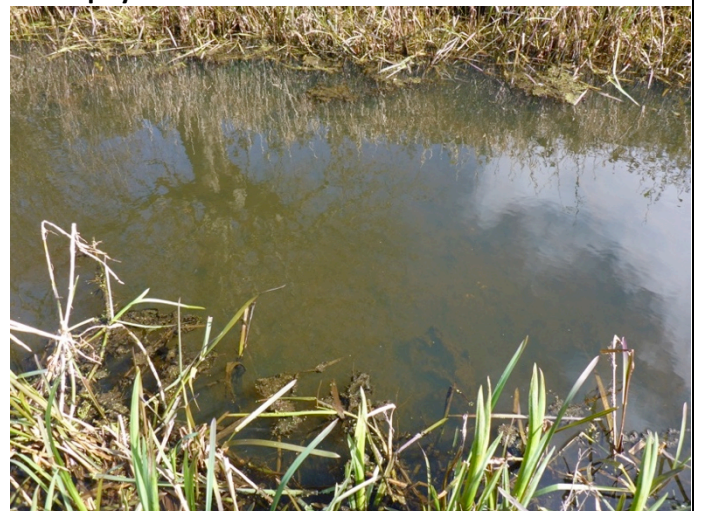
Photograph 10. Ditch channel with open water but little macrophyte growth within channel
