10 CULTURAL HERITAGE

This chapter assesses the direct and indirect likely significant effects on cultural heritage associated with the proposed River Deel (Crossmolina) Drainage Scheme and, based on this assessment, a number of appropriate mitigation measures are presented. UNESCO define the term ‘Cultural Heritage’ as encompassing several aspects of tangible assets, including archaeological sites, monuments, artefacts, and architectural heritage structures along with intangible assets such as folklore, oral tradition, and historical associations. The scheme has been designed to avoid direct impacts on cultural heritage assets.

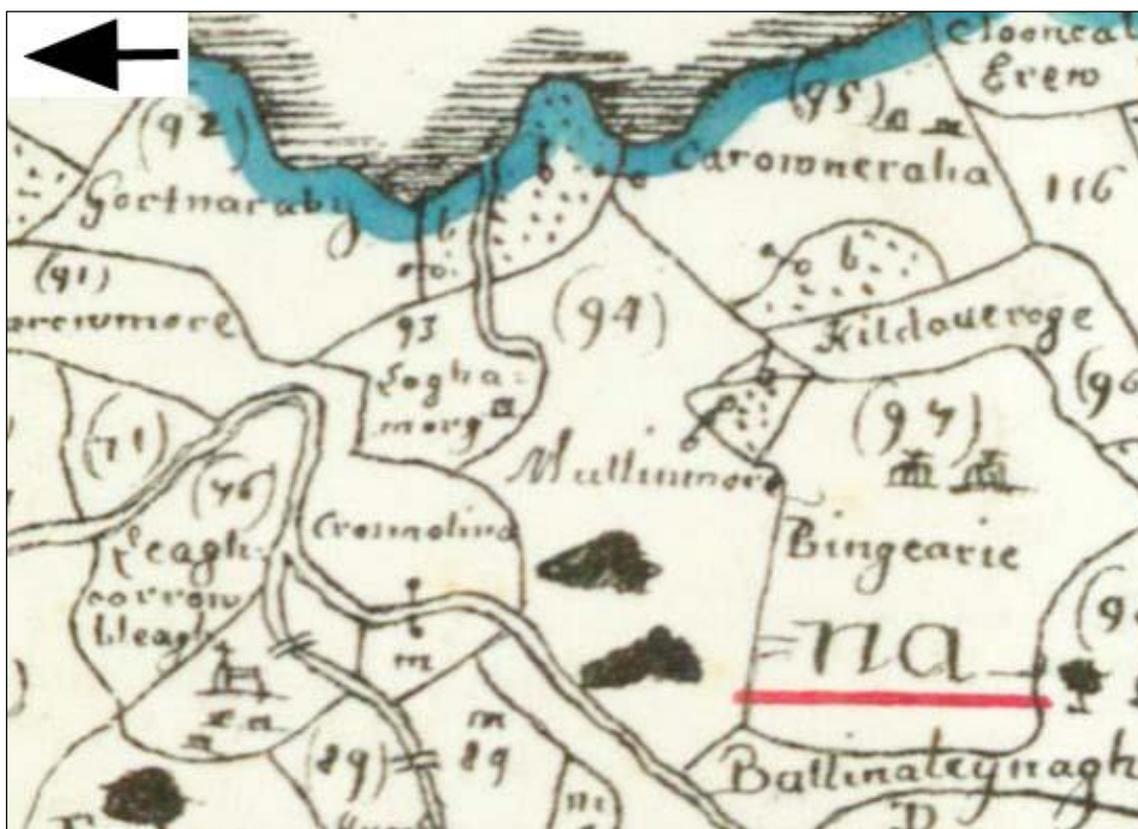
Figure 10.1: Down Survey map showing Mullinmore in centre (arrow indicates north)

The Down Survey of 1641 records that the townland of Mullenmore North was in the ownership of Sir Richard Blake while the 1670 Down Survey lists Richard Franklin as the landowner. The 1641 Survey records that Cartrongilbert townland was common land at the time while it is listed as a possession of Andrew Ram on the 1670 Survey. The area is named Mullinmore on the Down Survey map and no traces of a mill or any other structures are depicted (Figure 10.1).

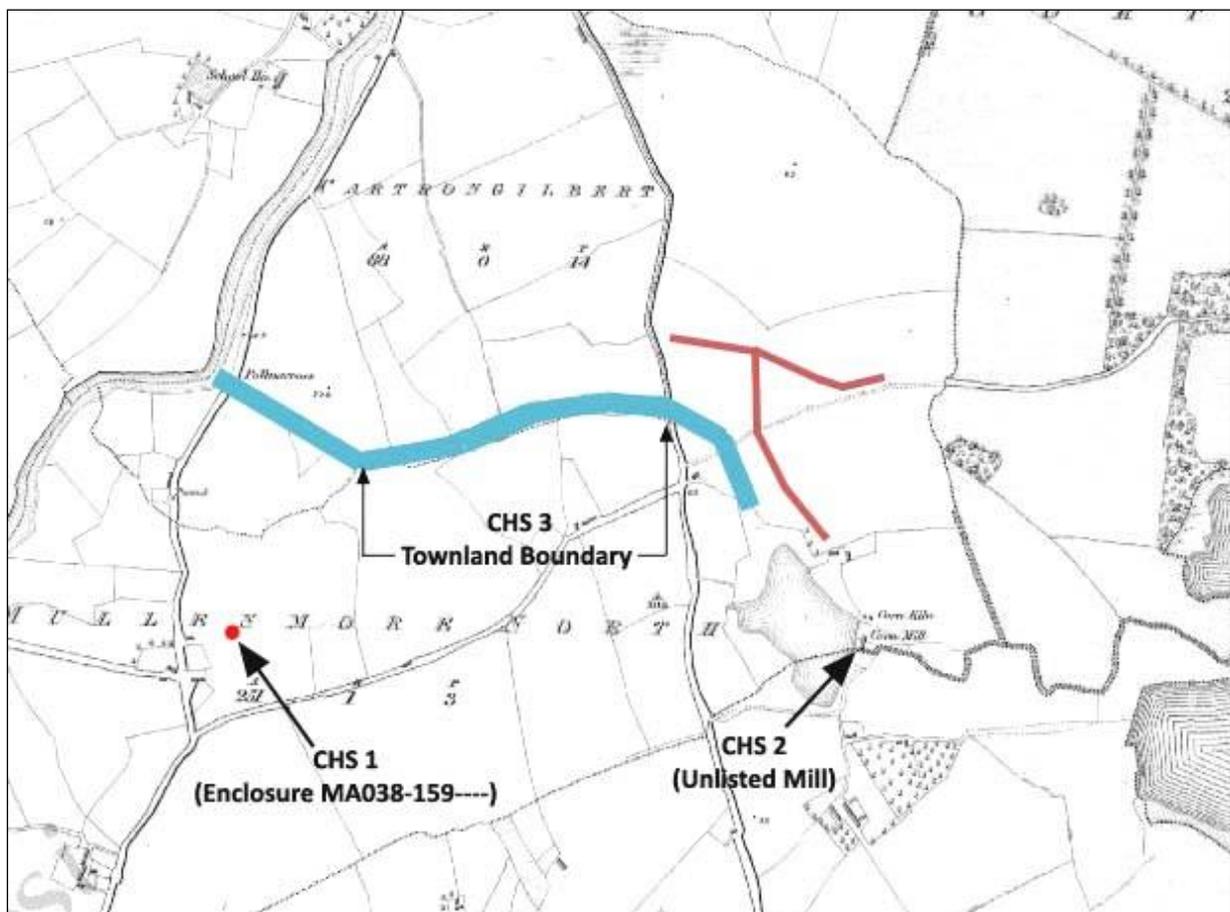
Figure 10.2: Extract from 1st edition OS map (survey date 1840) showing CHS locations and approximately lines of diversion channel (blue) and local road diversions (red) [OSI Licence SU 0003318]

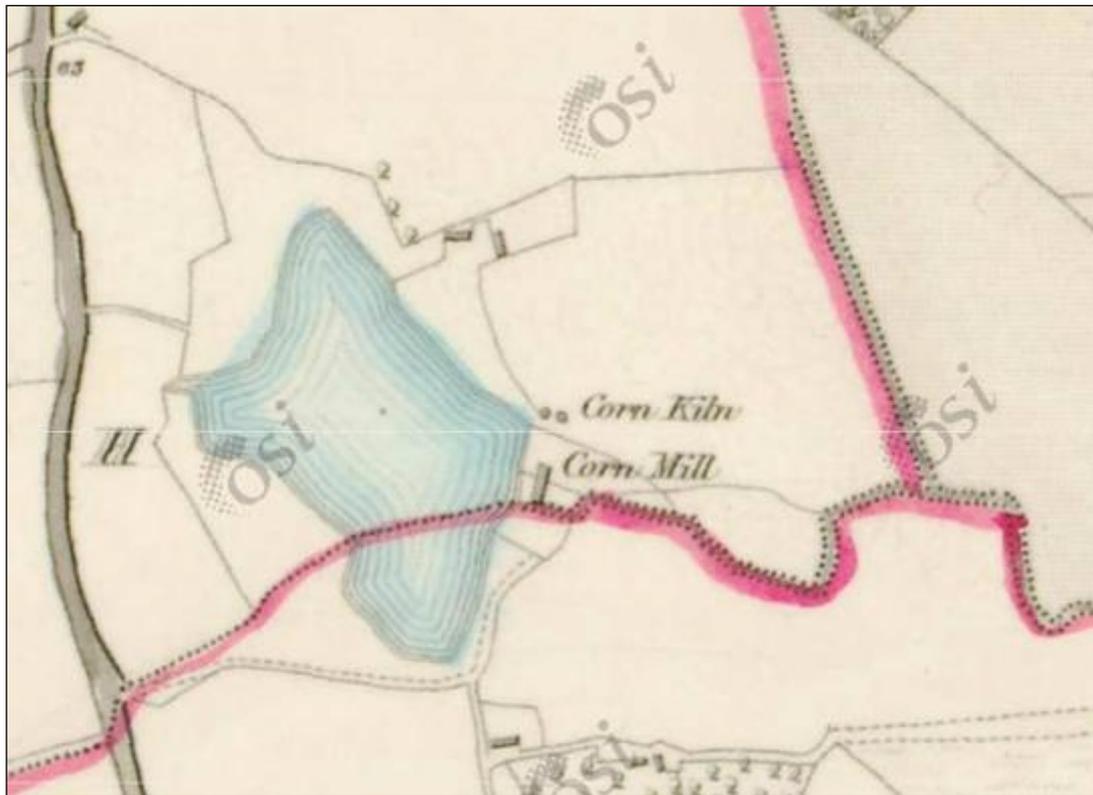
Figure 10.3: Extract from 1st edition OS map (survey date 1840), showing corn mill (CHS 2) and two corn kilns [OSI Licence SU 0003318]

The 6-inch OS map of 1840 (Figure 10.3) shows a corn mill (CHS 2), with two corn kilns to the north, within the proposed area of washland to the south of the eastern terminal of the diversion channel. The 25-inch OS map of 1900 shows a number of unnamed buildings at this location and, while a lime kiln is indicated to the southeast, there are no traces of the two corn kilns previously indicated in the area to the north. The existing remains of the corn mill are not listed as a recorded archaeological site or as a protected structure and are described in the Site Inspection section of this chapter (Section 10.3.4). There are no buildings, structures or potential archaeological features indicated on the line of the diversion channel and proposed local road diversions on either of these maps (Figure 10.2). The diversion channel does extend along a section of the townland boundary (CHS 3) between Mullenmore North and Cartrongilbert to the north.

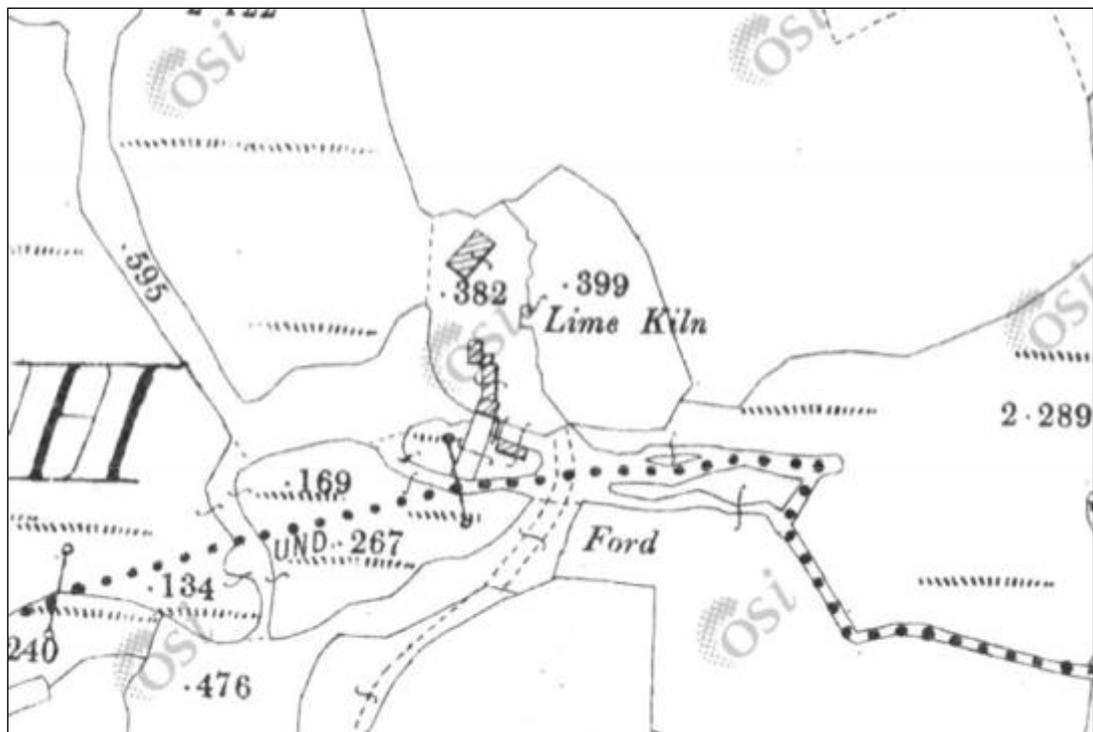
Figure 10.4: Extract from 25-inch edition OS map (survey date 1900) showing mill buildings (CHS 2) and lime kiln [OSI Licence SU 0003318]

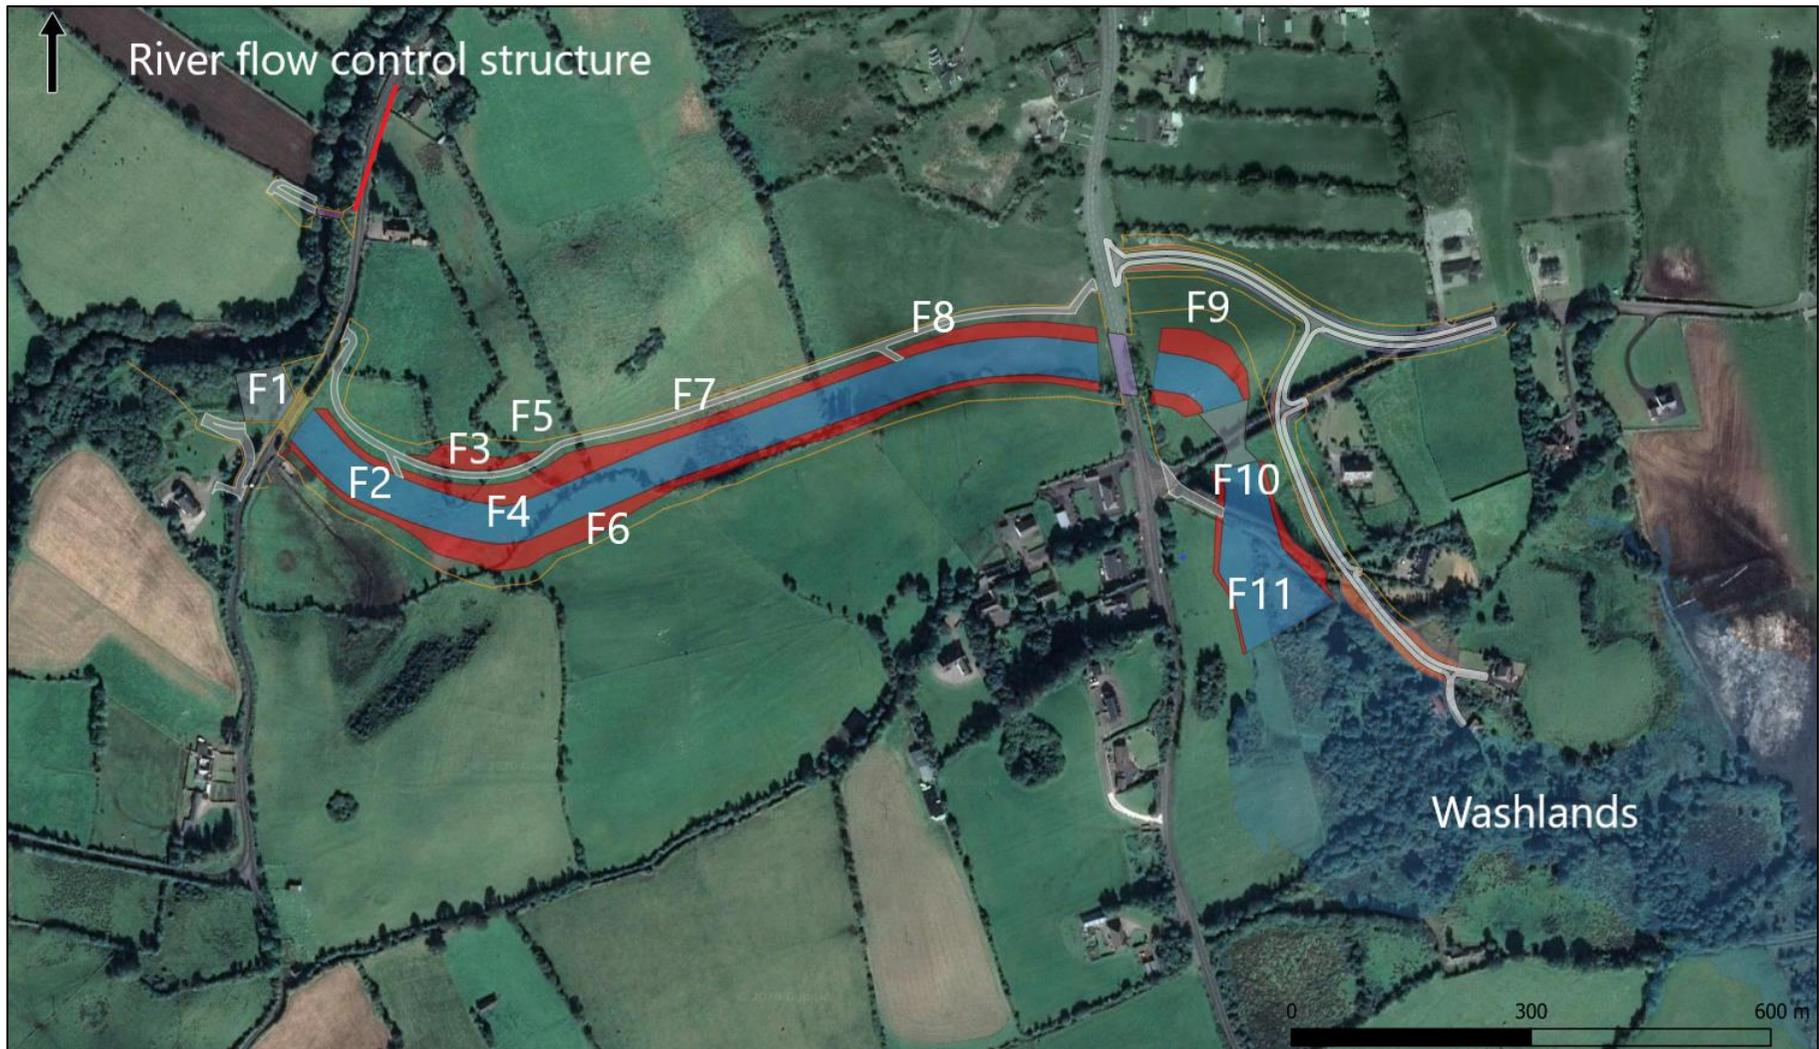
Figure 10.5: Layout of proposed scheme with field numbers indicated

Field/Area	Description
F1	<p>This riverside field is shown as two fields on the historic OS maps and the existing layout was created by the removal of a central N-S boundary in the 20th century. A modern dwelling house in the south end of the field was constructed in the early 2000s. There are no features indicated in the adjacent section of the river on the historic maps, both of which show the existing public road that extends outside the east field boundary.</p> <p>This area is generally level with grass to the south and sally trees along the river side to the north. A modern cairn formed of large limestone boulders is located on the side of the driveway leading to a modern house to the south. The field slopes gently to the river bank with a low (c.0.7m tall) earthen bank separating it from the river. The river channel was inspected from the east bank and nothing of an archaeological nature was noted.</p>

F2	<p>This field is shown as part of a larger field on the 6-inch map and the existing southern boundary, shown on the 25-inch map, was created in the second half of the 19th century.</p> <p>This field is level along the south and east sides and rises to the north and east. The ground surface is very boggy at the south with a large pool of standing water. Rushes evident throughout this field with horse grazing at the time of inspection. A large boulder (c.3mx2mx1m) is located at the boundary to the southeast. This field is enclosed by a low hedge to all sides, this is thin and intermittent to the south. Nothing of an archaeological nature was noted.</p>
F3	<p>This field is shown as part of a larger field on the 6-inch map and the existing eastern boundary, shown on the 25-inch map, was created in the second half of the 19th century.</p> <p>This is a rolling field with the south end falling gently to the south. No standing water or boggy areas were noted within this field, unlike others in the vicinity which may indicate land improvement works. It was in use as sheep grazing at the time of inspection and is enclosed with a thin hedge. Nothing of an archaeological nature was noted.</p>

F4	<p>This field is shown as part of a larger field on the 6-inch map and the existing northern boundary, shown on the 25-inch map, was created in the second half of the 19th century. The southern field bank forms part of the townland boundary (CHS 3) between Mullenmore North and Cartrongilbert to the north and is on the line of the proposed diversion channel.</p> <p>This field is very wet in the west end and a steep west facing-slope is located at the centre with a rolling plateau to the east. A small round pool was located on the upper portion of the field to the east of the centre. Several large rounded boulders, or bedrock outcrops, were evident in the west end of the field. The townland boundary to the south is formed by a low earthen bank (c.0.5m tall) topped by a hedge formed of bramble and small bushes and trees. No surface traces of a flanking ditch or drain were noted. This field was open to horses at the time of the inspection. Nothing of an archaeological nature was noted.</p>

F5	<p>This field is shown as part of a larger field on the 6-inch map and the existing eastern boundary, shown on the 25-inch map, was created in the second half of the 19th century. The southern field bank forms part of the townland boundary (CHS 3) and is on the line of the proposed diversion channel.</p> <p>This field slopes to the south at the south and contains occasional large rounded boulders. Horses were grazing the field at the time of inspection. This field was enclosed by thick bramble hedges with some trees and bushes. Nothing of an archaeological nature was noted.</p>
F6	<p>The existing layout of this large, irregular field is present on the historic OS maps. The northern field bank forms part of the townland boundary (CHS 3) and is on the line of the proposed diversion channel.</p> <p>This rolling field falls moderately to the north at the north end. Sheep were grazing the field at the time of inspection. The townland boundary to the north is formed of a low earthen bank (c.0.5m tall) topped by a hedge formed of bramble and small bushes and trees. No surface</p>

Field/Area	Description
	traces of a flanking ditch or drain were noted. Nothing of an archaeological nature was noted.
F7	<p>This large field is shown as two fields on the historic OS maps and the existing layout was created by the removal of a central N-S boundary in the 20th century. The southern field bank forms part of the townland boundary (CHS 3) and is on the line of the proposed diversion channel. The central section of the field adjacent to this boundary is indicated as a localised area of marginal, marshy ground on the 25-inch map.</p> <p>This pasture field slopes moderately down from the boundary to the west towards the east before levelling while there is a steeper south-facing slope further to the north. Some large areas of reed growth were evident and east to west cropmarks representing ridge and furrow cultivation were evident within this field in drone images. Nothing of an archaeological nature was noted.</p>

F8	<p>The existing layout of this large, irregular field present on the 6-inch map and there is now no surface trace of an N-S sub-division boundary shown in the eastern half on the 25-inch map. The R315 road extends N-S outside the east side of the field and is present on the historic OS maps. The OS aerial images show topsoil stripping in the southeast corner of the field and this undeveloped area, which is shown as marshy ground on the 25-inch map, appears to have undergone modern land improvement works. The southern field bank forms part of the townland boundary (CHS 3) as does the roadside section of the field in the area where the boundary turns to the north. The southern field boundary is on the line of the proposed diversion channel and there is no extant field bank along the east side of the field where a low concrete fence delimits the roadside.</p> <p>This field is rolling with sheep grazing at the time of inspection. Some rushes growing within this field, especially at the south. The eastern portion of this field was disturbed by ongoing land improvement works at the time of inspection. The townland boundary to the south is formed of a low earthen bank (c.0.5m tall) topped by a hedge formed of bramble and small bushes and trees. No surface traces of a flanking ditch or drain were evident. Nothing of an archaeological nature was noted.</p>

F9	<p>This rolling pasture field formed part of a large, irregular field shown on the historic OS maps which was sub-divided into a number of smaller fields during the 20th century. Lake Road, which extends E-W outside the southern boundary, is shown as a laneway leading into a property in Gortnaraby townland to the east on the 6-inch map. The 25-inch map shows a spring in area now located in the south end of the field with a narrow drainage channel extending south towards the mill site (CHS 2). The line of this channel is now truncated by Lake Road and there are no surface traces of the spring. The line of the diversion channel extends through the southwest corner of the field while the diverted local access road is located in the northern half. Nothing of an archaeological nature was noted within this area during the field inspection.</p>
F10	<p>The northern half of this field formed part of the same large plot as Field 9 to the north until the area was sub-divided into smaller fields in the 20th century. The driveway extending NW-SE towards a modern house located to the east follows the line of a field boundary present on the historic OS maps. The line of the drainage channel shown extending south from the spring on the 25-inch map extends through the proposed route of the drainage channel in this field.</p> <p>This field appears to have been recently disturbed by land improvement works along the northern side and a mound in this area is likely a result of this activity. An east to west band of standing water at the low point in the centre of the field mirrors the line of a former stream. Nothing of an archaeological nature was noted within this area during the field inspection.</p>

Field/Area	Description
F11	<p>The existing layout of this field is present on the historic OS maps and the former line of the spring drain is evident as an overgrown area on the line of the proposed diversion channel which terminates in this field.</p> <p>The line of the stream in this field was evident as a water filled channel within this field. The field is rolling with sheep grazing at the time of inspection. Nothing of an archaeological nature was noted within this area during field inspection. A pond, likely the former mill pond, is located in the southern portion of this field near the point where the diversion channel transitions to the proposed washlands.</p>
Mill Site (CHS 2)	<p>The extant remains of the corn mill complex are broadly of the same layout as that shown on the 25-inch OS map with the remains of an additional structure incorporated into a farm yard on the north side. The mill complex is in a very ruinous state, heavily overgrown and active collapse was noted within a number of the structures, all of which are of random rubble construction. The following description should be read in consultation with the photographic record presented in Appendix 10A and is not intended as a detailed building survey, which will be undertaken as part of the scheme mitigation strategy.</p> <p>A mill building at the south end of a north/south range of buildings was shown as unroofed on the 25-inch map and recent structure collapse was noted during the inspection. This structure is formed of two rooms and is intersected by a mill race at the north. This mill race emerges from beneath the building to the east. The stream and mill race flow within channels through this structure at four locations. In a number of areas, the water from the stream and mill race was evident flowing through the walls of the building. A large millstone is located within this structure.</p> <p>The very ruinous and roofless remains of a freestanding structure are located to the east of the main mill building, to the south of the mill race and the north of the stream.</p> <p>Adjoining the southernmost mill building to the north are the very ruinous and roofless remains of the former mill. A channel along the southern wall contained moving water and a large mill stone was located within this structure.</p> <p>Adjoining to the north was another ruinous and roofless structure.</p> <p>Adjoining to the north was a small structure which was roofed by corrugated iron sheeting, a recent collapse in the west wall was evident within this structure. Some farm materials were stored within this structure at the time of inspection.</p> <p>Some overgrown rubble to the north may represent the demolished remains of further structures adjoining this range of buildings to the north.</p> <p>A large freestanding building was located to the northeast of the north/south range of buildings. This was roofed by corrugated iron sheeting and was in use for agricultural storage at the time of inspection.</p> <p>To the northwest of the large freestanding building was the wall of a structure shown on the mid-20th century Cassini 6-inch map. This building has largely been removed but the southern wall had been incorporated into a yard to the north.</p> <p>A limekiln, shown on the 25-inch OS map, to the east of the north/south range of buildings and to the south of the large free standing building, was not located. A mound of demolition rubble was noted at its approximate location.</p> <p>No buildings or other features associated with the recorded historic iron work activity at this site were noted during the inspection.</p>
