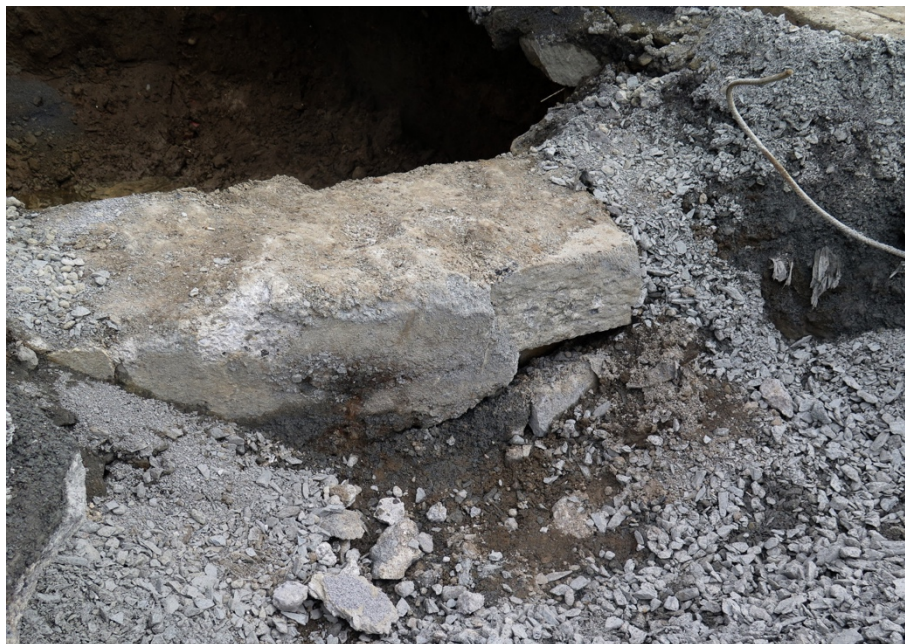
<b>Trench:</b> TT3-1	<b>Context:</b> C3-1-08	<b>Dates excavated:</b> 18/7/20
<b>Feature type:</b> Wall		
<b>Co-ordinates (ITM):</b> 557713.8114, 657547.9230		
<b>Minimum depth (ASL):</b> 3.0588		
<b>Depth of feature below surface:</b> 0.25m		
<b>Base of feature reached?</b> Y		
<b>Alignment:</b> SSW/NNE		
<b>Description:</b>	Upper parapet of wall revealed for one course	
<b>Date of construction:</b>	19th century wall terrace

Figure 35 Wall in TT3-1 (C3-1-08)

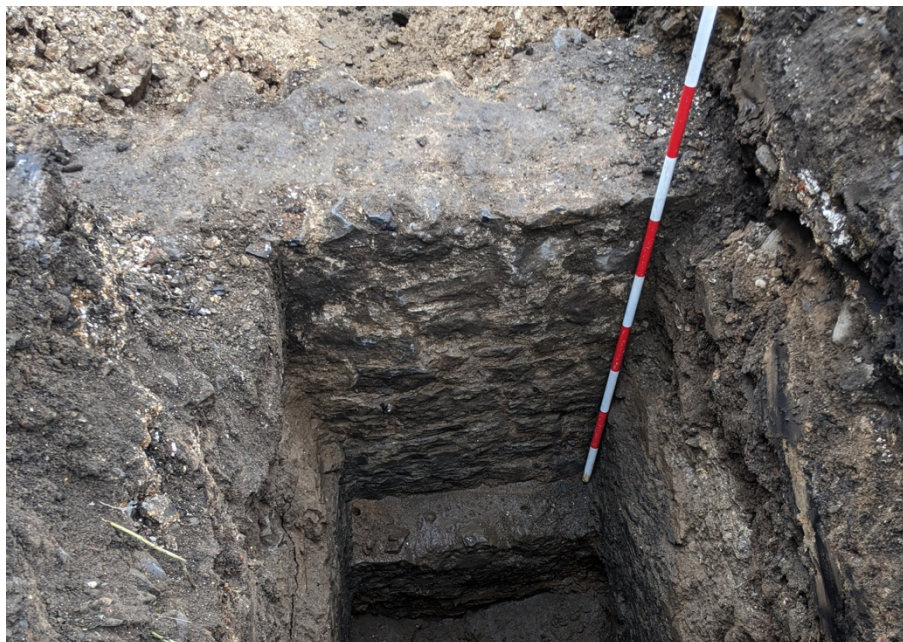
<b>Trench:</b> TT4-1	<b>Context:</b> C4-1-16	<b>Dates excavated:</b> 20/7/20
<b>Feature type:</b> Wall		
<b>Co-ordinates (ITM):</b> 557733.8251, 657522.7201		
<b>Minimum depth (ASL):</b> 3.1258		
<b>Depth of feature below surface:</b> 0.7-4.1m		
<b>Base of feature reached?</b> N		
<b>Alignment:</b> W/E, 94°		
<b>Description:</b>	Southern pier wall of New Quay, unexposed side, water side (north facing) robbed out.	
<b>Date of construction:</b>	1760s, built by 1769

Figure 36 Wall in TT4-1 (C4-1-16)

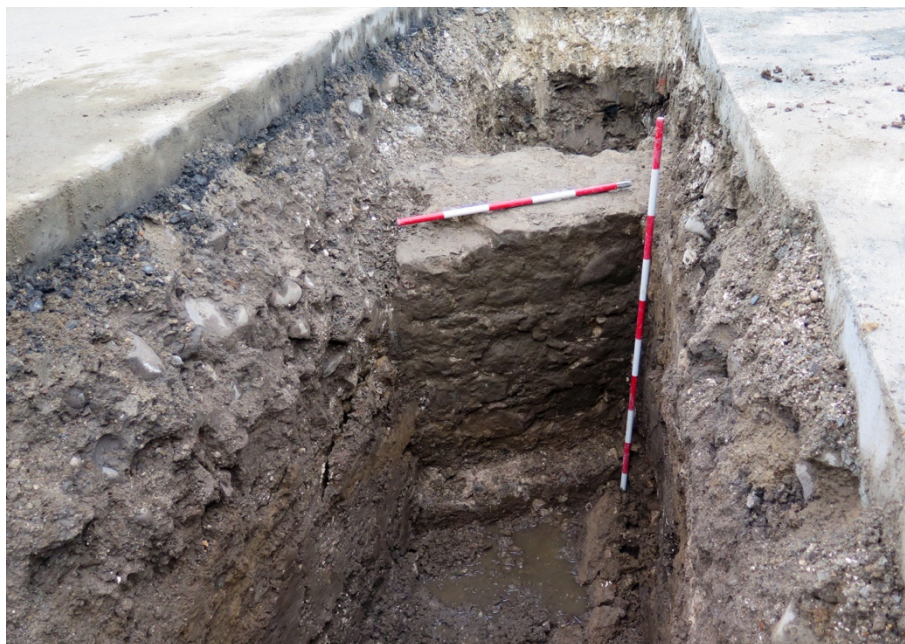
<b>Trench:</b> TT4-4	<b>Context:</b> C4-4-07	<b>Dates excavated:</b> 26/7/20
<b>Feature type:</b> Wall		
<b>Co-ordinates (ITM):</b> 557761.8209, 657520.7317		
<b>Minimum depth (ASL):</b> 3.1364		
<b>Depth of feature below surface:</b> 0.7-2.5m		
<b>Base of feature reached?</b> N		
<b>Alignment:</b> W/E, 94°		
<b>Description:</b>	Continuation of wall revealed 27m to the west in TT4-1, Southern pier wall of New Quay, unexposed side, water side (north facing) robbed out.	
<b>Date of construction:</b>	1760s, built by 1769

Figure 37 Wall in TT4-4 (C4-4-07)

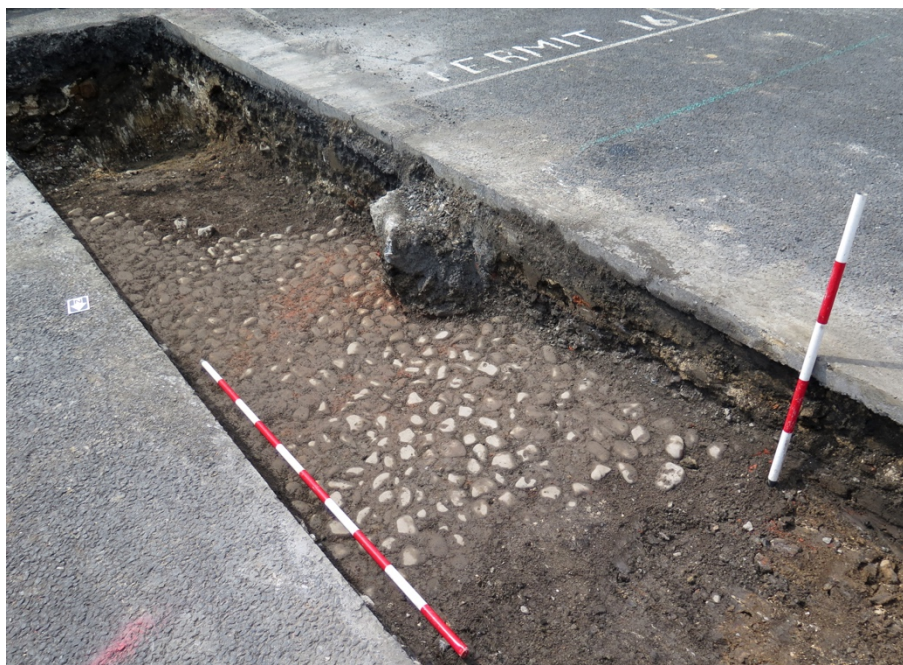
<b>Trench:</b> TT5-1A	<b>Context:</b> C5-1A-07	<b>Dates excavated:</b> 25/6/20
<b>Feature type:</b> Cobbled surface		
<b>Co-ordinates (ITM):</b> 557743.7876, 657552.8812		
<b>Minimum depth (ASL):</b> 3.0236		
<b>Depth of feature below surface:</b> 0.4-0.8m		
<b>Base of feature reached?</b> Y		
<b>Alignment:</b> n/a		
<b>Description:</b>	Cobbled surface of rounded stones set in mortar across a 4m stretch in the centre and south of the trench. The surface has sunken in the centre, and this dip corresponds with a pit under the cobbling; good condition	
<b>Date of construction:</b>	Early 19th century - contemporary with construction of the Courthouse or Potato Market

Figure 38 Cobbled surface in TT5-1A (C5-1A-07)

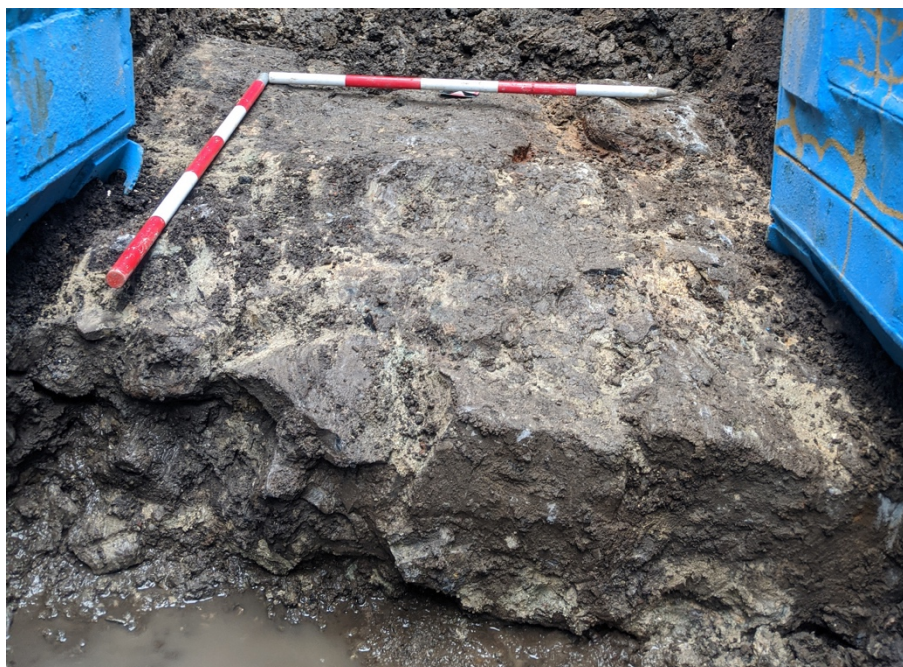
<b>Trench:</b> TT5-1A	<b>Context:</b> C5-1A-15	<b>Dates excavated:</b> 30/6/20
<b>Feature type:</b> Wall		
<b>Co-ordinates (ITM):</b> 557743.9404, 657552.1493		
<b>Minimum depth (ASL):</b> 1.2773		
<b>Depth of feature below surface:</b> 2.38-2.83m		
<b>Base of feature reached?</b> N		
<b>Alignment:</b> WSW/ENE, 106°		
<b>Description:</b>	Mortared limestone wall exposed at 2.38m depth, crossing the trench in a west-southwest/east-northeast alignment; 1.4m width. Limestone of varied size bonded with pale grey mortar. Rough facing on south side and finer face on north side; irregular coursing.	
<b>Date of construction:</b>	Pre-1760s Possible quay associated with late medieval harbour.

Figure 39 Wall in TT5-1A (C5-1A-15), view facing south

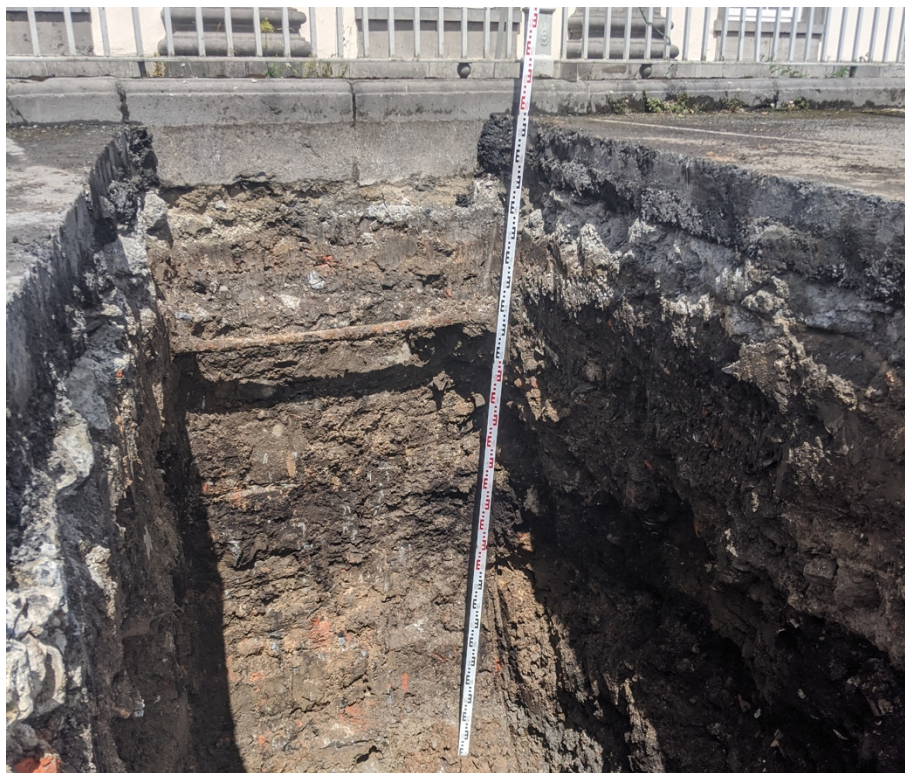
<b>Trench:</b> TT5-1B	<b>Context:</b> C5-1B-11	<b>Dates excavated:</b> 16/7/20
<b>Feature type:</b> Culvert/drain		
<b>Co-ordinates (ITM):</b> 557739, 657564		
<b>Minimum depth (ASL):</b> unknown		
<b>Depth of feature below surface:</b> 0.75-2.8m		
<b>Base of feature reached?</b> N		
<b>Alignment:</b> SW/NE		
<b>Description:</b>	South side of culvert exposed, running parallel and directly beneath the perimeter wall on south of the courthouse. Limestone rubble incorporating some brick.	
<b>Date of construction:</b>	1810 - contemporary with courthouse

Figure 40 Culvert at the north of TT5-1B (C5-1B-11)

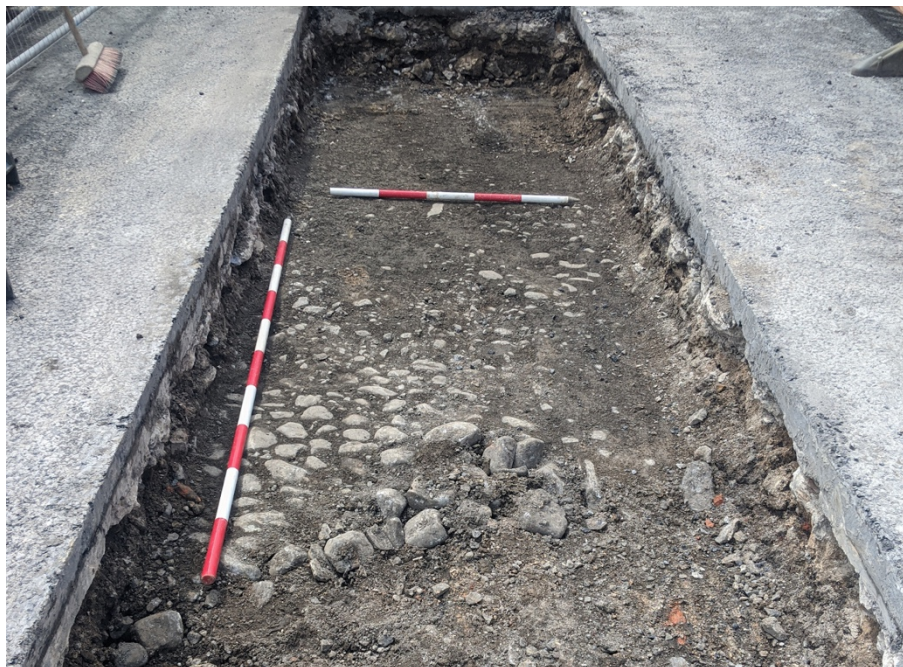
<b>Trench:</b> TT5-2A	<b>Context:</b> C5-2A-04	<b>Dates excavated:</b> 2/7/20
<b>Feature type:</b> Cobbled surface		
<b>Co-ordinates (ITM):</b> 557747.4863, 657558.5083		
<b>Minimum depth (ASL):</b> 3.5005		
<b>Depth of feature below surface:</b> 0.4-0.6m		
<b>Base of feature reached?</b> Y		
<b>Alignment:</b> n/a		
<b>Description:</b>	Patch of cobbled surface of rounded stones set in mortar at 400mm depth and spanning a continuous stretch of 2m maximum E/W; poor condition	
<b>Date of construction:</b>	Early 19th century - contemporary with construction of the Courthouse or Potato Market

Figure 41 Cobbled surface in TT5-1A (C5-2A-04)

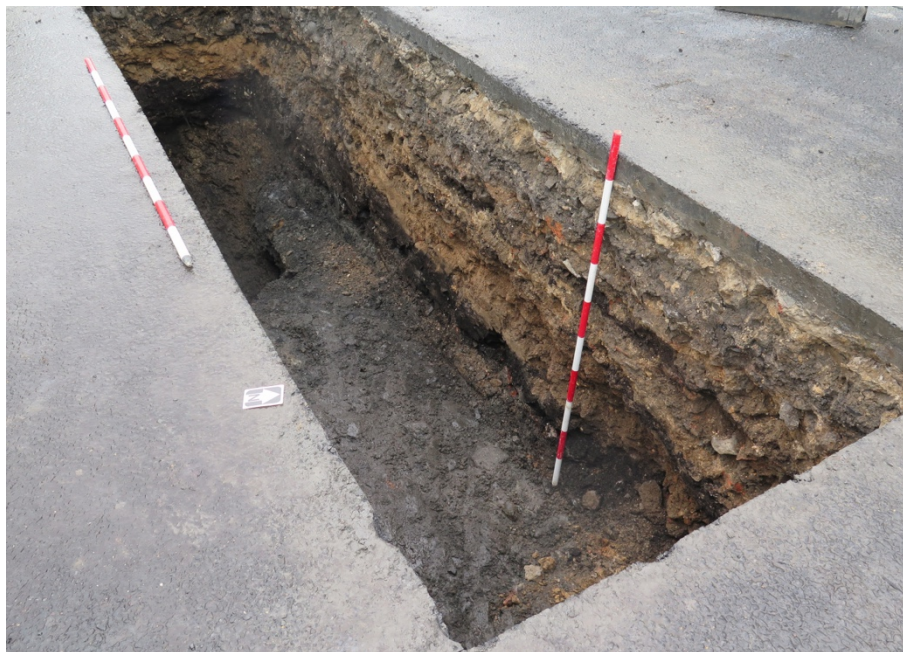
<b>Trench:</b> TT5-2A	<b>Context:</b> C5-2A-11	<b>Dates excavated:</b> 2/7/20
<b>Feature type:</b> Stone surface		
<b>Co-ordinates (ITM):</b> 557747.4863, 657558.5083		
<b>Minimum depth (ASL):</b> 3.5005		
<b>Depth of feature below surface:</b> 2-2.4m		
<b>Base of feature reached?</b> Y		
<b>Alignment:</b> n/a		
<b>Description:</b>	Compacted stone surface across eastern two thirds of trench; may be just a dense in-fill rather than a surface	
<b>Date of construction:</b>	Late 18th century – in-filling of harbour

Figure 42 Stone surface in TT5-2A (C5-2A-11)

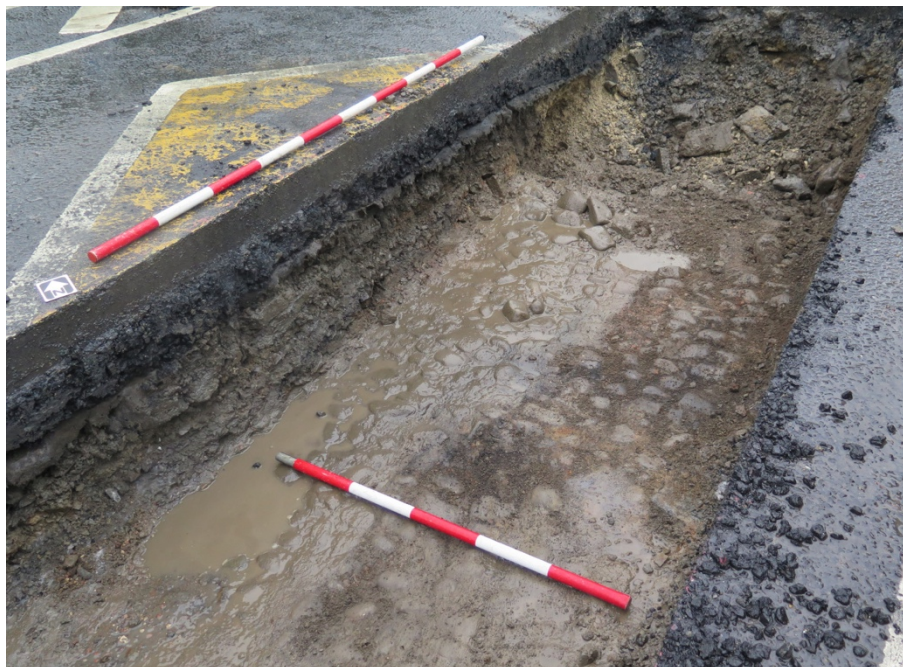
<b>Trench:</b> TT5-2C	<b>Context:</b> C5-2C-06	<b>Dates excavated:</b> 7/7/20
<b>Feature type:</b> Cobbled surface		
<b>Co-ordinates (ITM):</b> 557759.9072, 657567.6009		
<b>Minimum depth (ASL):</b> 3.4856		
<b>Depth of feature below surface:</b> 0.55-0.8m		
<b>Base of feature reached?</b> Y		
<b>Alignment:</b> n/a		
<b>Description:</b>	Patch of cobbled surface of rounded stones set in mortar at up to 800mm depth and spanning a continuous stretch of 2m maximum E/W; poor condition	
<b>Date of construction:</b>	Early 19th century - contemporary with construction of the Courthouse or Potato Market

Figure 43 Cobbled surface in TT5-1C (C5-2C-06)

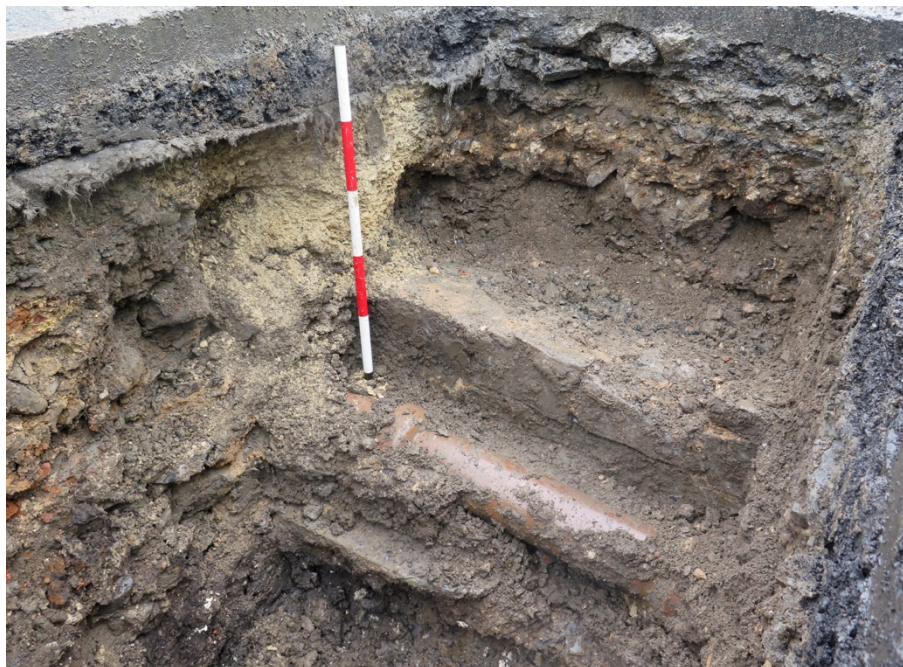
<b>Trench:</b> TT5-2C	<b>Context:</b> C5-2C-09	<b>Dates excavated:</b> 7/7/20
<b>Feature type:</b> Culvert/drain		
<b>Co-ordinates (ITM):</b> 557761.5004, 657569.5848		
<b>Minimum depth (ASL):</b> 3.1798		
<b>Depth of feature below surface:</b> 0.5-1.55m		
<b>Base of feature reached?</b> Y		
<b>Alignment:</b> NW/SE, 140°		
<b>Description:</b>	Stone lined culvert carrying a 6" terracotta pipe, at the NE end of TT5C. The culvert is approximately 950mm width and built of cut limestone blocks 200mm wide set to three courses	
<b>Date of construction:</b>	19th century

Figure 44 Culvert at the east of TT5-2C (C5-2C-09)

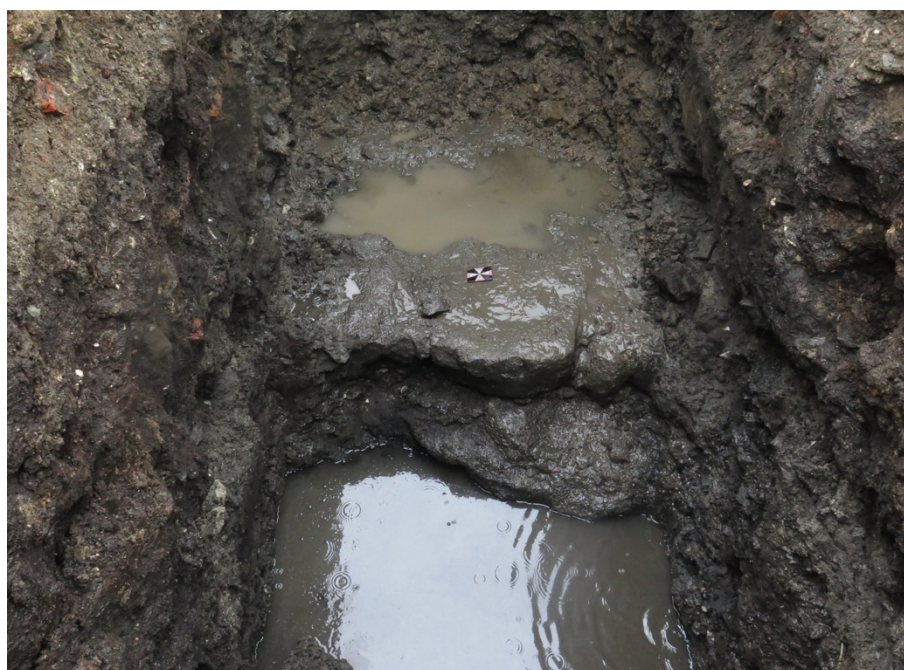
<b>Trench:</b> TT5-2C	<b>Context:</b> C5-2C-13	<b>Dates excavated:</b> 8/7/20
<b>Feature type:</b> Wall/foundation		
<b>Co-ordinates (ITM):</b> 557743.9404, 657552.1493		
<b>Minimum depth (ASL):</b> 1.2488		
<b>Depth of feature below surface:</b> 2.7-3.4m		
<b>Base of feature reached?</b> N		
<b>Alignment:</b> NNW/SSE, 150°		
<b>Description:</b>	Limestone mortared wall exposed at 2.7m depth, crossing TT5-3 in a northwest/southeast alignment. The upper course of the wall is 1100mm width; a second course (foundation) visible as a large boulder exposed for a height of 400mm and with an uneven face giving a total width of 1400mm. No bonding evident but may have eroded out. Fill abutting the southwest side is grey sand with frequent oyster shell and containing clay pipe and black glazed earthenware; fill on the 'inner' northeast side is brown clay.	
<b>Date of construction:</b>	Pre-1760s, quay wall associated with Late Medieval harbour.

Figure 45 Wall in TT-2C (C5-2C-13)

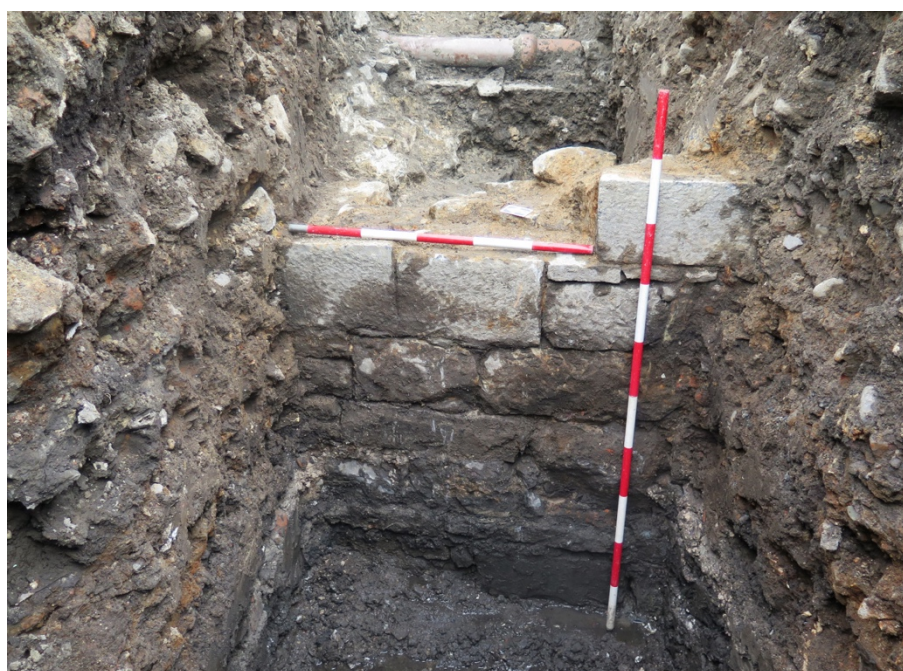
<b>Trench:</b> TT5-3	<b>Context:</b> C5-3-13	<b>Dates excavated:</b> 9-13/7/20
<b>Feature type:</b> Wall/foundation		
<b>Co-ordinates (ITM):</b> 557762.8512, 657563.3575		
<b>Minimum depth (ASL):</b> 2.4788		
<b>Depth of feature below surface:</b> 1.27-3.02m		
<b>Base of feature reached?</b> Y		
<b>Alignment:</b> NNW/SSE, 150°		
<b>Description:</b>	Limestone wall exposed at 1.27m depth. The upper course is 1100mm width, expanding to 1400mm on the rubble foundation; seven courses exposed; well cut and dressed outer face in the upper courses becoming rougher and with more irregular coursing lower down; possible repairs by inserting smaller stones, brick. The wall sits upon limestone bedrock at 3.4m below the present ground level. This wall is the continuation of wall C5-2C-13, but better preserved	
<b>Date of construction:</b>	Pre-1760s, quayside wall associated with Late Medieval harbour, with later (18th century) additions

Figure 46 Wall in TT5-3 (C5-3-13)

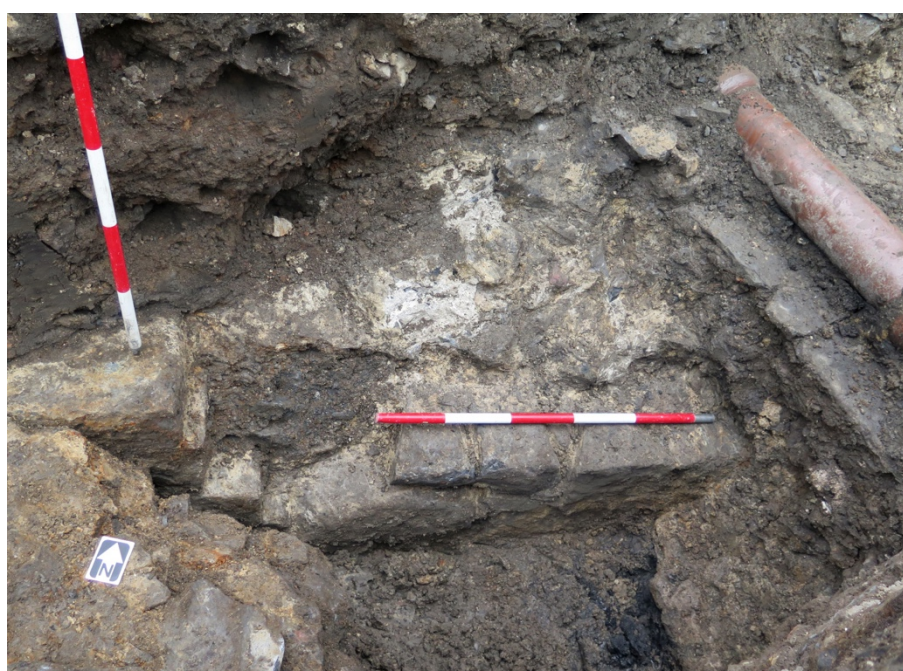
<b>Trench:</b> TT5-3	<b>Context:</b> C5-3-14	<b>Dates excavated:</b> 9-13/7/20
<b>Feature type:</b> Wall		
<b>Co-ordinates (ITM):</b> 557763.8023, 657564.1069		
<b>Minimum depth (ASL):</b> 2.1285		
<b>Depth of feature below surface:</b> 1.4-2.15m		
<b>Base of feature reached?</b> N		
<b>Alignment:</b> WSW/ENE, 80°		
<b>Description:</b>	Mortared limestone wall abutting and at right angles to wall C5-3-13. The wall has a mortared rubble core with angular limestone facing stones bonded by yellow mortar. Two courses and the top of a foundation were exposed for a depth of 750mm and a length of 2.35m. The exposed width of the wall is 1.1m, and it continues into the trench wall to the north. The wall is cut by a culvert to the northeast and is also cut by the retaining wall C5-3-13, so is earlier than this.	
<b>Date of construction:</b>	Medieval? May relate to projecting jetty as shown on Phillips' (1685) and Eyre's (1752) maps.

Figure 47 Wall in TT5-3 (C5-3-14)

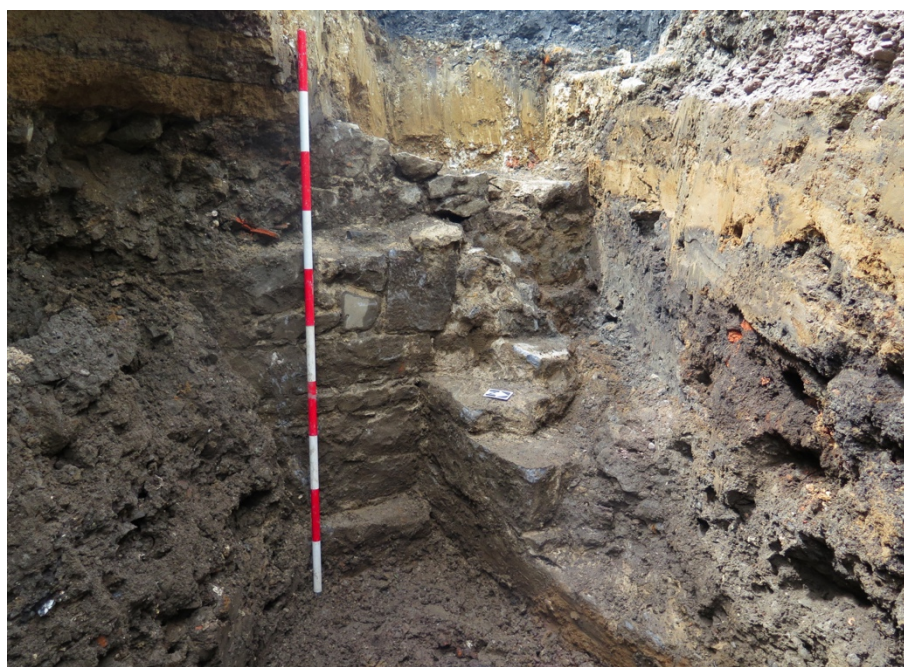
<b>Trench:</b> TT5-5	<b>Context:</b> C5-5-12	<b>Dates excavated:</b> 1/7/20
<b>Feature type:</b> Wall		
<b>Co-ordinates (ITM):</b> 557730.3616, 657544.2257		
<b>Minimum depth (ASL):</b> 2.8074		
<b>Depth of feature below surface:</b> 1.1-3m (base concealed by wall C5-5-13)		
<b>Base of feature reached?</b> N		
<b>Alignment:</b> WNW/ESE, 100°		
<b>Description:</b>	Mortared limestone wall of irregularly shaped and sized limestone blocks; well-constructed; irregular coursing consisting of three segments defined by sills which become progressively wider at greater depth. Minimum width: 1.1m. Height of wall revealed: 1.81m (right of image)	
<b>Date of construction:</b>	Pre-1769 wall, may be associated with medieval North Pier.

Figure 48 Walls in the west of TT5-5 (C5-5-12) and (C5-5-13)

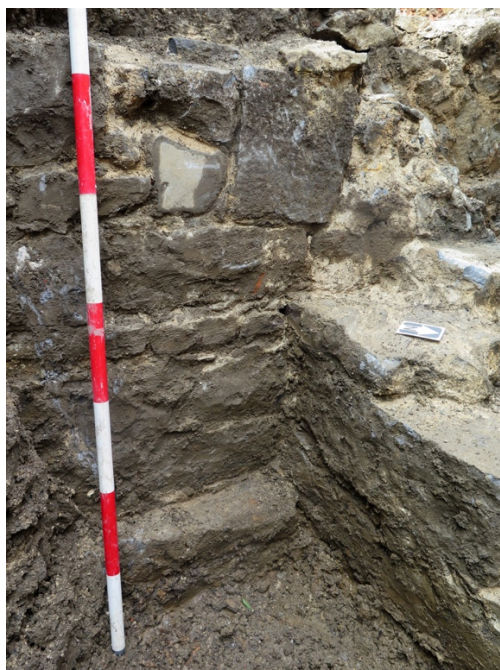
<b>Trench:</b> TT5-5	<b>Context:</b> C5-5-13	<b>Dates excavated:</b> 1/7/20
<b>Feature type:</b> Wall		
<b>Co-ordinates (ITM):</b> 557730.7810, 657545.0540		
<b>Minimum depth (ASL):</b> 2.054		
<b>Depth of feature below surface:</b> 1.65-3m		
<b>Base of feature reached?</b> N		
<b>Alignment:</b> NNE/SSW, 10°		
<b>Description:</b>	Mortared limestone wall aligned west/east, abutting and at right angles to wall C5-5-12, which has been tied in to this wall and which this wall pre-dates. The wall has a mortared rubble core with finer limestone facing stones bonded by yellow mortar.	
<b>Date of construction:</b>	1760s, built by 1769. Northern pier wall of New Quay, unexposed side, ontemporary with quay wall found in TT4-1 and TT4-4.

Figure 49 Detail showing junction of walls in the west of TT5-5 (C5-5-12) and (C5-5-13)

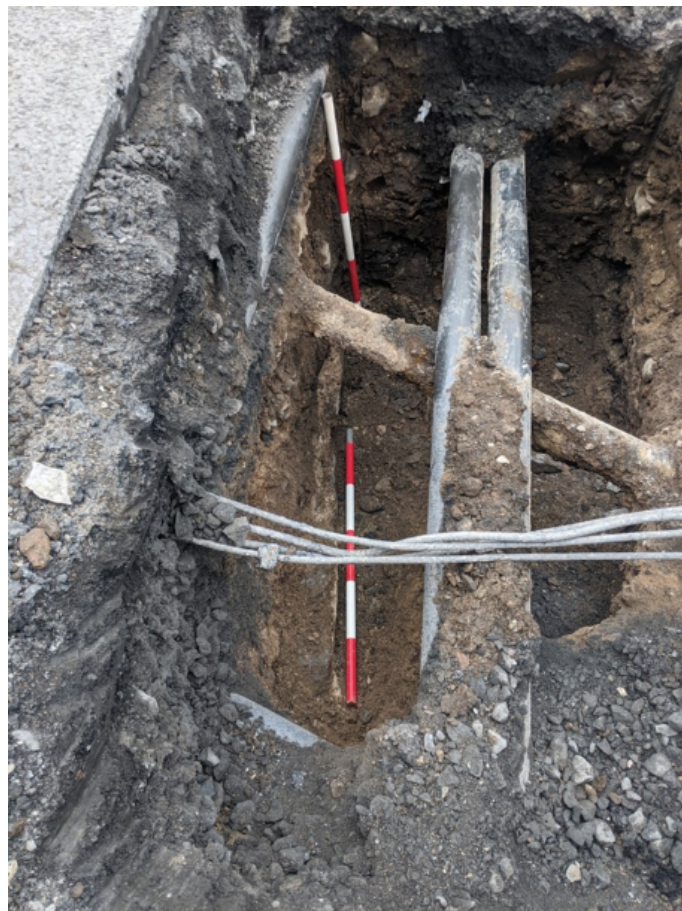
<b>Trench:</b> TT6-1	<b>Context:</b> C6-1AB-06	<b>Dates excavated:</b> 11/6/20
<b>Feature type:</b> Wall		
<b>Co-ordinates (ITM):</b> 557818.5192, 657529.9961		
<b>Minimum depth (ASL):</b> 3.4049m		
<b>Depth of feature below surface:</b> 1.28m		
<b>Base of feature reached?</b> N		
<b>Alignment:</b> NNE/SSW, 20°		
<b>Description:</b>	Mortared limestone wall running along west side of trench	
<b>Date of construction:</b>	Unknown

Figure 50 Wall foundation TT6-1A looking north.

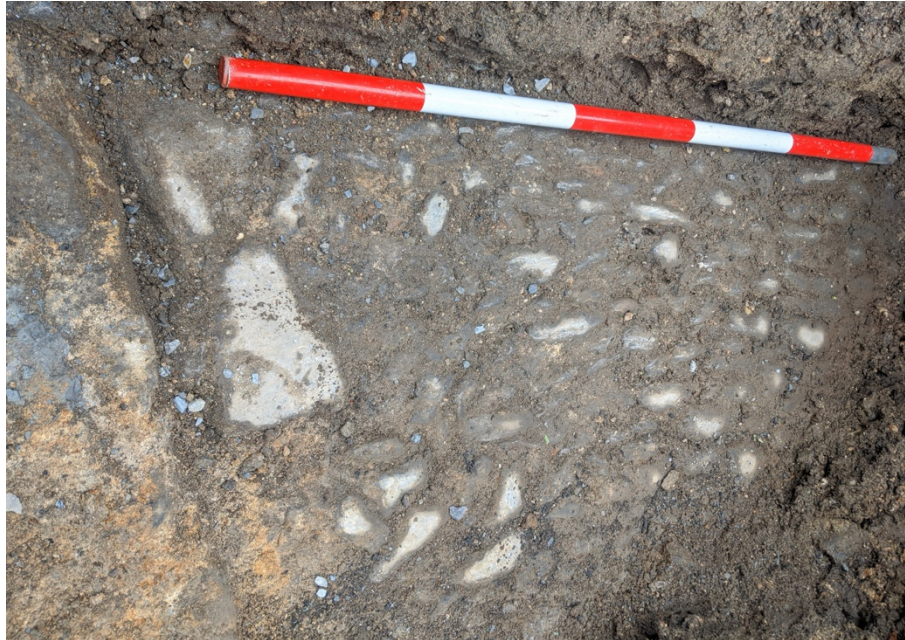
<b>Trench:</b> TT6-1	<b>Context:</b> C6-1AB-07	<b>Dates excavated:</b> 11/6/20
<b>Feature type:</b> Cobbled surface		
<b>Co-ordinates (ITM):</b> 557818.9163, 657528.7791		
<b>Minimum depth (ASL):</b> 3.4542m		
<b>Depth of feature below surface:</b> 1.3 m		
<b>Base of feature reached?</b> N		
<b>Alignment:</b> n/a		
<b>Description:</b>	Cobbled surface	
<b>Date of construction:</b>	16th-17th century. Access point to harbour, Quay gate was rebuilt in 1642, removed by 1769.

Figure 51 Cobbled surface in TT6-1 (C6-1AB-07)

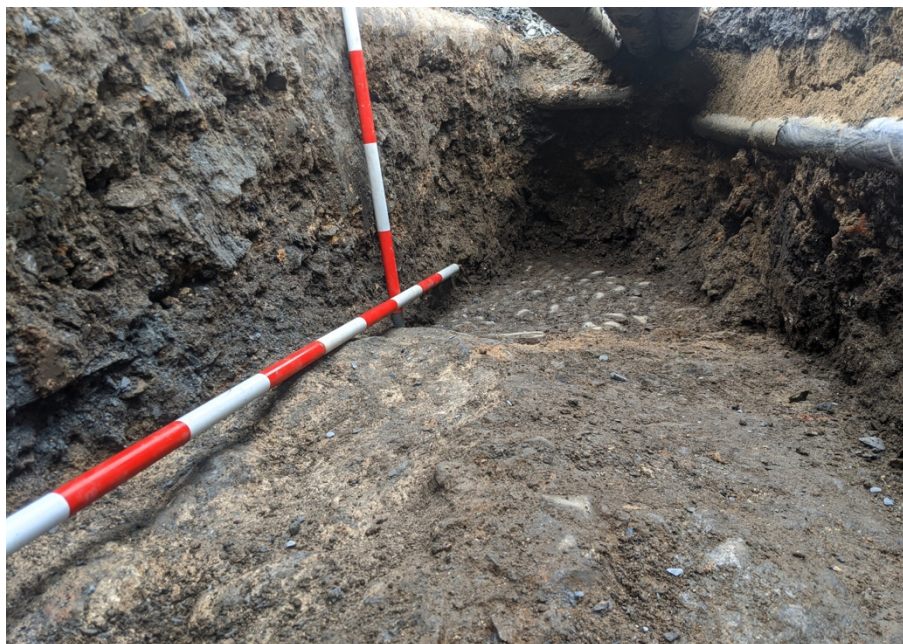
<b>Trench:</b> TT6-1	<b>Context:</b> C6-1AB-08	<b>Dates excavated:</b> 11/6/20
<b>Feature type:</b> Mortared surface		
<b>Co-ordinates (ITM):</b> 557818.5093, 657530.2125		
<b>Minimum depth (ASL):</b> 3.3599m		
<b>Depth of feature below surface:</b> 1.25m		
<b>Base of feature reached?</b> N		
<b>Alignment:</b> n/a		
<b>Description:</b>	Mortared or metalled surface abutting cobbled surface (C6-1AB-07) and wall (C6-1AB-06).	
<b>Date of construction:</b>	16th-17th century. Part of the Quay gate shown on maps dating from 1587 to 1769.

Figure 52 Mortared surface in TT6-1 (C6-1AB-08)

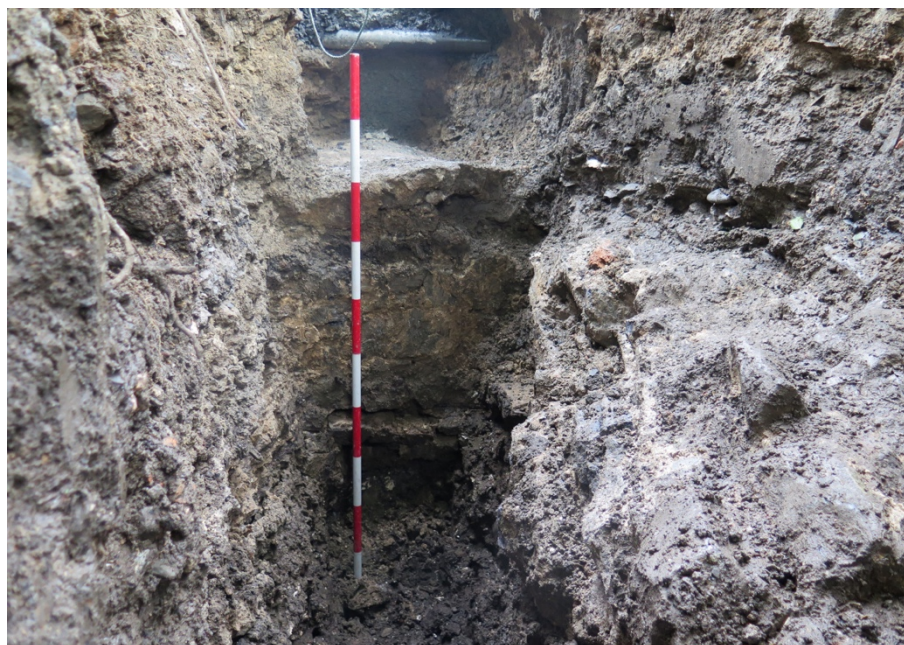
<b>Trench:</b> TT6-1	<b>Context:</b> C6-1CD-08	<b>Dates excavated:</b> 18/8/20
<b>Feature type:</b> Wall		
<b>Co-ordinates (ITM):</b> 557817.0822, 657523.9082		
<b>Minimum depth (ASL):</b> 3.3924m		
<b>Depth of feature below surface:</b> 1.4-2.6m		
<b>Base of feature reached?</b> Y		
<b>Alignment:</b> NW/SE, 110°		
<b>Description:</b>	Mortared limestone wall running across centre of the trench; mortar fragments adhered to the south-facing side of the wall	
<b>Date of construction:</b>	Late Medieval. Part of city defences between Quay Gate and bastion

Figure 53 Wall running across the centre of TT6-1 (C6-1CD-08)

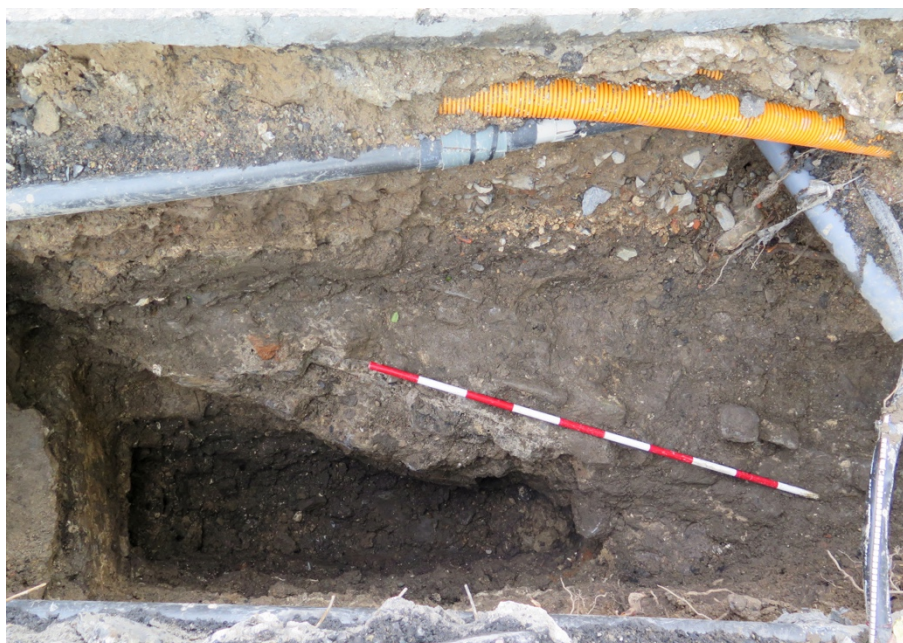
<b>Trench:</b> TT6-1	<b>Context:</b> C6-1CD-09	<b>Dates excavated:</b> 18/8/20
<b>Feature type:</b> Wall		
<b>Co-ordinates (ITM):</b> 557816.9169, 657523.2266		
<b>Minimum depth (ASL):</b> 3.1788m		
<b>Depth of feature below surface:</b> 1.5-2.9m		
<b>Base of feature reached?</b> Y		
<b>Alignment:</b> NNE/SSW, 200°		
<b>Description:</b>	Mortared limestone wall running N/S along east side of trench, perpendicular to (cut by) C6-1CD-08 to the north. Potential three-sided bastion, note upper side of feature was slightly concave, consideration was given to this being a drain. More likely associated with projecting bastion and access to south pier.	
<b>Date of construction:</b>	Late Medieval

Figure 54 Wall running along the east of TT6-1 (C6-1CD-09)
