River Bride (Blackpool) Certified Drainage Scheme

Supplementary Information Response
In relation to issues raised in Judicial Review

Updated Water Framework Directive Water Body Status Assessments

March 2025

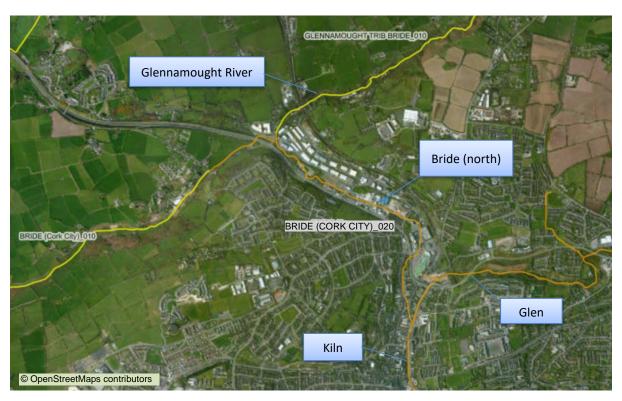
Figure 3-1 Location of RWBs with EPA status (2016-2021) (EPA watermaps)

The two directly affected RWBs are illustrated in **Figure 3.1**. In addition, the Bride (Cork City)_010 adjoins Bride (Cork City)_020. It is not directly affected by the proposal but is examined in terms of indirect and cumulative effects on water body status objectives and WFD compliance in §3.5.

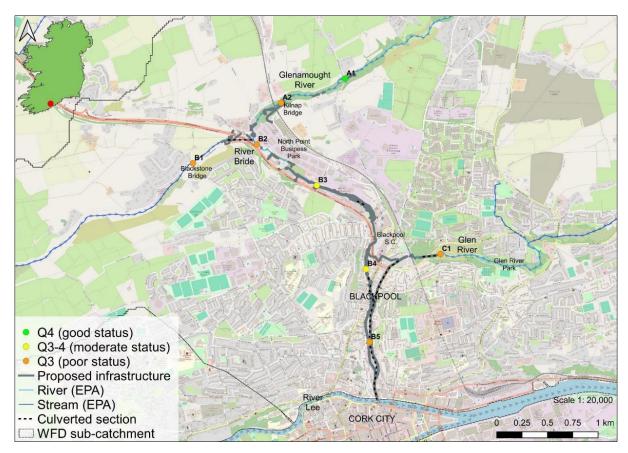
Figure 3-2 Q-value results 2024 field surveys (from Triturus, 2024a)

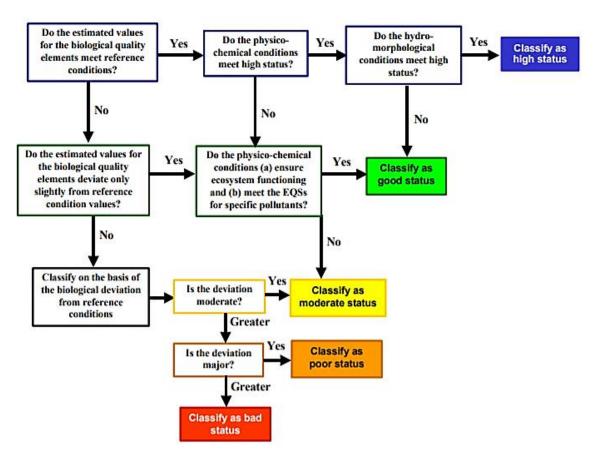
Figure 3-3 Relative roles of biological, physicochemical and hydromorphological elements in ecological status classification (from CIS Guidance EC, 2005)

The hydromorphological quality element is therefore only considered when assigning water bodies to the high ecological status class. For good and moderate status, hydromorphological conditions (morphology, hydrology, continuity) are, by default, "consistent with the achievement of the values specified ...for the biological quality elements." (WFD Annex V (1.2.1)).

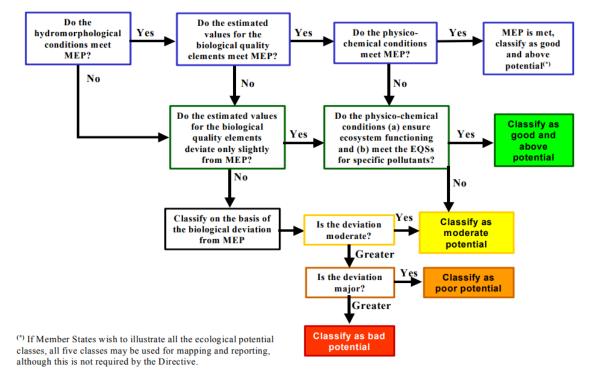
Figure 3-4 Relative roles of biological, hydromorphological and physicochemical quality elements in ecological potential classification (from CIS 2005)

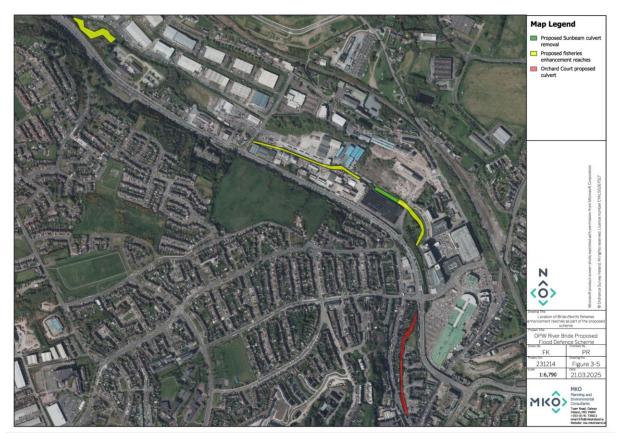
Figure 3-5 Location of Bride (North) fisheries enhancement reaches as part of the proposed scheme

Culvert installation and removal have potential to alter aquatic habitat the most notably. In this regard, there will be 342m of new culvert through Orchard Court, plus 72m of culvert removal at Sunbeam Industrial Estate, the latter being restored to open (walled) channel. The proposed modifications are shown on **Figure 3-5**.

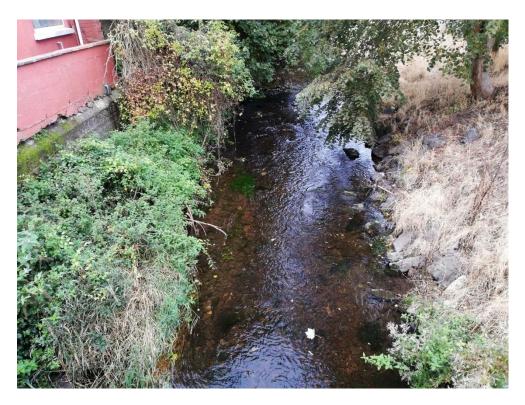
Image A1: Bride River – view upstream from entry bridge into Orchard Court showing boulder rip-rap, hard engineered walls and sprayed riparian zone. Natural in-stream substrates.

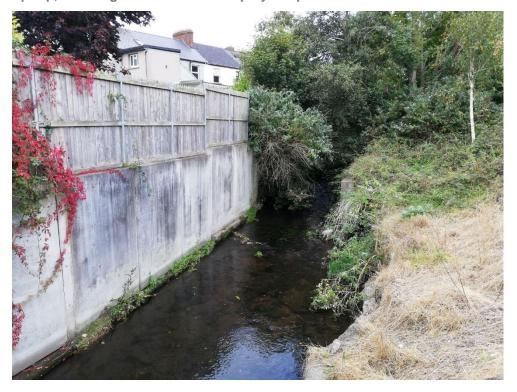
Image A2: Bride River – view upstream from within Orchard Court showing existing defences (concrete walls, boulder rip-rap).

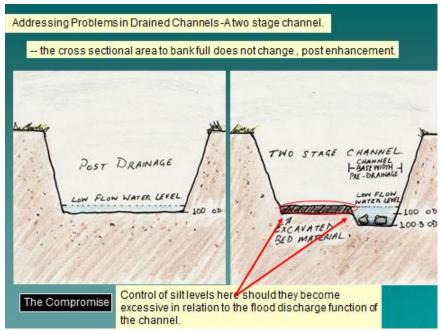
Figure 1. An illustration of the proposed "two stage" channel.

From a fishery perspective, it is crucial that post-drainage, there should be a "two stage" channel with the wetted width in low flow regimes having the same base width as is evident to-day – the concept of a "two stage" channel is illustrated in "Channels and Challenges" (O'Grady, 2006) (see also Fig. 1 below).

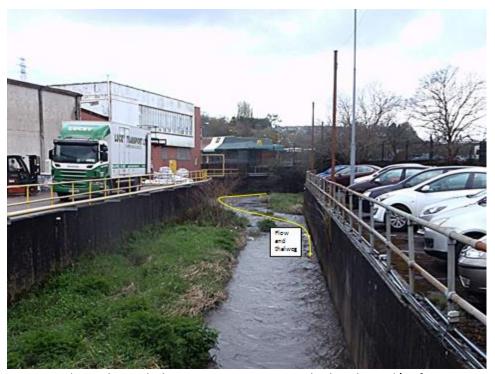
Figure 2. Channel morphology at an existing meander bend just d/s of CO6 _ 2250.

The channel reach within this programme of concern to fisheries, as defined in section 3.1.1 above, has a number of natural meanders. On each of these meanders the deposition of river silt presently illustrates the natural curvature of the channel. Essentially, post-drainage, the construction of a two-stage channel should mimic the existing pattern at a lower bed level at each meander point (see Figure 2 below by way of example).

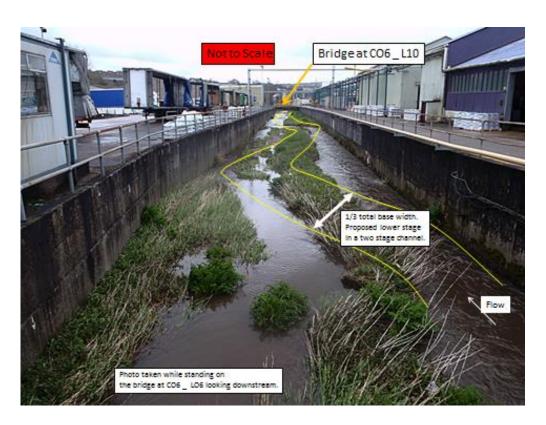
Figure 3. An outline sketch of the enhancement proposal for this reach following the implementation of the drainage programme.

The creation of a two-stage channel both in straight and meander sections of this channel will necessitate the construction of stone deflectors to function as the "higher tier" of the two bed levels. A suitable design for such a structure is illustrated in Figure 4.

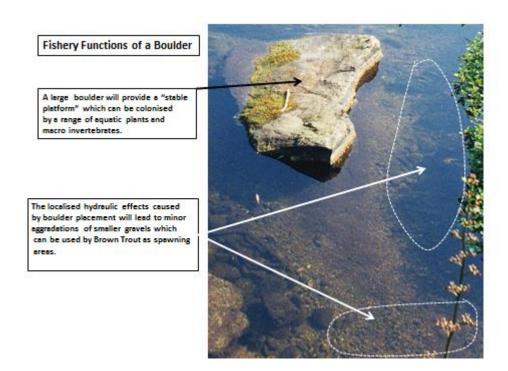
Figure 5. Visual evidence of the value of an introduced boulder.

- Localised hydrological alterations, caused by boulder placement, would provide resting
 places for trout and result in localised minor accumulations of the smaller gravels in the
 channel bed, downstream of individual boulders which would provide spawning
 opportunities for the trout.
- Stable boulders also provide an area which can be colonised by aquatic plants and invertebrates (Figure 5).

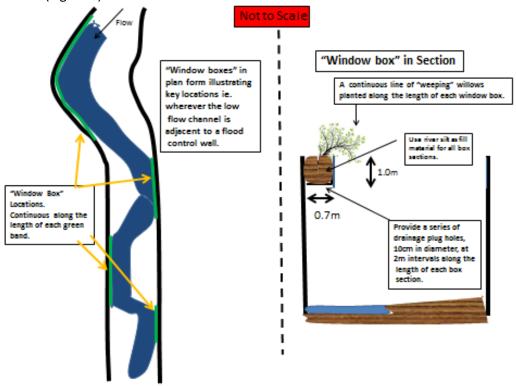
Figure 6. Detail in relation to the Willow planting proposal.

flood relief walls on selected channel reaches – wherever the low flow wetted reach is adjacent to the flood protection wall (Figure 6). Given the limited growing zone within these boxes the "weeping willows" will remain dwarf in nature and not interfere with flood flows (Figure 6).

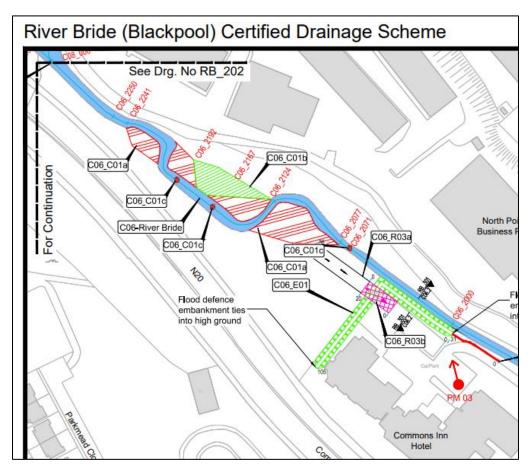
Figure A2: Fisheries enhancement area upstream Commons Inn Hotel

The reach of the Bride shown in Fig A2 is taken from Public Exhibition Drawing No. RB_203 Proposed Flood Defences - Plan Layout (Sheet 3 of 10) available online in the Project Documents page of the Bride (Blackpool) scheme website.
