# River Bride (Blackpool)

## Certified Drainage Scheme

Supplementary Information Response  
In relation to issues raised in Judicial Review

### **Ground 6 - Water Framework Directive Water Body Status Assessments**

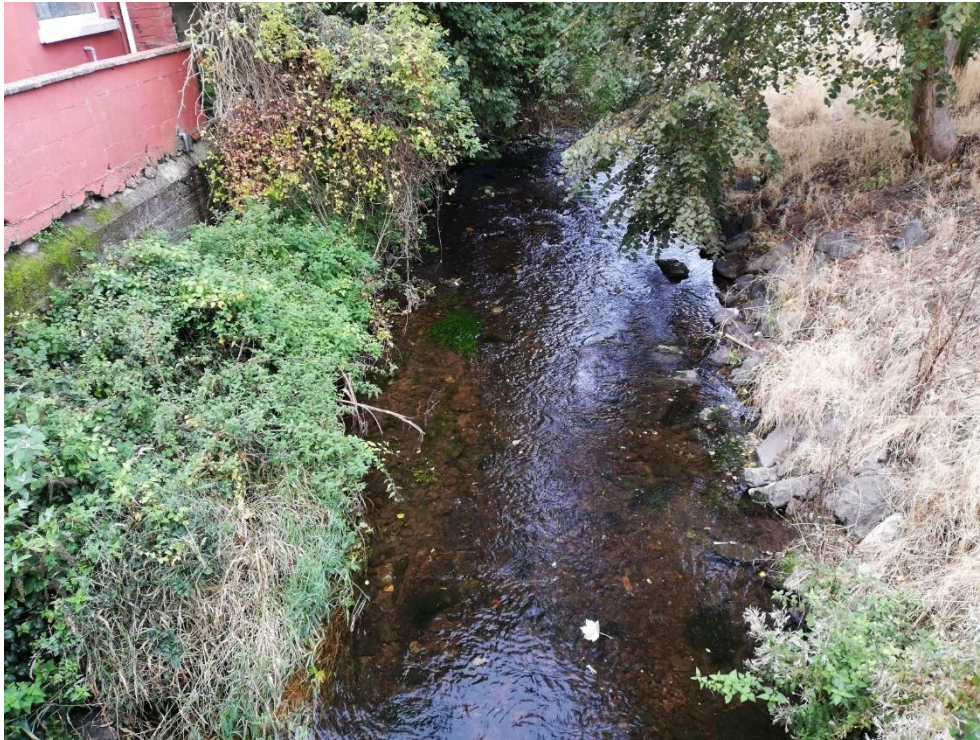
**Image A1: Bride River – view upstream from entry bridge into Orchard Court showing boulder rip-rap, hard engineered walls and sprayed riparian zone. Natural in-stream substrates.**

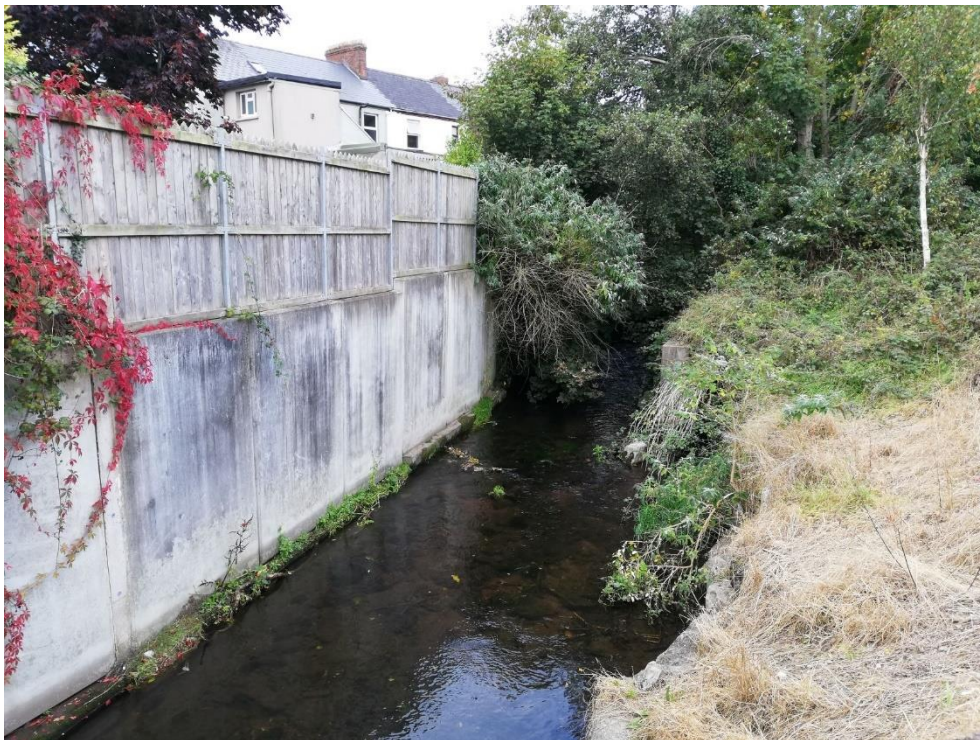
**Image A2: Bride River – view upstream from within Orchard Court showing existing defences (concrete walls, boulder rip-rap).**

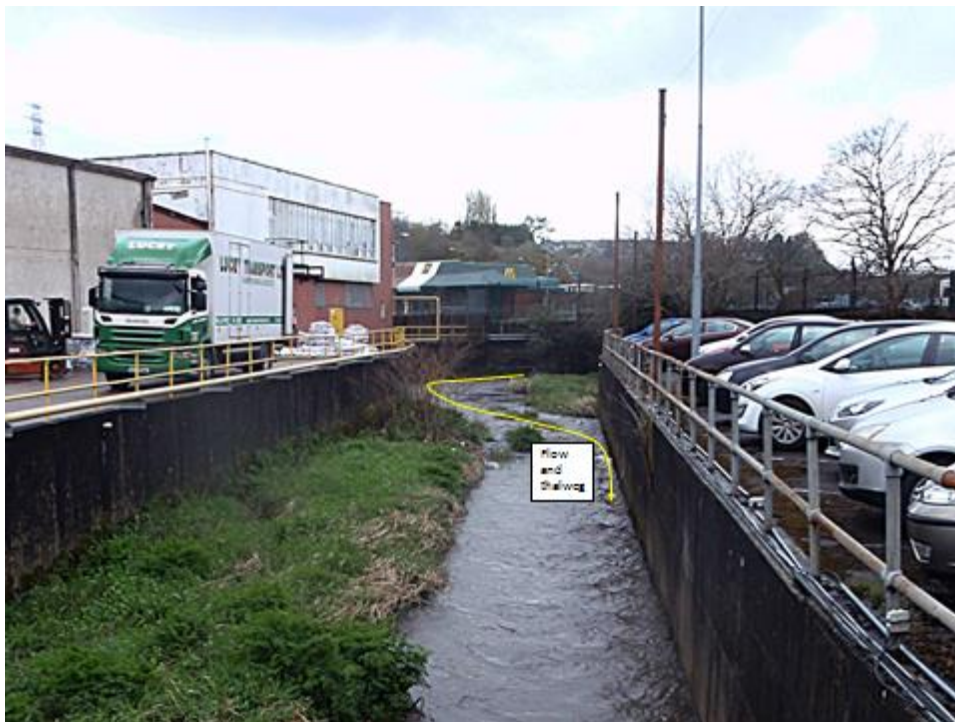
Figure 2. Channel morphology at an existing meander bend just d/s of CO6 \_ 2250.

The channel reach within this programme of concern to fisheries, as defined in section 3.1.1 above, has a number of natural meanders. On each of these meanders the deposition of river silt presently illustrates the natural curvature of the channel. Essentially, post-drainage, the construction of a two-stage channel should mimic the existing pattern at a lower bed level at each meander point (see Figure 2 below by way of example).
