Monthly Site Environmental Audit

Glanmire Flood Relief Scheme

30/05/24 To 26/06/24

ENVIRONMENTAL AUDIT

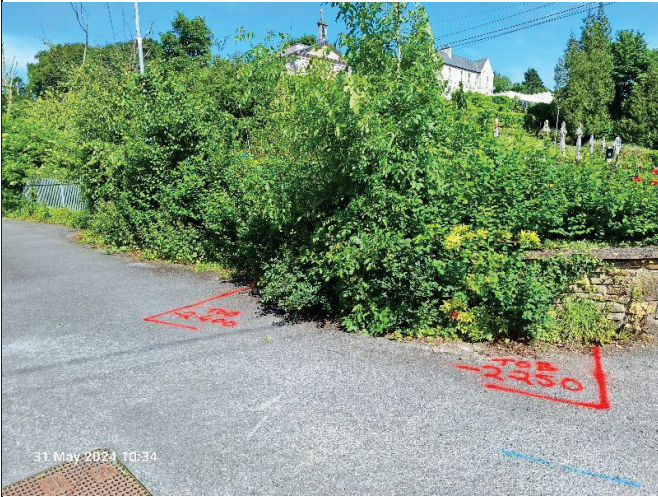
Figure 1			Figure 2

Caption 1			Caption 2		
Bird nest survey completed prior to vegetation clearance – Cois na Gleann.			Little Robin transplanted from Area 3
