Survey Area 2

CHS 07 Headrace of Glansillagh Mills

Survey Area 3

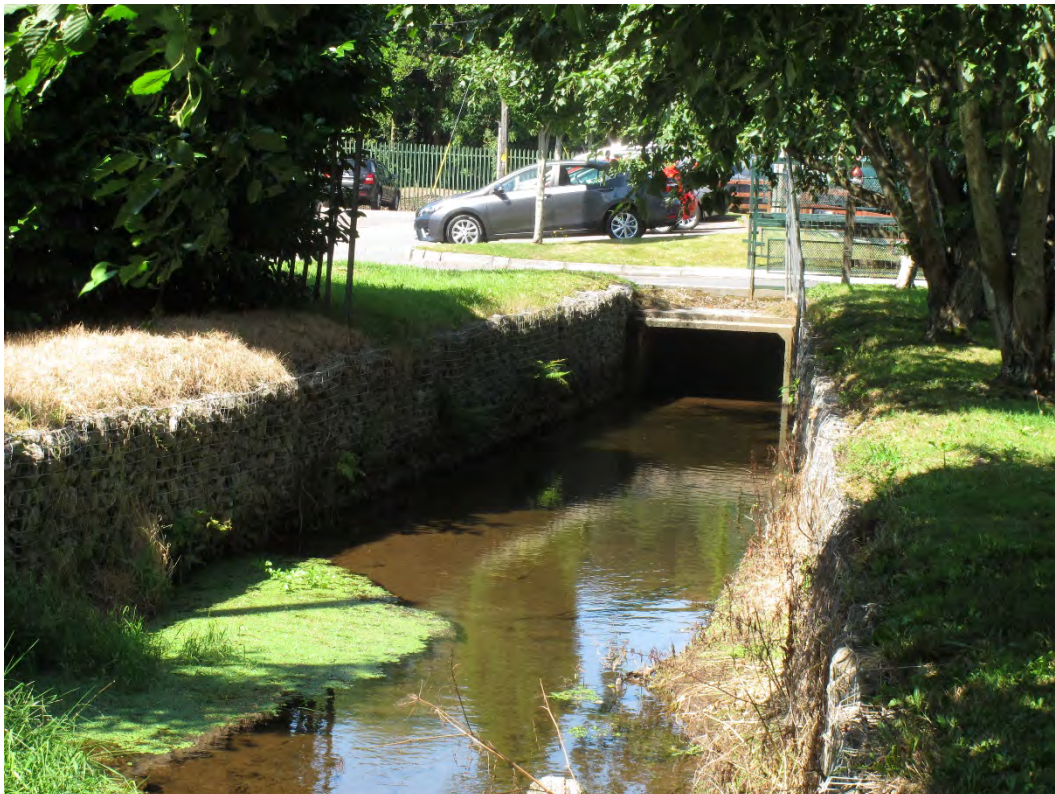
The banks/ side walls of the mill race have been significantly modified (Fig. 4,7 & 8; Plate 23). It now consists of gabion walls with boulders at the SE end. The original banks appear to have been removed or may be concealed behind the gabion walls.

Plate 23: View of CHS 07 head race Pike Mill, taken from northwest.

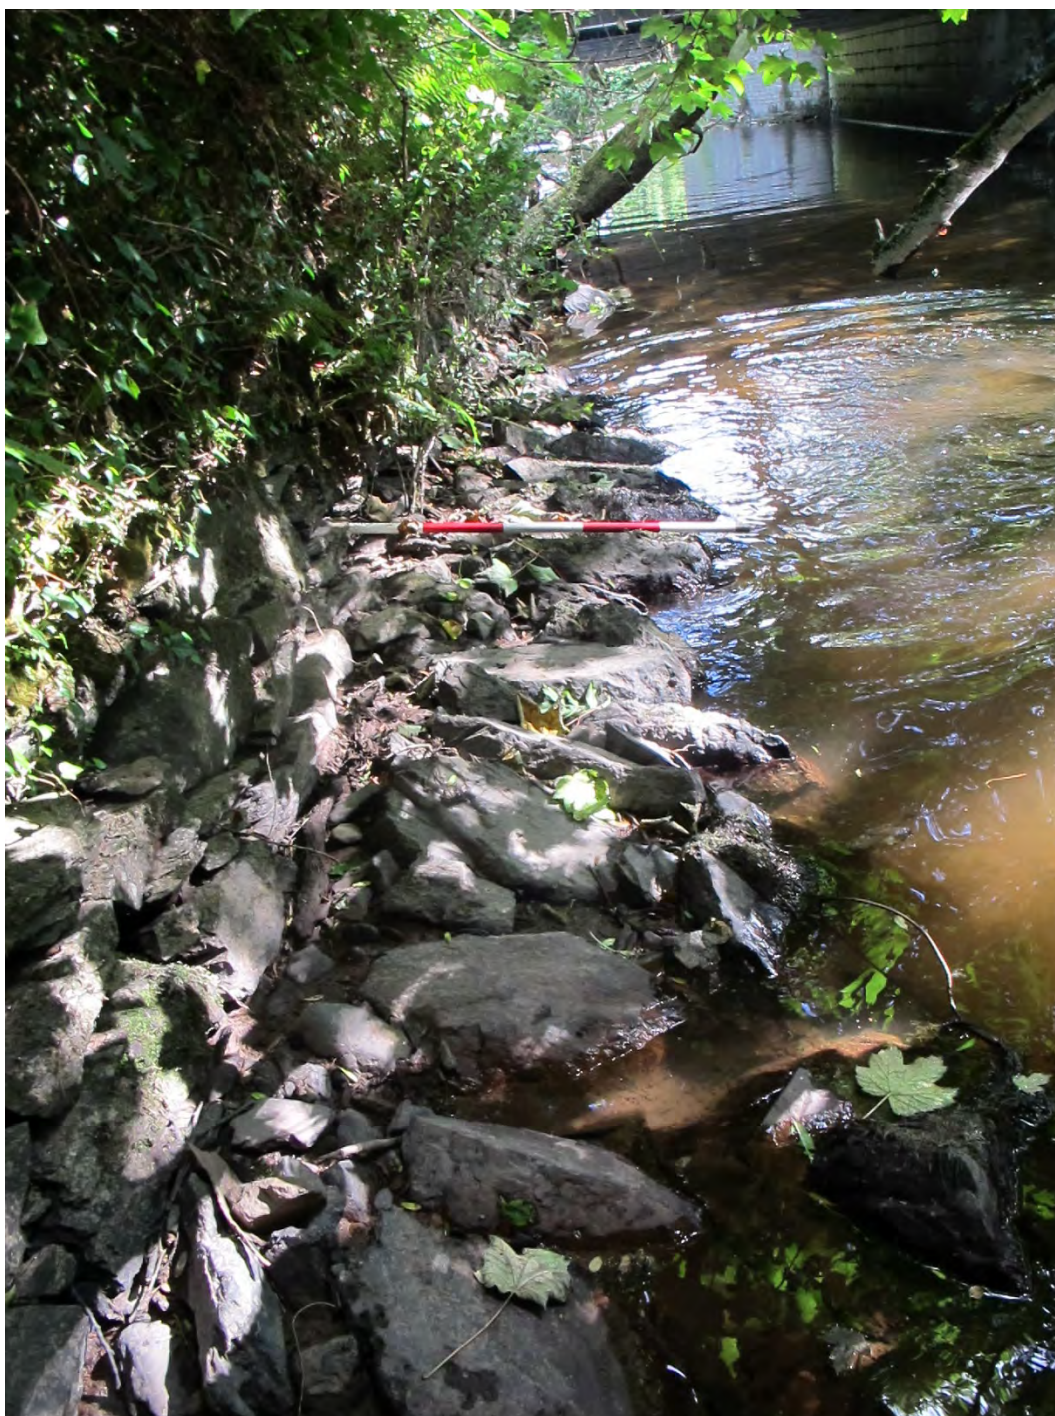
A riverbank revetment wall extends along most of Survey Area 3 (Fig. 9) albeit with sections missing in places exposing an earthen bank. In other sections it is replaced in an *ad hoc* fashion with various modern wall types including gabion walls, concrete walls or simply revetted with railway sleepers. It is of random rubble construction. An average height of 1.7m was recorded. At the northern limits of the survey a section of stone paving measuring 7.4m x 1.0m is present at the base of the wall (Plate 24 & 25).

Plate 24: View of CHS 08, revetment wall taken from north.

- No mitigation required at the northern limits of CHS 8.
- Licensed archaeological monitoring should be undertaken by an experienced underwater archaeologist.

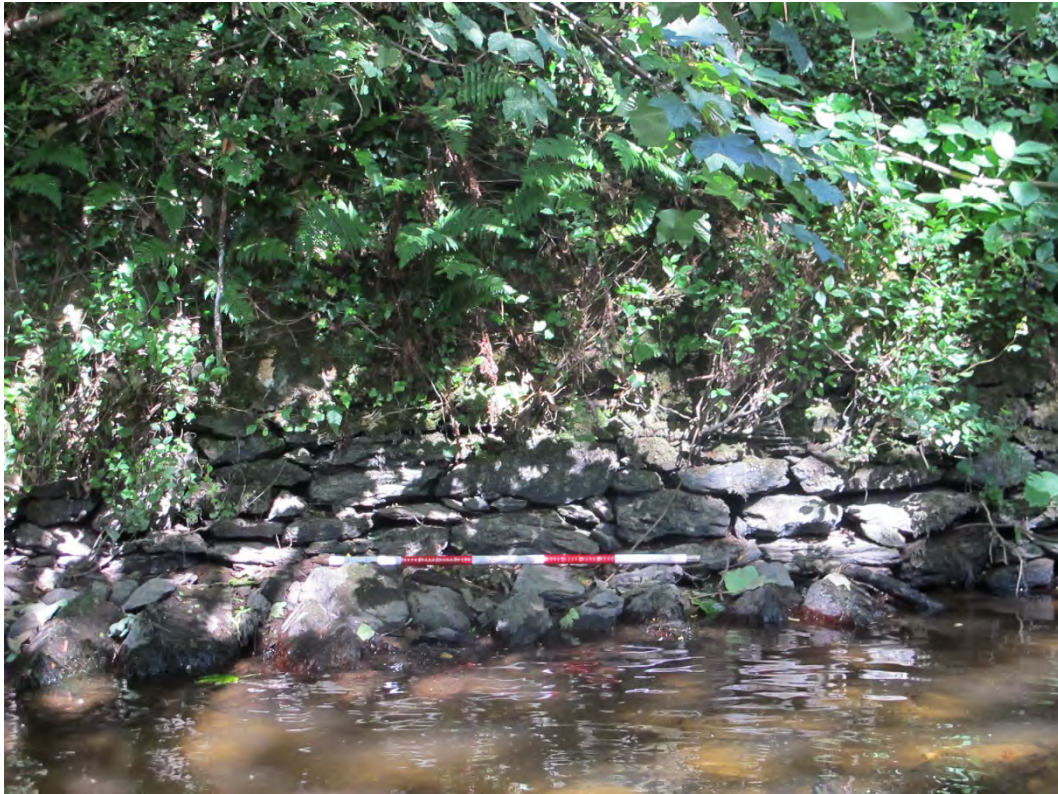
Plate 25: View of CHS 08, revetment wall taken from west.

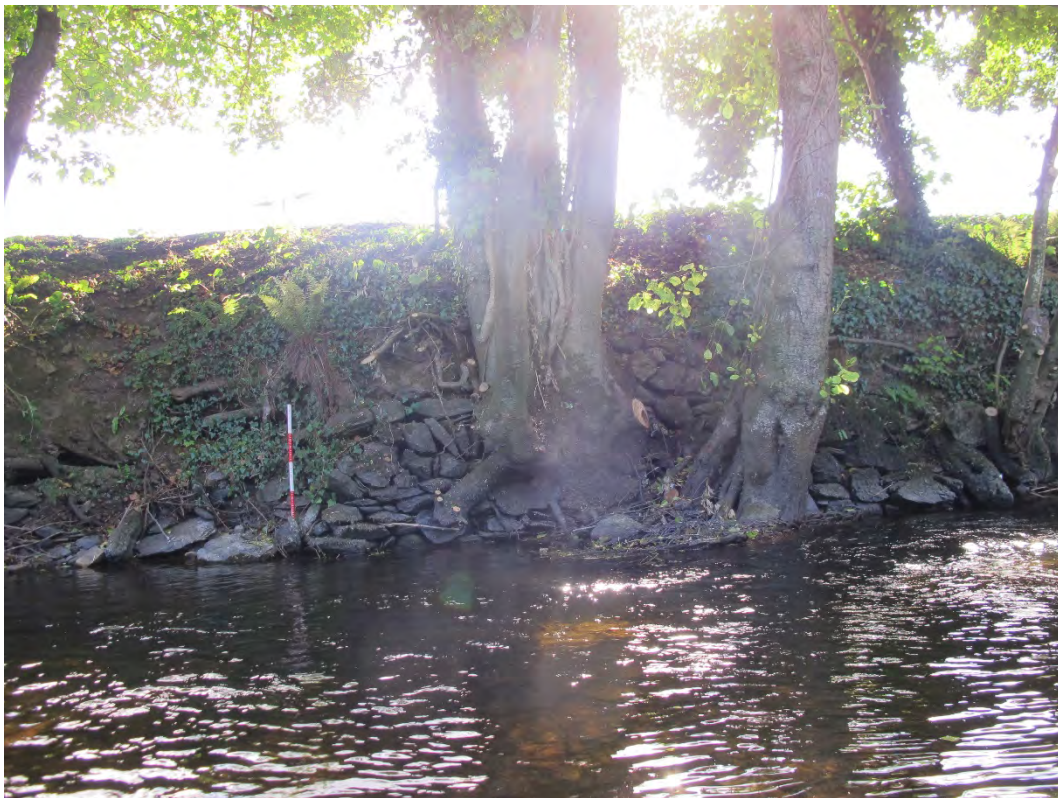
Three sections of the revetment wall on the western bank survive within the study area. The wall is constructed of uncoursed rubble sandstone (Plate 29). It has a max. height of 1.5m. It is in a poor state of preservation with outward bulging and a scour of up to 0.4m noted beneath the wall.

Plate 26: View of CHS 09, revetment wall taken from east.

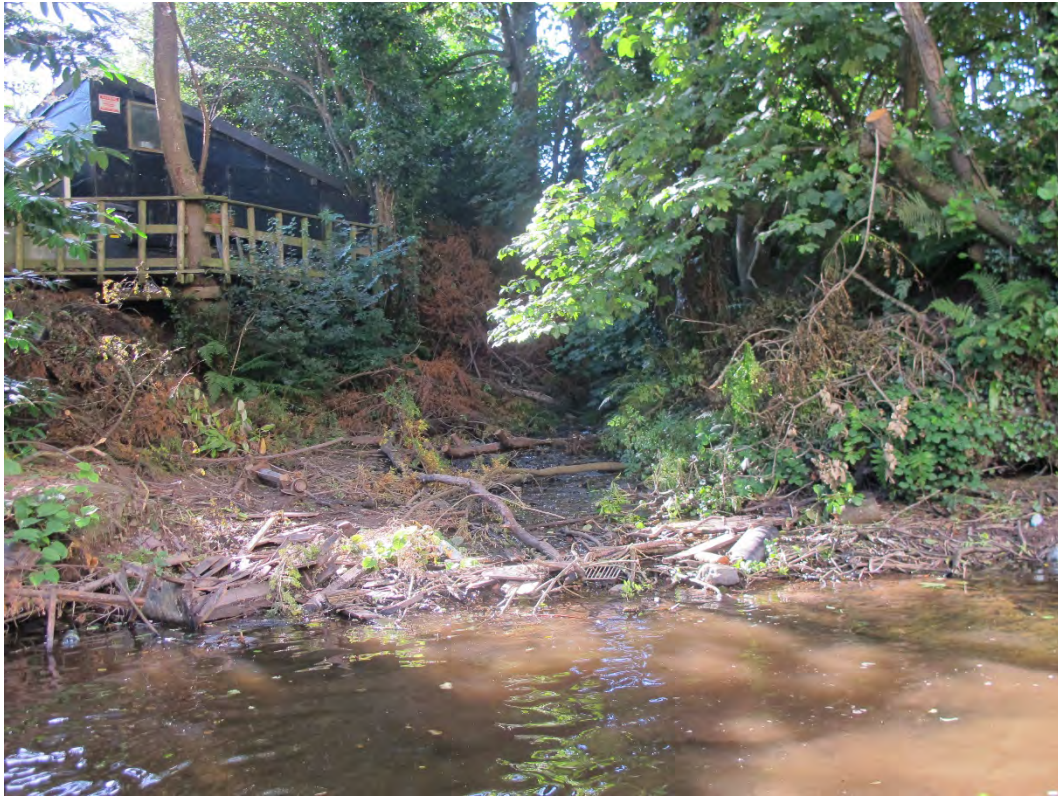
A tailrace issuing from a flour/corn mill at Spring Hill is visible on the western riverbank at ITM E572744 N575380. The mill race which is indicated on the 1st and 2nd edition OS Map also marks the townland boundary between Ballincrossig and Poulacurry North. At the time of the survey there

was no water flowing from the mill race. The race is c.4m wide. Its sides consist of overgrown earthen banks and no stone walling was recorded.

Plate 27: View of CHS 10, tailrace, Spring Hill Mill, taken southeast.

Licensed archaeological monitoring should be undertaken by an experienced underwater archaeologist.

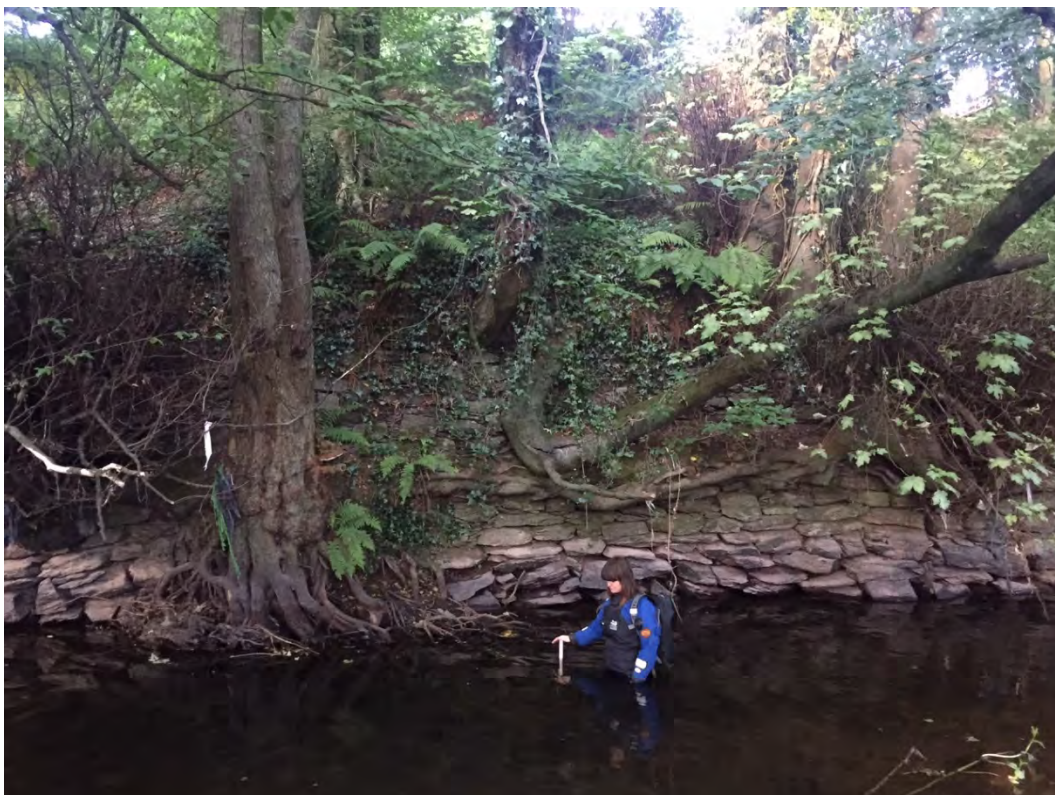
An east-west Weir is denoted on the 1st edition OS map of 1842 extending across a bend of the Glashaboy (Fig.9). Abutting the east terminus of the Weir is the remains of a headrace that fed into the Riverstown Flour Mill to the SE. The upstream approach section of the headrace consists of a substantial 3.0m high revetment wall (Plate 30) that runs in a NW-SE direction into the mill race, while the river sweeps around to the southwest. The millrace itself was not accessible as a large quantity of tree cuttings have been deposited on top of the structure in recent times.

Plate 30: View of revetment wall approaching headrace CHS 11.

- Mitigation by avoidance. Where possible impact by the construction works on the existing approach Headrace / Sluice wall and pre-famine Weir should be avoided. If unavoidable the proposed construction works should be faced with sympathetic material to minimise potential negative aesthetic visual impacts.
- Licensed archaeological monitoring should be undertaken by an experienced underwater archaeologist.

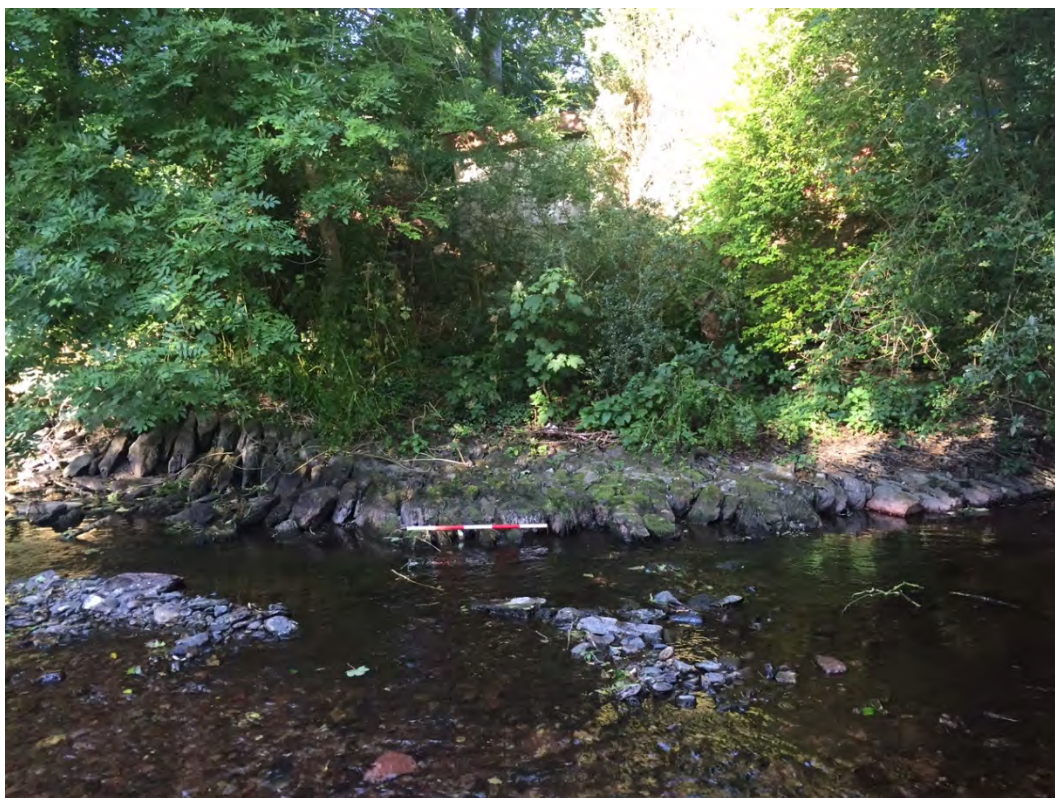
A coherent section of intra-riverine feature comprising well set and matched stones set on edge was recorded immediately south of the Headrace (Fig. & Plates 31 & 32). The feature, possibly a river access slip or revetment, projects from the eastern bank into the river in a WSW- ENE direction and slopes from a maximum height of 1.0 m beside the race down to the level of the riverbed. The Weir is not denoted on the 2nd Edition OS map and it is likely that this feature is possibly the remains of the weir indicated on the 1st edition OS map.

Plate 31: View of headrace CHS 11, taken from west.

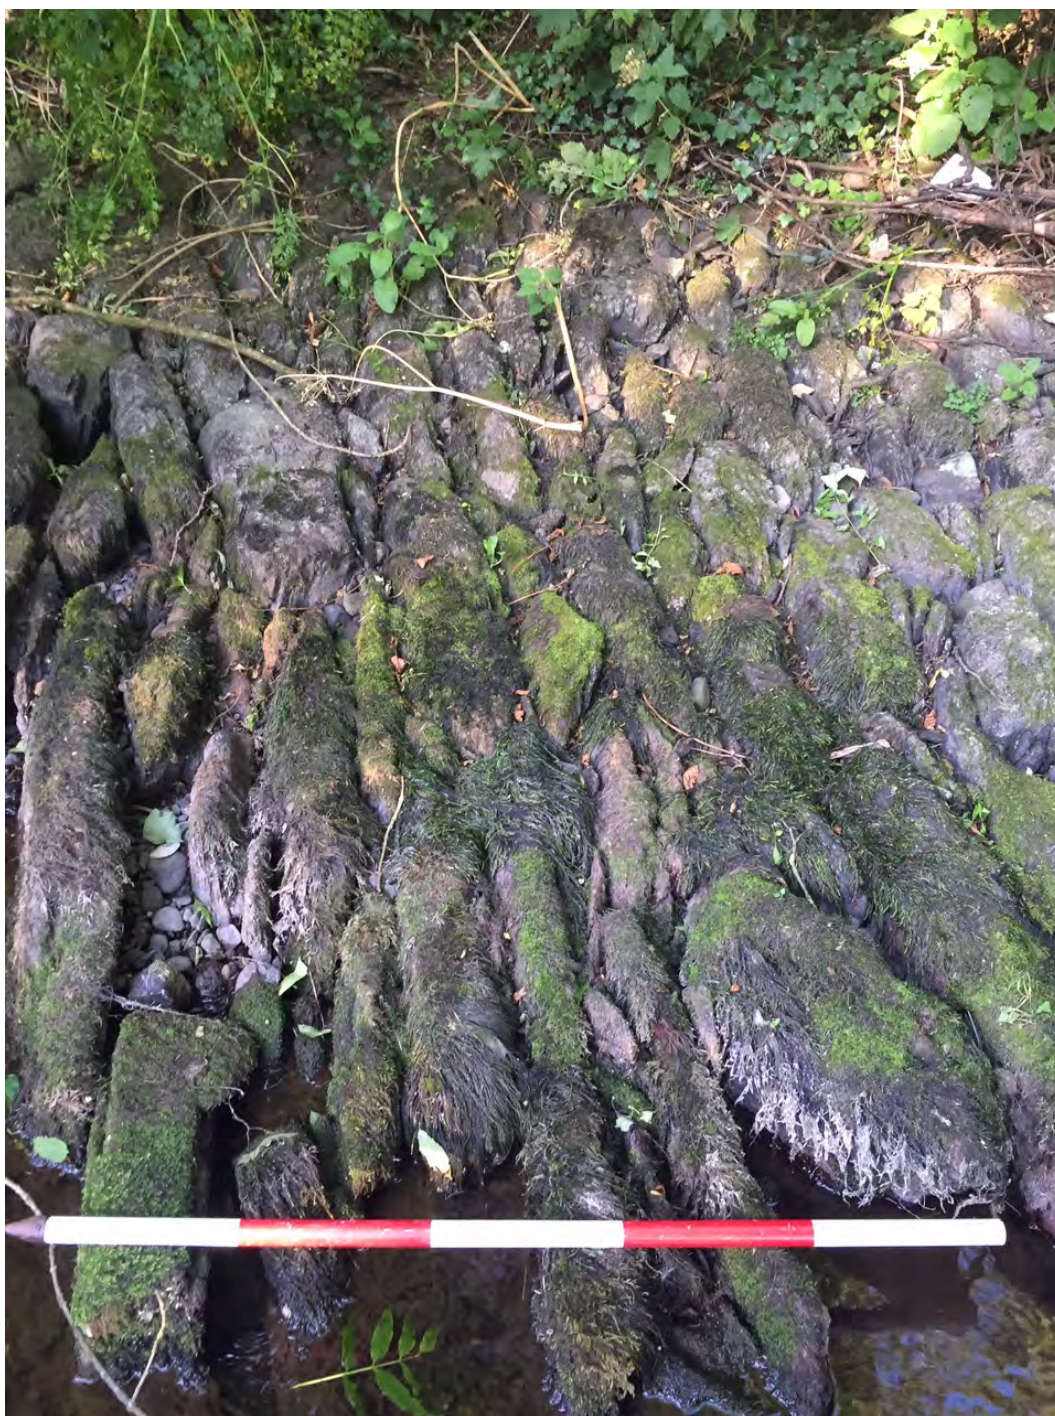
Plate 32: View of stone feature, possible remains of weir, taken from west

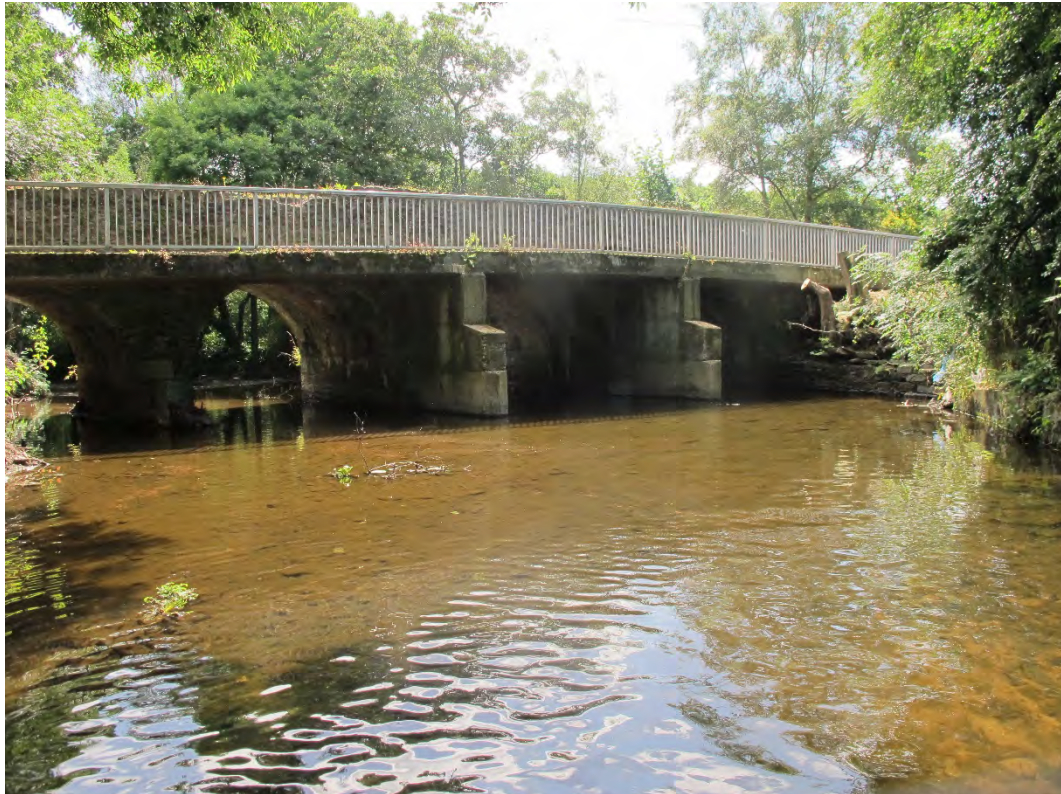
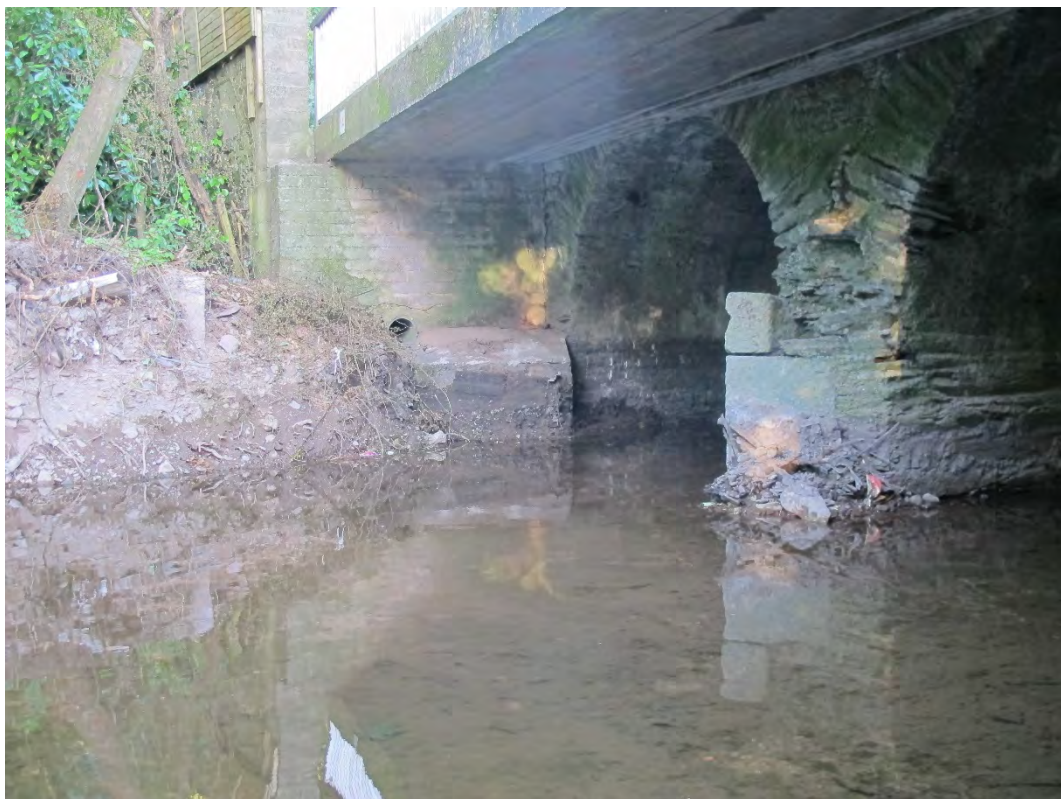
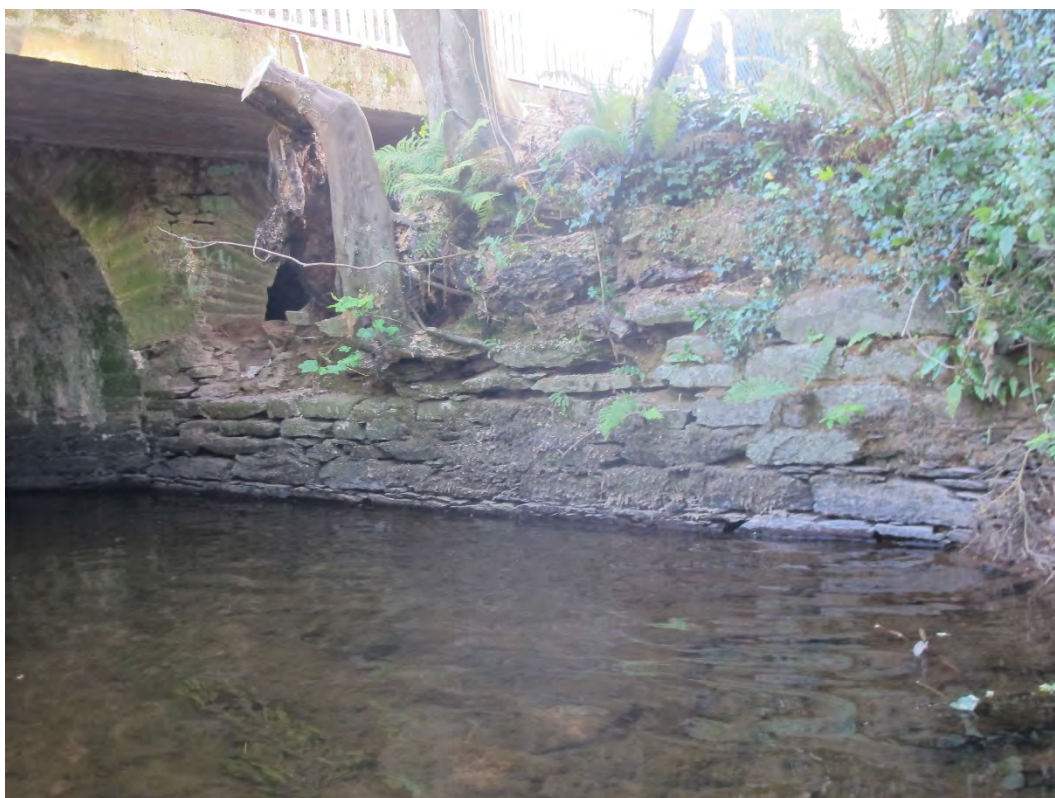
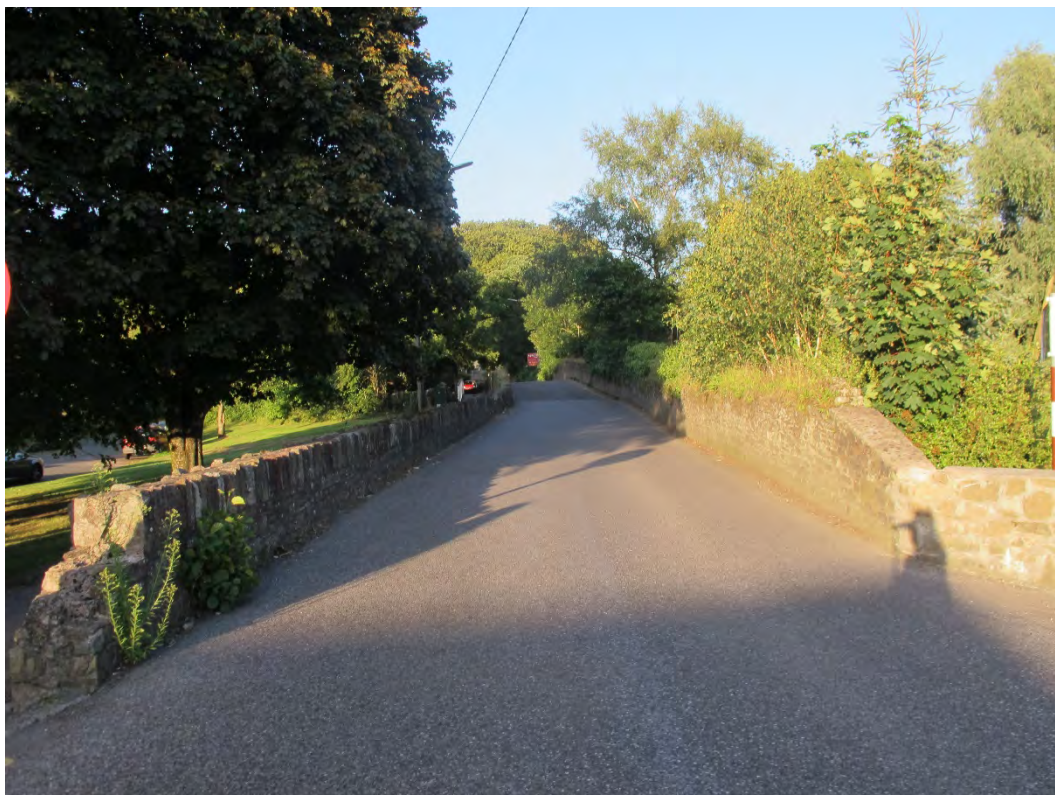
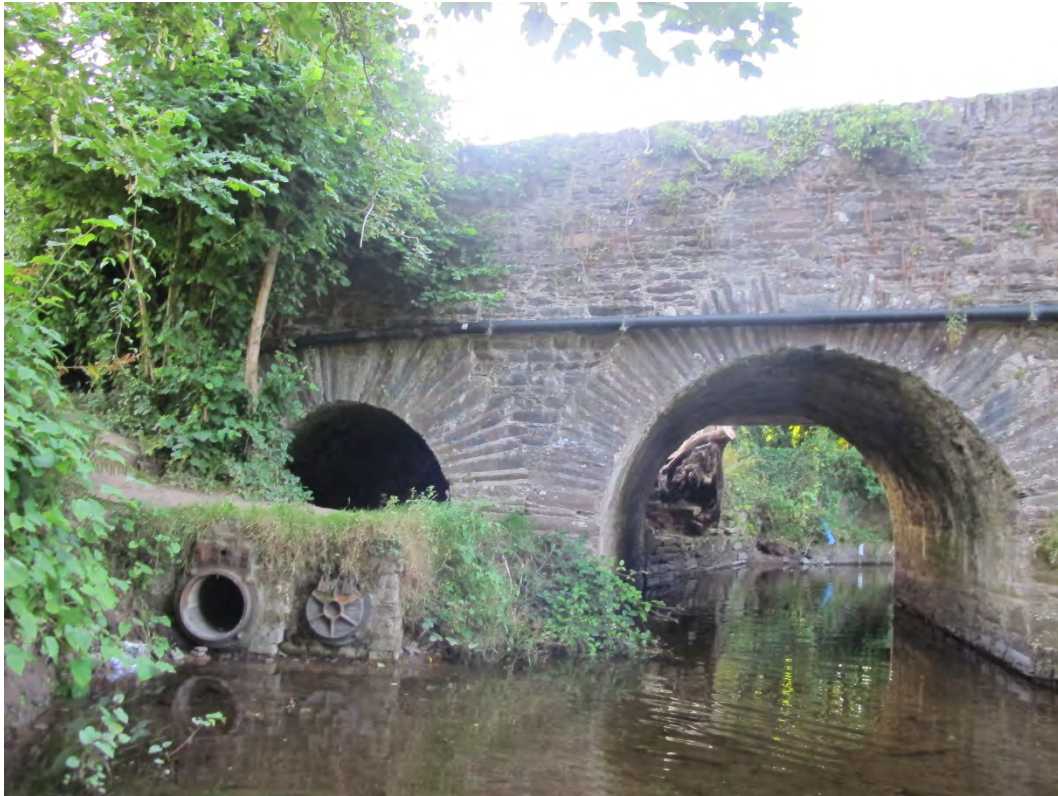
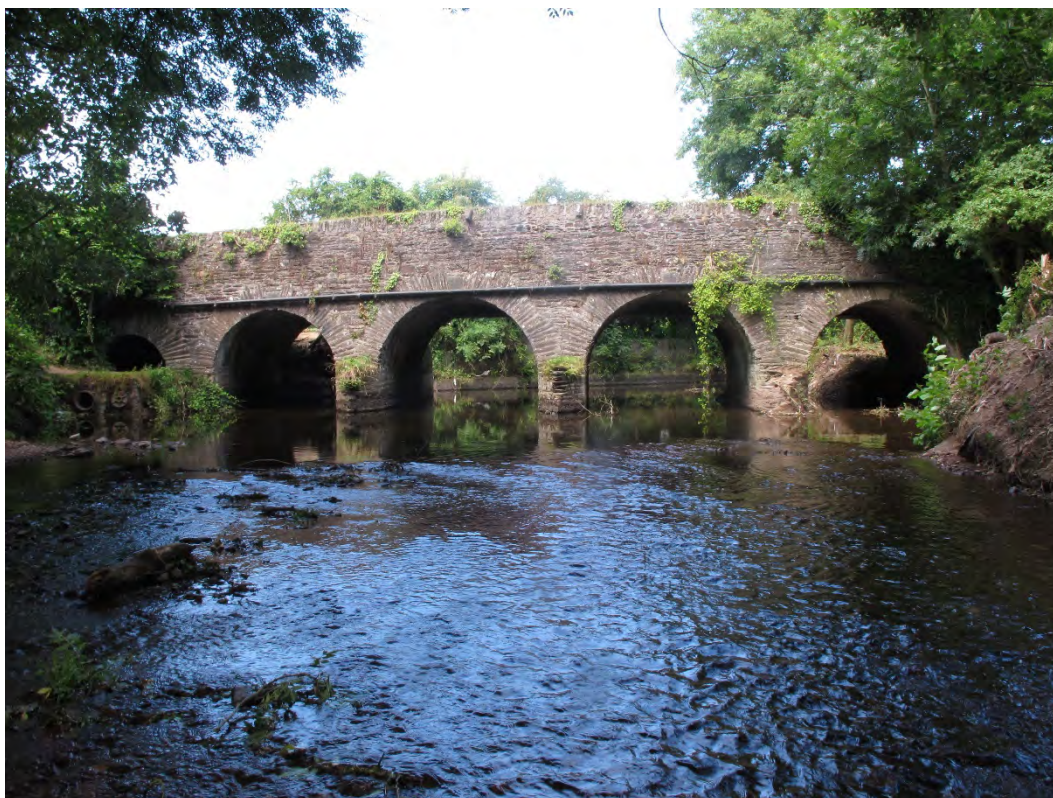
Riverstown Bridge is a recorded archaeological monument (RMP No. CO064-111) and a protected recorded structure (RPS No. 2096415). It is a hump-backed road bridge built of rubble sandstone. The bridge has five arches; measuring from west-to-east 2.50m, 3.70 m, 4.25 m, 4.25m, and 3.70m. The westernmost and smallest arch is blocked up and contains a cast iron outfall pipe. All five arches display arch rings of undecorated voussoirs.

No foundations were visible at the base of the piers. The piers are protected on both elevations by rubble-stone pointed cutwaters projecting outwards by 0.9m, and 1.15m in height. The cutwaters are damaged as a result of erosion and vegetation. The modern concrete extension to facilitate a footpath has damaged the bridge and conceals much of the northern elevation. The parapet has vertically set coping.

Plate 33: View of CHS 12, bridge taken from northeast

Plate 34: View of CHS 12, bridge with pedestrian bridge extension and recent earthen embankment to northeast..

Plate 35: View of CHS 12, bridge, blocked up arch on northwest.

Plate 36: View of CHS 12, bridge, carriageway.

Plate 37: View of CHS 12, bridge, western side of downstream elevation.

Plate 39: View of CHS 12, bridge, downstream elevation.

- Licensed archaeological monitoring should be undertaken by an experienced underwater archaeologist with regard to the proposed construction works C01-L05 & C01_L06.
- Mitigation by licensed archaeological testing in advance of construction should be undertaken with regard to all proposed works within the ZON associated with Riverstown Bridge a recorded monument and a recorded protected structure, including: - C0_L06; C01-L07; C01_P01; C01_R02; C01_C03 & C01_C04.
- The recorded protected structure Riverstown Bridge should be fully surveyed archaeologically in advance of construction works.

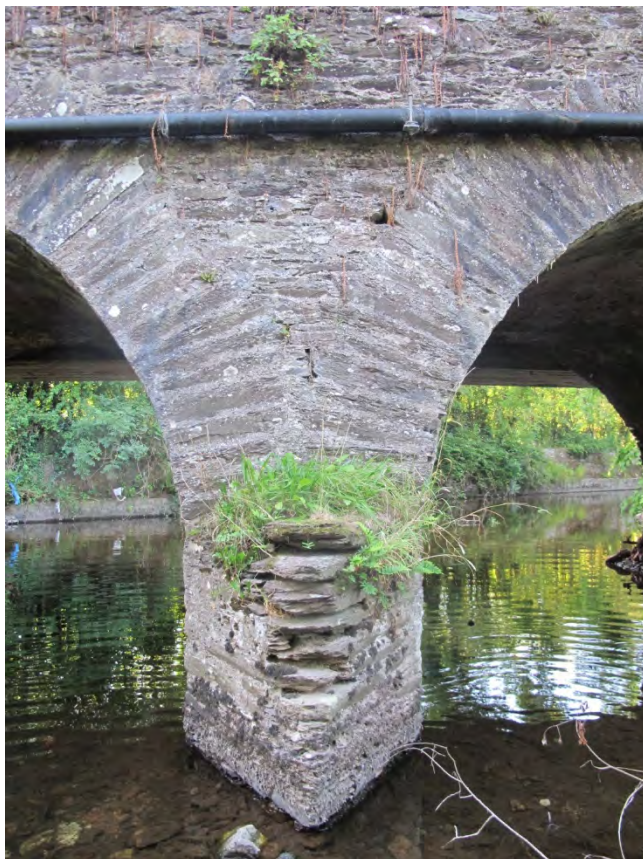
Plate 38: View of CHS 12, bridge, cutwater on downstream elevation.

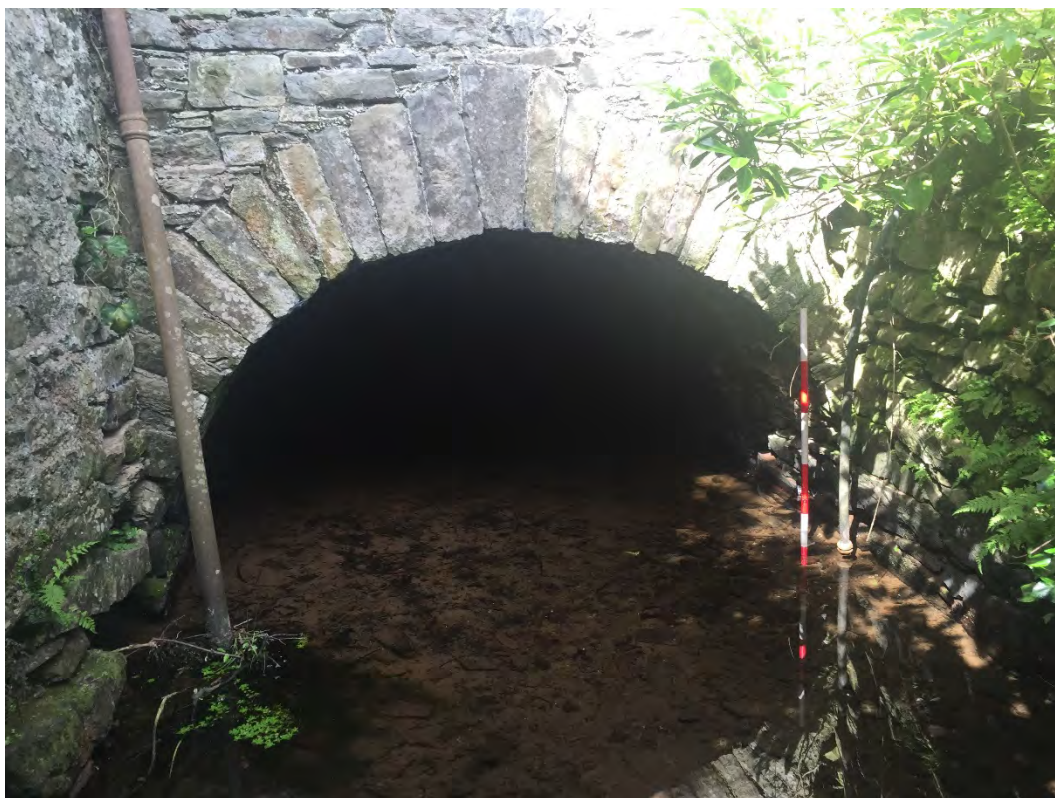
The Tailrace was inspected but the enclosed section of the race running underground and into the mill complex was not investigated for Health & Safety considerations. Furthermore, the building itself was outside the remit of this survey. Two separate races exit the mill and converge into a single race which flows in a southerly direction for c.100m before crossing under the R639 roadway and into the Glashaboy River. The eastern race issues from the mill through a 2.5m wide semi-circular

arch of twenty-six voussoirs (Plate 40). To the west of this is a crudely constructed wooden bridge spanning the second race (Plate 41). This is a twin culvert constructed of random rubble stone capped with large stone lintels (plates 42 & 43). Modern repairs comprising concrete support propping have been inserted at the exit, and the eastern channel of the twin culvert has collapsed.

Plate 40: View of CHS 13, from south.

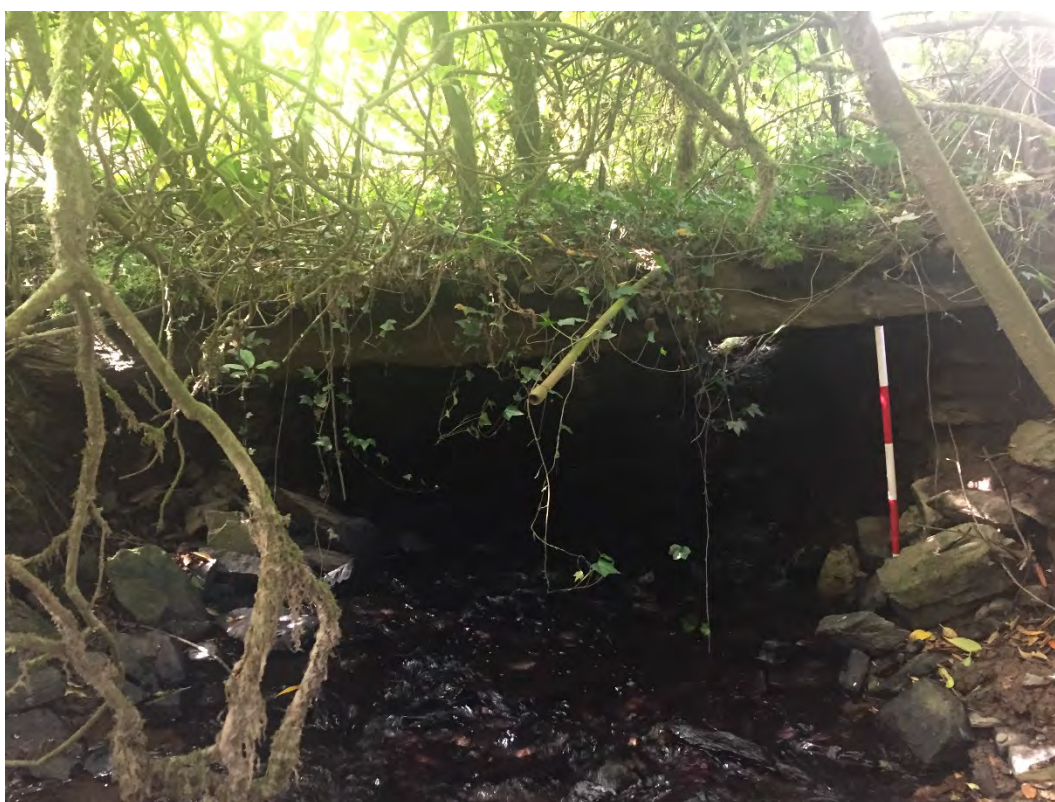
Plate 41: View of CHS 13, from south.

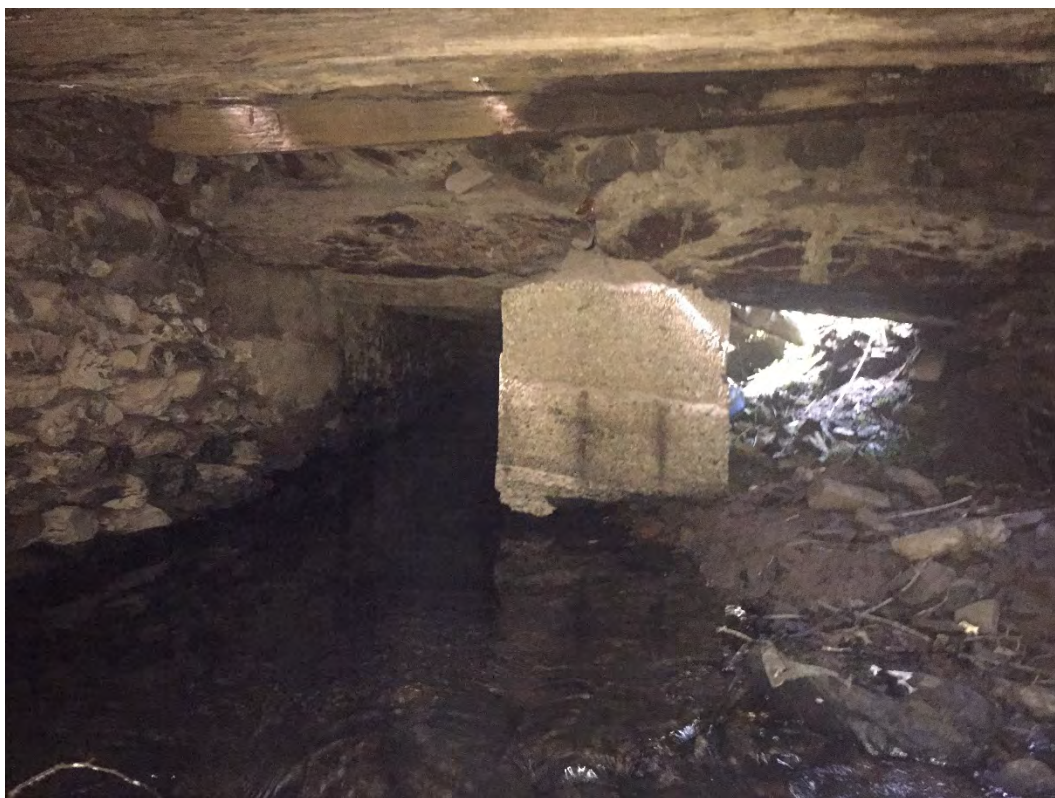
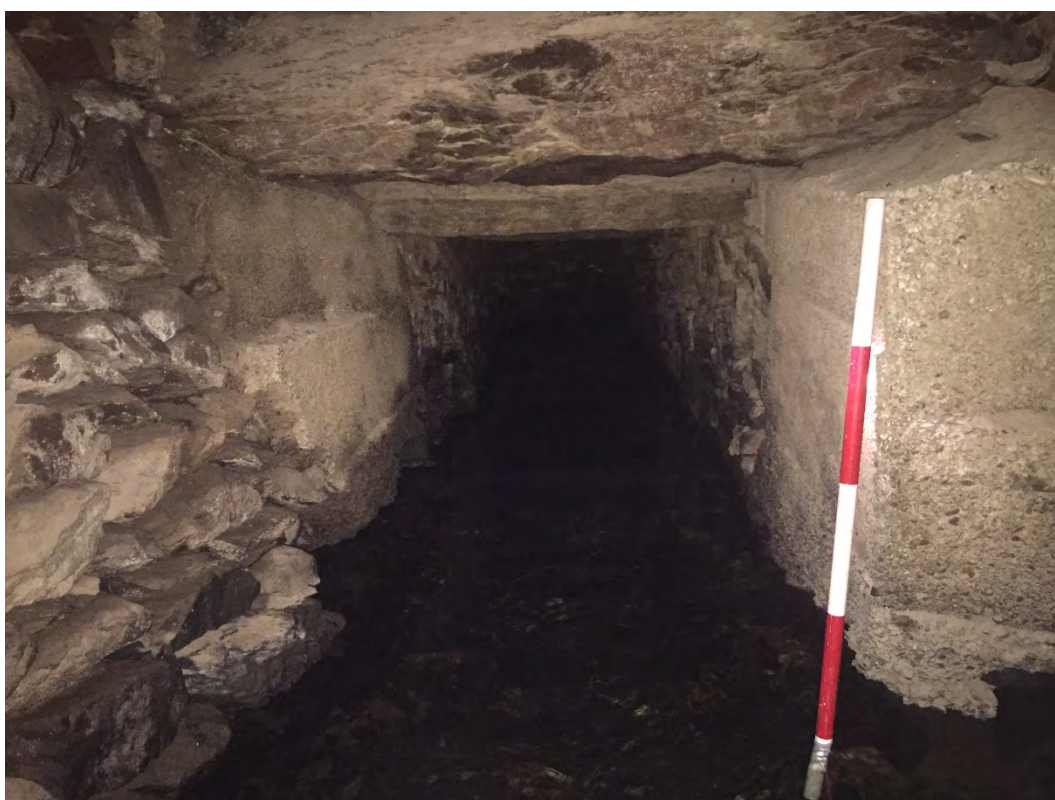
Plate 42: View of CHS 13, from south.

Plate 43: View of CHS 13, from south.

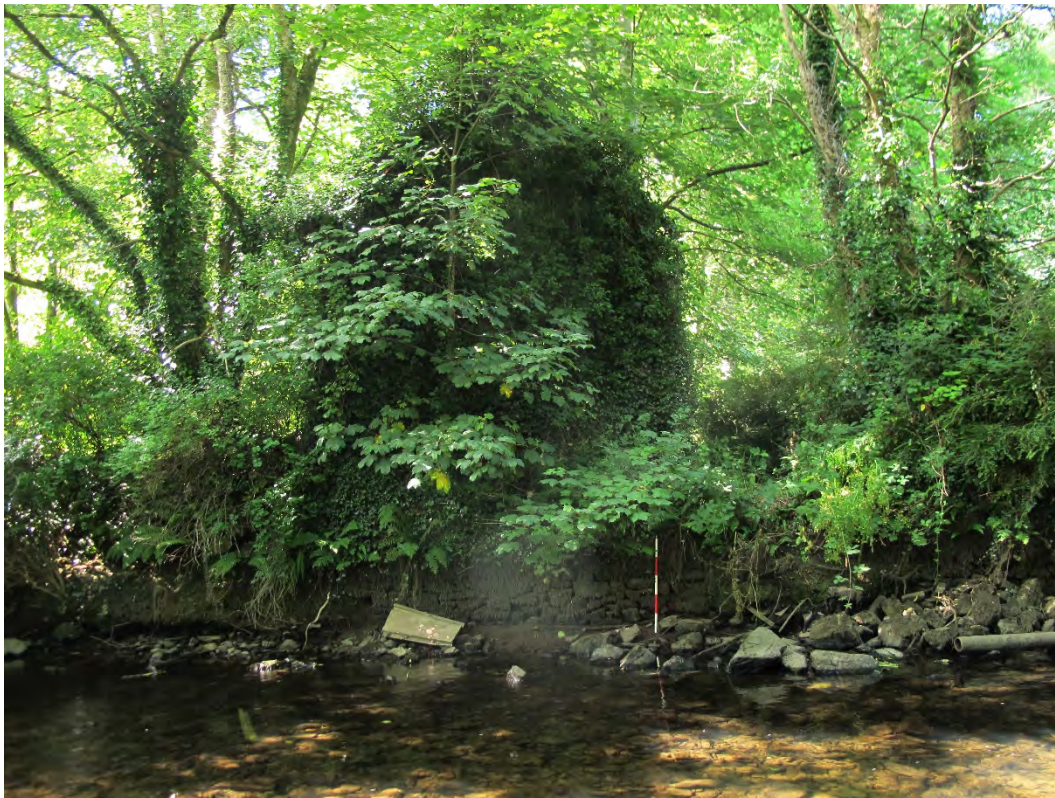
A second 2.5m high random rubble stone revetment wall with mortar bonding extends beyond the limit of Survey Area 5 in each direction. The wall is collapsed in sections and damaged by tree root action and erosion. The gable end of a relict extant structure abuts the western riverbank (Fig. 15, Plate 44). It is denoted on all editions of the OS maps. Concrete repairs and underpinning works are visible along this section of the revetment wall which is adjacent to the R639 roadway.

Plate 44: View of CHS 15, revetment wall, taken from southeast.

Licensed archaeological monitoring should be undertaken by an experienced underwater archaeologist with regard to the proposed construction works C01_L08 & C01-P02.

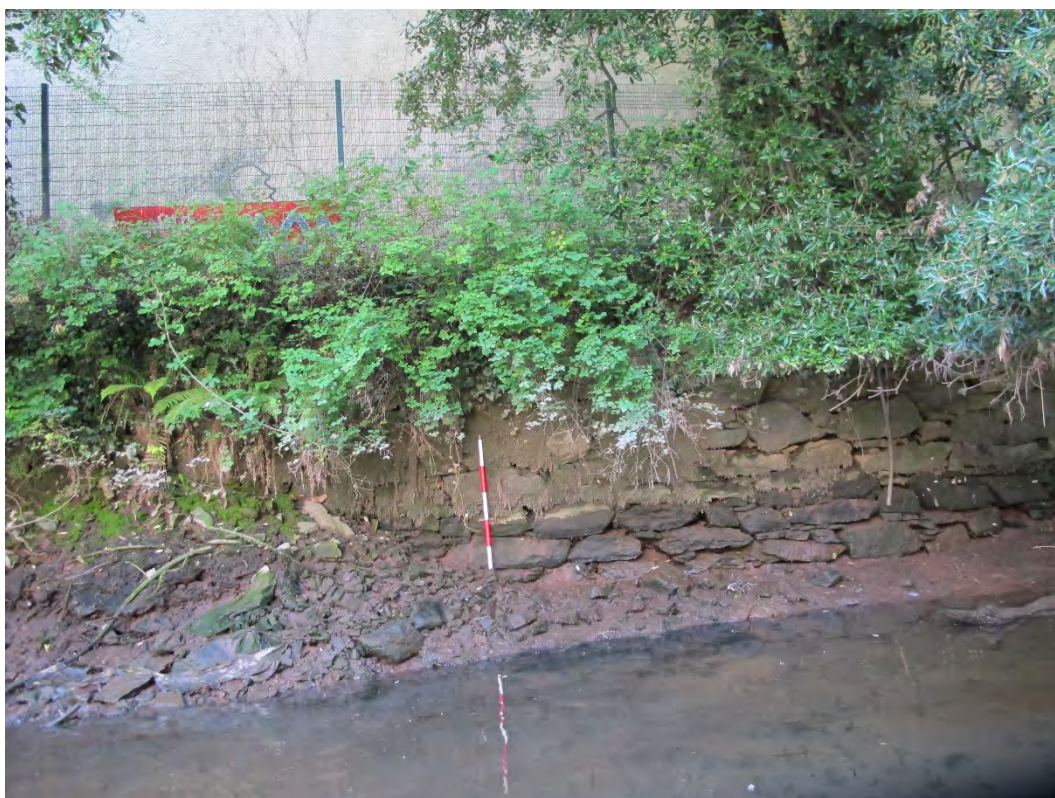
A revetment wall extends along the western bank for the majority of Survey Area 6 (Fig. 18, Plate 45). It is a roughly coursed sandstone wall, measuring up to 2.0m in height (Plate 45). The wall is constructed of large stones, the basal courses of which measure on average 0.5m x 0.3m. The mortar has been largely washed out.

Plate 45: View of CHS 16, revetment wall, taken from east.
