Survey Area 2

CHS 07 Headrace of Glansillagh Mills

Survey Area 3

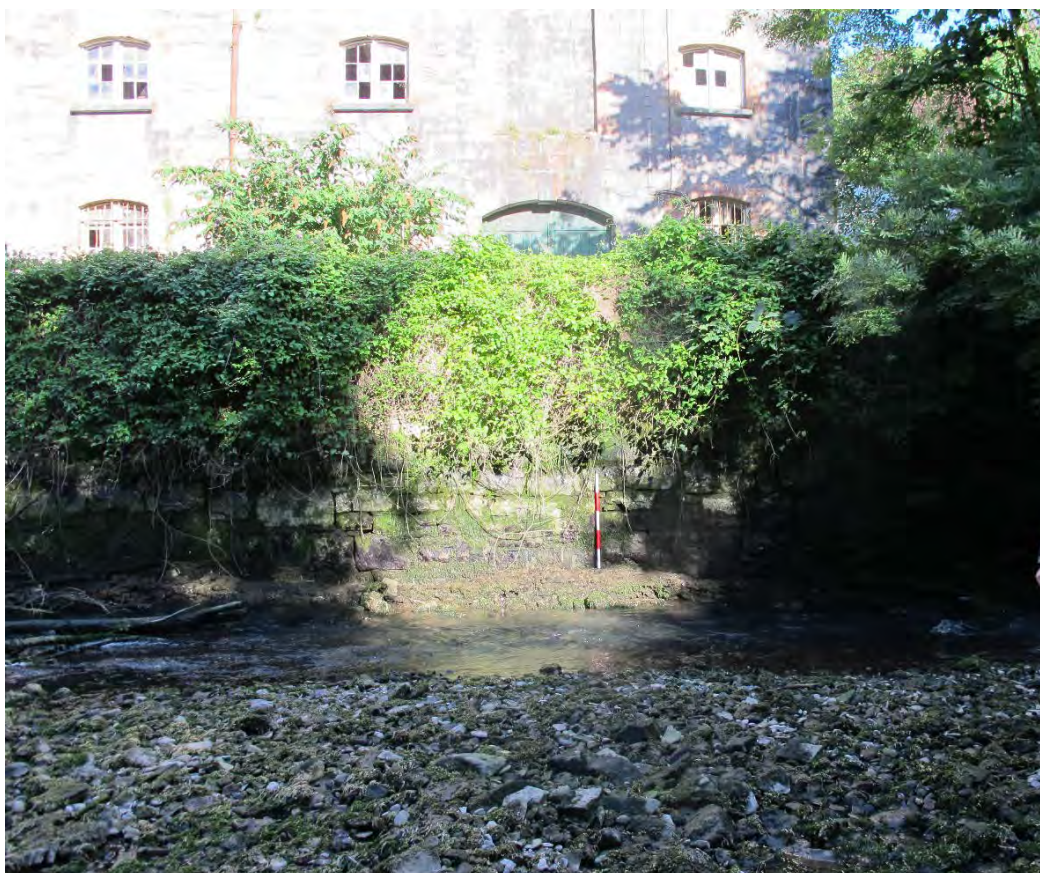
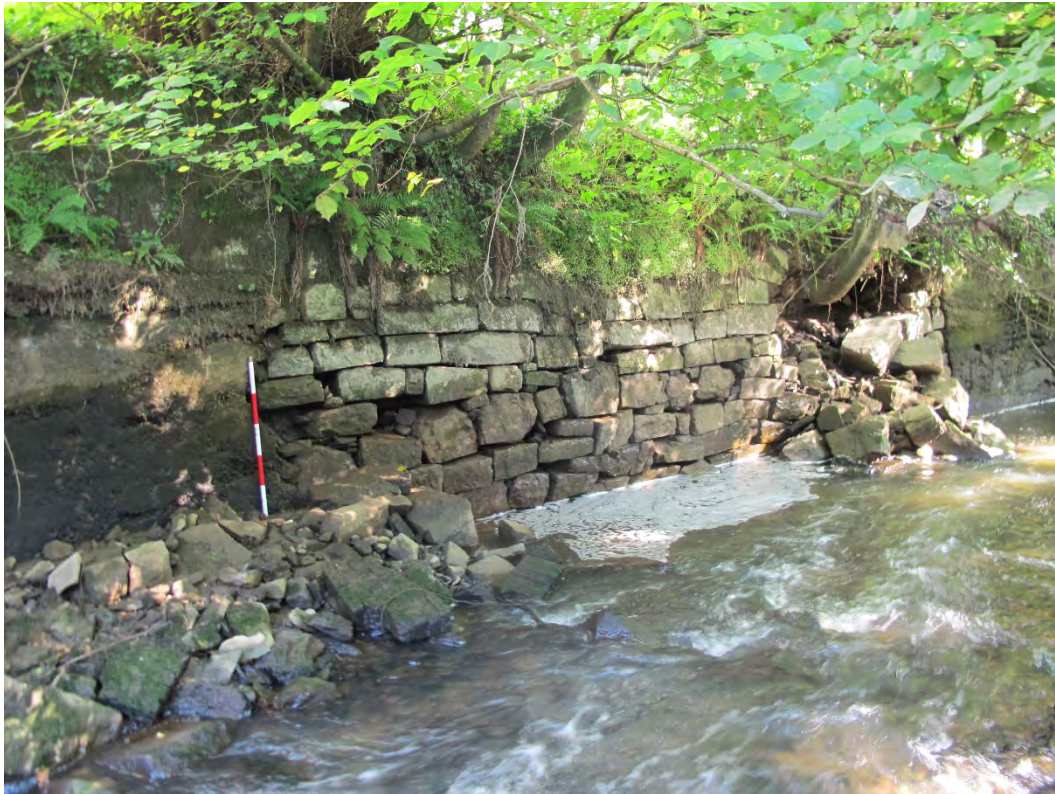
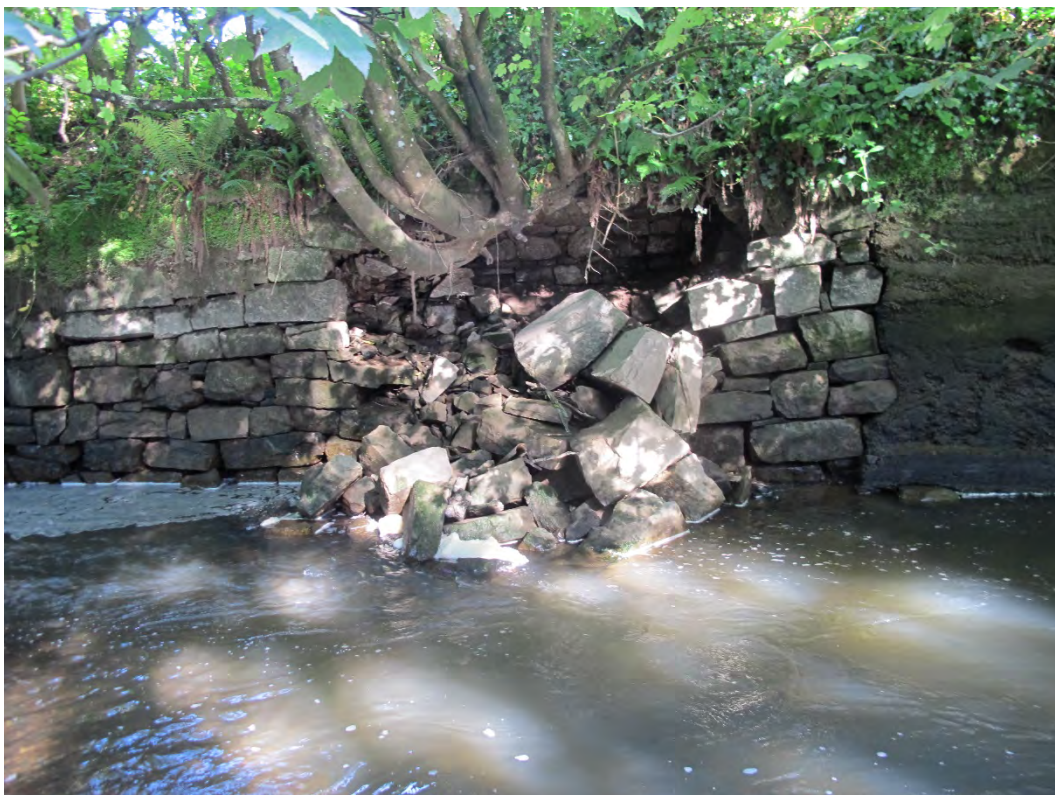
A revetment wall is visible on the east bank between the mill building and the tail race (Fig. 18, Plate 46). Due to an accumulation of sediment and dense vegetation it was not possible to examine the northern limits of this wall. It is possible that the wall continues further upstream concealed behind collapsed bank material. The wall is a substantial structure measuring up to 3.0m in height. It is constructed of dressed limestone blocks measuring from 0.30m x 0.30m up to 1m x 0.6m. Mortar bonding is visible in places. Tree root damage is particularly noticeable resulting in portions of the wall having completely collapsed as a result (plate 47 & 48). Three sections of the wall, measuring between 3.8 and 4.5m in width have been repaired with concrete.

Plate 46: View of CHS 17, revetment wall, taken from west.

Plate 47: View of CHS 17, revetment wall, taken from northwest.

Plate 48: View of CHS 17, revetment wall, taken from west.

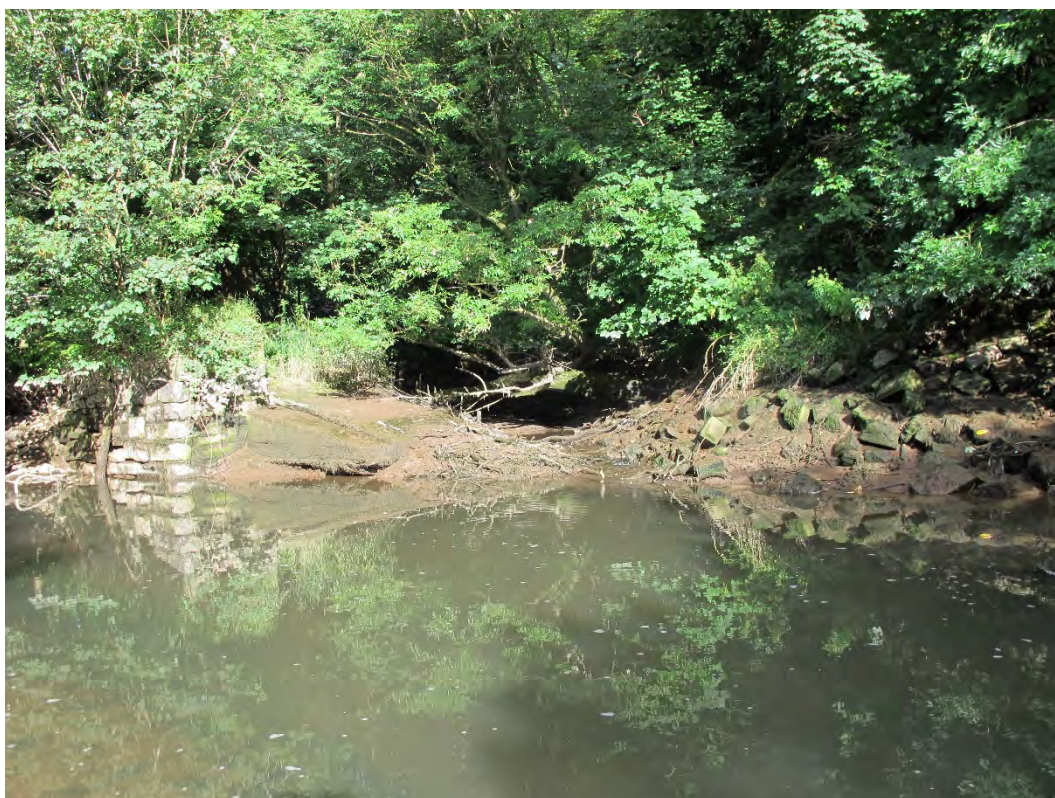
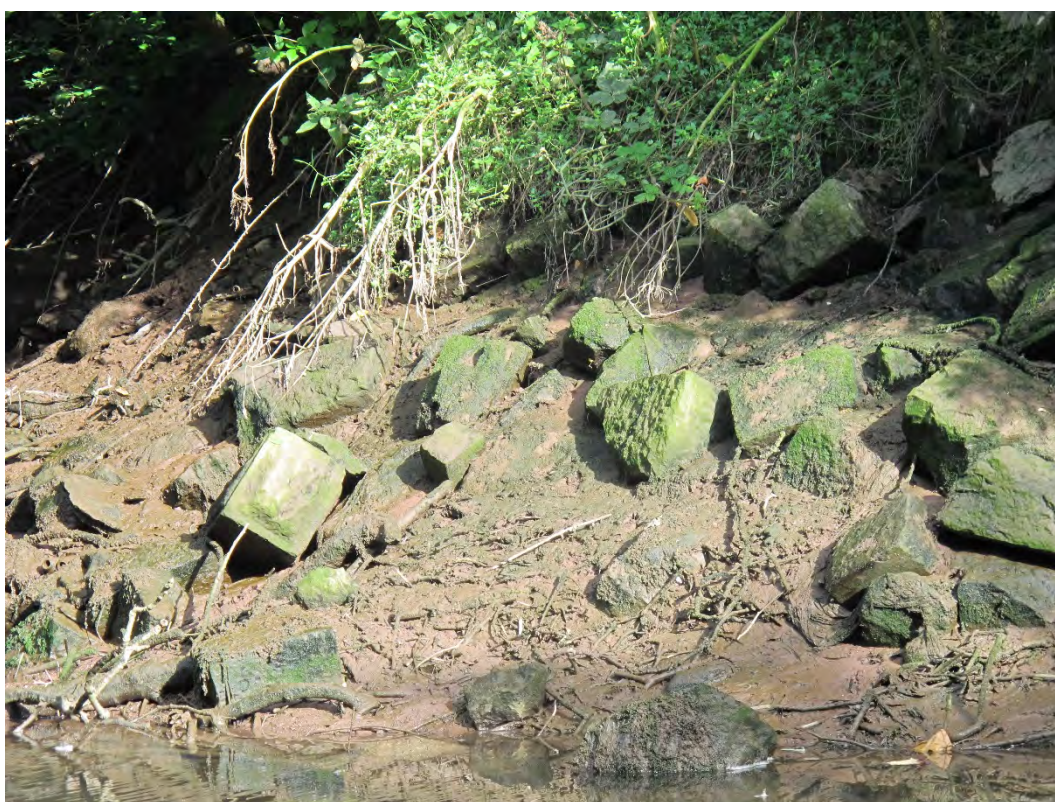
The tailrace for the Fountains Mill discharges into the river on a bend at the end of revetment wall CHS 17 (plate 49). The original exit point for the tailrace has been modified. A concrete slip supports /abuts the end of the revetment wall. The current concrete slip structure is most likely a replacement of an earlier 19th century slip. A Boat House shown on the 2nd Edition OS map, may have served the mill and indeed a nearby recorded Limekiln, CO075-002002. The south-eastern bank of the race has collapsed and now consists of mud with a large quantity of tumbled stone of which some are dressed limestone (Plate 50).

Plate 49: View of CHS 18, tailrace, taken from west.

Plate 50: View of CHS 18, tailrace taken from southwest.

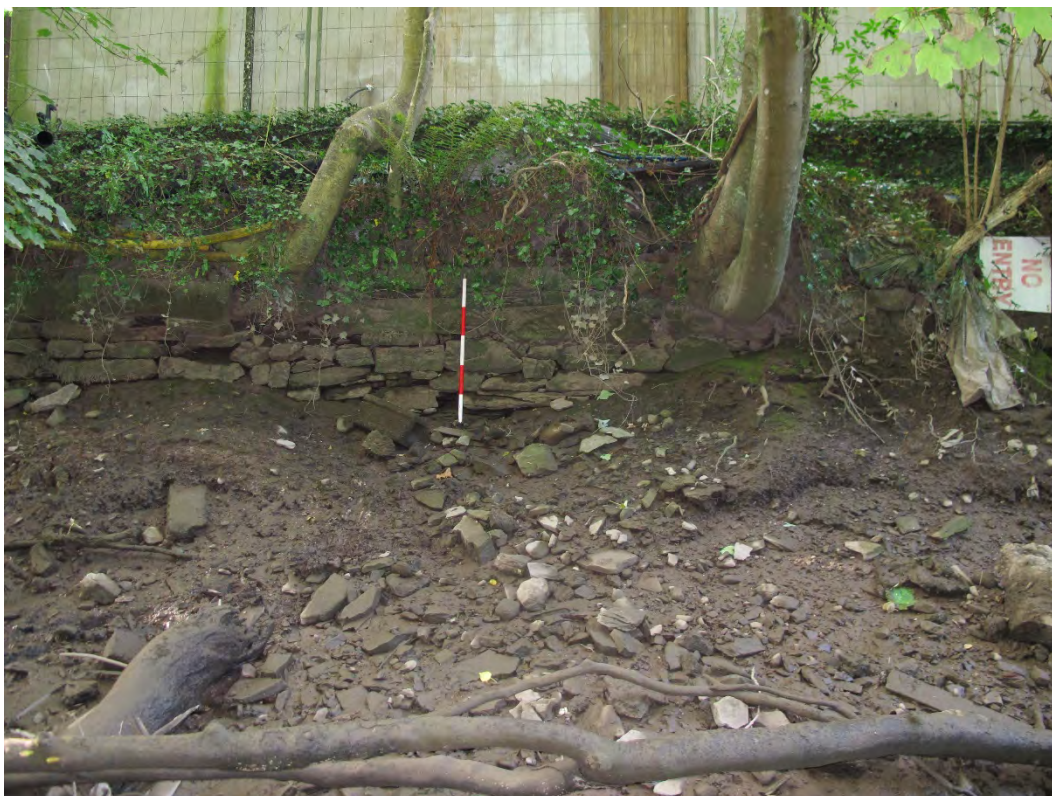
The heavily vegetated revetment wall on the west bank survives intermittently exposing the earthen bank (Figure 21,). Some sections have been replaced with boulders and concrete walling. The original stone revetment wall survives to a height of 1.8m. However, the basal courses are concealed beneath estuarine mud / silts (Plate 51). The west side of riverbed is also strewn by large quantities of debris and branches or trees deposited on the mud, largely by tidal action.

Plate 51: View of CHS 20, revetment wall, taken from south.

Licensed archaeological monitoring should be undertaken by an experienced underwater archaeologist with regard to the proposed construction works C01_L09.

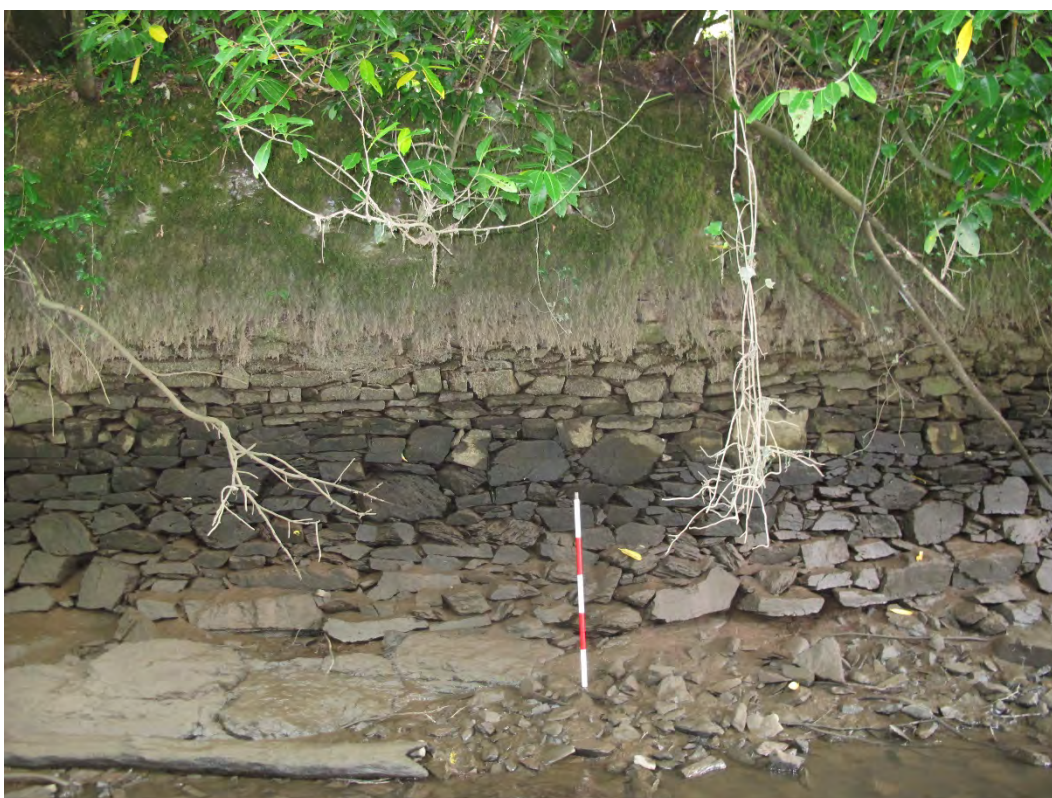
CHS 19 comprises a revetment wall extending along the east bank (Figure 21, Plate 52). The wall is constructed of roughly coursed stone with the larger stones (0.5m x 0.30m) at the base and smaller stones forming the upper courses. The revetment wall survives to a reduced height of 1.3m at the northern end and up to 4.0m in height in the southern end. Mature woodland extends along the eastern bank.

Plate 52: View of CHS 19, revetment wall, taken from north.

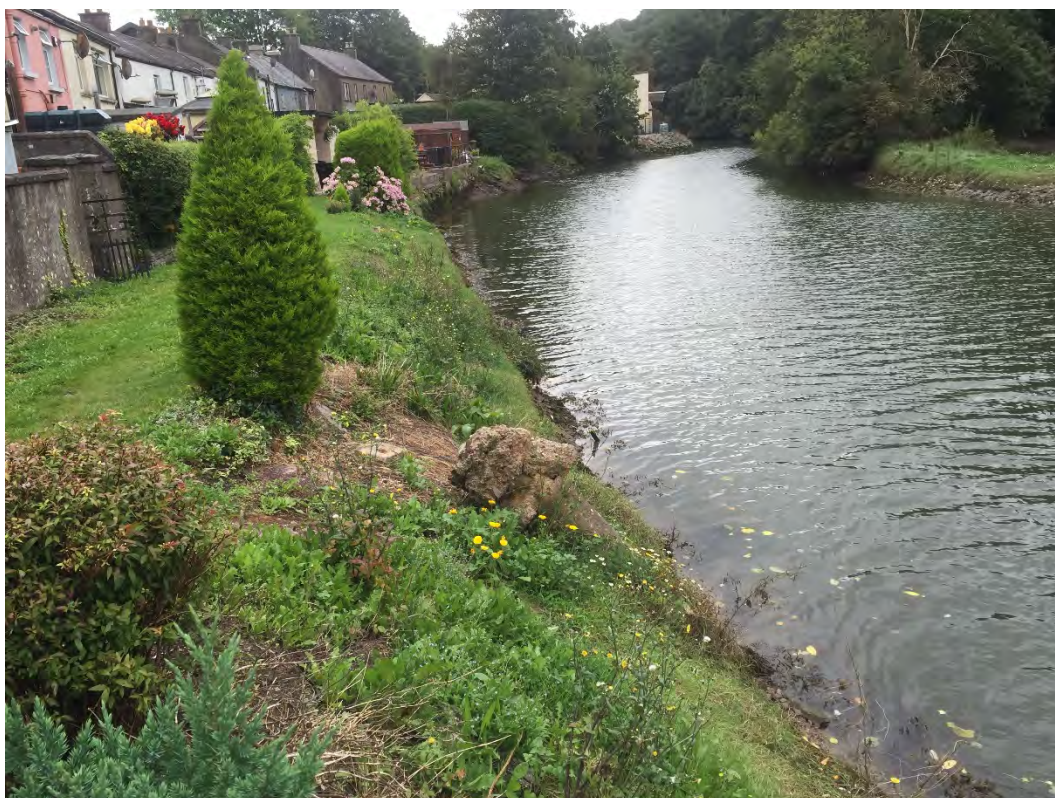
Locally this section of the western riverbank is known as the Sand Quay. However, no features of a formal quay wall were recorded here. Apparently, vessels up to 40-tons burden transported goods to this quay which was also referred to as the Dock and the Arch near the old Post Office (NIAH Reg. No. 20860015) built c. 1820 (www.askaboutireland.ie). The 1st Edition OS map shows a linear narrow strip of ground that may reflect the original quay area. However, it is not annotated. Today there is a narrow strip of grassy verge, 3.0m wide between Barry's Terrace and the river c. 5.0m above the riverbed. Furthermore, a short section of stone wall, 1.6m in height is also visible at the northern end of Barry's Terrace. These features may possibly reflect the remains of an earlier quay but only speculatively.

Plate 53: View of CHS 20 , Sand Quay.

Licensed archaeological testing should be undertaken at Sand Quay. Further mitigation may be required based on the results of this archaeological testing.
