KING'S ISLAND
FLOOD RELIEF SCHEME

EIAR Addendum Report Volume 1

October 2020

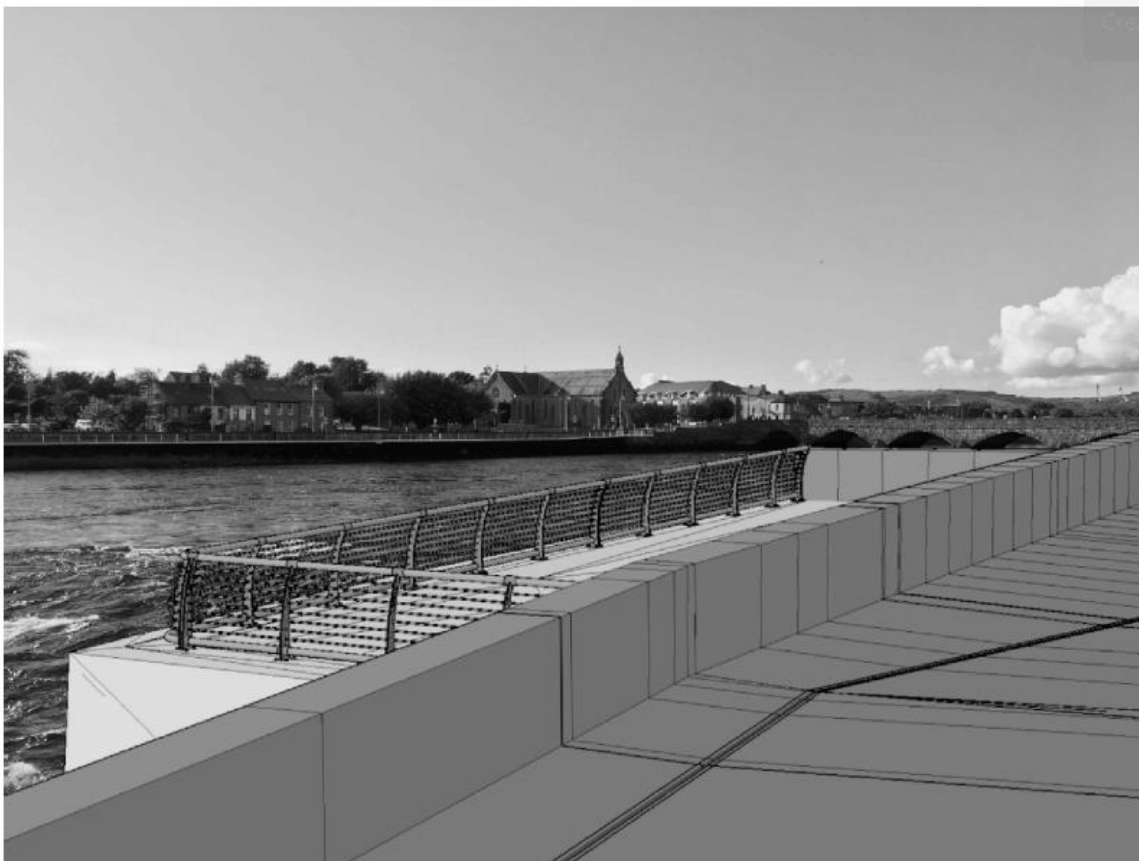
Figure 7-1. Artistic view of proposed Area B3 Railing Detail (extracted from planning drawing no. KIFRS-MQ-101)

The flood defences in this area around the archaeological testing and resolution are also being altered, previously it was proposed to use glazed flood defence panelling, this has been changed and will consist of stone clad RC parapets, founded on a grillage of bored concrete piles. The stone wall will separate the pedestrian footpath along the Civic Building from the archaeological remnants which will have a high quality curved metal railing (1.17m high) along the alignment of the quay wall edge (western and southern sides) to maintain a connection with the river and a section of the existing wall to be reconstructed to a height of 1.1m on the northern side, as shown in the artistic impression in Figure 7-1 below extracted from Drawing KIFRS-MQ-101-Area B3 Railing Detail.

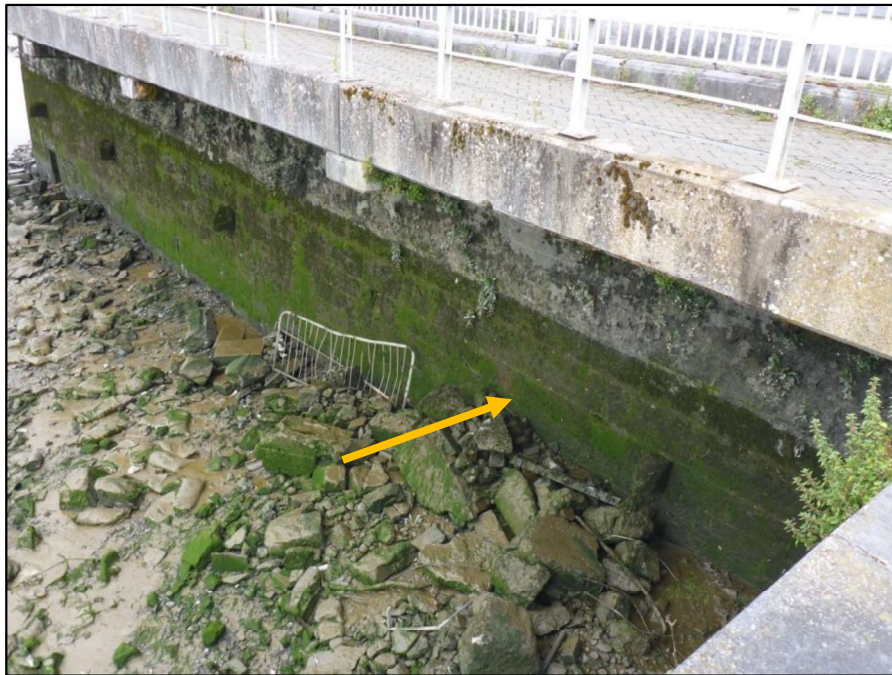
Photograph 4.1. Example of algal zone on quay wall (orange arrow)

The zone lowest on the wall, which has the greatest submergence period, is dominated by algae (Photograph 4.1). In many areas this also grades into the aquatic bryophyte zone (shown as red and orange arrows in Appendix A).

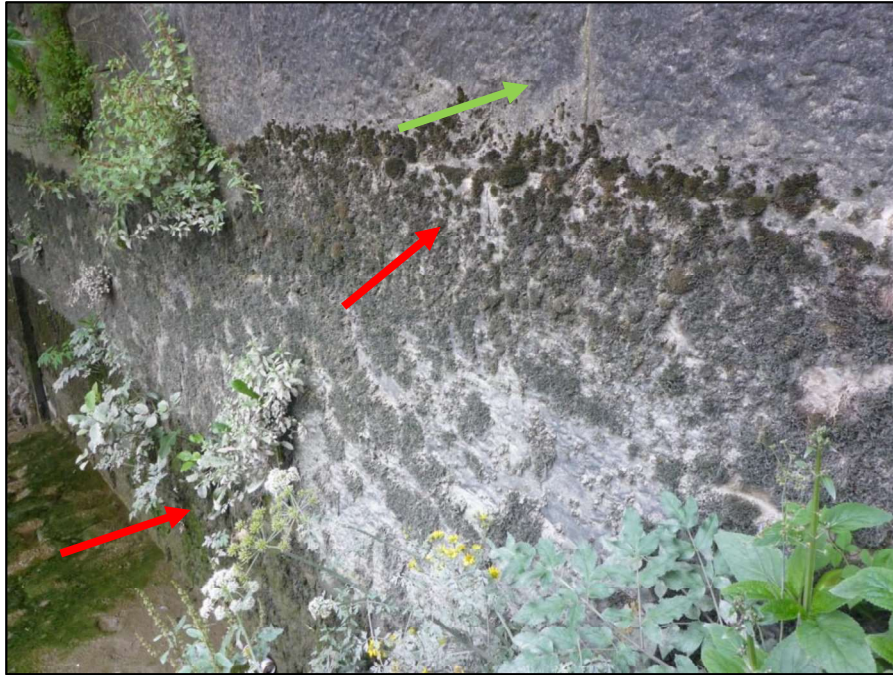
Photograph 4.2. Example of aquatic bryophyte zone on quay wall (red arrows) and non-aquatic bryophytes at the top of the high water line (green arrow)

The aquatic bryophyte zone is usually above the algal zone, but sometimes the algal zone is absent/sparse, or the aquatic bryophytes grow within the algal zone (see photographs in Appendix A and Photograph 4.2). The aquatic bryophyte species recorded within this zone are:

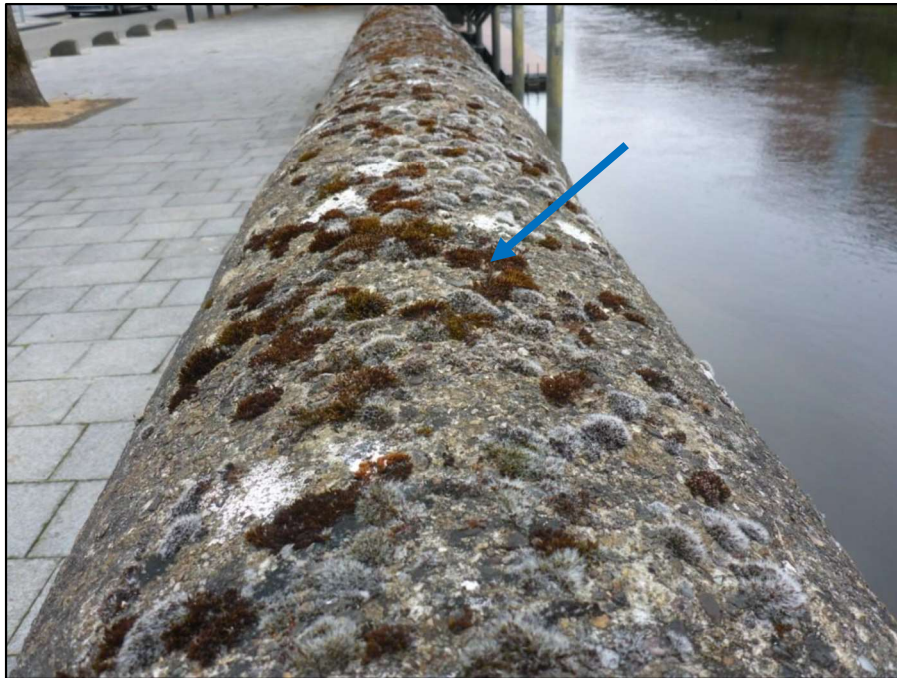
Photograph 4.3. Example of 'dry wall' bryophyte zone (blue arrow)

Above the high-water line, particularly on the tops of the walls, there is a community of 'dry wall' bryophytes. Species present include:

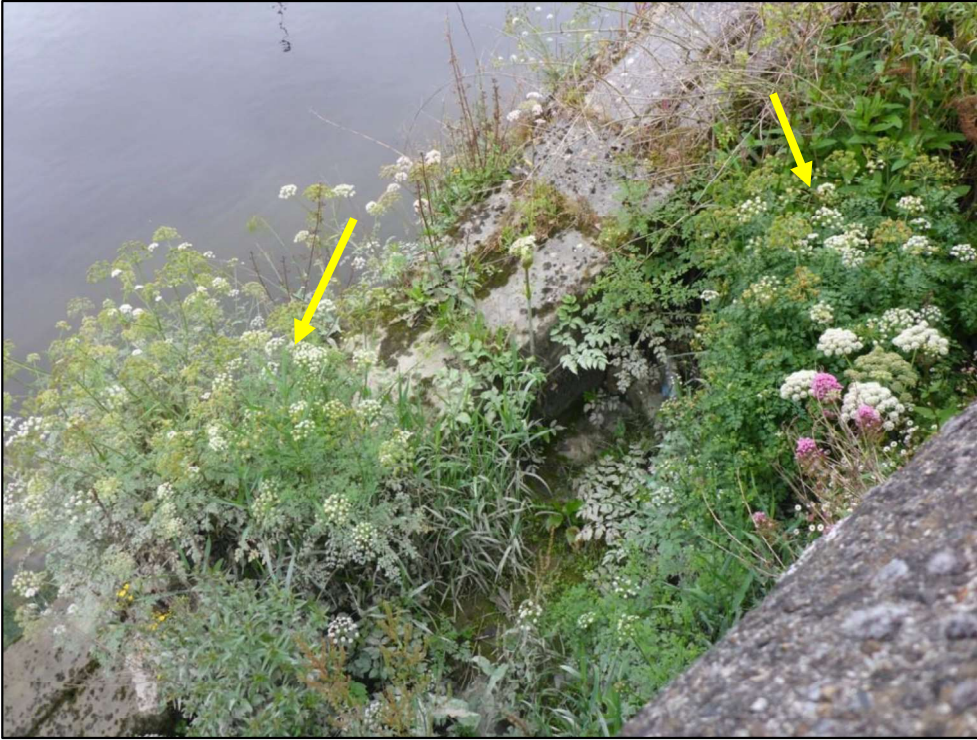
Photograph 4.4. Marsh/ tall-herb swamp plants by river (yellow arrows)

Plants typical of wetlands such as Tall-herb swamps (FS2) are locally frequent along the quay wall. These occur throughout the upper tidal range of the river, either growing in small flat areas which are inundated at high tide (Photograph 4.4) or directly from the wall itself (see additional photographs in Appendix A). Species typical of dry walls (usually non-native species) are frequent above the high water level.
