Lower Lee (Cork City) Drainage Scheme – Invasive Species Advance Treatment Stage 2

Appendix 5G – Bat Survey Report

Proposal: Blackpool Flood Relief Scheme, Cork City.

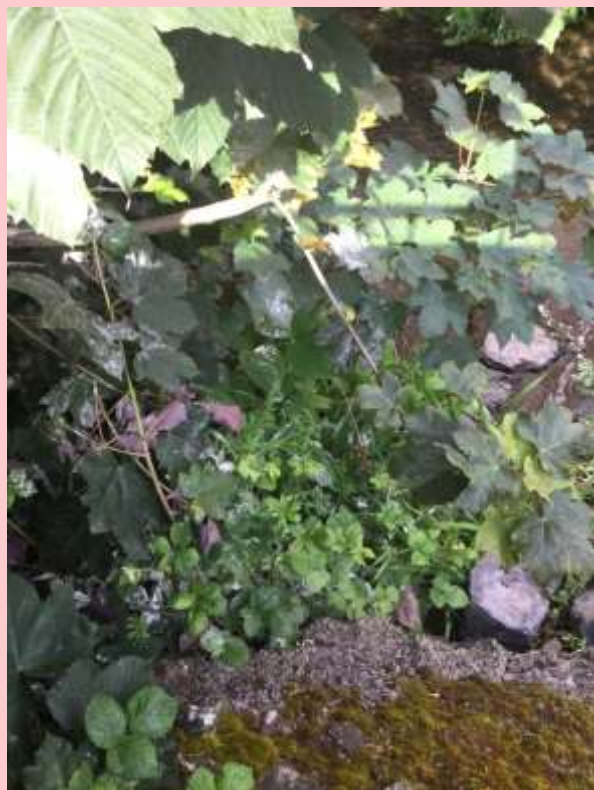
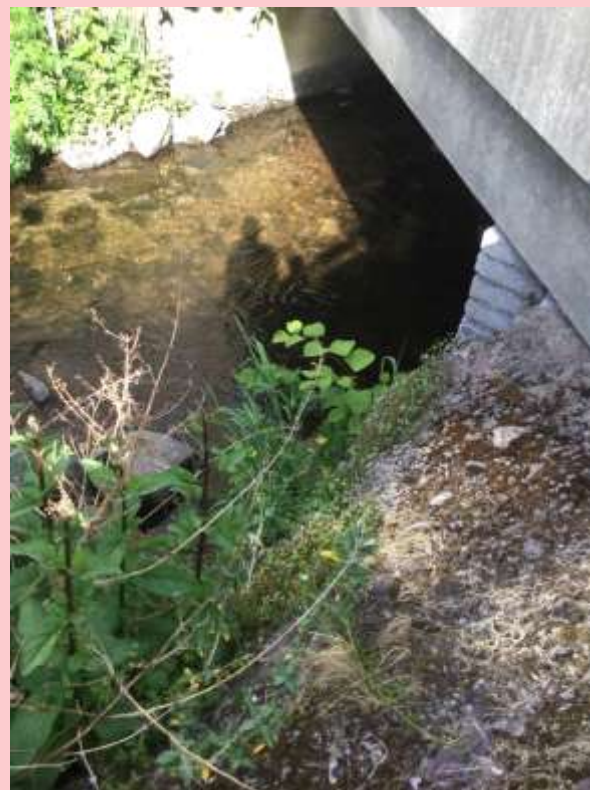
SiteID	J5201
Drawing Number	bride_008
Contractor Name	Japanese Knotweed Ireland Ltd
Surveyor Name	Aidan Lombard
Survey Date/Time	25/05/2020 09:09:00
Recommended Treatment	Foliar Spray
Species Recorded	JKT
Infestation Outside Fenceline	No
Measured Area	4.28
ITM X / ITMY	167413.7844 73409.2222
Notes	New location 2020. Two stands of Japanese Knotweed on river bank. Query for inclusion 2020

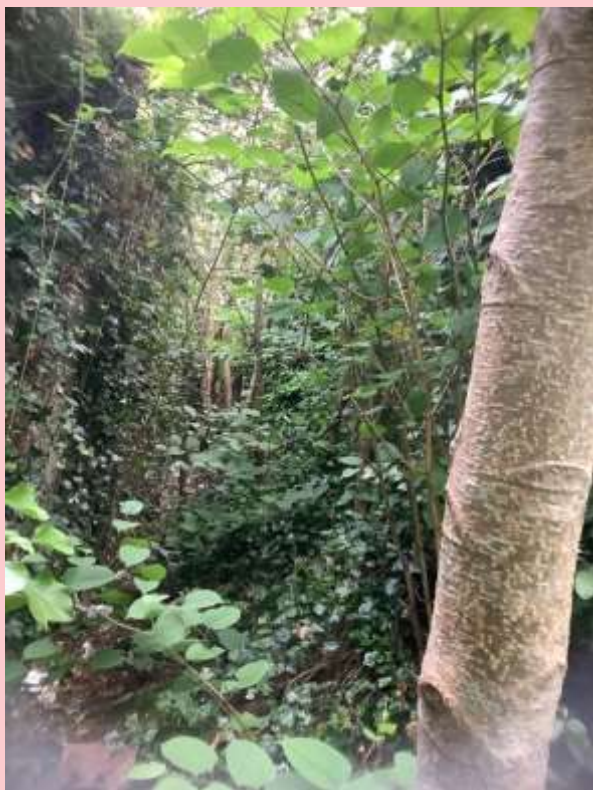
SiteID	J5202
Drawing Number	bride_007
Contractor Name	Japanese Knotweed Ireland Ltd
Surveyor Name	John Walsh
Survey Date/Time	25/05/2020 09:28:00
Recommended Treatment	Foliar Spray
Species Recorded	JKT
Infestation Outside Fenceline	Yes
Measured Area	17.55
ITM X / ITMY	167451.8558 73667.9007
Notes	New location 2020. Japanese knotweed growing near the road. New growth. Query for inclusion 2020

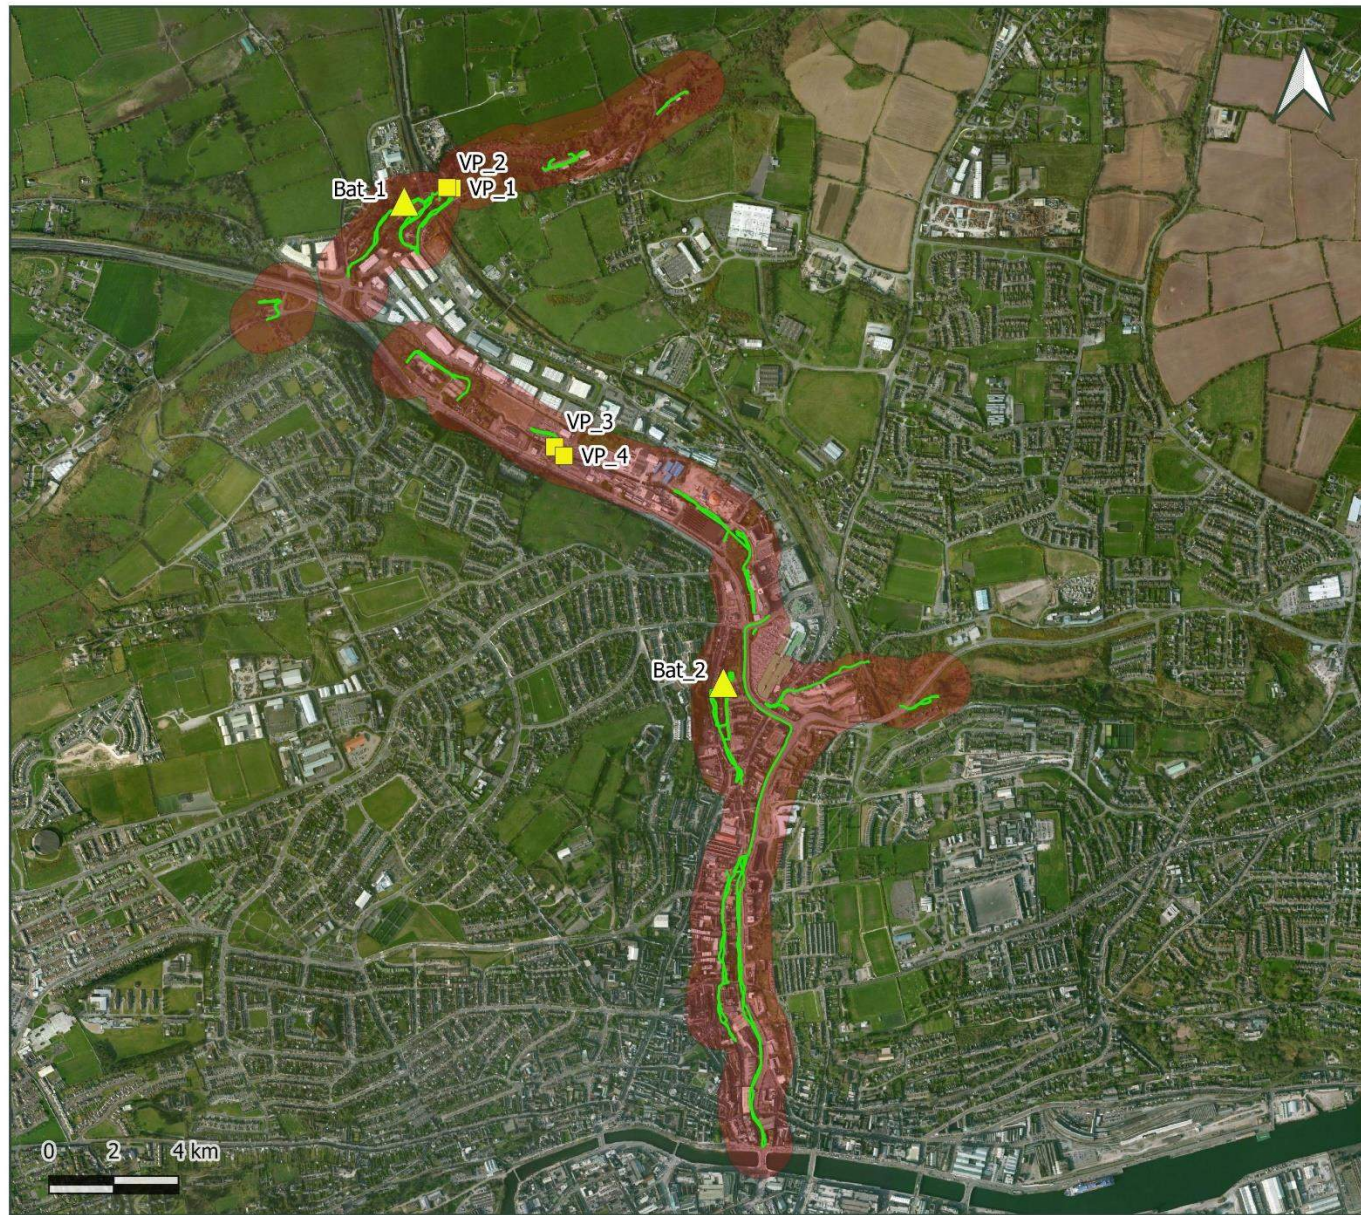
Figure 2.1

All surveys were carried out on foot, but for safety reasons the survey carried out on the Blackpool Bypass was driven, at a speed of 20km/hr. **Figure 2.1** shows the survey routes used as recorded by a GPS device carried by the surveyor. All transects were walked at least once.

Vantage point surveys were utilised in a number of areas where a prominent viewpoint was available or where access to target areas was restricted. The surveys sought to identify and record bat activity by visual means at dawn, utilising ultrasonic detection as a supporting tool. The purpose of the vantage point surveys was to identify foraging and roosting behaviour. **Figure 2.1** shows the locations of vantage points.

Passive detectors were deployed in two locations along the proposed scheme. Areas chosen had suitable bat habitat and were identified during active surveys as being areas of relatively high bat activity. The locations of passive bat monitoring points are shown in **Figure 2.1**. Details of the survey period including average nightly weather conditions are shown in **Table 2.2**.

Bat Survey Methodology

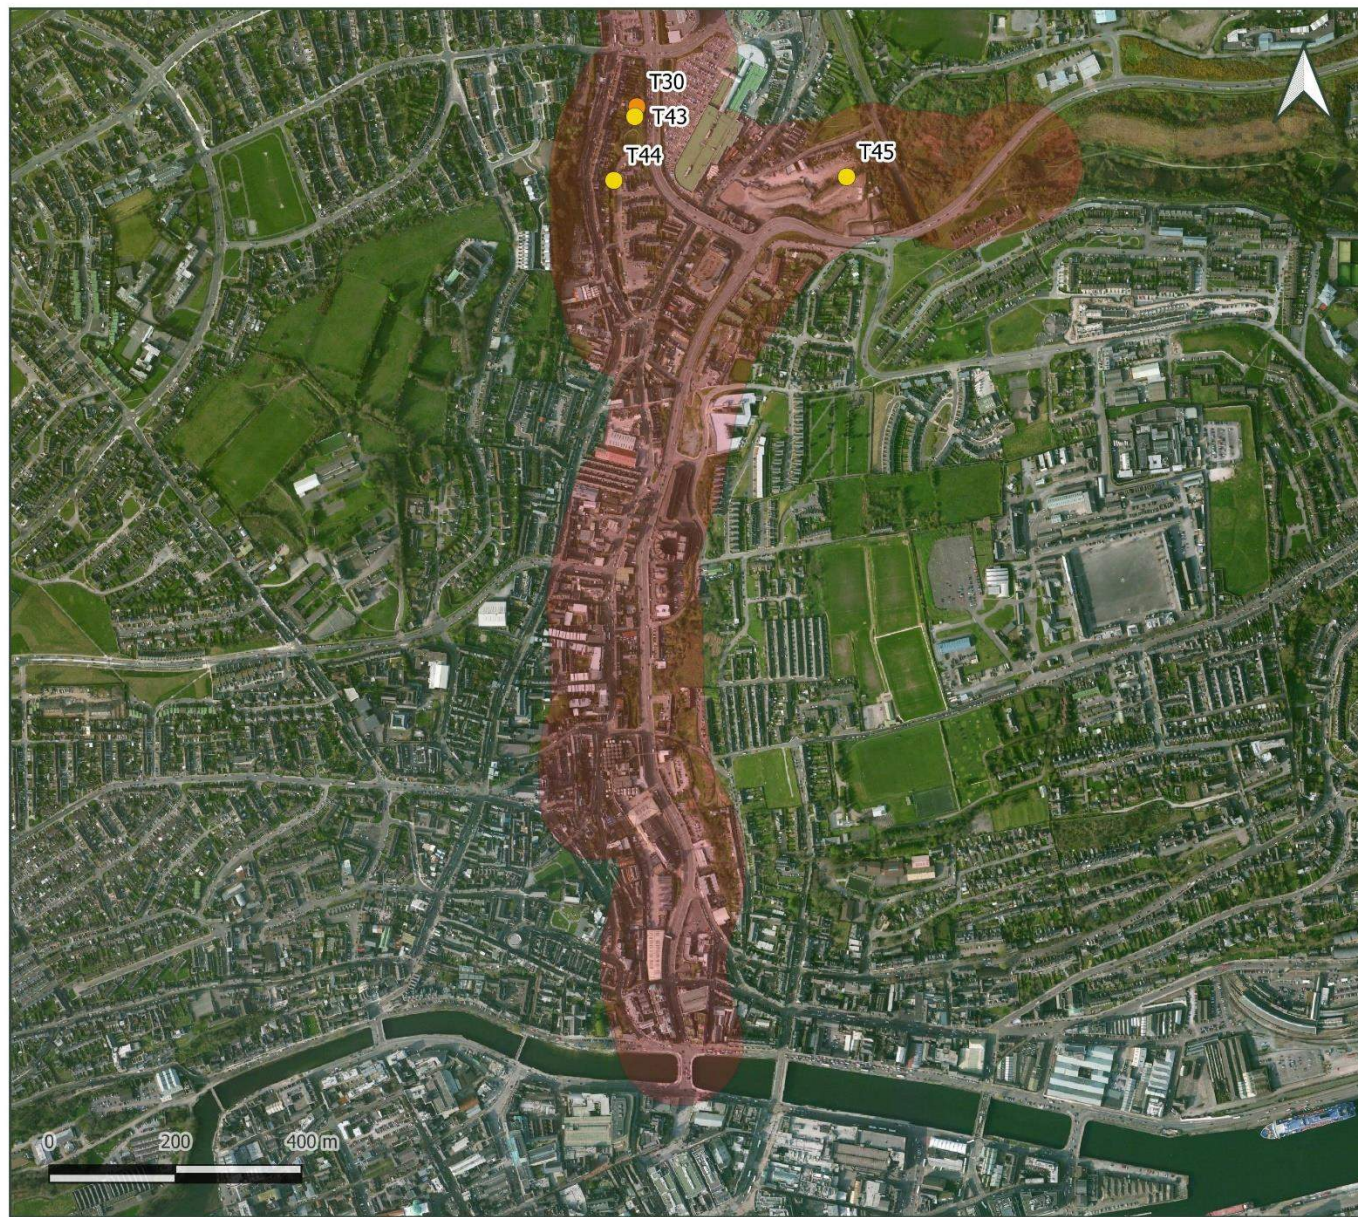
Figure 3.6
Visual Survey Results [Trees]

No trees in the study area were considered to have 'high' potential to support roosting bats. A total of 21 trees were identified which were considered to have 'moderate' potential for roosting bats. **Table 3.4** provides a description of trees with 'low' and 'moderate' potential for roosting bats. Trees (or groups of trees) with 'low' potential are described where they are within or immediately adjoining the proposed works area. Trees with 'negligible' potential for roosting bats are not included here. The locations of trees described in **Table 3.4** are shown in **Figure 3.5** and **Figure 3.6**.

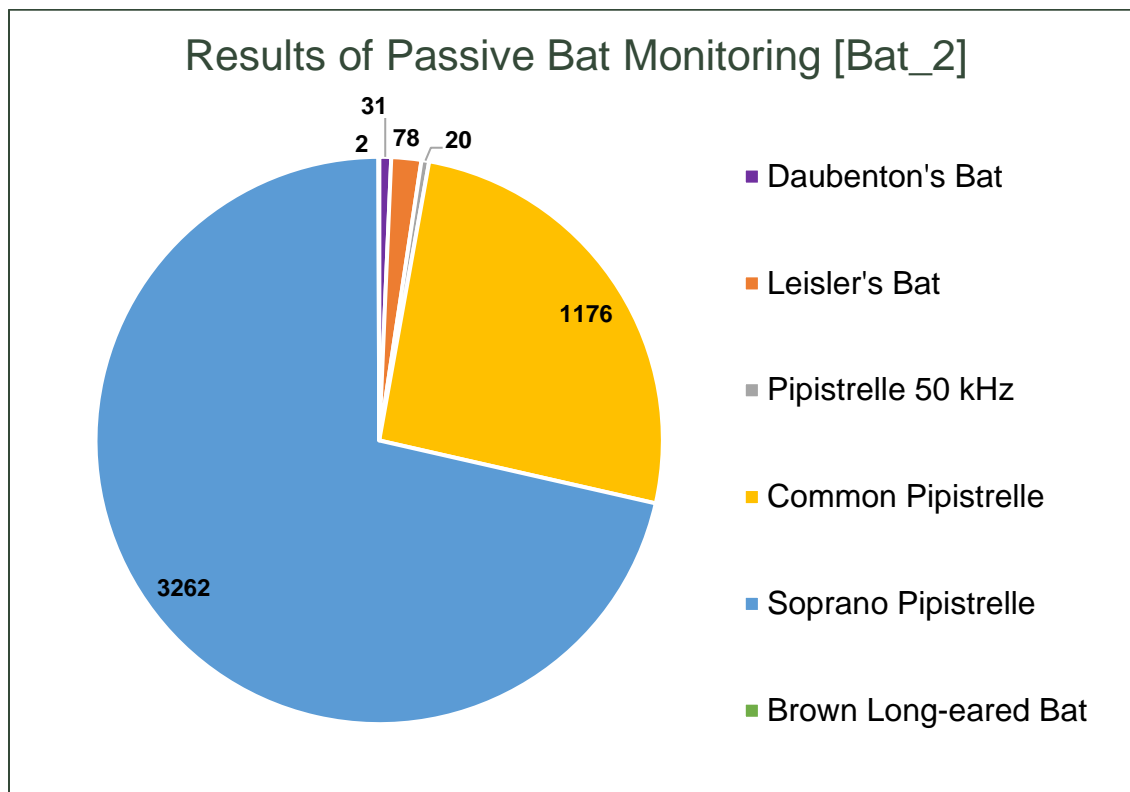
Figure 3.7 and **Figure 3.8** present the result of the passive bat detection survey at 'Bat_1' and 'Bat_2' respectively. Brown Long-eared Bat was additionally recorded during transect surveys in Glenamought Valley. 'Pipistrelle 50 kHz' describes a registration from either a Soprano or Common Pipistrelle where the peak frequency occurs at approximately 50 kHz and the species cannot be accurately determined.

Figure 3.8 – Results of passive bat monitoring at monitoring point Bat_2

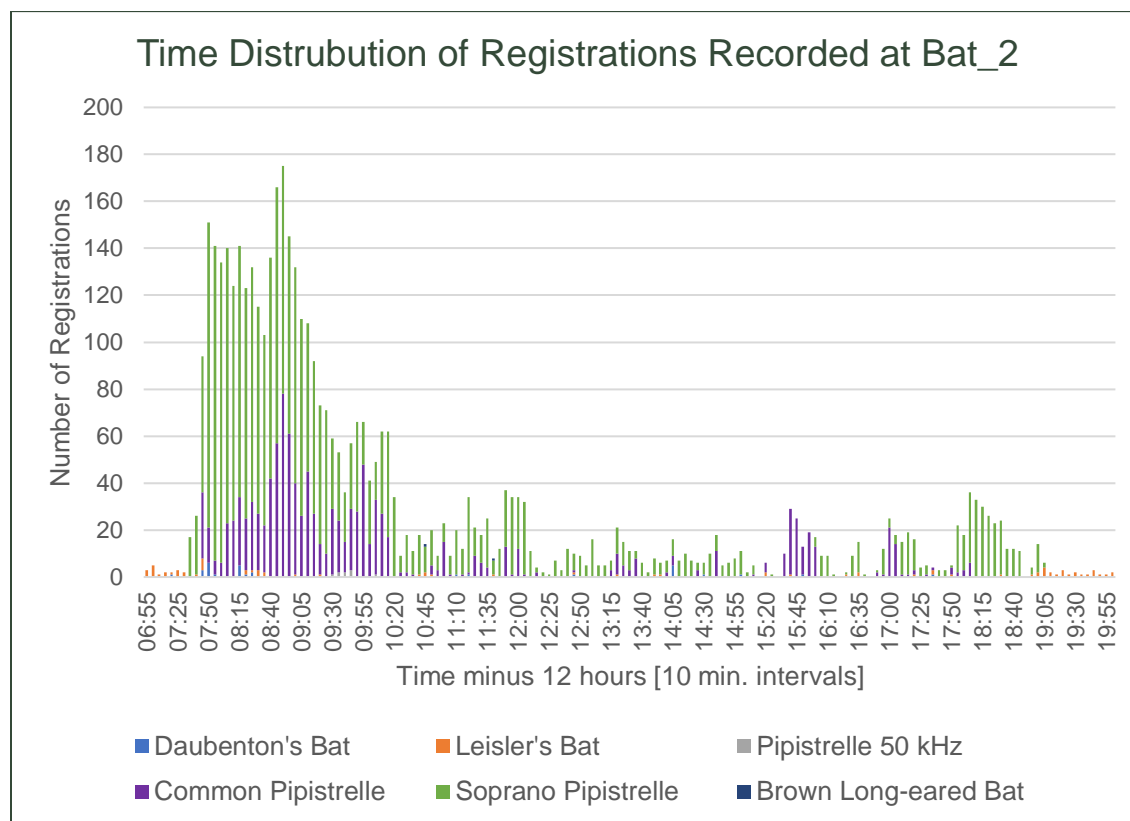
The average time of first detection of Soprano Pipistrelles by the detector at 'Bat_2' was 26 minutes after sunset. The range was 23 minutes to 30 minutes. The average emergence time for Soprano Pipistrelles is approximately 20 minutes after sunset, but this may be longer in an urban environment if artificial light falls on a roost access point and causes a delayed emergence time (Boldogh *et al.* 2007). Soprano Pipistrelle bats (and possibly other species) are likely to be roosting in relative proximity to the site. In urban areas suitable foraging opportunities are often the limitation to bat presence, and not the availability of roosts.

Figure 3.9 – Results of passive bat monitoring at monitoring point Bat_2 (Orchard Court).

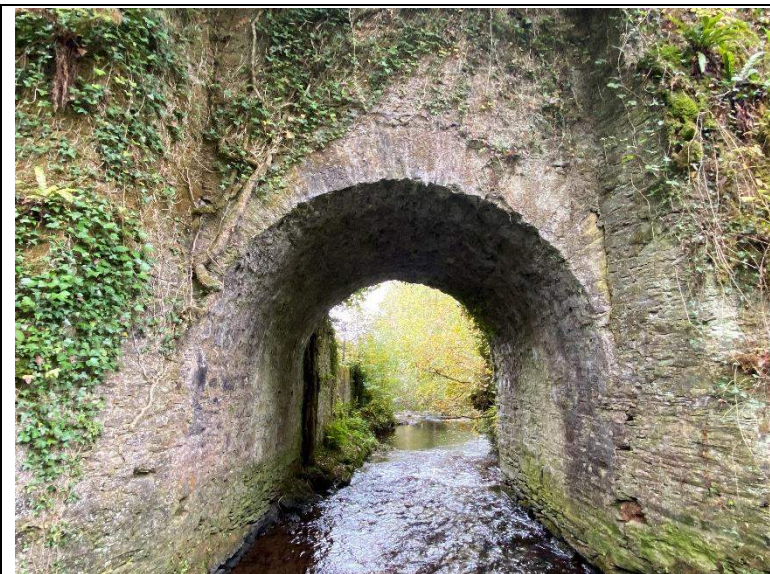
A1. Bridge B01 - Located on the Glenamought River. Sheltered location proximal to suitable bat foraging habitat. Crevices within the bridge barrel and at the joint between spandrels and buttresses.

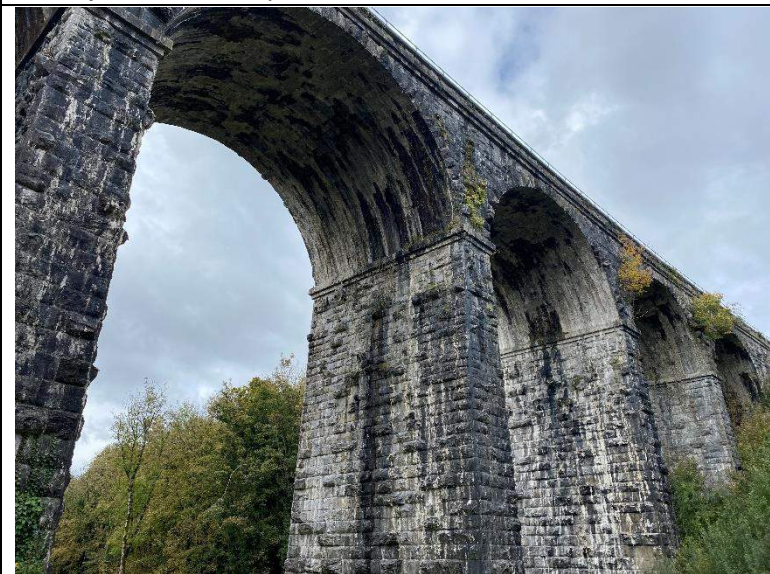
A3. Bridge B03 - Located on the Glenamought River. No PRFs visible from ground level. No evidence of roosting was detected during activity surveys.

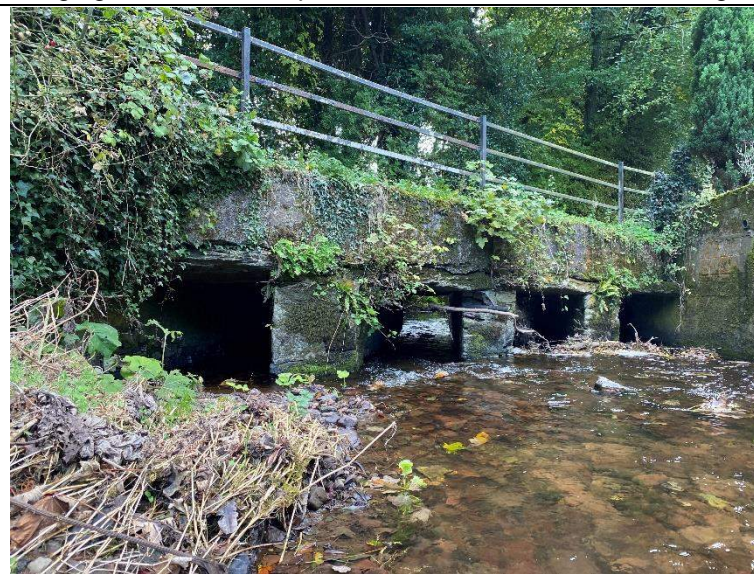
A4. Bridge B04 - Located on Glenamought River. Gaps in stonework and where stonework meets concrete deck provide gaps suitable for roosting bats. No evidence of roosting was detected during activity surveys.

Removal of trees to facilitate the replacement of a bridge on the Glenamought River (C08_B01) will result in a gap of approximately 10m in the treeline on the downstream side of the existing bridge. While this may result in a slight negative impact on commuting, it is expected that good connectivity will be maintained by trees on the opposite bank.

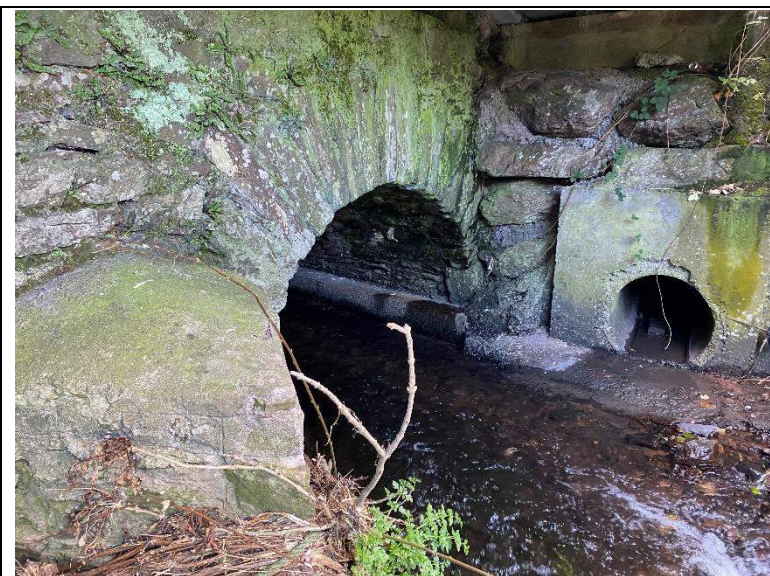
A5. Bridge B06 (U/S) - Located on Bride River. Two span masonry bridge with some gaps in stonework. Evidence of historic repairs.

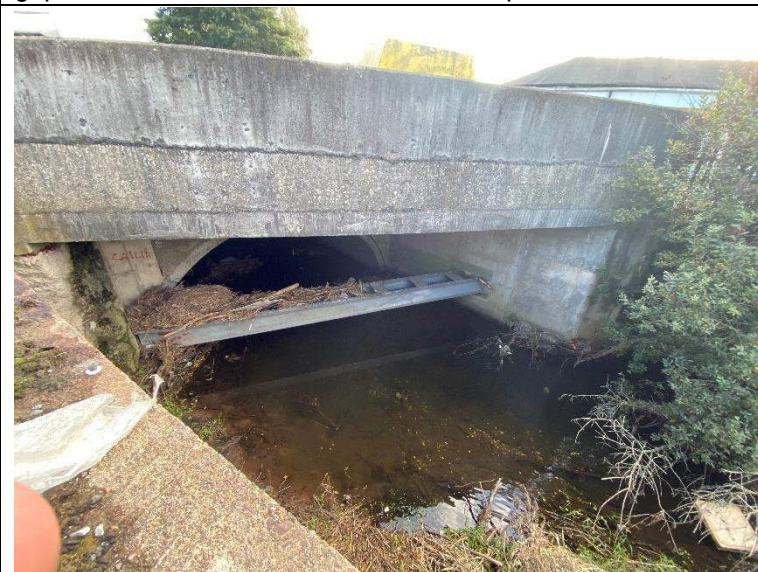
A8. B09 - Modern cast concrete bridge which presents few opportunities for bats. Occurs in a location which experiences significant light pollution at night.

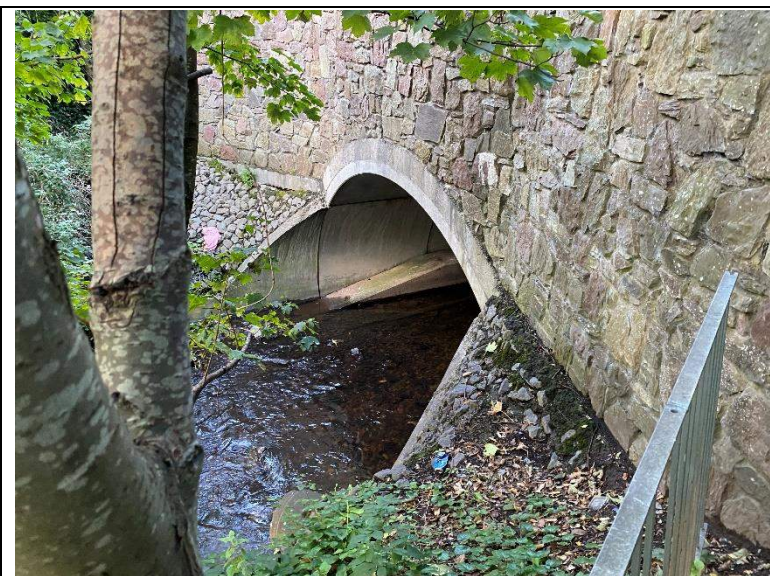
A9. B10 - Modern bridge with cast concrete barrel which presents few opportunities for bats.

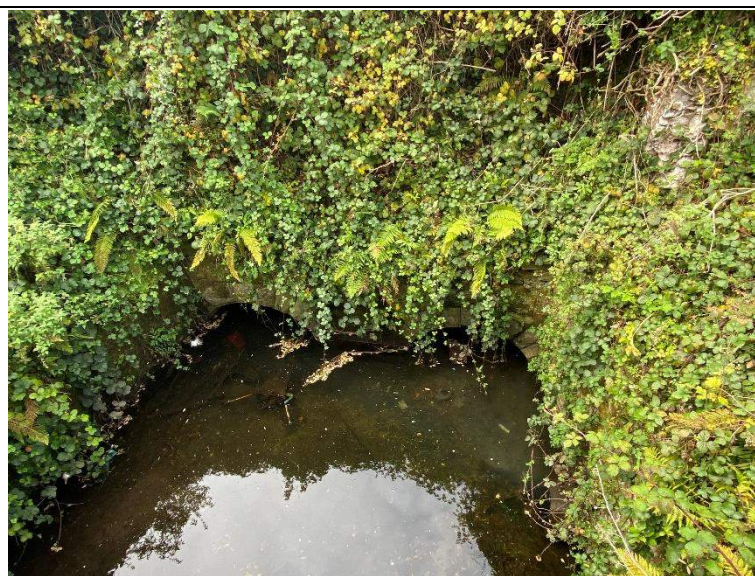
A10. B11 - Old masonry culverts on Glen River. Unlikely to have any value to bats due to their low level relative to level of watercourse (photo taken at low flow levels). No works are proposed but fencing works taking place adjacent.

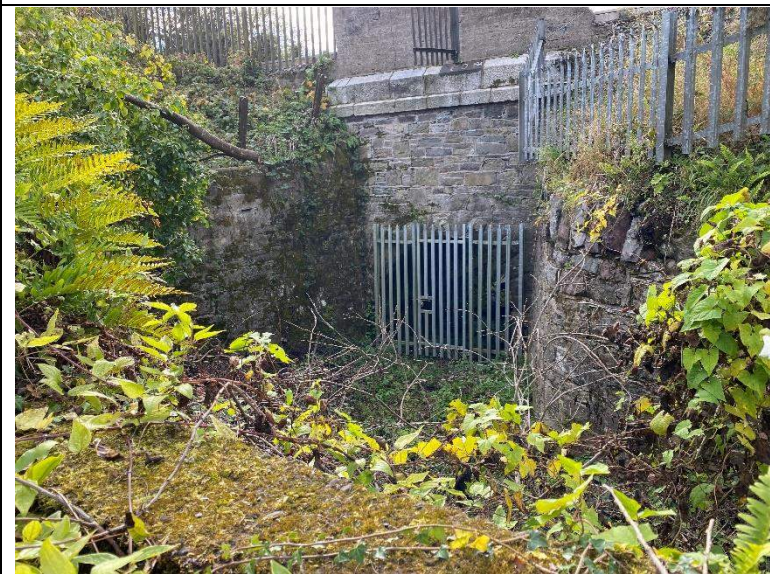
A11. B12 - Disused railway underpass. Not accessible for survey. A replacement security gate is proposed.

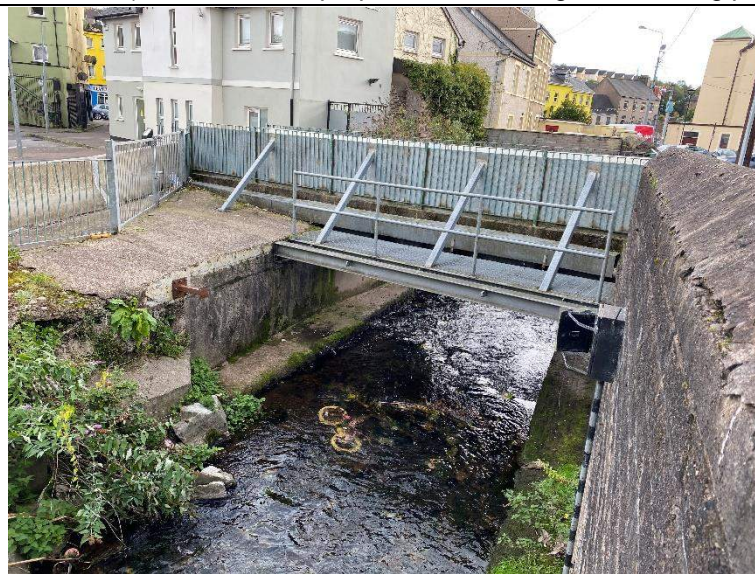
A12. B13 - Footbridge over River Bride. Steel and concrete construction. Occurs in a location which experiences significant light pollution at night.
