Intake Structure, Flow Control Structure and Diversion Channel

Washlands

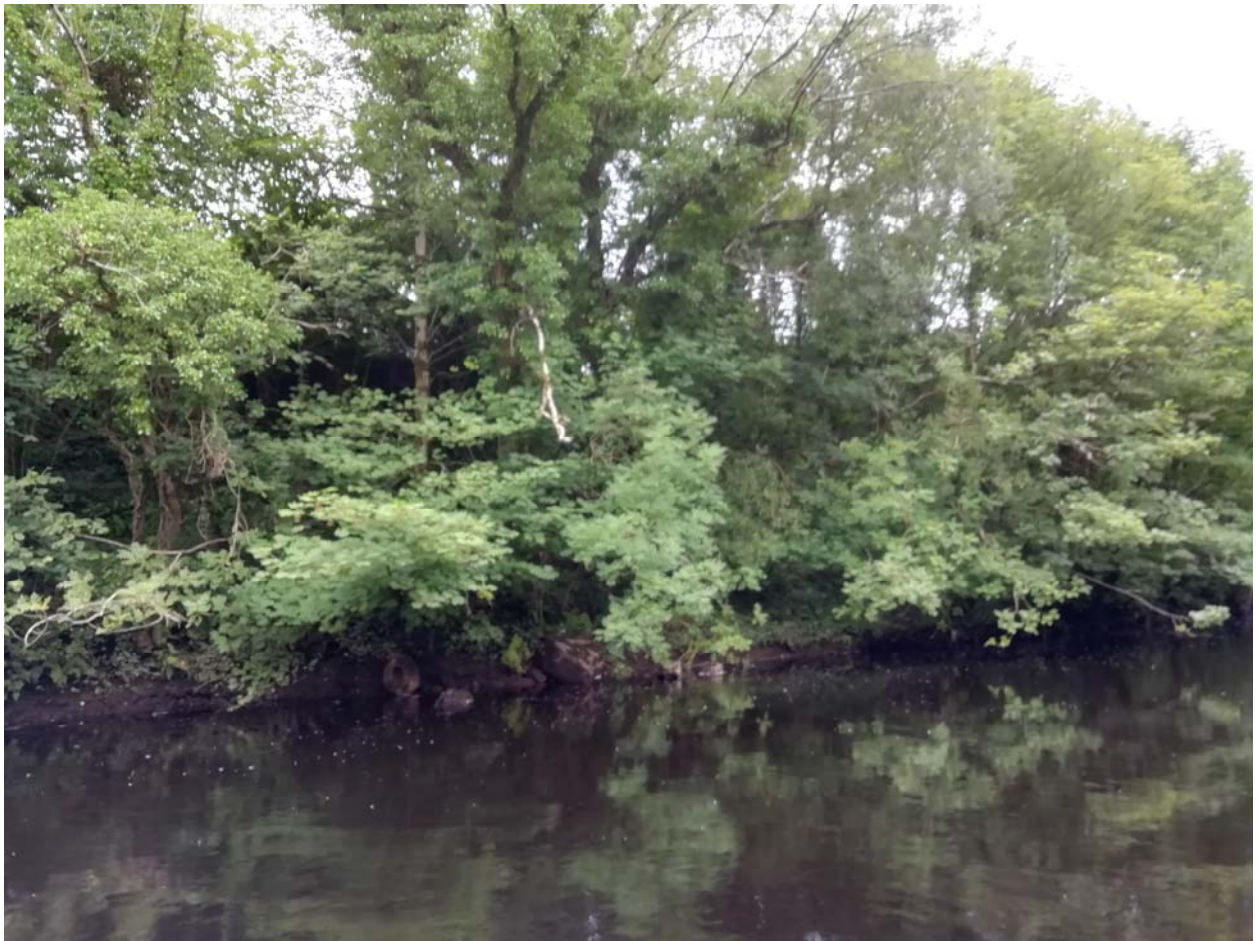
Plate 5.1 River Deel in flow at the location of the flow control structure.

The flow control structure will be located within the River Deel approximately 100m downstream of the intake weir. In this area, the river is bordered by a Tree Line (WL2) on the western bank, which separates it from a field of Improved Agricultural Grassland (GA1). This tree line is dominated by sycamore, ash and willow species. Works associated with the flow control structure will be located in this field. The tree line is shown as viewed from the field in Plate 5.3. The eastern bank in this area is formed by a steep wooded bank that leads up to the public road. This area is dominated by species including ash, hazel and hawthorn (*Crataegus monogyna*) and with a ground flora of ivy (*Hedera helix*) with hart's tongue fern (*Asplenium scolopendrium*) and the occasional occurrence of species including wood avens (*Geum urbanum*), dandelion (*Taraxicum officinale* agg.) and seedlings of ash, sycamore and hawthorn. This woodland is shown in Plate 5.4 and is classified as Mixed Broadleaved Woodland (WD1) the subject of a detailed habitat assessment as provided in Appendix 5A.

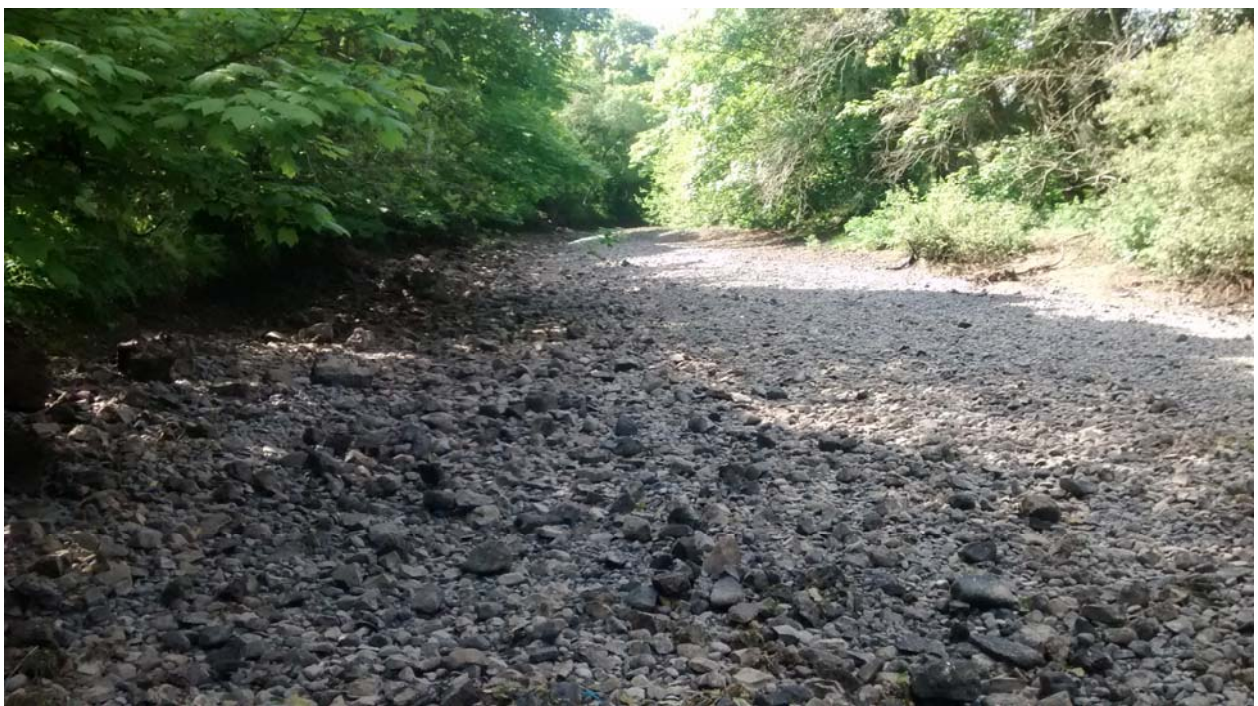
Plate 5.2. River Deel with no flow at the location of the flow control structure.

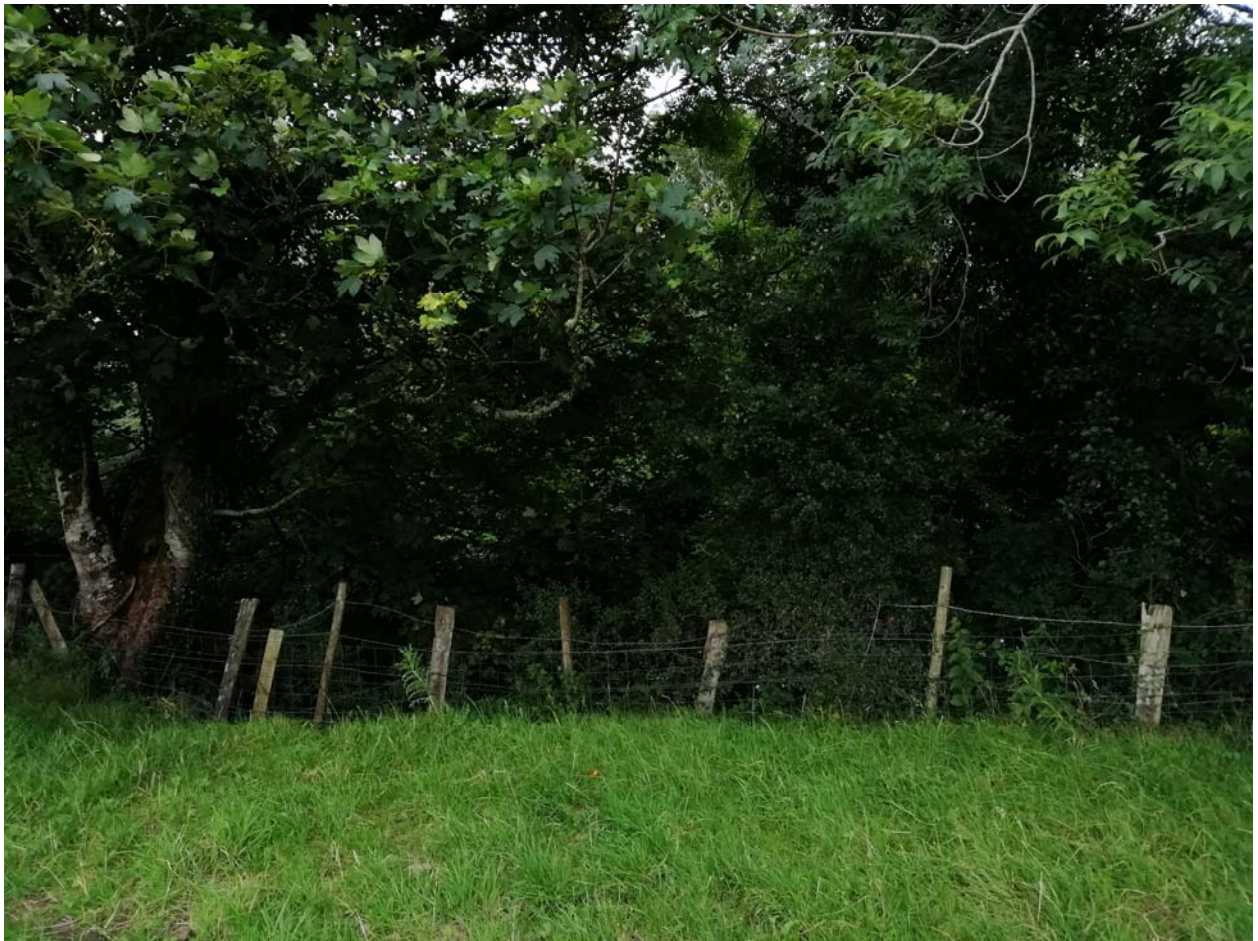
Plate 5.3. Tree Line in the vicinity of the flow control structure, as viewed from the field to the west.

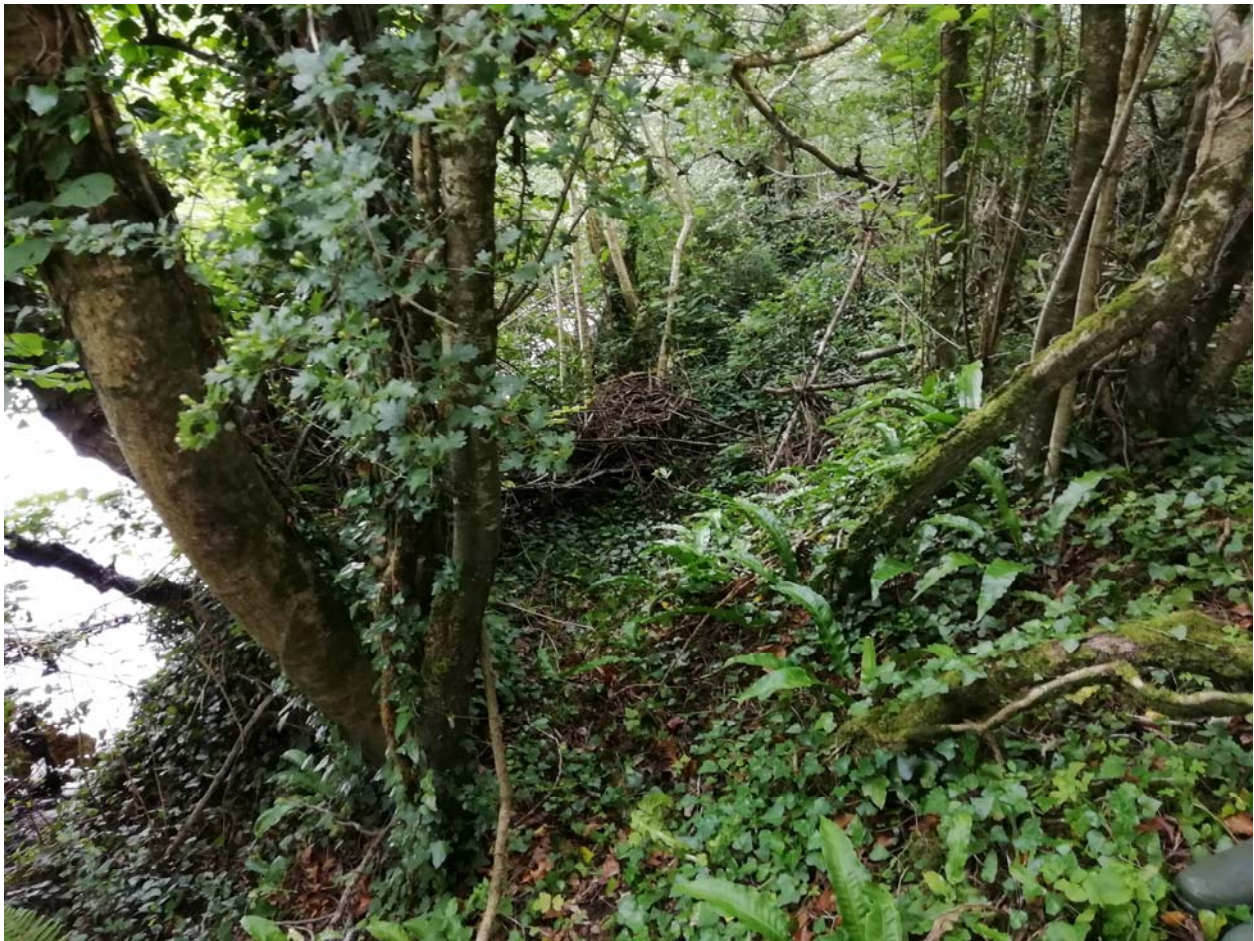
Plate 5.4. Mixed Broadleaved Woodland on the eastern bank of the river by the flow control structure

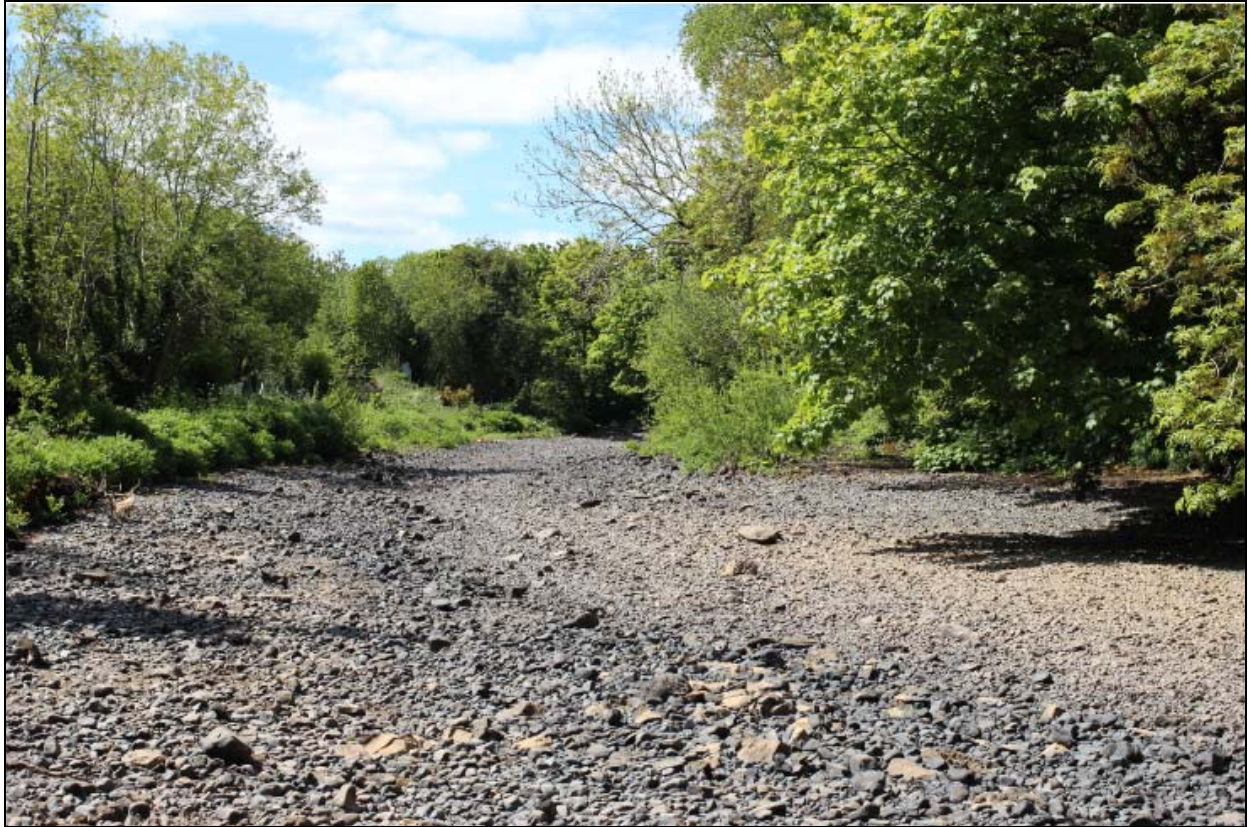
Plate 5.5 River Deel in dry conditions at the location of the intake structure

The proposed intake structure and associated works border the river for approximately 150 metres with the intake structure located outside the SAC and in the adjacent field. The section of bank within the study area supports a wide bank of deposited silty material with growth of plant species including marsh marigold (*Caltha palustris*), cow parsley (*Anthriscus sylvatica*), and Meadowsweet (*Filipendula ulmaria*) (Plate 5.5). This wide bank is separated from the adjoining lands by an old earthen bank, on top of which is a Tree Line (WL2), dominated by Sycamore and Ash and used to form the boundary with the adjacent agricultural field. This marks the boundary of the River Moy SAC. This field was in agricultural production until at least 2000 (aerial photography) but now forms part of the grounds of a dwelling house. There were no trees within the field in 2005 when the house was under construction (or recently constructed) but in the intervening years, scrubby woodland has grown up adjacent to the old field boundary. This is classified as Wet willow-alder-ash woodland (WN6) but is very scrubby and includes only immature trees with scrub encroaching into the field/garden and did not correspond to Annex I woodland as they represent the recent colonisation of a field of Agricultural Grassland (GA1) with willow scrub and immature woodland. The intake structure will be located in this area of recently established scrub and woodland (Plates 5.6 & 5.7). A narrow section of Mixed Broadleaved Woodland (WD1) is located between the local road and the River Deel at the northern end of the intake structure and continues to the flow control structure and beyond. A small stand of Japanese Knotweed (*Fallopia japonica*) is located

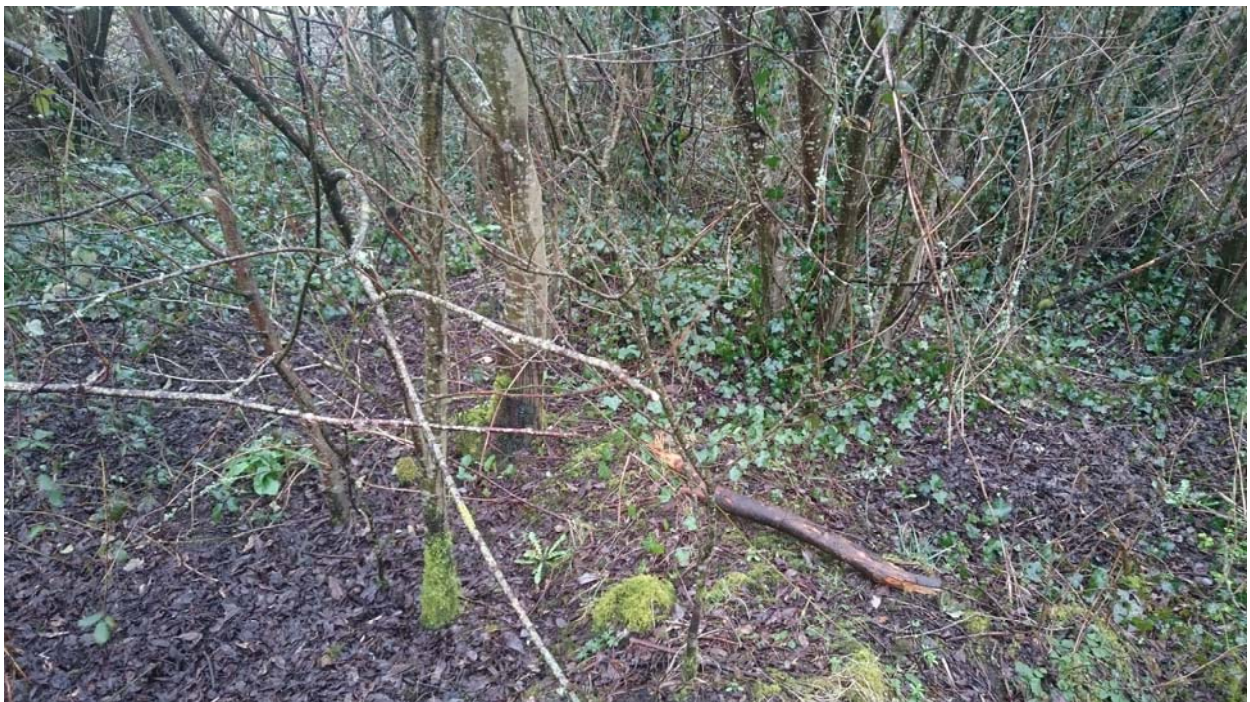
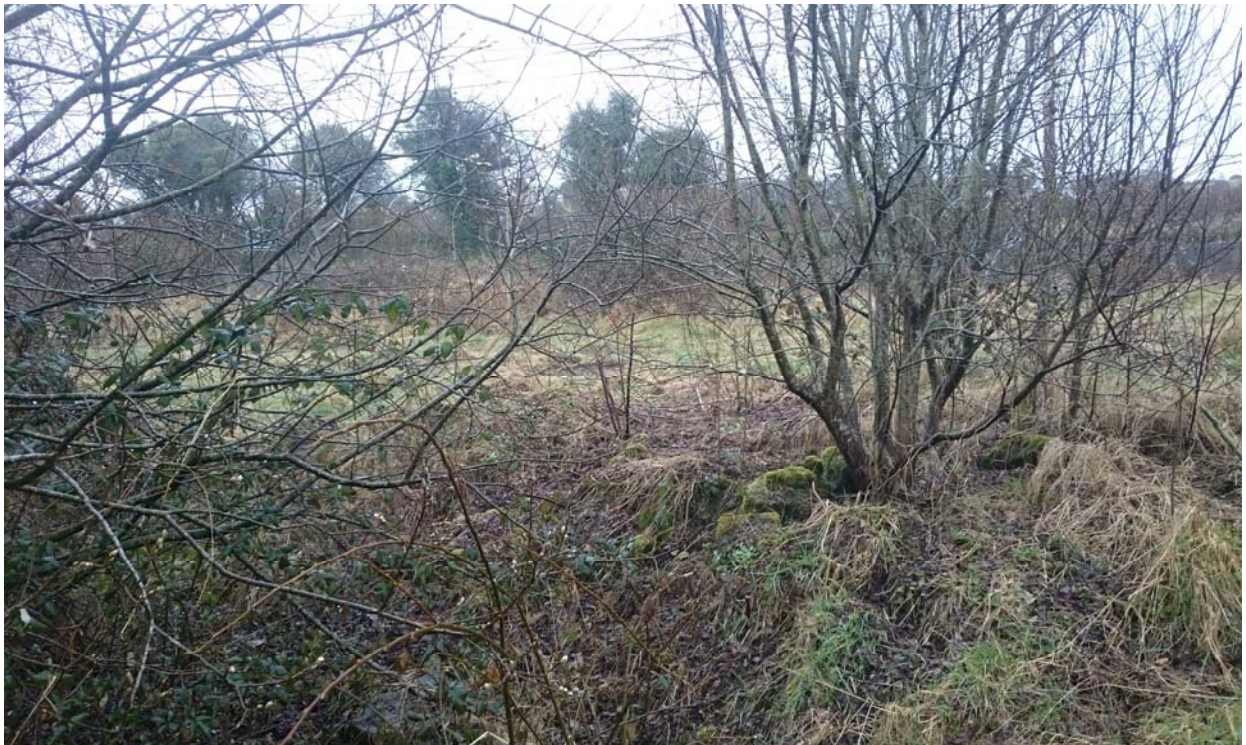
Plate 5.6 Wet-willow-alder-ash (WN6) woodland which has recently encroached on to Dry-meadows and grassy verges grassland (GS2) field .

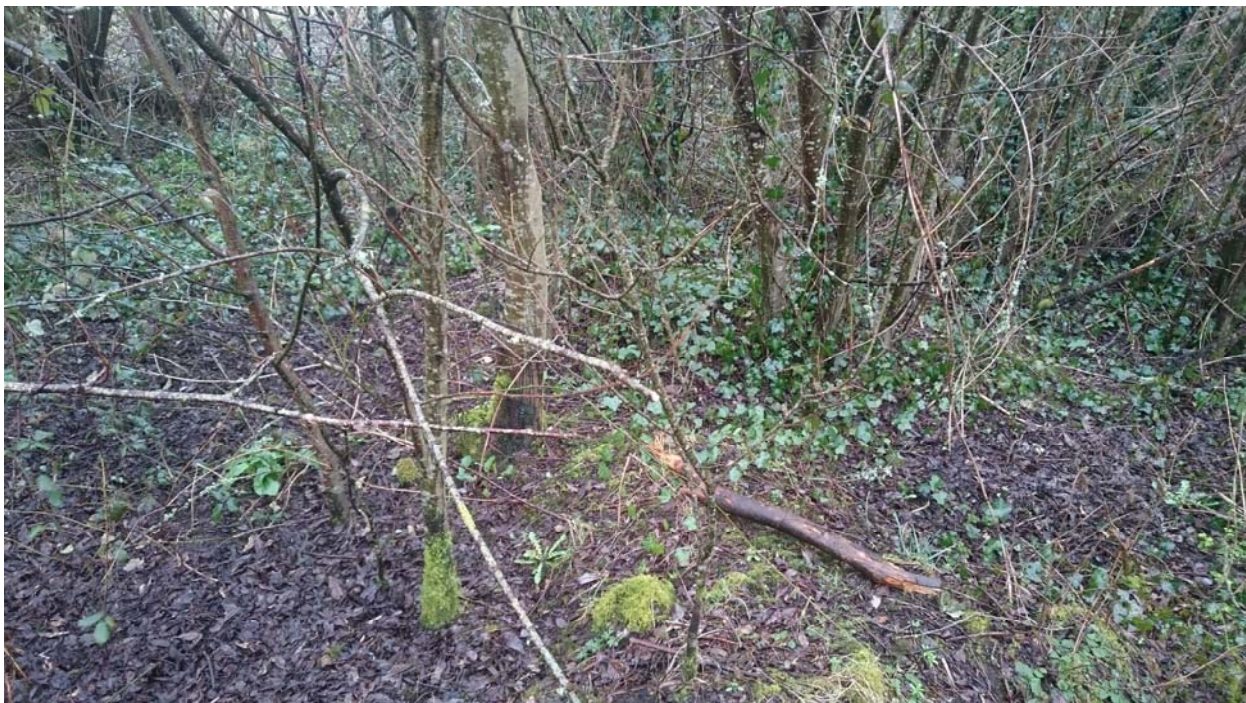
Plate 5.7 .Immature woodland where the intake structure is proposed

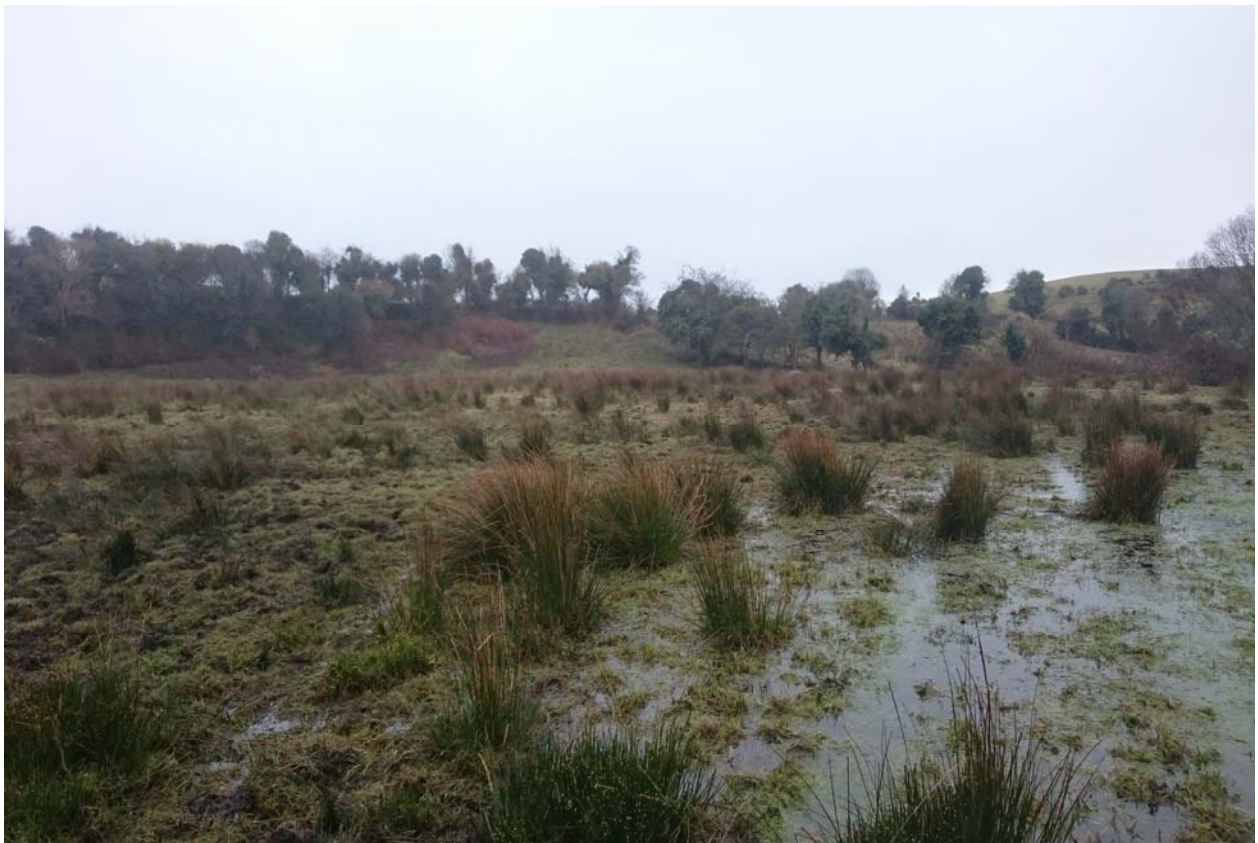
Plate 5.8 Wet grassland (GS4) demarcated with hedgerows (WL1) and scrub (WS1) where proposed diversion channel will be constructed.

location and is dominated by species-poor Wet grassland (GS4) and Improved agricultural grassland (GA1) (Plates 5.8 & 5.9). Hawthorn (*Crataegus monogyna*) Hedgerows (WL1) demarcate the field boundaries and a small area of hawthorn dominated Scrub (WS1) with gorse (*Ulex europeaus*), elder (*Sambucus nigra*) and bramble (*Rubus fruticosus* agg.) was found along one of the field boundaries. Other small patches of bramble Scrub (WS1) were recorded in scattered locations adjacent to field boundaries. Moving to the east, small man made drainage ditches were recorded running parallel to hedgerows. Stands of the non-native invasive species Japanese Knotweed (*Fallopia japonica*) were recorded on the approach to and adjacent to the R315 (Plate5.10).

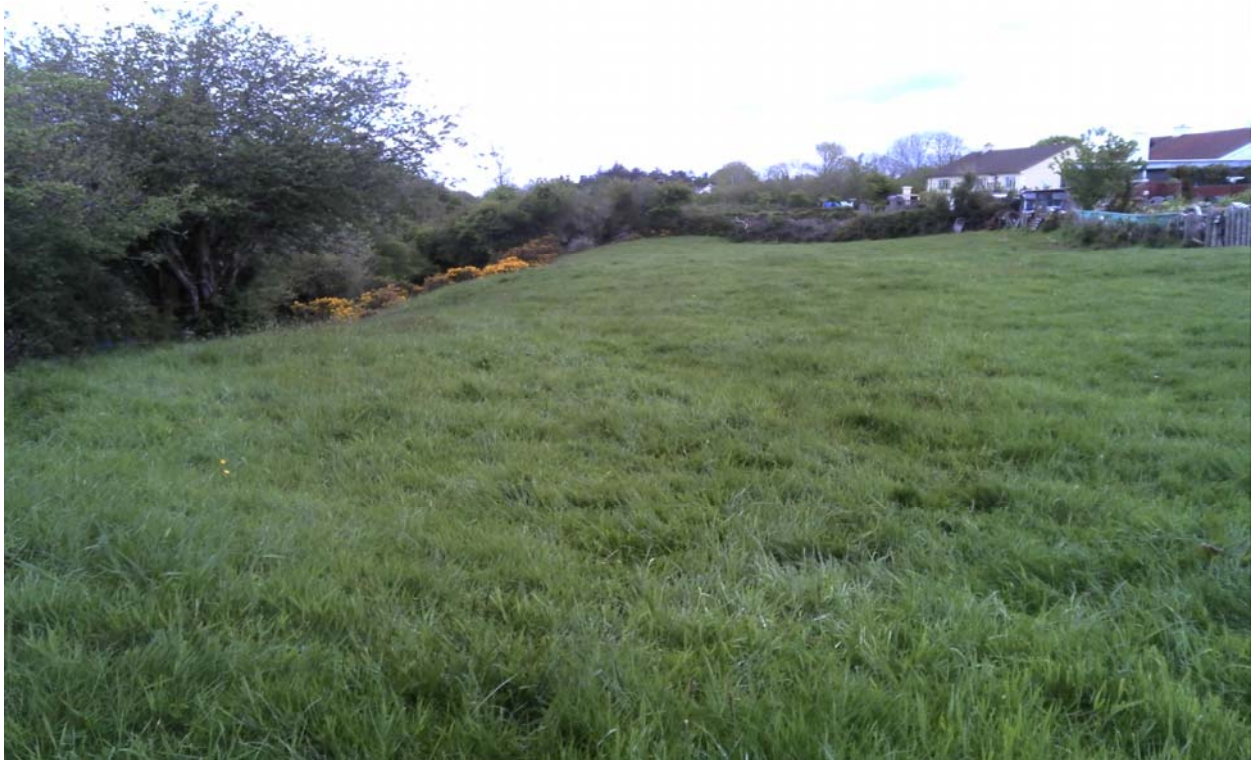
Plate 5.9 Improved agricultural grassland (GA1) within the final section of the diversion channel footprint

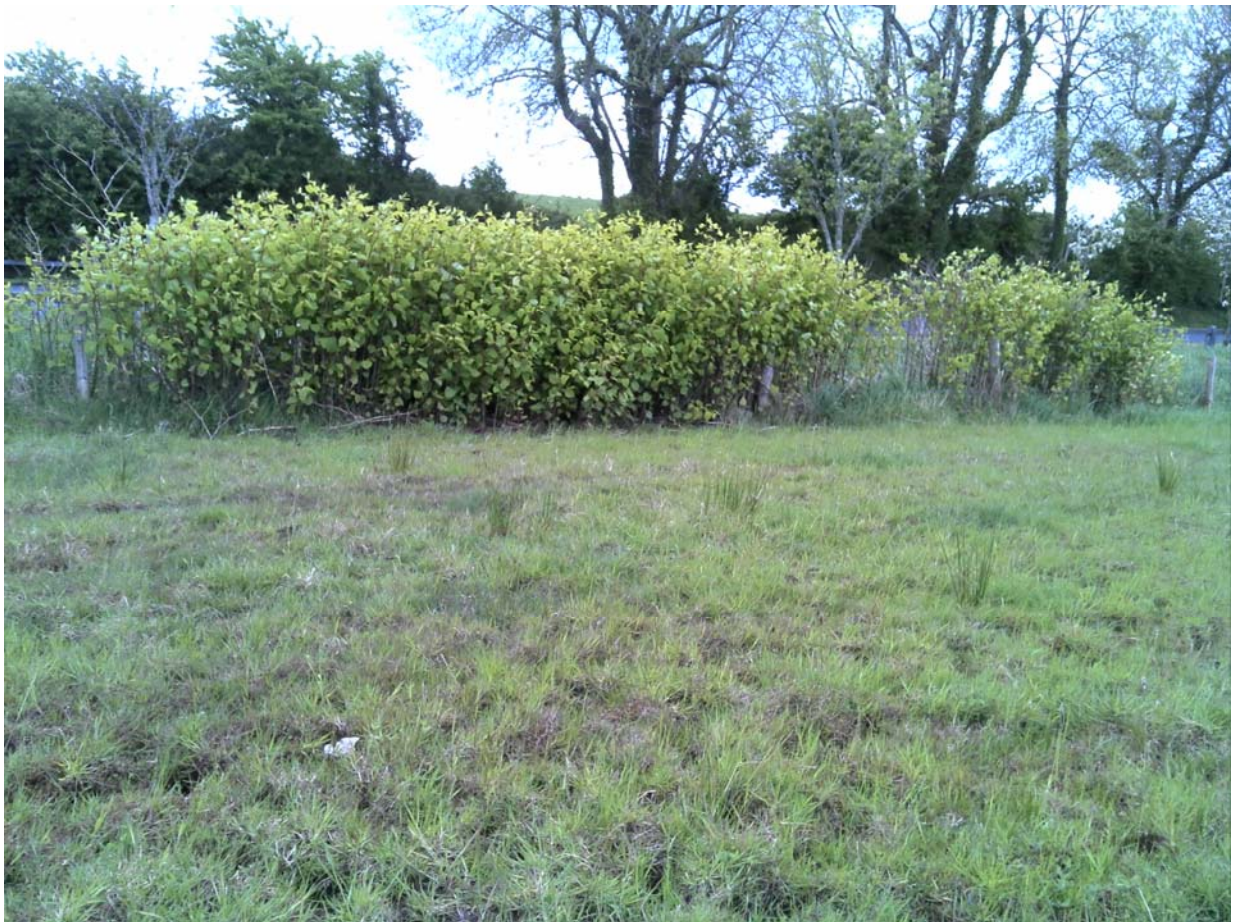
Plate 5.10. Japanese Knotweed adjacent to the R315

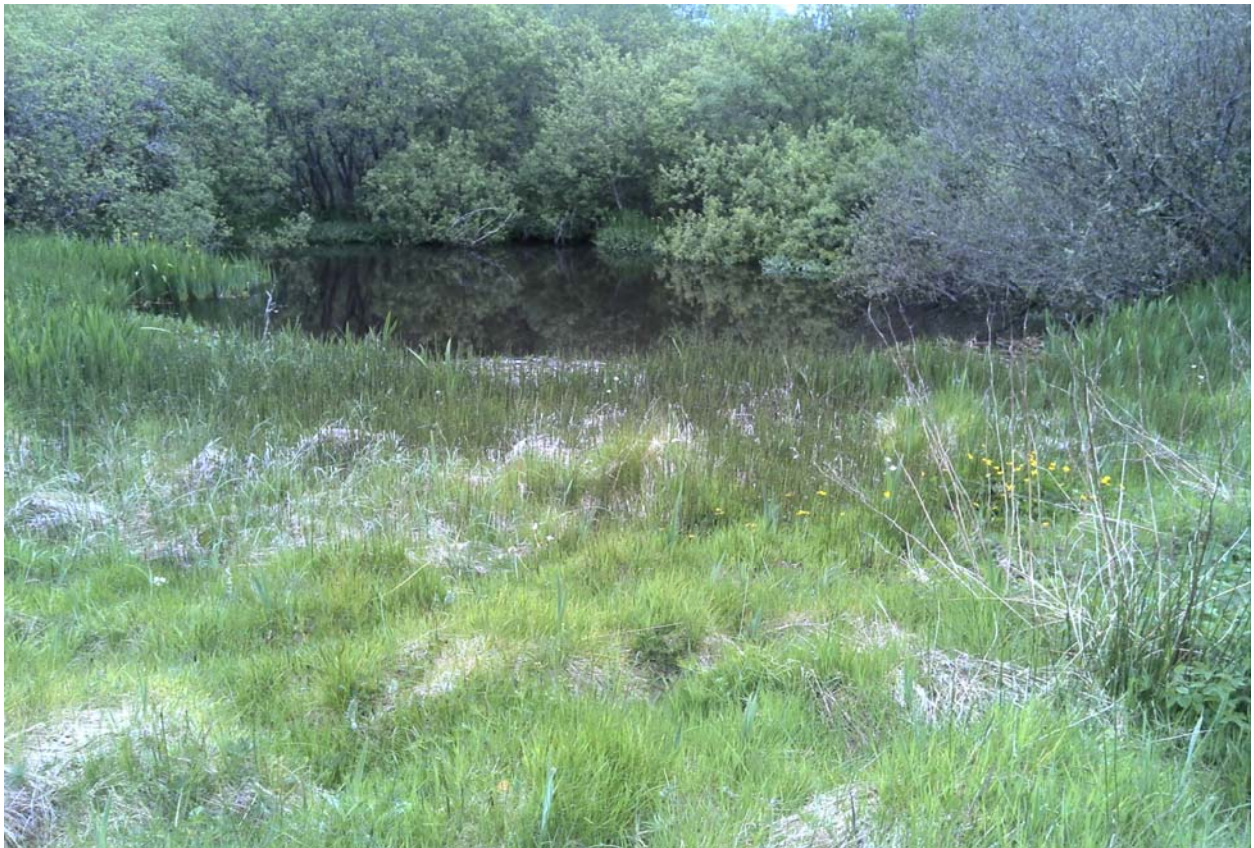
Plate 5.11. Lower Mullenmore Spring surrounded by emergent vegetation and woodlands

Spring fed ponds (FP1), as evident from upwelling water, provide the sources of the river and are surrounded by wet woodlands. Aquatic vegetation recorded within the springs included duckweed (*Lemna* sp.), broad-leaved pondweed (*Potamogeton natans*), yellow iris (*Iris pseudacorus*) and branched bur-reed (*Sparganium erectum*), horsetails (*Equisetum* spp.), bog bean (*Menyanthes trifoliata*) marsh marigold (*Caltha palustris*), water mint (*Mentha aquatica*) and sedges (*Carex* spp.) were recorded from the emergent vegetation (Plate 5.11). No tufa formations were observed at these springs.

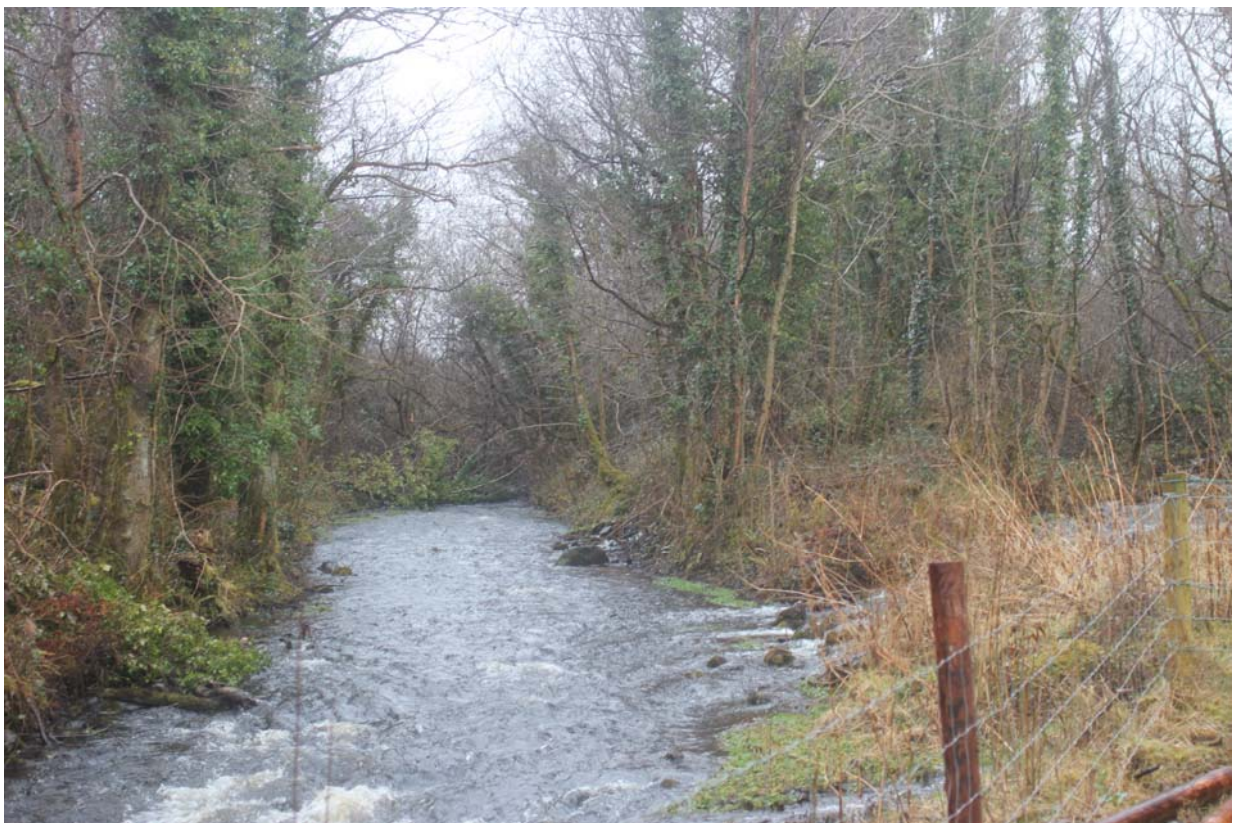
Plate 5.12. Short Section of Eroding River close to Mullenmore Springs

The upper branches of the river are partially eroding for short sections (Plate 5.12) but they quickly merge to form a watercourse that has been classified as a Lowland depositing river (FW2) with flat gradient, sluggish flow and silty substrate. This channel spends much of its time submerged under flood waters from Lough Conn.

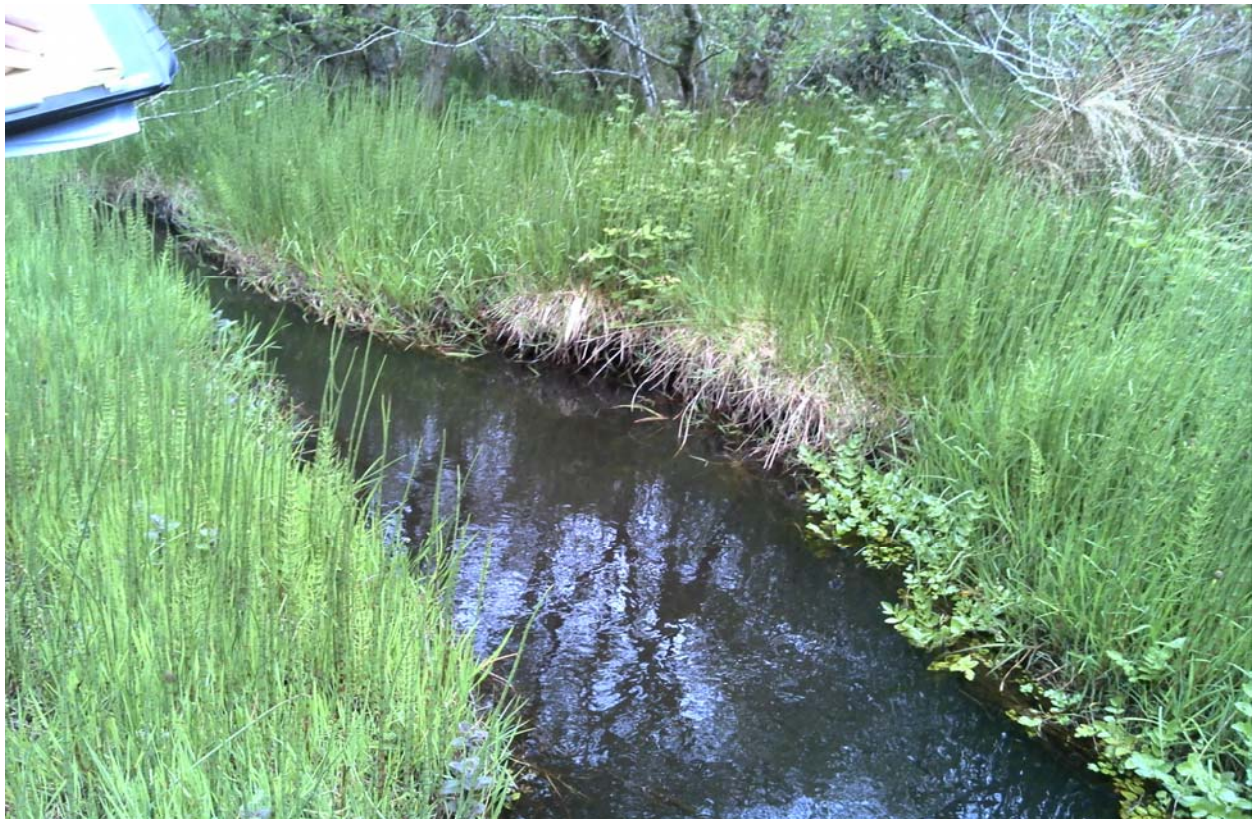
Plate 5.13 Lower Reaches of the Mullenmore Stream

The short eroding sections of the river were devoid of aquatic plants and emergent vegetation with only the aquatic moss *Fontanilis* sp. recorded. The following species were recorded from the lower depositing section of the river: yellow iris, branched bur-reed, horsetails, bog bean, marsh marigold, water mint. Floating bur-reed (*Sparganium emersum*) was recorded in-stream (Plate 5.13).

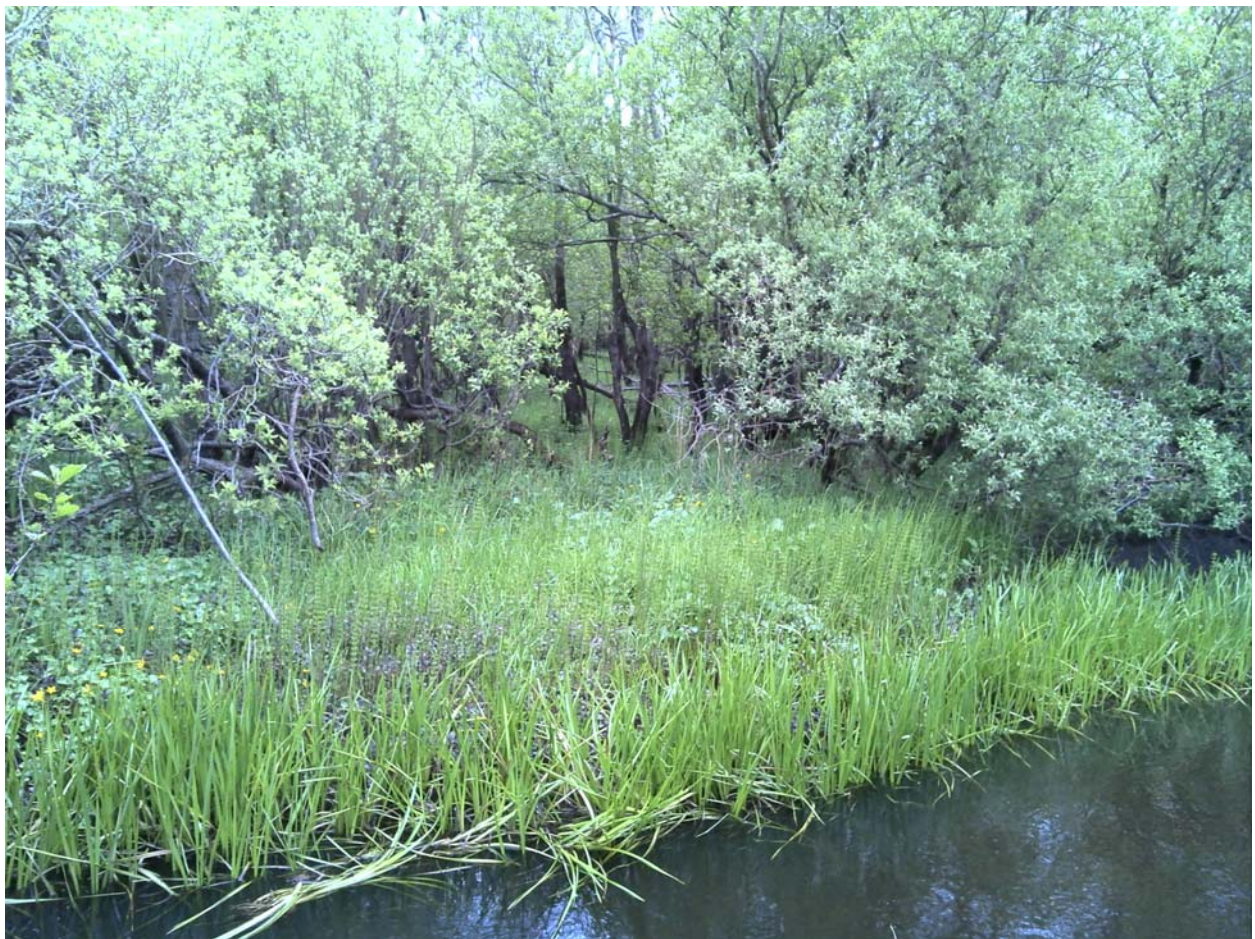
Plate 5.14. Annex I Alluvial Woodland adjacent to the Mullenmore Stream and Lough Conn

The woodland within the wash-lands was classified as Wet willow-alder-ash (WN6). The woodland was dominated by grey willow, alder, ash with occasional sycamore. Ground vegetation included meadowsweet (*Filipendula ulmaria*), nettle (*Urtica dioica*) and yellow iris. These areas of wet woodland were found to correspond to the Annex I Priority Habitat Alluvial forests with *Alnus glutinosa* and *Fraxinus excelsior* (*Alno-Padion*, *Alnion incanae*, *Salicion albae*)* [91E0] (Plate 5.14).

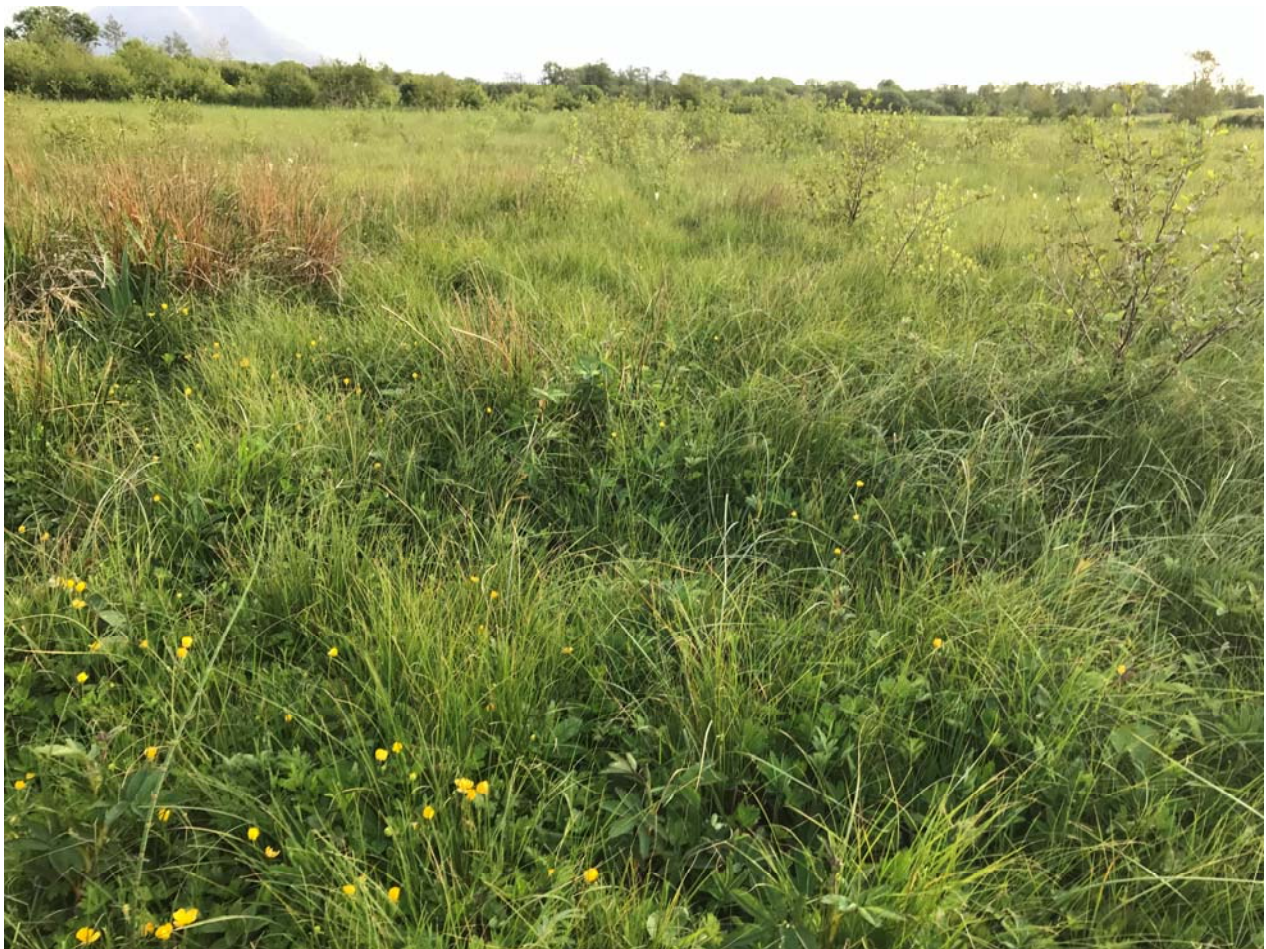
Plate 5.15. Marsh (GM1) grading into wet grassland (GS4) adjacent to Lough Conn

To the north of the river on the approach to the shores of Lough Conn, an area of Marsh (GM1) was recorded (Plate 5.15). A detailed botanical assessment of this habitat was carried out in July 2019 and is provided in Appendix 5E. A drain forms western boundary of the marsh habitat and common reed (*Phragmites australis*) is dominant in this area. Species recorded from the marsh included water mint (*Mentha aquatica*), bog bean (*Menyanthes trifoliata*), marsh pennywort (*Hydrocotyle vulgaris*), lesser spearwort (*Ranunculus flammula*), marsh marigold (*Caltha palustris*), bird's-foot-trefoil (*Lotus corniculatus*), (*Lychnis flos-cuculi*), silverweed (*Potentilla anserina*), common spike-rush (*Eleocharis palustris*) and marsh ragwort (*Senecio aquaticus*), self-heal (*Prunella vulgaris*), marsh cinquefoil (*Comarum palustre*), lesser spearwort (*Ranunculus flammula*) and water horsetail (*Equisetum fluvatile*). Sedges and grasses including common cottongrass (*Eriophorum angustifolium*), common sedge (*Carex nigra*), bottle sedge (*Carex*
