Monthly Environmental Audit – Oct 2025

Glanmire Flood Relief Scheme

01/10/25 to 31/10/25

ENVIRONMENTAL AUDIT

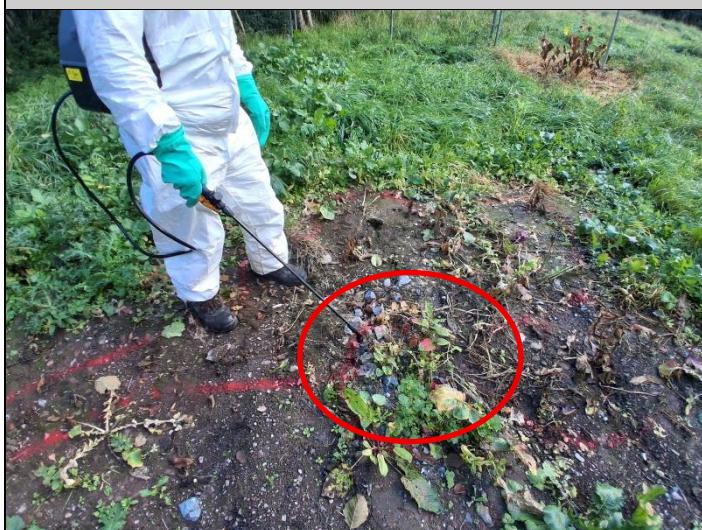
Photograph 1

The Grove

Japanese & Bohemian knotweed continuing to emerge in late October.

- Permit to Pump No. 150 was issued on 23/10/25 to facilitate the dewatering of the installed tanks at Hazelwood Pump Station.
- Japanese knotweed & Bohemian knotweed surveys and chemical treatment continued on the 20/10/25 at the Temporary Holding Facility at Sallybrook and in Area 4. Due to persistent mild weather conditions Japanese & Bohemian knotweed plants are still emerging.

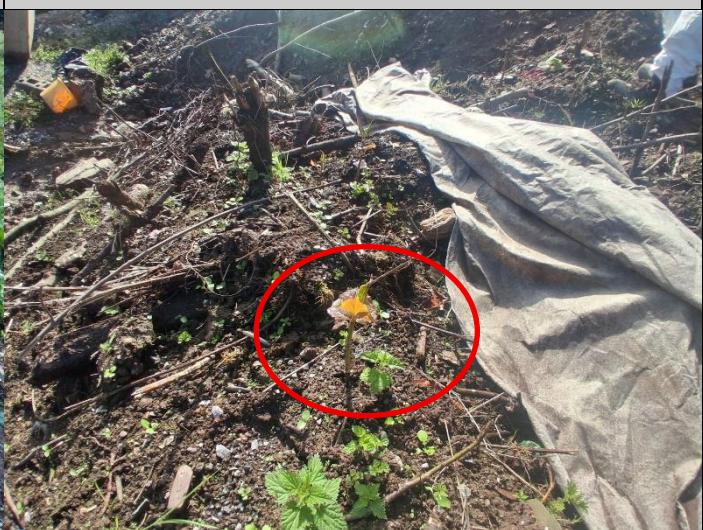
Photograph 2

Sallybrook

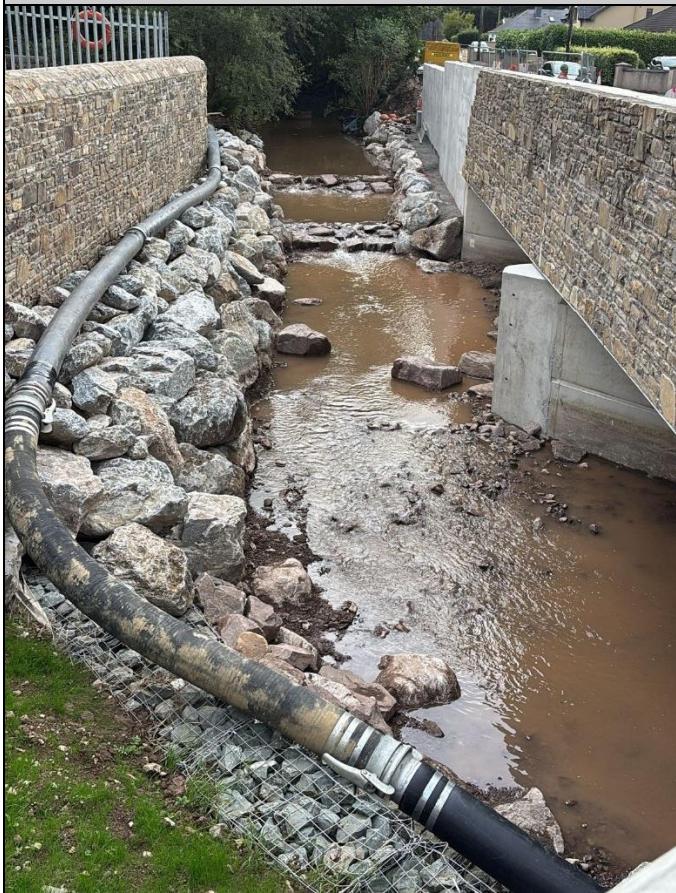
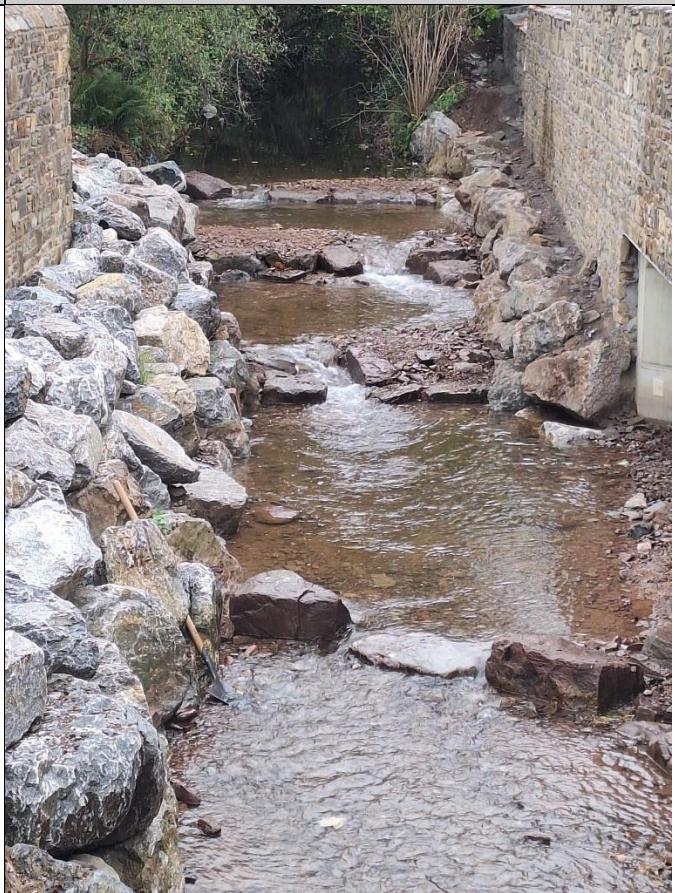
Caption 3	Caption 4
<p>Brooklodge</p> <p>Alterations were made to the two <i>in situ</i> transverse alignments of anchor boulders in the Glenmore River at Brooklodge in order to create the characteristic alternating step pool features. These works involved an adjustment to both rows of anchor boulders to create a step which would accommodate a low flow path and a low flow resting pool (deep scour pool) for fish. A third row of anchor boulders with a step was also installed.</p>	<p>Brooklodge</p>

- Alterations were made to the two *in situ* transverse alignments of anchor boulders in the Glenmore River at Brooklodge in order to create the characteristic alternating step pool features. These works involved an adjustment to both rows of anchor boulders to create a step which would accommodate a low flow path and a low flow resting pool (deep scour pool) for fish. A third row of anchor boulders with a step was also installed on 17-18/10/25.

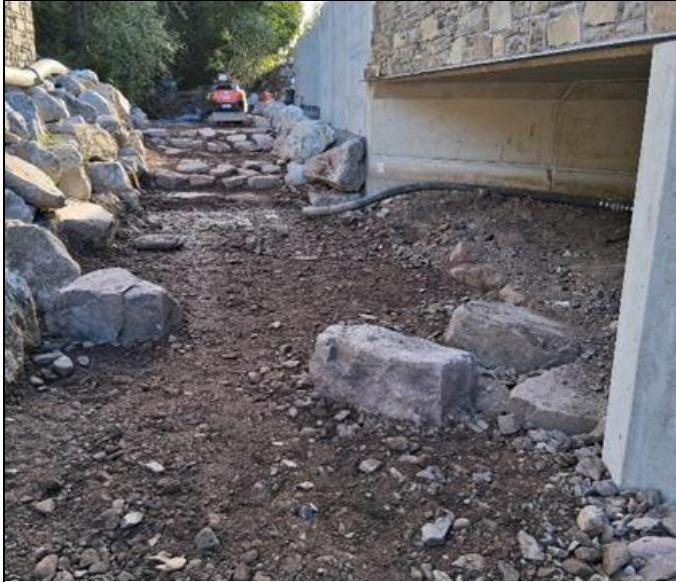
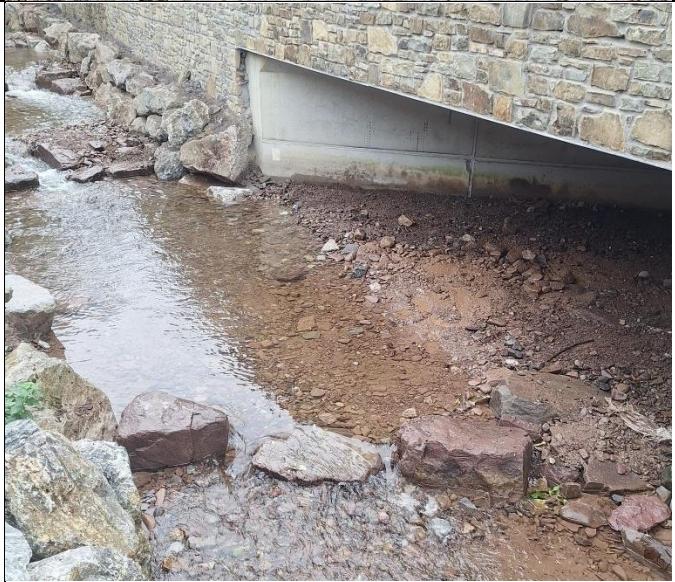
Plan of Proposed Typical Step Pool Arrangement (for Brooklodge)

(Source: Glashaboy River (Glanmire/Sallybrook) Drainage Scheme EIAR Addendum - Request for Further Information October 2020.

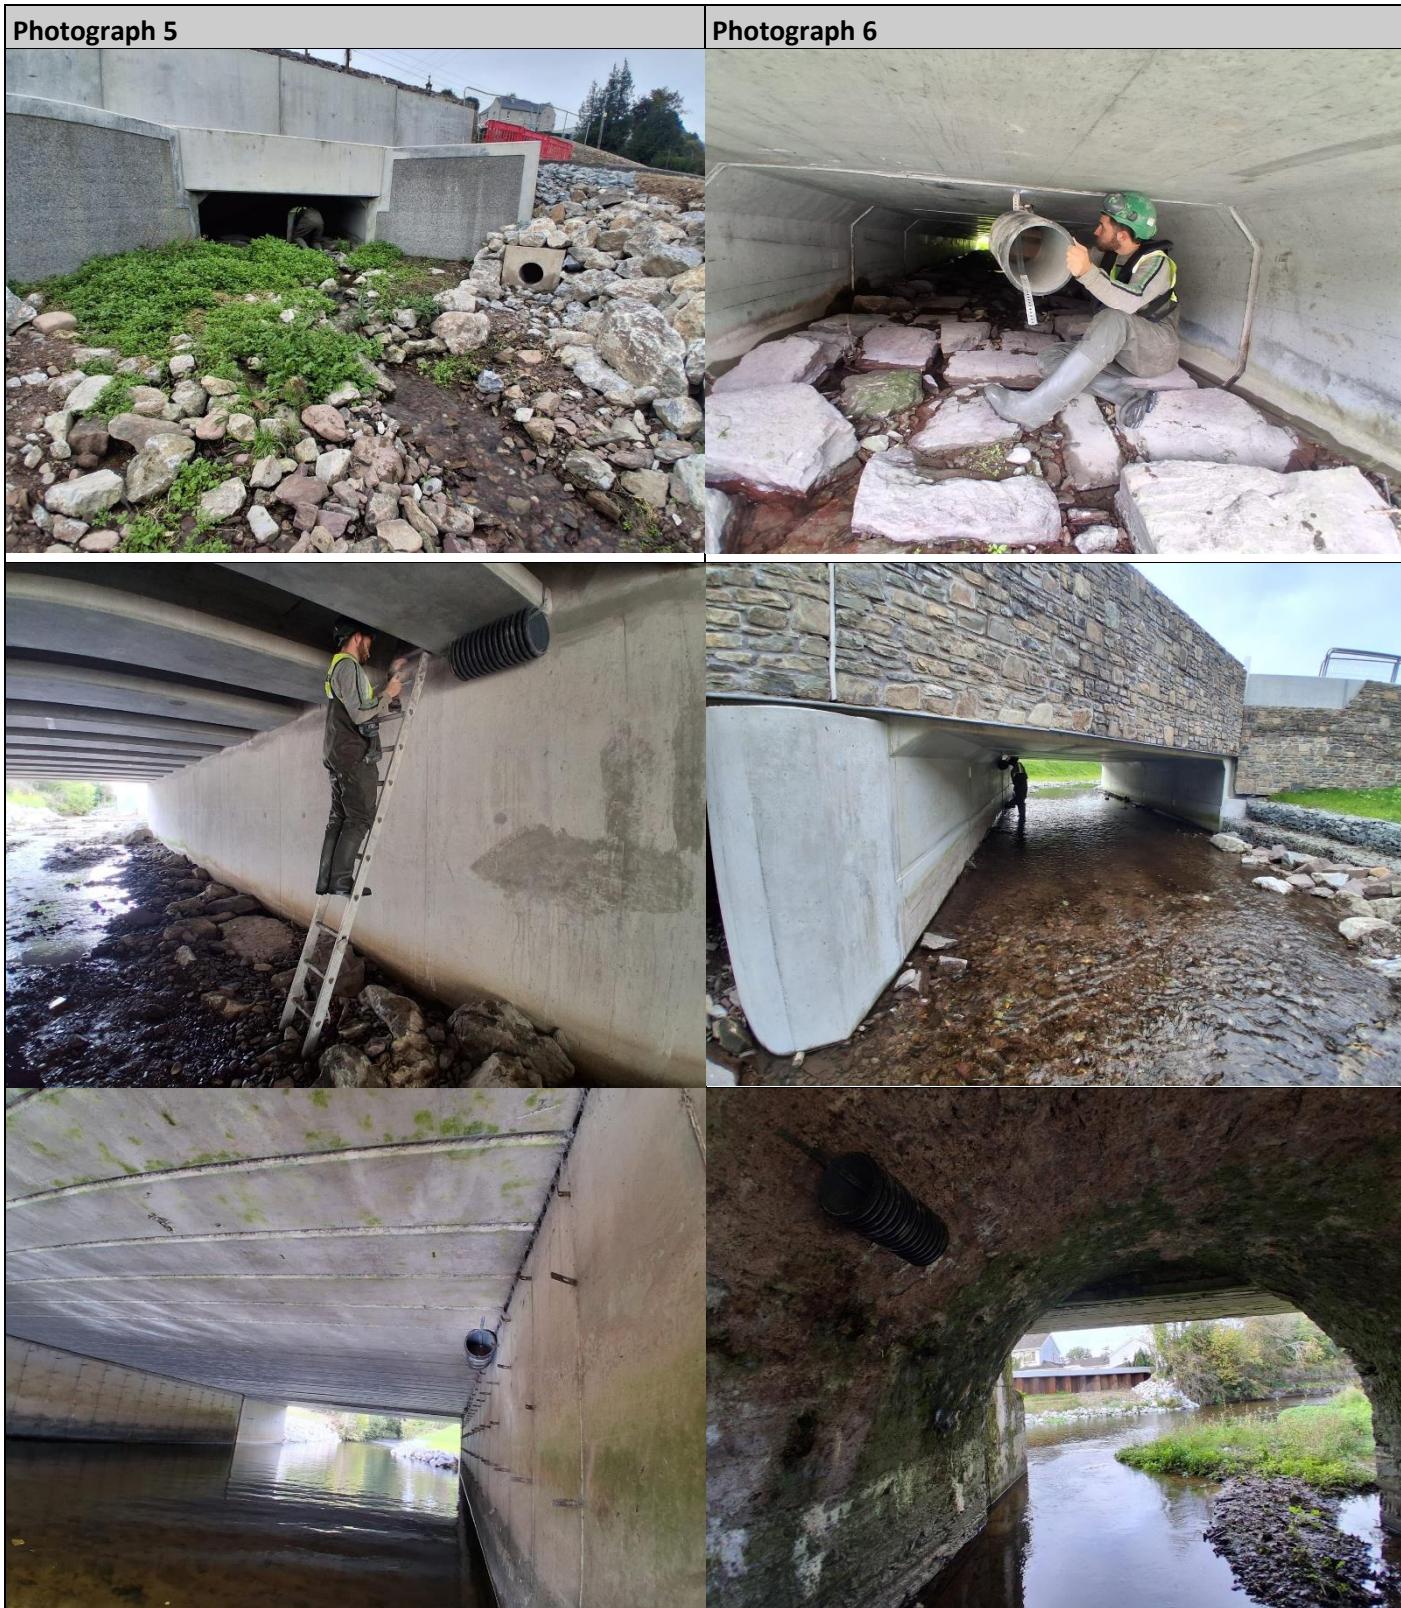
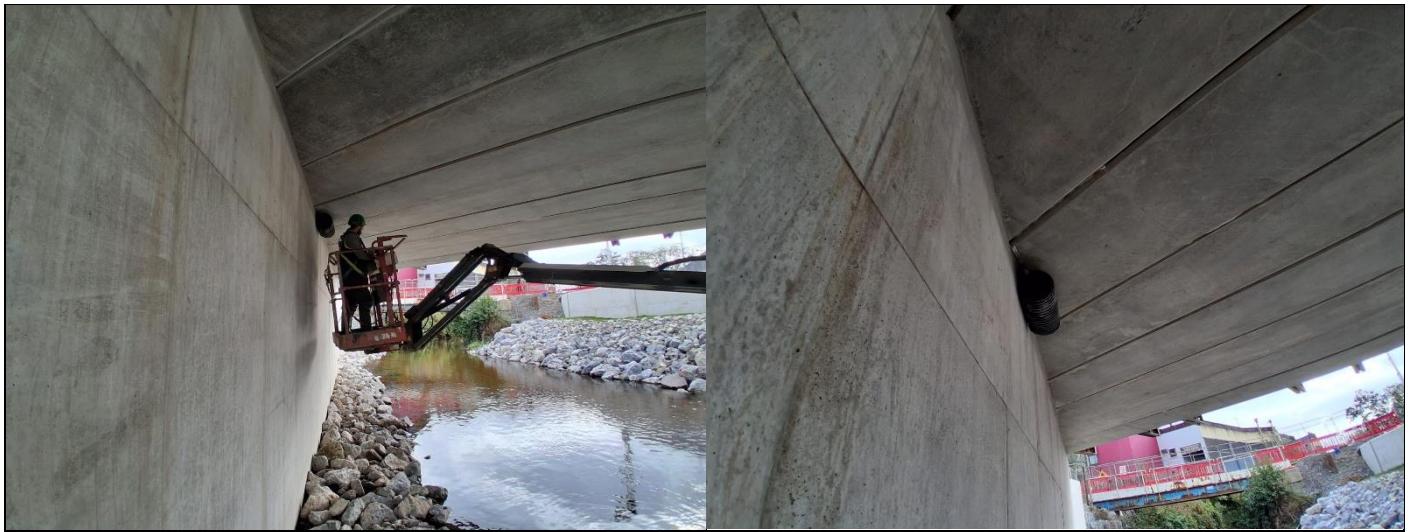
Caption 5	Brooklodge	Caption 6	Brooklodge
-----------	------------	-----------	------------

Installation of Dipper nest boxes of structures across the Scheme

- Installation of dipper nest boxes on bridge structures across the scheme was undertaken in consultation with Sam Bayley NPWS Conservation Ranger on 10-11/10/25.

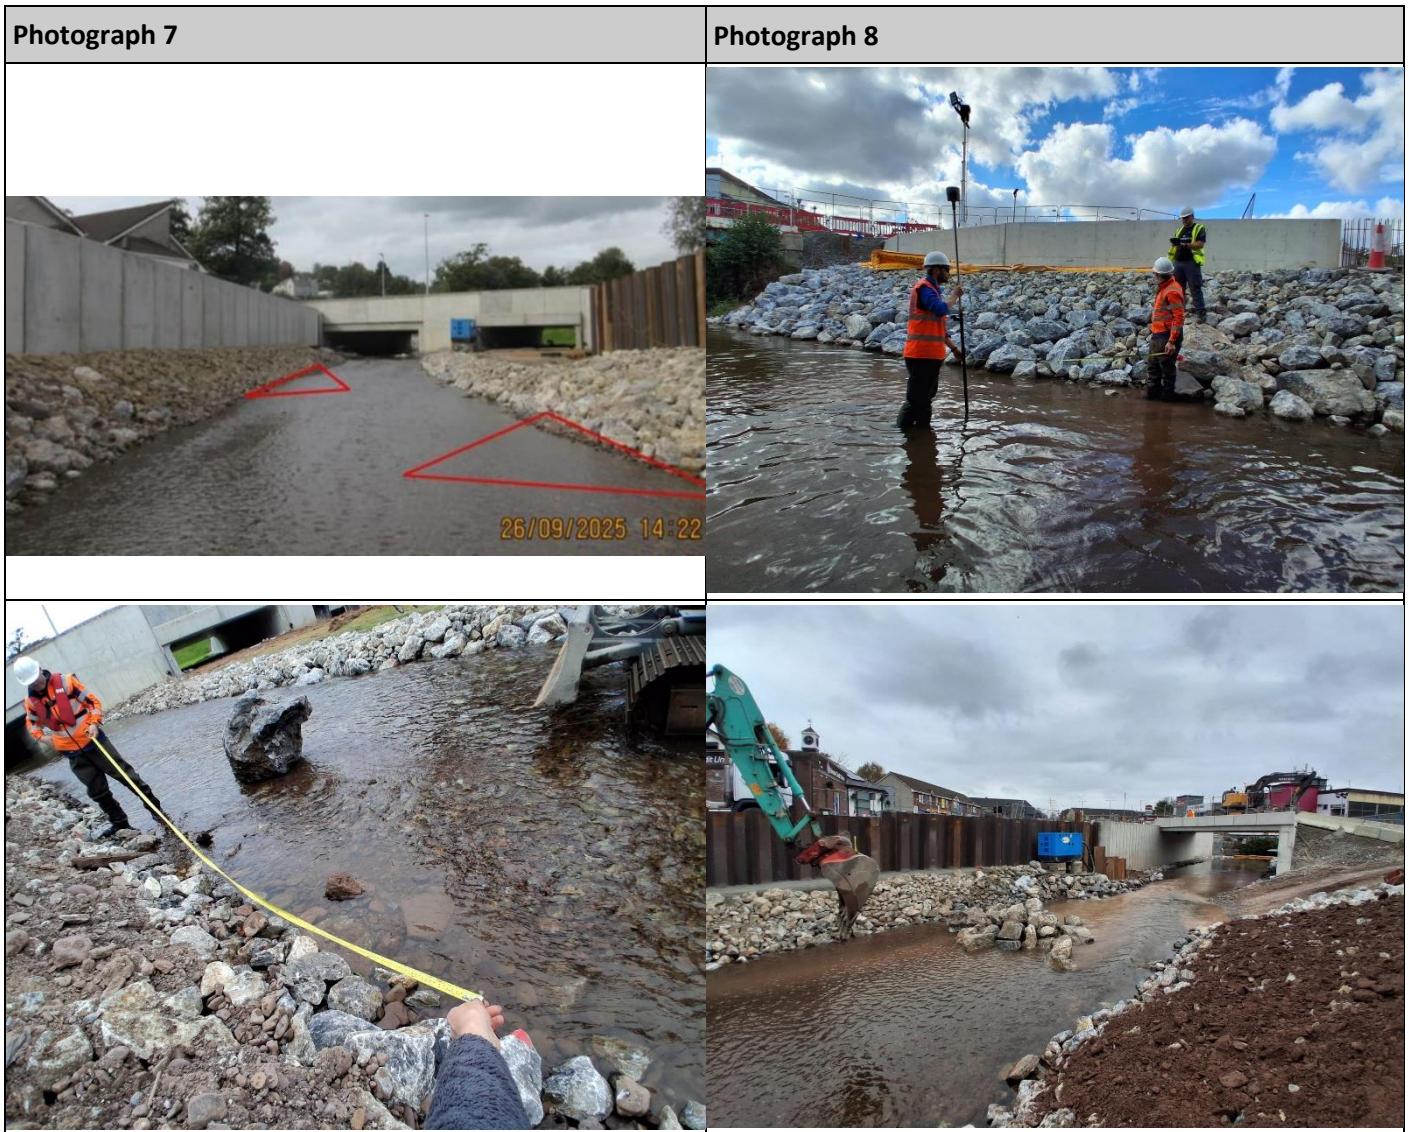
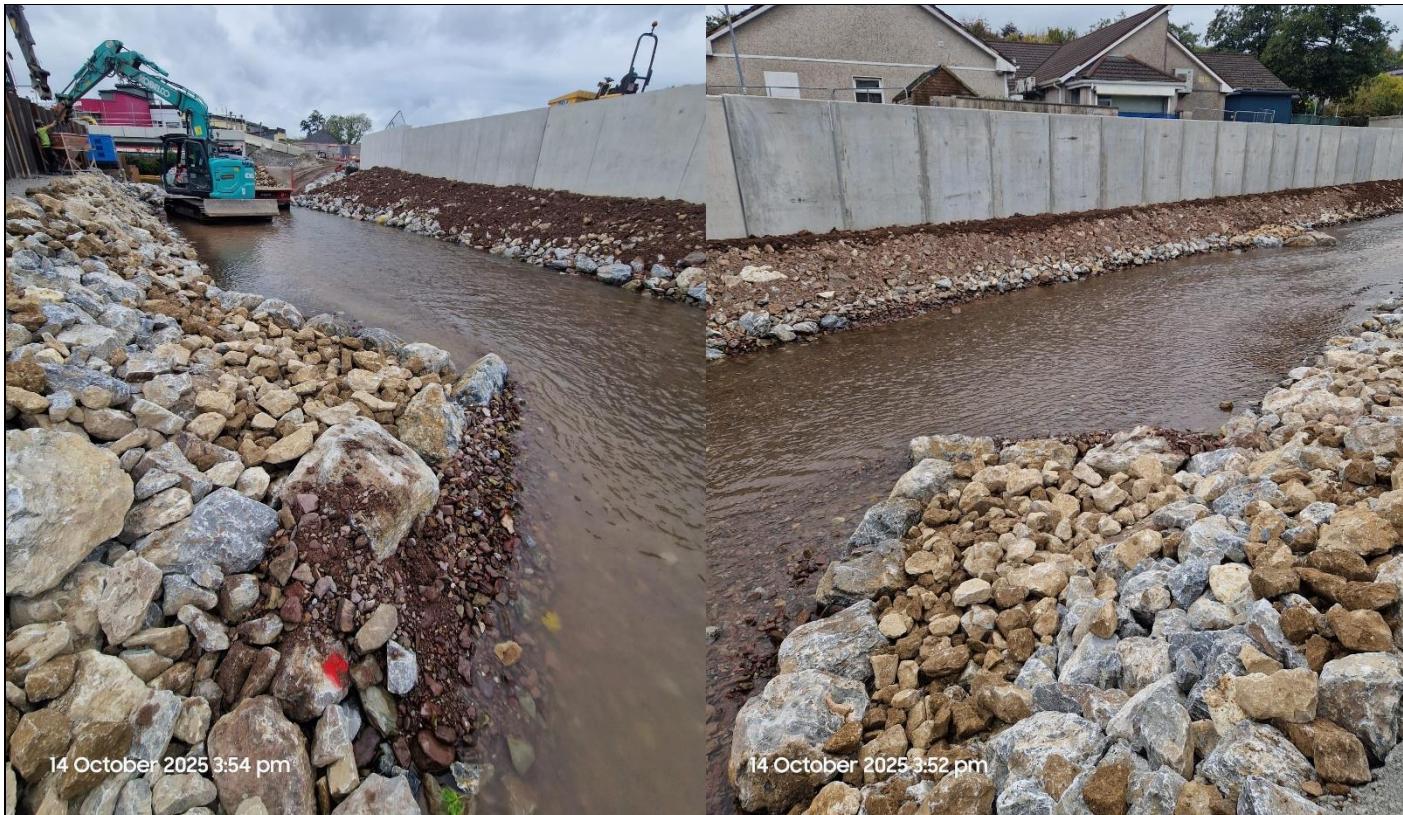
Caption 7

Installation of 2 no. single wing alternating deflector weirs at Hazelwood

- Installation of 2 no. alternating single wing deflector weirs on the Glashaboy River at Hazelwood commenced on 14/10/25. The objective is to restore sinuosity in the historically straightened channel, by redirecting the flow away from the riverbank towards the centre of the channel to create a meandering thalweg. Overtime the deflector weirs will improving flow heterogeneity by generating varied flow conditions including deeper scour pools and areas of slower-moving "slack water" thus providing resting areas for fish.

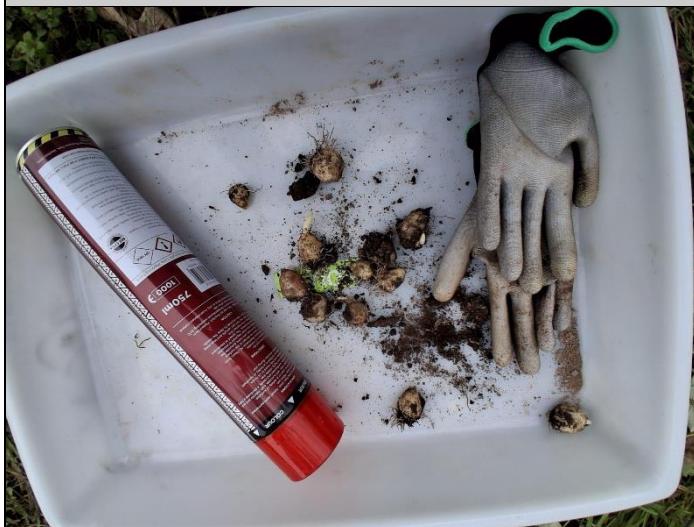
Photograph 9

Springmount

Bulbous vector material of the 'regulated' species Spanish bluebell and its hybrid were recovered during drainage works at Springmount. The vector material was disposed of in the burial cell.

- Vector material of the 'regulated' species 'Spanish bluebell' was recovered during drainage works at Springmount under the supervision of the IAPS Specialist Ecologist on 06/10/25. Biosecurity measures were deployed.

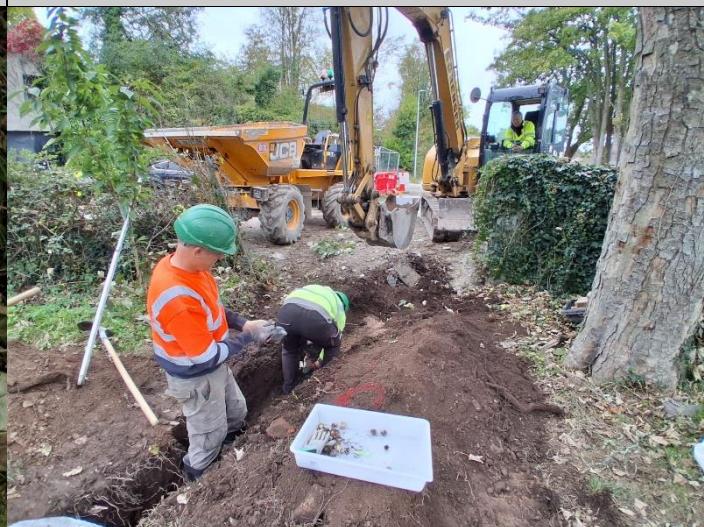
Photograph 10

Springmount
