## Monthly Environmental Audit – April 2025

## Glanmire Flood Relief Scheme

## ENVIRONMENTAL AUDIT

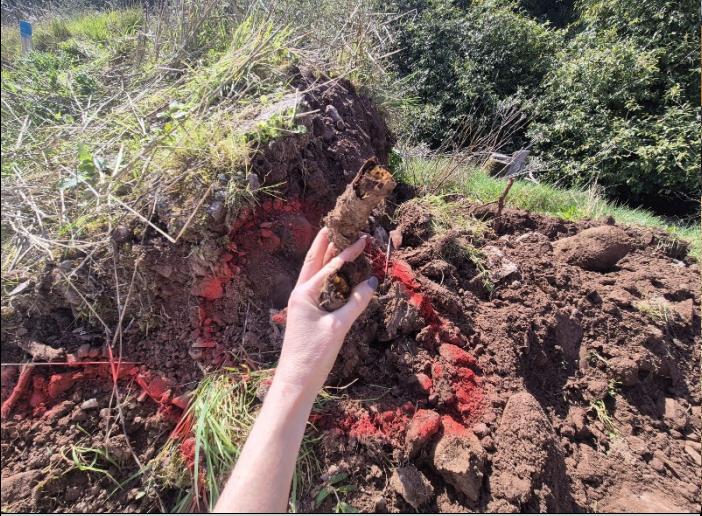
Photograph 1	Photograph 2

- The partial removal of the existing embankment at Sallybrook commenced on 09/04/25 under the supervision of the IAPS Specialist Ecologist. Biosecurity control measures were deployed.

Caption 1	Caption 2
Knotweed rhizomes recovered during embankment works at Sallybrook	Biosecurity control measures deployed at Sallybrook during embankment removal works

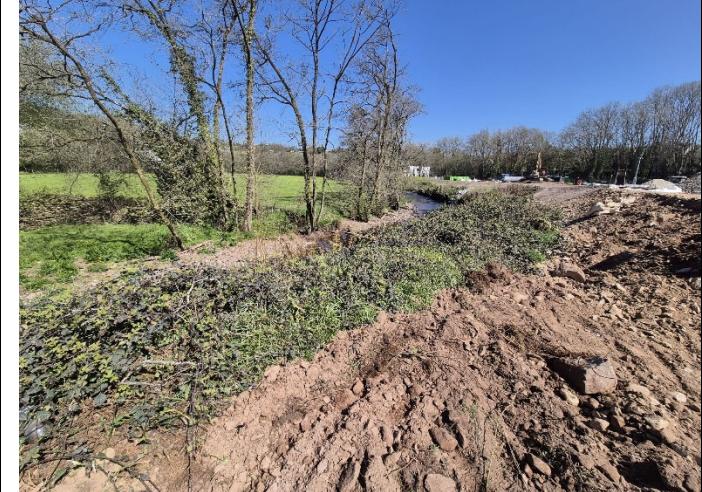
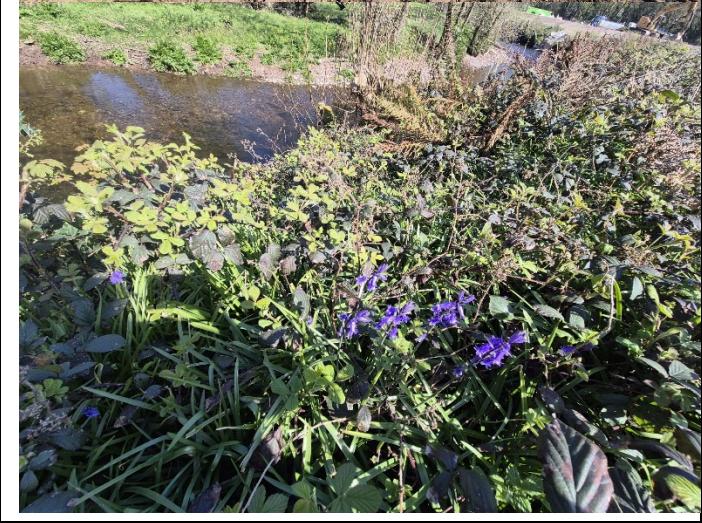
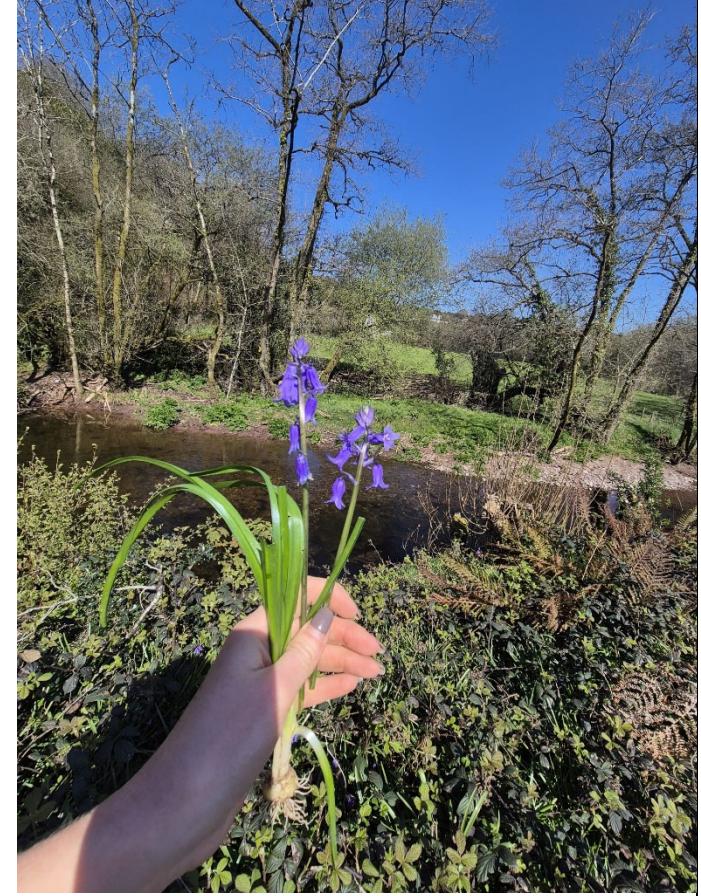
Photograph 3	Photograph 4

- Spanish bluebell hybrid was encountered along the embankment on the perimeter of the works area on 10/04/25. Dispersal of vector material was minimised under supervision by the IAPS Specialist Ecologist. A small amount of vector (bulbous) material was placed in the Temporary Holding Facility. Due to the requirement to transport vector material of the 'regulated' invasive species Spanish bluebell on a public road, in order to access the burial cell, SCE has requested that Spanish bluebell is included on the renewed licence from NPWS.

Caption 3	Caption 4
Spanish bluebell hybrid encountered during embankment works at Sallybrook

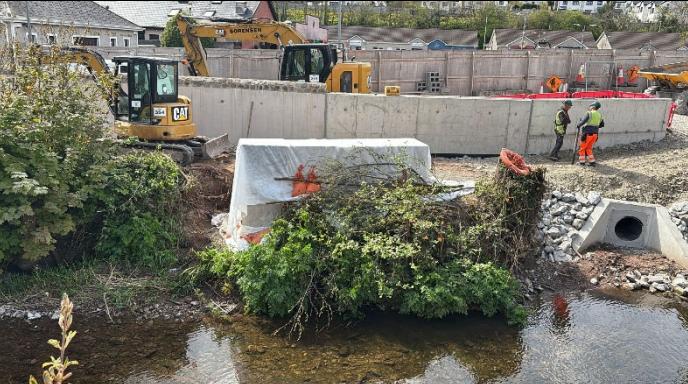
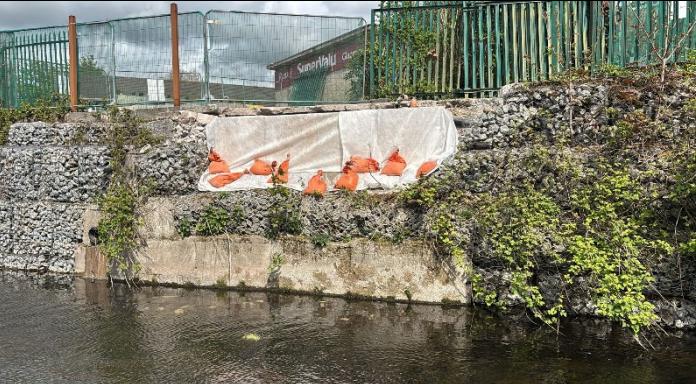
Photograph 7	Photograph 8

- Permit to Clear Vegetation No. 012 (GFRS-PTCV-012) was issued on 15/04/2025 to accommodate the installation of a new permanent bridge structure and a temporary Bailey Bridge structure over the Glashaboy River to replace Hazelwood Shopping Centre Bridge.

- Temporary structural supports were put in place to facilitate the Bailey Bridge over the Glashaboy River at Hazelwood Shopping Centre Bridge on 17/04/2025.

Caption 7 Hazelwood Shopping Centre Bridge	Caption 8 Hazelwood Shopping Centre Bridge
Clearance of vegetation and installation of temporary structural supports for the Bailey Bridge at Hazelwood Shopping Centre

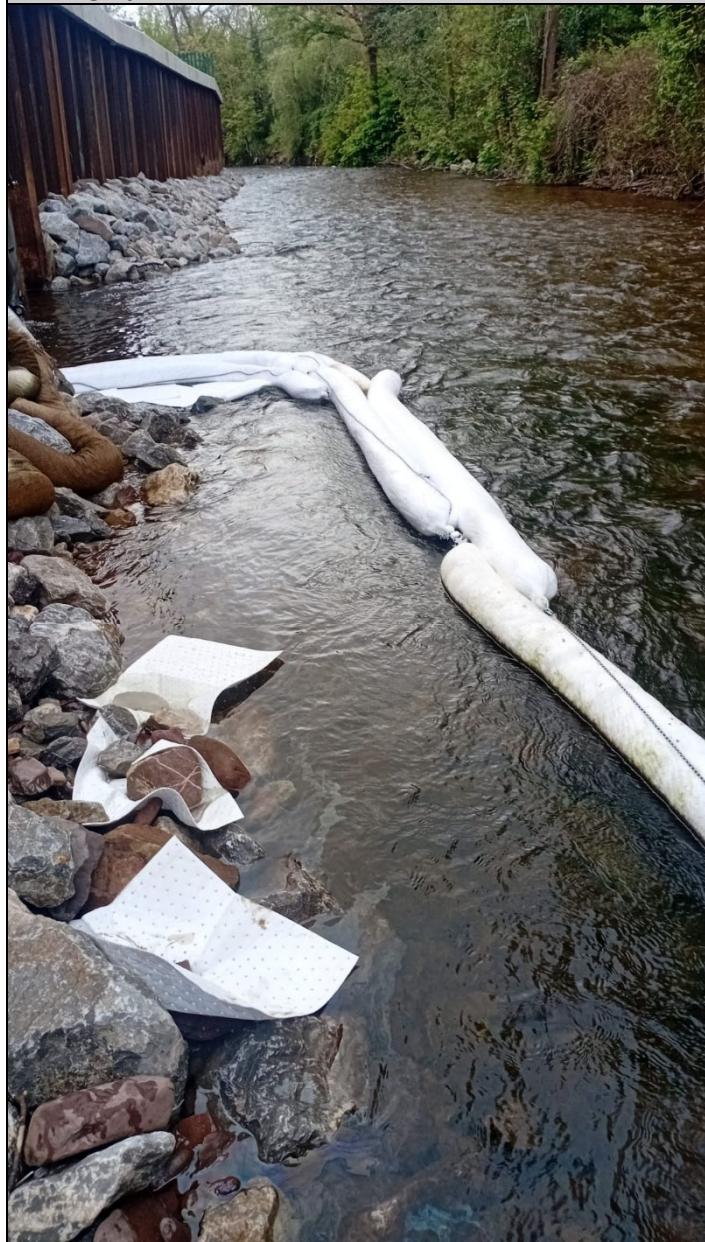
**Photograph 9**

- Environmental Incident Report (GFRS-EIR-014) was issued on the 21/04/2025 in respect of an incident which took place at the Overflow culvert, at Hazelwood Bridge on the 19/03/2025.
- The hydrocarbon control measures at Sallybrook Stream outlet were impacted by heavy rainfall and higher fluvial flows on the 25/04/25. The hydrocarbon control measures were replaced on the 28/04/2025.
- Monitoring of the dewatering of the pump station chamber at Meadowbrook continued under Permit No. 129.
- Monitoring of silt control measures and discharge at the Overflow Culvert at Hazelwood Bridge continued under Permit to Pump No.s 130 and 133.

**Caption 9**

**Sallybrook Stream**

The hydrocarbon control measures at Sallybrook Stream outlet were replaced on the 28/04/25 after high fluvial flows.

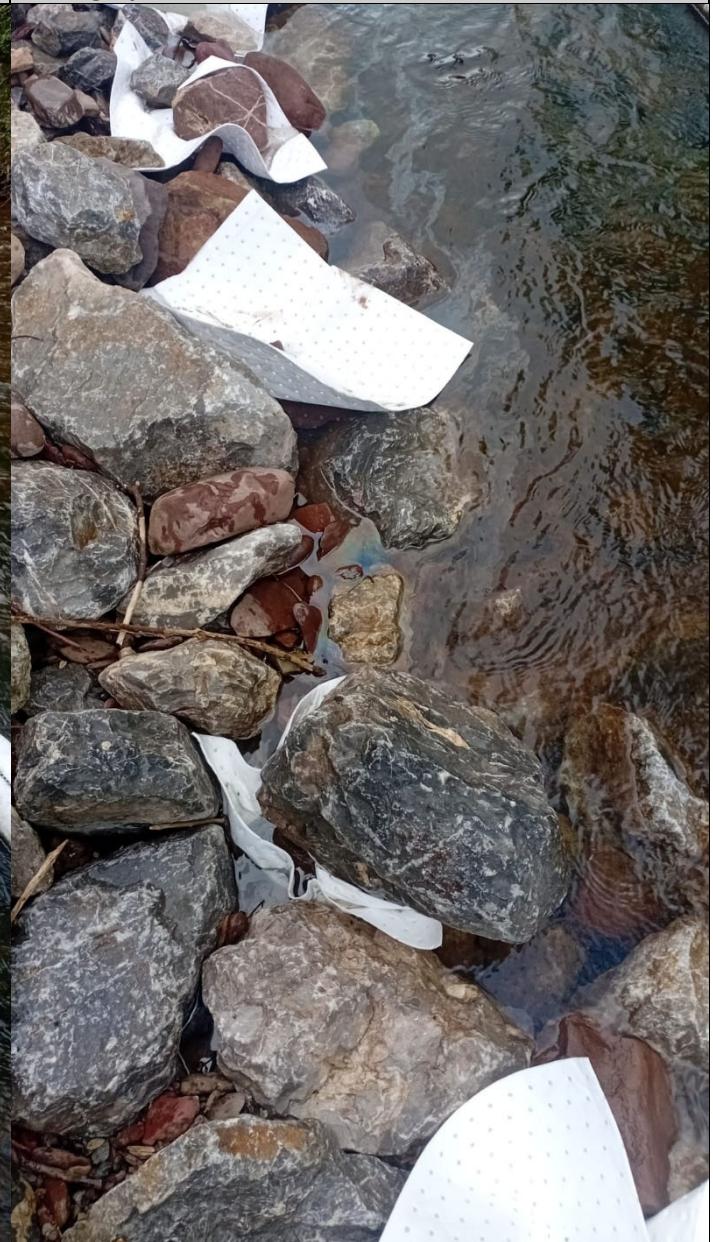
**Photograph 10**

**Caption 10**

**Sallybrook Stream**
