## Landscape Constraints

### Arboricultural

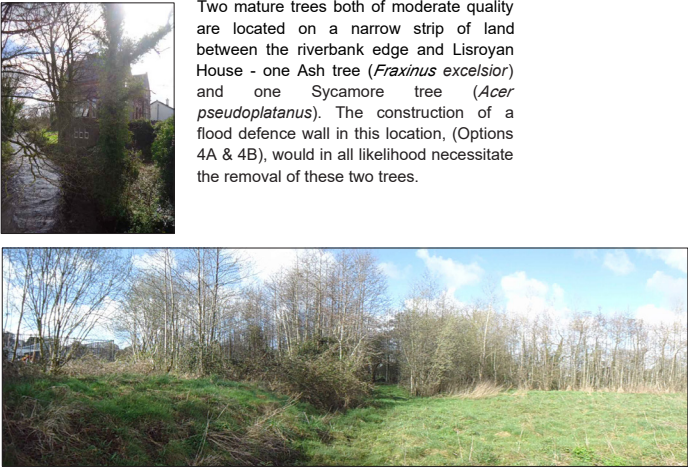
Character Area 4(i)

Trees located between Station Road and the River Suck are primarily groups of young Alder (*Alnus glutinosa*) succession woodland, interspersed are Willow species (*Salix* sp.), and to a lesser extent Ash (*Fraxinus excelsior*) and Hawthorn (*Crataegus monogyna*).

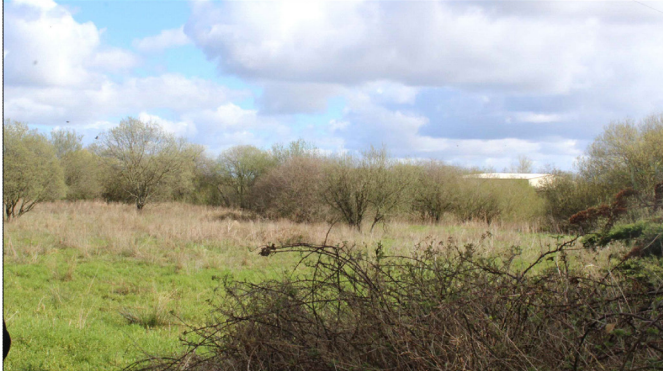
Character Area 4(ii)

Trees located between Sarefield Crescent to the back area of the town are primarily groups of young Alder (*Alnus glutinosa*) & Birch (*Betula pendula*) successional woodland, interspersed are Willow species (*Salix* sp.), and to a lesser extent Ash (*Fraxinus excelsior*).

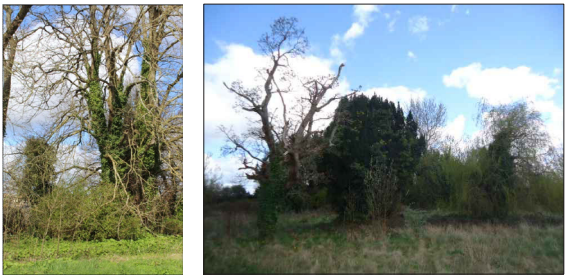
A small number of older trees which presumably were part of the former convent gardens remain in this area - most notably formal linear planting of Lime (*Tilia* sp.) and occasional Yew (*Taxus baccata*) and Cypress (*Cupressus*).

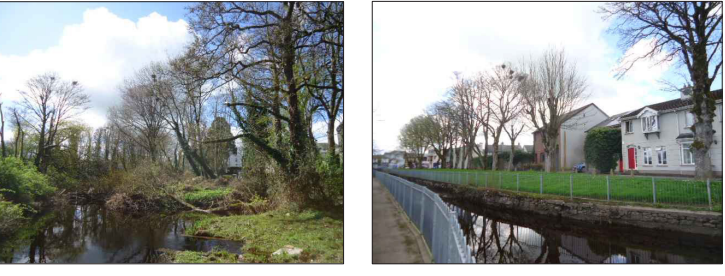
Character Area 5(i)

Trees located immediately west of Colahan's hardware at Riverview, to the bend in the River Suck, are primarily groups of young Alder (*Alnus glutinosa*) & Ash (*Fraxinus excelsior*), interspersed with Willow species (*Salix* sp.). A number of ornamental street tree and parkland tree species are also present within the urban park area including Beech (*Fagus sylvatica*), Chestnut (*Castanea hippocastanum*) and Norway Maple (*Acer platanoides*).

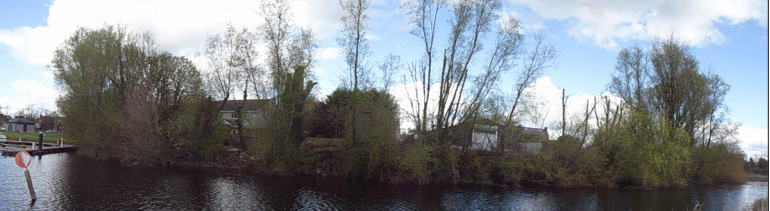
Character Area 5(ii)

Trees located in close proximity to the West Bridge, the park which lies to the south and the adjoining Marina area, are primarily groups of Ash (*Fraxinus excelsior*) & Poplar (*Populus* sp.) interspersed with Willow species (*Salix* sp.). A number of ornamental street tree and parkland tree species are also present within the urban park area including Beech (*Fagus sylvatica*), Cherry (*Prunus avium*), Weeping Willow (*Salix alba Chrysocoma*).

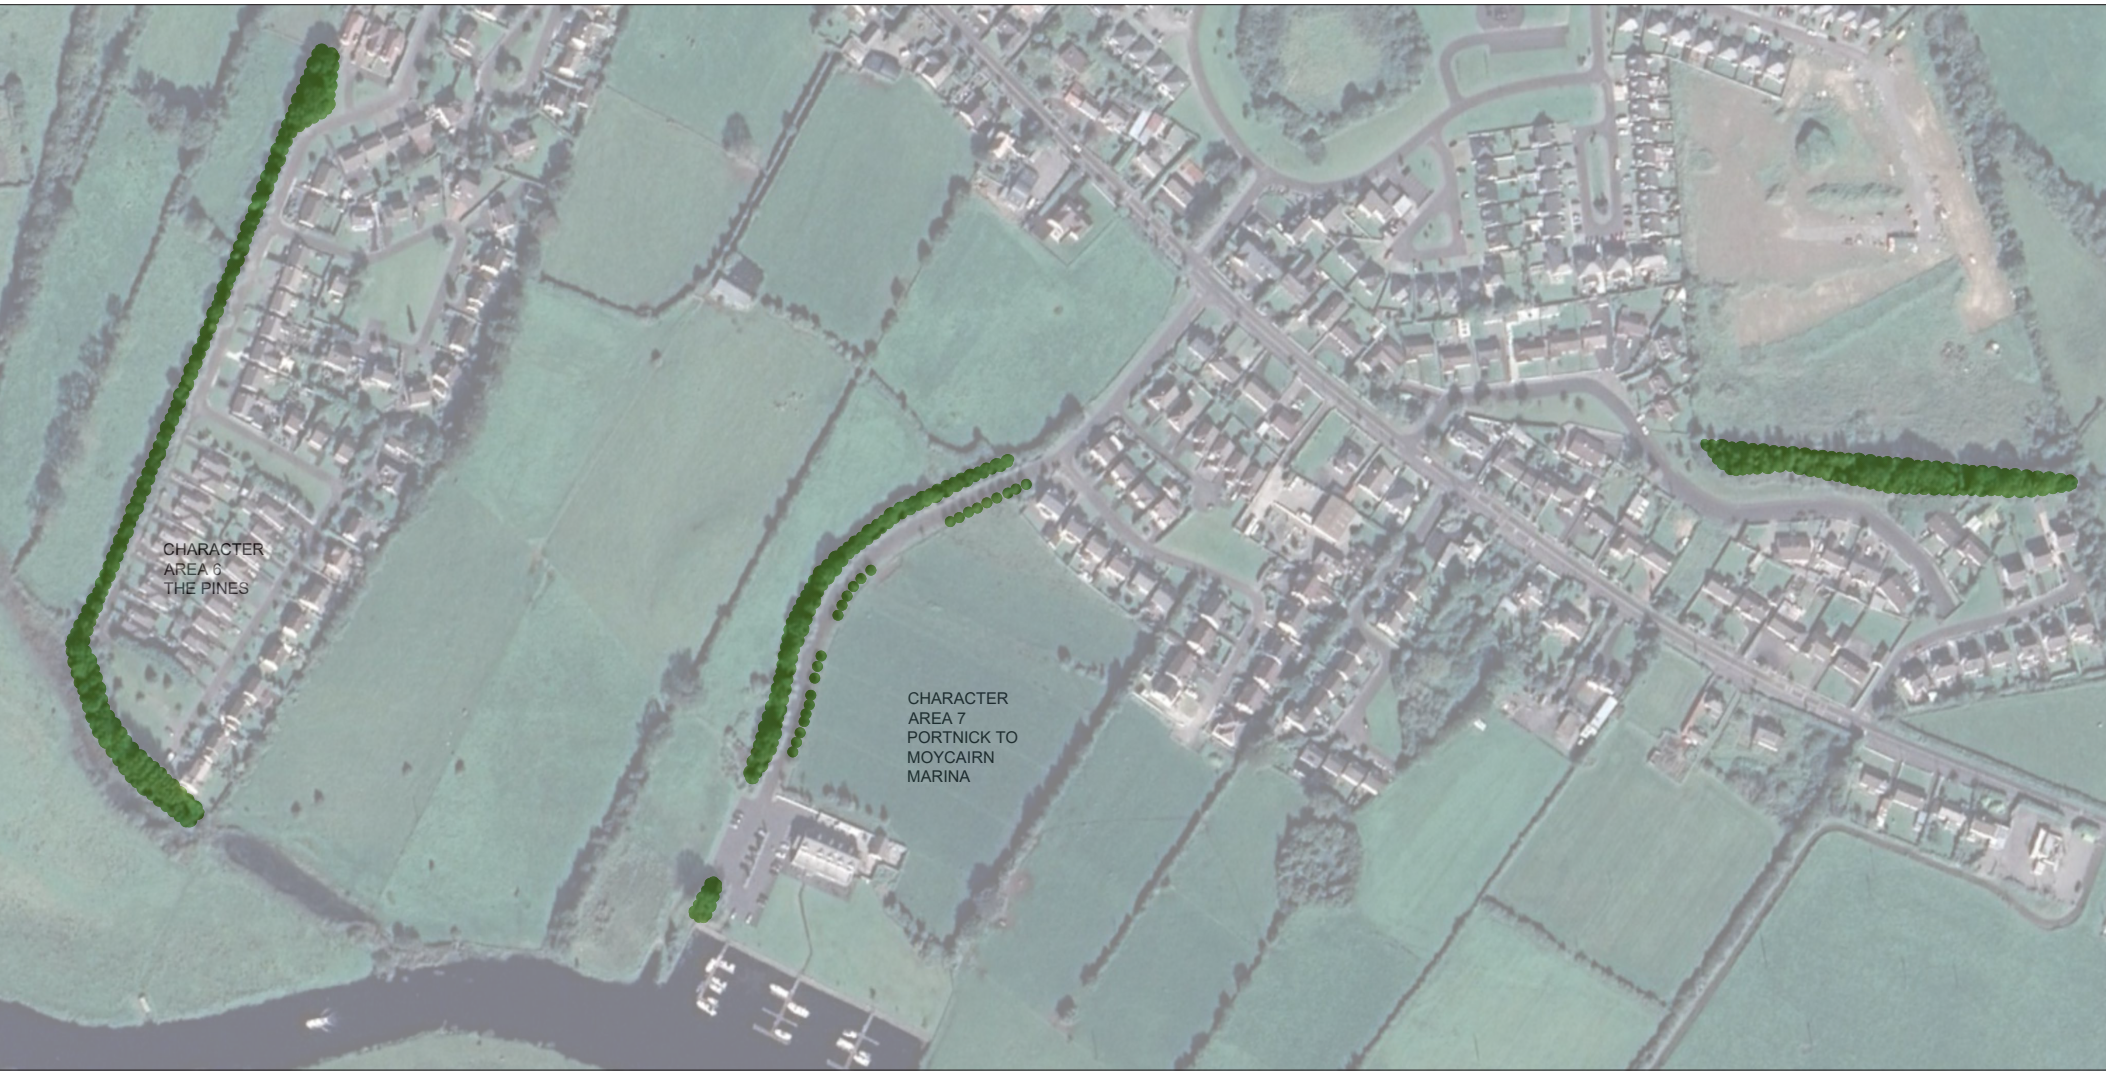
Trees located along the boundaries of The Pines residential estate form part of the surrounding field boundary hedgerows composed primarily of Hawthorn (*Crataegus monogyna*), with regular groups of young to middle aged, often multi-stemmed, trees. Hedgerow species trees are primarily Ash (*Fraxinus excelsior*), but also Alder (*Alnus glutinosa*) & Willow species (*Salix* sp.). Many of this ash display symptoms of Ash Dieback disease.

A continuous group of young Poplar (*Populus* sp.) are located at the southern boundary. Non-native Cypress (*Cupressus Leylandii*) are present and include a mix of young to middle age specimens of typically low individual value increasing to moderate collective value.
