Appendix C2 Supporting Bird Species Desktop and Survey Data

Appendix C3 Summary of Opposite-leaved pondweed *Groenlandia densa* Data for NPWS

KING'S ISLAND *GROENLANDIA DENSA* SURVEY

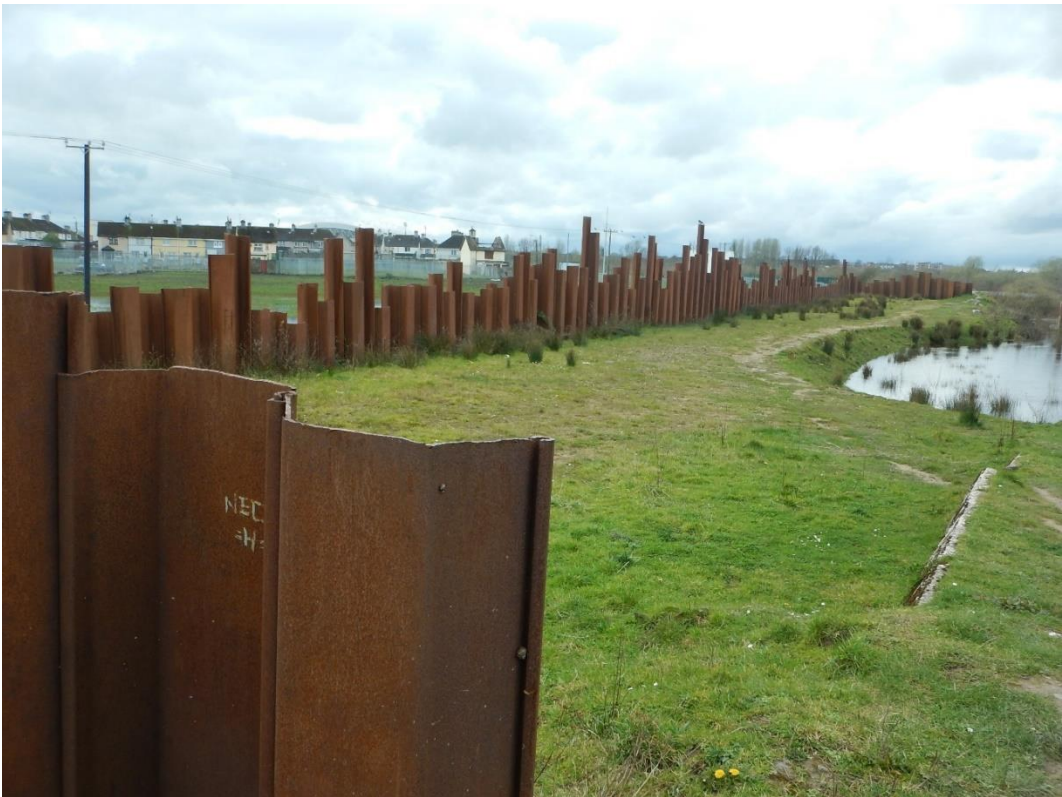
Plate 8-13: Sheet piling and earthen pathway

There is currently an existing embankment encircling the north of the island and an associated footpath. Approximately 520m of the existing embankment is located within the SAC. The crest of the embankment is formed by large sandbags which were installed as temporary flood defence measures during previous high flood events, however many of these sandbags are damaged and no longer provide adequate defence. There is an open drain on the eastern side of the existing embankment which currently contains a protected species, pondweed (*Groenlandia densa*).

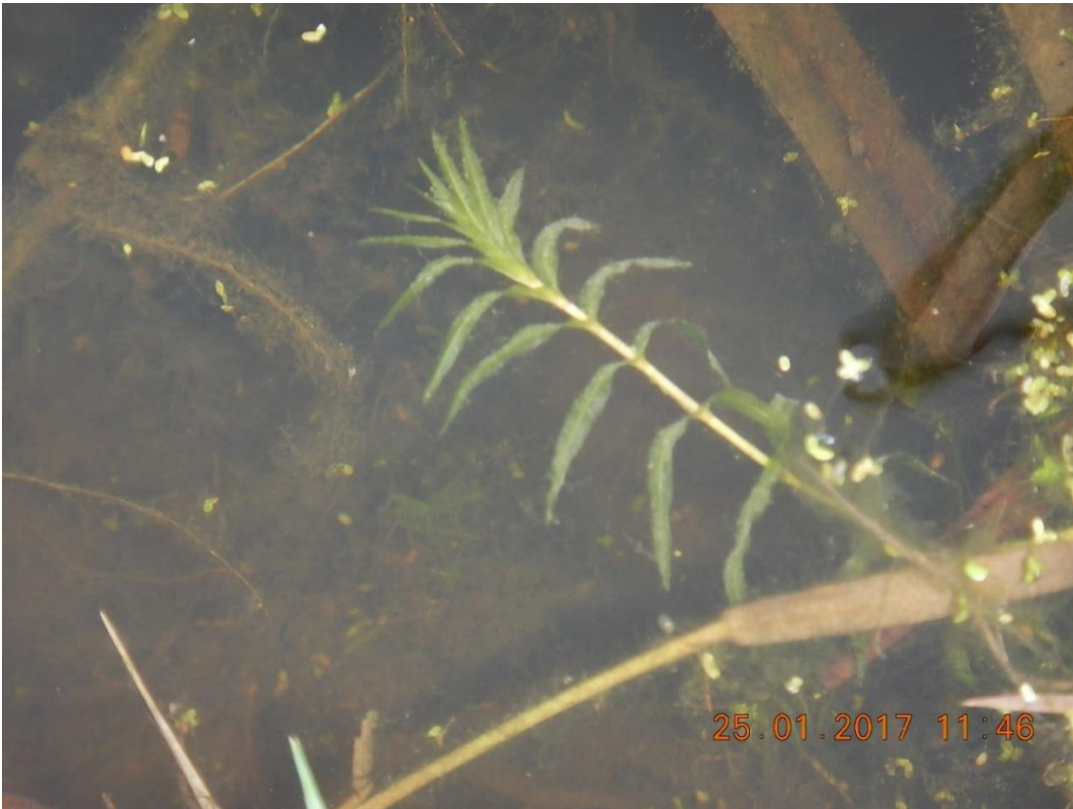
Plate 8-14: Opposite-leaved pondweed (Denyer, 2017)¹

Opposite-leaved Pondweed was observed in the ditch to the north west of the site during the walkover survey on the 17/01/2017 by botanist Tanya Slattery (JBA) (Plate 1-14, Appendix C1). As this plant is protected under the Flora Protection Order, confirmation of the species identification, based on photographs taken during the survey, was obtained by Aquatic Macrophyte specialist Joanne Denyer. Joanne Denyer proceeded to obtain a derogation license from the NPWS, in order to confirm the extent of its range within this area and develop possible translocation or alternative habitat development plans in consultation with the NPWS.

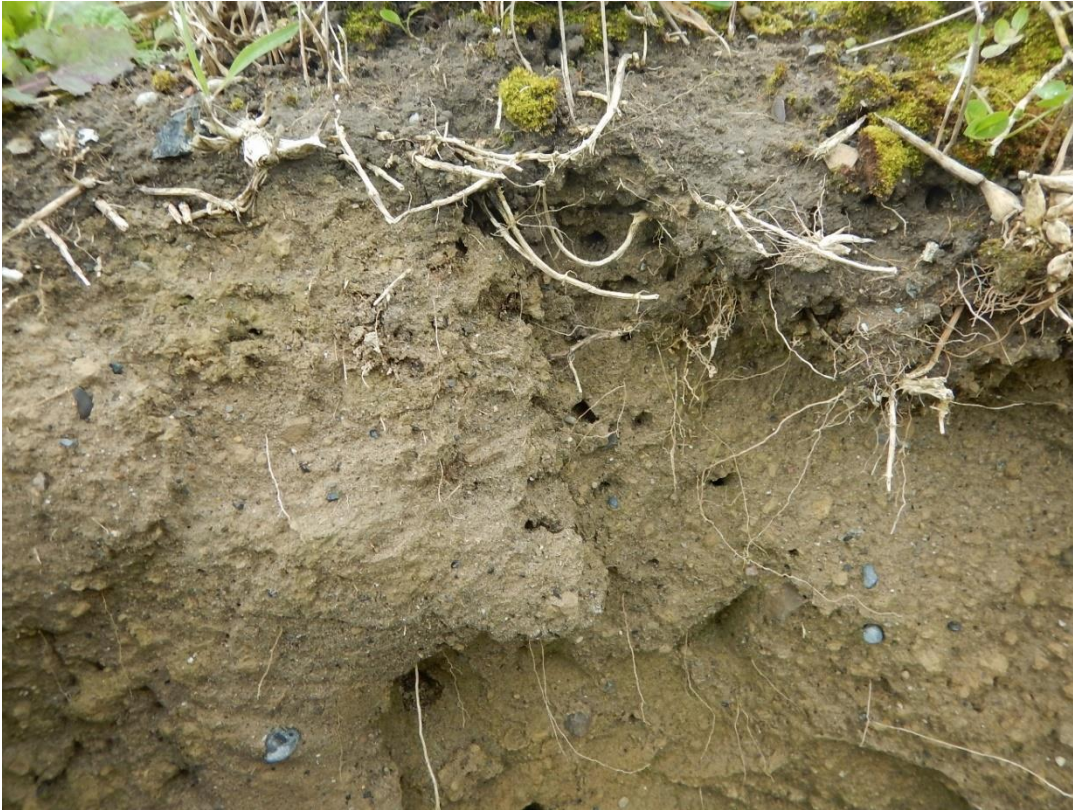
Plate 8-18: Entrance holes to mining bee nests in sandbags

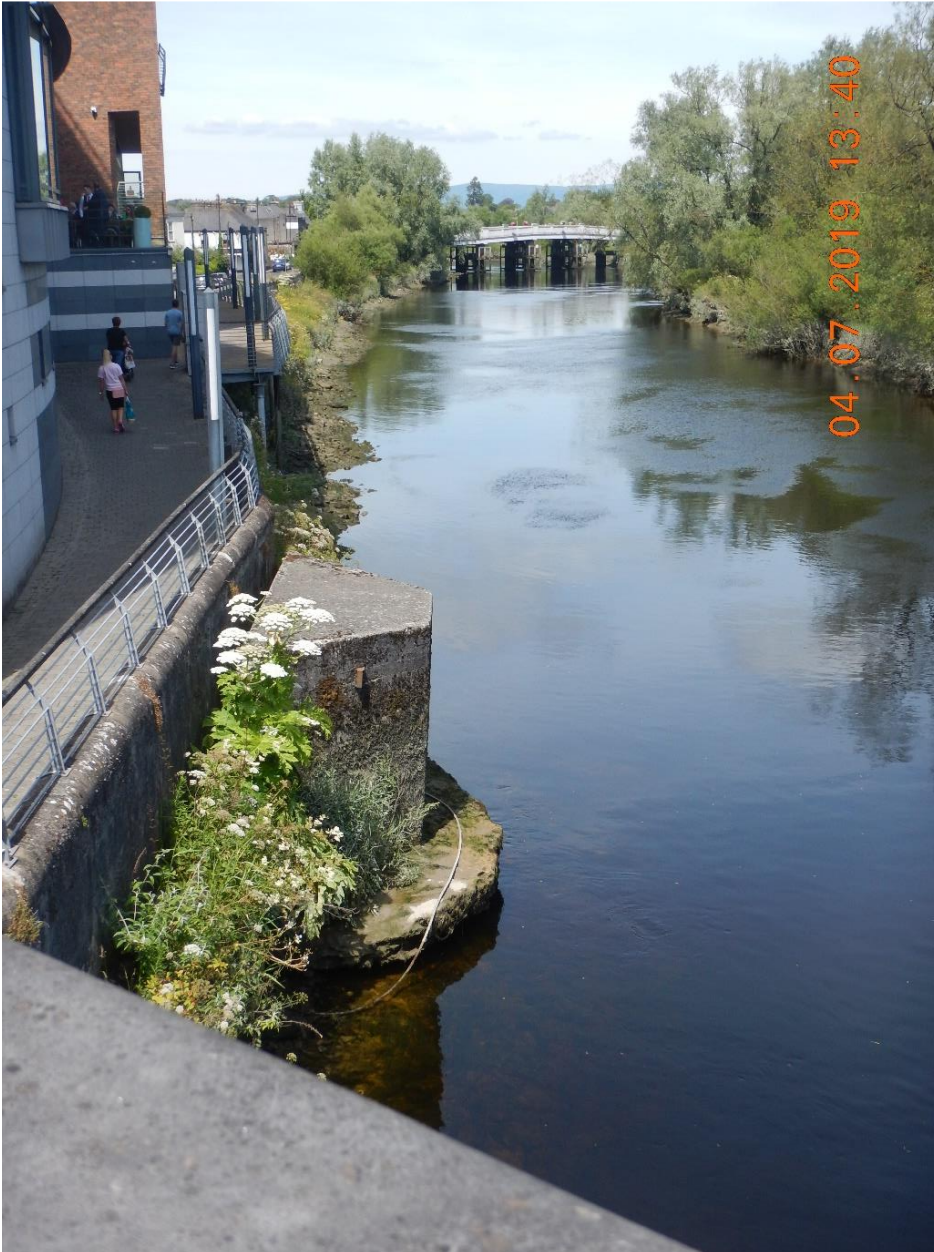
Plate 8-20: Area A9 to be electro-fished (bank beside walkway)
