Glashaboy River FRAM Scheme

Final Hydrology Report

November 2016

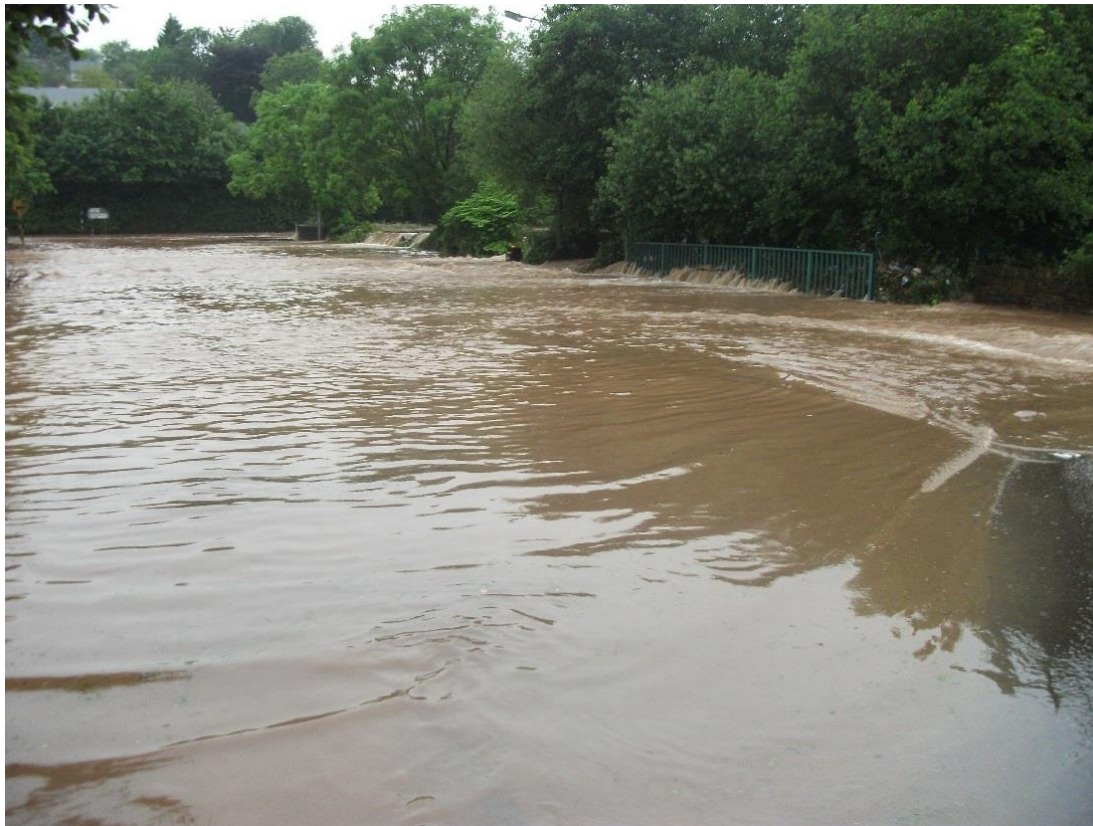
Figure 2-2 - Flow path to Hazelwood Shopping Centre

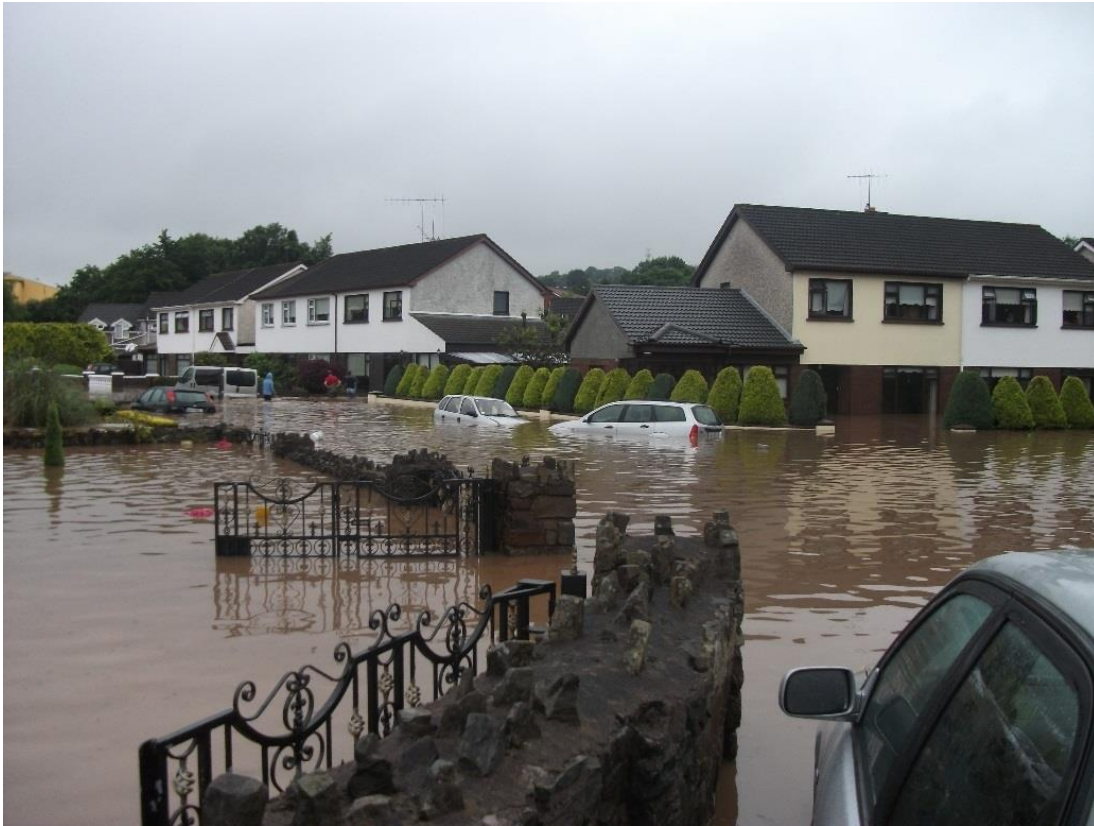
The Meadowbrook housing estate is low lying and there is an earthen flood protection embankment north of the estate and a flood protection wall at the east side of the estate. The flow entered the estate in two locations. At the upstream end, at the confluence of the Springmount Stream and Glashaboy, waters overtopped a low spot in the defence wall. Water also overtopped the embankment at the downstream end of the estate, immediately upstream of the Riverstown Bridge. Pluvial runoff from the R615, to the west, was also noted as a probable contributor

Figure 2-3 - Meadowbrook Estate under 2012 floodwaters

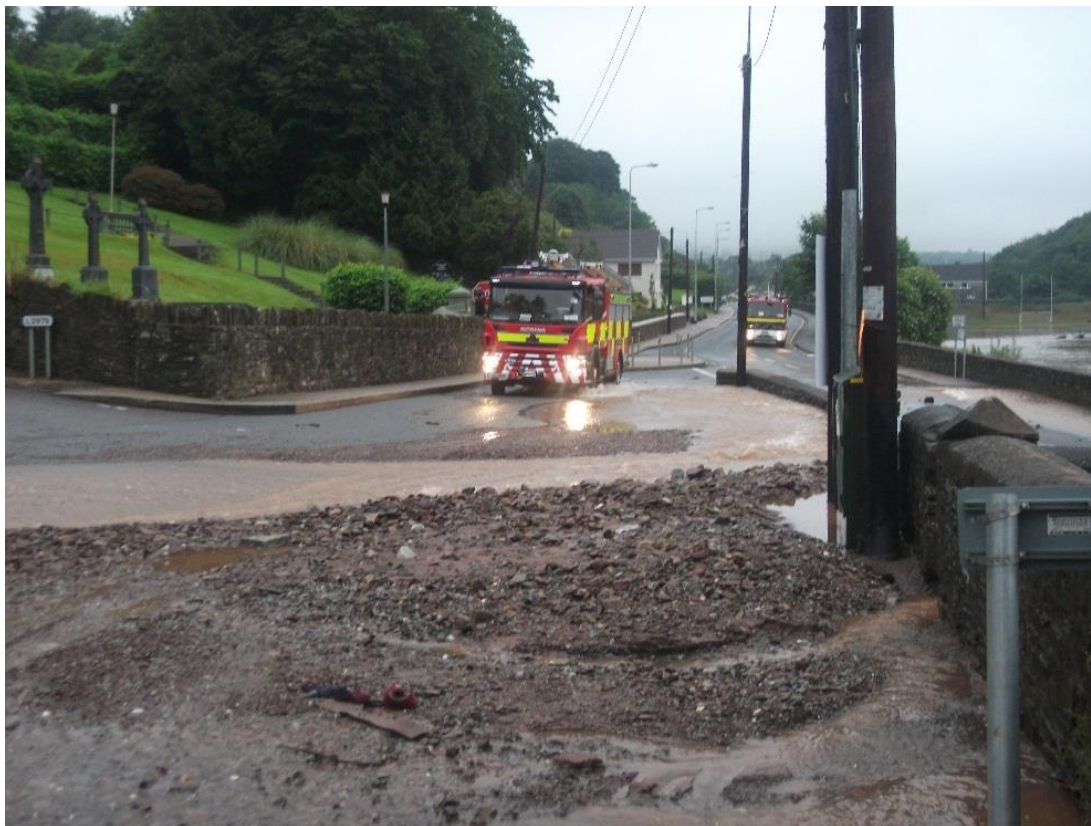
Partial Blockage of the Cois na Ghleann stream culvert under a local road west of the R369 regional road caused flooding of the R369/local road junction. The Glashaboy River flooded the R369 regional road and some road surface damage and potholing was widespread on roads in the Riverstown / Glanmire Area. However, by early afternoon on June 28th most of the floods had subsided.

Figure 2-4 - Flow path due to flood flow from Cois na Ghleann stream

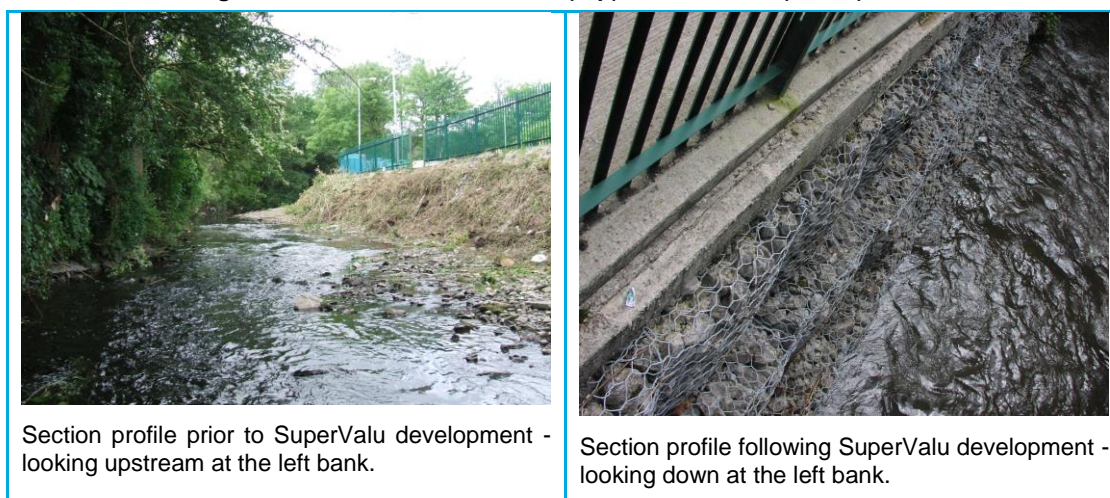
The model section 4GLA3715, used for this rating review, underwent a section change due to the development of SuperValu in approximately 2010/early 2011⁴. This has changed the left bank of the section from a steep grassy slope, to a similarly stepped gabion bank.

Figure 5-4 - Left Bank Post 2011 (top) and Pre 2011 (below)

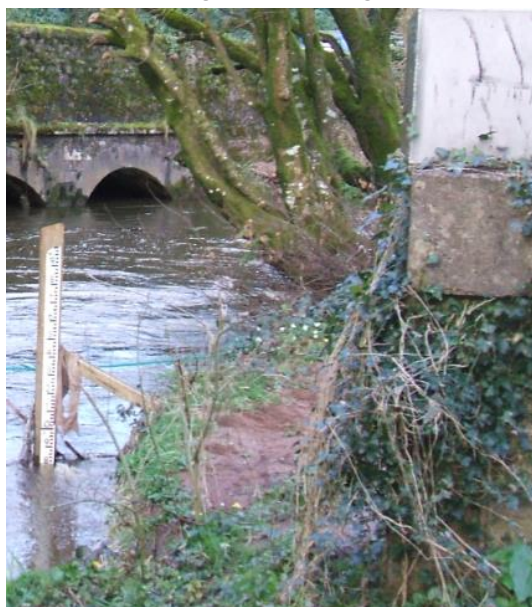
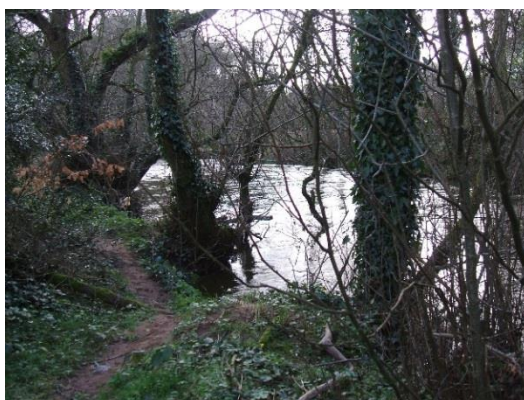
Figure 5-8 - Gauge at Glanmire (19006) and downstream view

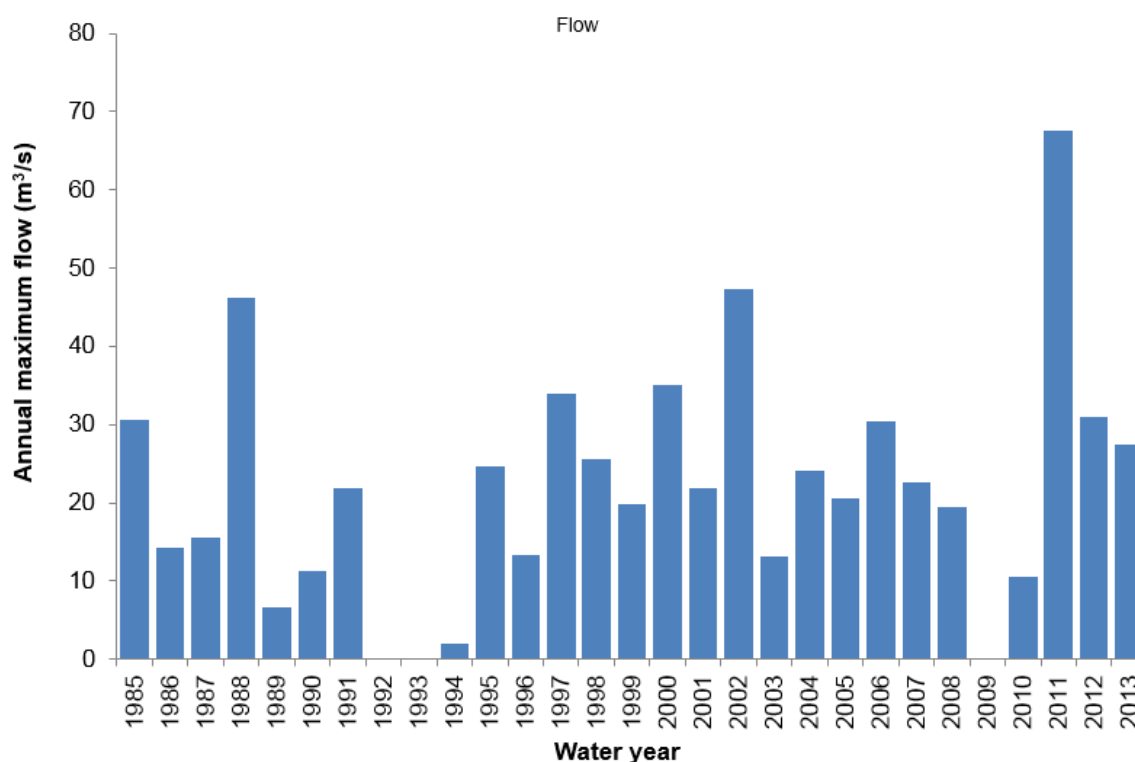
Figure 6-1 - Annual Maximum Series at Station 19032

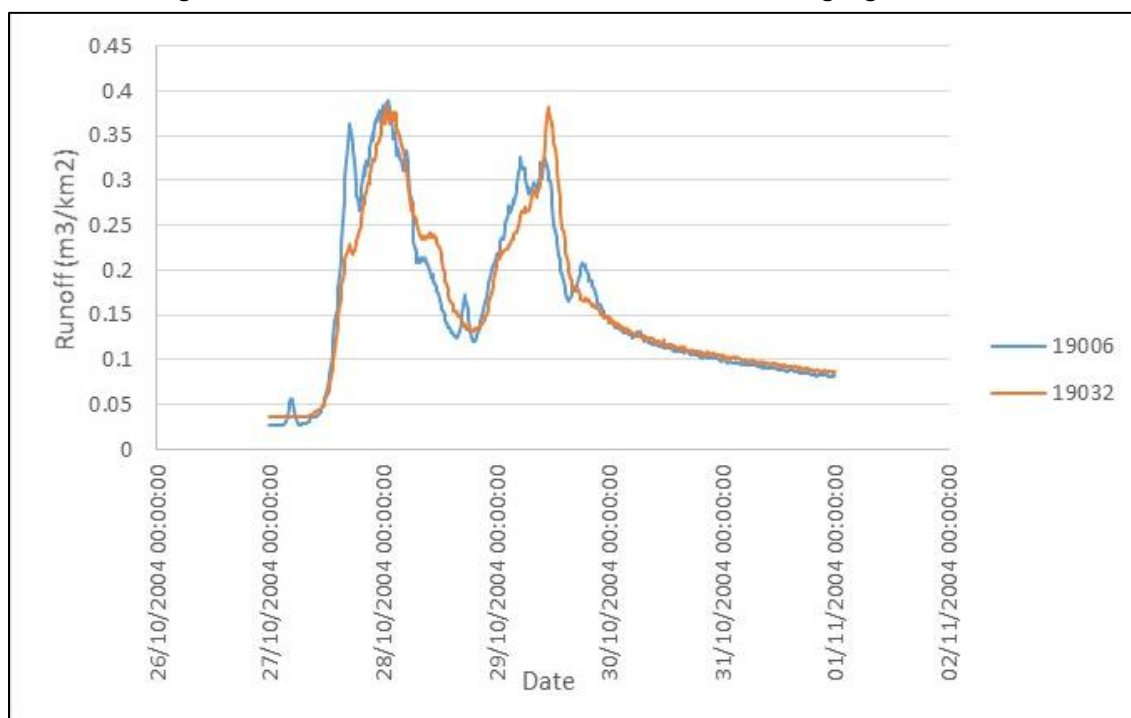
Figure 6-8 - 2004 event at the Glanmire and Meadowbrook gauges

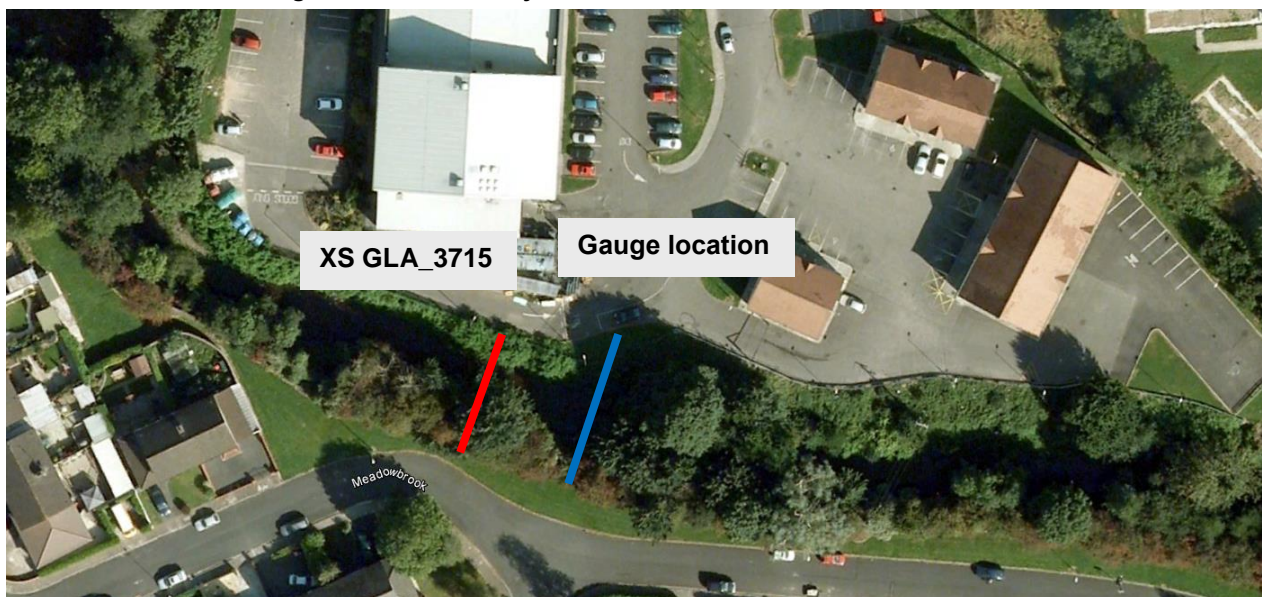
The development of SuperValu created a change of the left bank of the river bordering the site. The effect of this change was to the left bank, where it changed from a steep earth bank to a gabion basket wall. An aerial view of the change is presented below. It should be noted that the channel downstream of the gauge section has not changed.

Figure 6-10: Glashaboy at Meadowbrook 2007

Figure 6-11: Glashaboy at Meadowbrook 2013

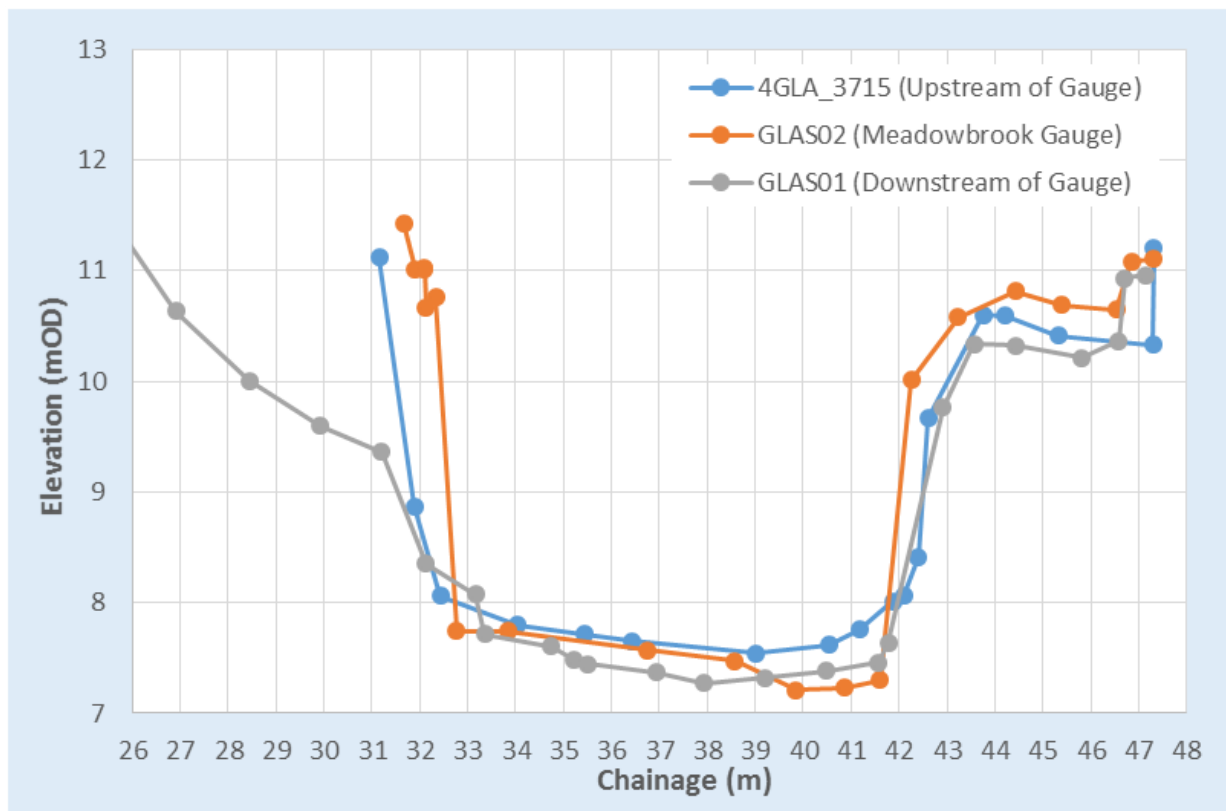
The rating for the gauge was only available from the original survey point taken at XS GLA_3715 15m upstream of the gauge. Following the calibration exercise and the levels observed in this section of channel it was decided to sensitivity check the validity of this approach and additional infill survey was taken of the gauge section (GLAS02) and a section 30m downstream (GLAS01). Figure 6-12 depicts the new sections and the GLA_3715 section which has been updated on the left to represent the SuperValu development. These sections represent the river post the SuperValu

The section at the GS was found to be very similar to that previously adopted. However, the section downstream reflected the previously wider channel, but only occurred over a relatively short section of the watercourse.

Figure 6-12: Cross-sections upstream and downstream of Meadowbrook gauge

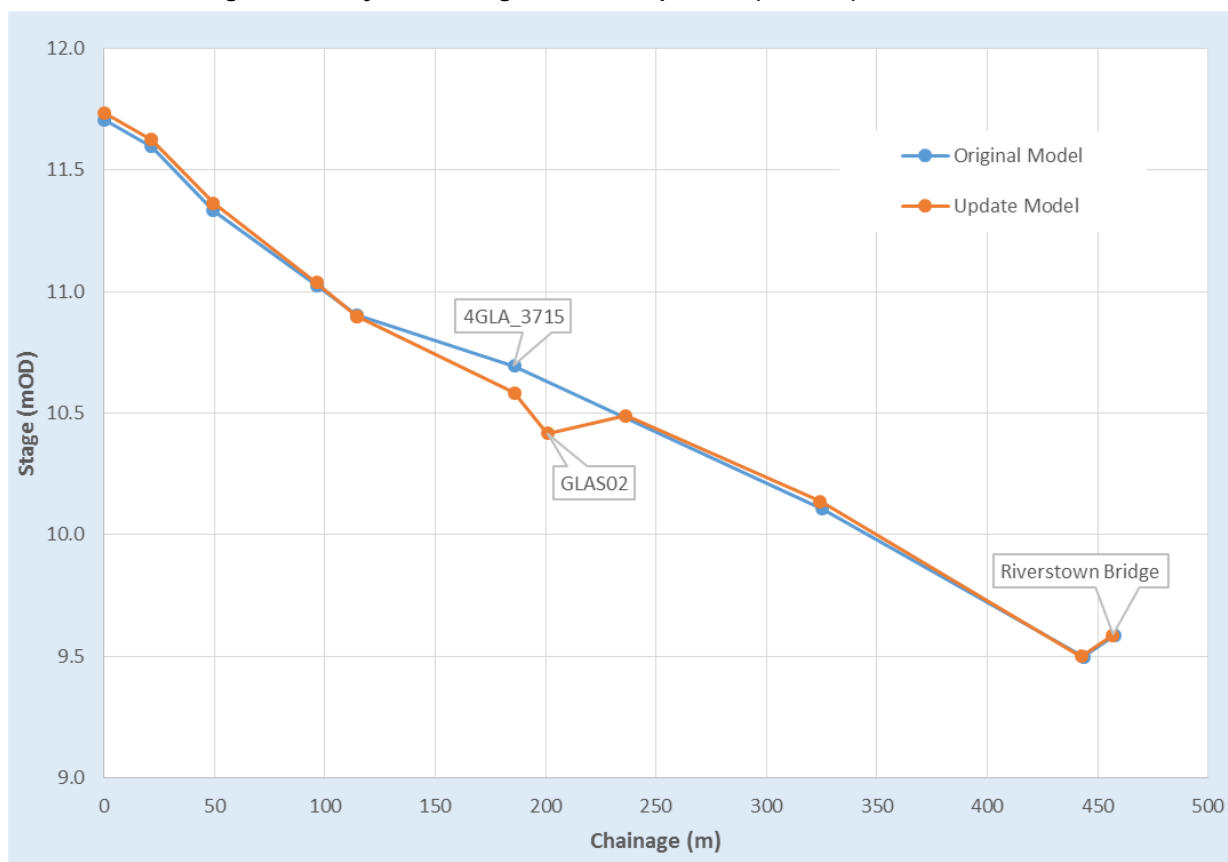
Figure 6-13: Hydraulic long section comparison (1% AEP)

Hydraulically this may be a phenomena of the ISIS model and is very local. No observations have been reported of an acceleration zone around the GS.

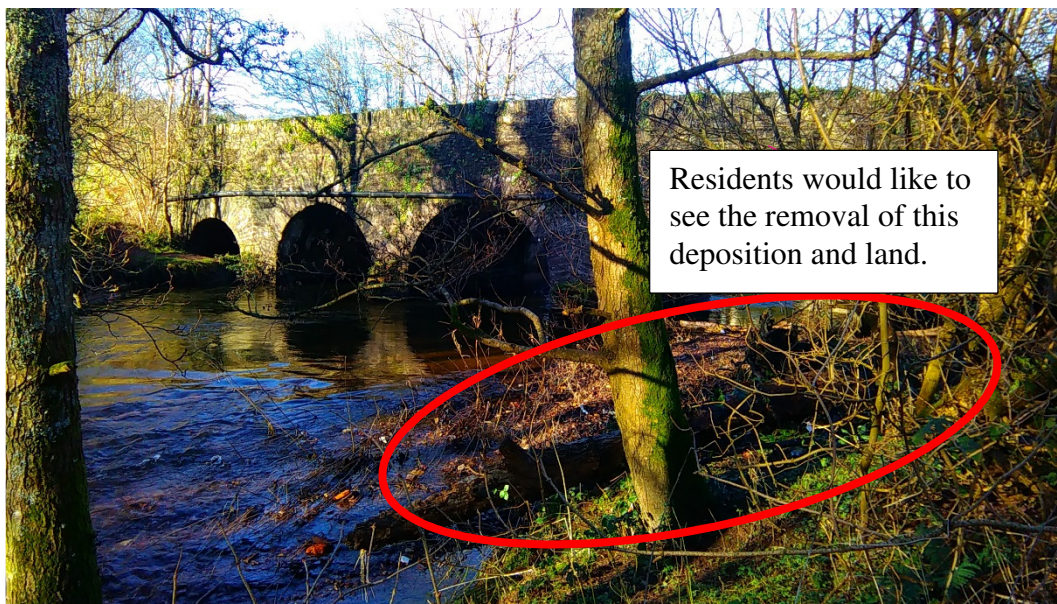
Residents had noted that during the event the arches of Riverstown Bridge remained relatively free flowing.

Figure 6 The downstream face of Riverstown Bridge

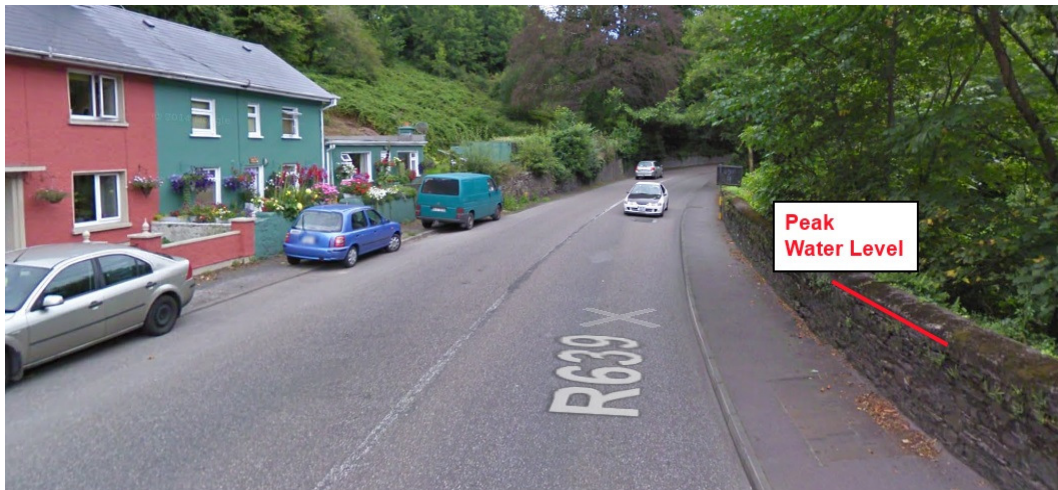
Figure 9 Water Level reached outside The Grove, Glanmire.

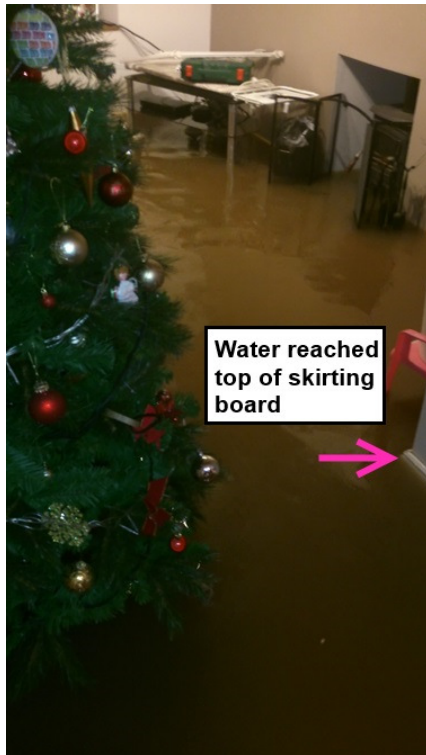
Figure 10 below shows the interior of his ground floor living room flooded to the top of the skirting board, an approximate depth of 150mm. The resident has commented that the water depth in his house would have been deeper only that he had a demountable flood gate installed on the hall door. The photo was not taken at the peak of the flooding either, so it is only an indication of how deep the flooding was.

Figure 10 Interior of the No1. The Grove

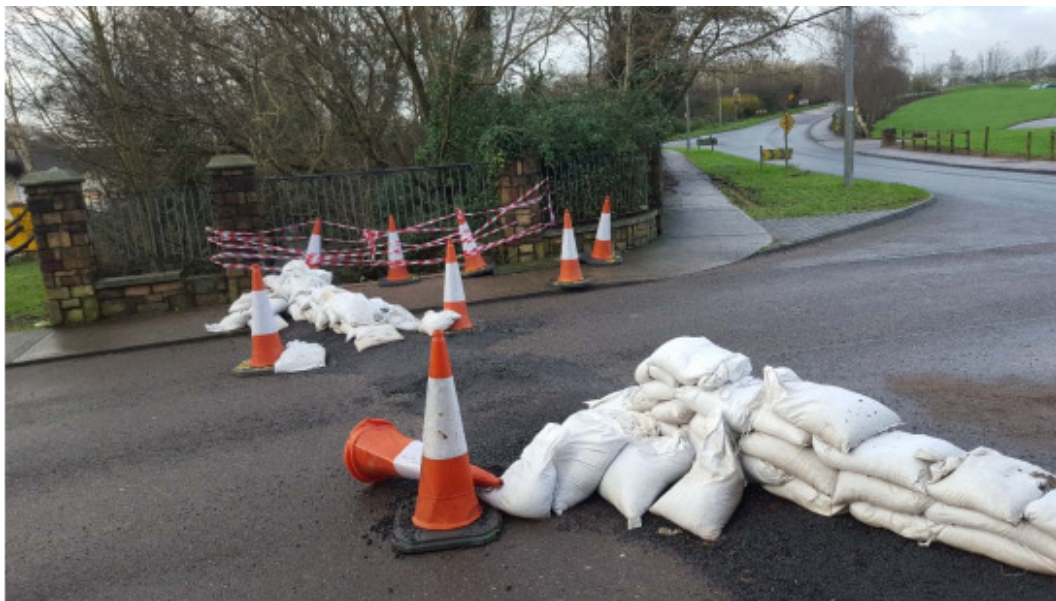
Figure 14 Flow Route 1 ramp blockage and demolished bridge parapet wall

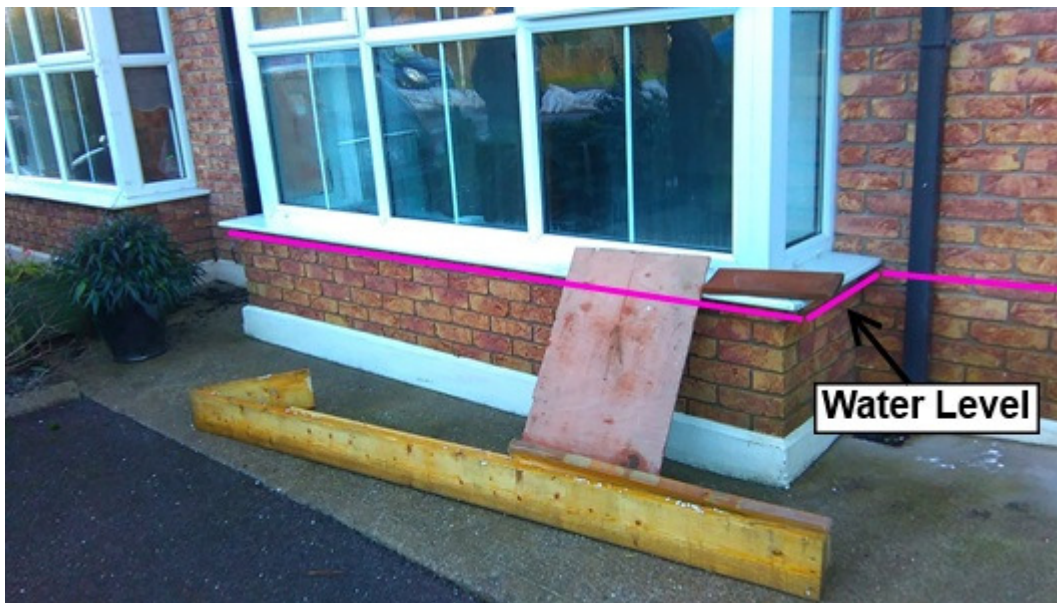
A local, present on the night of the flooding stated that water reached the bottom of the bay windows as shown in Figure 16.

Figure 16 Level reached by flood waters

Internally, the water in No.34 & No.33, the first and second house in the row was at the 3rd stair step (approximately 600mm deep). The water in No. 32, the third house in the row was approximately 250mm deep. Figure 17 below, shows that water in the rear garden of the house reached the bottom of the swing seat. In No. 31, the fourth house, water was 50mm to 60mm deep.

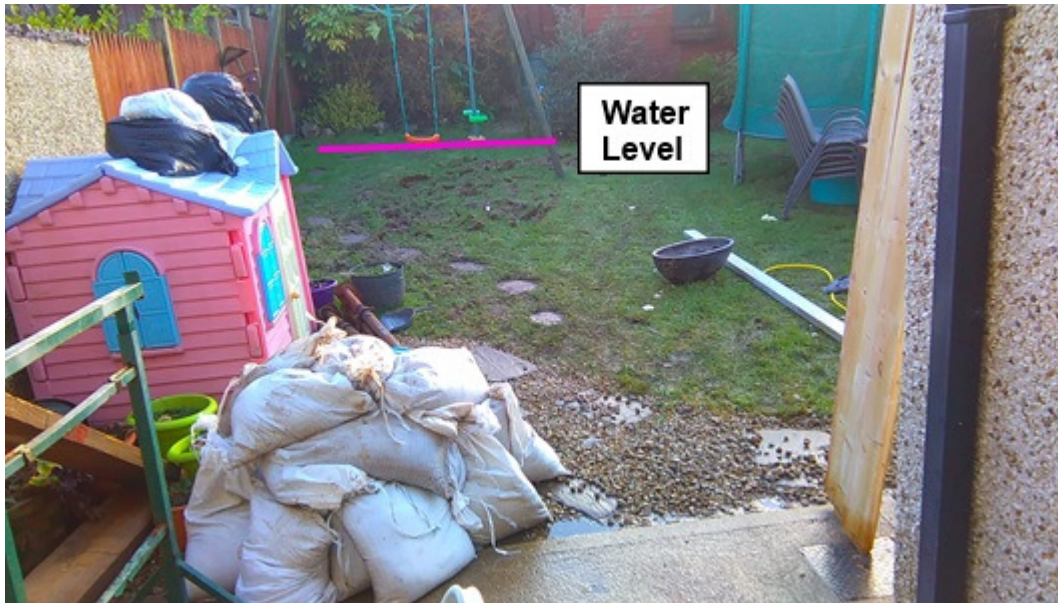
Figure 17 Rear Garden water level reach the bottom of the swing

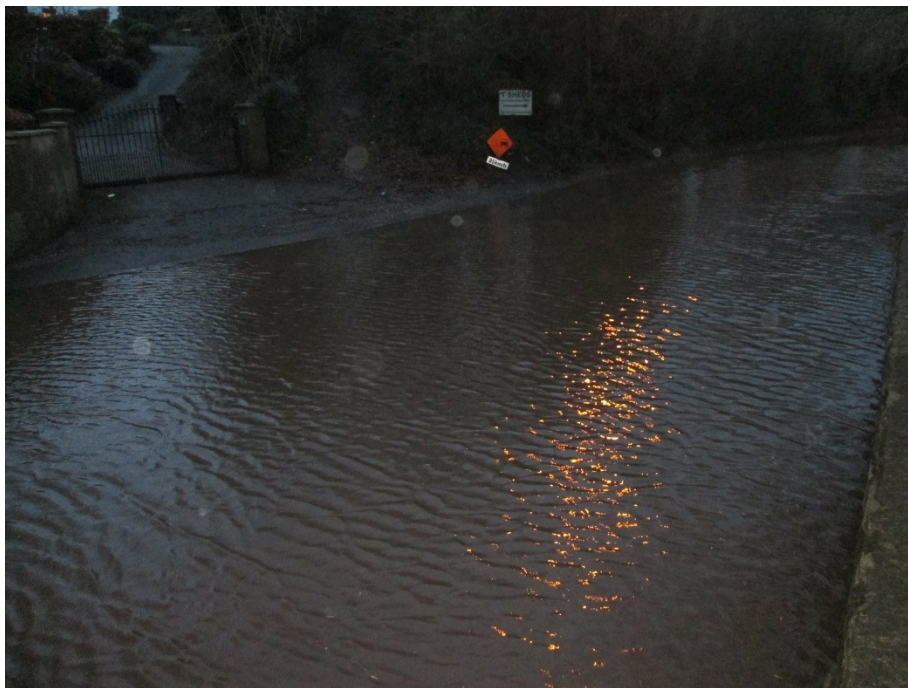
Figure 18 Flooding on the R639 (see Figure 19 for location)
