Monthly Environmental Audit – June 2025

Glanmire Flood Relief Scheme

01/06/25 to 30/06/25

ENVIRONMENTAL AUDIT

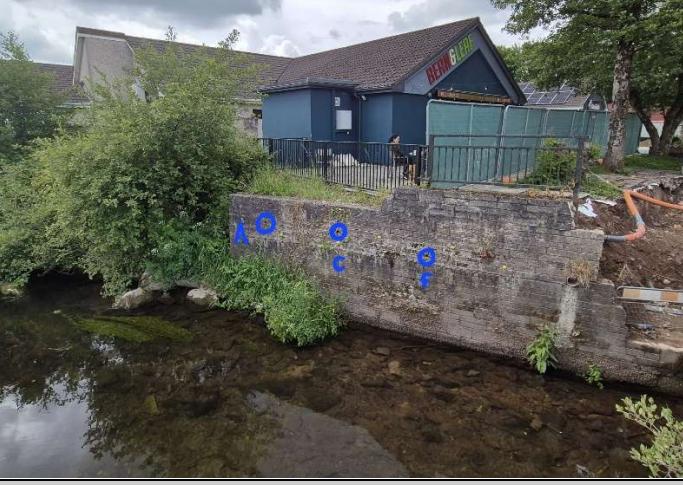
Photograph 1	Photograph 2

Caption 1	Caption 2
Sallybrook Buffer zone established around the Skunk cabbage at Sallybrook Stream	Hazelwood Bridge Remaining active Sand martin bird nests in Weep Holes A, C and F

- A buffer zone was established around the American skunk cabbage at Sallybrook Stream on the 10/06/25.
- Installation of erosion matting on the embankment at Sallybrook recommenced on the 10/06/25 under the supervision of the IAPS Specialist Ecologist due to the presence of the 'regulated' species Japanese and Bohemian knotweed, and Spanish bluebell.

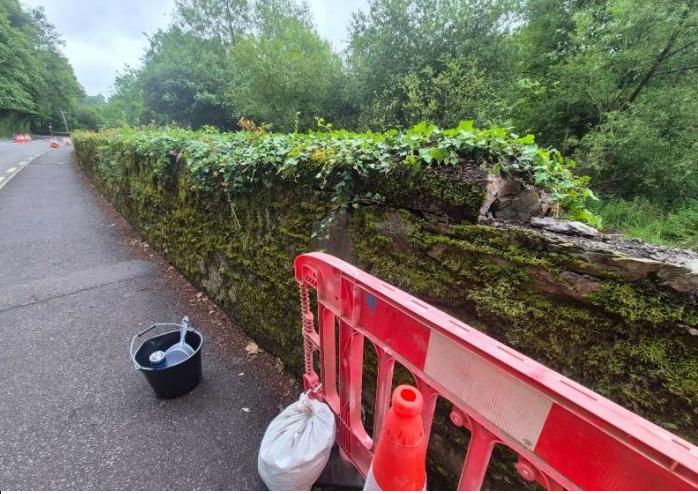
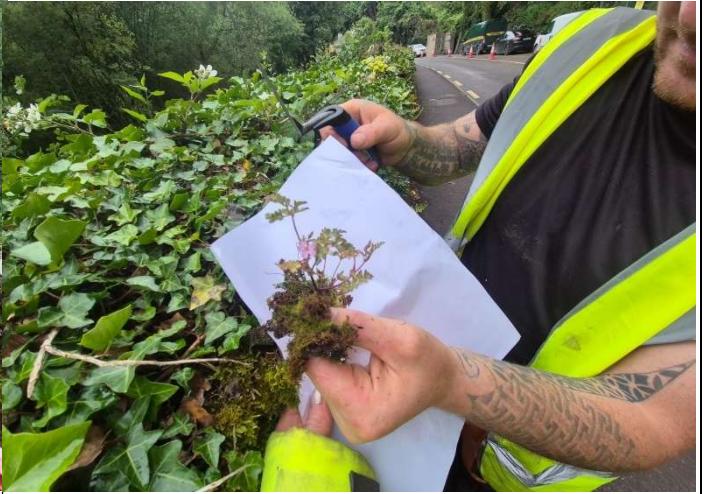
Photograph 3	Photograph 4

Caption 3	Caption 4
The Grove Survey for Little robin and translocation to pots within the Environmentally Sensitive Area at the site offices in the main compound in Circus Field	The Grove/Circus Field

- Surveys for Little-robin were undertaken on the 12/06/25 and the 16/06/25 prior to the programmed demolition of the masonry stone wall in Area 4: The Grove. Little robin and its hybrid were translocated to pots in the 'Environmentally Sensitive Area' at the main site compound at Circus Field. Given the presence of persistent warm weather conditions, the Site Ecologist also brought a number of plants home to ensure consistent watering until the plants had established.

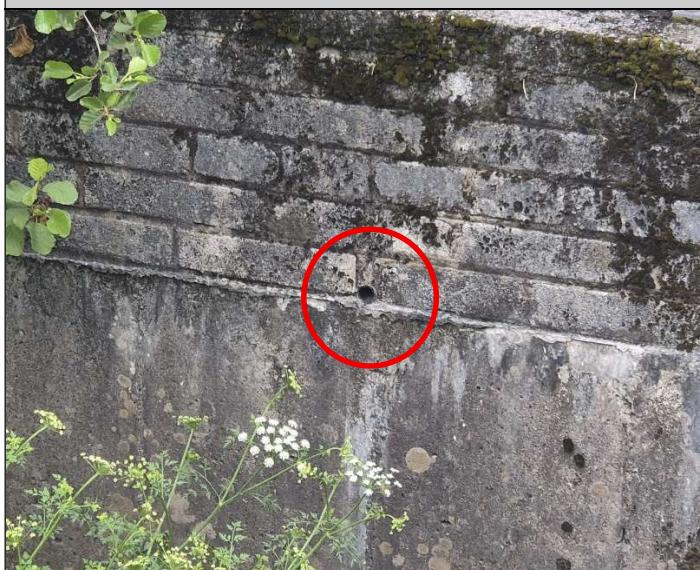
Photograph 5

Caption 5 Hazelwood Shopping Centre Bridge

Blocking of 2 no. weep holes in retaining wall at Hazelwood Shopping Centre Bridge

- Further to the monitoring of 2 no. weep holes at Hazelwood Shopping Centre Bridge on 05/06/2025, action was taken by the Site Ecologist in terms of blocking the entrances to prevent birds from taking up nesting as a precaution.

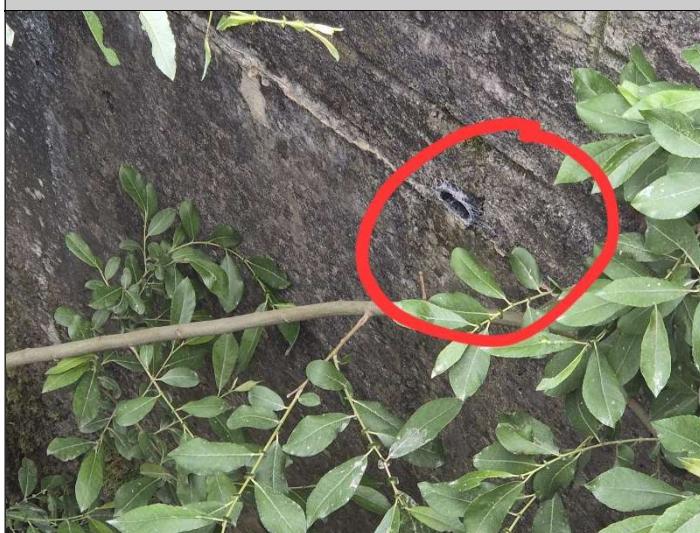
Photograph 7

Caption 7 Hazelwood Shopping Centre Bridge

Blocking of 2 no. weep holes in retaining wall at Hazelwood Shopping Centre Bridge

- Further to the monitoring of the 8 no. weep holes at Hazelwood Bridge on 06/06/2025, action was taken in terms of blocking the entrances to 5 no. weep holes to prevent birds from taking up nesting i.e. a second brood of eggs. Three active nests remain i.e. Weep Holes A, C and F

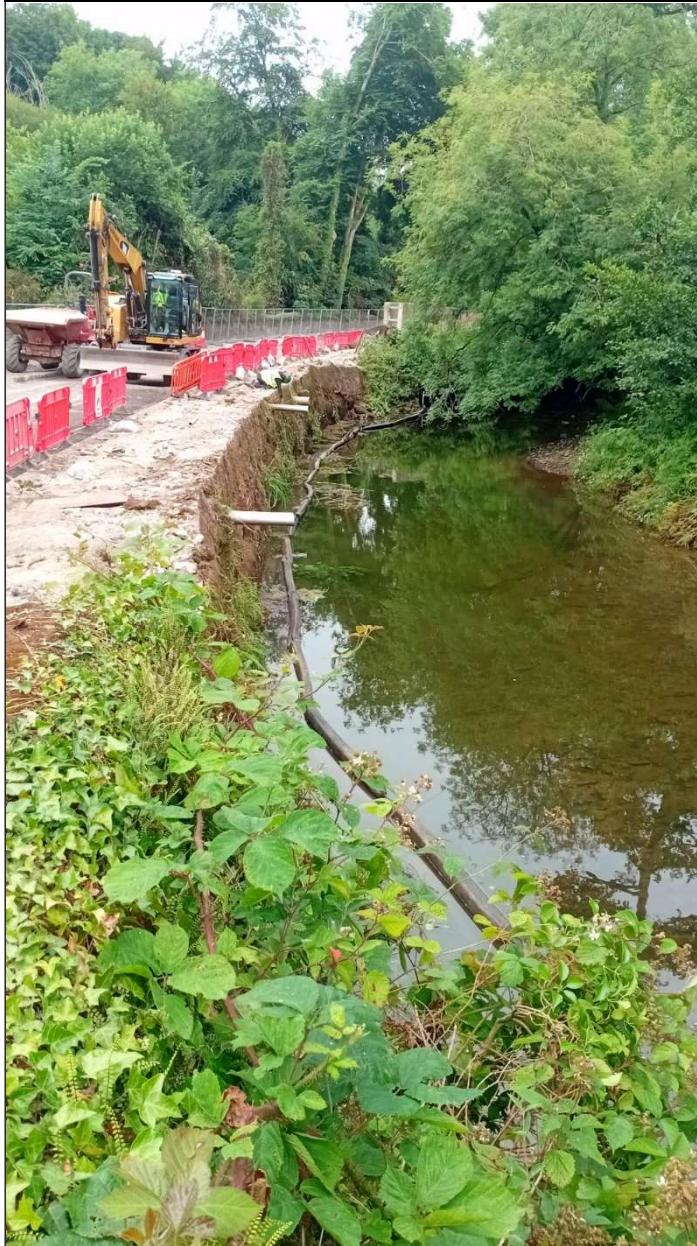
Photograph 9

The Grove

Silt curtains at The Grove for silt control

- Silt control measures installed in the Glashaboy River at Area 4: The Grove to accommodate demolition of the existing stone masonry wall.
- Further to a request from the ER Team, the downstream sonde (d/s) at Hazelwood was relocated by Capitol Water Systems Ltd. on the 30/06/2025 to within 100m of the works at Hazelwood Shopping Centre Bridge. It should be noted that the river approximately 100m downstream of the works is constrained in terms of safe access and soft ground conditions underfoot, the presence of a zone of mixing in the water column, the presence of an outfall (Springmount Stream), a slow-moving body water on one side of the channel and, a wide and shallow river margin on the opposite bank. In the absence of optimum conditions, the current location is being trialed to determine its suitability in light of the various constraints.

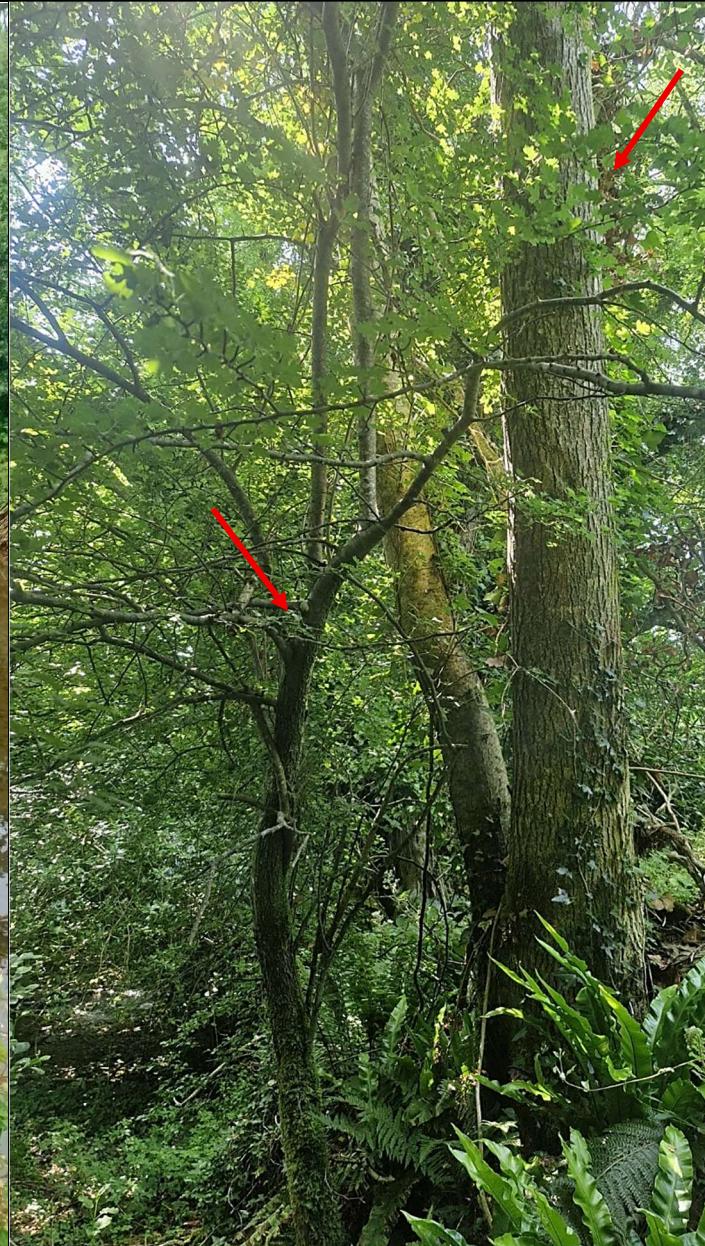
Photograph 10

Bleach Hill

Hawthorn tree removed from the location of the bat box at Bleach Hill

- Demolition of the deck of Hazelwood Shopping Centre Bridge commenced on 16/06/2025.
- Based on a recommendation by bat specialist, Dr. Isobel Abbott, an immature Hawthorn (*Crataegus monogyna*) tree was removed from in front of 1 no. bat box (Schwegler 1FF) on the 18/06/25 at Bleach Hill under Permit to Clear Vegetation No. 17 (GFRS-PTCV-017). The spinose tree was removed as it was deemed to be an obstruction to bats attempting to gain entry to the artificial bat roost.

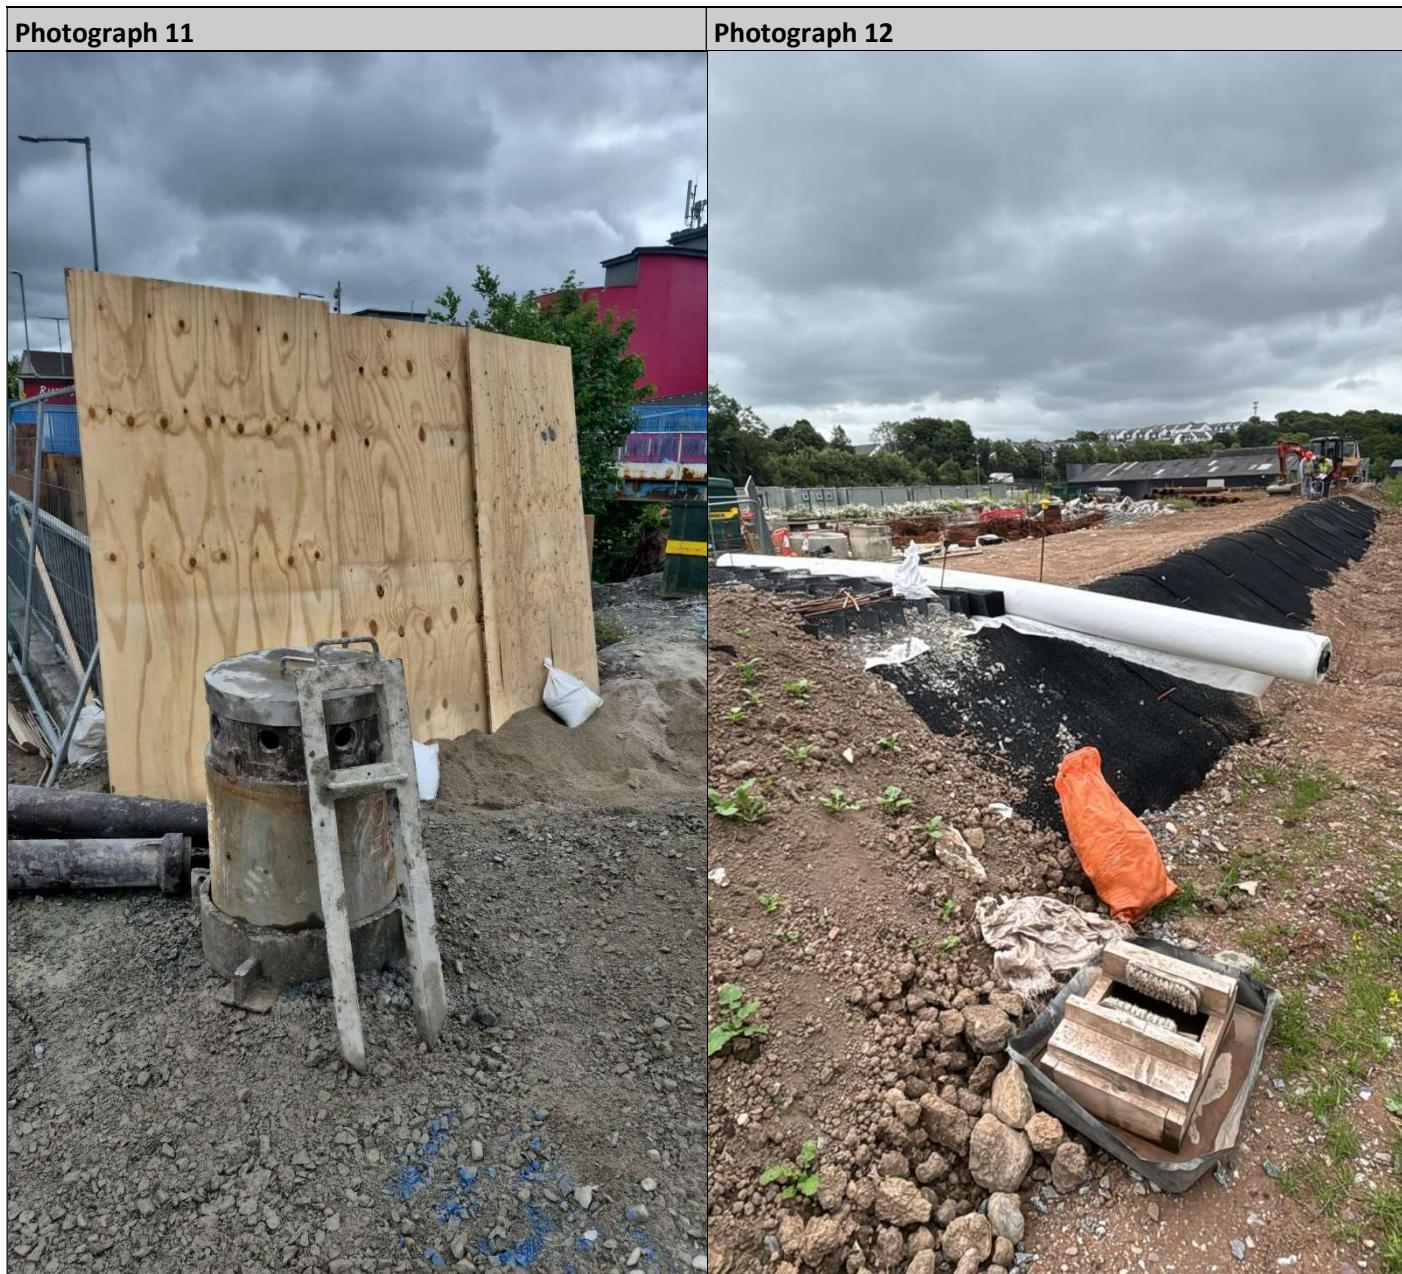
Caption 11	Hazelwood	Caption 12	Sallybrook
Silt and Cementitious materials control measures at Hazelwood Shopping Centre Bridge		Installation of erosion matting on the embankment at Sallybrook

- Rotary Bored Piling commenced on 03/06/2025 at Hazelwood Shopping Centre Bridge. A host of silt and cementitious material control measures were deployed for containment purposes to minimise the accidental spillage and release of polluting substances during the piling process.

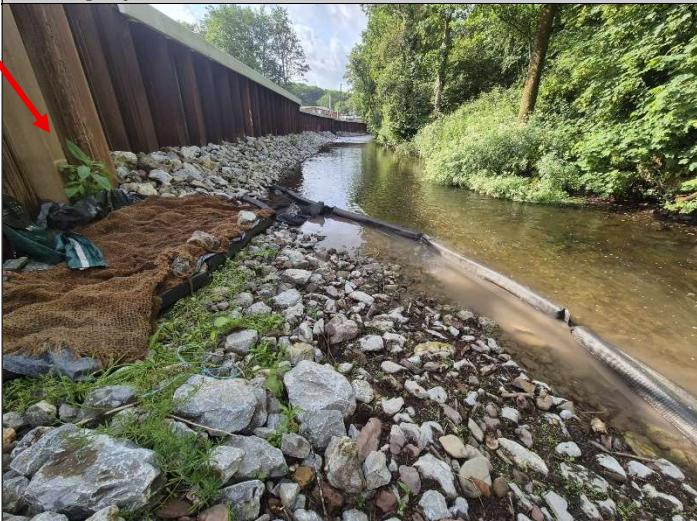
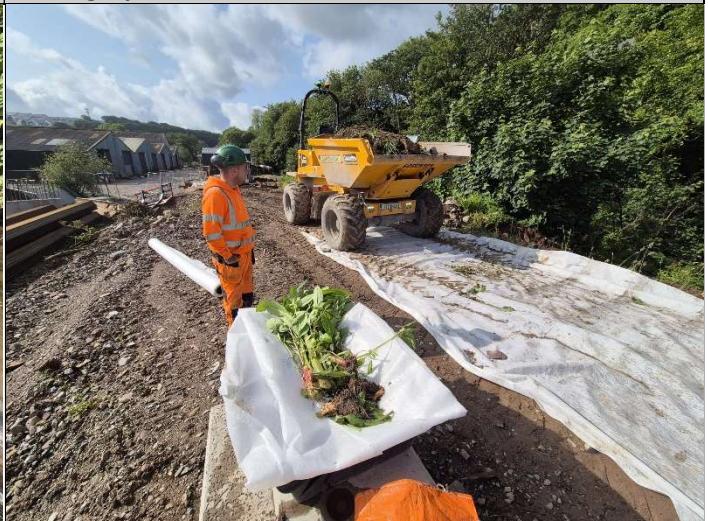
Photograph 13

Sallybrook

“Balsam bashing” at an outfall in sheet pile wall in Sallybrook, which was subsequently removed by the IAPS Specialist Ecologist and placed in the Temporary Holding Facility until the plants have desiccated.

- Environmental Tour 031 took place on the 13/06/25 - main findings related to house-keeping, future works, silt control measures, and Little robin (*Geranium purpureum*) and the hybrid (*Geranium purpureum x robertianum*).
- A walkover survey of the riverbank between was undertaken between Sallybrook and Grandons by the IAPS Specialist Ecologist on the 13/06/25 to facilitate the removal of the 'regulated' invasive species Himalayan balsam which was recorded present at a stormwater outfall in the sheetpile wall at Sallybrook, where silt control measures had been deployed under Permit to Pump No. 136.

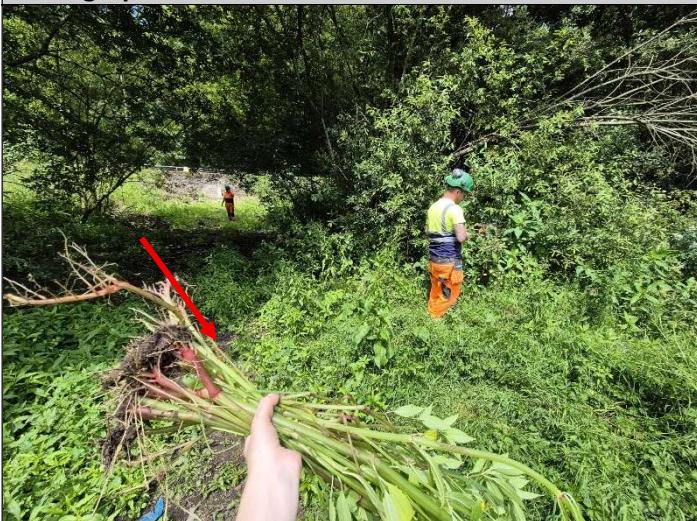
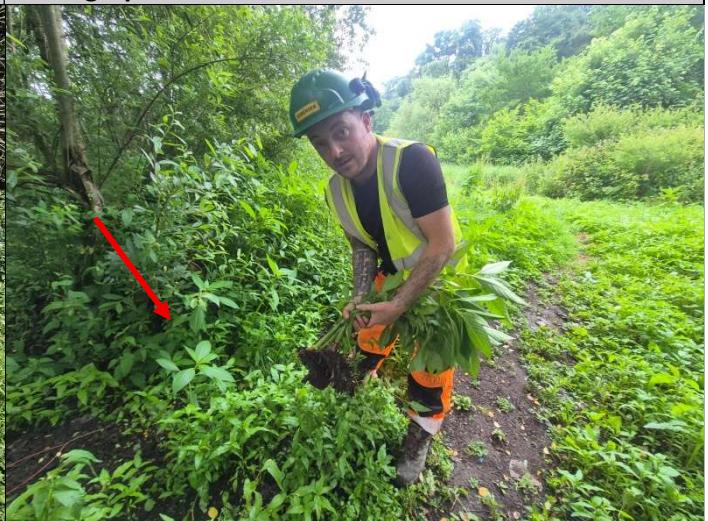
Photograph 15

The Grove

“Balsam bashing” at Area 4: The Grove by the IAPS Specialist Ecologist and SCEs Environmental Team.

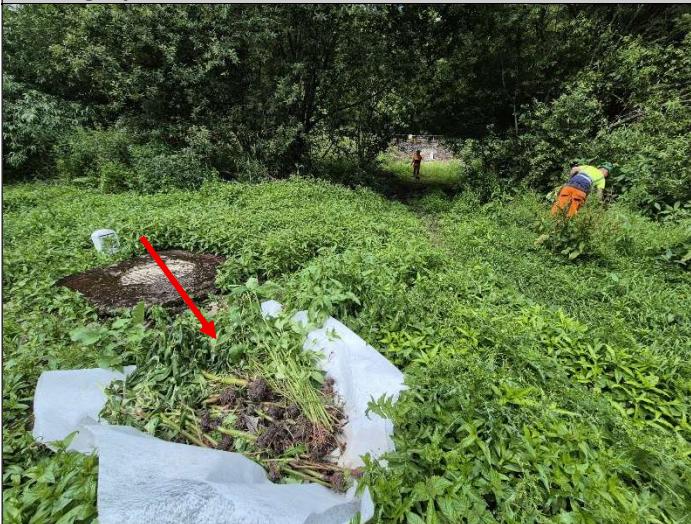
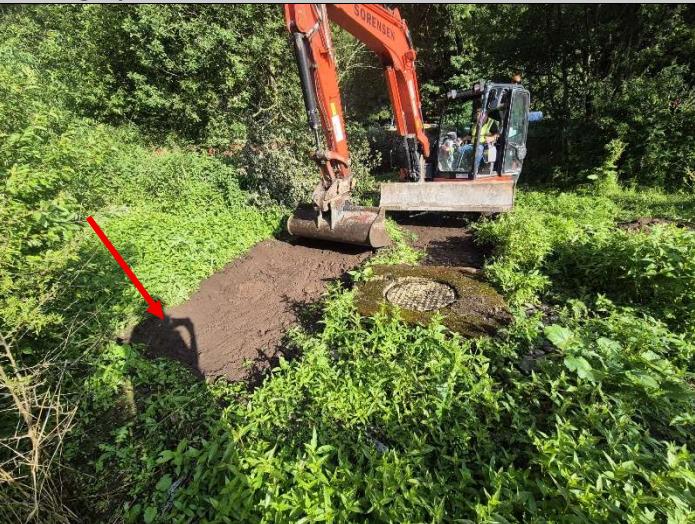
Photograph 17

The Grove

“Balsam bashing” at Area 4: The Grove by the IAPS Specialist Ecologist and SCEs Environmental Team. Site investigation for chemically dormant Japanese and Bohemian was undertaken, once the Balsam Bashing was completed, under the supervision of the IAPS Specialist Ecologist.

- Targeted site investigation for chemically dormant Japanese and Bohemian knotweed took place on the 20/06/2025 in Area 4: The Grove under the supervision of the IAPS Specialist Ecologist.

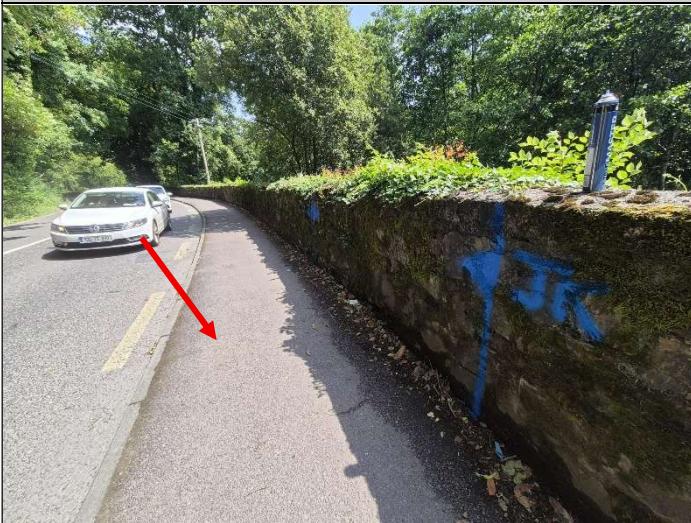
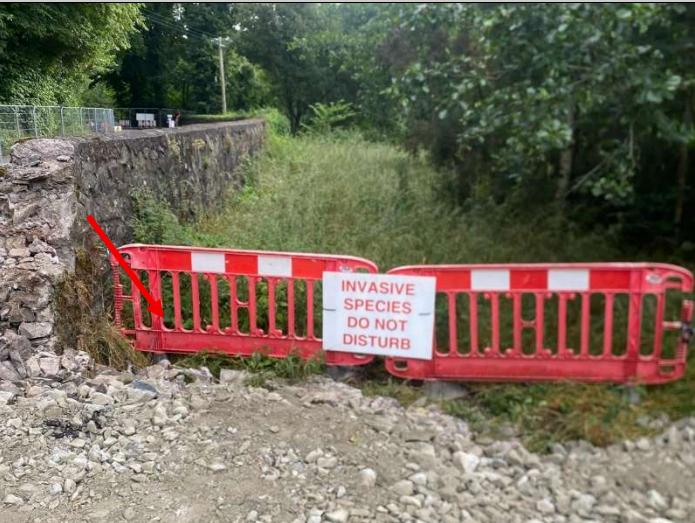
Photograph 19

The Grove

A survey for visible Japanese and Bohemian knotweed stands was undertaken by the IAPS Specialist Ecologist in advance of the demolition of the wall

- A survey for Japanese and Bohemian knotweed was undertaken by the IAPS Specialist Ecologist on the 16/06/25 along the remaining roadside boundary wall in Area 4: The Grove. Locations of all visible knotweed stands were demarcated.

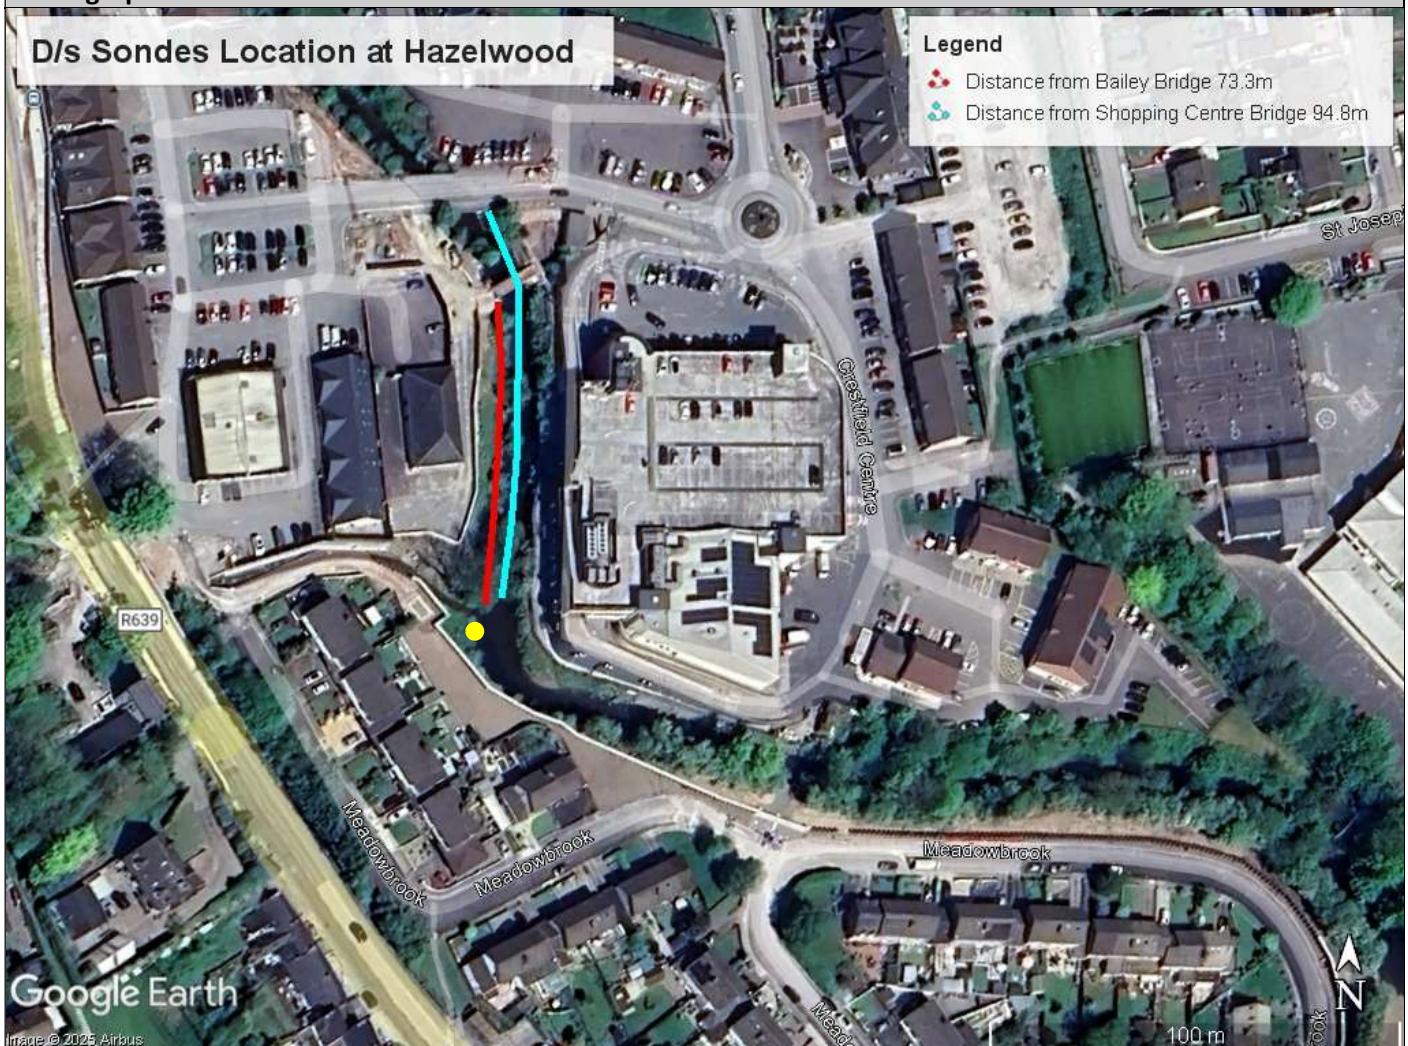
Photograph 21

Caption 19 Hazelwood

The downstream sondes at Hazelwood was relocated from the OPW Hydrometric Station to the location shown in yellow just downstream of the confluence with Springmount Stream.
