KING'S ISLAND
FLOOD RELIEF SCHEME

**EIAR Addendum Report
Volume 3**

King's Island Flood Relief Scheme Preliminary Stratigraphic Report on Archaeological Testing (Volume 2)

Archaeological Testing for the proposed King's Island Flood Relief Scheme, Limerick

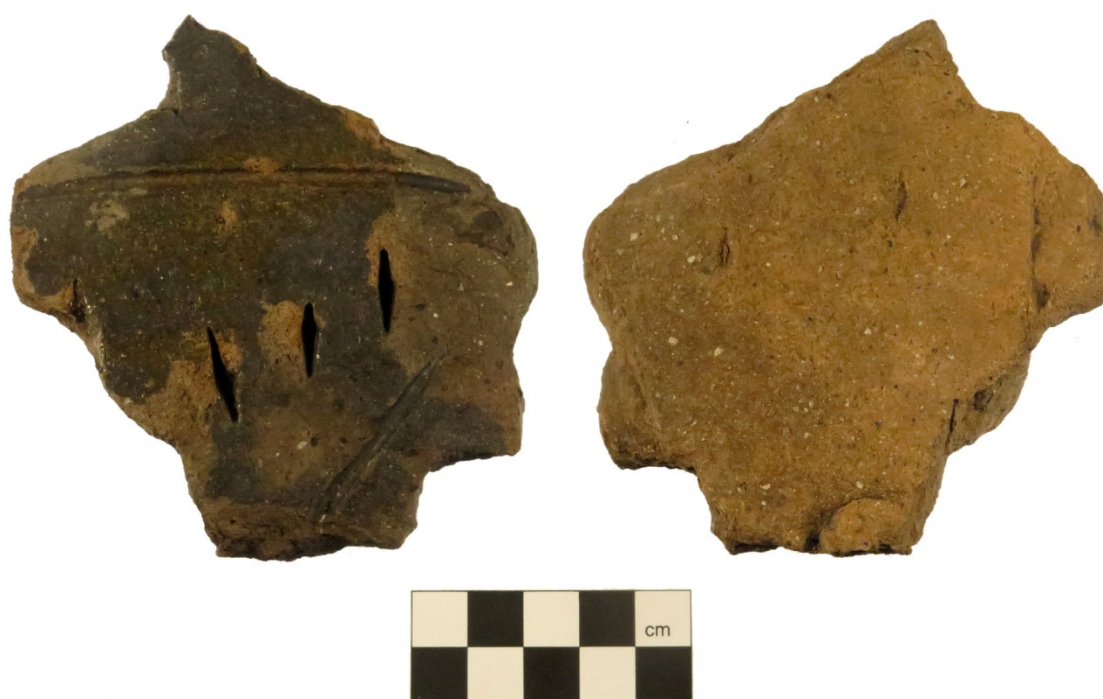
Figure 1 Glazed coarseware with stabbed and incised surface from TT6-4

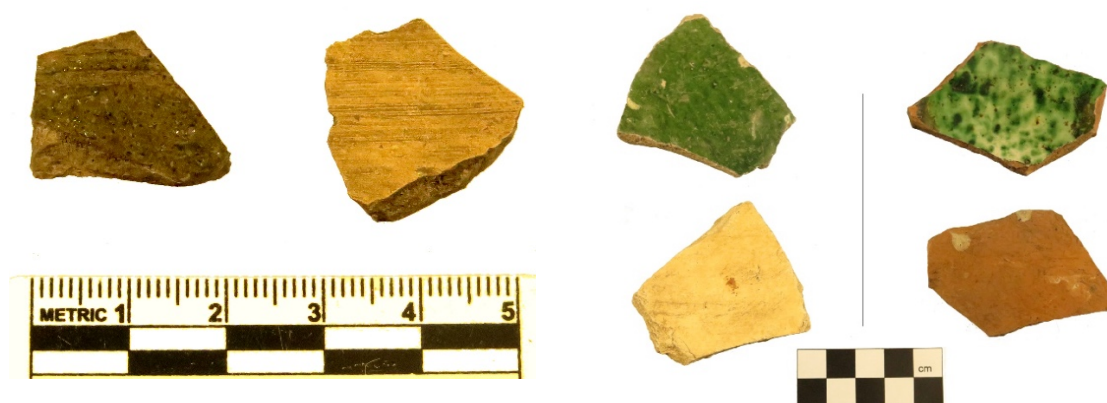
Figure 2 Green glazed fineware from TT6-4 (left) and from TT6-2, possible Saintonge ware (middle) and mottled green glaze ware from TT1-3 (right)

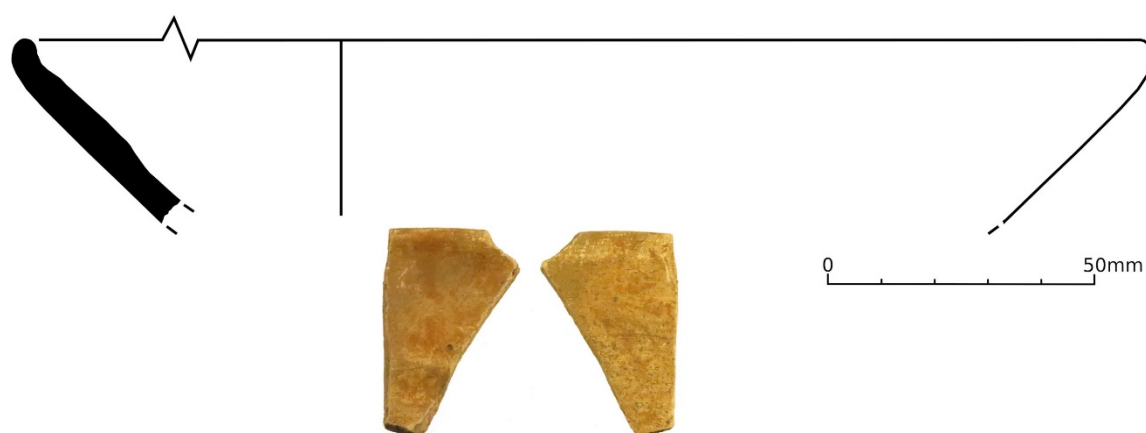
Figure 3 Rim of unglazed fineware bowl from TT6-2

Also recovered from TT6-2 was a rim sherd of a thin-walled dish or bowl in very fine, pinkish pale brown fabric which is unglazed but has a white slip coating (Figure 3). This artefact, almost certainly an import, appears to be medieval.

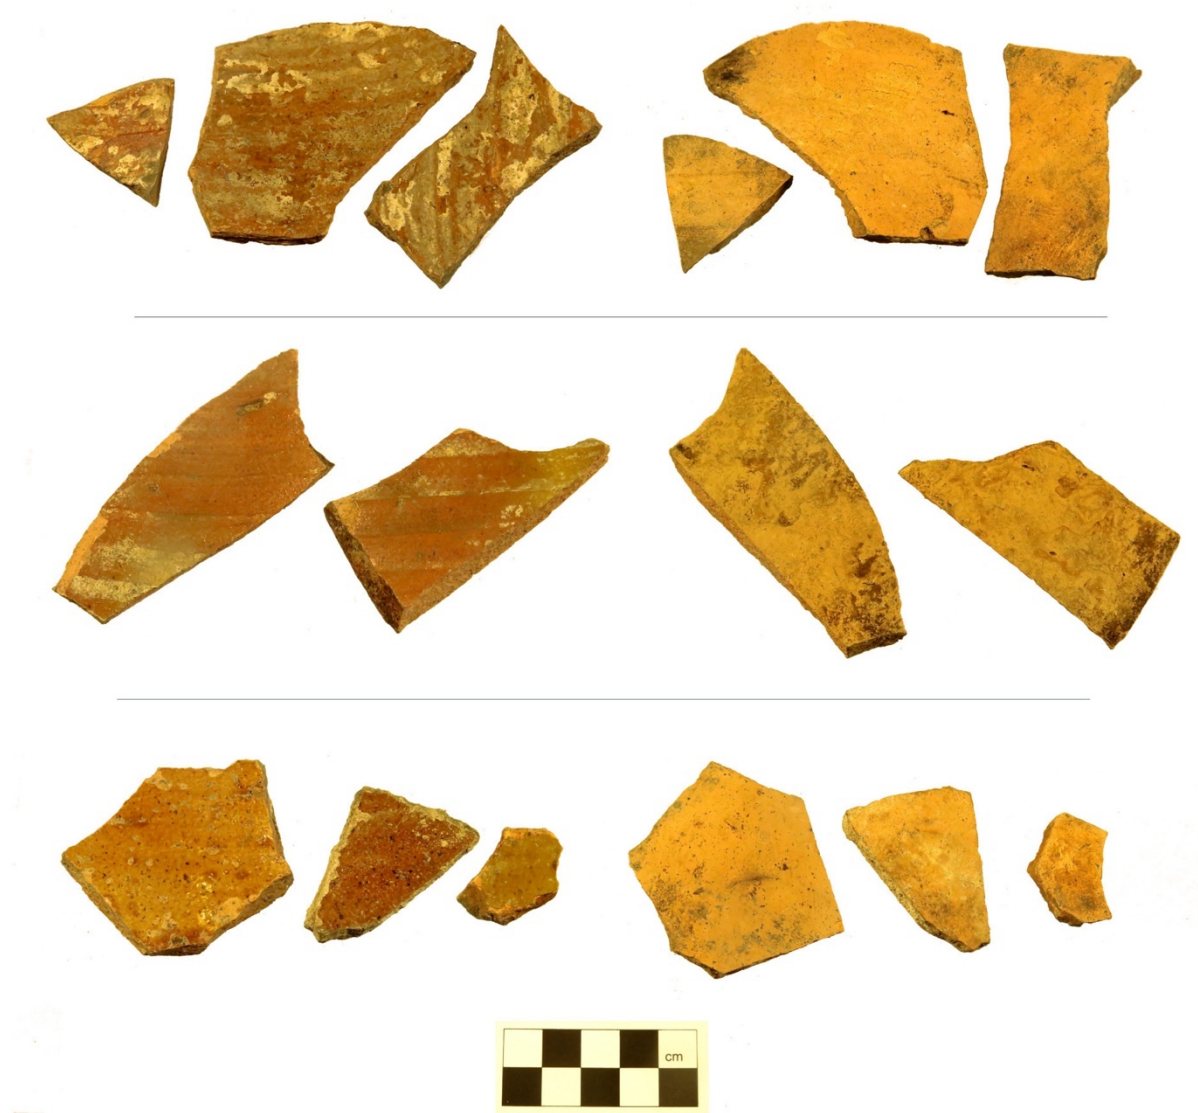
Figure 4 Glazed red earthenware sherds (interior left, exterior right) from TT7-1

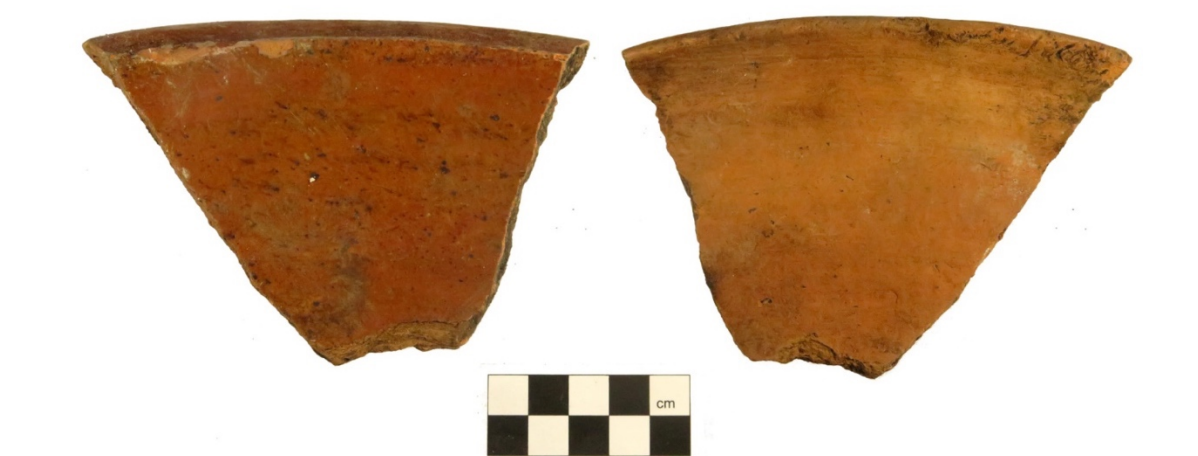
Figure 5 Glazed red earthenware bowl from TT1-3

Production of this ware is marked by long-term continuity in vernacular potting traditions. A large fragment of a bowl from TT1-3 has a flat-topped rim with the typical interior glazed and exterior unglazed (Figure 5). The presence of this bowl in the context of the brewery building means that it can probably be dated to the 19th century. This demonstrates the continuity of local production and usage of glazed earthenware over several hundred years.

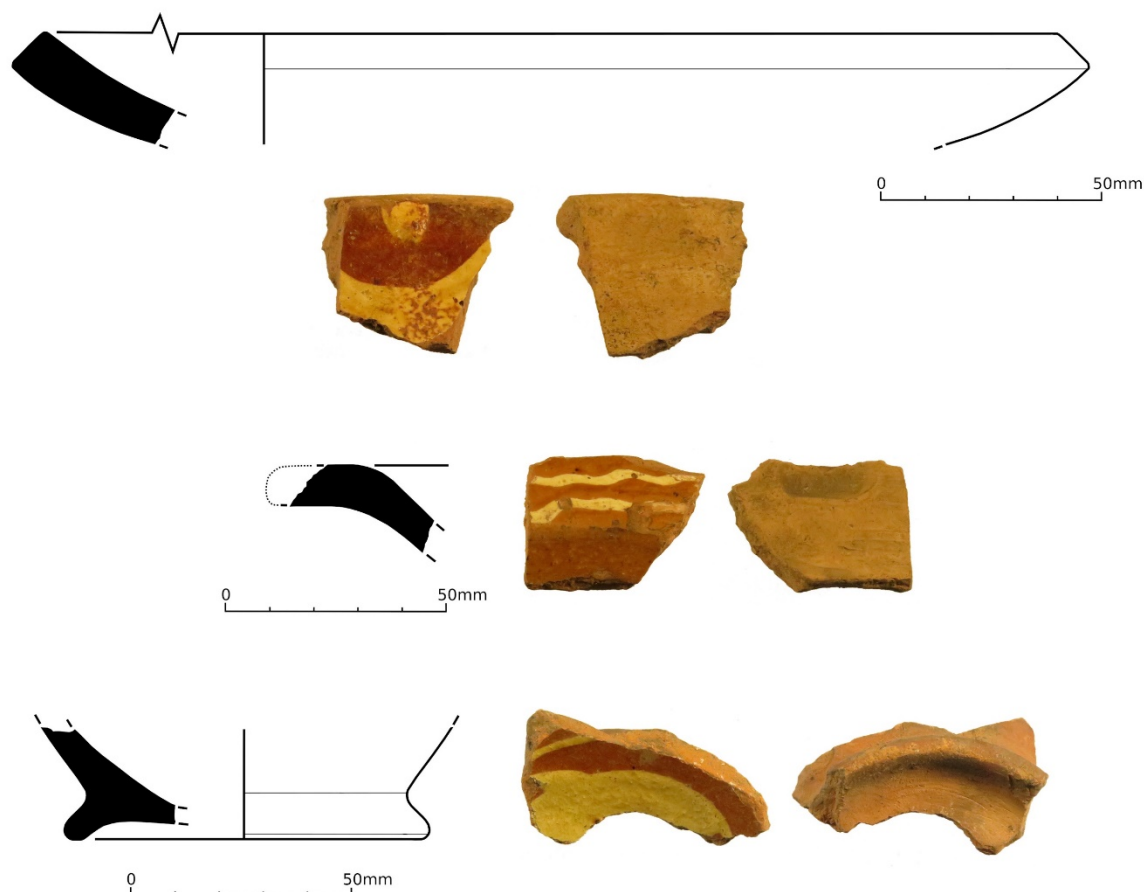
Figure 6 Slip painted wares from TT6-1 (top and middle) and TT6-2 (below)

Three sherds of polychrome, 'slip painted', glazed ceramics were recovered from TT6-1 and TT6-2 (Figure 6). Two of these are rim fragments (one only partial) and another is the base of a footed vessel. The two rims are from large dishes: one has a ledge rim and the other has a triangular shaped rim and a diameter of 360mm. All of the sherds are from different styles of vessel in terms of their form and decoration, though all use the same glaze colours. A clear or brown coloured glaze is applied above cream slip and on top of this the decorative elements, which consist of dots and swirls, are painted in a pale yellow or cream colour. Decorated glazed red earthenware recovered from King John's Castle is dated to the 17th century and related with the presence of Dutch immigrants who worked in the linen industry (Wiggins et al. 362-364).

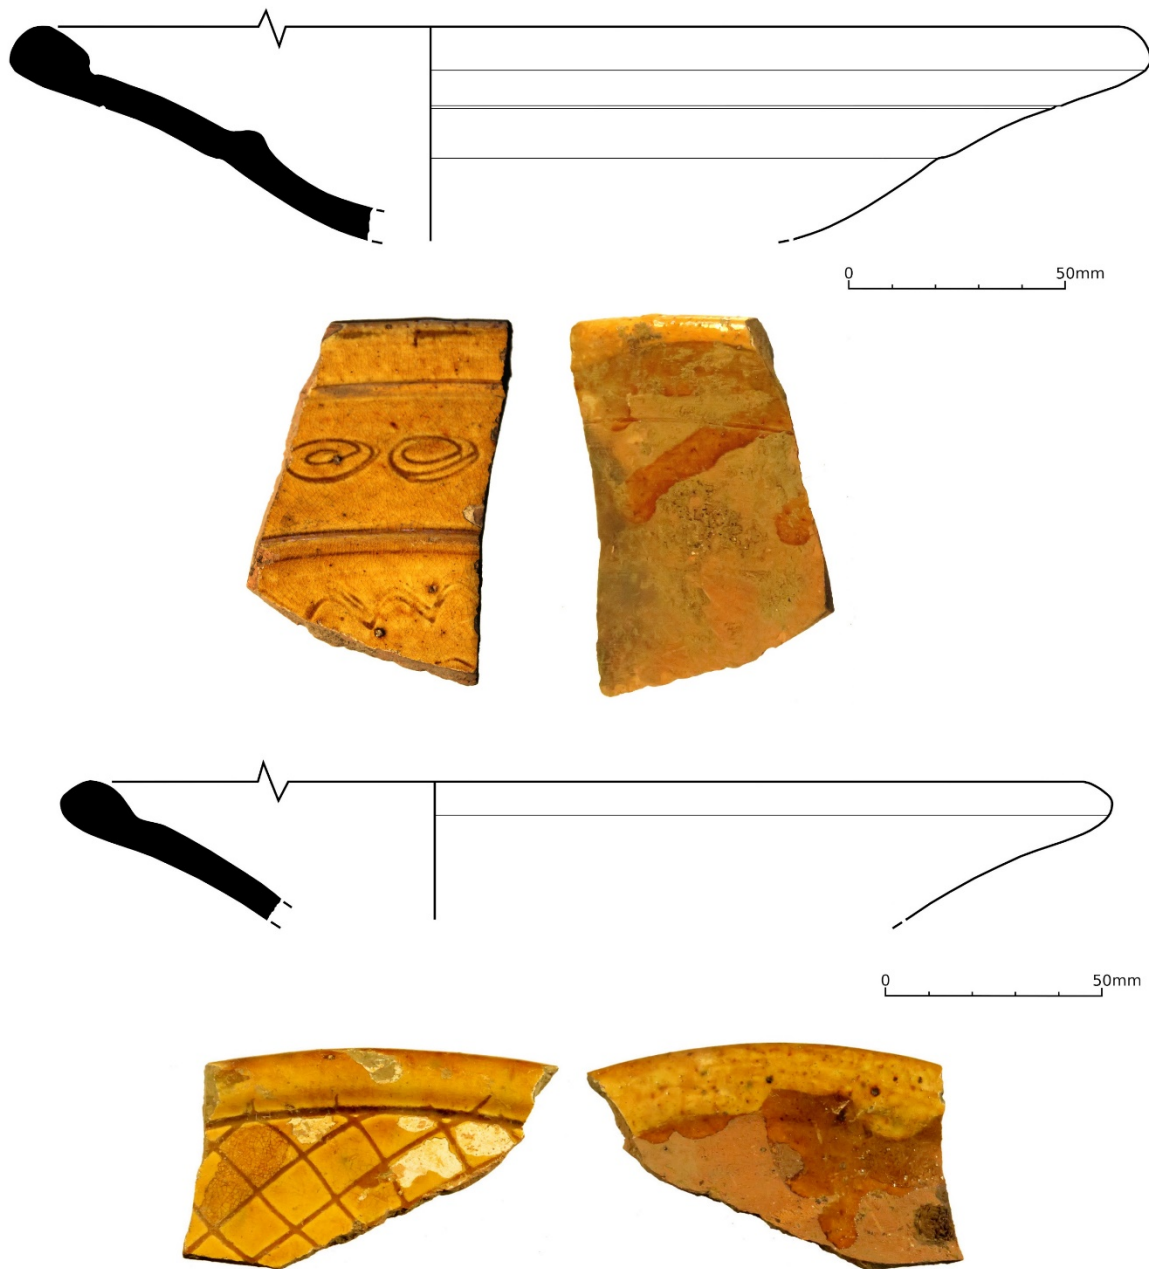
Figure 7 Sherds of North Devon sgraffito ware, from TT6-1 (above) and TT7-2 (below)

Two rim fragments of North Devon sgraffito decorated dishes were recovered from TT6-1 and TT7-2 (Figure 7). A close parallel to the dish rim with wavy decoration recovered from TT6-1, though more complete, was found in Custom House, Flood Street, Galway (Delaney

1997; Fitzpatrick et al. 2004: 400). The example from TT7-2 has diamond shaped cross hatched decoration. Both likely date from the 17th century and come from large dishes or platters, with rim diameters of 300-320mm.

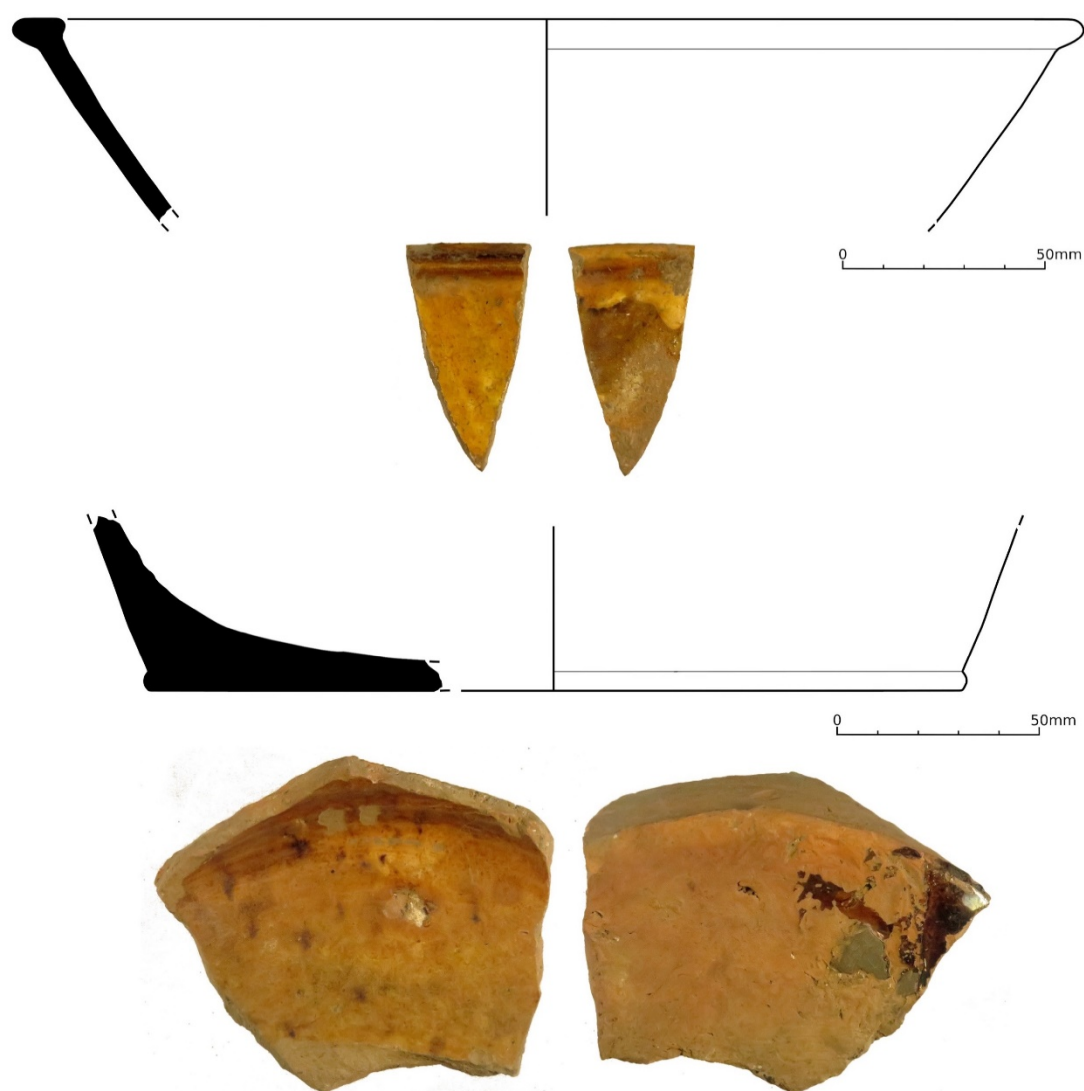
Figure 8 Yellow and brown glazed sherds from TT1-3

Sherds with yellow and brownish yellow glaze might be identified as undecorated North Devon ware as the fabrics and bichrome glaze are similar, though there are differences in the forms, which tend to be closed jugs and jars with flat bases and flat or ledge rims. A distinctive feature is the presence of glaze smudges on the underside, which come from being stacked during the firing process. This sort of deficiency is a mark of some of utilitarian vessels, as discussed by McCutcheon and Meenan (2011: 106) in the context of black glazed storage vessels, who note that minor flaws on functional vessels would not have mattered for objects not intended for display and that less than perfect vessels, possibly classified as 'seconds', were still in use. Diagnostic sherds of plain yellow glazed ware were recovered from TT1-3 (a rim and base) (Figure 8).

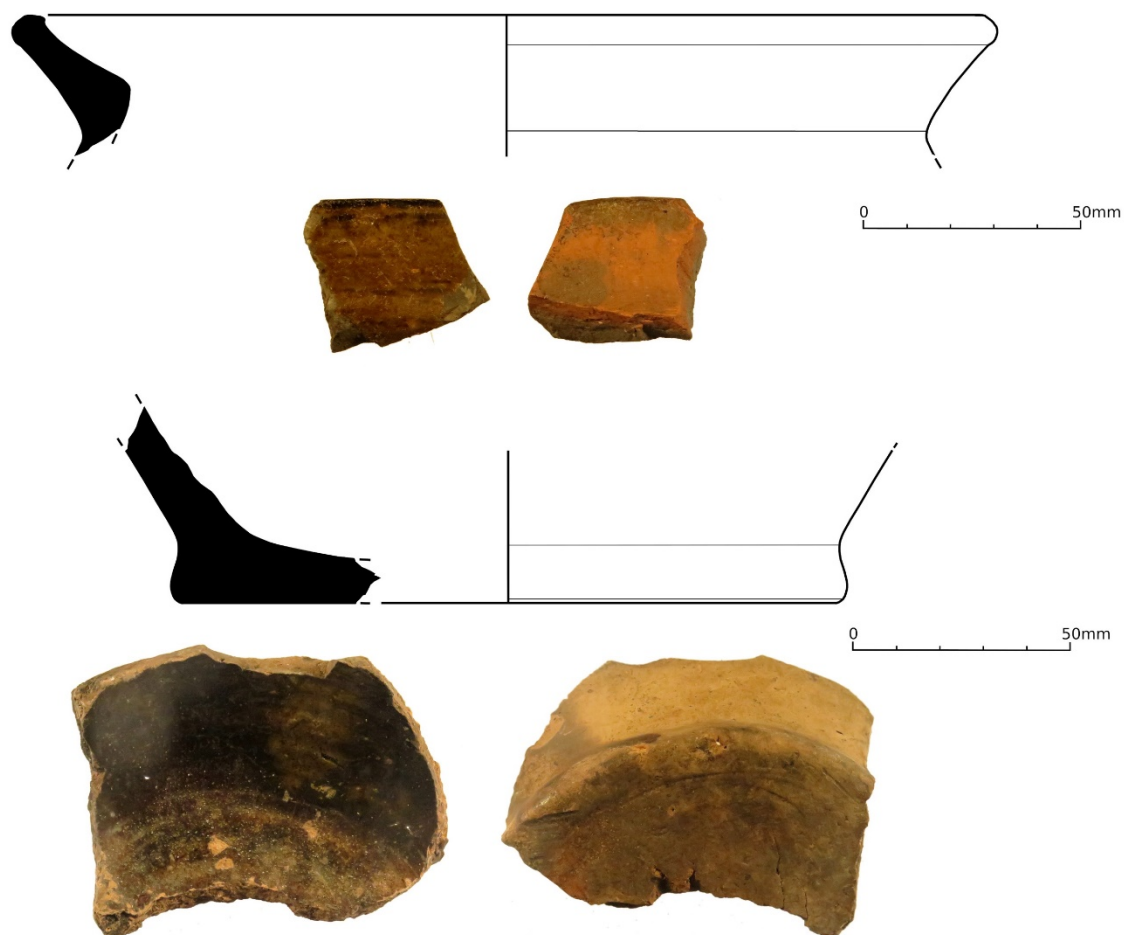
Figure 9 Olive green glazed wares from TT7-1 (above) and TT6-1 (below)

A number of sherds with olive green coloured glaze were recovered from Area 6 and 7. These include internally glazed jugs and jars which have a flat base and an everted rim of another

closed form vessel (Figure 9). These sherds are distinguished from the medieval green glazed sherds discussed above by their coarser and redder fabric and the dark green colour of the glaze, though a medieval or early post-medieval date is conceivable.

Artefact number: TT6-1-04 (Figure 9)		
Part: Base	Diameter: 150mm	Wall thickness (min.): 7.4mm
Form: Closed, jar or jug. Flat base. Shallow ribbing on interior, smooth exterior wall		
Fabric: Medium fine, regular firing, slightly bricky and angular fracture; regular fine grits, fair sorting, sparse, fine mica. Colour: reddish yellow (5YR 6/6)		
Surface: Glazed interior, unglazed exterior. Unslipped. Glaze is thickly coated and dark green or dark olive grey (5Y 3/2) with zone of lighter yellowish green.

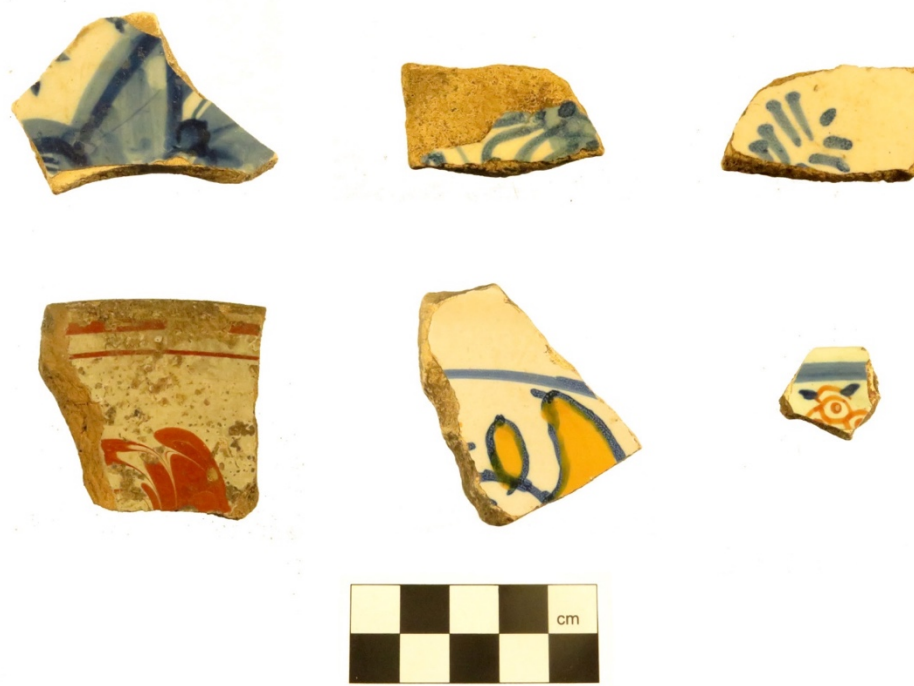
Figure 10 Tin glazed monochrome and polychrome decorated ceramics

Hand decorated, tin glazed ceramics, including blue on white and polychrome, were recovered in small quantities from trenches in Area 1 and 6 (Figure 10). These are distinguished from the later, 19th century transfer printed earthenware, where the decoration was mechanically applied (discussed below).

The hand decorated sherds include a possible fragment of faience, a ceramic imported from Portugal in the first half of the 17th century (Fitzpatrick et al. 2004: 380-383). From Area 1, in contexts dating from the 18th to 19th century, a base fragment of a marbled pattern footed bowl and a polychrome blue and yellow whiteware were recovered.

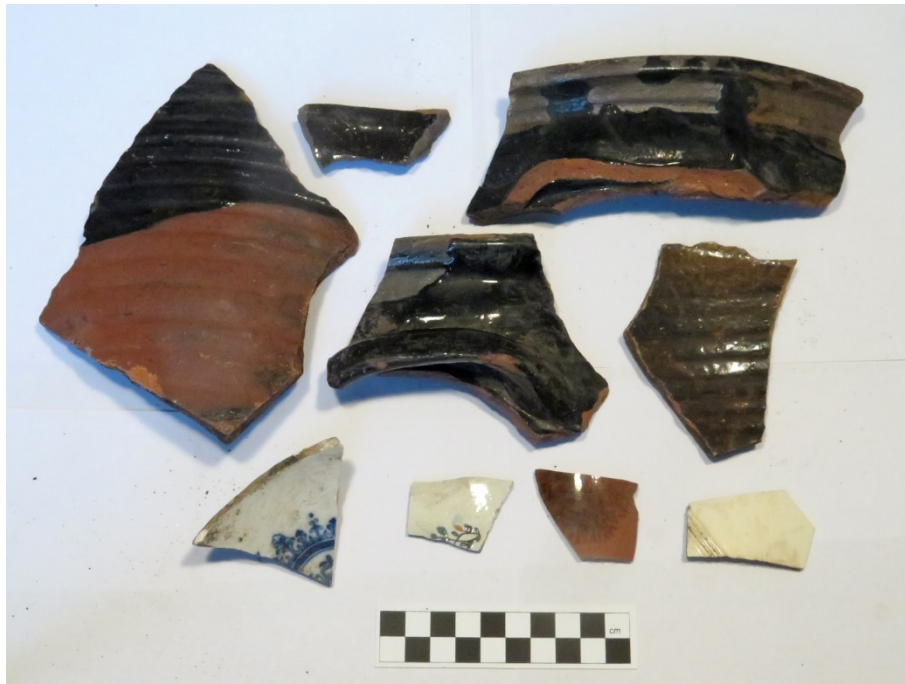
Figure 11 *Black-glazed and other ceramics from TT5-1*

Sherds of black-glazed earthenware were frequently present in later excavated contexts, and sometimes at considerable depth, especially in the harbour fills at the base of trenches in Area 5 (Figure 11) and the northwest of Area 6. Diagnostic sherds of black-glazed ware were recovered from five trenches (TT5-1, TT5-2, TT5-3, TT6-2 and TT7-2); smaller body sherds were present in most trenches excavated Area 1.

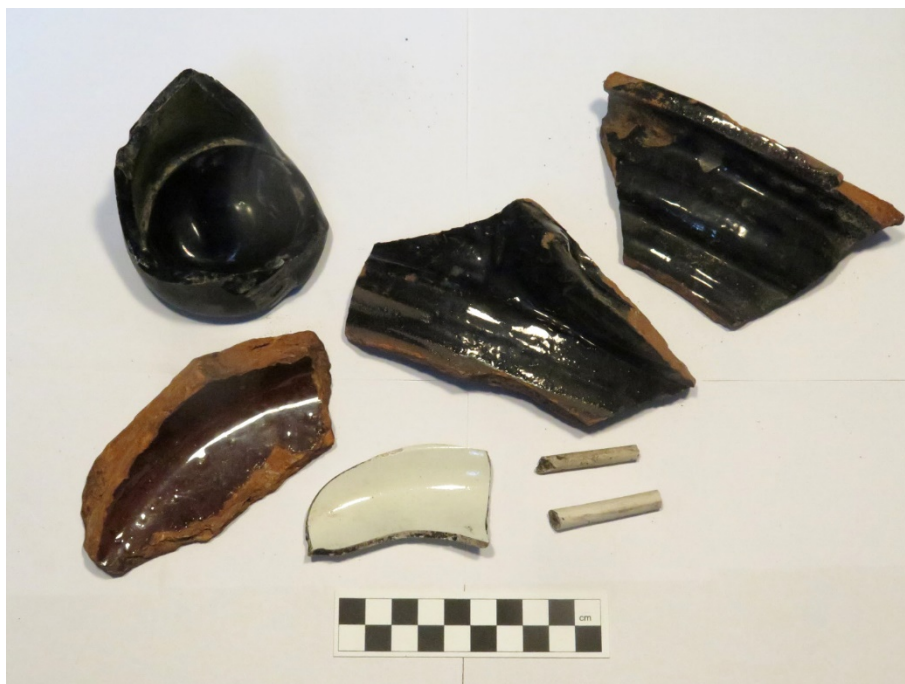
Figure 12 *Black-glazed and other ceramics from TT5-1*

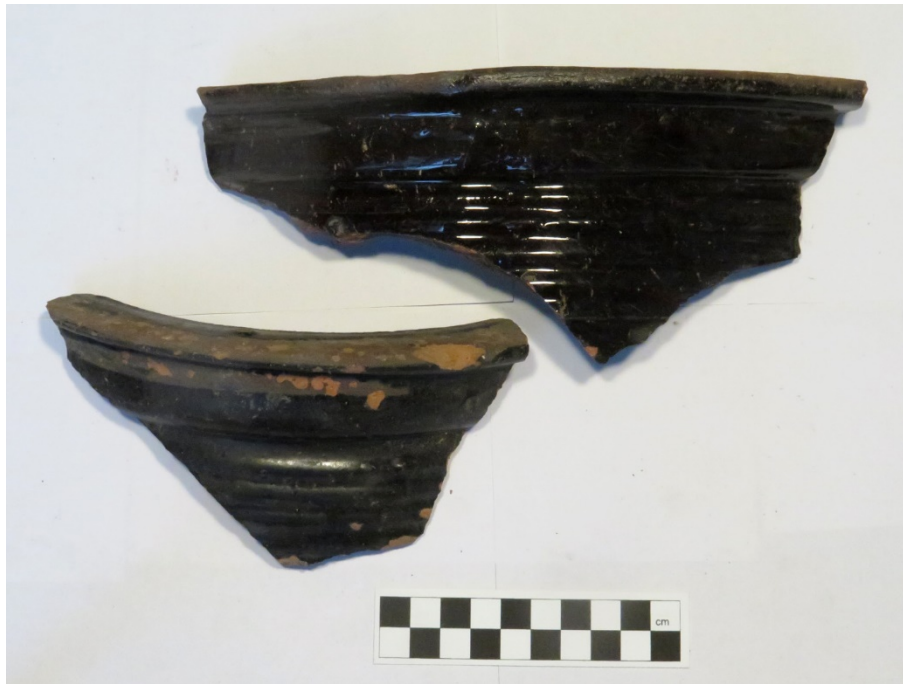
Figure 13 *Black-glazed storage vessel rims from TT5-3*

The black-glazed earthenware is characterised by its dark red, bricky fabric coated with evenly and thickly applied black glaze and the generally large sized vessels including basins with thick rims, ribbed body and lug handles. Several black-glazed sherds were recovered from TT5-1, below the level of the cobbled surface, which is contemporary with construction of the Courthouse, so date from the very start of the 19th century or earlier. The large dimensions and closed form of black-glazed vessels that were used for bulk storage, is shown in two large rim fragments from TT5-3, the larger of which has a diameter of 380mm (Figure 13). Smaller black-glazed vessels were also in use, as shown by a small strap handle, perhaps belonging to a jug or pitcher from TT6-2 (Figure 14).

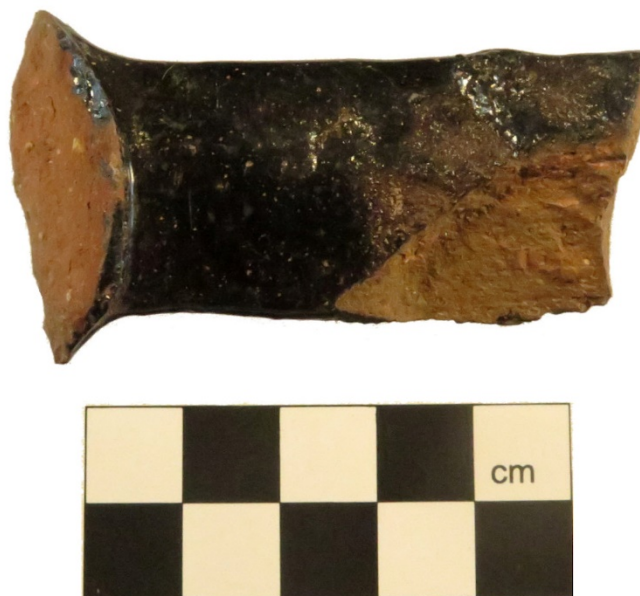
Figure 14 *Black-glazed ware strap handle from TT6-2*

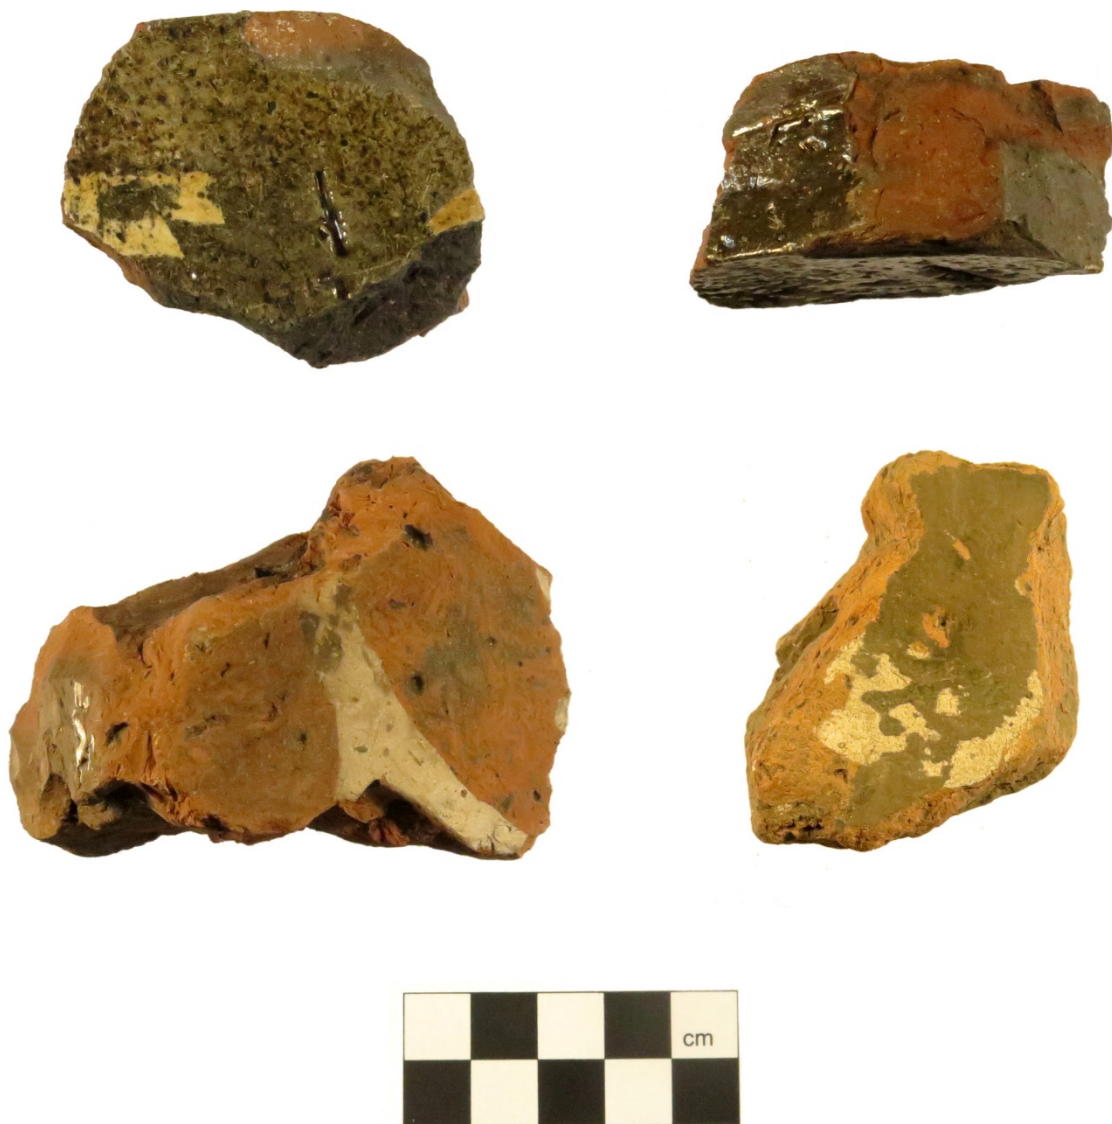
Figure 16 Medieval glazed floor tiles from TT6-4 and TT6-1

The possible floor tiles come from the basal context of TT6-4 (C6-4-11) where a fragment of medieval glazed pottery and a small strip of gold were also found (Figure 16). Both are squared pieces of dense red pottery, with one straight edge surviving. One is mainly unglazed, 28mm thick and has an inlaid white line running across its top. The other is 37mm thick and its top and two sides have green glaze with cream slip painted coating. Both have flat, rough undersides. Another possible medieval floor tile comes from TT6-1, which has a matt coating of dark green over white slip.

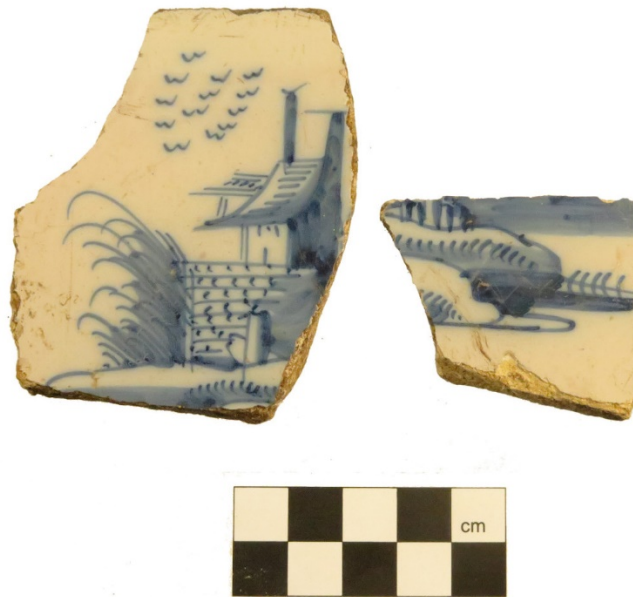
Figure 17 Dutch wall tile from TT1-3

Two fragments of a glazed wall tile with blue, hand-painted decoration, were recovered in Area 1, from TT1-3 (Figure 17). The tile shows a rural scene, with a small building, perhaps a mill, beside water, with a fence, barrel and reeds in front and stylised birds in the sky. The tile is likely to be Dutch and can be broadly termed 'Delft', though tiles of this style were also made in England. The tile probably dates from the late 17th or 18th century, but similar hand-painted tiles were made into the 19th century. Delft tiles were found during nearby excavations at King John's Castle (Sweetman 1980: 224; Wiggins et al. 2006: 472); the later find was interpreted as coming from the wall of a 17th century building which was later demolished to build the 19th century infantry barracks.

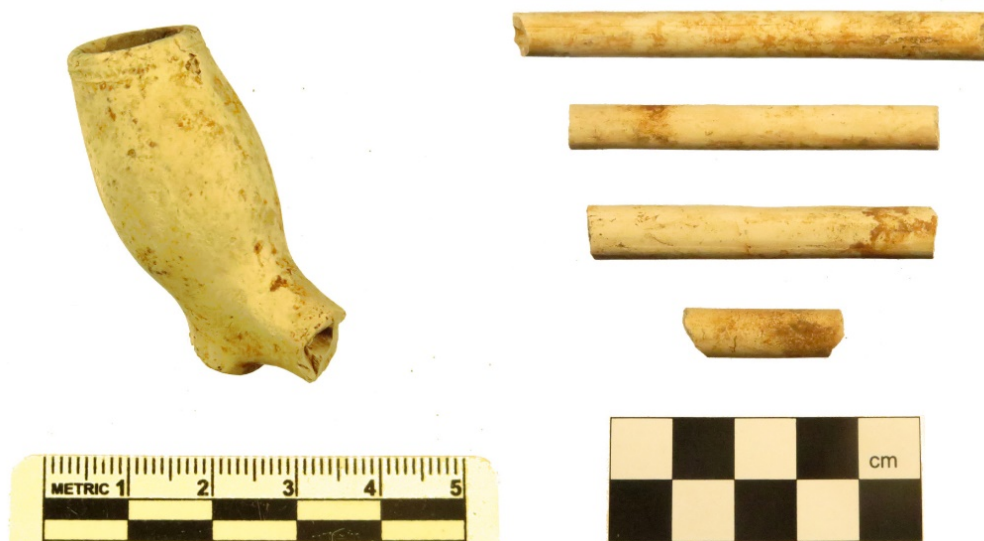
Figure 18 Clay pipe bowl from TT6-1 (left) and stems from TT6-2 (right)

A large number of fragmentary clay tobacco pipe stems were unearthed. Of the ten stem fragments that were retained, none had markings that would assist identification; only one pipe bowl was found during the excavations (Figure 18).

The pipe bowl, which is largely intact, was recovered from TT6-1. This bulbous bowl had a small diameter (15.4mm) and a short stubby base or heel. There are no identifying markings on the pipe, other than rilling around the rim of the bowl. Judging by the size and angle of the bowl and the flat heel, it is possible that this is a Dutch pipe and dates from the late 17th or early 18th century. Though comparison may be made with clay pipes from other port settings in Limerick (Wiggins et al. 2016: 451-459) and Galway (Fitzpatrick et al. 2004: 427-447), the lack of markings hinder more certain identification of this pipe.

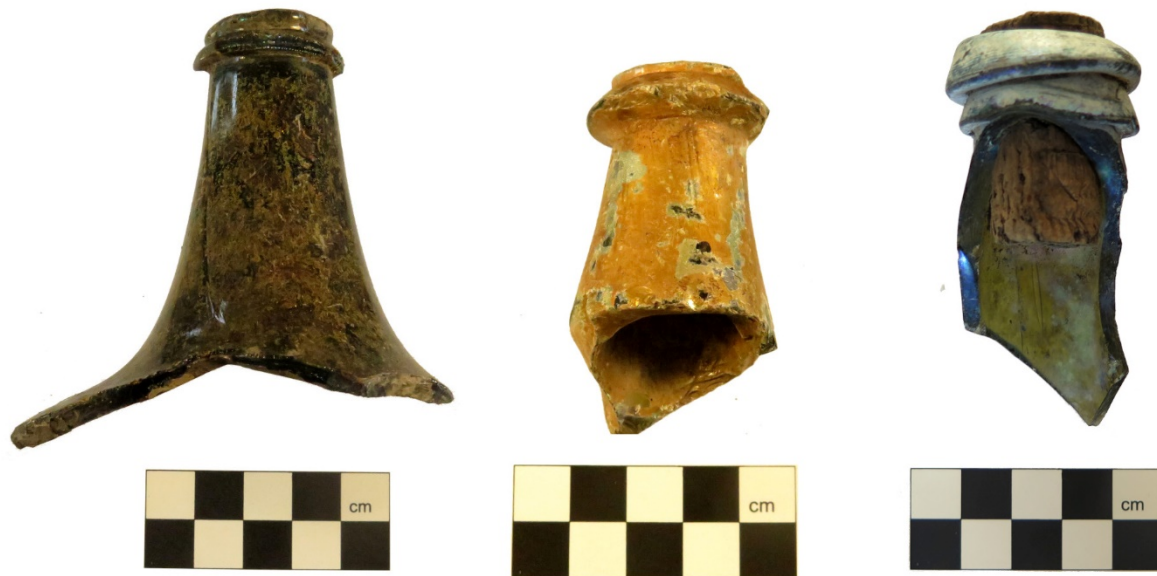
Figure 19 Glass bottle finishes from (left to right) TT1-3, TT6-2 and TT5-1

The glass artefacts recovered from the excavations consist mainly of bottles; a small amount of modern window glass was found, but no vessel glass. Glass bottles were recovered especially from trenches in Area 5 which yielded the largest, most intact fragments. Most are large wine bottles, with base diameters of 140-180mm, and can be dated to the 18th-early 19th century and relate to either consumption refuse from the former buildings at Merchant's Quay or trading activity, though there were no concentrations large enough to identify a 'bottle dump' as such. From TT5-1, the neck and finish of a bottle still retains its cork in place (Figure 19).

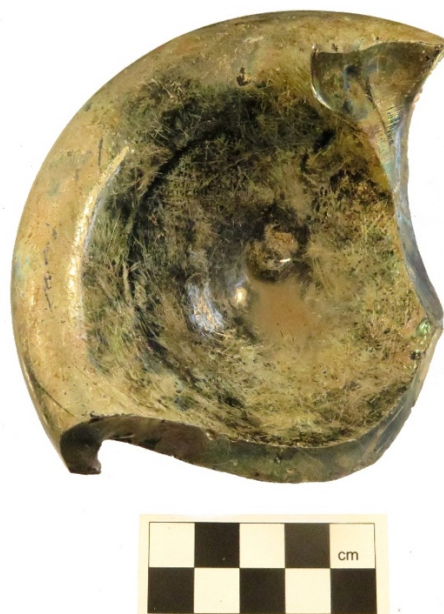
Figure 20 Large glass bottle base from TT6-2

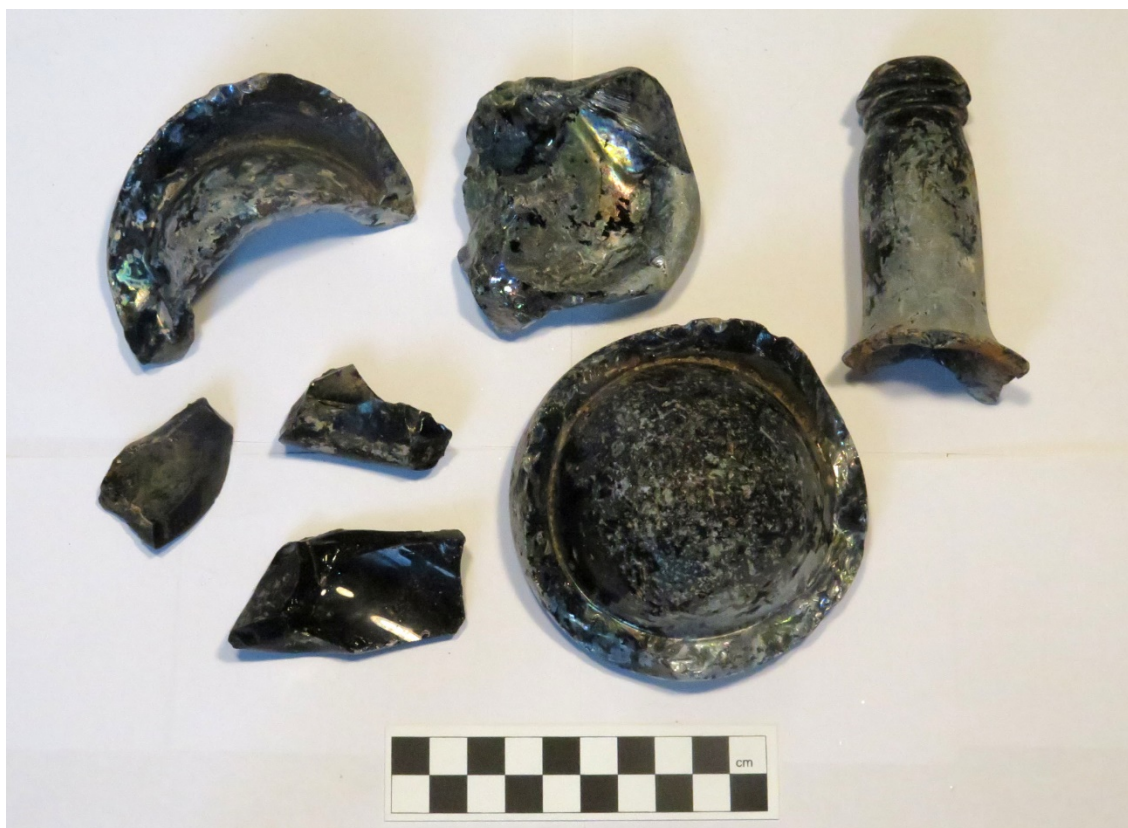
Figure 21 *Bottle glass from TT5-2*

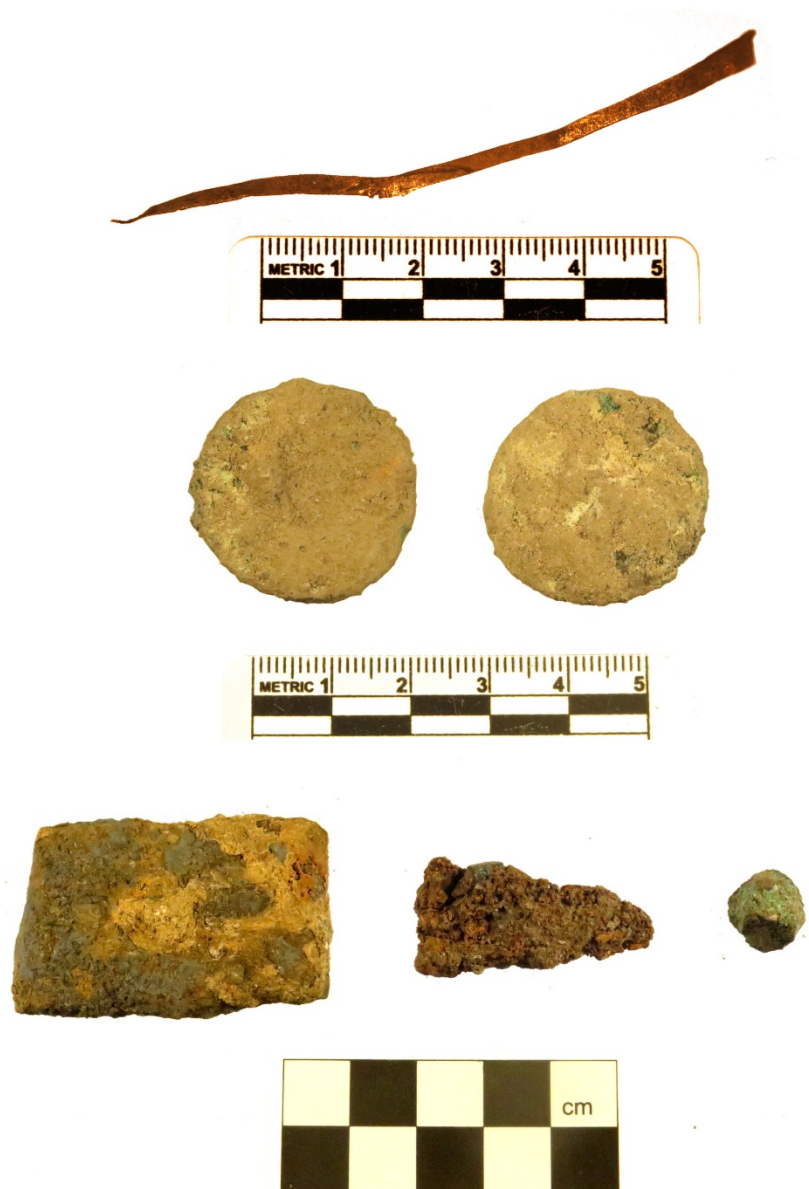
Figure 22 Metal artefacts: a gold strip from TT6-4 (top); copper coin from TT6-1 (middle); lead, iron and copper fragments from TT6-2 (bottom)

A circular coin or token was recovered from TT6-1D, directly beside the Potato Market wall. It has heavy accretions; until conservation has been done it is impossible to identify. It appears to have a high copper content, judging from the green that shows though in places where there are not thick accretions. Its diameter is 29.3mm and its width is 3mm.

The other three metal artefacts, all from TT6-2, are a square shaped piece of lead, a small spherical fragment of copper and a triangular shaped fragment of iron.

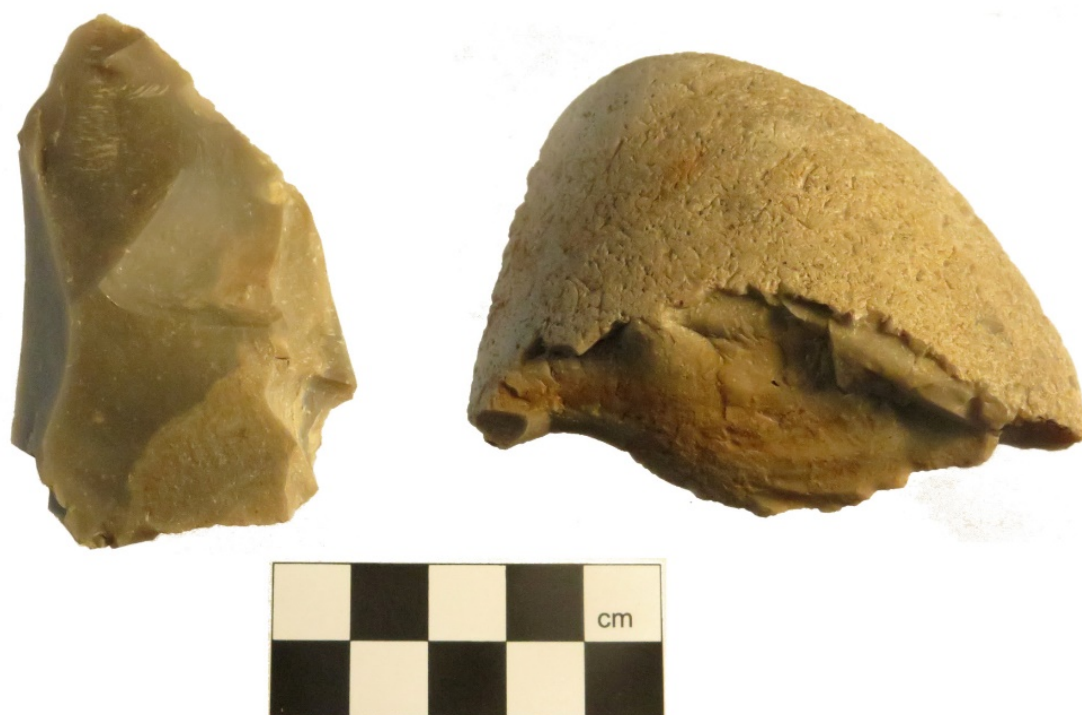
Figure 23 Flaked quartzite from TT6-1

Two flaked quartzite artefacts were recovered from the lower fills of TT6-1C (Figure 23). These come from depths below the level of the east/west aligned wall. Pieces of flint were also recovered from these depths, but these are rounded and non-artefactual. However, the quartzite objects appear to bear flake scars, and one has a prominent bulb of percussion. Though there are not clear morphological characteristics, it is possible that these are prehistoric artefacts that derive from alluvial fills beside the River Shannon. Notably, neither flint nor quartzite is naturally occurring in the Limerick area.

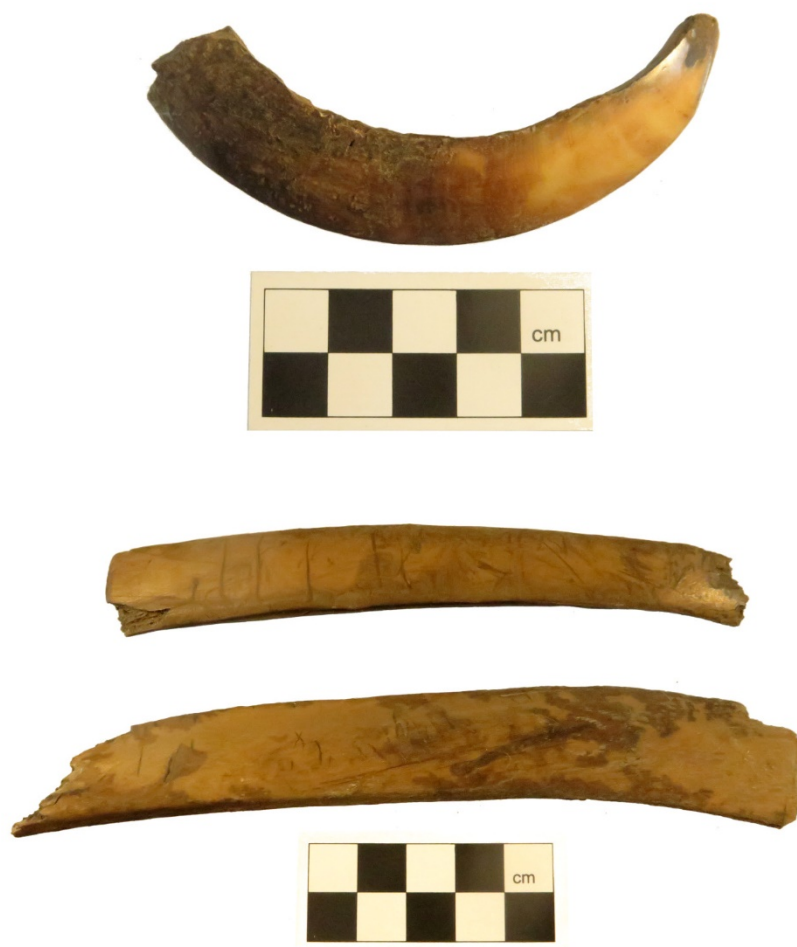
Figure 24 Tusk from TT6-1 and bones with butchery marks from TT6-2

A large quantity of bone was present in TT6-2, and some of these bore butchery marks, as the illustrated examples show (Figure 24). This appears to be consumption refuse, probably pre-dating the Georgian renovations of the area, though it might equally derive from the terrace of houses located here during the first half of the 19th century.

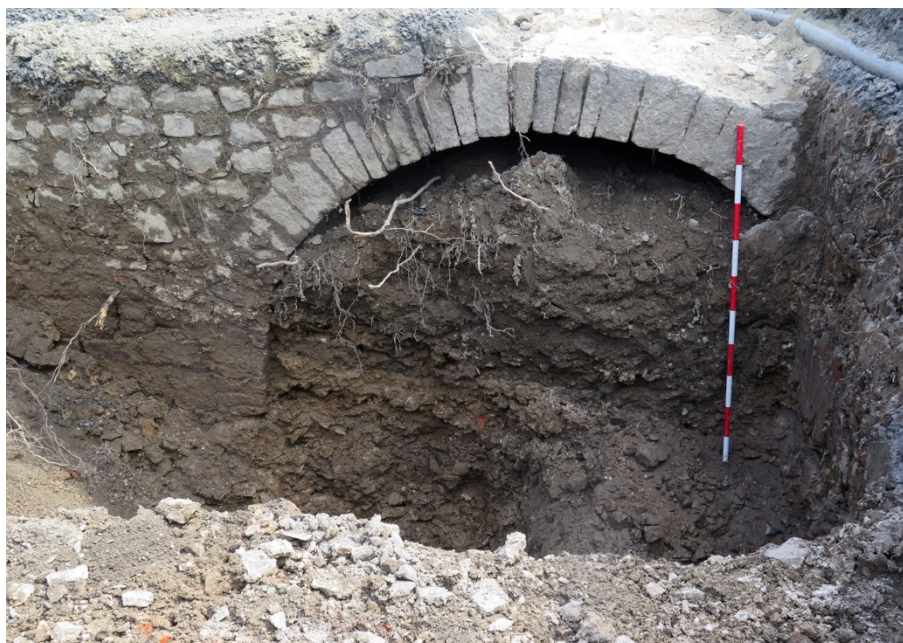
Trench: TT1-1	Context: C1-1-05	Dates excavated: 28/5/20
Feature type: Arch of barrel vault/tunnel		
Co-ordinates (ITM): 557685.2113, 657687.6101		
Minimum depth (ASL): 3.8161m		
Depth of feature below surface: 0.28-3.4m		
Base of feature reached? N (foundation reached)		
Alignment: WSW/ENE, 70°		
Description:	Stone built barrel vault with north-facing arch exposed, directly to the west of C1-1-06. The arch has a span of 3.65m and height of 1.85m from the impost to the keystones. The arch and abutment are set on a plinthed foundation of rectangular blocks.	
Date of construction:	17th century mill/brewery associated with Golden Mills and City Brewery (established 1739).

Figure 25 Arch of barrel vaulted tunnel in TT1-1 (C1-1-05)

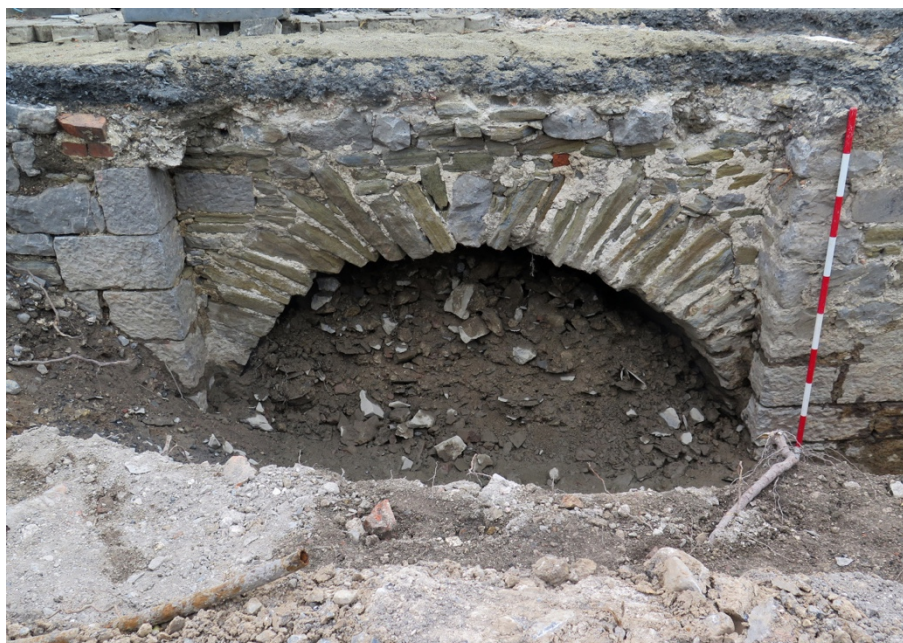
Trench: TT1-1	Context: C1-1-06	Dates excavated: 28/5/20
Feature type: Arch of barrel vault/tunnel		
Co-ordinates (ITM): 557692.4252, 657690.9870		
Minimum depth (ASL): 3.8161m		
Depth of feature below surface: 0.3-2.2m		
Base of feature reached? N		
Alignment: WSW/ENE, 70°		
Description:	Stone built barrel vault with north-facing arch exposed, directly to the east of C1-1-05. The arch has a span of 3.04m and exposed height of more than 1.5m. Voussoirs are sandstone and the keystone is limestone keystone, all bonded with thickly applied white mortar	
Date of construction:	17th century mill/brewery, associated with Golden Mills and City Brewery (established 1739)

Figure 26 Arch of barrel vaulted tunnel in TT1-1 (C1-1-06)
