KING'S ISLAND
FLOOD RELIEF SCHEME

**EIAR Addendum Report
Volume 3**

King's Island Flood Relief Scheme Preliminary Stratigraphic Report on Archaeological Testing (Volume 2)

Archaeological Testing for the proposed King's Island Flood Relief Scheme, Limerick

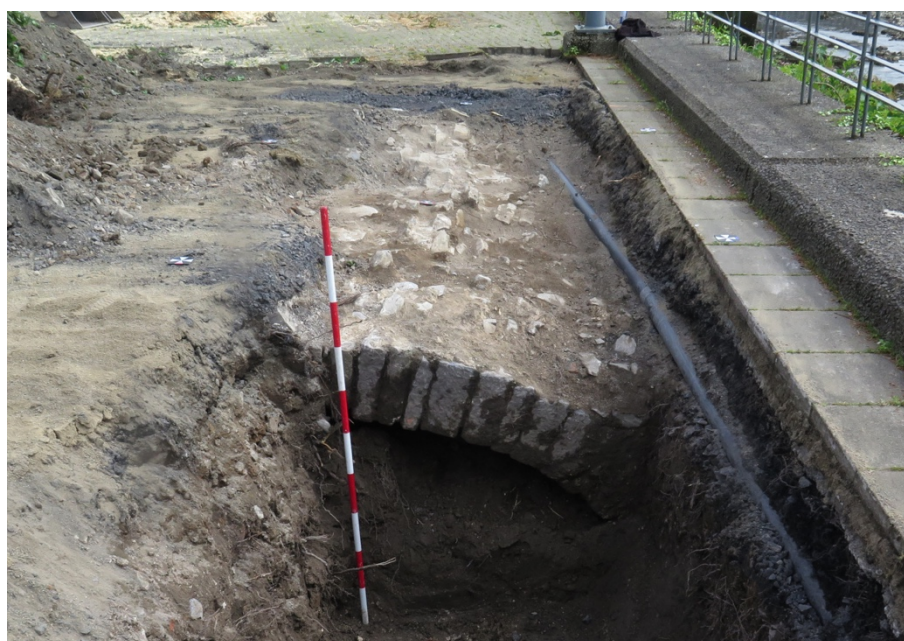
Trench: TT1-2	Context: C1-2-04	Dates excavated: 26/5/20
Feature type: Barrel vault		
Co-ordinates (ITM): 557685.2113, 657687.6101		
Minimum depth (ASL): 3.8161m		
Depth of feature below surface: 0.28m (max depth of 3.4m reached in TT1-1)		
Base of feature reached? N		
Alignment: N/S		
Description:	Top of stone barrel vault – arch excavated at north end in TT1-1 (C1-1-05)	
Date of construction:	17th century mill/brewery, associated with Golden Mills and City Brewery (established 1739)

Figure 27 Barrel vault/tunnel in TT1-2 (C1-2-04)

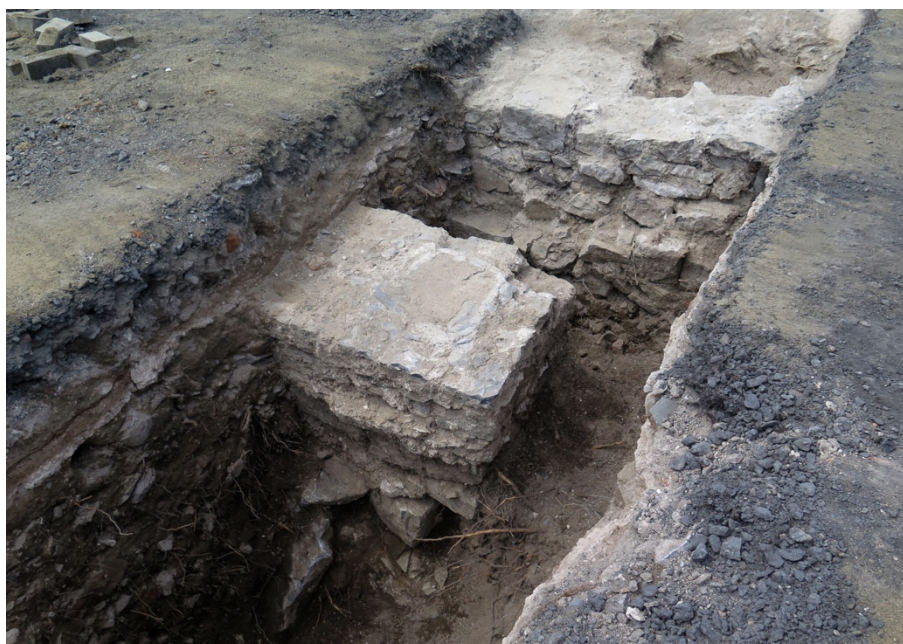
Trench: TT1-3	Context: C1-3-12	Dates excavated: 2/6/20
Feature type: Pier/pad		
Co-ordinates (ITM): 557689.5756, 657685.7840		
Minimum depth (ASL): 3.5508m		
Depth of feature below surface: 0.55-1.65m		
Base of feature reached? Y		
Alignment: N/S		
Description:	Mortared limestone pad to support superstructure; circular shadow of mortar on top where column base would have once sat	
Date of construction:	17th century internal foundations for brewery

Figure 28 Pier/pad in TT1-3 (C1-3-12)

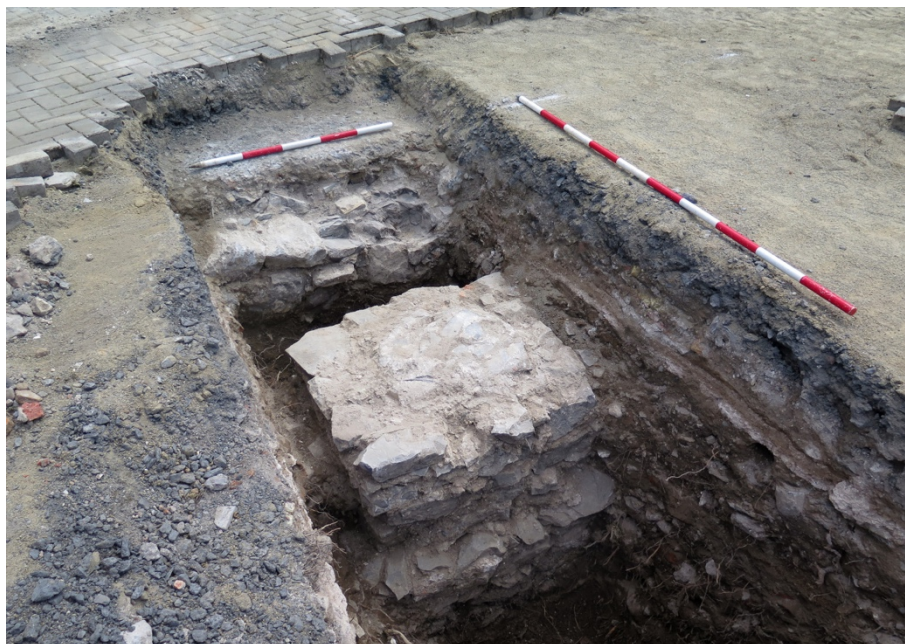
Trench: TT1-3	Context: C1-3-13	Dates excavated: 2/6/20
Feature type: Pier/pad		
Co-ordinates (ITM): 557692.5662, 657685.9035		
Minimum depth (ASL): 3.6612m		
Depth of feature below surface: 0.5-1.3m		
Base of feature reached? Y		
Alignment: N/S		
Description:	Mortared limestone pad to support superstructure; circular shadow of mortar on top where column base would have once sat	
Date of construction:	17th century internal foundations for brewery

Figure 29 Pier/pad in TT1-3 (C1-3-13)

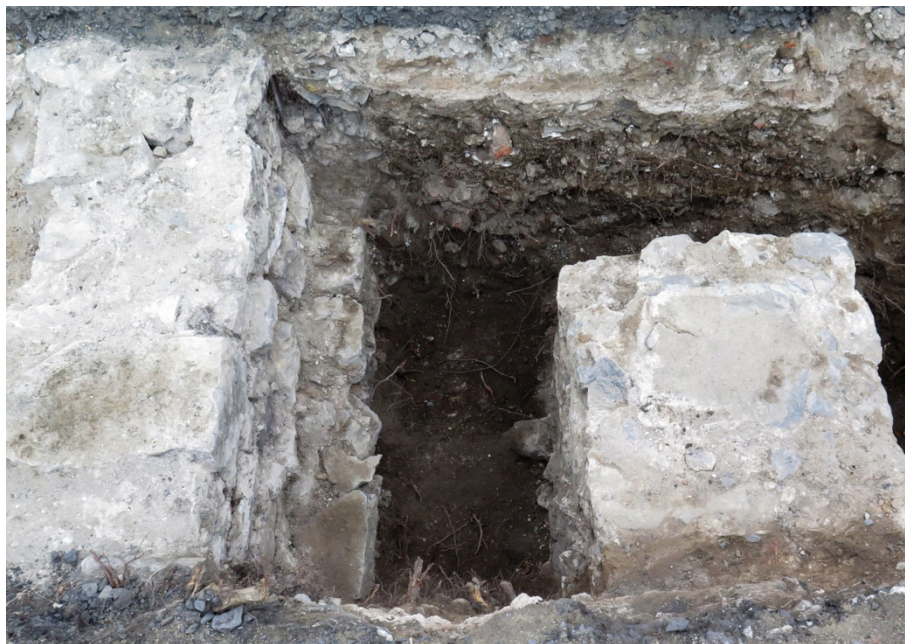
Trench: TT1-3	Context: C1-3-14	Dates excavated: 2/6/20
Feature type: Wall abutment		
Co-ordinates (ITM): 557688.0750, 657684.9957		
Minimum depth (ASL): 3.8278m		
Depth of feature below surface: 0.45-1.2m		
Base of feature reached? N		
Alignment: NNW/SSE, 170°		
Description:	Abutment wall of barrel vault running to the west (C1-1-05)	
Date of construction:	17th century

Figure 30 Abutment wall of barrel vault in TT1-3 (C1-3-14)

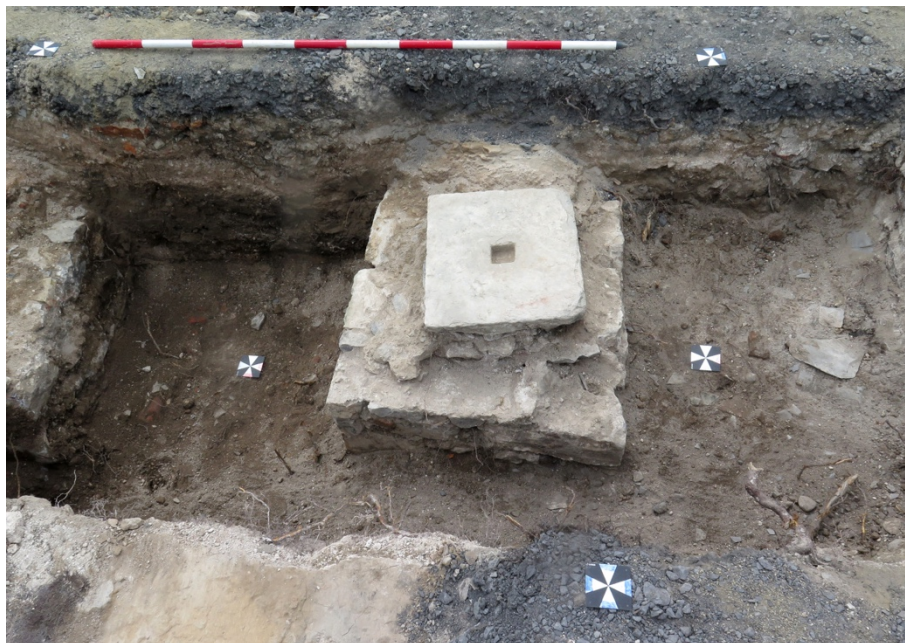
Trench: TT1-3a	Context: C1-3a-08	Dates excavated: 8/6/20
Feature type: Pier/pad		
Co-ordinates (ITM): 557689.5414, 657687.8959		
Minimum depth (ASL): 3.8788m		
Depth of feature below surface: 0.3-0.8m		
Base of feature reached? N		
Alignment: N/S		
Description:	Mortared limestone pad with socketed square column base in centre to support upright	
Date of construction:	17th century internal foundations for brewery

Figure 31 Pier/pad in TT1-3a (C1-3a-08)

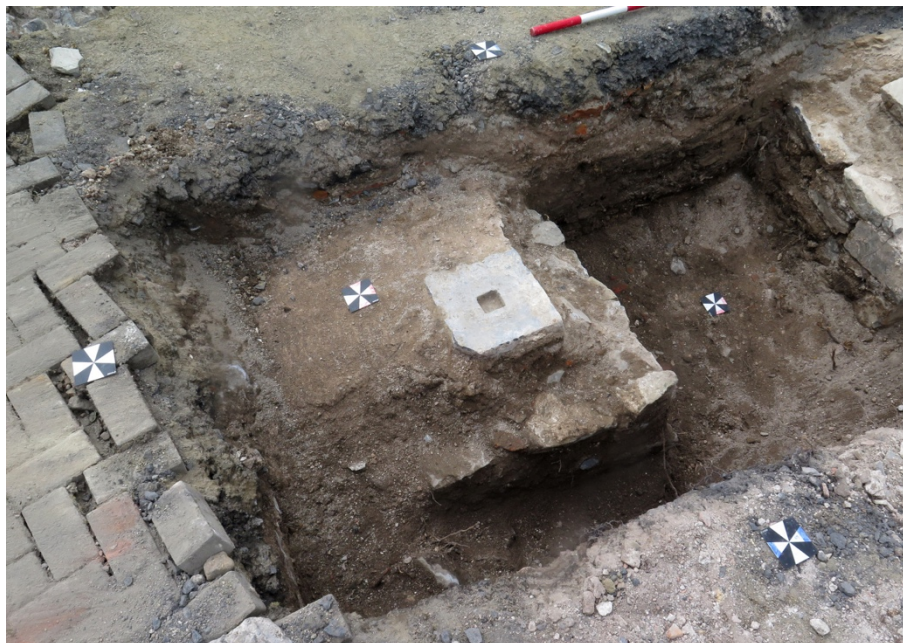
Trench: TT1-3a	Context: C1-3a-09	Dates excavated: 8/6/20
Feature type: Pier/pad		
Co-ordinates (ITM): 557691.6520, 657688.4511		
Minimum depth (ASL): 3.9121m		
Depth of feature below surface: 0.3-0.8m		
Base of feature reached? N		
Alignment: N/S		
Description:	Mortared limestone pad with socketed square column base in centre to support upright	
Date of construction:	17th century internal foundations for brewery

Figure 32 Pier/pad in TT1-3a (C1-3a-09)

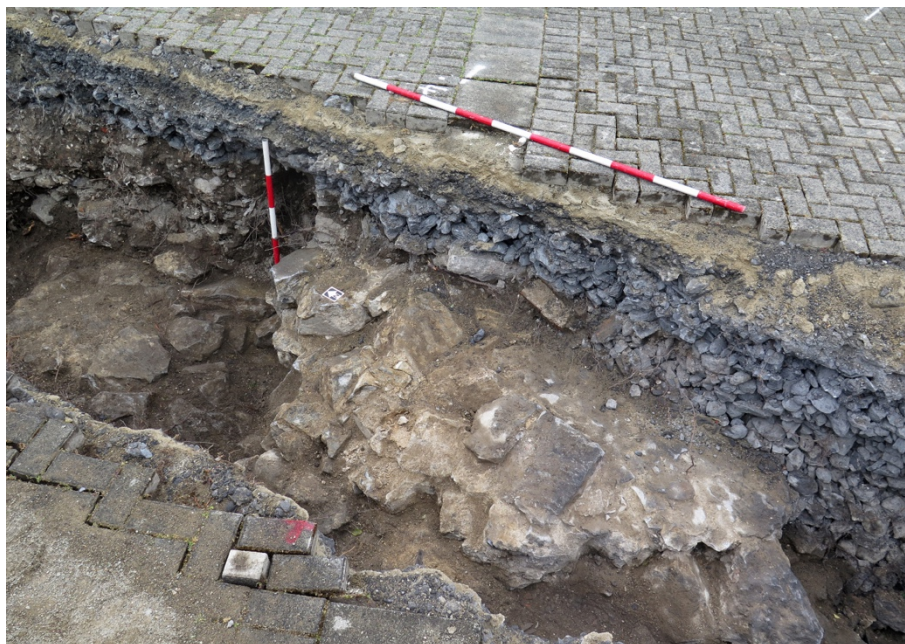
Trench: TT1-4	Context: C1-4-09	Dates excavated: 4/6/20
Feature type: Foundations		
Co-ordinates (ITM): 557695.6404, 657675.1379		
Minimum depth (ASL): 3.4511m		
Depth of feature below surface: 0.45-1.2m		
Base of feature reached? N		
Alignment: N/S (approximate)		
Description:	Heavily mortared rubble foundations at the south of TT1-4, suspected to belong to medieval bridge exposed in previous excavations that was linked to mill wheel house	
Date of construction:	Late Medieval

Figure 33 Mortared foundations in TT1-4 (C1-4-09)

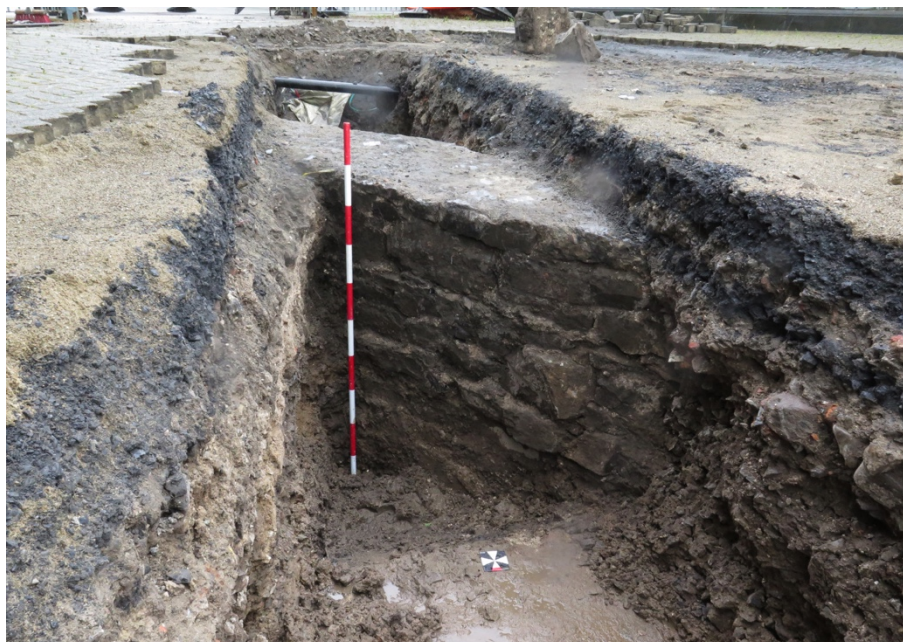
Trench: TT2-1	Context: C2-1-10	Dates excavated: 22/5/20
Feature type: Wall		
Co-ordinates (ITM): 557720.2477, 657604.5379		
Minimum depth (ASL): 3.5798		
Depth of feature below surface: 0.4-1.6m		
Base of feature reached? N		
Alignment: SW/NE, 65°		
Description:	Wall revealed for length of 2.3m, Matches with the outer western boundary wall of the Women's Prison compound. The wall is in good condition	
Date of construction:	1813, construction of the Women's Prison

Figure 34 Wall in TT2-1 (C2-1-10)

A single trench was excavated in Area 2 and exposed infilled ground abutting the foundation of the southern boundary wall for the Gaol built in built in 1811-1813. Elements of this complex have already been incorporated into the fabric of the Civic offices.
