Monthly Environmental Audit – Aug 2025

Glanmire Flood Relief Scheme

ENVIRONMENTAL AUDIT

| Audit Number | GFRS-EA-2025AUG | Date | 04/09/2025 |

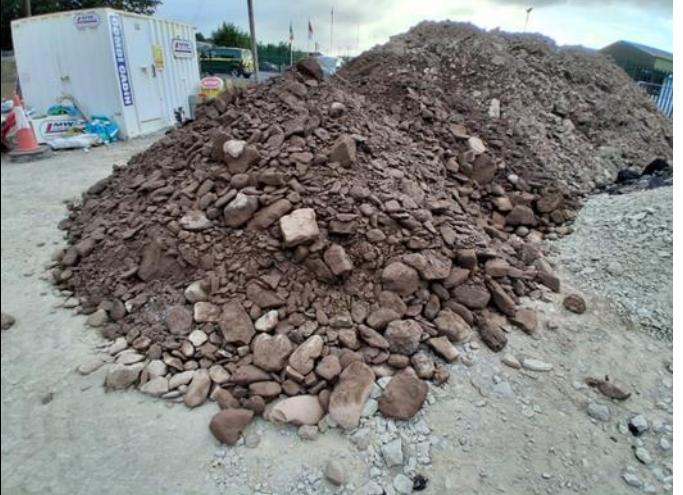
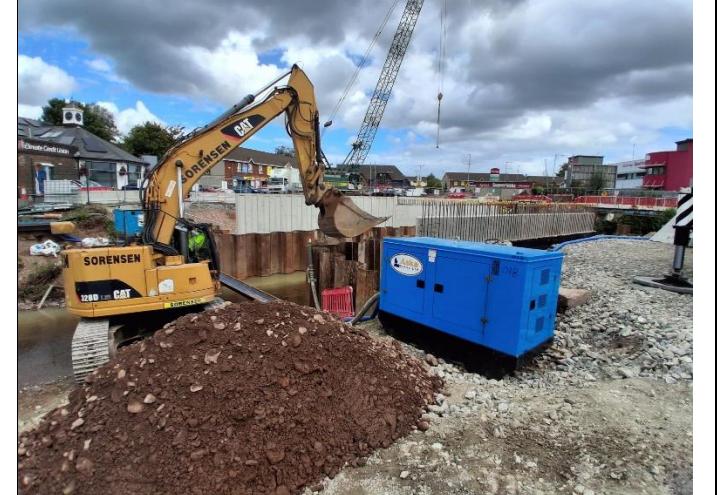
| Photograph 1 | Photograph 2 |

| Photograph 1 | Photograph 2 |
|--|--|
| Caption 1 Copper Valley Vue Installation of rock armouring and erosion matting at Copper Valley Vue | Caption 2 Copper Valley Vue |

- Installation of erosion matting on the banks of the Glenmore River and rock armouring “in the wet” continued at Copper Valley Vue.
- Installation of permanent sheetpiles “from the wet” continued at Hazelwood Shopping Centre Bridge.

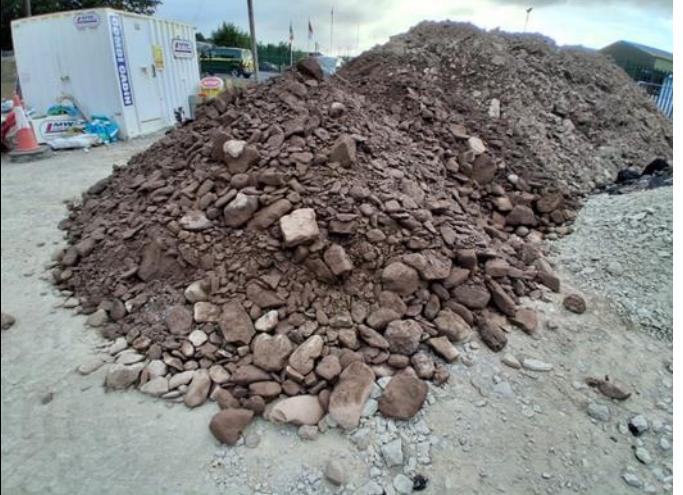
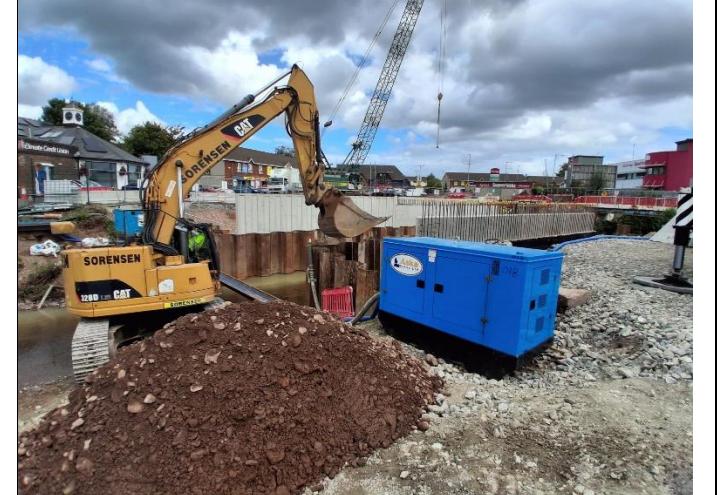
| Photograph 3 | Photograph 4 |

| Photograph 3 | Photograph 4 |
|---|---|
| Caption 3 Area 3 Site Compound @ New Line River gravels which were removed from the cofferdam of the eastern abutment of Hazelwood Shopping Centre Bridge and stored in Area 3: Site Compound @ New Line, were then reused instream on the western riverbank of the Glashaboy River at the base of the western abutment of the Hazelwood Shopping Centre Bridge. | Caption 4 Hazelwood Shopping Centre Bridge |

- Installation of rock armouring commenced upstream of Hazelwood Bridge and overflow culvert on the 22/08/25.
- River gravels were removed from the cofferdam of the eastern abutment of Hazelwood Shopping Centre Bridge and stored in Area 3: Site Compound @ New Line. These gravels were then reused instream on the western riverbank of the Glashaboy River at the base of the western abutment of the Hazelwood Shopping Centre Bridge on 26/08/24 to assist with bringing the riverbed and margin up to the required design level.

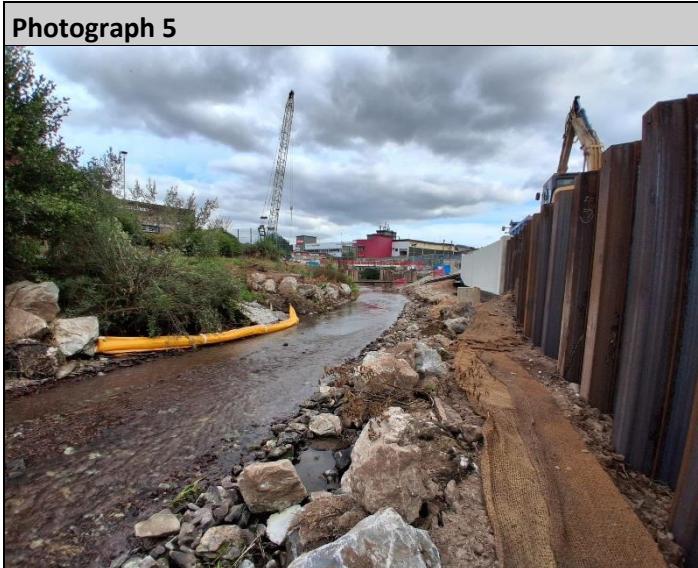
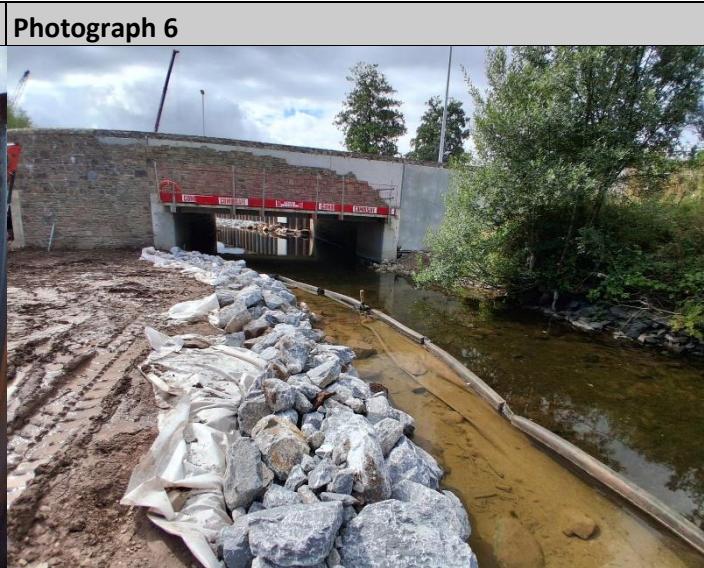
| Photograph 5 | Photograph 6 |

| Photograph 5 | Photograph 6 |
|---|---|
| Installation of rock armouring at Hazelwood | |

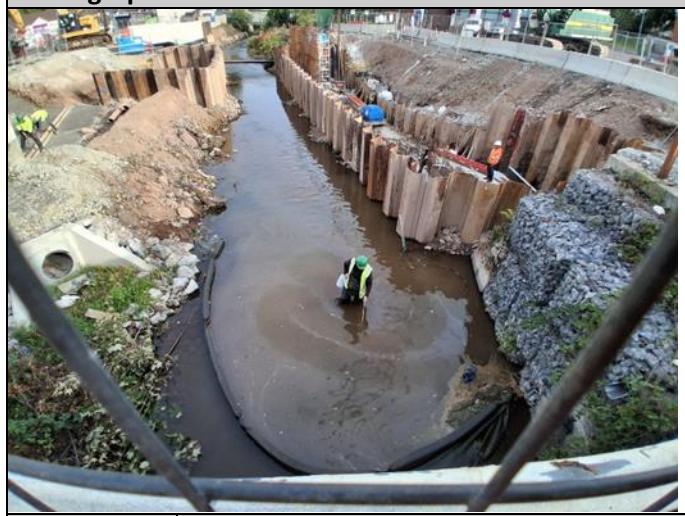
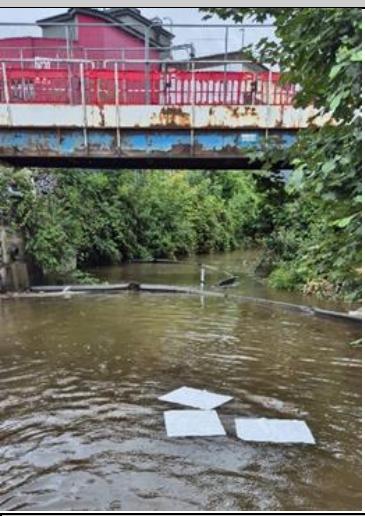
| Photograph 7 | Photograph 8 |

| Photograph 7 | Photograph 8 |
|--|---|
| Deployment of hydrocarbon control measures at Hazelwood to address a localised hydrocarbon sheen | |

- Hydrocarbon control measures were deployed at Hazelwood Shopping Centre Bridge due to the presence of a localised hydrocarbon sheen between 12/07/- 06/08/25 which included Bioversal RC, oil socks and oil absorbent pads as required. Machines working instream were also sprayed with Bioversal RC prior to deployment. As a precaution, shuttering pans were also moved and covered in plastic to prevent run off of shuttering oil during periods of heavy rainfall. A single definitive source of hydrocarbon contamination has not been confirmed as the hydrocarbon sheen occurred on both wet and dry days (when there was no runoff into stormwater gullies within the works area) and on days when there were no machines working instream.

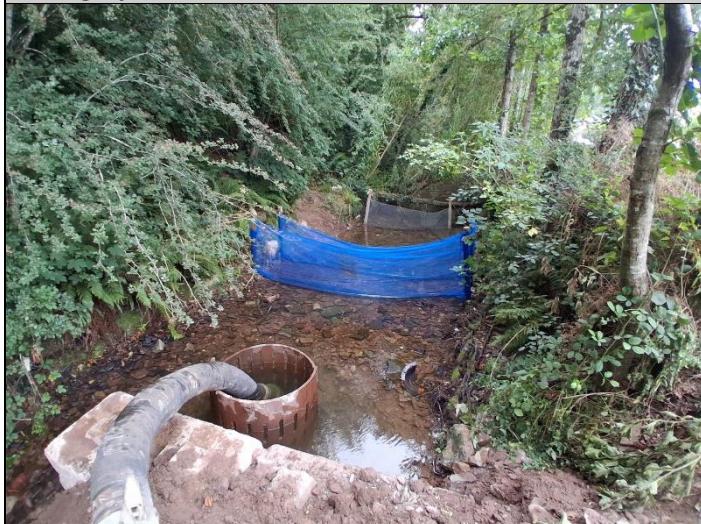
Photograph 9

Brooklodge

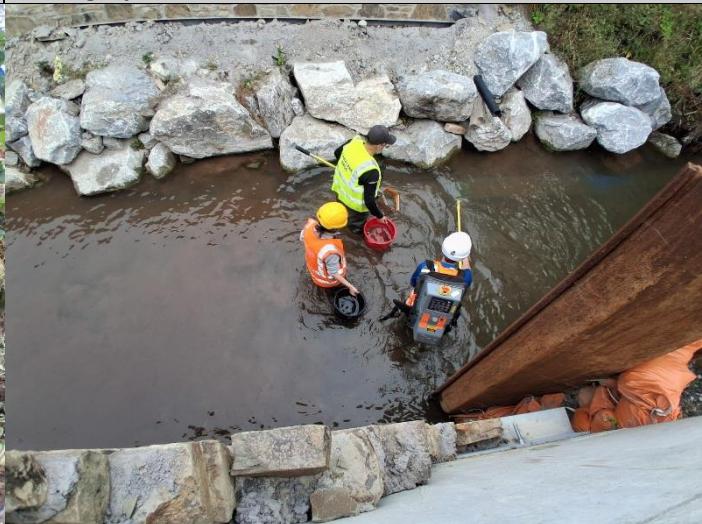
Photograph 10

Electrofishing to create an instream dry works area was undertaken by Triturus Environmental Ltd.

- E-fishing was undertaken by Triturus Environmental Ltd on the 29/08/25 at Brooklodge Culvert to further extend the dry instream works area.
- Monitoring of 2 no. Otter holts (No.s N7A and N7B) continued at Meadowbrook under the licence to Photograph/Film a Protected Wild Animal (Otter).

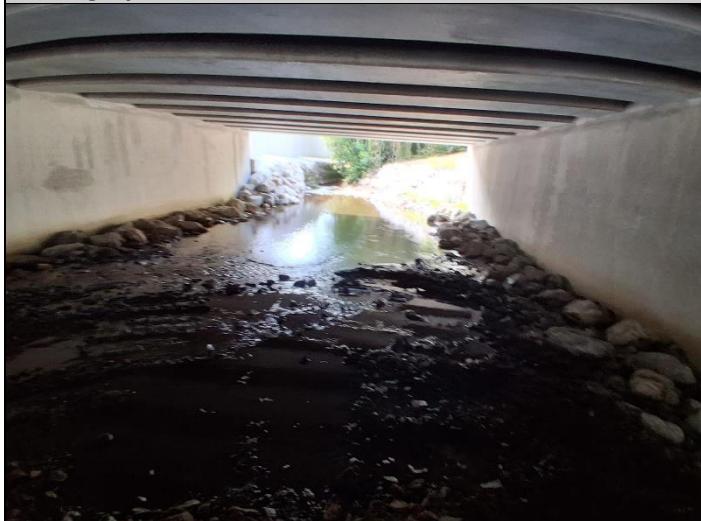
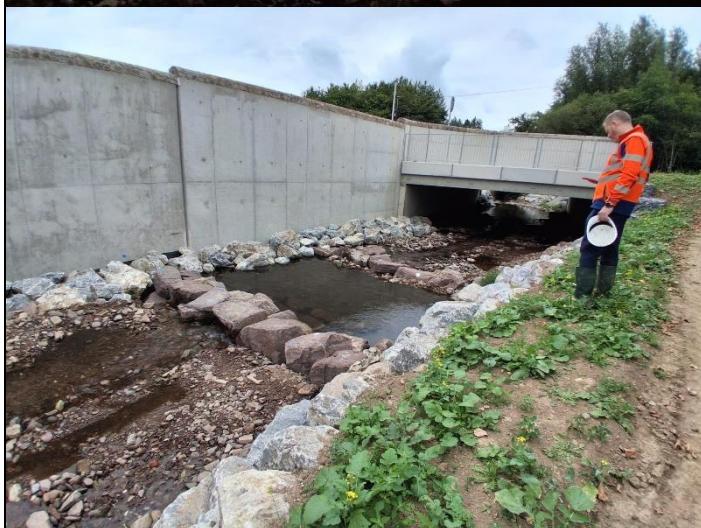
Photograph 11

New Line

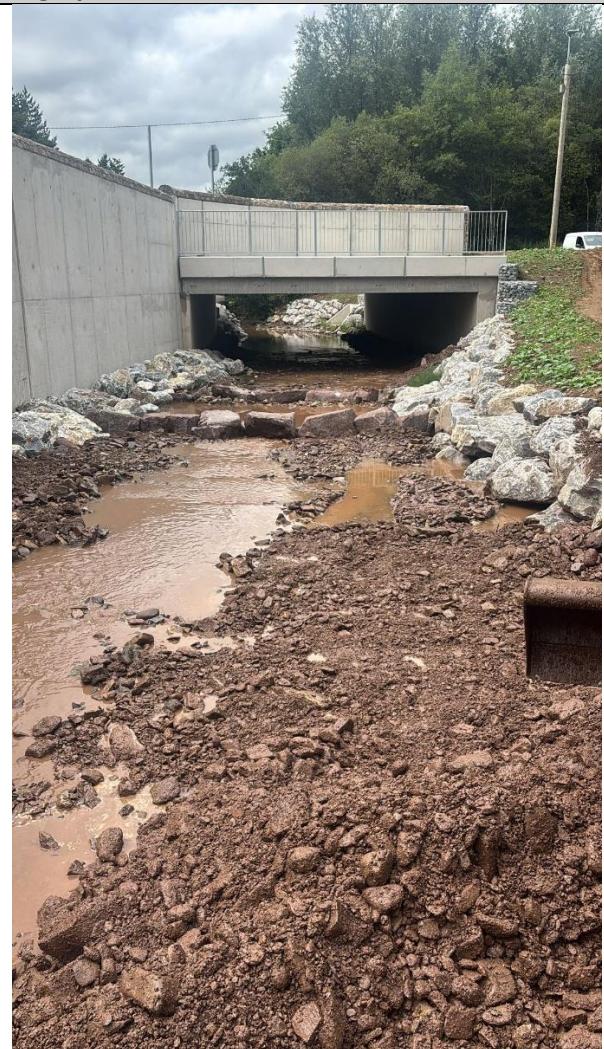
Photograph 12

The bed of river gravels which had deposited within New Line culvert were recovered and placed upstream of the step pools.

- Monitoring of the silt control measures set up at the designated infiltration area (beside the Credit Union) to accommodate the dewatering of the eastern abutment of Hazelwood Shopping Centre Bridge continued.
- The bed of deposited river gravels which had built up underneath New Line culvert were recovered and placed upstream of the step pools at New Line on the 13-14/08/25.
- E-fishing was undertaken by Triturus Environmental Ltd on the 14/08/25 at Brooklodge Culvert to facilitate the creation of a dry instream works area to accommodate the completion of RC Walls, rock armouring and step pools for fish passage at Brooklodge Culvert.
- Instream works to restore the Hydromorphology of the Glenmore River between Brooklodge Culvert
