## **Environmental Report November 2025**

Glashaboy Flood Relief Scheme

**Document code:** FFEC-GFRS-2025-011

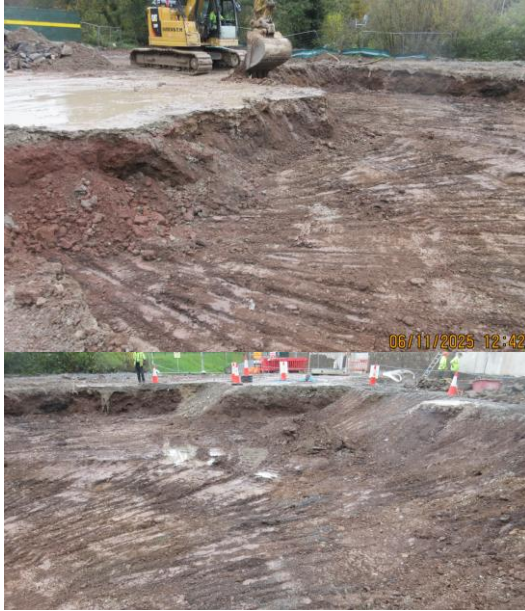
| Item number | Date | Comment | Image | ECoW Action/Recommendation | Sorensens's Action response |
|---|---|---|---|---|---|
| 11.1 | 05/11/2025 | <p>Construction of the burial cell for all IAPS vector material stockpiled throughout the scheme commenced at Circus Field.</p> <p>Given that previous land clearance mapping indicated knotweed at this location, supervision for possible Japanese knotweed rhizomes during the initial excavations is required.</p> | | Supervision by an IAPS Specialist during the initial excavation of surface layers is recommended to confirm that no rhizomes are present. | As works progressed, the IAPS Specialist Ecologist undertook regular monitoring, at the location of the onsite burial cell at Circus Field, for the presence of Japanese & Bohemian knotweed. |

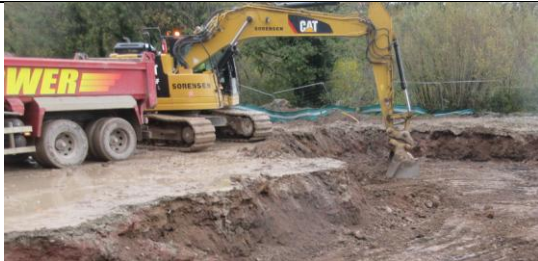
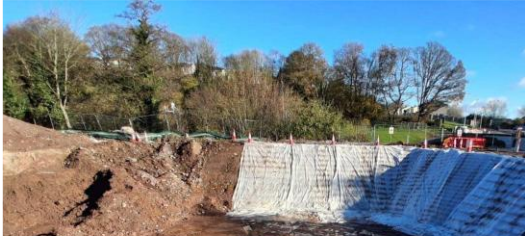
| Item number | Date | Comment | Image | ECoW Action/Recommendation | Sorensens's Action response |
|---|---|---|---|---|---|
| 11.2 | 05/11/2025 | The berm previously installed as a root protection zone (RPZ) in front of the river treeline, has been removed, with only the eastern edge of the current excavation remaining as a reference. | | Establish a more highly visible RPZ to help minimise the risk of accidental root damage during the ongoing excavation works. | A cone and rope barrier was installed along the eastern boundary of Circus Field parallel to the riparian corridor of the Glashaboy river and successfully maintained throughout the excavation works. |

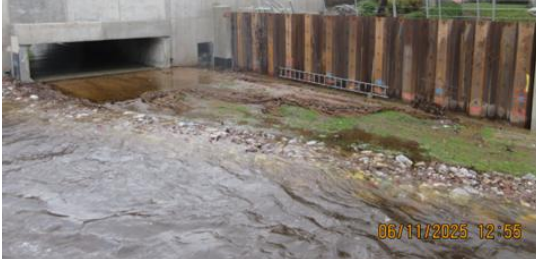
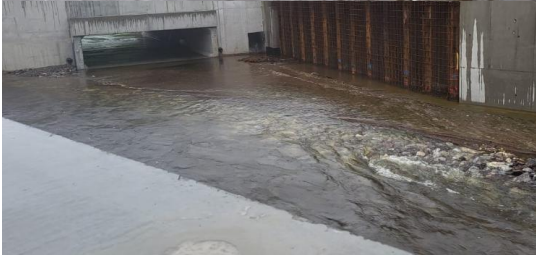
| Item number | Date | Comment | Image | ECoW Action/Recommendation | Sorensens's Action response |
|---|---|---|---|---|---|
| 11.3 | 06/11/2025 | Several sections of coir mesh positioned at the outlet of the overflow culvert at Hazelwood have been washed out and are now bunched together, leaving areas of exposed ground where grass seed has not yet established. Minimal washout occurred here as most material used was gravel and stone below a thin layer of soil. | | Consider reinstalling coir mesh securely once water levels recede and it is safe to do so. | Area to be completed when river levels allow including the use of coir mesh if required. |

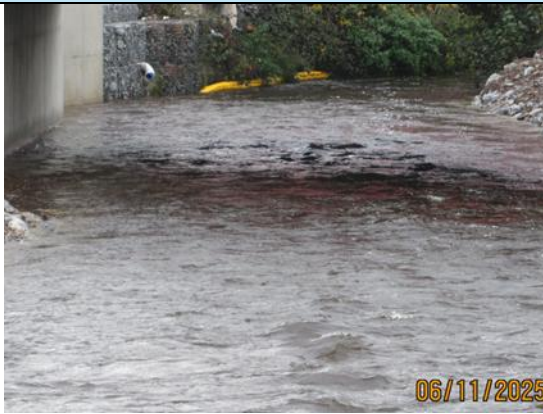
| Item number | Date | Comment | Image | ECoW Action/Recommendation | Sorensens's Action response |
|---|---|---|---|---|---|
| 11.4 | 06/11/2025 | A yellow silt curtain remains in the river just downstream of the pedestrian bridge at Hazelwood. | | Remove when safe to do so. | While all of the black silt curtains were removed by the 19th of October 2025 (end of the instream works window extension), one yellow silt curtain was left in situ given the depth of water along the river margin at this location. It is to be removed when water levels and velocity in the Glashaboy river are lower. |

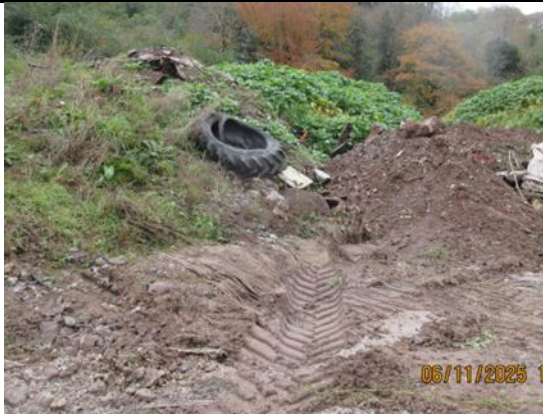
| Item number | Date | Comment | Image | ECoW Action/Recommendation | Sorensens's Action response |
|---|---|---|---|---|---|
| 11.5 | 06/11/2025 | The wood mulch stored within the temporary cell, arising from tree clearance works at Sallybrook, was reviewed. It was noted that the mulch may be combined with the bulk soil material, subject to confirmation that the level of decomposition is suitable for incorporation into the permanent cell. | | Carry out checks on the mulch material once accessible to assess its suitability for inclusion in the permanent cell, and to determine the most appropriate method for its incorporation. | The bark mulch in the Temporary Holding Facility was 'turned' on three occasions to accelerate the decomposition process. It is proposed to mix the bark mulch arisings through the soil in the Temporary Holding Facility prior to disposal in the Onsite Burial Cell. |

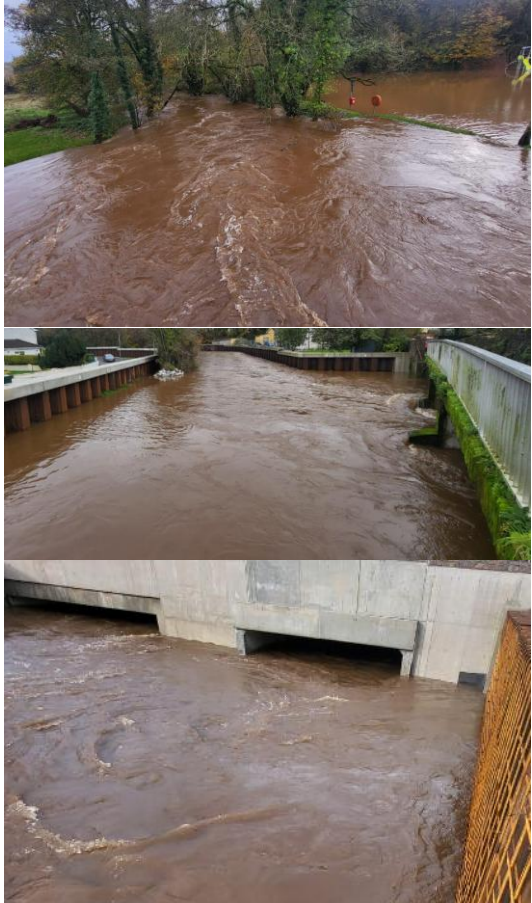
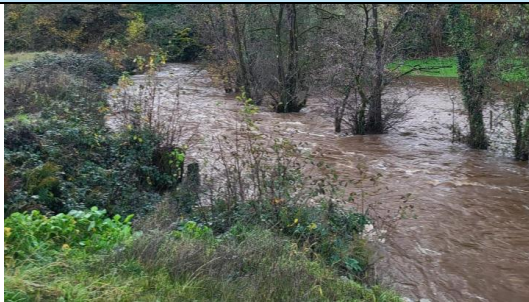
| Item number | Date | Comment | Image | ECoW Action/Recommendation | Sorensens's Action response |
|---|---|---|---|---|---|
| 11.6 | 10/11/2025 | Periods of heavy rainfall resulted in elevated water levels and localised flooding in the surrounding area. All installed flood defence measures proofed successful. | | The ER team inspected and recorded the high water event. | No action required. |

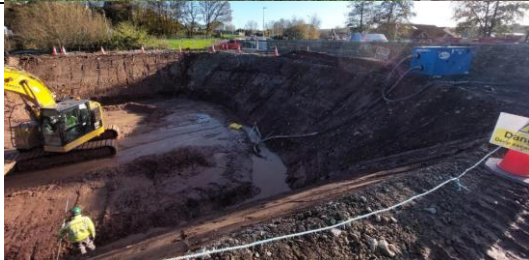
| Item number | Date | Comment | Image | ECoW Action/Recommendation | Sorensens's Action response |
|---|---|---|---|---|---|
| 11.7 | 10/11/2025 | Permit to Pump No. 151 was issued to facilitate the dewatering of the excavation for the burial cell at Circus Field. | | Reviewed permit to pump and pump set up. | Pumped proceeding successfully through the works as required to control water levels within the excavation. |

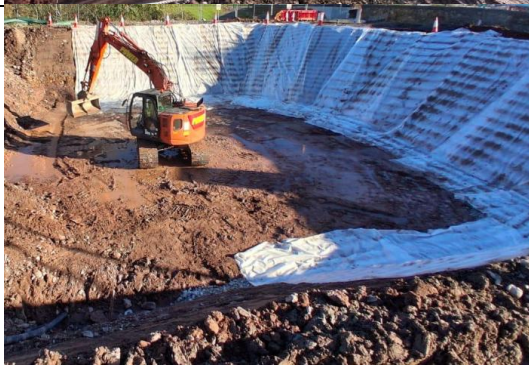
| Item number | Date | Comment | Image | ECoW Action/Recommendation | Sorensens's Action response |
|---|---|---|---|---|---|
| 11.8 | 20/11/2025 | Terram layers were added to the steep excavations sides to ensure cell membrane integrity. | | Inspections of the works were ongoing through the works. | Works progressed steadily throughout the month, with no delays, setbacks, or issues encountered. |

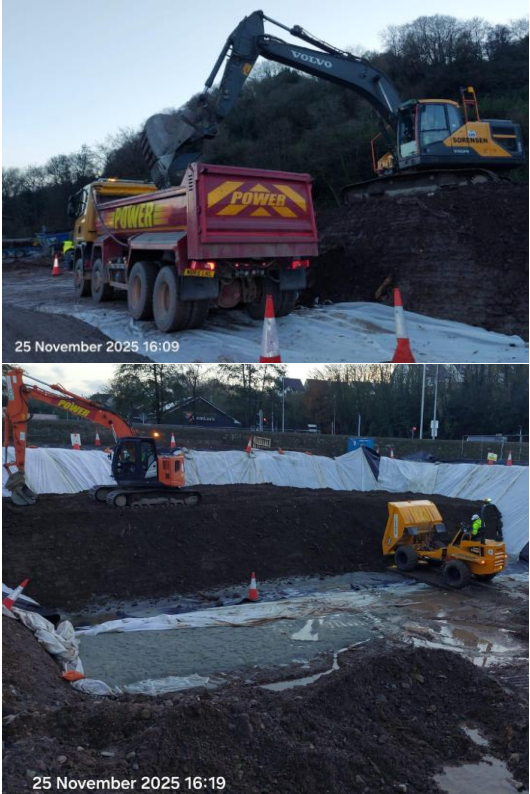
| Item number | Date | Comment | Image | ECoW Action/Recommendation | Sorensens's Action response |
|---|---|---|---|---|---|
| 11.10 | 25/11/2025 | The transportation of IAPS Vector material from the Temporary Holding Facility in Sallybrook to the burial cell at Circus Field commenced on 25/11/2025 under NPWS Licence No. Reg 49 58/2024 Extended. | <p>25 November 2025 16:09</p> <p>25 November 2025 16:19</p> | Inspections of the works were carried out on an ongoing basis throughout the construction period. | The removal of vector material from the temporary holding facility in Sallybrook was initiated and proceeded under the supervision of the IAPS Specialist Ecologist. |
