TT4-4

TT4-4 was located to the west of TT4-3. It was orientated NNE/SSW and measured 8.5m long by 1.5m wide. It was dug to a maximum depth of 2.5m.

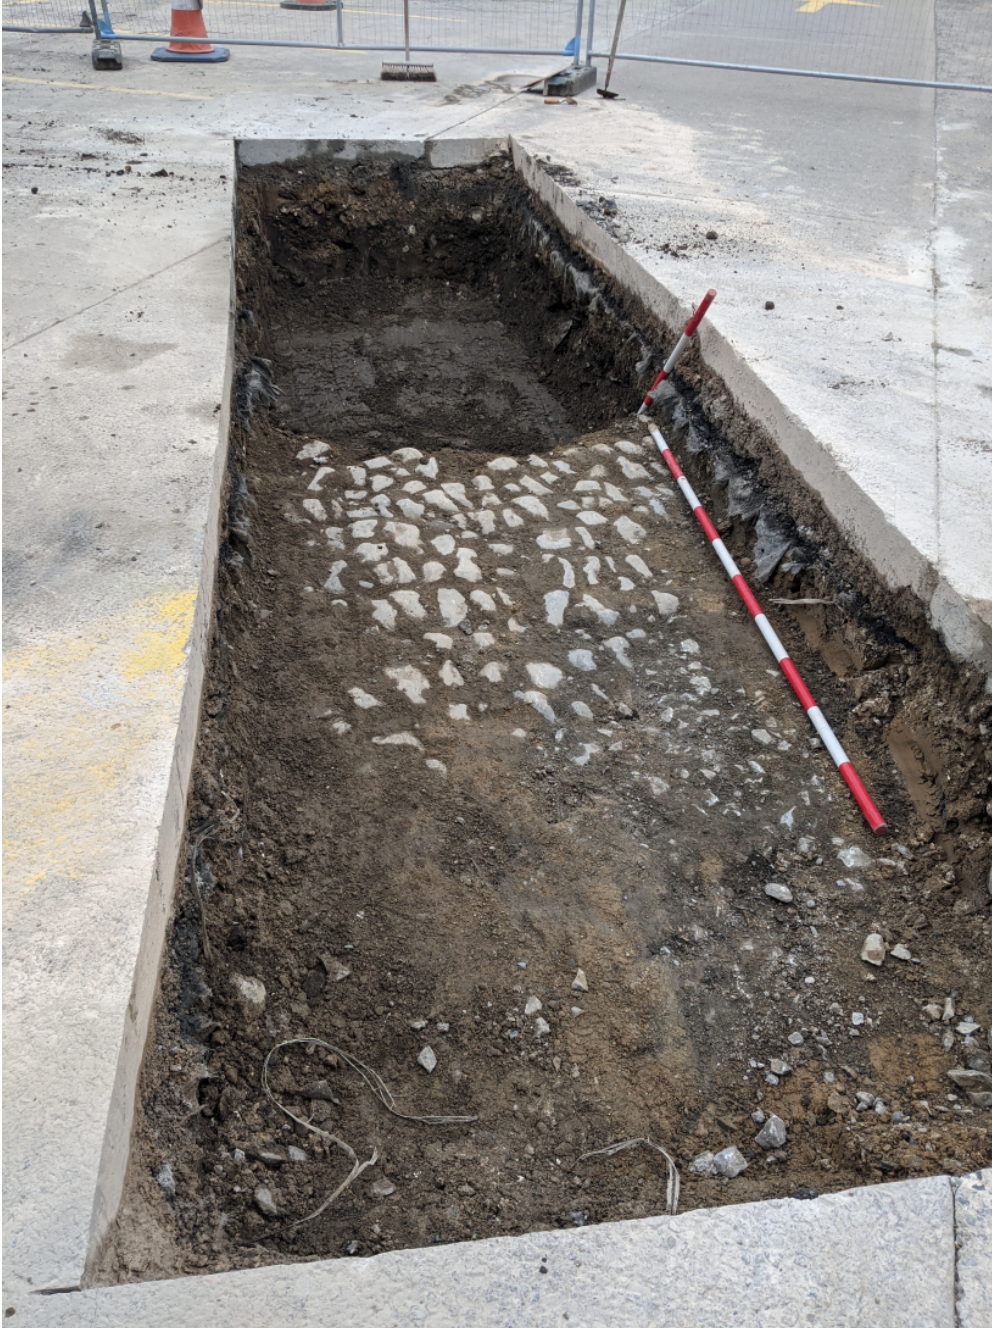
Figure 59 *TT4.3 looking NE to cobbles.*

The wall 800mm wide at the top was of uncoursed limestone rubble construction bonded with a white gritty mortar (figures 57-59). As found in TT4-1B, the northern face was very uneven and rubbly, a result of having its ashlar stone face robbed out for re-use. The southern retaining face was near vertical and fell 1.3m to a projecting plinth 300mm wide. The maximum height of the wall exposed was 1.6m in a 2.3m deep trench. The maximum width at its base, plinth included was approximately 1.45m.

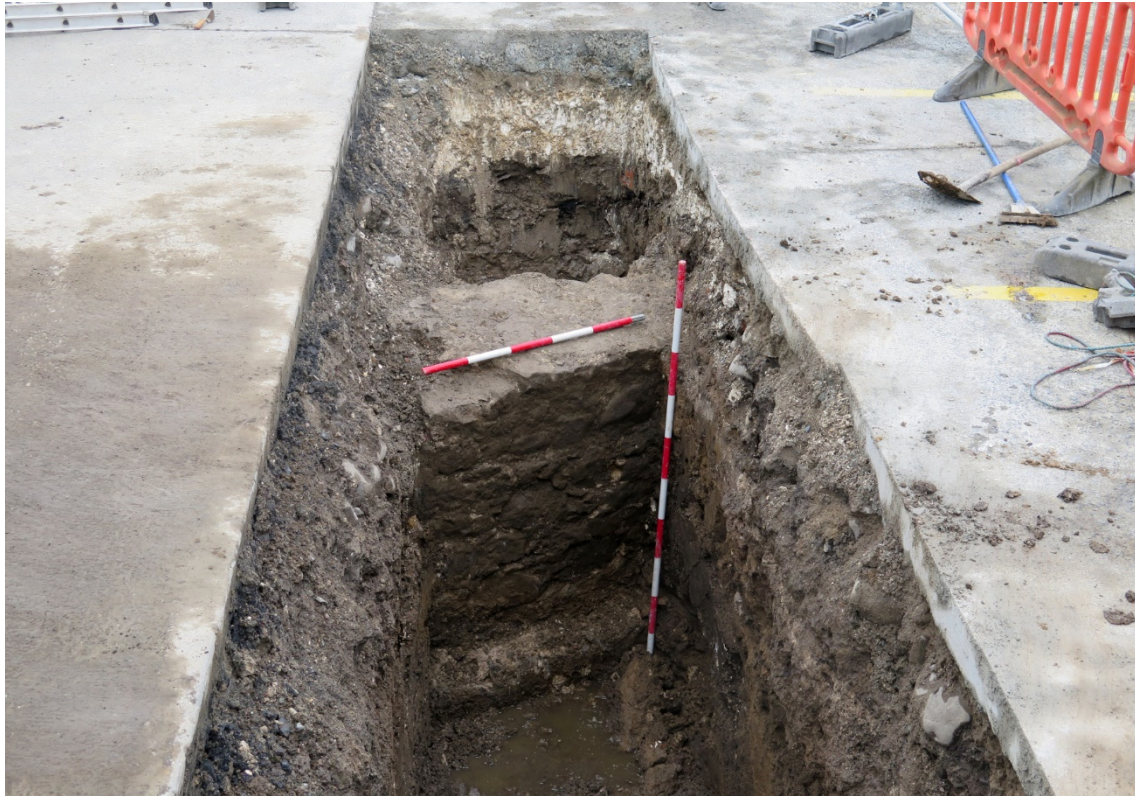
Figure 60: TT4-4, looking SW to rear of 1760's quay wall on plinth (compare to wall found in TT4-1).

TT4-4 exposed infilled ground over a poorly preserved cobbled layer sealing a rubble-built wall with facing stone robbed out from the quayside northern face. The south elevation was better preserved and more regular, set on a plinth. Flush with the top of the wall and running the length of the trench to the south was a mortar rich layer 200mm thick. Below this were two layers of sand and gravel. The lower deposit TT4-4-10 had frequent oyster shells.

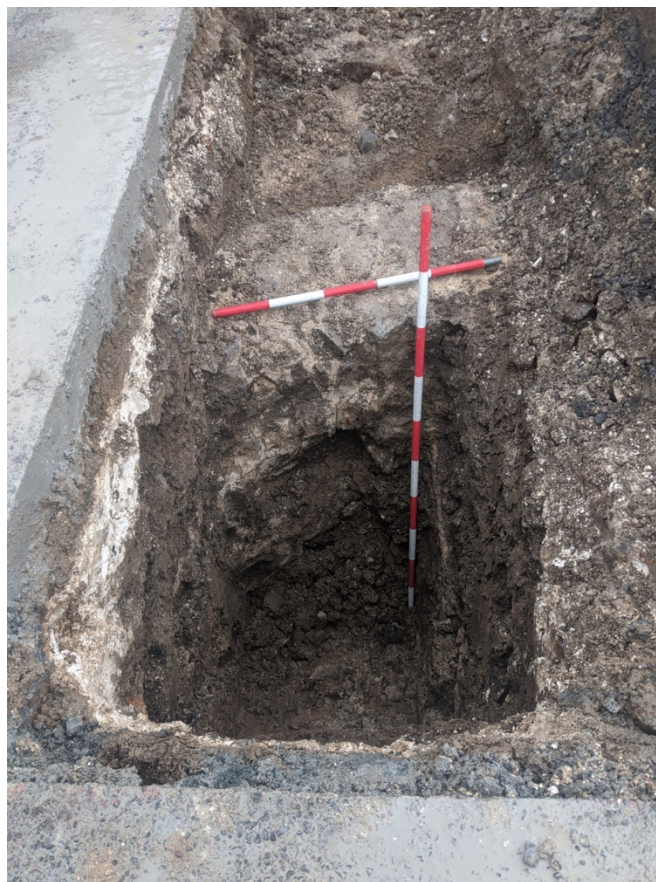
Figure 61 Looking SW to robbed out face of quay wall in TT4-4.

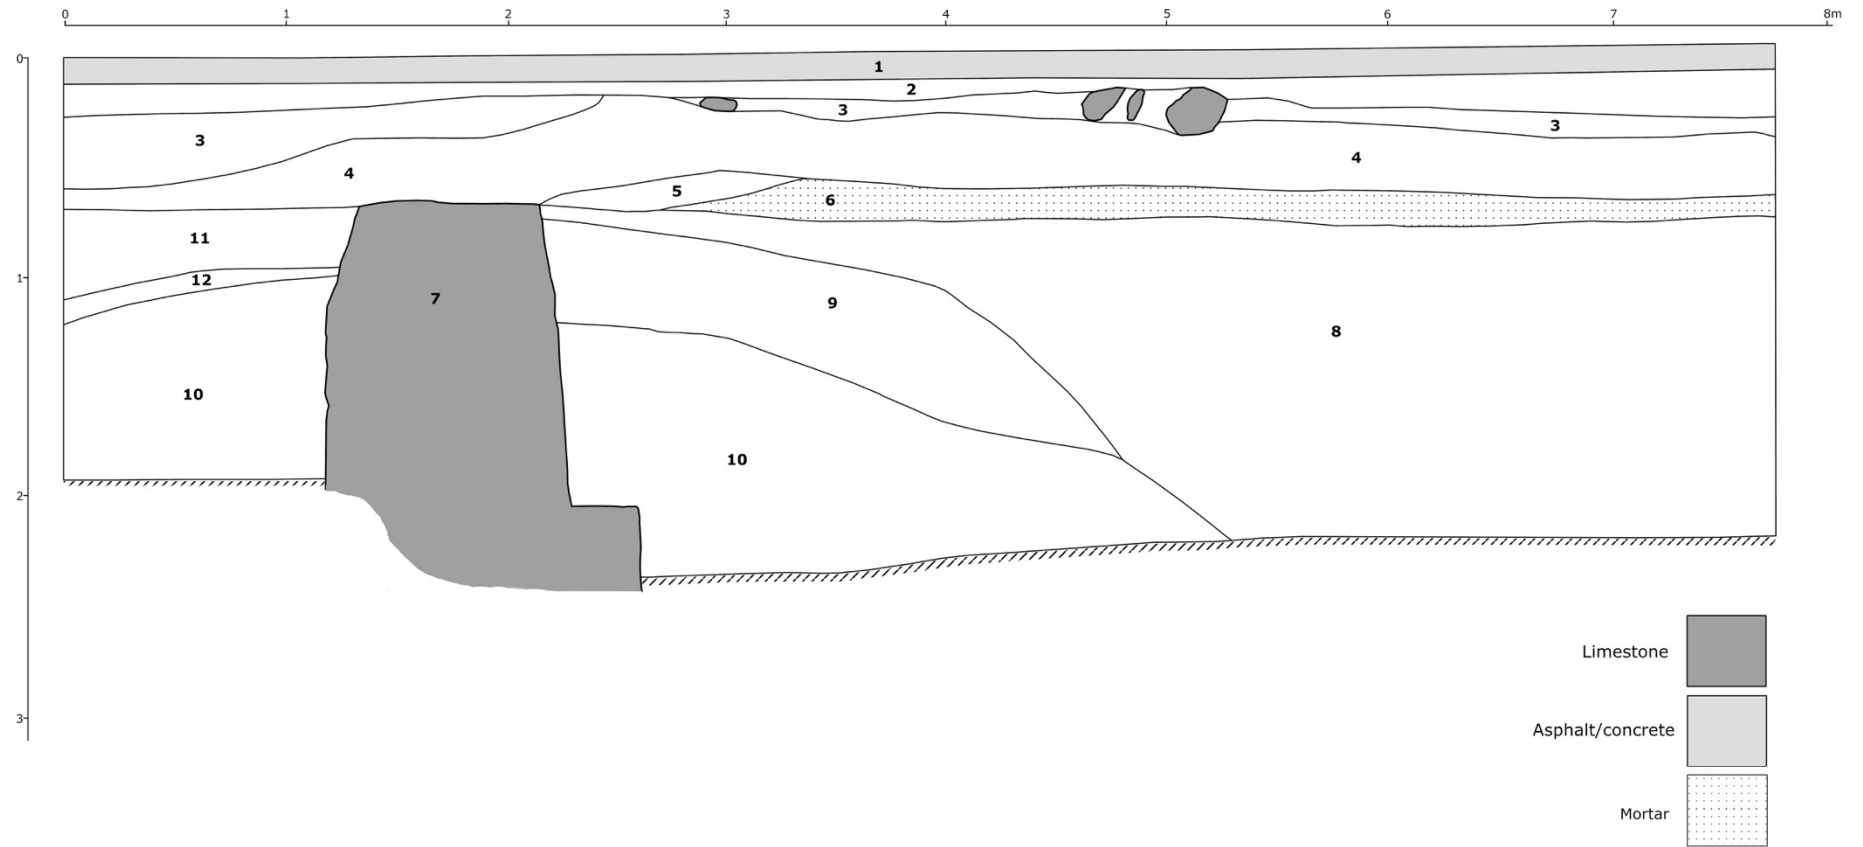
Figure 63 TT4-4 profile drawing of west-facing wall

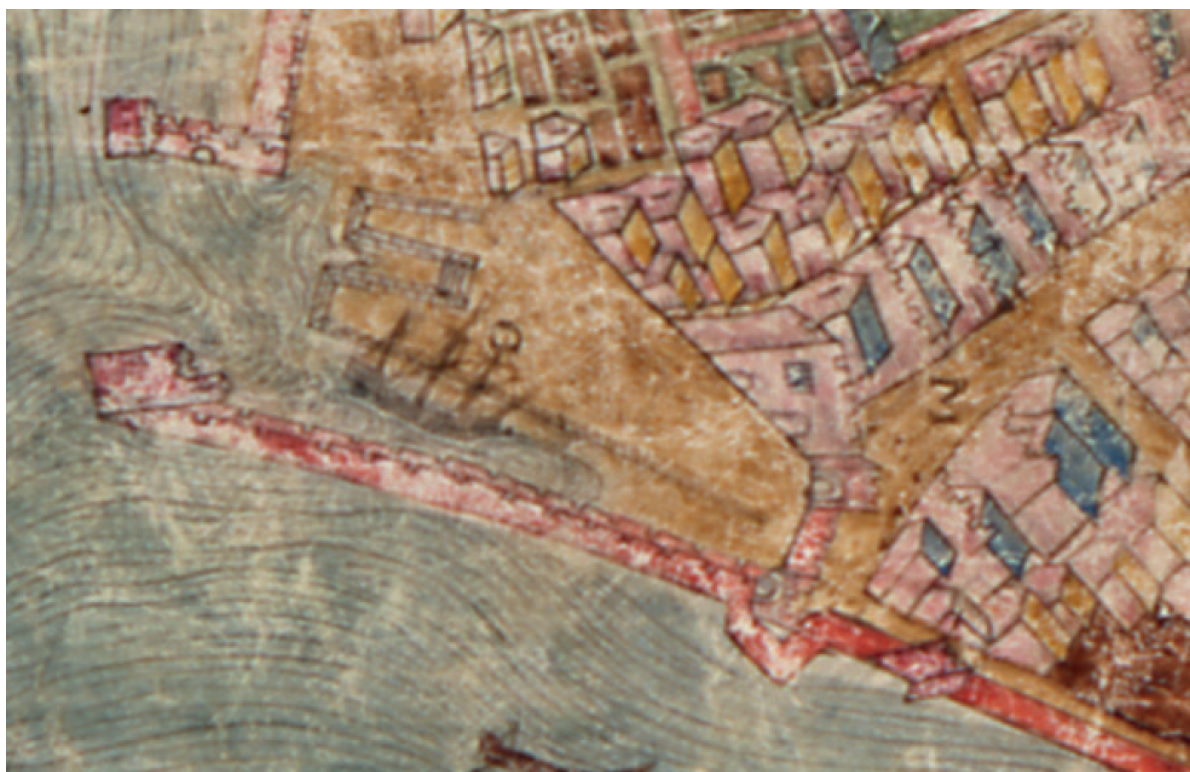
Figure 64. Extract from *Limerick c.1590* by Hardiman (Trinity College Dublin) (*Irish Historic Towns Atlas No. 21 Limerick, Map 6*) showing the quays area, with gated entrance to the east.

Hardiman's map of 1590 shows the quays as having a long dock inside the southern quay wall opening to a wider, rectangular dock between the arm like piers (Figure 64). The space between the quayside and the grounds of the Cathedral have rows of houses. A bastion is shown projecting into the Abbey River at the landward side of the south pier.

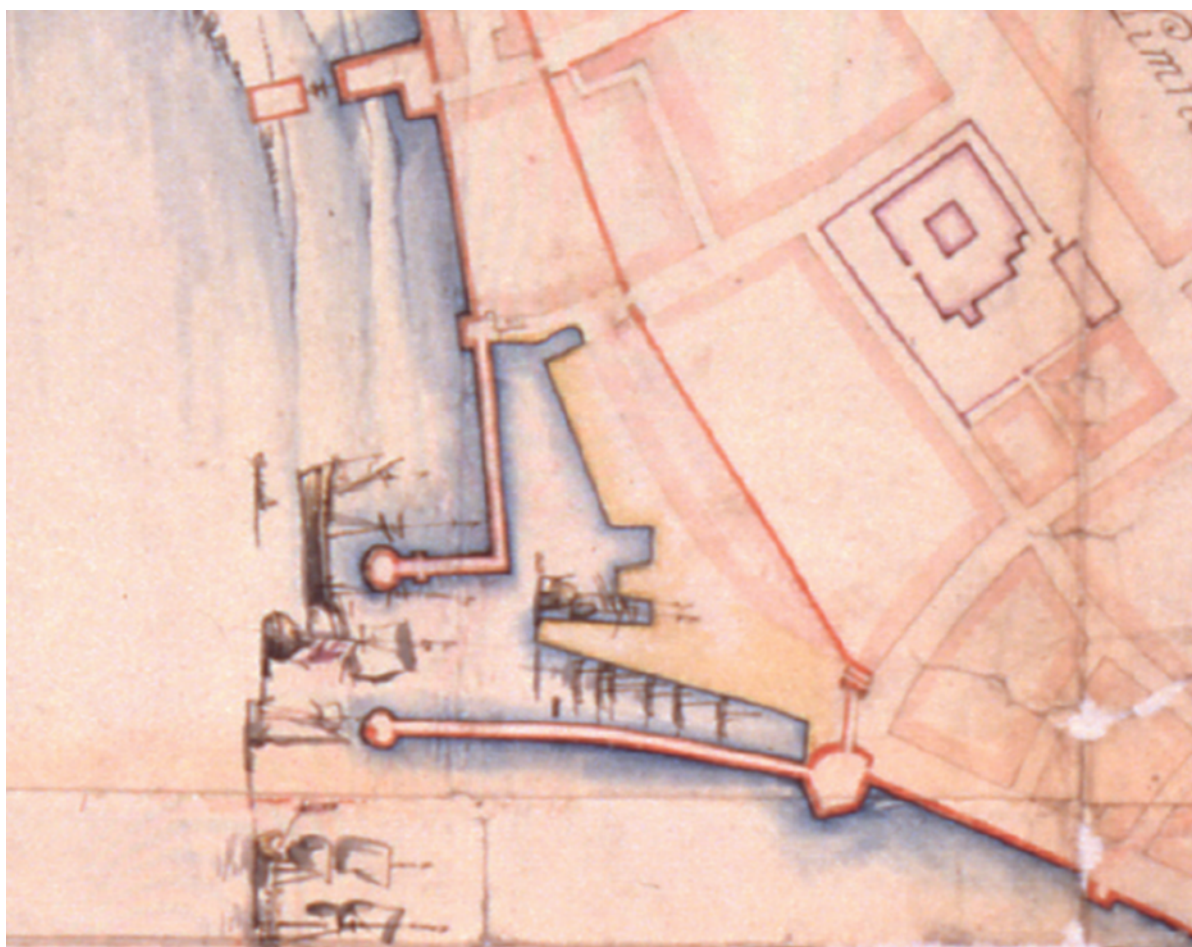
Figure 65 Extract from *Limerick*, 1685 by Thomas Phillips showing a single entrance into the harbour.

Following the Cromwellian siege the military surveyor and engineer of fortifications and harbours, Thomas Phillips visited Limerick in 1685 to map the town. Phillip's plan shows the harbour as having an irregular back wall with four rectangular bays, the longest running along the south pier. This long dock is shown with ships at anchor. The northern pier is shown as forming a right angle sheltering the docks. A gifted artist, Phillip's drew a prospect of the town looking north east across the Shannon in pen and ink. This drawing shows a view of the western town defences from Thomond Gate to Irishtown via Baals Bridge; the belfry of St. Marys dominating the skyline. The harbour mouth, viewed from modern day Clancy's Strand, shows the squat north tower and tall slender south tower flanking the docks with moored ships at bay. Quay gate is obscured; however, three storey buildings are visible along Merchants Quay. It is noteworthy that the earlier Civil Survey, albeit incomplete for this area, describes the houses along Merchants Quay as all being built in the cage work style.

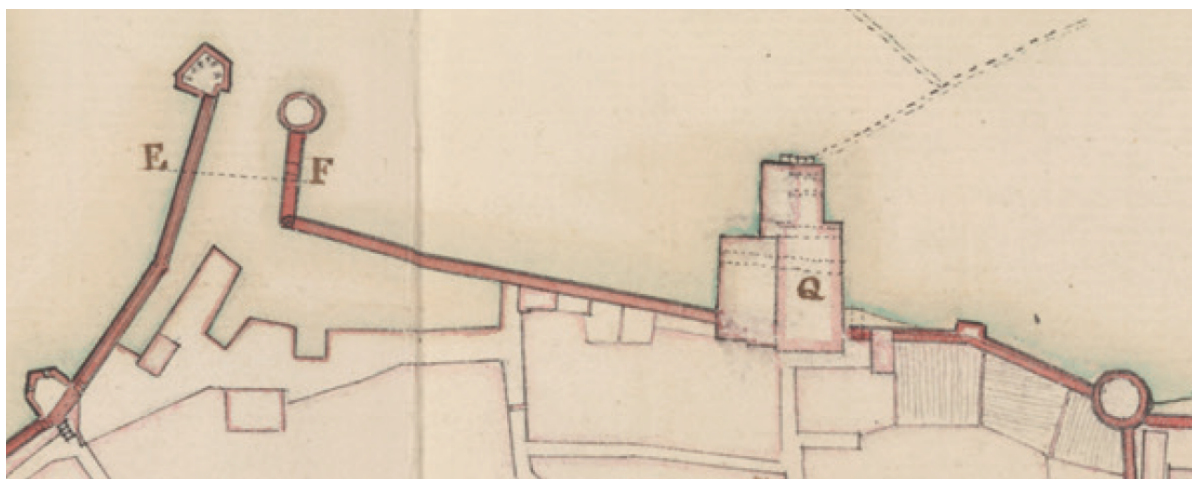
Figure 67 *Extract from Willian Eyres' map, 1752m showing the harbour, note apparent tunnels at 'Q', Mills and Breweries.*

In the 18th century the most detailed maps for the quays are Eyres's map of 1752 and White's map of 1760. Eyres's survey is additionally detailed with cross sections between the south and north piers. James white a catholic priest and chronicler of the times, states that he drew his map for his own amusement measuring much of the distances by steps 'before the walls were thrown down, the new quay or bridge to Marydyke were made'. This preamble shows how conscious White was of documenting the town and particularly the harbour before its complete re-development in the 1760s as documented in Colles's Plan (1769). The map shows the familiar irregular shaped quays protected by the projecting north and south piers. Internally the quayside from south to north has a long rectangular dock beside two smaller bays, behind the angle of the wall leading to the northern tower is another dock orientated roughly north south, later the general site of the Court House.

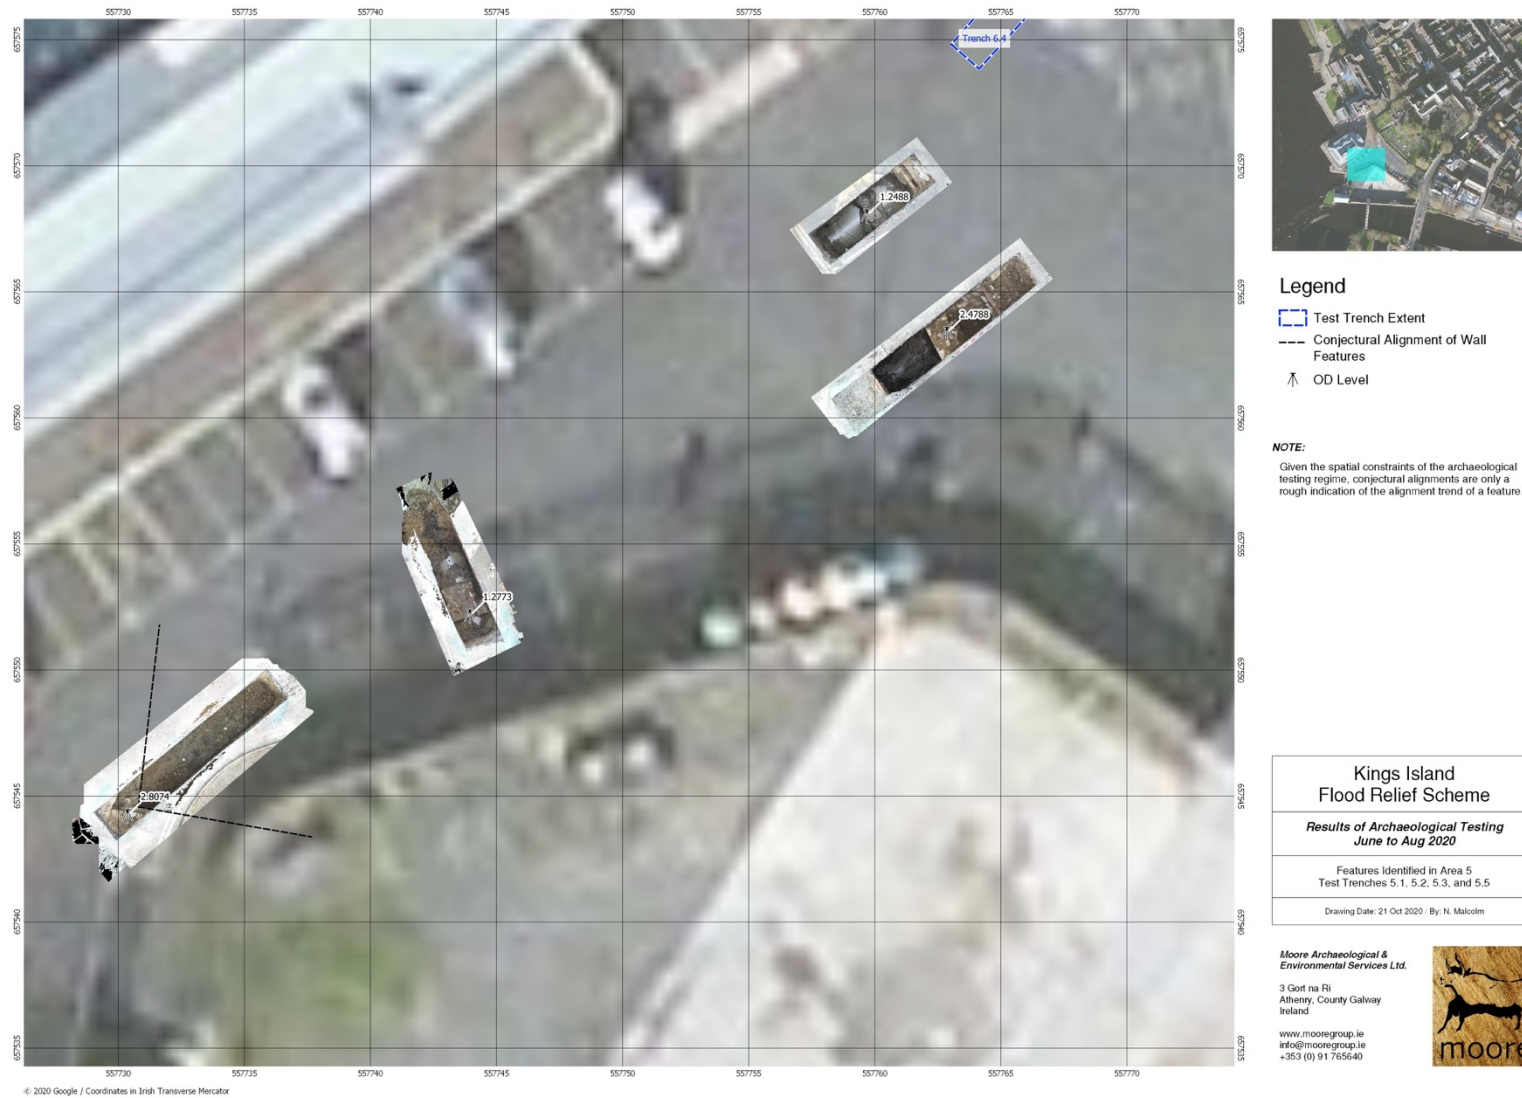
Figure 69 Map of archaeological testing in Area 5.

Five trenches were excavated in Area 5, located southeast of Limerick Courthouse, in the parking area between the River Shannon to the west and the Merchant's Quay to the east. There has been limited documented archaeological work in the land crossed by Area 5. Archaeological monitoring of civil works to upgrade lighting has taken place here, though nothing of an archaeological nature was found (Coyne 2016: 347). Renovation of Limerick Courthouse in 2003 did not involve any documented archaeological work, though anecdotally, a large culvert is said to have been revealed, running along the south of the building.
