**Re: Derogation license for otter (indirect holt disturbance) under section 54 of S.I. No. 477 of 2011 (Birds and Natural Habitats Regulations), Glashaboy River, Co. Cork.**

LETTER: Bat Duties, Glanmire FRS,  
Glanmire, Co. Cork

Glashaboy FRS - Site Clearance Report (February) 2022

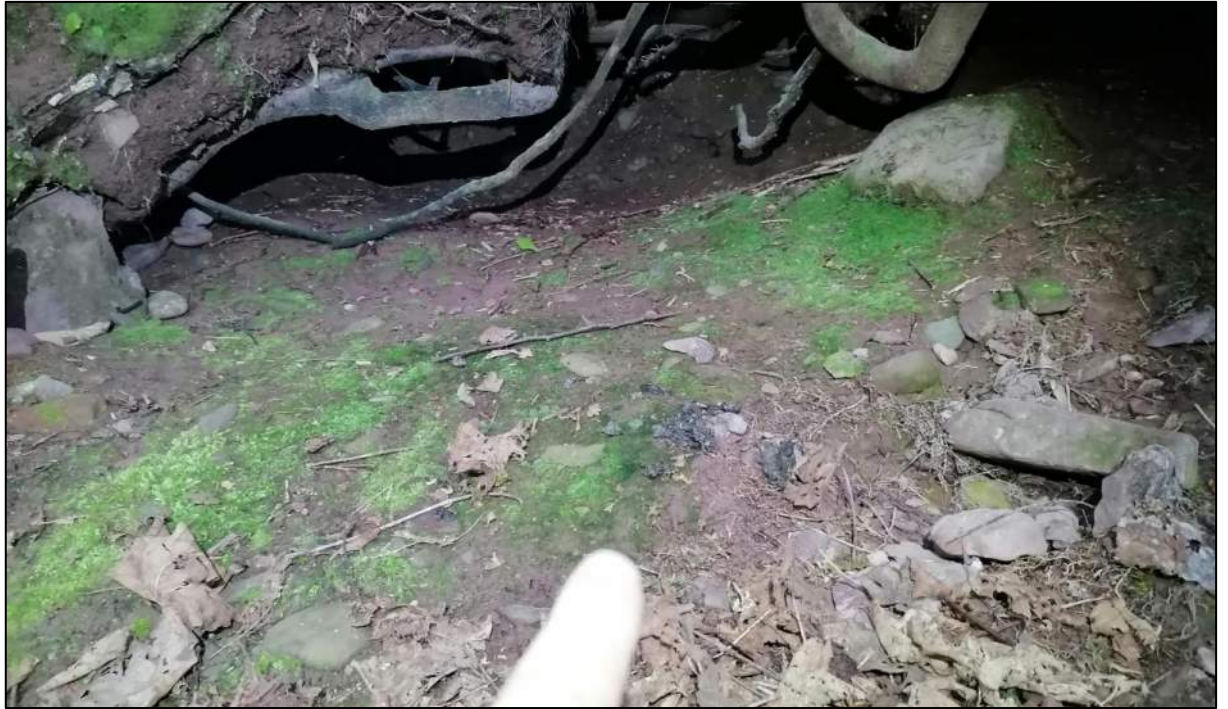
**Plate 1** – Example of otter holt (N2) on the Glashaboy River under root system with fresh spraint and well-worn slides to river

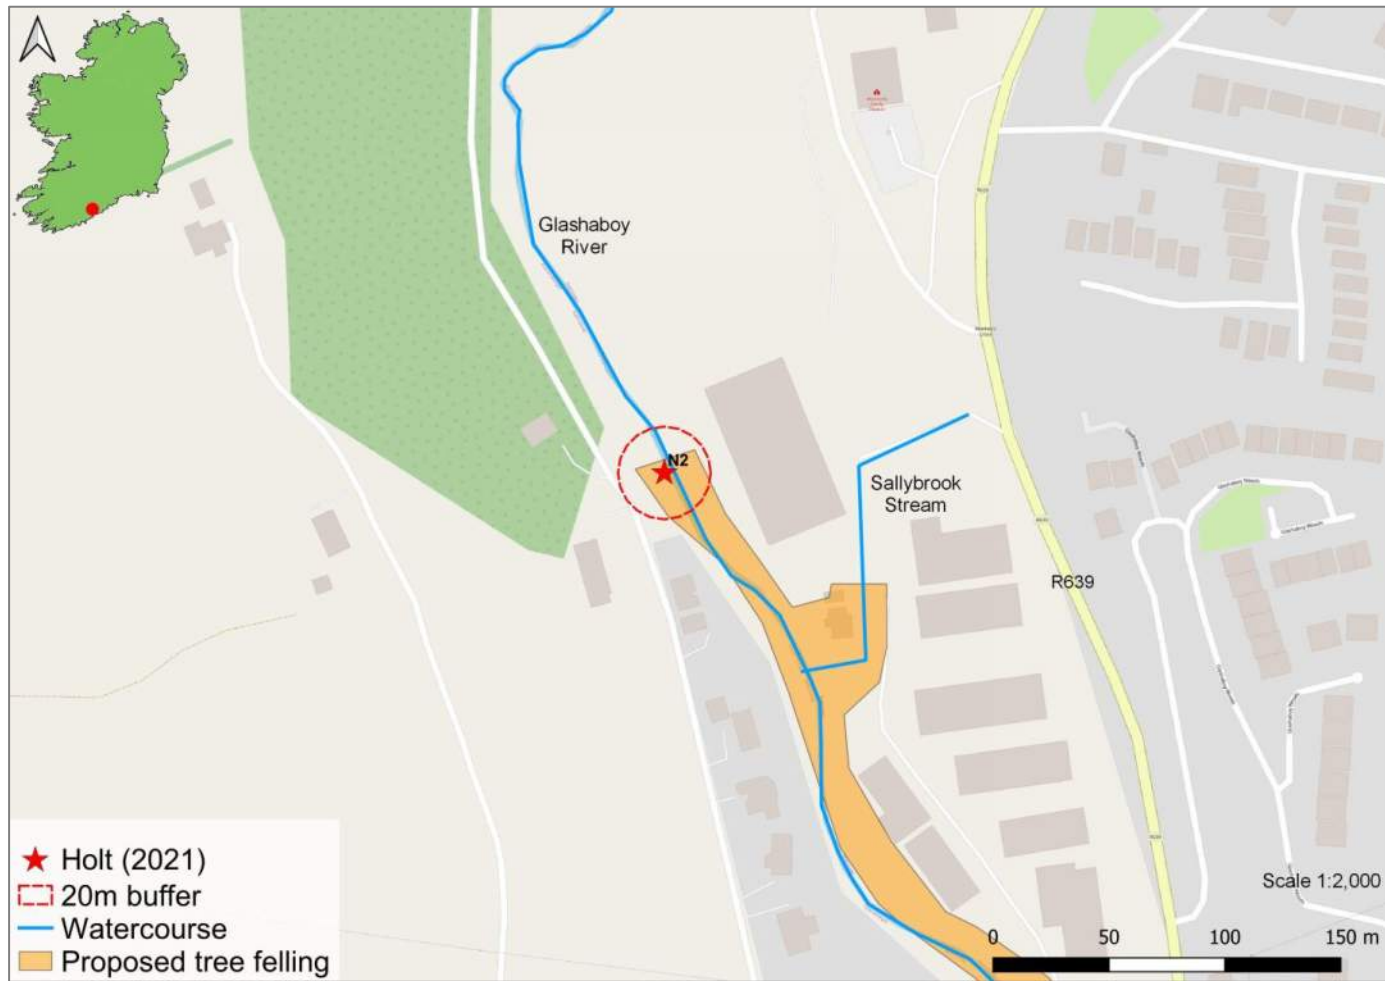
Figure 2 – Holt N2 in the vicinity of proposed tree felling area at Sallybrook

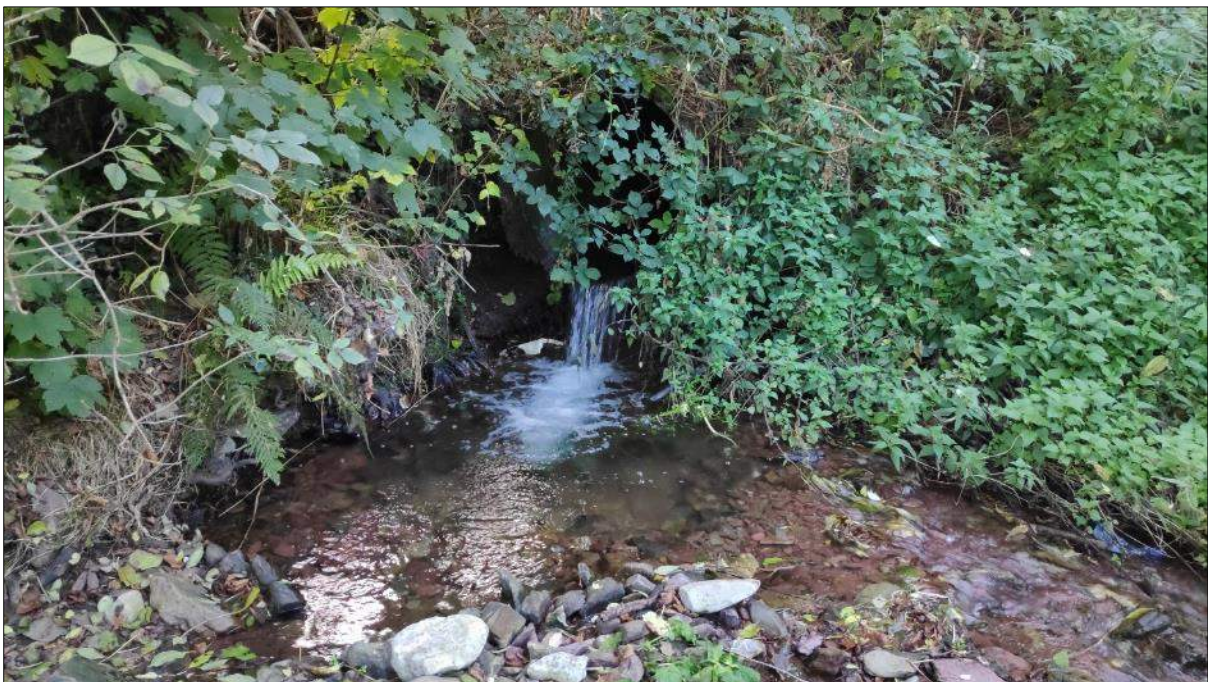
**Plate 3.12** Confluence of the Lisnahorna Stream with the Glashaboy River via a perched pipe culvert (significant barrier to fish migration at base flows)

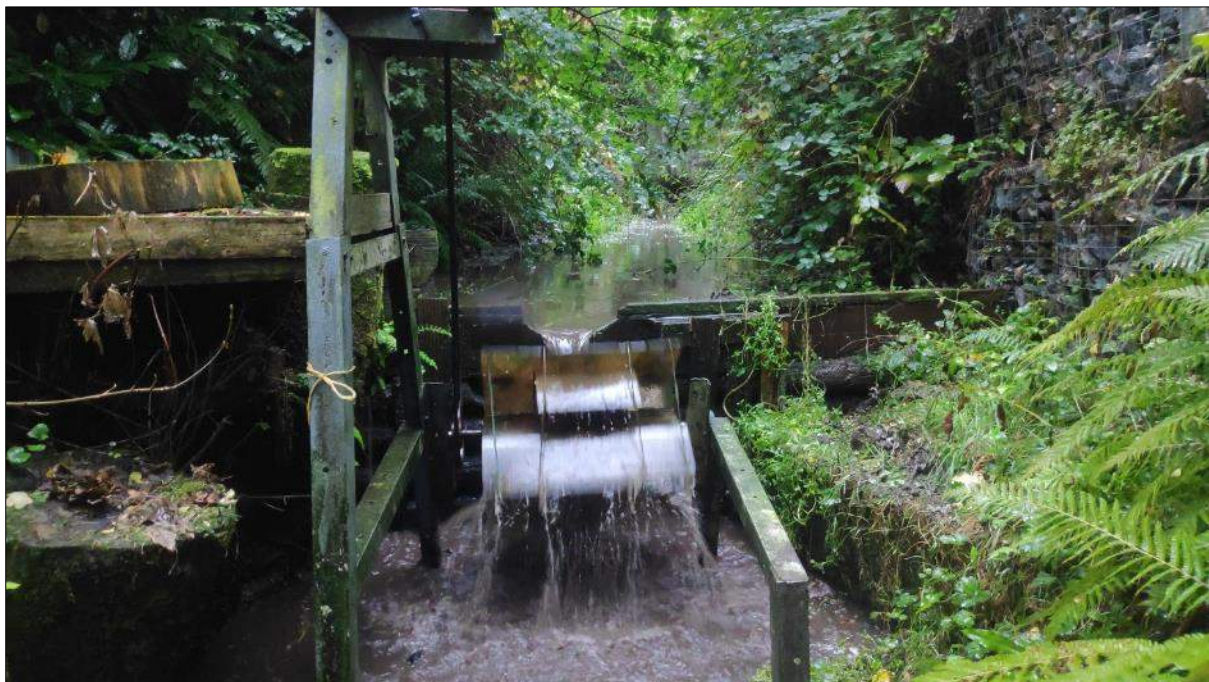
**Plate 3.16** Representative image of site 7 on lower reaches of the Rathcooney Stream showing locally-installed hydro-electric turbine, September 2022 (significant barrier to fish migration)

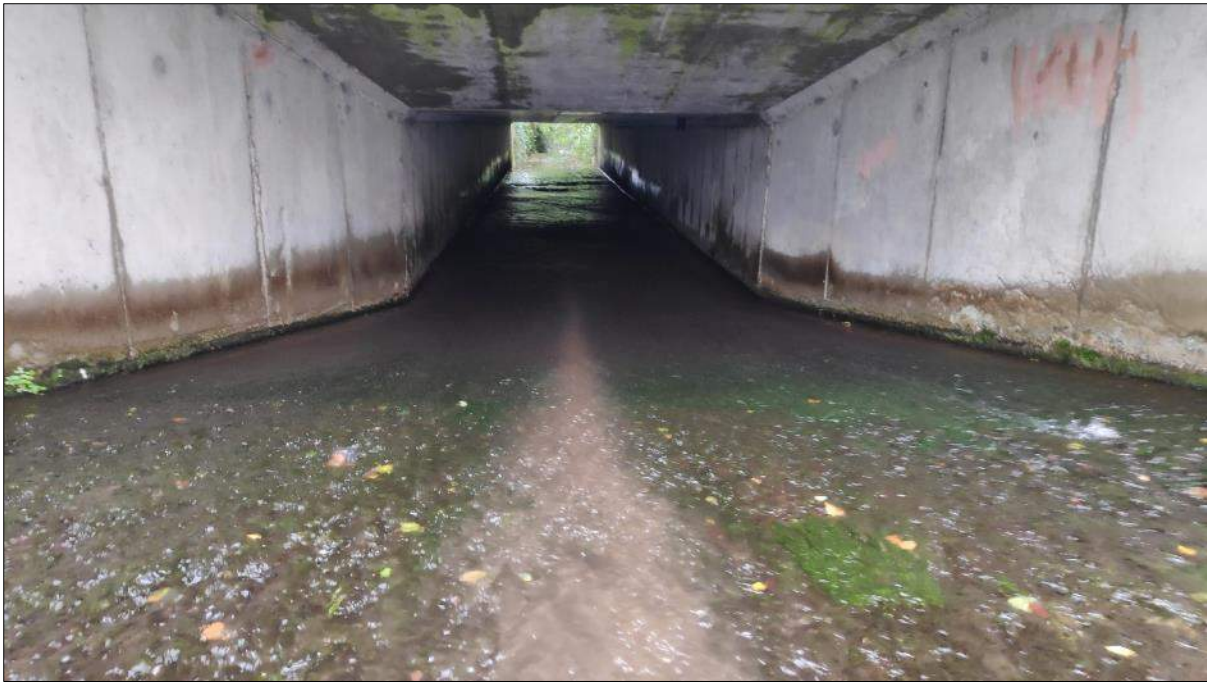
**Plate 3.21** Sloping box culvert present at site 9 on the Lisheenroe Stream (a significant barrier to fish migration)
