Monthly Environmental Audit – February 2025

Glanmire Flood Relief Scheme

01/02/25 to 28/02/25

ENVIRONMENTAL AUDIT

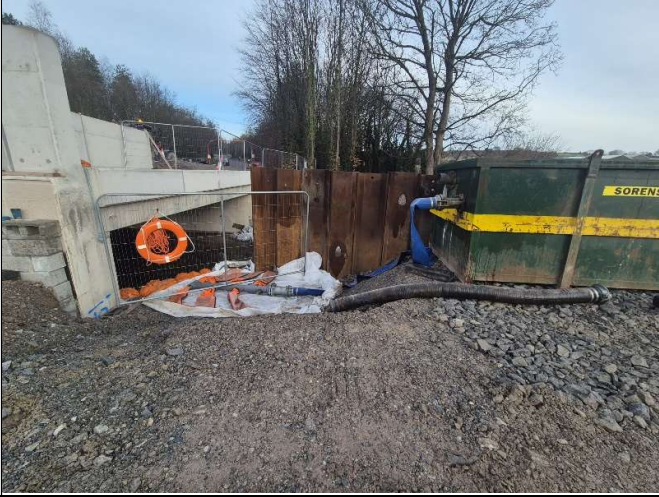
Figure 3			Figure 4

Caption 3			Caption 4		
Silt control measures (settlement tank and manifold system) in place at the discharge point for the RC Wall at New Line.			Member of SCE's Environmental Unit taking handheld turbidity meter readings from the discharge point at New Line.

- Permit to Pump No. 121 was issued on 04/02/2025 to dewater the excavation/cofferdam in order to facilitate the construction of the RC Wall upstream of the culvert at New Line (GFRS-PTP-121). Pumping commenced on 04/02/2025, along with monitoring of the silt control measures and the discharge from the settlement tank under Permit to Pump No. 121. In addition to visual checks, the turbidity (NTU) of the pumped water was monitored and tested daily prior to discharge with a handheld device, by the Site Ecologist, or other nominated member of the SCE's Environmental Unit. Where turbidity levels were found to be at an unacceptable level, pumping was ceased and/or silt control measures were adjusted/enhanced.

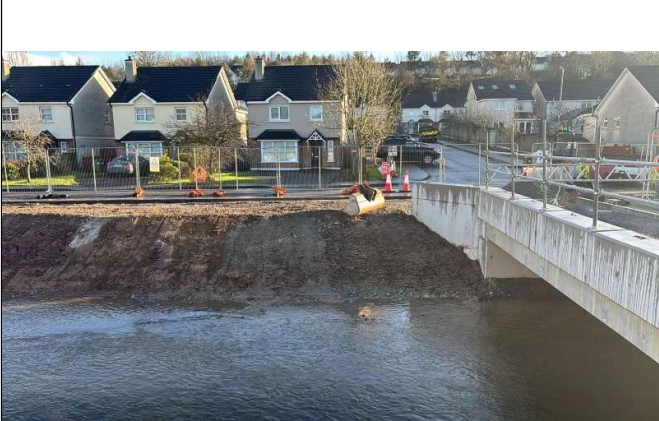
Figure 5			Figure 6

Caption 5		Copper Valley Vue	Caption 6		Copper Valley Vue
Temporary erosion protection works at Copper Valley Vue (before)			Temporary erosion protection works at Copper Valley Vue (after)

- As a temporary works measure Coir Mesh was placed on the southern banks of the Glenmore River at Copper Valley Vue on the 05/02/2025 to stabilise the banks against high energy fluvial flows, whilst awaiting details of the final design.

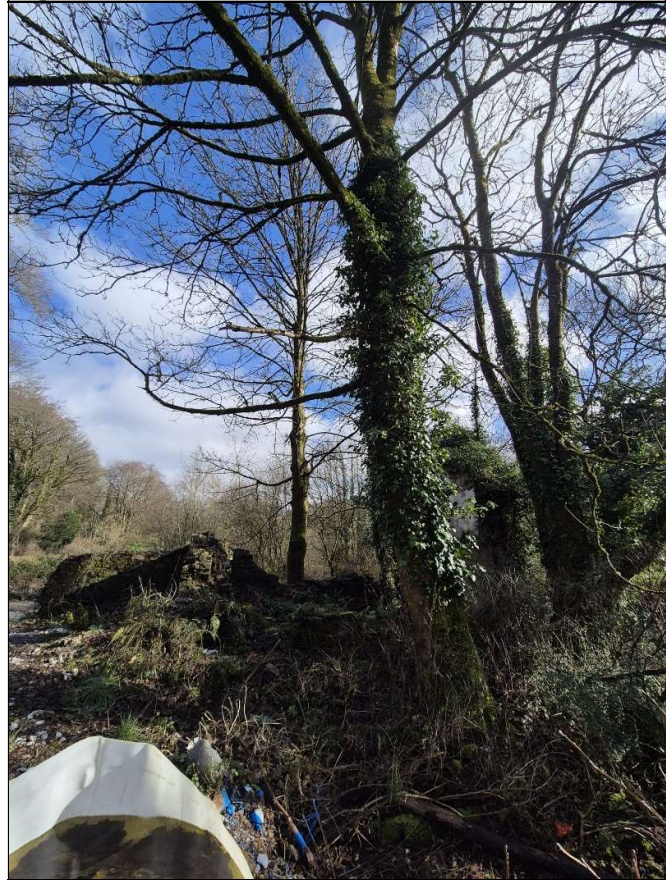
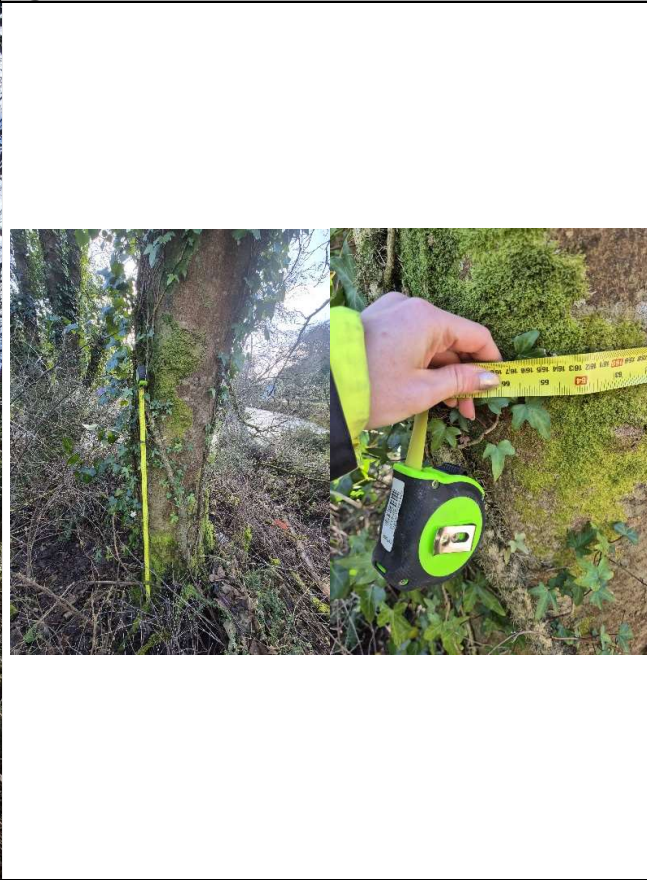
Figure 7	Figure 8

Caption 9	Caption 10
The Grove	The Grove
<p>Clearance of vegetation to accommodate the Pump Station and RC Walls at The Grove was supervised by the Site Ecologist. 1 no. mature Sycamore (<i>Acer pseudoplatanus</i>) an invasive species categorised as “Medium Impact” by the National Biodiversity Data Centre (NBDC) was felled along with a group of Willow trees.</p>	<p>The Sycamore tree had a DBH of 167cm @ 1.3m. No cracks, crevices, hollows, tree wounds, peeling bark or heavy ivy cover <i>etc</i> which could conceal the presence of bat roost was noted. Biosecurity measures were deployed given that the presence of Japanese knotweed is indicated on the Site Clearance drawings at this location. No signs of last seasons growth of Japanese knotweed were noted. This may be due to the fact that the plants are in “chemical dormancy” as a result of a historical chemical herbicide treatment programme.</p>

- Permit to Clear Vegetation issued on the 25/02/2025 to facilitate the construction of a Pump Station and RC Wall at The Grove (GFRS-PTCV- 007). Works were supervised by the Site Ecologist.
