TT5-3

Table 16: TT5-3 summary of results

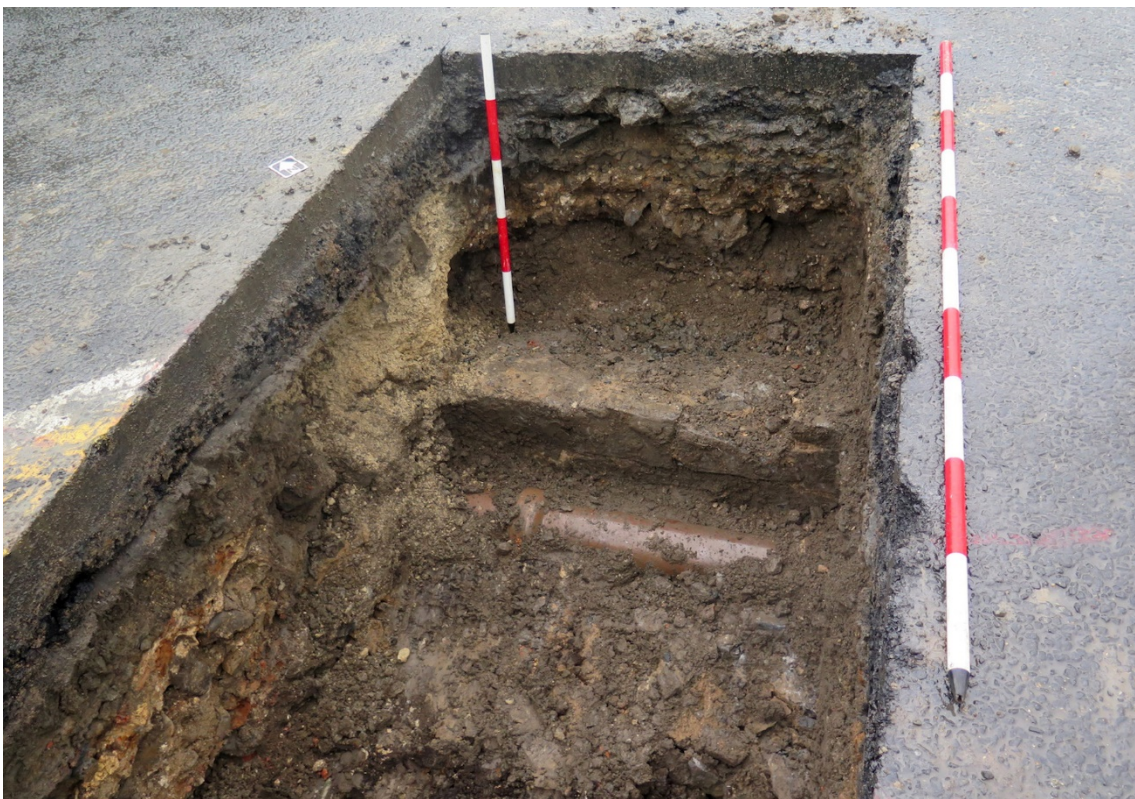
Figure 88 Stone lined culvert for terracotta pipe in the northeast of TT5-2C

Below the road surfaces was a layer of aggregate consisting of grey gravel (C5-3-04) mixed with dark reddish brown soil and a thin layer of light red sandy mortar-rich fill containing brick and slate (C5-3-06). Across the northern two metres of the trench, this was cut by dark brown fill containing a stone lined culvert with ceramic pipe (C5-3-05). This was the continuation of the culvert revealed at the north of TT5-2C. Its base is at 1.38m, and it sits on a horizontal limestone slab. After revealing the culvert and pipe, this area was left in place and excavations focused on the centre of the trench.

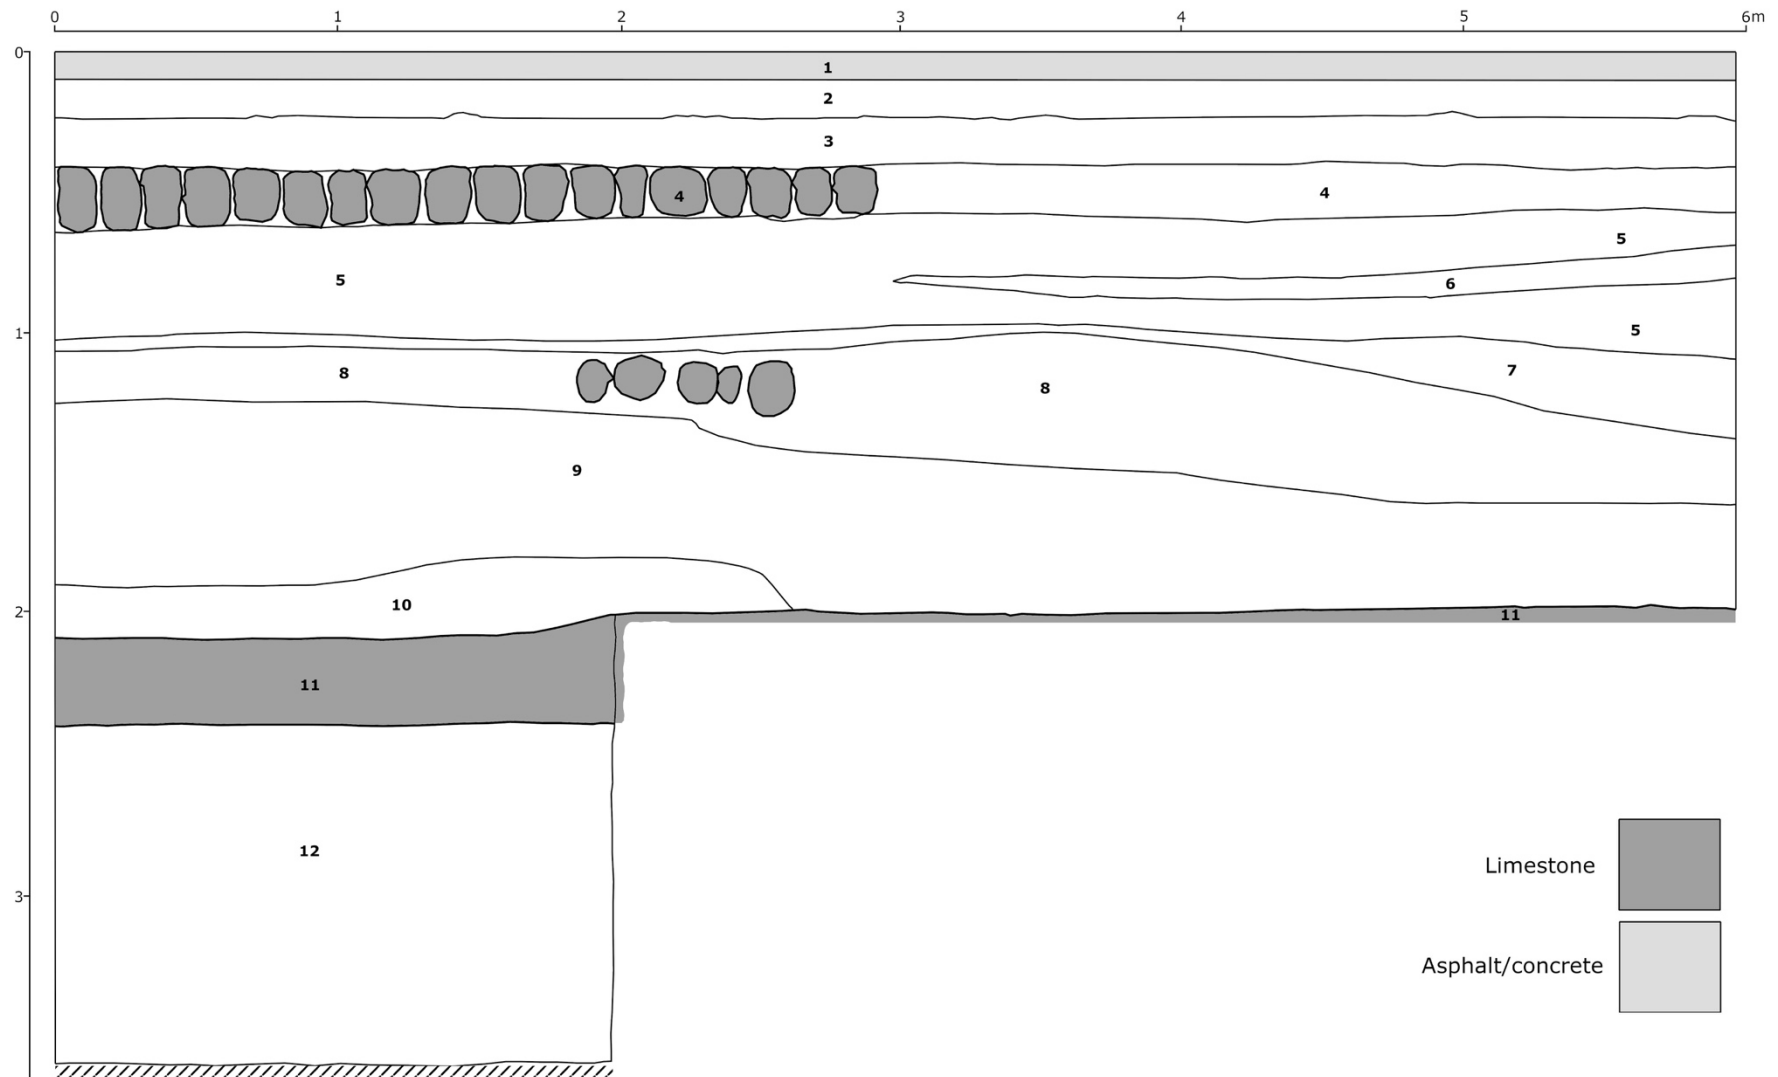
Figure 90 TT5-2A profile drawing of south-facing wall.

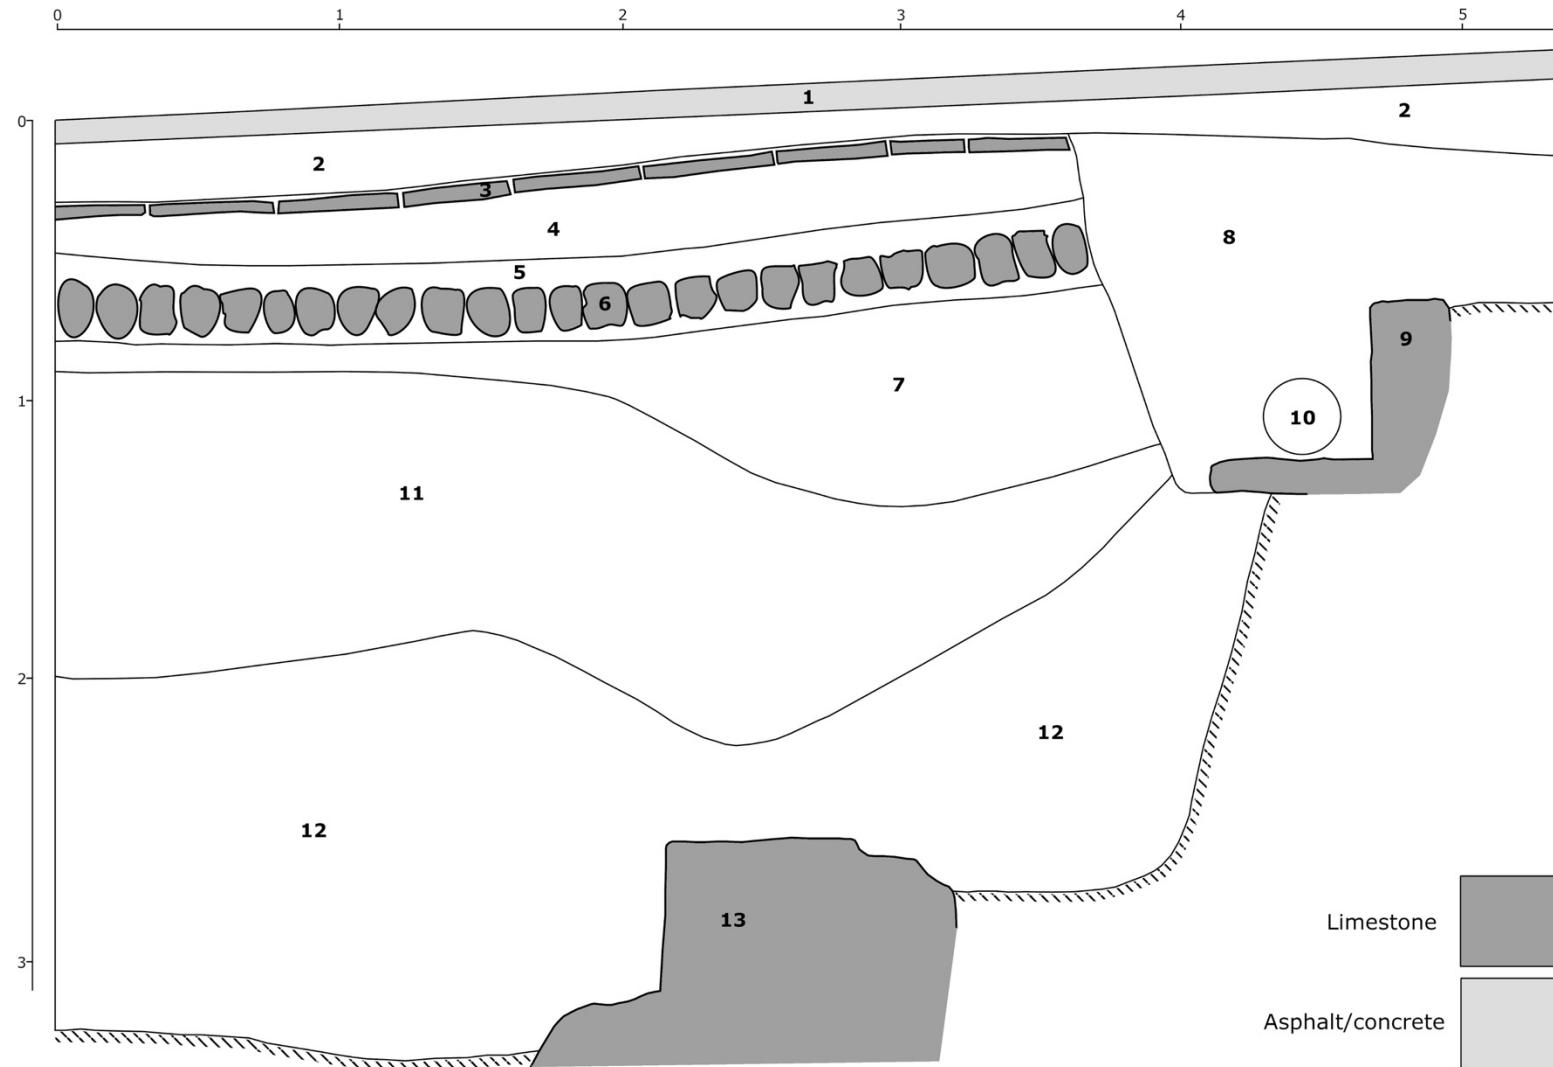
Figure 91 TT5-2C profile drawing of south-facing wall.

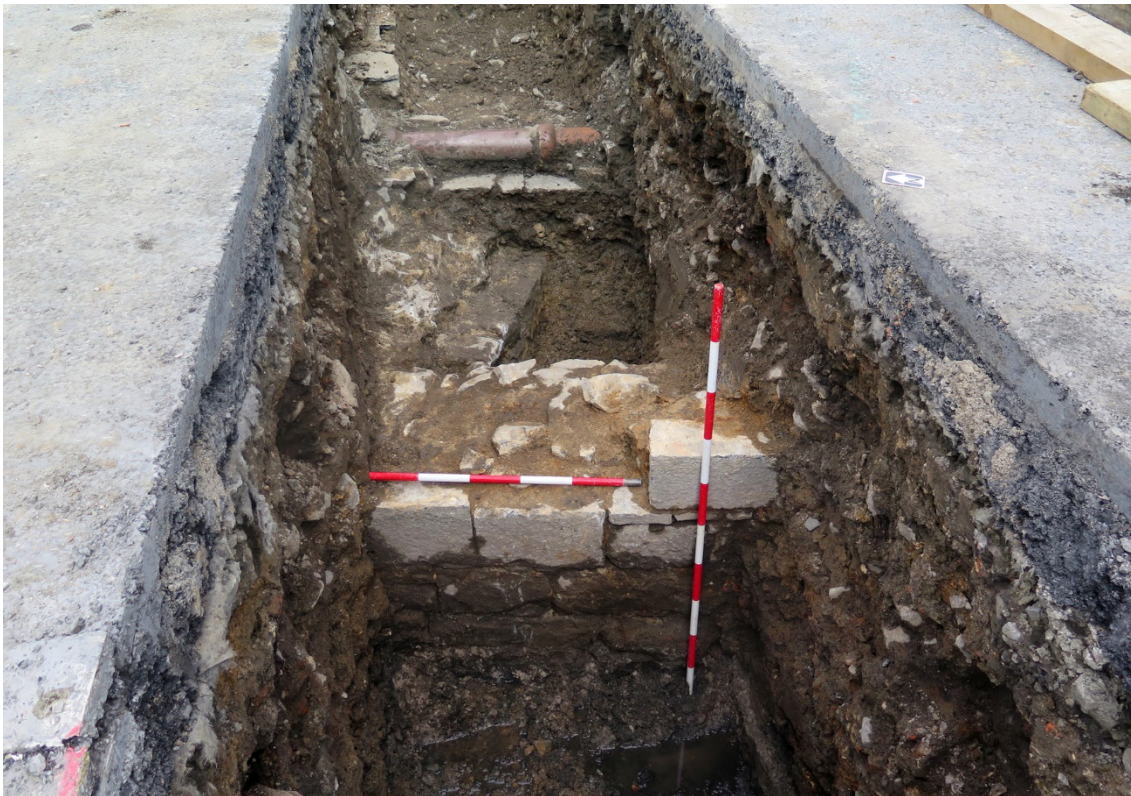
Figure 93 East-facing view of TT5-3

At 1.27m depth, the top of a limestone wall (C5-3-13) was revealed, aligned north-northwest/south-southeast, and continuing the line of the quay wall exposed at the base of TT5-2C (Figure 93). The upper two courses are of well-cut and dressed rectangular masonry with a rubble core and yellow sandy mortar bonding. A total of seven courses were revealed on the western face of the wall, which are regular towards the top but irregular below the upper three courses, where smaller stones and some brick have infilled gaps which may be the result of repairs and the stones are progressively angular and less worked (Figure 102). Towards the base, the wall is formed of rougher limestone boulders, and these sit upon limestone bedrock, which was revealed at 3.02m below the surface at the base of the wall and dropping to 3.4m below the surface 1m to the southwest of the wall.

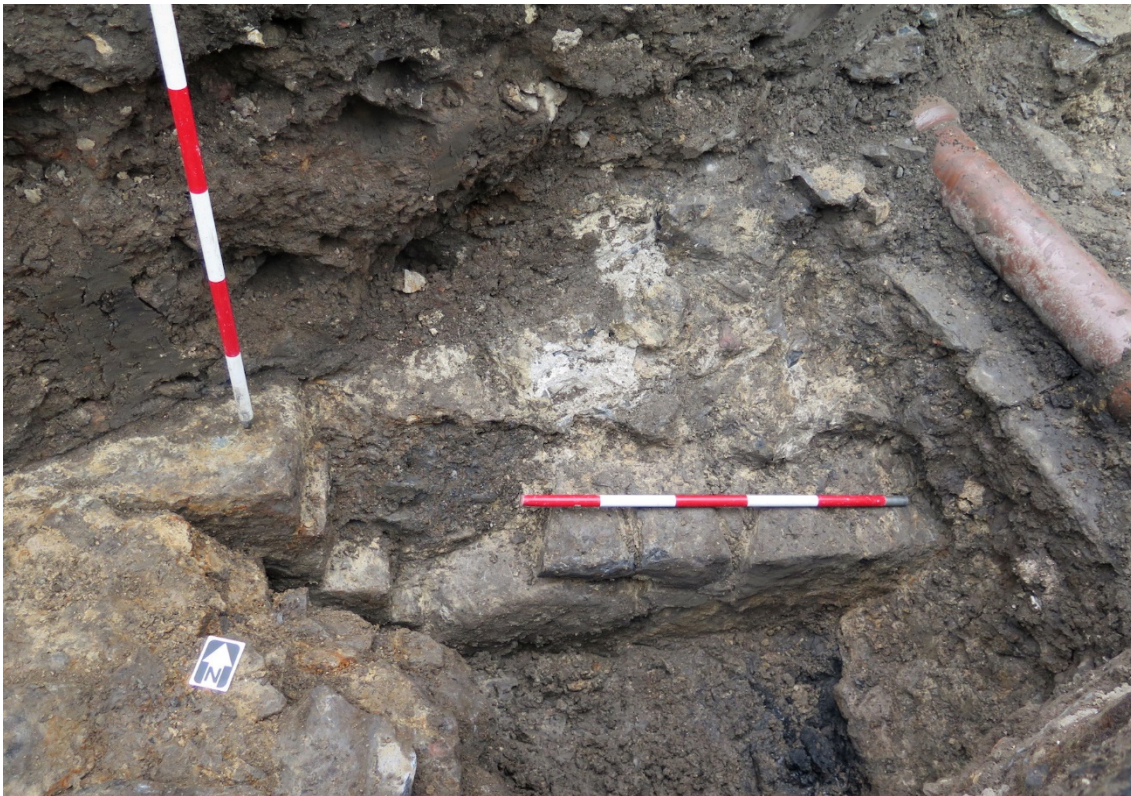
Figure 97 North-facing view of wall C5-3-14

suspected structural features. The width of wall (C5-3-13) was found to be 1m on its upper courses and expanding to 1.3m at the foundation level. Using a combination of mechanical and manual excavation, a second, lower wall (C5-3-14) was exposed, running perpendicular to the north of the quay wall, but not at right angles (the angle between the walls is approximately 75°) (Figure 96). The top of this second, east/west aligned wall was revealed at a depth of 1.4m, and it consists of a mortared rubble core which continued into the north wall of the trench so not allowing its full width to be exposed, though it is at least 1.1m. Its south face has small, square shaped cobbles of which two courses were exposed, below which were larger stones which may be the top of its foundations. The wall is cut at its east by the culvert (C5-3-05) and at its west by the quay wall (C5-3-13) so that a 2.3m length survived (Figure 97). Its western termination indicates that it pre-dates the quay wall and may therefore be associated with the medieval quay before its 18th-century transformation, though no artefacts or other dating evidence were found to support this theory.

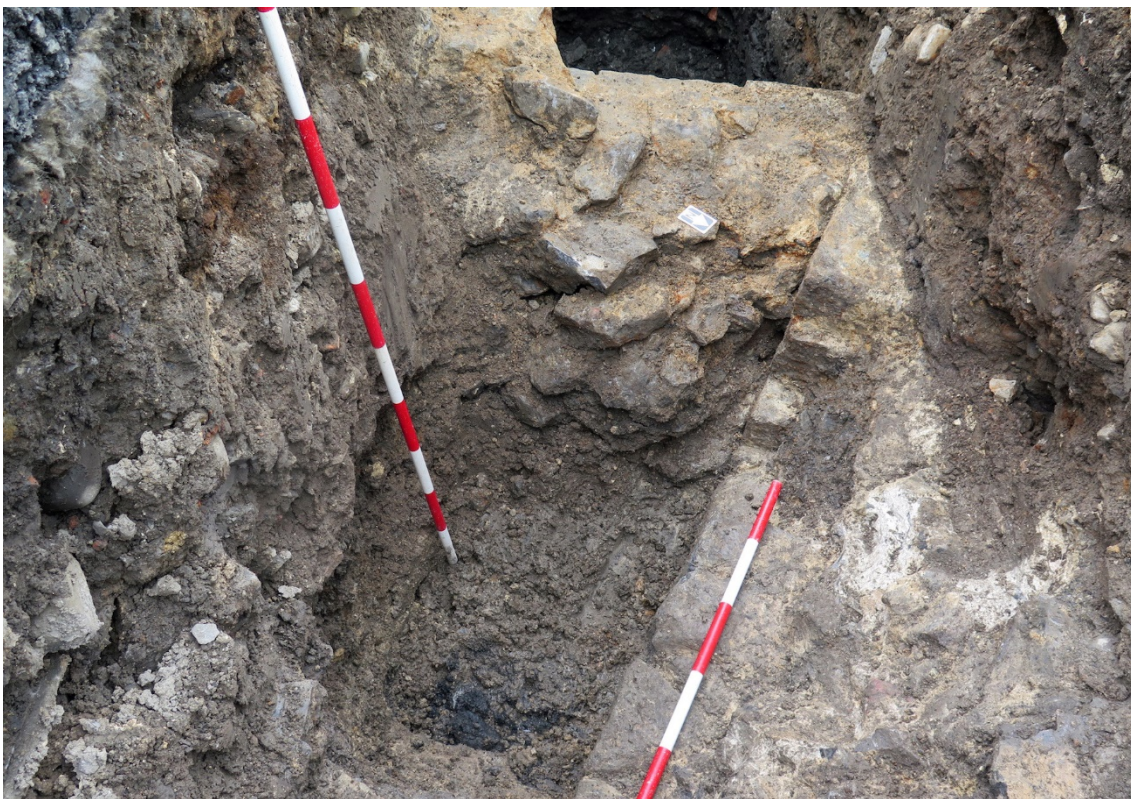
Figure 98 West-facing view of junction between walls C5-3-13 and C5-3-14

The north/south aligned wall (C5-3-13) crossing TT5-3 is the southern continuation of the quay wall uncovered just to the north (C5-2A-12) and in a much better state of preservation. The stretch exposed in TT5-3 is preserved to a height of 1.75, with seven courses of intact facing stone, its foundations built on limestone bedrock. The abundance of oyster shell within the alluvial silty sand that abuts the base of the wall's western side support its identification as the quay's retaining wall. On the eastern side of the wall, a second wall was uncovered (C5-3-14), running at an irregular angle and of different construction which employed a larger amount of sandy mortar and smaller, irregular stones. This wall was exposed for a length of 2.3m and is cut at the east by a culvert (C5-3-05). These three features allow for a proposed sequence of construction: the earliest feature is the east/west aligned wall (C5-3-14) which was cut by the quay wall (C5-3-13) to its west and later by the culvert (C5-3-05) to the east. Though there is no definite dating evidence, it is possible that both the walls represent remnants of the medieval quay, possibly a projecting jetty. The east wall possibly being earlier, the north south wall refaced at a later stage.

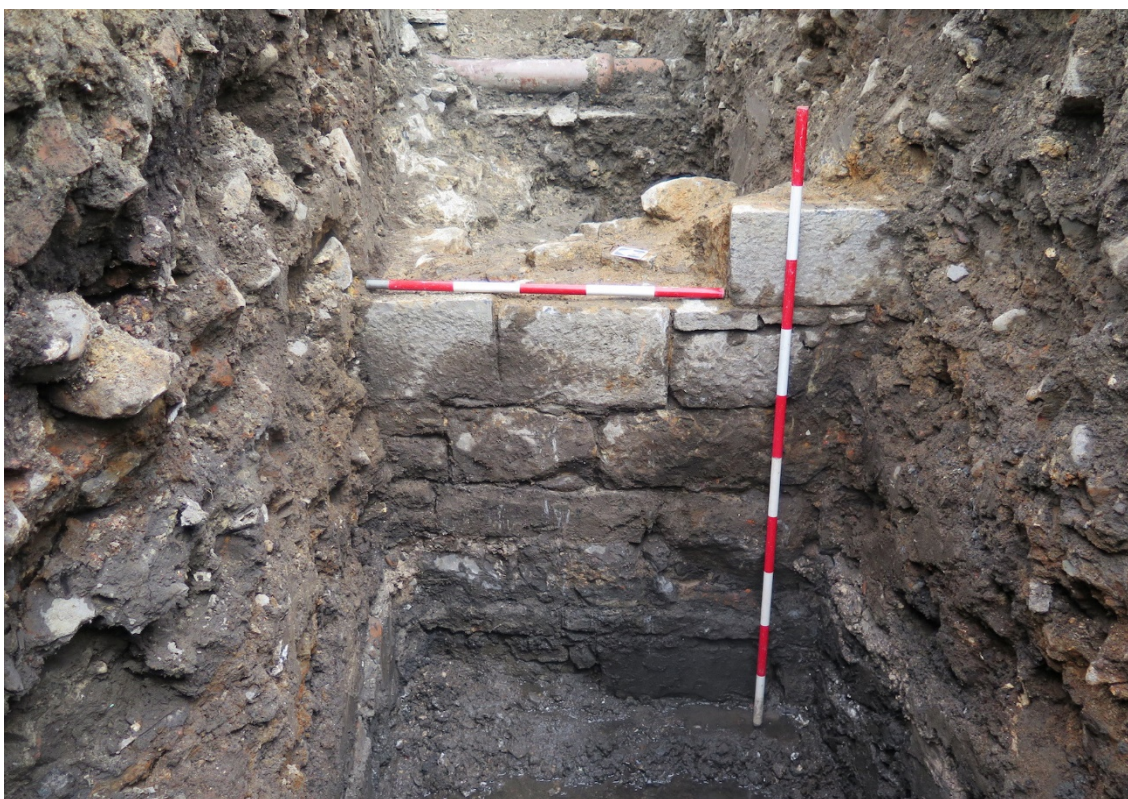
Figure 99 *Western face of wall C5-3-13 at completion of excavation.*

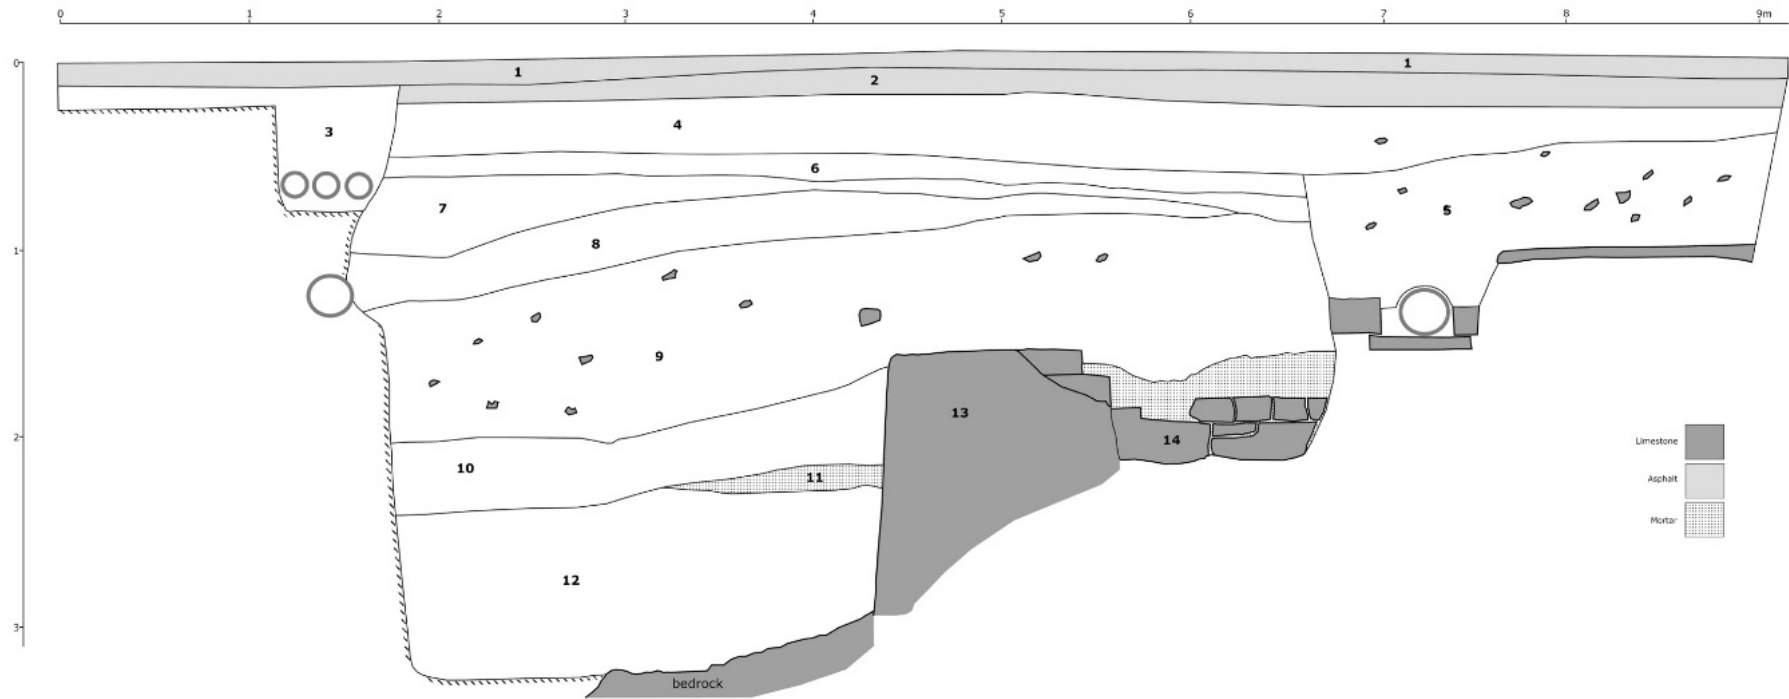
Figure 101 TT5-3 profile drawing of southeast-facing wall

The fills abutting the south of the wall support its identification as the 18th-century quay wall. At the top level of the wall was grey clayey sand (C5-3-10), and a lens of mortar-rich sand with brick which abuts the middle of the wall. Below that, and forming the basal layer which sits on the bedrock, was black silty sand which was wet and contains a large quantity of oyster shell as well as white earthenware, brick, slate and clay pipe stems (C5-3-12). This is identical to the alluvial deposits found in the equivalent position to the south of the quay wall in TT5-2C (C5-2C-12). After reaching the base of the wall and the bedrock, a trench box was installed to access the trench and clean, examine and document the wall's construction; a scale drawing was made of the wall's southwest facing elevation (Figure 101).

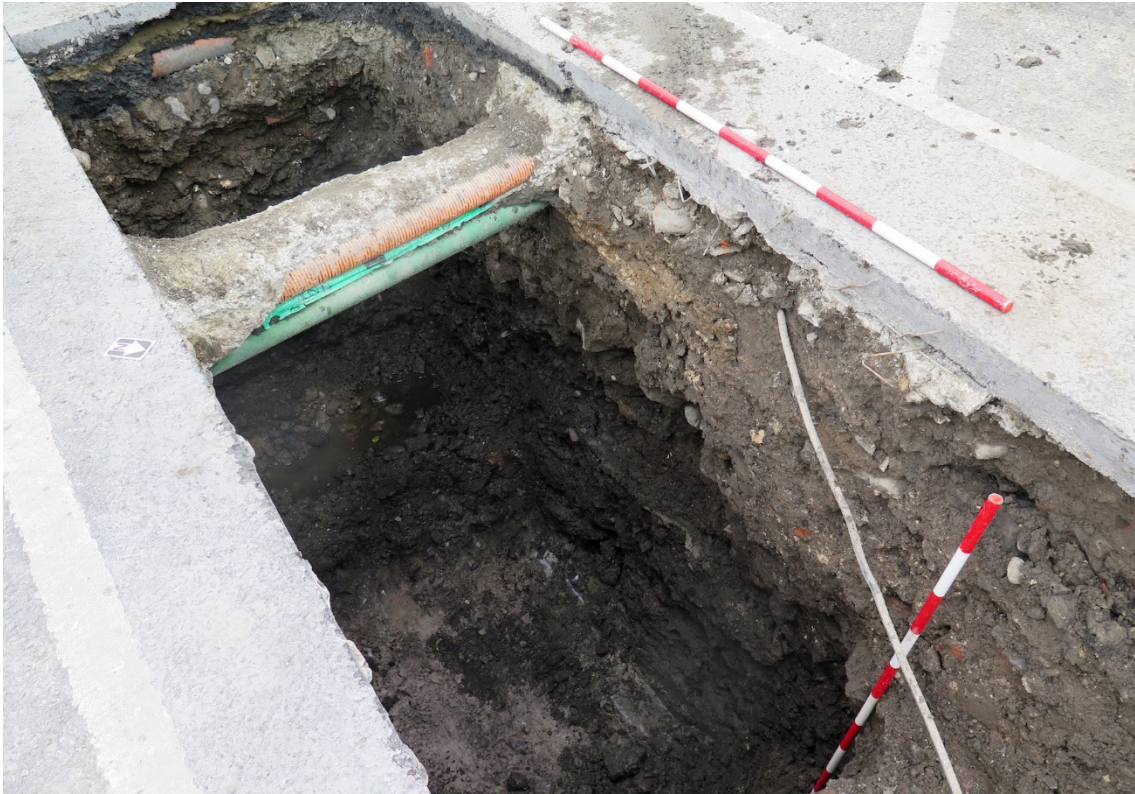
Figure 104 Southern half of TT5-4, facing southwest

Excavations in TT5-4 found the ground here has been highly disturbed through the installation of services. Below the asphalt surface (C5-4-01) and concrete and gravel road base (C5-4-02) was a small patch of cobbled surface (C5-4-03), which is the only survival of a historic built feature. The cobbled surface has been broken up on either side by services. To the south are three plastic ducts at 300mm depth and to the north is a lead pipe at 500mm depth (Figure 104). Just to the north of this lead pipe was a substantial cut into which a ceramic pipe is set at a depth of 1.3m (C5-4-04) (Figure 105). To avoid damaging this pipe, earth was retained beneath it and excavations continued on either side. These revealed a series of redeposited sandy fills containing brick and mortar being mainly pale brown coloured on the north side (C5-4-05) and deeper and grey coloured on the south (C5-4-06) side of the ceramic pipe. From approximately 1.5m depth and continuing below 2m was a highly compacted and gravel rich fill with frequent stone and containing brick (C5-4-07) below which was a lens of grey sand which overlays black silty sand with no artefacts but frequent animal bone (C5-4-08). The basal fill was grey sand with infrequent angular stone (C5-4-09) which overlays bedrock at 3.1m depth.
