Environmental Report June 2025

Glashaboy Flood Relief Scheme

Prepared by: Rory O' Connor

Document code: FFEC-GFRS-2025-006

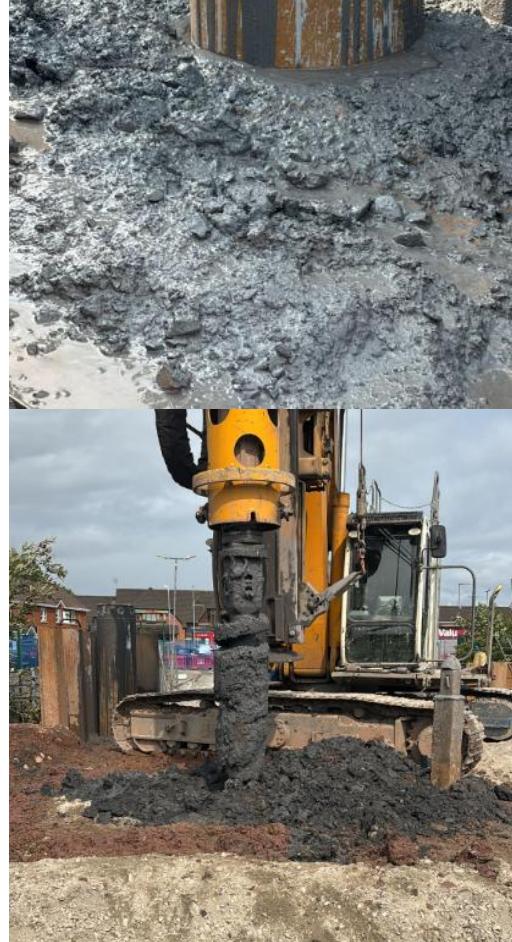
Informed of incident by site ecologist.	No action required by SCE. The local fire brigade responded to the incident and implemented appropriate control measures to address the fuel spill.
6.2	03/6/2025	Rotary pile driving operations are ongoing at the Hazel Shopping Centre. Saturated, muddy material is being contained within the designated work area through the use of a temporary bund.		Monitored ongoing works for implementation of environmental mitigations to protect the adjacent	The material was subsequently scraped and removed from the work area and transported to an appropriate designated location.

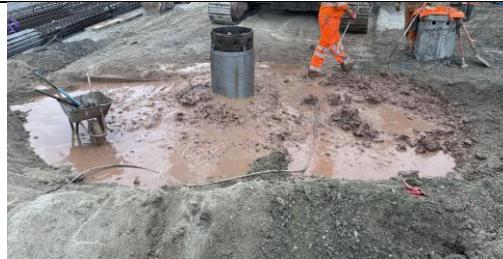
Partial supervision of the concrete pour was undertaken, with checks carried out on the effectiveness and implementation of mitigation measures.	Effective siltation control measures were put in place prior to the works and maintained and supervised throughout the works.
6.15	11/06/2025	Rotary bored piling on the East Abutment - Pile No. 5, 6 and 7. Concrete pour completed for No. 5

Partial supervision, with checks carried out on the effectiveness and implementation

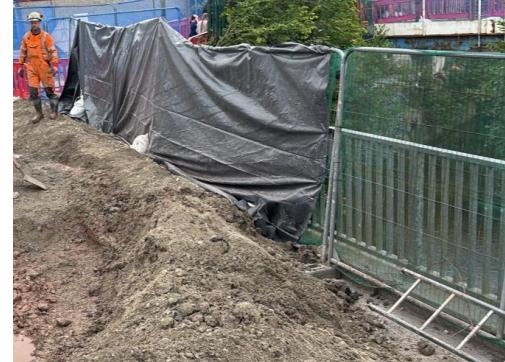
Item number	Date	Comment	Image	ECoW Action/Recommendation	Sorensens's Action response
		Berm, timber hoarding, metal road plates, and 1200 gauge plastic utilised as control measures to contain spoil from boring tool and displaced water during concrete pour.

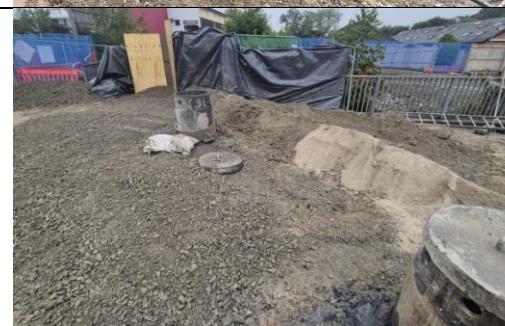
of mitigation measures.	
6.16	12/06/2025	Concrete control measures at Hazelwood Shopping Centre Bridge for concrete pour

Partial supervision of the concrete pour was undertaken, with checks carried out on the effectiveness and implementation of mitigation measures.

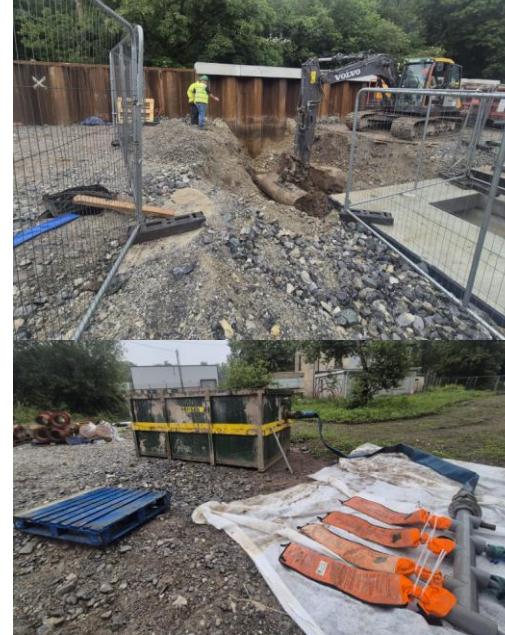
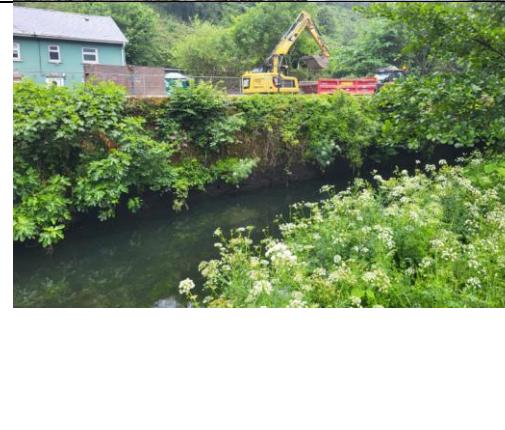
6.20	12/06/2025	<p>The existing wall in Area 4 is scheduled for demolition as part of the design to replace it with a reinforced concrete (RC) wall. Prior to works, vegetation was inspected for signs of bird nesting. Additionally, the otter survey report from January 2025 was reviewed to identify any nearby active holts or related</p>

<p>Liaised with site ecologist to confirm environmental checks were carried out.</p>	<p>Bird survey and otter checks were carried out for the associated works in line with best practise.</p>

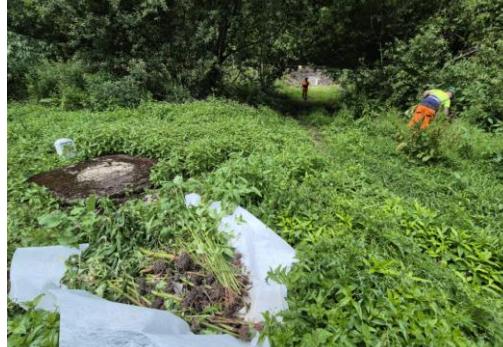
Discussed with site ecologist.	Some plants were removed and relocated compound at Circus Field.
6.29	16/06/2025	Second phase of Balsam Bashing in Area 4 was carried out.

Surveyed the area in question for invasive plant species and discussed with site ecologist required control methods.	Good biosecurity measures were implemented in relation to the management of Himalayan balsam, helping to prevent its spread during site activities.

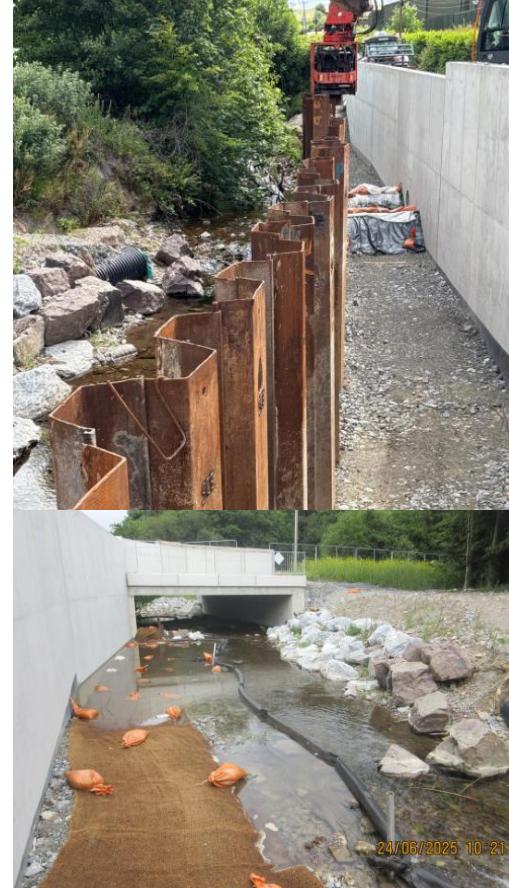
Item number	Date	Comment	Image	ECoW Action/Recommendation	Sorensens's Action response
		primarily in a downstream-to-upstream direction to further reduce silt generation associated with the works.

Reviewed methodologies in consultation with the site ecologist.	Effective silt management was established, maintained, and supervised throughout the works.
