Appendix D (NIS)

Geomorphological Audit

D Geomorphic audit of the Glashaboy River and assessment of the proposed Drainage Scheme

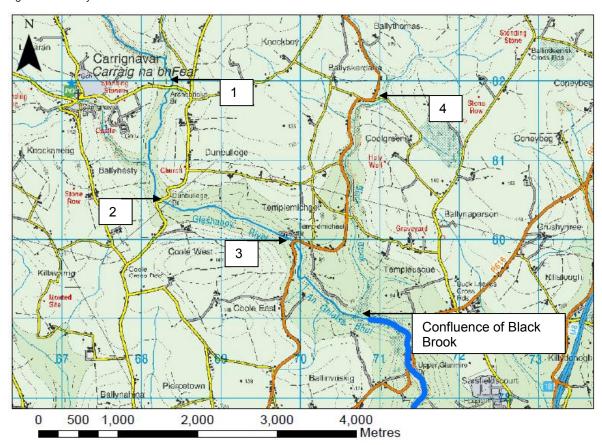
Figure 3-1 Survey Reach Overview

The upper sections of the Glashaboy between Carringnavar to Upper Glanmire Bridge (1 to 2 on Figure 3-1) are predominantly rural. The floodplain in most locations is narrow and dominated by farmland and woodland. The channel exhibits a pool-riffle morphology which is dominated by a cobble and gravel bed, with little evidence of significant transport of cobble and gravel sized material given the amount of bed algae present across this sediment (Figure 3-2). Limited large accumulations of gravel as bar features were noted even in areas where the gradient was reduced. This suggests a limited upstream supply of gravels and/or the ability of the channel to flush sediment downstream during higher flow events.

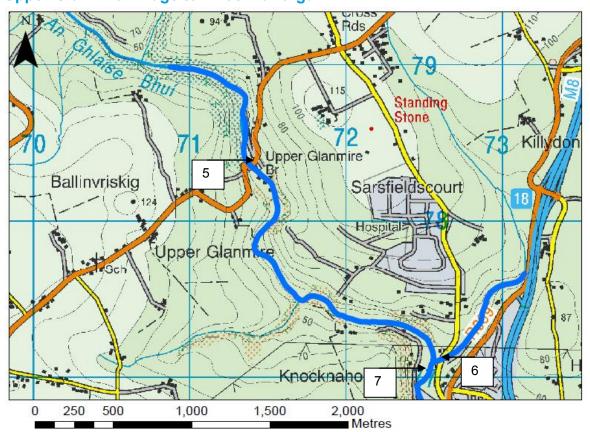
In the reach between Upper Glanmire Bridge and Knocknahorgan the river valley narrows which results in a confined floodplain. At Upper Glanmire Bridge a weir is leading to local bank erosion (Figure 3-6), due to the direction of flows passing under the bridge. Banks have been reinforced using gabion baskets, however, in the long term the river may undercut these baskets.

Downstream of Upper Glanmire Bridge, flow energy in the channel reduces and areas of gravel and small cobble deposition occur (sizes of gravels range from 4cm to 40cm). Gravel splays occur at tributary confluence points (Figure 3-6) along this section, suggesting an active supply of gravels is present from the steep tributaries joining the river (Figure 3-7).

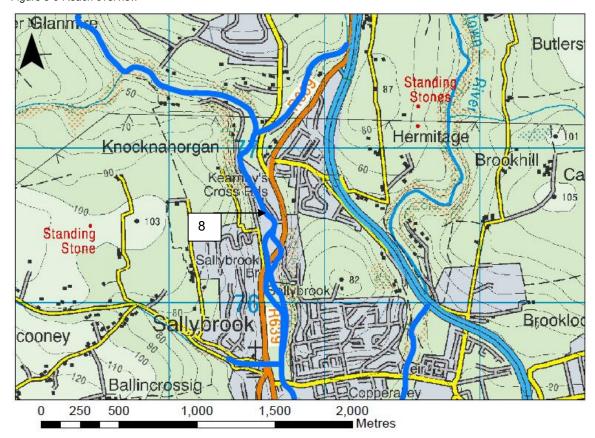
Figure 3-9 Reach overview

As the river approaches Sallybrook the channel and its floodplain become subject to greater urban influences including embankments, weirs and limited floodplain connectivity due to the presence of flood embankments.

As the channel approaches Sallybrook the valley widens and becomes less confined. The wider floodplain along this reach has been developed / built upon which acts to constrict the channel. In some areas informal flood embankments have been constructed. In other areas active bank erosion is occurring as the channel attempts to naturally adjust within is confined channel. This is exacerbated by the higher energies during flood conditions as a result of the channel constriction. Hard measures, such as walls have been constructed to reduce the erosional impact of the river (particularly on the outside of bends) and some of these are now failing (such as adjacent to the petrol station). The erosion of banks acts as a strong sediment supply of gravels and fine materials. Deposition is also common through this reach, with several gravel bars (which are unvegetated, signalling frequent movement) being present. However, in the lower portions of the reach the channel becomes incised as a result of the influence of old mill leats and weirs (some existing and some now removed). As a result of these structures the channel is disconnected by over 1m from the floodplain (due to the channel eroding downwards in an attempt to adjust its bed gradient) and deposition is minimal, due to floodplain disconnection and high in channel energy levels. The channel in this lower section is dominated by coarser cobbles.

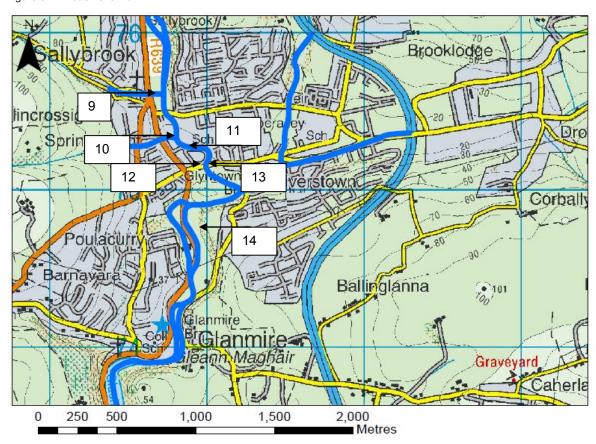
Figure 3-11 Reach overview

Downstream of Sallybrook the channel flows through a narrow urban corridor. The channel remains slightly incised, possibly due to historic straightening due to protected river banks. Sediment is delivered to this reach via several steep tributaries.

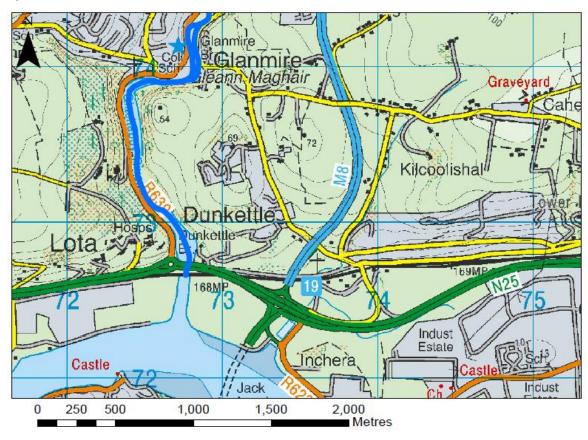
Figure 3-19 Reach overview

At Glanmire bridge, deposition of gravels is occurring on the left bank (Figure 3-20). Downstream of the bridge the river gradually becomes wider and eventually is influenced by the tidal regime. This influences water levels and flow conditions downstream of Glanmire, resulting in some deposition of tidally derived muds and silts. The deposition of this sediment appears low therefore there is little risk of increased sedimentation in this section.
