Environmental Report July 2025

Glashaboy Flood Relief Scheme

Document code: FFEC-GFRS-2025-007

The following is the clients Ecological Clerk of Works (ECoW) monthly review of the Glashaboy River (Glanmire/Sallybrook) Drainage Scheme. It details observations made on site regarding environmental and ecological factors involved in the scheme. This formulates a monthly review to be submitted to the Environmental Monitoring Group (EMG).

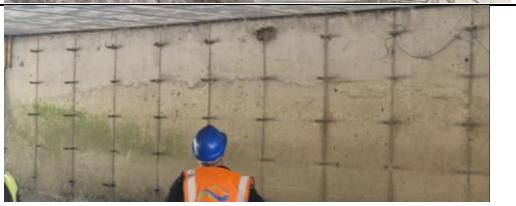
7.2	01/07/2025	A nest under the Hazelwood Road Bridge was inspected and confirmed to be an active Swallow nest.

Periodic monitoring and liaising with site ecologist in relation to swallow nest activity.	Although this nest is not within the direct footprint of the works, it is located in between two work areas. Subsequently, it was communicated to workers and will be monitored periodically for its status.

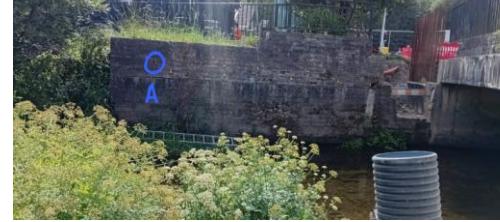
Item number	Date	Comment	Image	ECoW Action/Recommendation	Sorensens's Action response
7.5	02/07/2025	<p>Weep Hole F was blocked off this afternoon after young birds had fledged.</p> <p>There is still activity at Weep Hole A which was blocked on the evening of the 08/07/2025 after checks confirmed no nesting.</p>

<p>Periodic monitoring and liaising with site ecologist in relation to weep hole nesting activity.</p>	<p>Blocked off was done in consultation with NPWS and only after weep hole was confirmed inactive by previously nesting sand martins.</p>

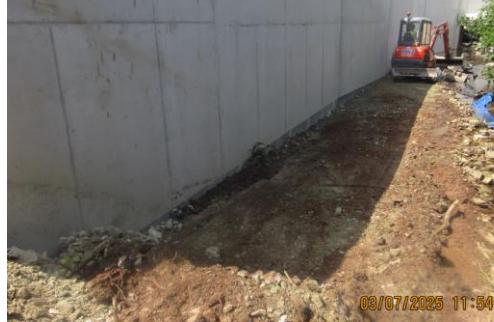
7.6	03/07/2025	<p>Works at New Line involved the removal of the temporary berm and excavation of a toe trench to anchor the rock armour. Activities were carried out in semi-dry conditions.</p>

<p>The works were supervised on site, with close coordination between the machine operator and the site ecologist.</p>	<p>The works were supervised by the site ecologist.</p> <p>Silt curtain arrangements were in place around the active work area to minimise the release of suspended solids into the watercourse. Water quality sondes were installed both upstream and downstream to record and transmit key parameters, including NTU, pH, dissolved oxygen, temperature, and conductivity.</p> <p>Start-stop protocols were implemented and enforced as needed to manage and</p>

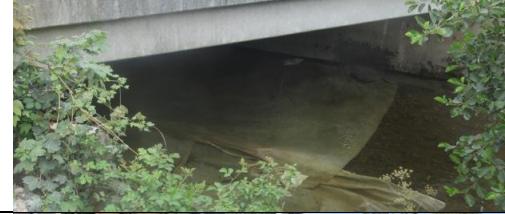
Item number	Date	Comment	Image	ECoW Action/Recommendation	Sorensens's Action response
7.11	08/07/2025	As part of preparatory works for the lifting of bridge beams from the old Shopping Centre Bridge, a road sweeper was deployed to remove dust and small debris, preventing these materials from entering the river.

Pre-works discussions were held to establish mitigation measures aimed at reducing the risk of material entering the watercourse during the operation.	Terram sheeting was also installed in the watercourse beneath the bridge to capture any falling debris during beam removal and to facilitate efficient retrieval once lifting operations are complete.

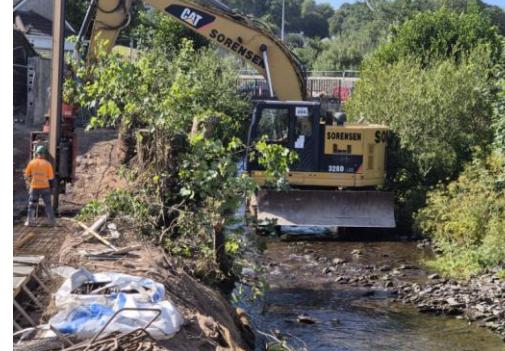
7.12	08/07/2025	Driving permanent sheet piles to accommodate a stitch onto the RC Wall. Piling took place from the river.

Supervised.	Tracking was minimised, and water quality was continuously monitored throughout the works. Biodegradable hydraulic oil was used in the tracked machinery to reduce environmental risk.

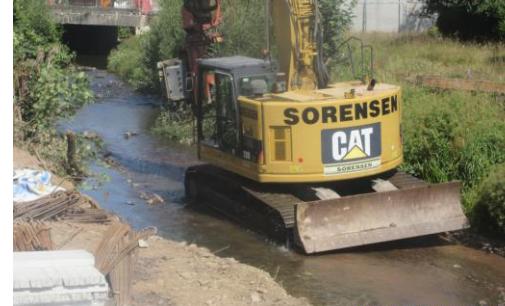
10/07/2025 11:42		
7.13	09/07/2025	<p>Bridge beams were lifted today. Some debris visibly entered the river but was largely contained by the previously installed Terram sheeting. Larger materials were moved to river margins where sheet piling for the cofferdam will create a dry working zone for removal during the upcoming abutment excavations.</p>

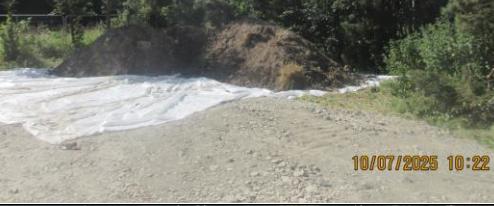
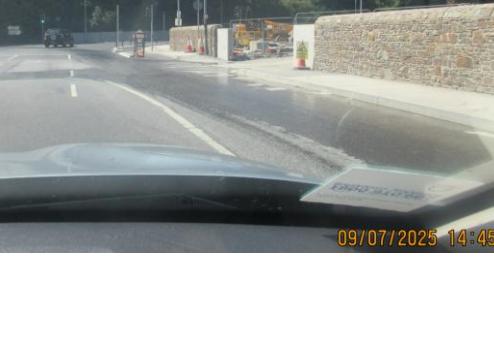
7.15	09/07/2025	<p>Dust control measures were implemented throughout the month as required. Particular attention was given to the Circus Field; due to its ongoing heavy use and its proximity to a coffee shop located directly across the road.</p>

Recorded.	Dust control implemented as weather conditions necessitated.

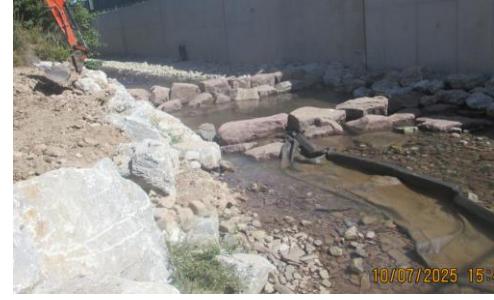
7.18	10/07/2025	Area 3 – Both steps pools have been installed, and rock armour work is nearing completion. Silt control measures may be removed if no further in-stream activities are planned.

Supervision of works and checks to design and final layout of step arrangement.	The works were supervised by the site ecologist. Silt curtain arrangements were in place and adjusted as needed. Water quality sondes monitored. Start-stop protocols were in operation.

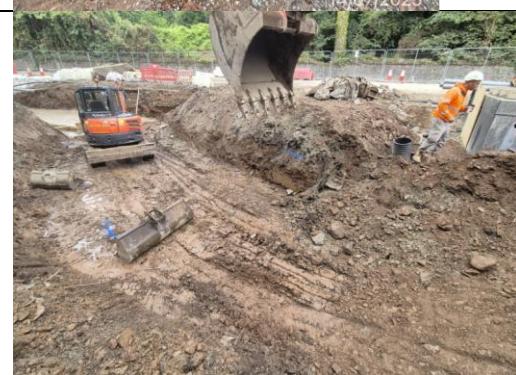
The discharge area was regularly inspected throughout the pumping period, which spanned several days.	A permit to pump was issued, taking into account various ecological factors to ensure full compliance with environmental requirements.
7.22	15/07/2025	Excavating continuing in Area 4 for RC Walls through a known potential JKW infested area.

Partial supervision was provided, with ongoing liaison between the ground crew and the site ecologist.	Biosecurity measures were in place. Most importantly supervision.

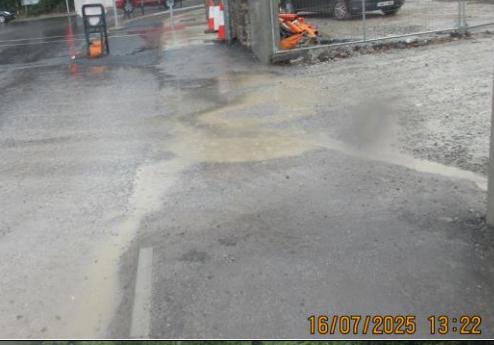
7.25	16/07/2025	Earth material excavated within Area 4 for the reinforced concrete (RC) wall, which is contaminated with Japanese Knotweed (JKW), has been stockpiled on a floodplain. The associated risks were communicated to the SCE, who acknowledged and accepted liability for these risks.

Discussed with site ecologist.	SCE are willing to accept the low risk, considering the time of year and the unlikely combination of significantly elevated water levels and severe weather conditions that would be required for this area to flood. The material is expected to be removed within the next few weeks, once the Regulation 49(2) transport licence is issued by the NPWS.

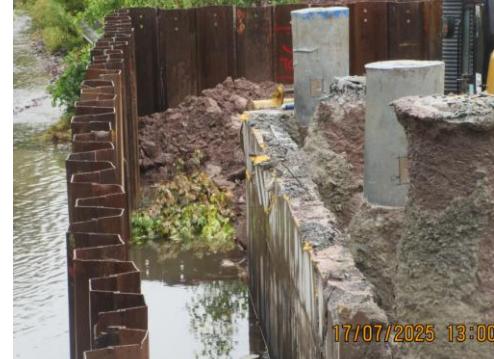
7.30	17/07/2025	Minor amount of earth material added to east coffer dam channel accidentally.

A photograph showing earth material added to the east coffer dam channel. The date 17/07/2025 13:00 is visible in the bottom right corner of the image.	Advised caution to driver.	No more material was added. The material that was added to the channel was removed the same day.

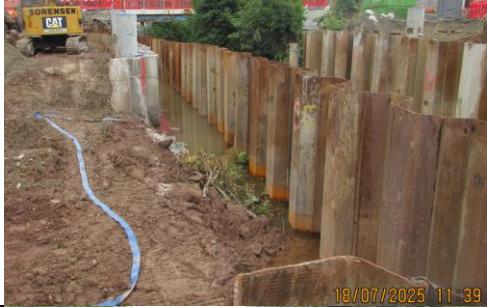
Item number	Date	Comment	Image	ECoW Action/Recommendation	Sorensens's Action response
7.31	17/07/2025	Area 2, electro fishing was carried out on the eastern coffer dam channel at Hazelwood.

Discussed works and findings with site ecologist.	The e fishing was carried out professionally and in line with conditions granted by the license.
7.32	18/07/2025	Pumping commenced on the eastern coffer dam at hazelwood.

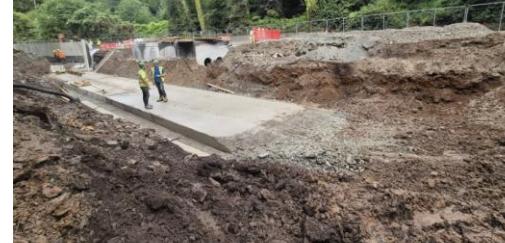
7.36	18/07/2025	Japanese Knotweed (JKW) was encountered in Area 4. Biosecurity measures have been implemented to manage the risk of spread.

Liaised with site ecologist.	The material has been stored temporarily on the floodplain, pending the issuance of a licence from the NPWS. Storage is at the contractor's own risk.

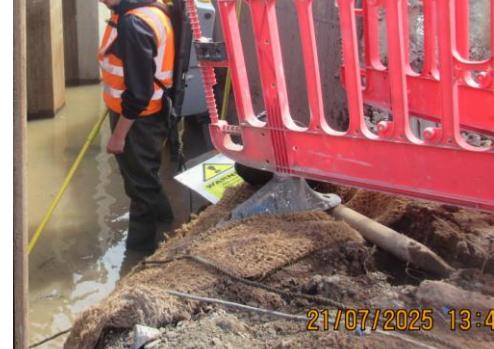
Item number	Date	Comment	Image	ECoW Action/Recommendation	Sorensens's Action response
7.39	21/07/2025	An electrofishing rescue was conducted at the western cofferdam prior to its closure from the river.

Discussed with site ecologist and monitored fish rescue operations.	A fish rescue was carried out under licence from Inland Fisheries Ireland, in full compliance with the conditions set out in the licence, including any specified temperature restrictions.

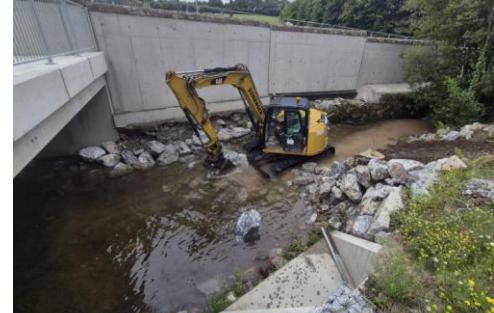
7.40	21/07/2025	Rock armouring works at New Line today.

Monitored some of the works, checks on silt curtain arrangement and liaised with site ecologist and driver.	Start stop protocols in place to manage silt loading of river which was informed by NTU readings being transmitted by the water sondes. Three downstream silt curtains were also in place to slow silt release into channel.

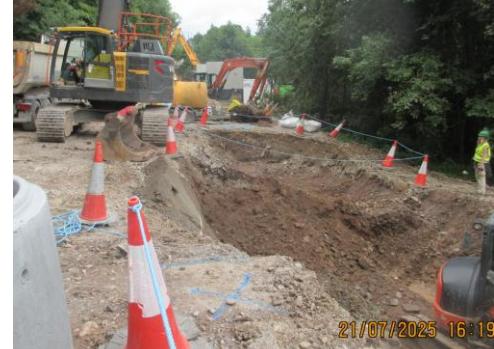
7.41	21/07/2025	Area 4 excavations for RC wall carried out under supervision of knotweed specialist/site ecologist.

Checks were carried out to ensure that works were undertaken in accordance with the SCE Biosecurity Plan, the works specifications.	Biosecurity measures are in place and functioning well. Any encountered Japanese Knotweed rhizomes are being removed and transferred to a temporary stockpile.

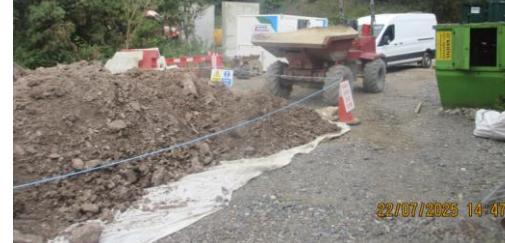
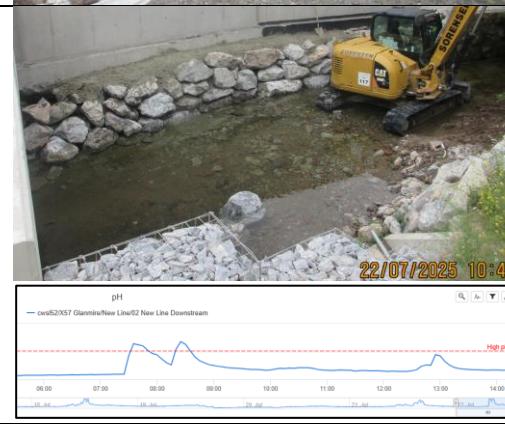
7.42	22/07/2025	Semi-wet concrete was used at New Line today, and an accidental spillage resulted in two brief pH spikes, exceeding the limit of 9.03 and reaching up to 9.30. Although the spikes were short in duration, this was not considered good practice.

Inspected the works area after the incident and liaised with the SCE and ER team to raise the issue.	Greater care was taken following the incident, and no further elevated pH readings were recorded at this location.

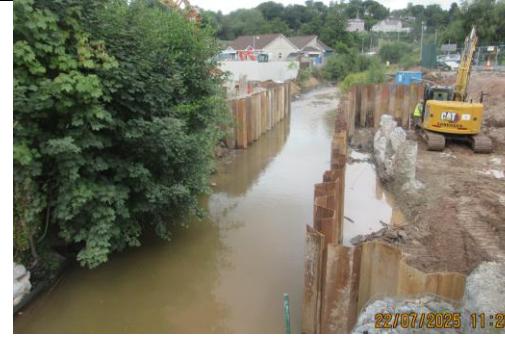
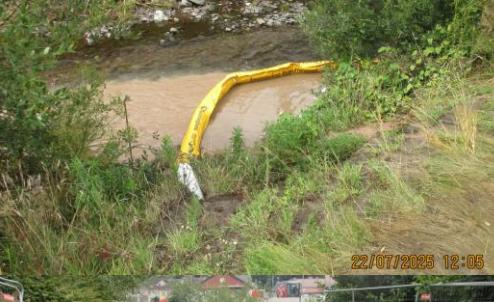
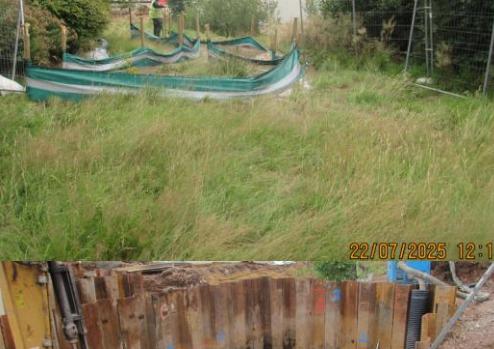
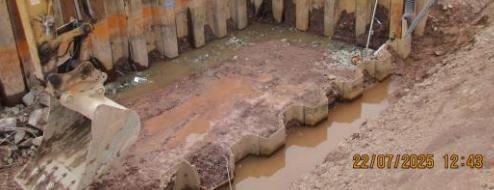
7.43	22/07/2025	Dewatering of the eastern abutment at Hazelwood, from the shopping centre to the Credit Union attenuation area, is not functioning effectively. The river appears visibly silty, despite no in-stream works taking place in this area. While some improvements have been

Item number	Date	Comment	Image	ECoW Action/Recommendation	Sorensens's Action response
		made, further action is needed, as this location is expected to serve as a long-term discharge point for occasionally highly turbid water.

Liaised with the SCE and ER team and spoke with the General Operative (GO) to adjust the silt curtains and silt fencing.	Some adjustments were made to the silt curtains, which provided partial improvement. Within the cofferdam being dewatered, additional drainage stone was added to enhance filtration before the water reaches the pump. Excavation within the water

inside the cofferdam was halted to reduce further disturbance.

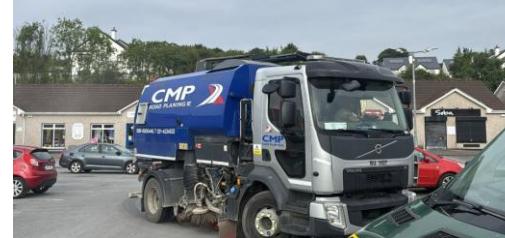
7.46	23/07/2025	A road sweeper was deployed to the Hazelwood Shopping Centre Bridge works area to clean material from the road surface. This measure aims to prevent washout into stormwater gullies and, ultimately, into the Glashaboy River in the event of heavy rainfall.

Held discussions with the site ecologist regarding the planned works	This measure aims to prevent washout of fines materials into stormwater gullies and, ultimately, into the Glashaboy River in the event of heavy rainfall. Alternately, it reduces dust associated with the works during prolonged dry conditions.

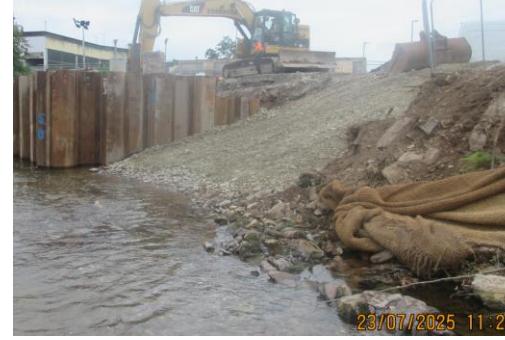
7.47	23/07/2025	Improved ramp installed at Hazelwood to be used for plant entering river to complete approved instream works.

Discussed situation with site ecologist with general agreement ramp could be improved.	The introduction of a more gradually graded slope, along with the placement and compaction of stone material, effectively prevented washout that would have occurred if loose earth had been left exposed instead.

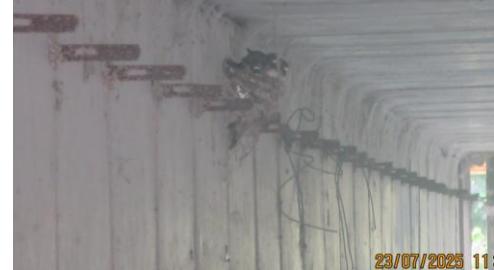
Item number	Date	Comment	Image	ECoW Action/Recommendation	Sorensens's Action response
7.48	23/07/2025	An active shallow nest under the Hazelwood Road bridge is receiving ongoing monitoring. The swallow chicks under Hazel Road Bridge were checked, with at least three visible. Fledging is likely to occur within the next week or two given the size of the chicks.

Periodic checks were undertaking and ongoing communication with site ecologist regarding the nest's activity.	An active swallow nest beneath the Hazelwood Road Bridge is being monitored regularly. While there is no immediate risk to the nest or chicks from current works, due to the proximity of nearby activity, care is being taken to ensure ground personnel are informed of the nest's presence to avoid any unintentional disturbance

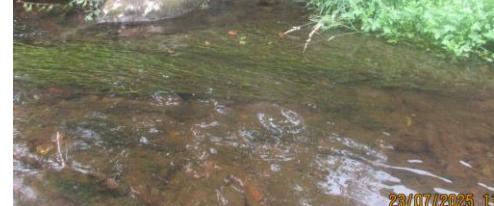
7.49	23/07/2025	Two additional water crow foot plants were relocated from the toe of the Bean and Leaf revetment wall. These plants were to be unavoidably damaged from necessary works.

Relocated plants with hope they'll be able to be reinstated following works.	SCE were not asked to carry out this work but were informed it was taking place. No action was required.

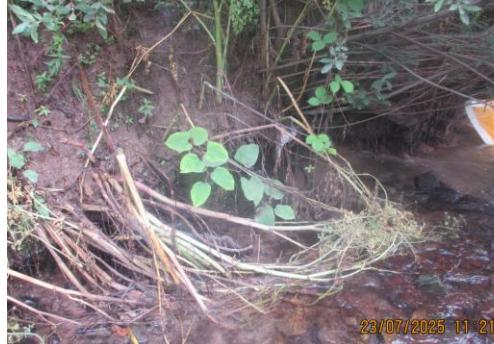
Item number	Date	Comment	Image	ECoW Action/Recommendation	Sorensens's Action response
7.50	23/07/2025	JKW stem visible from riverbank at Credit Union within the footprint of the attenuation area.

23/07/2025 11:21	Informed site ecologist.	The exposed JKW stem was removed to the temporary stockpile for contaminated material on the west side of the river.

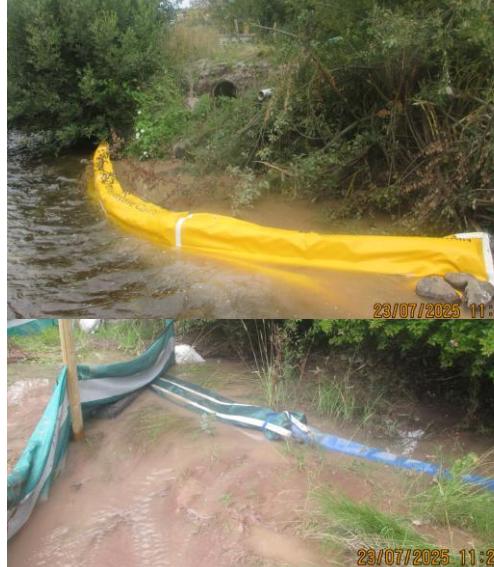
7.51	23/07/2025	Enhancements were made to the attenuation area at Credit Union.

23/07/2025 11:23 23/07/2025 11:29	Ongoing monitoring of NTU levels via the online sondes data. Ongoing discussions with site ecologist regarding silt management.	Enhancements included silt curtain arrangements and increased silt sock on lay flat discharge point.

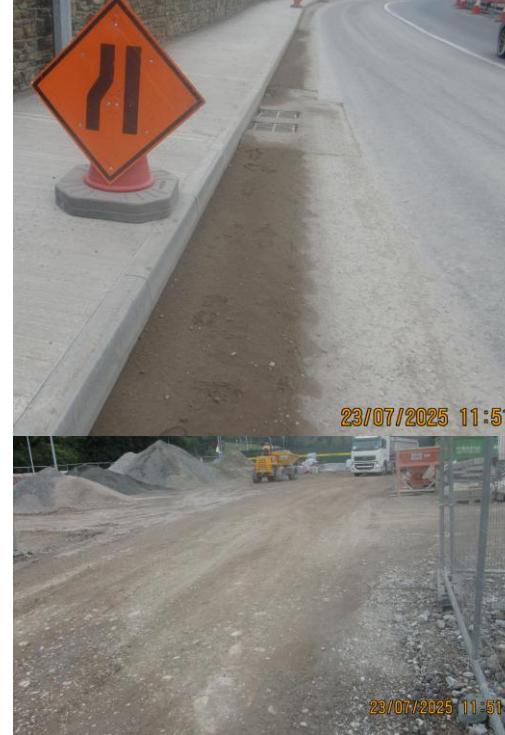
7.52	23/07/2025	There is a noticeable accumulation of fine material along Hazelwood Road. This		Liaised with site ecologist regarding the	This roadside material build up was targeted by a road sweeper deployed to address

Item number	Date	Comment	Image	ECoW Action/Recommendation	Sorensens's Action response
		material appears to originate from the Circus Field, which is currently being used for the stockpiling of various earth and rock materials. As a result, there is an increased risk of fine sediment being washed into the Glashaboy River via the stormwater gullies during periods of heavy rainfall.

need to remove the material prior to heavy rains occurring.	such issues across the scheme's sites.
7.53	23/07/2025	Blinding was placed over the rock armouring at New Line. Bean bags and Terram were installed as control measures to contain cementitious materials. Additionally, Terram was placed within the rock

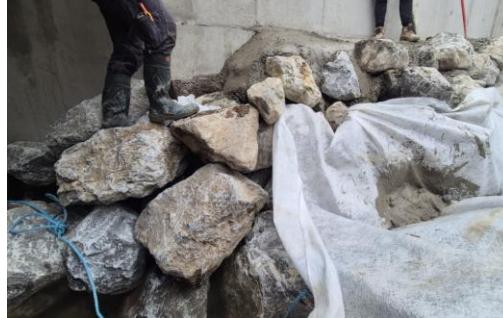
Item number	Date	Comment	Image	ECoW Action/Recommendation	Sorensens's Action response
		armouring to prevent cementitious material from entering the marginal riverine habitat.

Liaised with site ecologist regarding the mitigation measures required for these works.	Well-conceived and implemented control measures. Notable improvement on yesterday's performance.

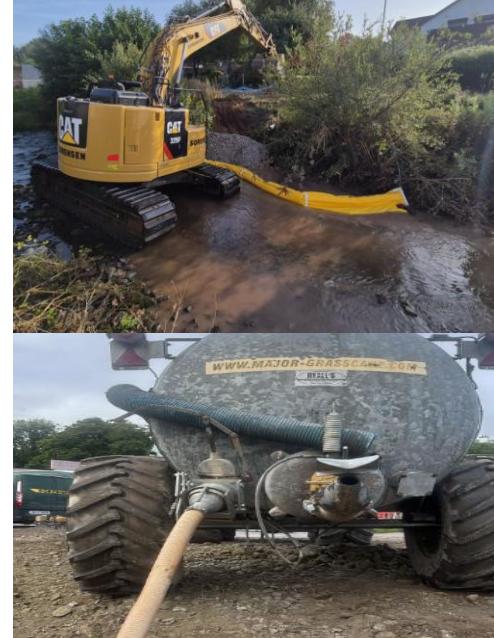
Item number	Date	Comment	Image	ECoW Action/Recommendation	Sorensens's Action response
7.55	24/07/2025	<p>The attenuation area in Credit Union lands was enhanced by the Installation of gravels to improve filtration This necessitated tracking in river.</p> <p>A vacuum tanker was deployed today to assist with dewatering operations at the western abutment excavation. This measure was implemented during a particularly intensive phase of excavation works, which generated highly silty water.</p>

Informed by the site ecologist and recorded for documentation purposes.	Ongoing supervision of silt management was carried out by the site ecologist, with enhancements and adjustments implemented continuously as conditions required.

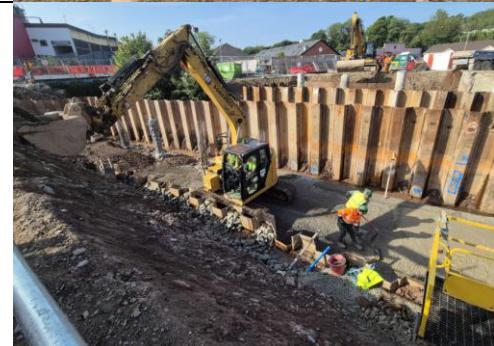
7.56	24/07/2025	A dry mix has been put in place along the length of the internal perimeter drainage channel to assist with containment of the concrete pour.

Measures should be in place to prevent concrete from entering the cofferdam channel during the pour scheduled for the morning of 24 th July.	Positive measures were implemented to mitigate pH water quality risks from pour.

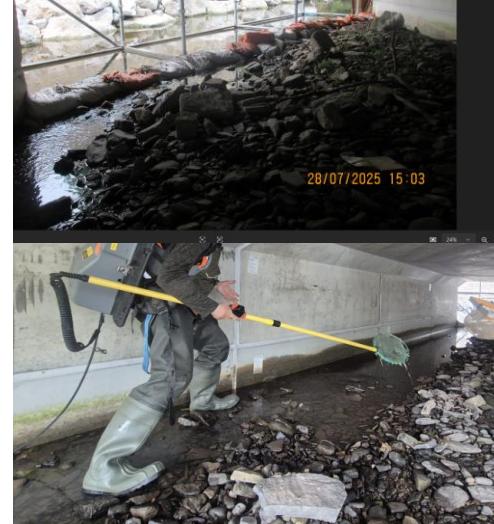
Item number	Date	Comment	Image	ECoW Action/Recommendation	Sorensens's Action response
7.58	24/07/2025	Electrofishing activities were carried out in the overflow culvert at Brooklodge / Copper Valley Vue. Sandbags were installed to divert most of the water into the primary culvert, enabling effective fish rescue. Trout species were reportedly relocated following the electrofishing.

Discussed with site ecologist and area inspected.	The operation was undertaken due to the vulnerability of fish being potentially trapped in the overflow culvert during periods of rising temperatures and reduced flow levels. Also rescue required in advance of works to be carried out within and downstream of the overflow culvert.

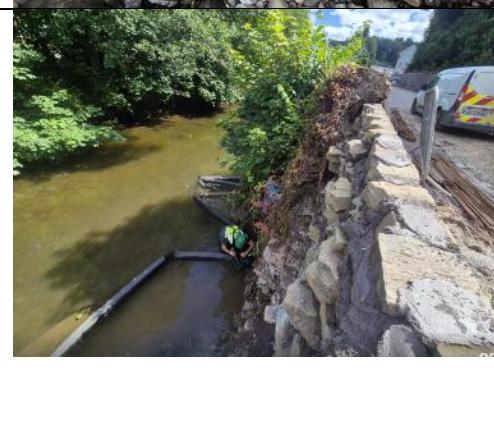
7.59	28/07/2025	Area 4 Vegetation clearance from wet side of wall c. 15m.

Informed by the site ecologist regarding the scope of works and the mitigation measures in place to manage environmental risks.	Mitigation measures and ecological supervision were in place to ensure that the works proceeded in accordance with best environmental practice.

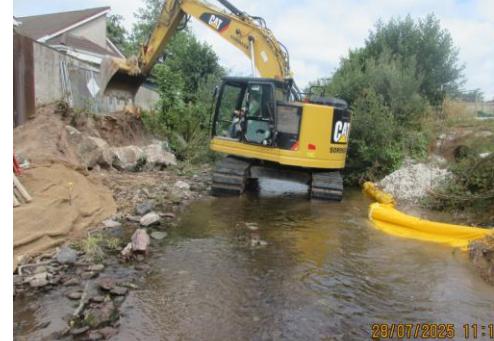
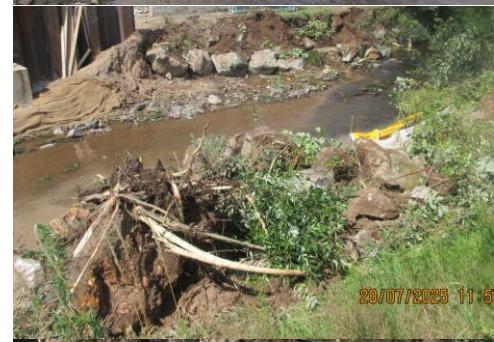
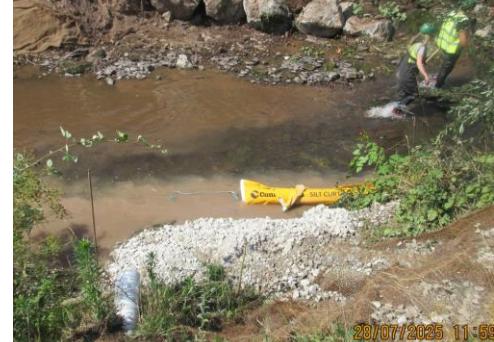
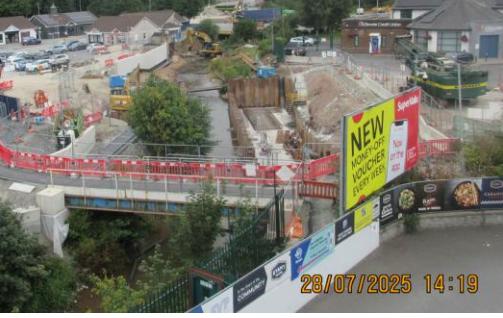
Item number	Date	Comment	Image	ECoW Action/Recommendation	Sorensens's Action response
7.60	28/07/2025	<p>Area 2 – Removal of old rock armour in preparation for sheet piling was a source of siltation. Simultaneously, dewatering ongoing dewatering of the east and west abutment excavations to attenuation area on Credit Union grounds was also a source of siltation.</p> <p>Throughout the workday, NTU readings from the sondes reached the agreed short-duration upper threshold of 209 NTU. This limit was established as part of the three-month instream works period allowance, with the understanding that such elevated levels may occur briefly during high-intensity activities. Preceding and subsequent days recorded comparatively low NTU levels.</p>

Item number	Date	Comment	Image	ECoW Action/Recommendation	Sorensens's Action response
		By managing silt loading over a broader time frame, this approach allows for necessary, intrusive instream works to proceed while avoiding prolonged or repeated sediment shocks to the river environment.

<p>Ongoing monitoring of NTU levels via the online sondes data. Ongoing discussions with site ecologist regarding silt management.</p>	<p>Minor adjustments were made under supervision of the site ecologist to the attenuation area, including repositioning of some gravels, silt curtains, and separation of discharges - the clean water discharge from the east abutment did not require routing through the attenuation system or silt curtains arrangement. In combination, these measures reduced the levels of silt accessing the river.</p> <p>Start stop protocols were also in place regarding the rock armour works which temporally reduced silt loading from these works.</p>

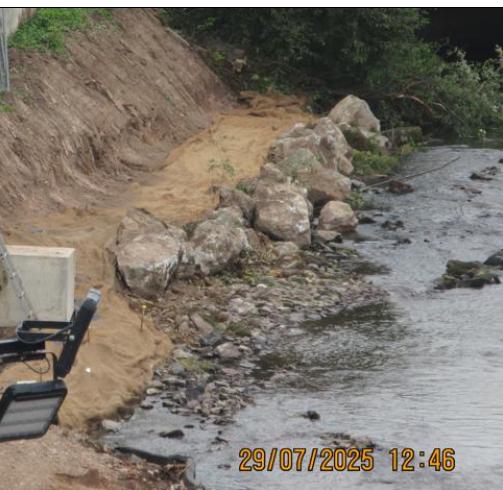
28/07/2025 14:19		
7.61	29/07/2025	Vegetation was removed from the east bank of Hazelwood to allow work on the pre-existing rock armour. This resulted in the exposure of bare soil, posing a siltation risk from potential washout. To mitigate this, coir mesh was installed as a control measure.

29/07/2025 12:46	Notified of site activity by the site ecologist; recorded for documentation purposes.	Positive measure to prevent possible run off and avoidable siltation of watercourse until permanent works are carried out.

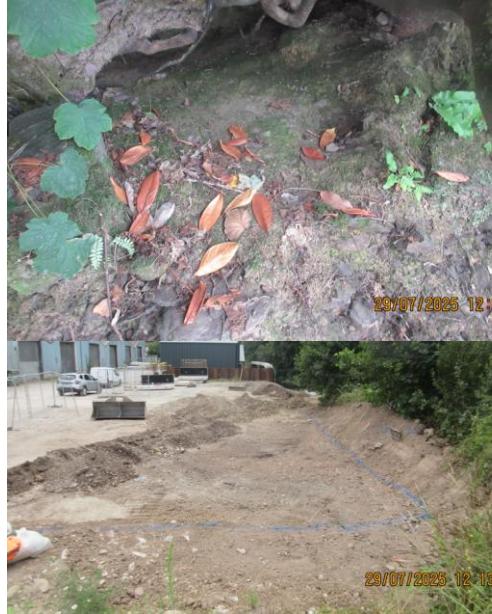
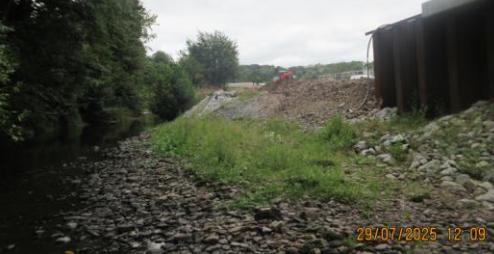
7.63	29/07/2025	<p>Area 1 – Vegetation was cleared in preparation for a Change Order involving the replacement of 40m of flood embankment with a permanent sheet pile wall.</p> <p>Continued vegetation clearance and Japanese knotweed (JKW) supervision took place in Area 1. Where JKW was identified, it was left in place where possible for later treatment in accordance with the Biosecurity Plan</p>

<p>The status of a nearby otter holt was rechecked and found to be unchanged, with continued signs of no activity.</p>	<p>Appropriate control measures were implemented proactively to address the identified environmental risks.</p> <p>Vegetation was cleared under supervision from the site ecologist / IAPS (Invasive Alien Plant Species) Specialist, with checks for Japanese Knotweed and also bird nesting surveys conducted both prior to and during the works.</p>

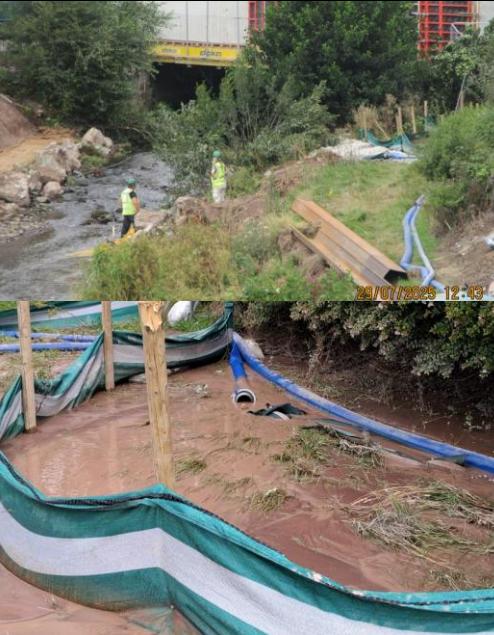
7.64	29/07/2025	Ongoing dewatering of the east and west abutment excavations to attenuation area on Credit Union grounds. The situation requires ongoing monitoring and adjustment to manage silt loading into Glashaboy.

Ongoing checks are being carried out on the online water quality data transmitting NTU readings, along with inspections of the physical attenuation measures in place.	In this instance, adjustments were made to the coir mesh and the silt sock, which resulted in the water running clear.

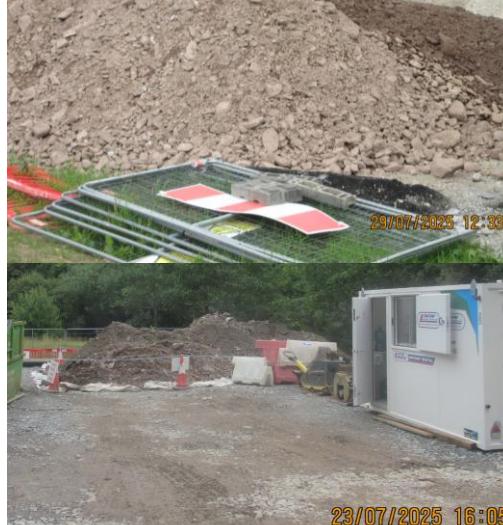
Item number	Date	Comment	Image	ECoW Action/Recommendation	Sorensens's Action response
7.65	29/07/2025	<p>River gravels continue to be stockpiled at the New Line site for proposed placement within the riverbed upstream of the new bridge. These gravels originate from abutment excavations at Hazelwood, where natural riverbed deposits were encountered.</p>

<div style="display: flex; justify-content: space-around; width: 100%;"> 29/07/2025 12:30 23/07/2025 16:05 </div>	<p>Discussed gravel retrieval and reuse within the scheme with the site ecologist.</p>	<p>While the gravel may carry some silt (some of which will be naturally washout from rain), the material itself consists of Old Red Sandstone, which is not easily sourced through local quarries. As such, it is considered ideal for reuse within the scheme's riverworks and holds value as a resource</p>

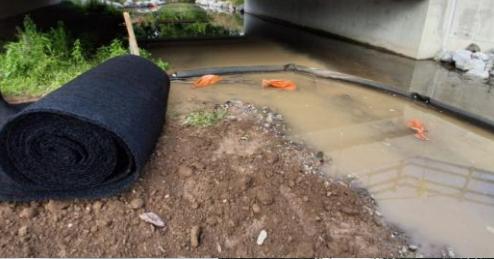
7.67	30/07/2025	<p>Area 3 Control measures in place at Copper Valley Vue in advance of installation of erosion matting</p> <p>Controlled release of silt (silt curtains were opened to permit fish passage) at Copper Valley Vue took place this evening</p>		The position of downstream sondes was checked, and the silt curtain arrangement was inspected to ensure effectiveness.	<p>A silt curtain arrangement was installed prior to the commencement of works. Following an initial burst of activity, the curtain was adjusted to improve its effectiveness.</p> <p>In advance of the works, water quality sondes were installed and set up by Capital Water Systems to monitor key parameters, including NTU (turbidity),</p>

temperature, and dissolved oxygen. The works were carried out under the supervision of the site ecologist.

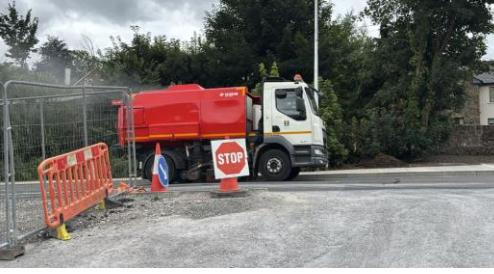
7.68	30/07/2025	A road sweeper was in operation across the works sites as part of dust control measures. This action also removes material from the road that if a heavy downpour was to occur would wash out into the Glashaboy contributing to elevated turbidity.

Notified of site activity by the site ecologist; recorded for documentation purposes.	Positive measures were implemented to control dust and prevent potential silt-laden material from entering watercourses.

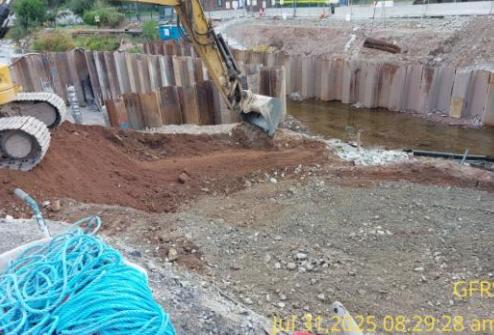
7.69	31/07/2025	Reshaping of riverbank beside western abutment of bridge. Addition silt curtain in place.

Communicated with site ecologist regarding exposed riverbank.	Coir mesh was installed that day to control run off and erosion.

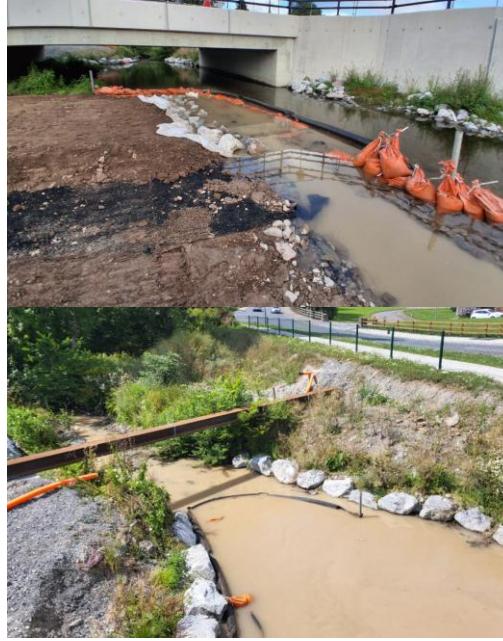
Item number	Date	Comment	Image	ECoW Action/Recommendation	Sorensens's Action response
7.70	31/07/2025	<p>Silt control measures are to be reviewed and adjusted at the Copper Valley Vue site following elevated NTU readings that exceeded the 190 NTU threshold. While the turbidity levels were higher than desirable and resulted in visible water discolouration, other key water quality parameters—such as pH, dissolved oxygen (DO), and temperature—remained within healthy ranges for aquatic species. Additionally, the section of river where the in-stream excavations for the erosion matting installation were taking place did not contain attractive fish habitat, reducing the likelihood of any sensitive species being present in the immediate area.</p>

<p>Inspected works and mitigations – not working. Suggested alternate measure- river gravel bund along works to create dry area.</p>	<p>Silt curtains were deployed around the excavation area, and a controlled release of suspended solids was carried out periodically. However, this method proved ineffective in significantly reducing the high NTU levels entering the watercourse, but sediment loads were restricted to short duration spikes. A gravel bund was added upstream of the top silt curtain to deflect water from driving out sediment behind the curtains. Water quality parameters were monitored in real time via data from the installed sondes to inform live supervision and guide mitigation actions on site.</p>
