Environmental Report September 2024

Glashaboy Flood Relief Scheme

Date of issue: 04/10/2024

Document code: FFEC-GFRS-2024-009

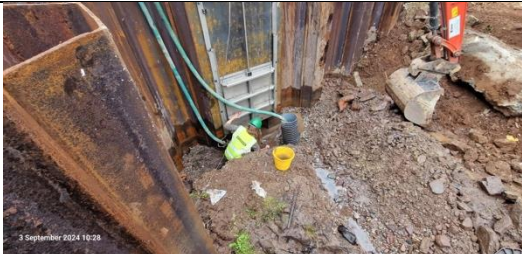
9.2	03/09/2024	Grandon's Mill race, fish rescue undertaken following necessary drying out to allow for rock armour works.

Partial supervision fish rescue and checks of mitigation measures.	Digging from dry to prevent contaminated water entering the main channel. Fish rescue carried out.

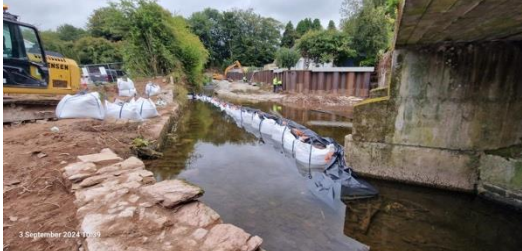
9.3	03/09/2024	Meadowbrook above Riverstown bridge: Sandbags installed with plastic closed off alongside riverbank. Area E fished, fish recorded and released downstream.

Advised on dry out procedures and supervised some of the fish rescue.	Fish rescue carried out. Silt mitigations installed downstream. Supervision of the area carried out however total dry out could not be achieved. See Item 9.12 for additional information.

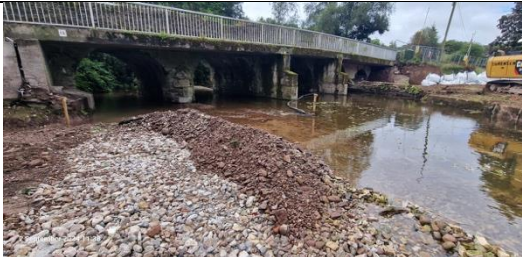
9.5	02/09/2024	Meadowbrook. River widened to facilitate flows when cofferdam installed. Minimal works and short in duration.

Minor silt generated was observed.	Silt mitigations were installed downstream. Downstream silt levels were being recorded and monitored with an in-situ sonde.

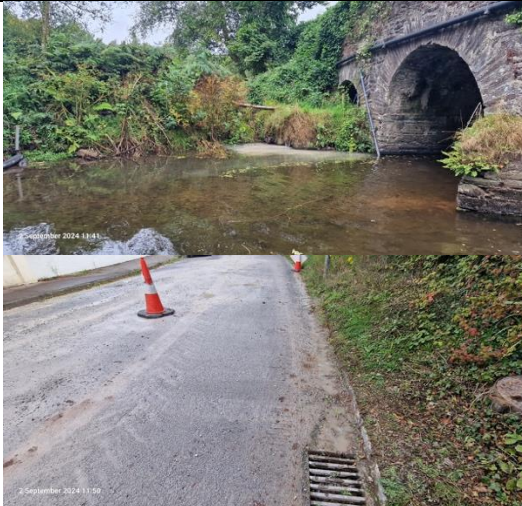
9.6	02/09/2024	Silt outflowing from pipe below Riverstown bridge. Surface water generated on road in Meadowbrook estate at entrance to bridge works area as a result of road washing for dust suppression. The silt generated was minor and short in duration.

Inspected drain and pipe. Discussed with site ecologist present on site at the time.	Silt mitigations were installed downstream. Downstream silt levels were being recorded and monitored with an in-situ sonde. The mud was cleaned from the road.

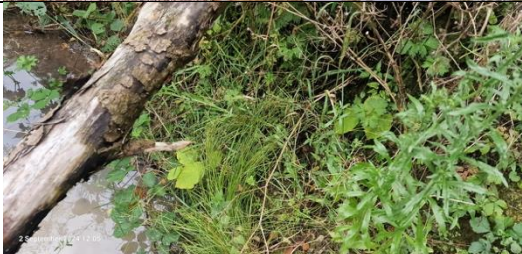
9.8	02/09/2024	Japanese knotweed growing below Riverstown Bridge, adjacent to ground to be removed for opening arch of bridge.

Recorded JKW and discussed with site ecologists.	Sorensen's to monitor excavation works for knotweed rhizomes and follow its Biosecurity Plan Rev 2 during these works.

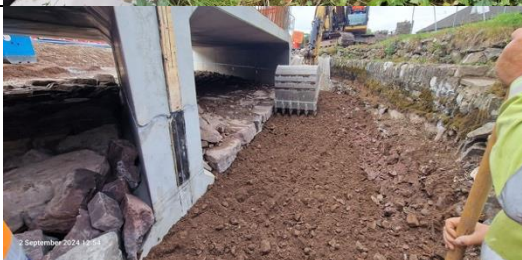
9.9	02/09/2024	Brooklodge: Clay and gravels installed above culverts. Clay used to prevent water escaping under culvert.

Discussed works with site foreman	Clay added following previous discussions with site ecologists.

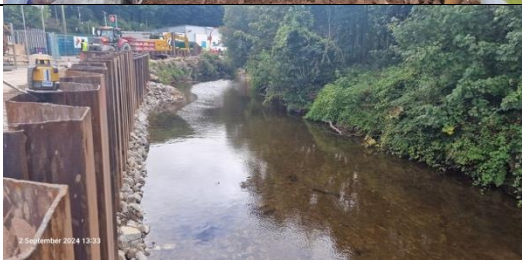
9.10	02/09/2024	Following the completion of rock armouring alongside the Gym at Sallybrook, the silt curtains were removed.

Discussed with site ecologist.	The curtains were removed gradually, which helped to disperse the silt more slowly, allowing additional time for settlement and dilution. This approach effectively minimised its overall environmental impact.

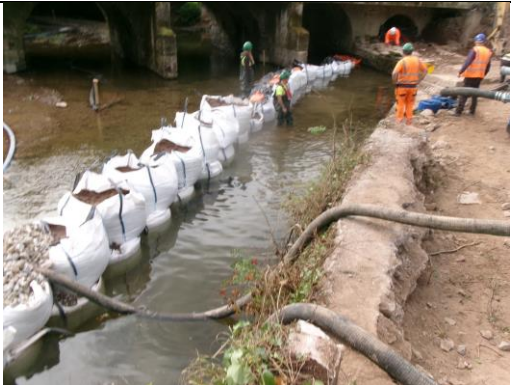
9.12	04/09/2024	Ongoing operations to dry out a section of the Glashaboy river above the Riverstown bridge to facilitate works. Smaller sandbags were added around one tonne sand bags in addition to. A second pump was also deployed.

Monitored and discussed operations with site ecologist and site foreman.	The drying-out operation was supervised by the site ecologist. Fish rescue nets and buckets were on hand as a precaution in case any fish or other aquatic species were observed, ensuring a backup in case any had avoided capture during the e-fishing conducted the previous day. No fish species were subsequently reported or observed throughout the remainder of the works.

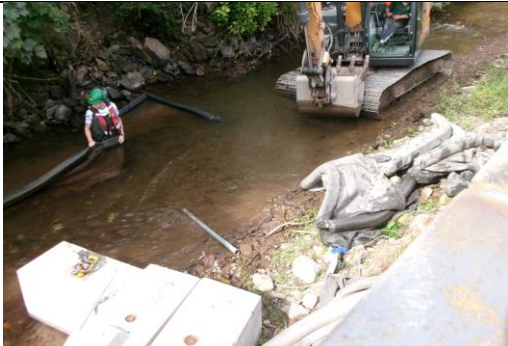
9.14	05/09/2024	Silt mitigation setup in the final section of the rock armour works. The mitigation measures include silt curtains, allowing for fish passage, and Kelly blocks to redirect river flows.

Supervision for part of the silt mitigation setup in conjunction with site ecologist.	The site ecologist supervised the rock armouring works using a stop/start method to manage silt. While this helped distribute the sediment load, the intensive digging in the wet riverbed still released substantial sediment.

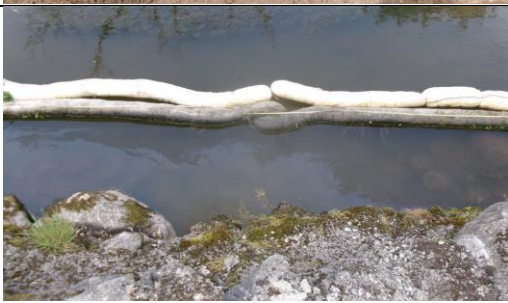
9.16	05/09/2024	Oil booms alongside Grandon's car showroom in place to address Grandon's contamination were inspected. Older oil booms are to be removed by Sorensen, while the newer ones will remain in place after the completion of works in this area.

Discussed with site ecologist.	Sorensen to liaise with Grandon's regarding the site handover, with particular focus on the contamination mitigation procedures in place.

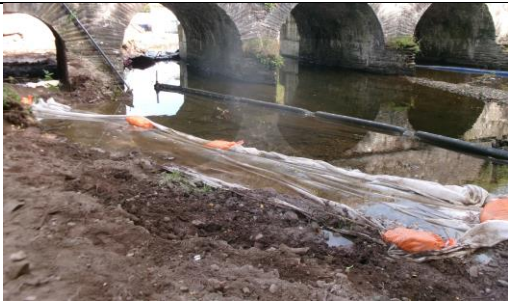
9.17	09/09/2024	Digging out blocked eye of Rivertown bridge and riverbank downstream. Biosecurity measures required as JKW is visibly growing here.

Discussed biosecurity to be carried out with site ecology team.	Terram was used as a failsafe to catch rhizomes entering the watercourse. Work was supervised by an invasive plant species specialist. This is good practice that minimises the generation of JKW-contaminated material by inspecting excavations with each bucket scoop.

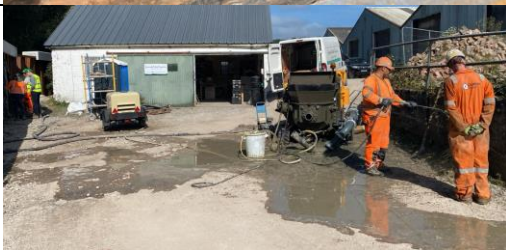
9.19	09/09/2024	Concrete shot trial was conducted without adequate measures to contain concrete wastewater produced.

Spoke with, Foreman and site ecologist. Notification of Safety Issue was issued by an Arup engineer. (NSI 026)	Area was cleaned up the following day. No wastewater entered the river during the trial or during the cleanup. Shotcrete trial would prove unsuccessful. Alternate method to be developed.

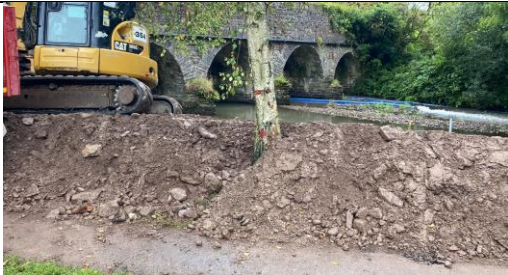
9.21	10/09/2024	Riverbank works at Riverstown bridge formed a bund along the riverbank but banded to close to the birch tree present.

Reported to site ecologists.	A small area was later cleared around the tree. Although the site ecologist initially instructed the driver to avoid the tree, this guidance was not immediately followed until it was reiterated. Due to the brief duration of activity near the tree, it experienced no negative effects.

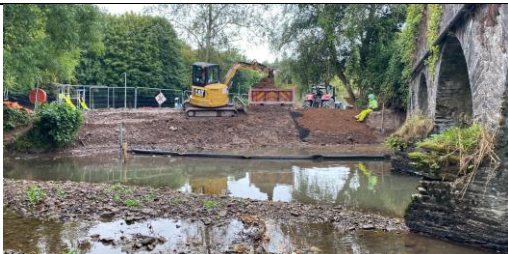
9.22	10/09/2024	Excavations of the JKW area at Rivers town bridge.

Excavation to the formation level was completed under supervision, with a small load containing Japanese Knotweed rhizomes carefully removed and transferred to the holding cell. Secumat and a layer of topsoil

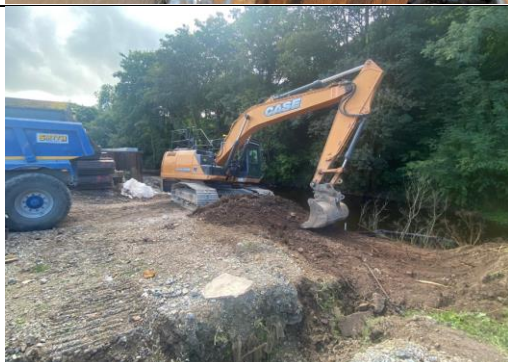
Partial supervision of works with site ecologist. Stop / start approach.	Works were supervised by site ecologist. Silt configuration was effective at slowing down silt dispersal. Driver allowed water to drain before depositing into dumper. Works were stopped multiple times to allow silt to dilute and settle.
9.25	11/09/2024	Digging out for headwall in Area one with possible JKW present.

Discussed works and biosecurity measures with site ecologist.	Works were supervised by site ecologist. JKW was encountered with excavated material added to the nearby holding cell.

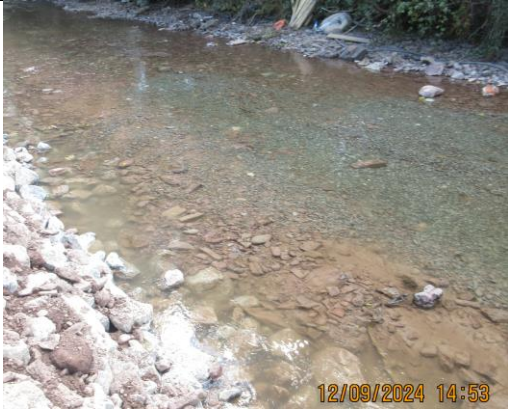
9.28	12/09/2024	Gravels from the check dam installed as part of silt mitigations for rock armouring excavations were partially removed.

Documented and discussed with site ecology team. It was recommended to leave remain stone in place.	Not all gravel could be removed, as doing so would have further disturbed the riverbed. Remaining gravel to be left in place.

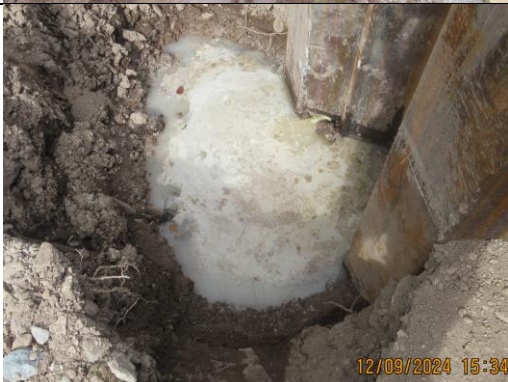
9.30	12/09/2024	Deli outfall from Grandons centre kitchen emitting greasy material into the main channel.

Discussed with ER team. Reported to the city council.	No action required by main contractor as the responsibility for this issue lies with the Grandons.

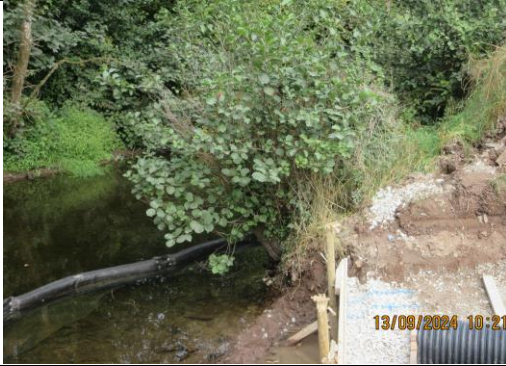
Item number	Date	Comment	Image	ECoW Action/Recommendation	Sorensens's Action response
					with water, which would be pumped from the already installed sump to the gravel within the sheet pile wall.
9.32	13/09/2024	Stump and regeneration retained proactively by the site ecologist.

Recorded.	The regenerating alder stump along the waterway will be retained to provide shading, maintain bank stability, and support continued regrowth.
9.33	13/09/2024	The rock armour from chainage 350 to the terminus was inspected, as it had not yet received blinding with river gravels. Given the small surface area and the low height from the water surface, it is considered impractical to add gravel in this area if it cannot be done from the dry. This approach aims to avoid further disturbance to the river.

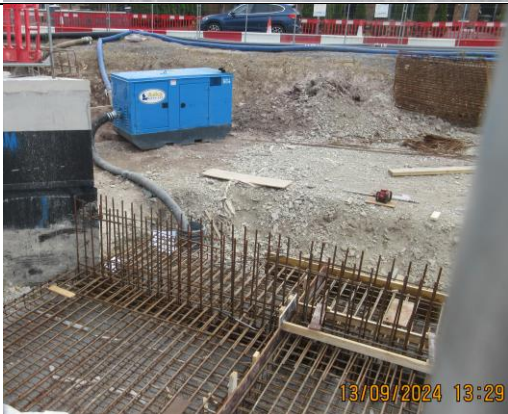
9.35	13/09/2024	During the concrete pouring at CVV, the sump was checked and confirmed to be in place. Mitigation measures were also reviewed.

Inspected and recorded.	Measures to protect the dewatered area from concrete contact were in place during the concrete pouring.

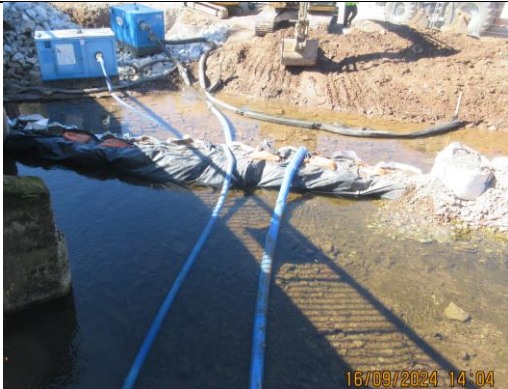
9.38	16/09/2024	Grading is taking place next to the main channel at Meadowbrook. Additional silt curtains have been installed adjacent to and downstream of the pumping area in the main channel. The area will be treated with erosion matting, topsoil, grass seed, and coir mesh.

Discussed silt mitigation with site ecologist.	Area following the grading received agreed measures.

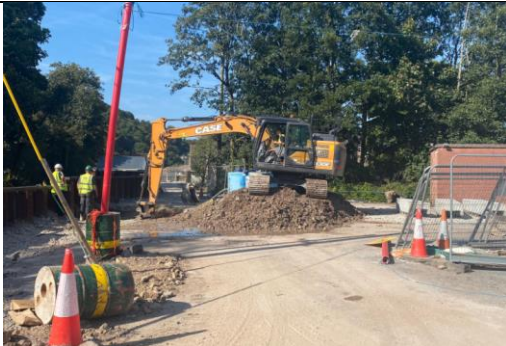
9.40	19/09/2024	Excavation at Eurofins being carried out to connect the drainage line to the main channel. A large flap valve will be installed, along with the final section of the drainage pipe. Water is being pumped from the excavation site into a nearby drain. No permit for pumping was requested from the site ecologist by the work crew. The water is contaminated with diesel.

Pumping was instructed to stop immediately upon inspection. The site ecologist was informed of the situation.	The site ecologist was not informed that these activities were scheduled to occur at this time and arrived on site to inspect promptly. Oil mats and booms were deployed in the drain to capture any residue. Work was halted for the remainder of the day. The excavated material is to be considered contaminated. A reminder was given to the charge hand about the procedures when pumping to consult with the site ecologist before commencing any pumping.

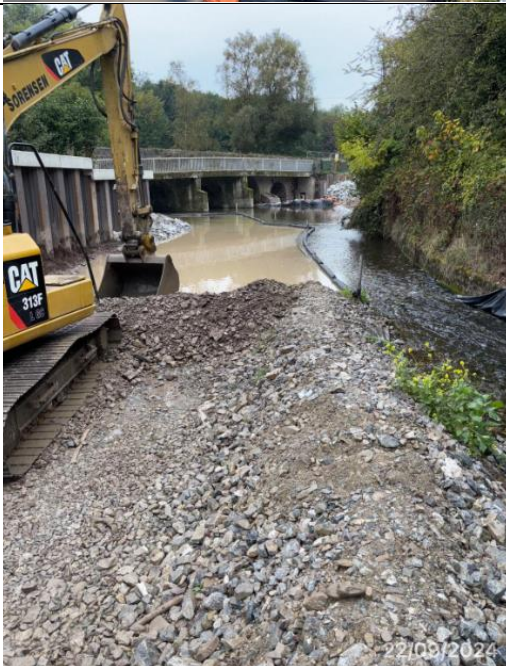
Discussed silt control measures with site ecologists.	Good silt control measures deployed around instream works area.
9.44	22/09/2024	Works commenced to reinstate the channel at Meadowbrook.

Discussed silt control measures with site ecologists.	Good silt control measures deployed around instream works area.

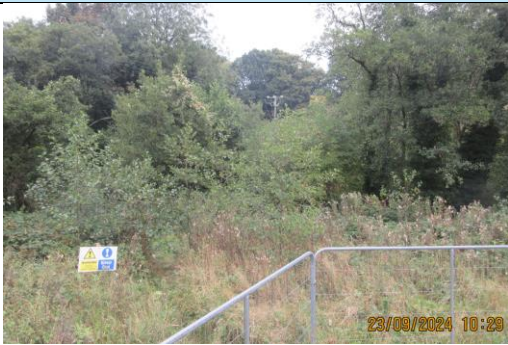
Item number	Date	Comment	Image	ECow Action/Recommendation	Sorensens's Action response
9.45	23/09/2024	Cois na Gleann stream works commence to remove the underground existing pipe and construct approximately 18 meters of new stream bed, banks. The work necessitated the removal of some vegetation, primarily young alder trees and mixed herbaceous plants. This area is expected to regenerate rapidly once the work is completed.

Action carried out to improve the ecology of the stream by removing the old, buried pipe which forms a barrier for aquatic species wishing to utilise the stream.	Works carried out in line with Change Order issued by ER with details agreed onsite between the ER team and contractor.

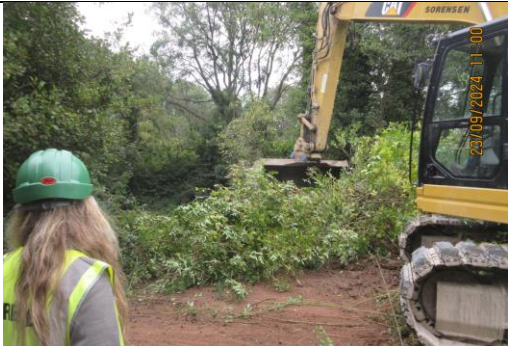
9.46	23/09/2024	Cois na Gleann channel creation supervision by Japanese Knotweed specialist throughout the works as area is within an area of JKW.

Supervised works for quality control and implementation biosecurity measures.	Biosecurity measures were employed throughout the works at this area.

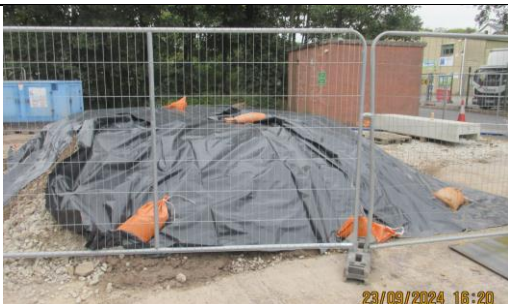
Inspected and spoke site engineer. Discussion were on the locations of concrete wash out and the need to clean up the minor amounts of concrete on the ground as soon as possible.	Concrete washout was not present. Agreement made to wash concrete at circus field where wash out is present. Small piles of wet concrete deposited on the ground near river to be cleaned immediately.
9.48	23/09/2024	Excavated material from Eurofins (Item 9.40) covered to prevent wash out from rain. Material to be tested and disposed of accordingly.

Discussed measures with site ecologist.	Measures undertaken to contain potential contamination from excavated material.

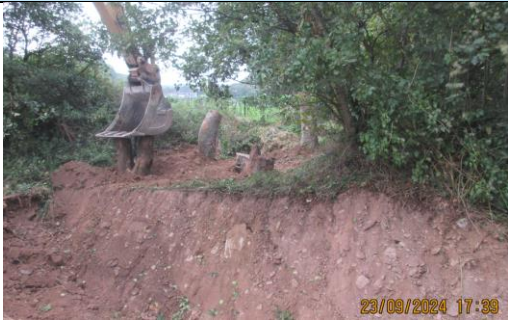
Item number	Date	Comment	Image	ECoW Action/Recommendation	Sorensens's Action response
9.49	23/09/2024	Biodiversity enhancement measures carried out at corner of Circus field by installing cut tree trucks generated from elsewhere on the Scheme. Wood in time will dry and degrade to provide habit for solitary bees and wasps and other insects.

Liaised with site ecologist to organise and oversee the works.	Work was carried out following confirmation emails to ensure later compensation to the contractor, as the work is classified as additional.

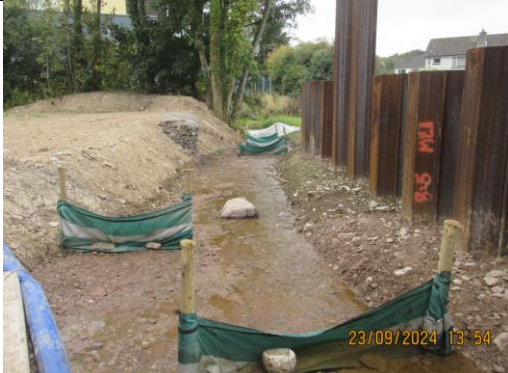
9.50	23/09/2024	Springmount stream rewetted following the completion of culvert and stream rehabilitation works. Silt control measures were employed to limit the short duration yet unavoidable plumes of silt when rediverting a stream such as this.

Inspected and discussed details of works with site ecologist.	Good deployment of silt control measures.

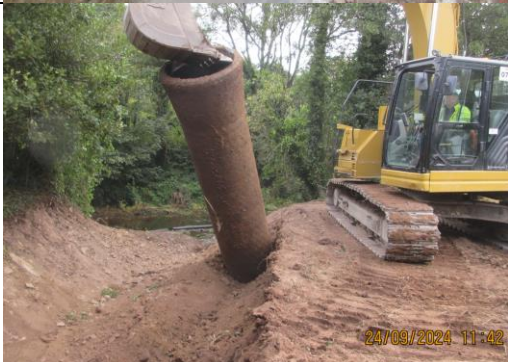
Documented and discussed with site ecologist.	Additional oil booms and absorbent mats were deployed in areas where residues were emanating from the rock armour.
9.52	24/09/2024	Removal of four sections of pipe total length c18m from Cois na Gleann stream.

Supervised and recorded works.	Works carried out in line with Change Order issued by ER with details agreed onsite between the ER team and contractor.

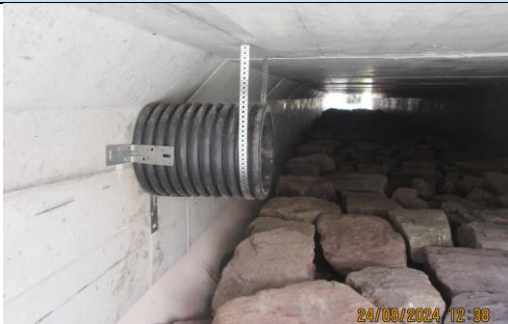
Item number	Date	Comment	Image	ECow Action/Recommendation	Sorensens's Action response
9.53	24/09/2024	Installation of artificial dipper nest into Cois na gleann culvert. this is a follow up action by the contractor following the discovery of an active dipper nest in the old brick work which was removed to facilitate the installation of the new culvert.

A black corrugated metal culvert is installed in a stone-lined channel. The culvert is made of several sections joined together. The surrounding area is filled with large, flat stones. A timestamp '24/09/2024 12:38' is visible in the bottom right corner of the image.	Notified of action by site ecologists and later inspected.	Action based with regard to academic research which concluded a higher uptake by breeding dipper of a cut pipe opposed to more sophisticated artificial nest boxes.

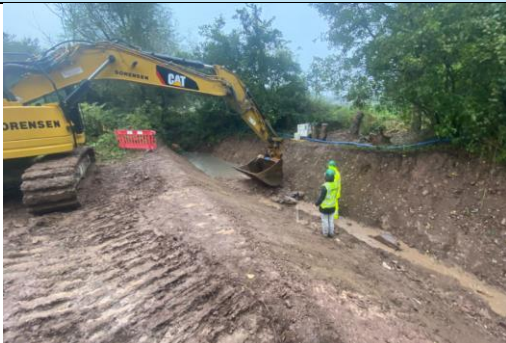
Item number	Date	Comment	Image	ECoW Action/Recommendation	Sorensens's Action response
9.56	25/09/2024	Stream enhancement works include creation of pools, riffles and runs as part of a river ecology. This is achieved by placement of flagstones and a gravel berms within the channel.

Agreed ecology enhancement measures with site ecologist on site.	Good supervision and direction by site ecologist

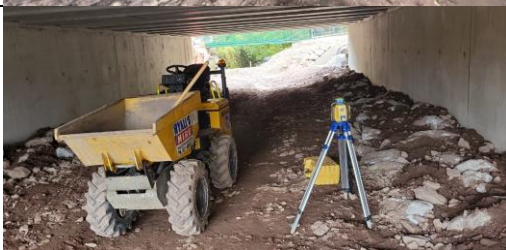
9.57	25/09/2024	New Line bridge: Low flow channel created and river gravels added and incorporated into flagstones placed at the sides under the bridge to create more natural environment for aquatic species when rewetted.

Liaised with site ecology team to achieve best results.	Positive measures carried out by main contractor.

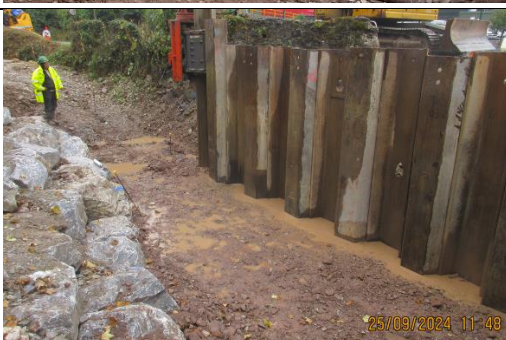
9.58	25/09/2024	Installation of temporary sheet piles upstream of New Line bridge create a narrow section of 1m when measured to recently installed rock armour.

Discussed with site ecologists and ER team.	Rock armour was later pulled back to allow for greater flow width between the sheet piles.

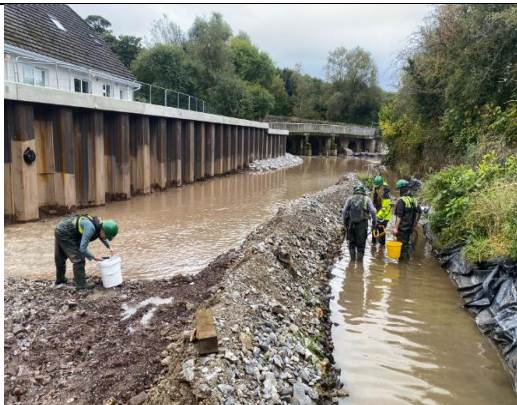
Supervised works. Directed driver on channel reinstatement details.	Efforts were made to reduce the silt generated from the works but was not fully possible.
9.60	25/09/2024	Fish rescue carried on the Meadowbrook diversion channel prior to its dry out as water is redirected back into the main channel.

Supervised and discussed with site ecologists.	Effective fish protection measures were implemented.

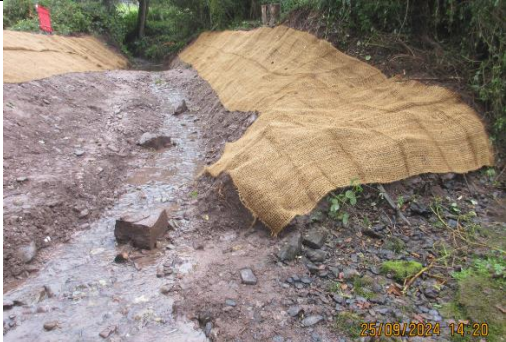
Item number	Date	Comment	Image	ECoW Action/Recommendation	Sorensens's Action response
9.61	25/09/2024	Cois na Gleann channel creation and connection to Glashaboy river established. Banks were coir meshed and grass seeded.

Works carried out alongside site ecologist.	Positive ecological enhancement carried out to a high standard. The stream will be monitored throughout the winter. There is a possibility for minor adjustments next year, if necessary.

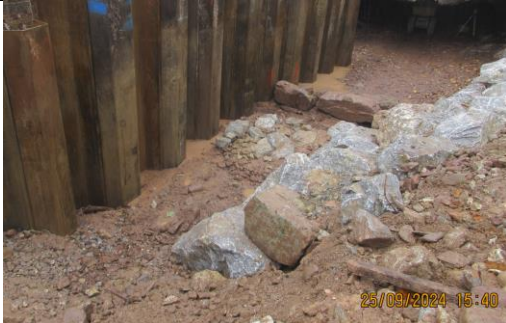
9.62	25/09/2024	Upstream of New Line Bridge, steps were constructed using red sandstone flagstones to create a series of drops that facilitate fish passage, in accordance with the design.

Discussed details with site engineers and site ecologists.	Steps installed to allow fish to migrate further upstream. The river will be monitored throughout the winter. There is a possibility for adjustments next year, if necessary.

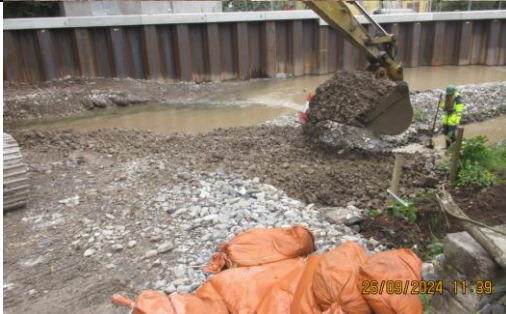
9.63	26/09/2024	Infilling of former diversion channel at Meadowbrook following the reinstatement of the original channel. Works were supervised by site ecologist. Several eels were rescued in the process.

Partial supervision of works. Queried driver and site ecologist on works methodologies.	Good practices were implemented to minimise the loss of aquatic life resulting from the works.

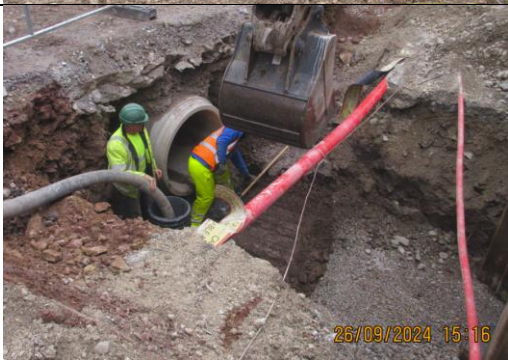
9.65	26/09/2024	Eurofins: clay plug installed around pipe and gravel to plug flow of contamination from Pat O Donnells.

Discussed situation with site ecologist and ER team.	Clay plug to be followed by concrete plug.

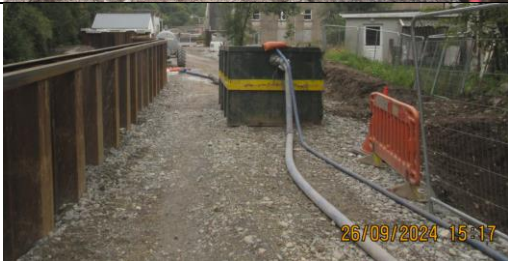
9.66	26/09/2024	Contaminated water from Eurofins, originally pumped into a closed drainage line, is now directed through a settlement tank and a manifold system with filtration bags designed to retain hydrocarbons. The filtration bags are surrounded by oil booms, and the treated water is then dispersed into the ground behind the sheet piles.

Discussed with site ecologist prior to pumping set up.	A minor amount of contamination was observed seeping from the rock armour in the main channel, where the filtered water was emanating. Oil booms were deployed around this point to contain the low volume amount of residue.

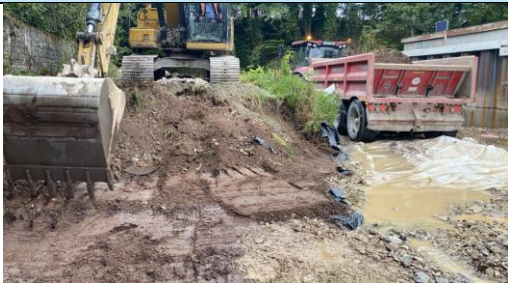
Item number	Date	Comment	Image	ECoW Action/Recommendation	Sorensens's Action response
9.67	26/09/2024	Gravel deposits above Riverstown Bridge, where Japanese knotweed (JKW) was present, were removed. Clean stone was placed on top of the gravel to allow the excavator to track over the area and facilitate the gravel removal.

Partially supervised for implementation of biosecurity measures.	Additionally, Terram was laid on the ground to catch any fallen debris during the loading of the trailer. The works were supervised by a Japanese knotweed specialist.

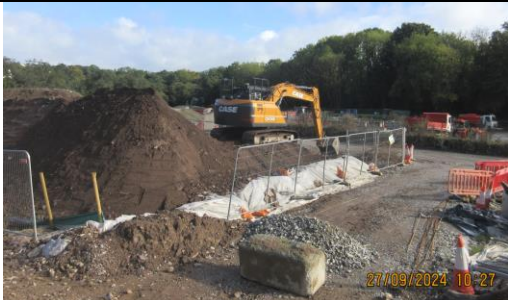
9.68	27/09/2024	Volume added to holding cell at Sallybrook following works at Cois na Gleann channel creation and Meadowbrook gravel removal.

Recorded.	Additional volume of material was added due to two separate Change Orders from the client. The contaminated material will be permanently buried at a later stage once the details are finalised and approved.

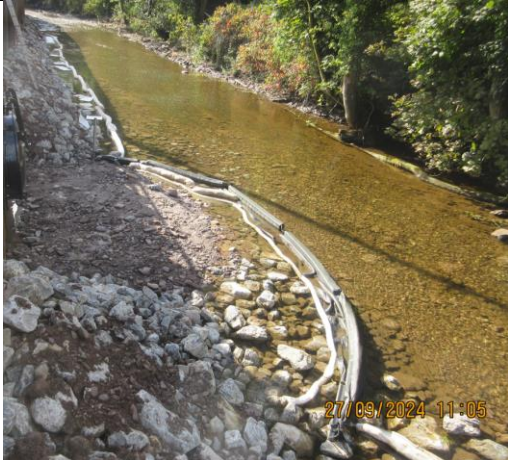
9.69	27/09/2024	Measures to contain contamination into the main channel from the drainage line works at Eurofins.

Recorded.	Oil booms in combination with silt curtains to contain leaking contamination.

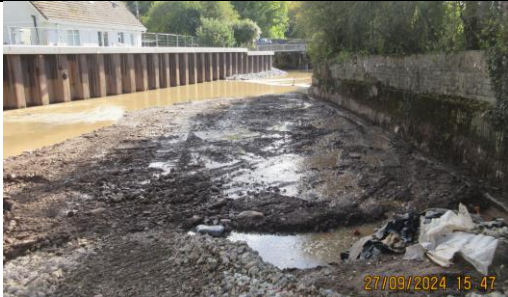
Informed site ecologists.	Ground was later scraped, and material added back into the holding cell.
9.71	27/09/2024	Clean river gravels were added to the area where gravels were removed at Meadowbrook.

Discussion took place about the amount and depth of the gravel required here. Supervised grading of gravels as agreed.	Gravels added to reduce possibility of any remaining JKW that could remain below the formation level from washing out.

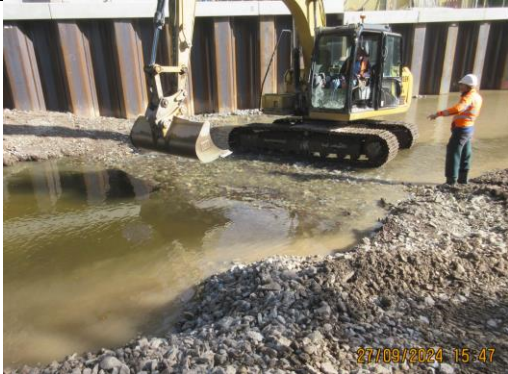
Item number	Date	Comment	Image	ECoW Action/Recommendation	Sorensens's Action response
9.72	27/09/2024	Shoals of gravel was added to enhance the main channel at Meadowbrook. These additions create pools and riffles, facilitating fish passage upstream and increasing oxygen levels in the water.

Driver was directed by the ECoW.	Gravels were recycled from the area to create the shoals.

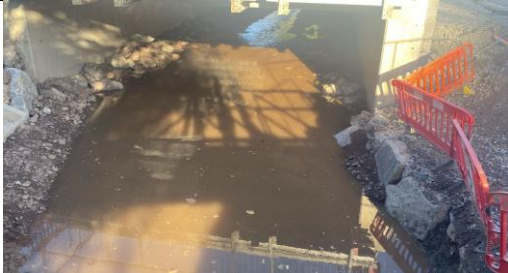
9.73	27/09/2024	New Line bridge river section rewetted. Siltation inevitably occurred but was relatively short in duration.

Supervised by the ECoW.	Fish passage was achieved shortly after rewetting by the depth of the low flow channel through the bridge and upstream from the rock ramps installed.

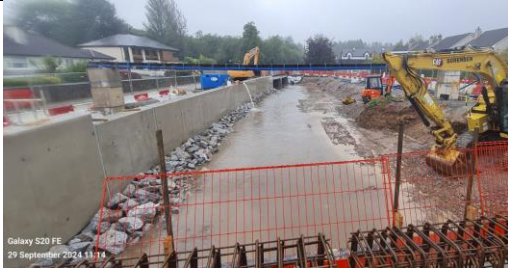
9.74	29/09/2024	Heavy rainfall overwhelmed the pumps above Brooklodge Culvert and Copper Valley Vue Bridge, leading to the rewetting of the New Line River channel. This caused a brief period of high siltation.

A review of downstream water monitoring data confirmed that the siltation was of short duration and limited in extent.	Construction related debris such as sandbags were removed the following day.

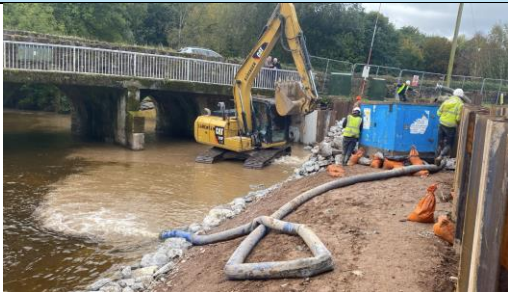
Item number	Date	Comment	Image	ECoW Action/Recommendation	Sorensens's Action response
9.75	30/09/2024	Meadowbrook estate: Pumping out rainwater from drainage line in order to install flap valve outlets.

Spoke with site ecologist on site at the time.	Silt curtains were present downstream. Urgency was enhanced by the fact that flooding occurred in the Meadowbrook estate the previous day as the surface drainage system had not yet been connected into the main channel which could now be achieved through the installation of three flap valves.
9.76	30/09/2024	Fences and sandbags remain in place following the previous day's heavy rains, which overwhelmed the pumps and prompted the removal of the dam along the Glenmore River.

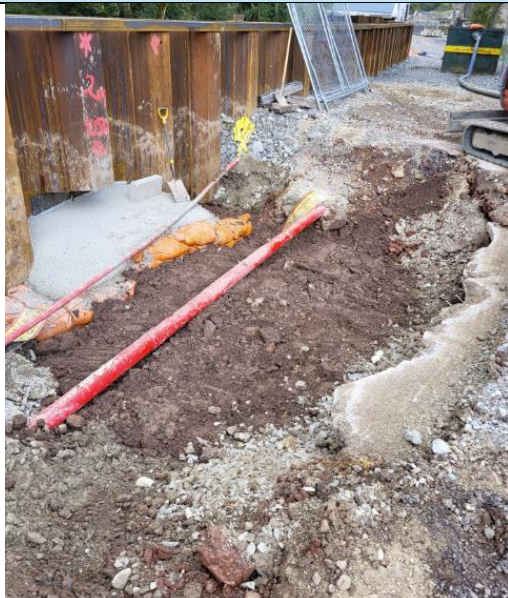
Item number	Date	Comment	Image	ECoW Action/Recommendation	Sorensens's Action response
9.77	30/09/2024	Backfilling and final concrete capping around Eurofins drainage outline, a source of contamination in the previous days.

Activities were documented, and measures were discussed with the grounds crew and ecology team.	Preventive measures were employed to plug any further contamination from reaching the Glashaboy river which appeared effective.
