# 1 Project background and objectives

This section of the report summarises the qualitative findings of the geomorphological / fluvial audit conducted on the Glashaboy River and the lower sections of the Butlerstown River and Glenmore River during April 2014 and August 2016, following the large flood events of 2015. Tidal reaches were visited at low tide to maximise the opportunity to view the bed conditions within the watercourse / estuary.

# Glashaboy River (Glanmire/Sallybrook) Drainage Scheme

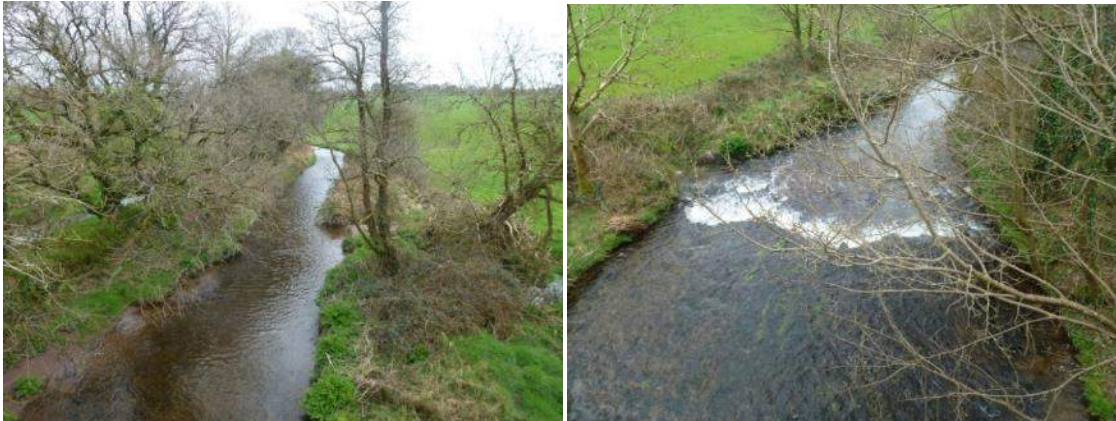
Figure 3-2 Ardnabricka Bridge (Point 1)

The upper sections of the Glashaboy between Carrignavar to Upper Glanmire Bridge (1 to 2 on Figure 3-1) are predominantly rural. The floodplain in most locations is narrow and dominated by farmland and woodland. The channel exhibits a pool-riffle morphology which is dominated by a cobble and gravel bed, with little evidence of significant transport of cobble and gravel sized material given the amount of bed algae present across this sediment (Figure 3-2). Limited large accumulations of gravel as bar features were noted even in areas where the gradient was reduced. This suggests a limited upstream supply of gravels and/or the ability of the channel to flush sediment downstream during higher flow events.

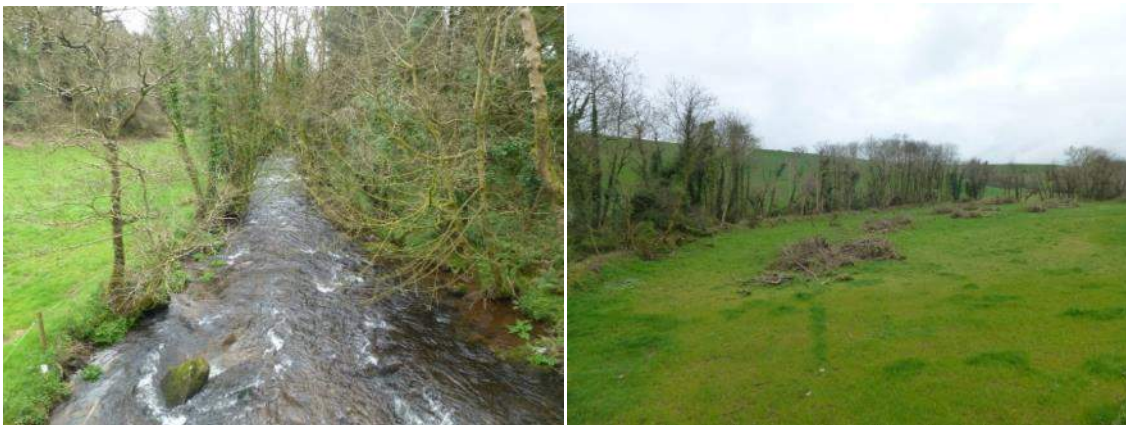
Figure 3-3 Dunbulloge Bridge (Point 2)

Evidence within the reach of historic channel management exists, including old dredging embankments (Figure 3-3) and channel straightening. Channel straightening and dredging has led to some disconnection of the channel from its floodplain in certain areas (although this is not excessive in the upper reaches). Modifications to the channel such as dredging and straightening

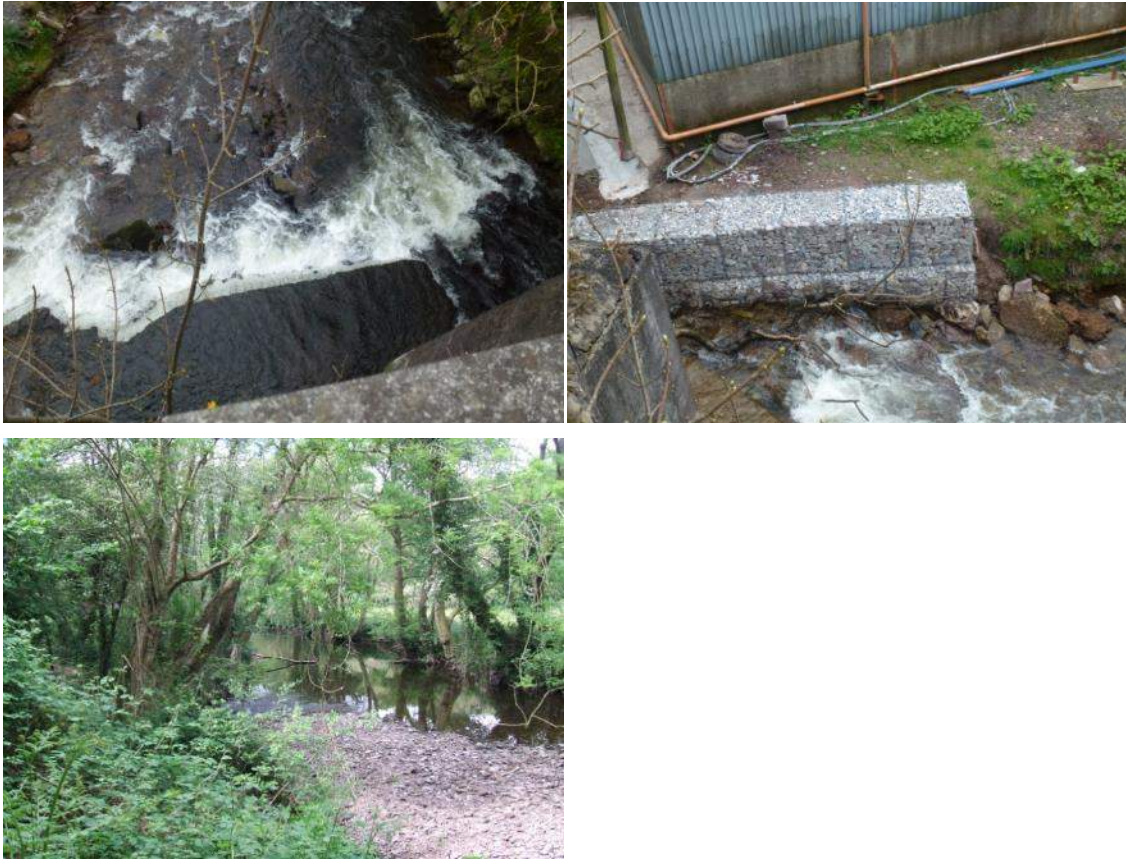
Figure 3-6 Upper Glanmire Bridge (Point 5)

In the reach between Upper Glanmire Bridge and Knocknahorgan the river valley narrows which results in a confined floodplain. At Upper Glanmire Bridge a weir is leading to local bank erosion (Figure 3-6), due to the direction of flows passing under the bridge. Banks have been reinforced using gabion baskets, however, in the long term the river may undercut these baskets.

Downstream of Upper Glanmire Bridge, flow energy in the channel reduces and areas of gravel and small cobble deposition occur (sizes of gravels range from 4cm to 40cm). Gravel splays occur at tributary confluence points (Figure 3-6) along this section, suggesting an active supply of gravels is present from the steep tributaries joining the river (Figure 3-7).

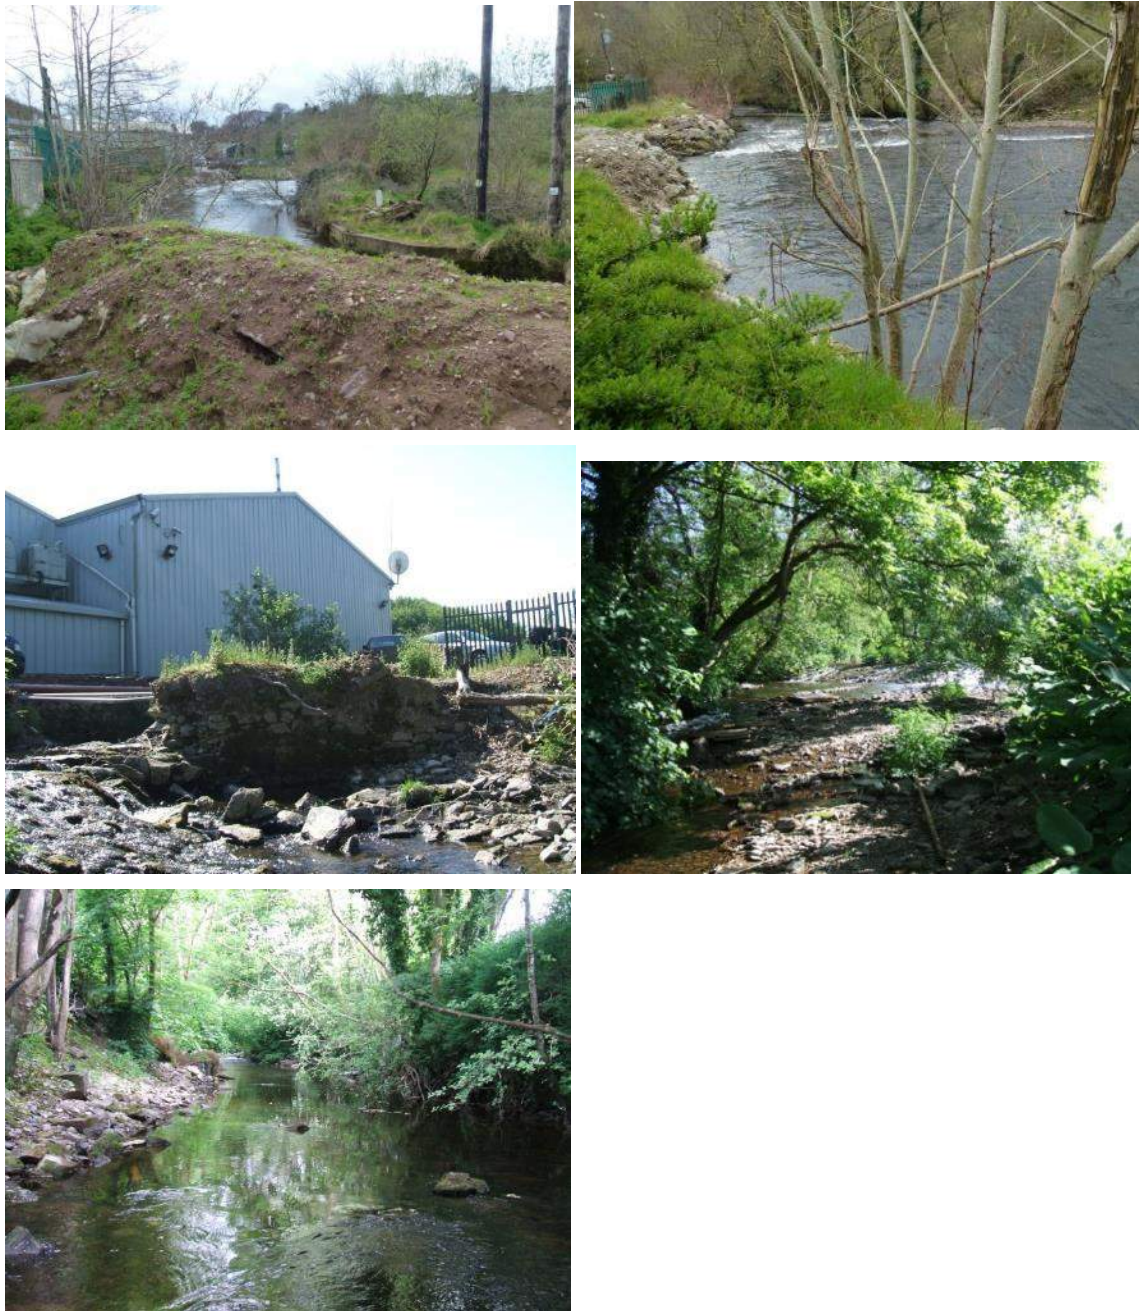
Figure 3-10 Channel upstream of Sallybrook (Point 8)

As the channel approaches Sallybrook the valley widens and becomes less confined. The wider floodplain along this reach has been developed / built upon which acts to constrict the channel. In some areas informal flood embankments have been constructed. In other areas active bank erosion is occurring as the channel attempts to naturally adjust within its confined channel. This is exacerbated by the higher energies during flood conditions as a result of the channel constriction. Hard measures, such as walls have been constructed to reduce the erosional impact of the river (particularly on the outside of bends) and some of these are now failing (such as adjacent to the petrol station). The erosion of banks acts as a strong sediment supply of gravels and fine materials. Deposition is also common through this reach, with several gravel bars (which are unvegetated, signalling frequent movement) being present. However, in the lower portions of the reach the channel becomes incised as a result of the influence of old mill leats and weirs (some existing and some now removed). As a result of these structures the channel is disconnected by over 1m from the floodplain (due to the channel eroding downwards in an attempt to adjust its bed gradient) and deposition is minimal, due to floodplain disconnection and high in channel energy levels. The channel in this lower section is dominated by coarser cobbles.

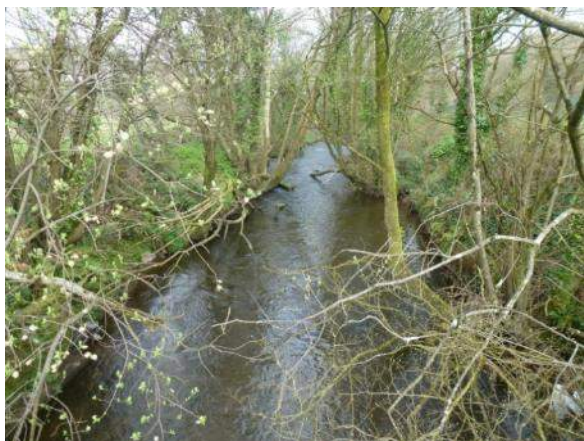
Figure 3-12 Downstream of Sallybrook (Point 9)

Downstream of Sallybrook the channel flows through a narrow urban corridor. The channel remains slightly incised, possibly due to historic straightening due to protected river banks. Sediment is delivered to this reach via several steep tributaries.

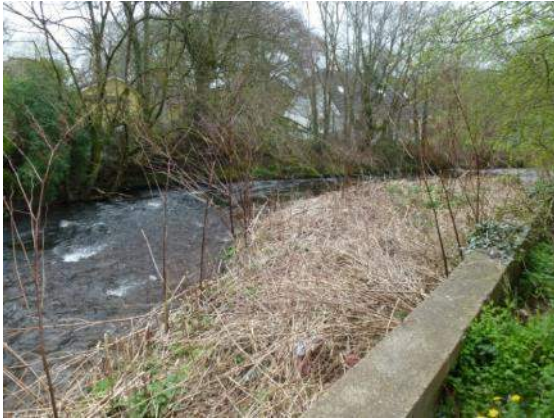
Figure 3-15 Defences downstream of the Glanmire shopping centre, adjacent to the housing estate (Point 11)

Downstream of the shopping centre the channel widens slightly. Flood defences exist, which protect an adjacent housing estate. The defences act as a constraint to the channel in terms of its floodplain connection. The wider nature (Figure 3-15) of the channel here has allowed for the

deposition of some sediment (dominated by fines). In the majority of cases the depositional features are vegetated which suggests that the channel has reacted following past intervention (i.e. it has adjusted to a more natural narrow channel), probably as a result of the construction of the flood defences. This indicates that if any future maintenance of this section occurs (such as sediment removal or flood defence improvements) deposition of this nature will continue to occur.

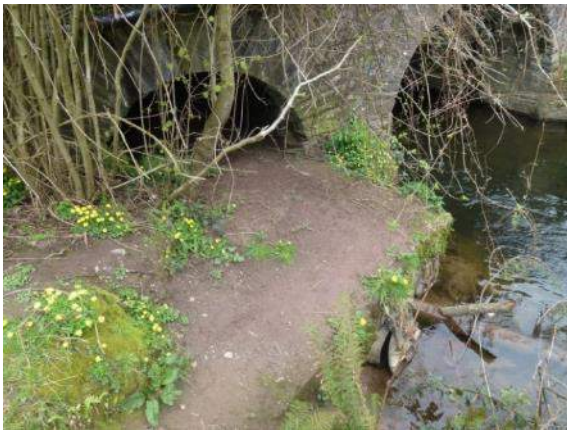
Figure 3-16 Upstream of the park (Point 12)

Downstream of the housing estate the channel enters a parkland area and connection to the floodplain is improved. In areas of the channel where flows are reduced fine sediment deposition is occurring (Figure 3-16) and in some areas small pockets of gravels (Figure 3-17) have been deposited, however, gravel deposition is not widespread. If sediment is removed as part of any future maintenance works, it should be expected that sedimentation will re-establish itself naturally.

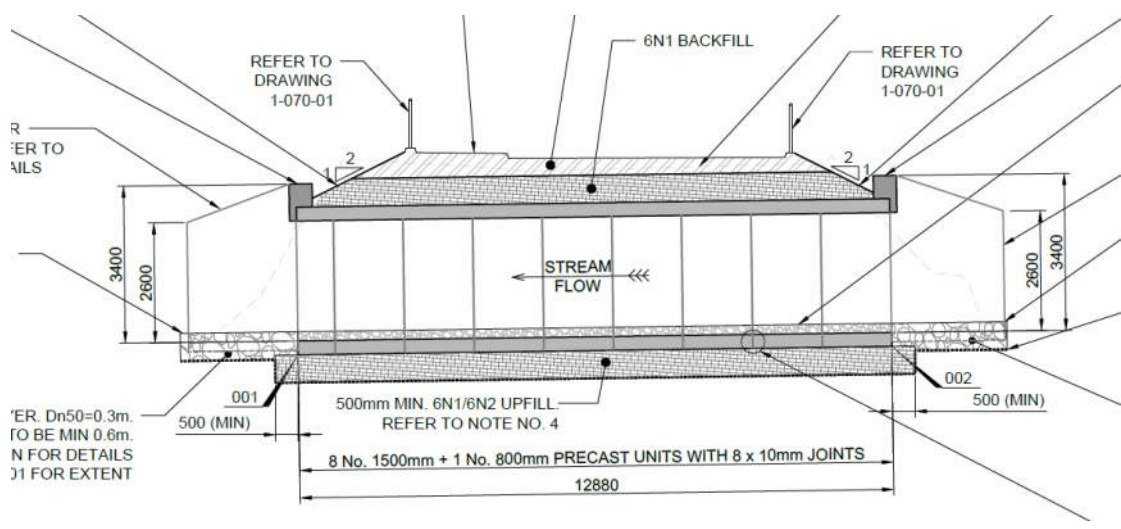
Figure 5-2. Cúil Chluthair proposed new culvert

The new culvert has been designed with the invert depressed into the river bed, to allow long-term resilience of the structure by allowing movement of gravels and delivery to the downstream reach, as well as allowing fish passage through the structure. A double layer of rip rap (Dn50 = 300mm) will be inserted into the bed at the downstream and upstream ends of the structure to prevent scour. This design measure is based on modelled flows in the post-scheme scenario.

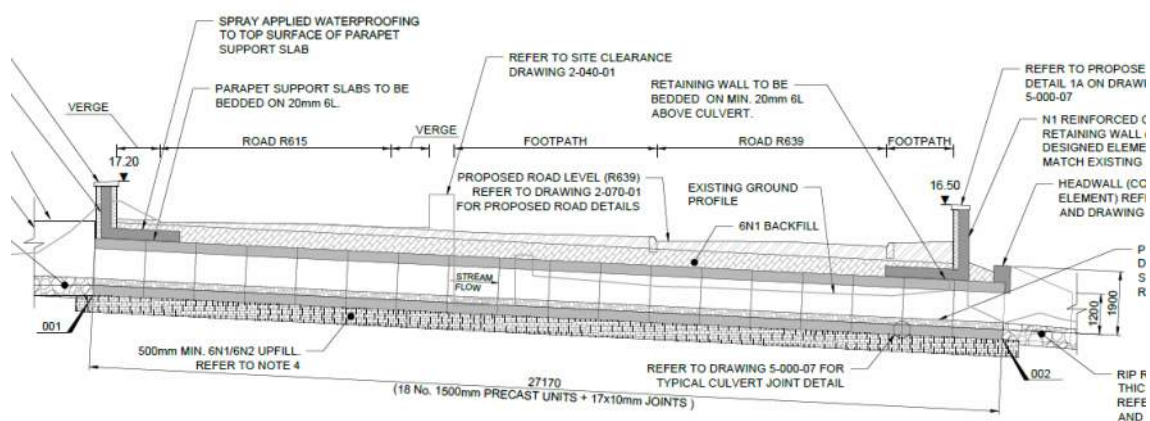
Figure 5-5. Proposed culvert at Cois na Gleann (C07\_B01)

The proposed structure is one closed box culvert, approximately 27m in length and set at a gradient of 4.6%. In comparison, the existing culvert is a series of stepped structures, which dissipate flow energy through higher drops and act as barriers to sediment transport. The new culvert is likely to increase stream power within the culvert, with a change the sediment transport regime within the culvert and the downstream reach.

Inclusion of rip rap armour layer on the stream bed ( $D_{n50} = 0.3\text{m}$ , min. thickness of 0.6m, length of 2.5m) at the transition out of the culvert has been included in the design to protect against the creation of a scour pool. Rock armour has also been included in the design to protect downstream banks against erosion. Additionally, the proposed bed of the culvert is rock slabs which should act to dissipate flow velocity to some degree within the culvert.

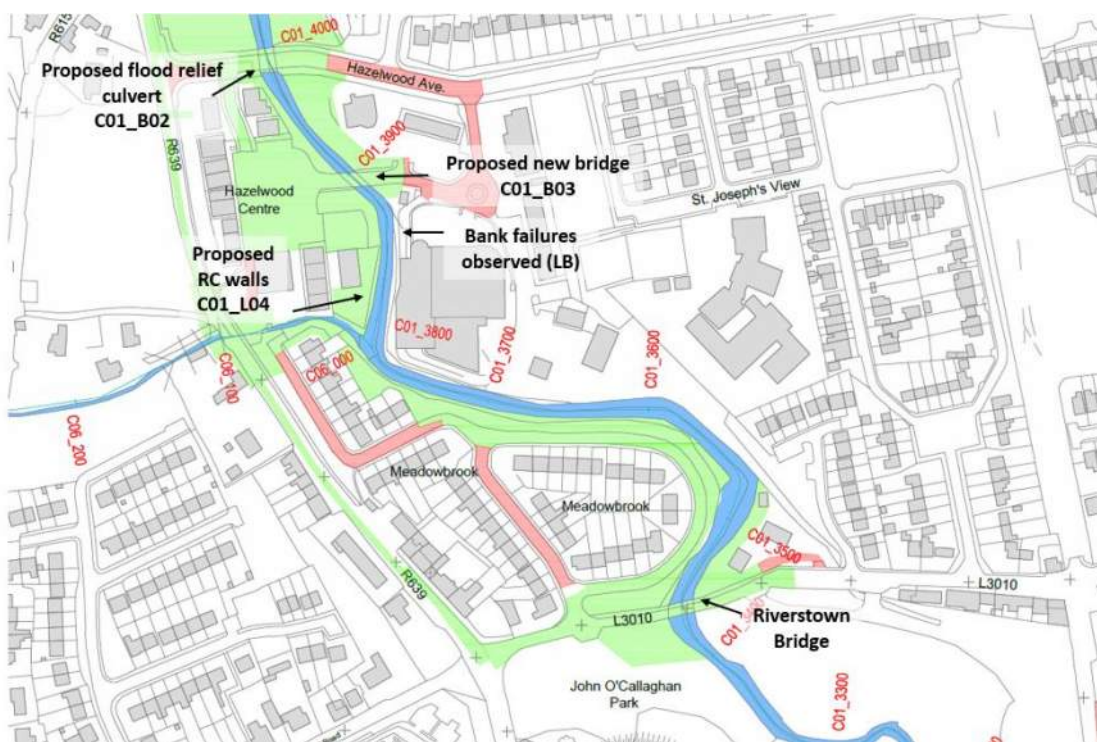
Figure 5-9. Proposed RC flood wall on right bank, no works proposed on left bank (clipped from drawing ref. GR-502, where green = indicative extent of works)

A replacement bridge is proposed, which will increase conveyance through this reach. Bridge footings are proposed below the existing bed level, which will provide protection against future bed lowering (caused by future high flows and/or increased runoff due to urbanisation of the catchment) and allow sediment to transport freely through this reach. Proposed concrete abutments will prevent further localised scouring, a trend which is already being observed particularly on the left bank of the channel.

Reinforced concrete walls are proposed on the right bank, to be set back from the river's edge. No works are proposed on the left bank.

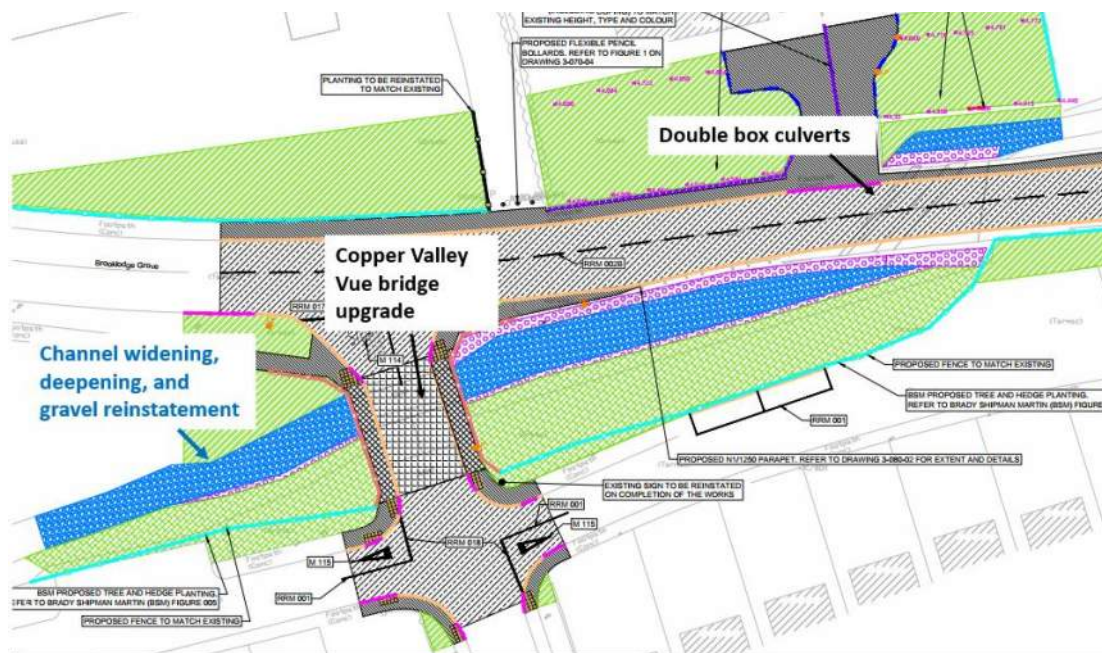
Figure 5-16. Proposed channel works at Brooklodge Grove

An overview of works proposed through this section of Glenmore stream is shown in Figure 5-16, which include bridge upgrade at Copper Valley Vue bridge, upgrade of the existing three culverts to double box culverts, regrading of the channel along a 105 meter length of channel, as well as removal of a small weir upstream of the proposed culverts.

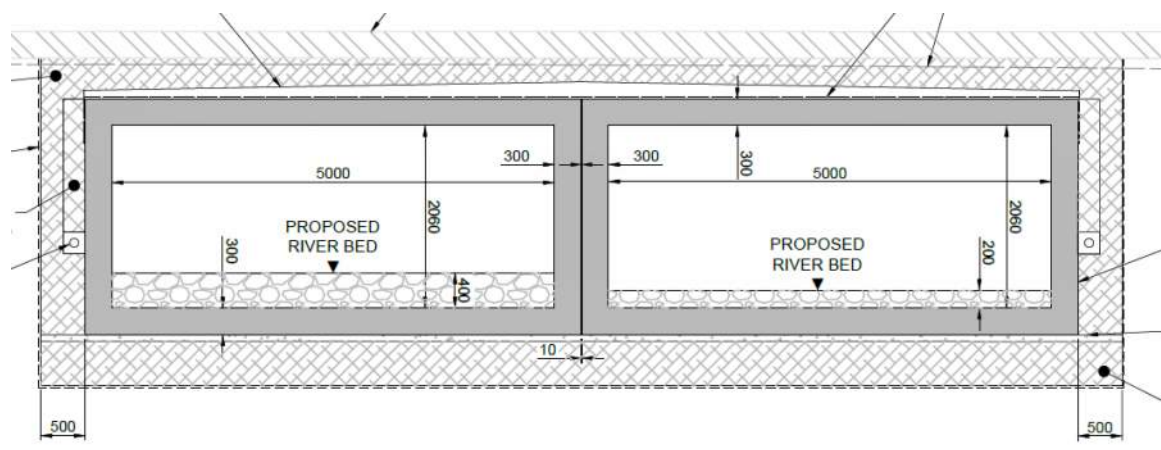
Figure 5-17. Cross-section of proposed double box culverts at Brooklodge

It is proposed to replace the three existing culverts, (2.32m span arch culvert, 2.95m wide by 0.68m high culvert and 2.95m wide by 0.67m high culvert) with two rectangular precast culverts each 5m wide by 1.95m high. The two culverts are shown in Figure 5-17: one to convey the low-flow channel, and one to convey flood flows. The invert of both culverts will be placed 30 to 50 cm below the existing bed level, and the bed will be filled with natural gravel material, with one culvert bed higher than the other. The flood relief culvert is proposed slightly above the low flow channel to ensure flows and fish passage are maintained through one culvert and not dispersed. This will ensure continuous transport of gravels through the culvert to downstream reaches, and prevention of future culvert perching given observed incision of the bed. Proposed rip-rap on the bed upstream and downstream transitions should ensure protection against future perching.

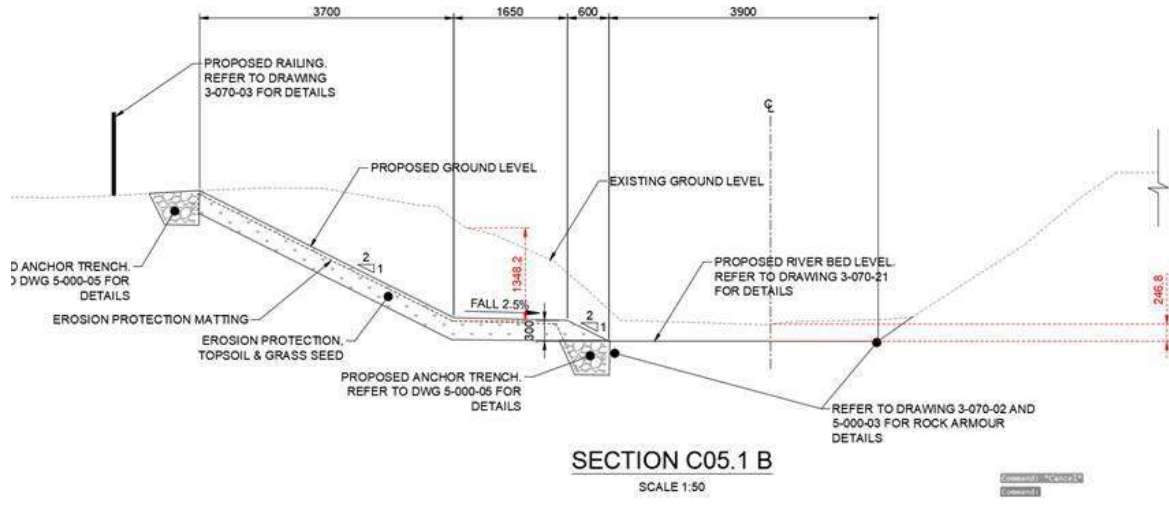
Figure 5-18. Cross-section of proposed river lowering and widening. Lowering will occur through the existing channel thalweg, and widening to introduce a 2-stage channel only to be wetted during flood flows

Along the left bank, a larger cut is proposed (approx. 1.3m) but will be out of the existing main river channel. The left bank of the river is proposed to be cut and constructed with engineered side slopes with erosion protection matting and rock armour placed to ensure stability of the riverbank, thereby creating a 2-stage channel, shown in Figure 5-18.
