Project Number:	6075	Document Number:	Appendix 7.1	Revision:	09
Project Name:	GLASHABOY FRS	Document Title:	PHOTOMONTAGES	Date:	07 March 2018

- 1.1 The Office of Public Works are undertaking the Glashaboy Flood Relief Scheme. The scheme will include works at a number of locations along the Glashaboy River and its tributaries including Bleach Hill Stream, Cois na Gleann Stream, Springmount Stream, Butlerstown Stream and Glenmore Stream (Figs. 1 and 2). An Environmental Impact Assessment (EIA) is currently being prepared on the scheme. As part of this EIA, the Underwater Archaeological Unit at the Department of Arts Heritage and the Gaeltacht were consulted and they recommended archaeological wading and metal detector surveys at a number of locations where works are proposed for the scheme in order to assess the archaeological potential of the watercourses and their environs.

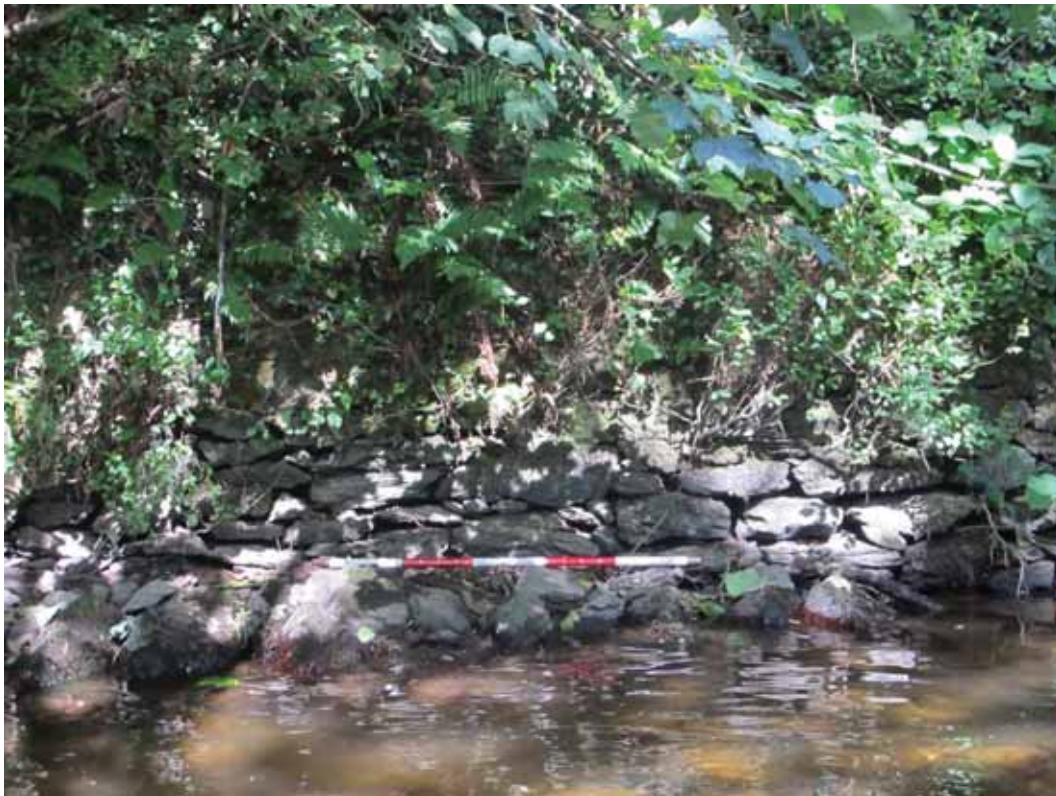
**Plate 25:** View of CHS 08, revetment wall taken from west.

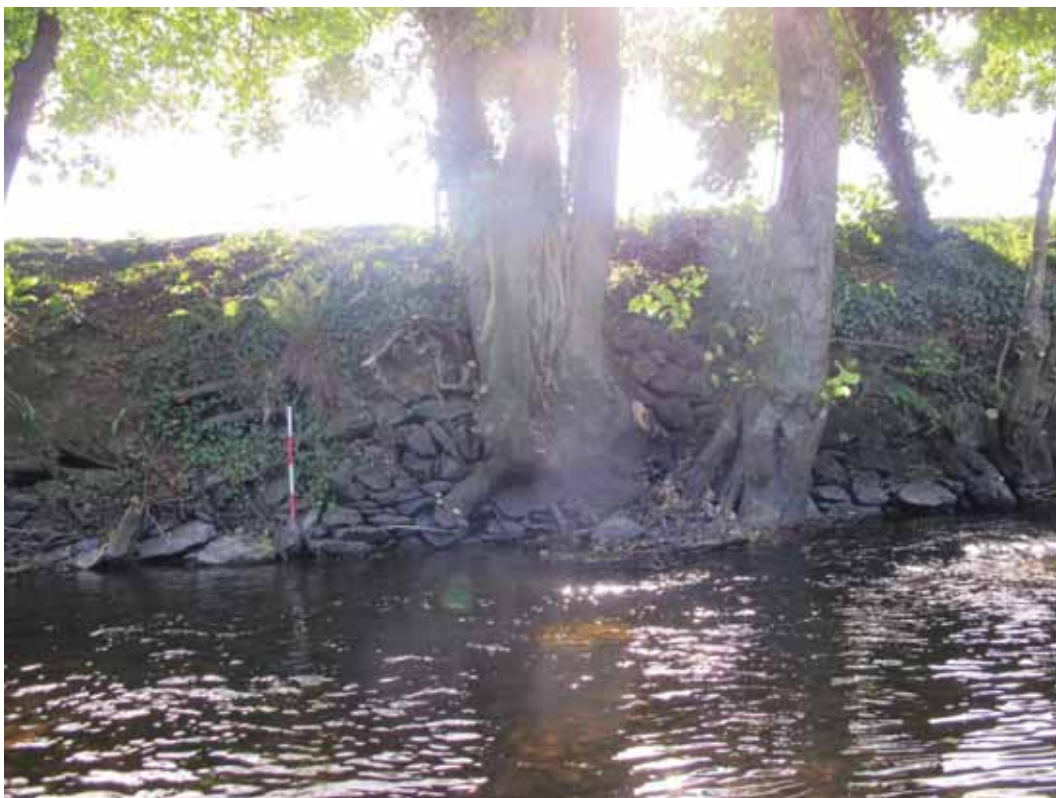
**Plate 26:** View of CHS 09, revetment wall taken from east.

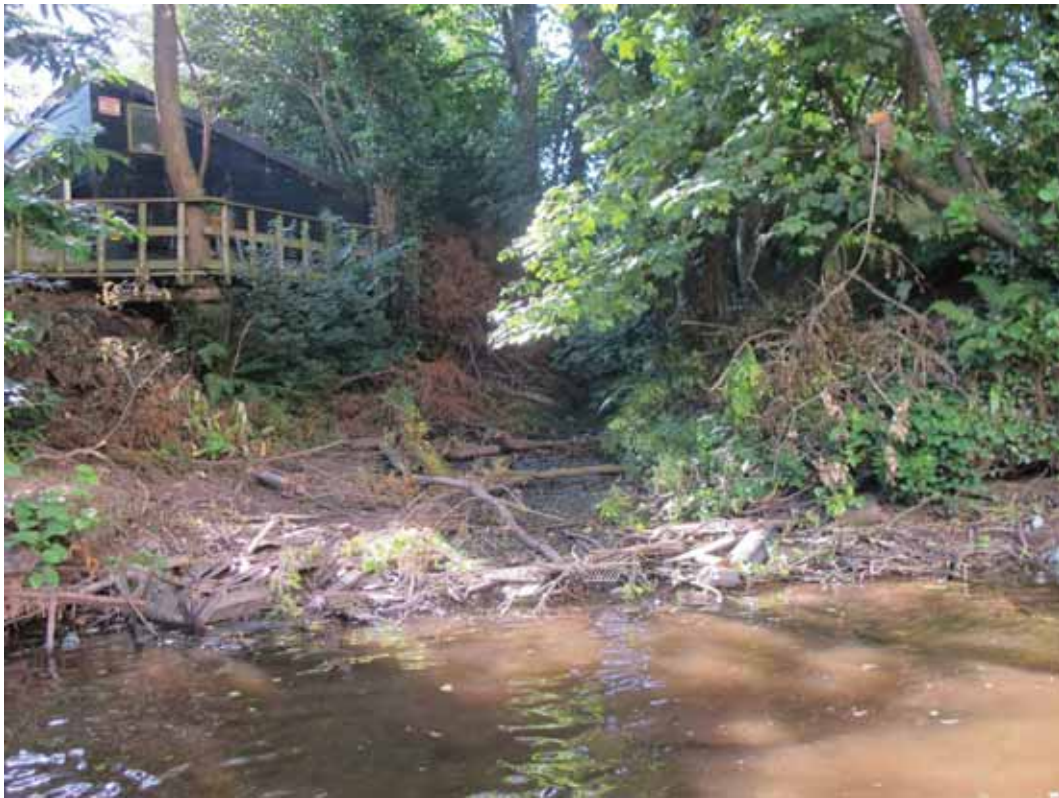
**Plate 27:** View of CHS 10, tailrace, Spring Hill Mill, taken southeast.

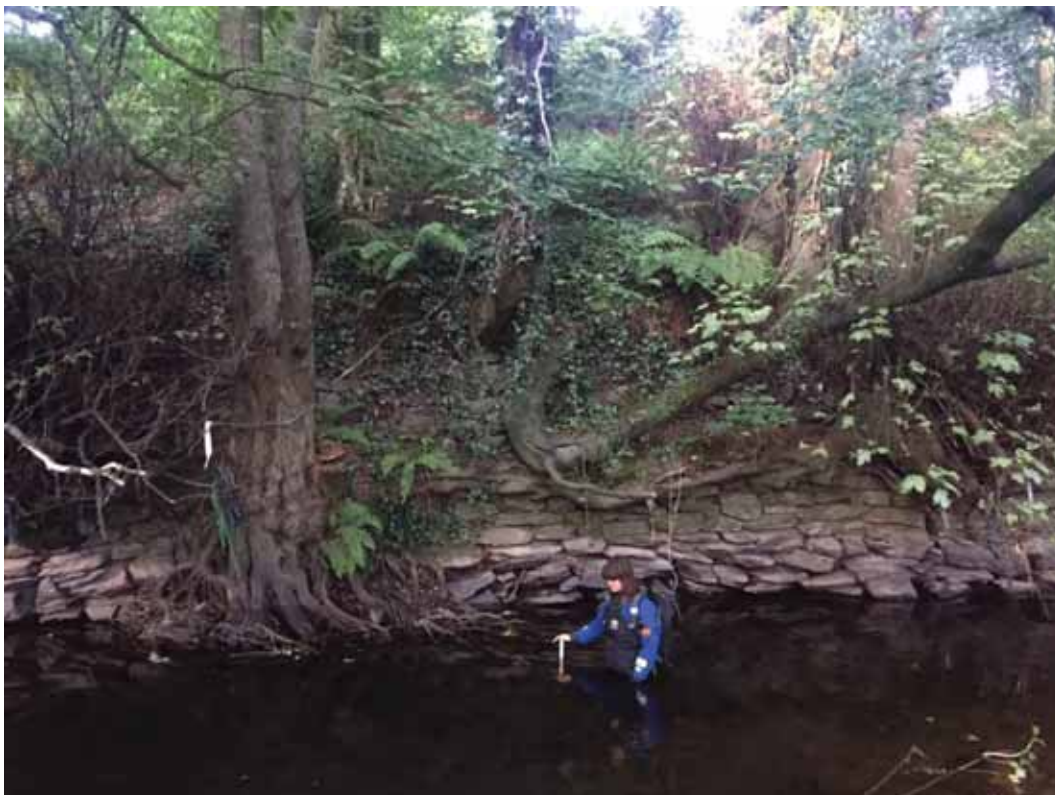
An east-west Weir is denoted on the 1<sup>st</sup> edition OS map of 1842 extending across a bend of the Glashaboy (Fig.9). Abutting the east terminus of the Weir is the remains of a headrace that fed into the Riverstown Flour Mill to the SE. The upstream approach section of the headrace consists of a substantial 3.0m high revetment wall (Plate 30) that runs in a NW-SE direction into the mill race, while the river sweeps around to the southwest. The millrace itself was not accessible as a large quantity of tree cuttings have been deposited on top of the structure in recent times.

**Plate 30:** View of revetment wall approaching headrace CHS 11.

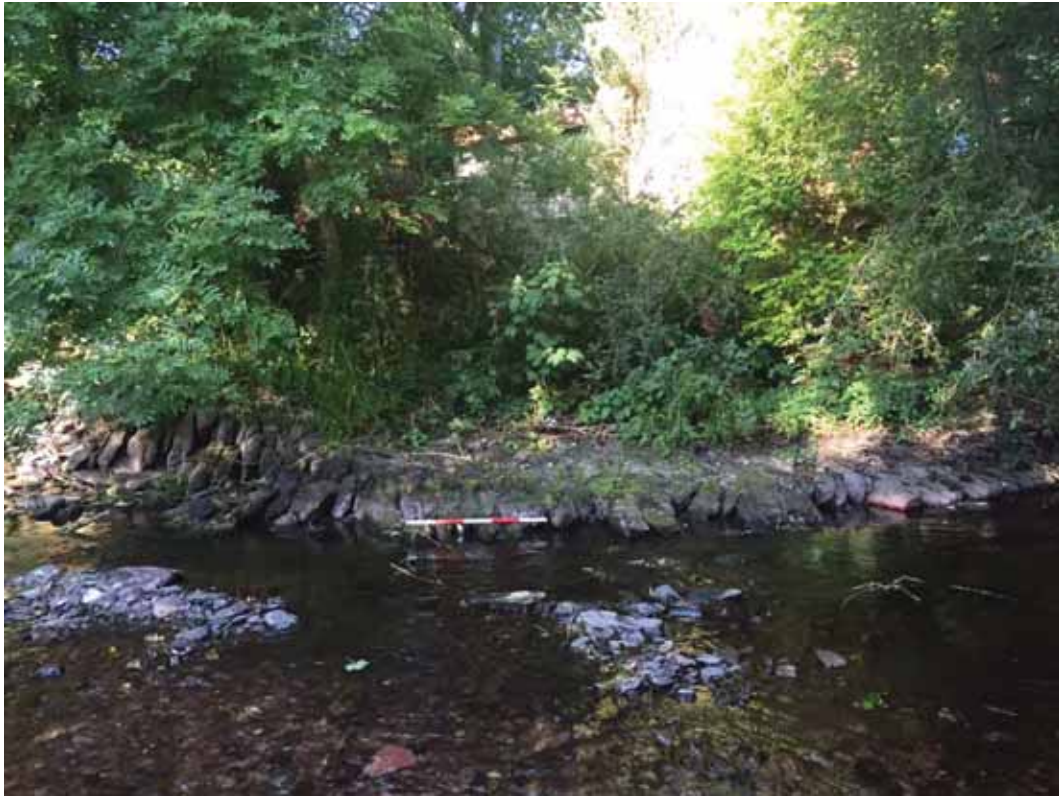
**Plate 31:** View of headrace CHS 11, taken from west.

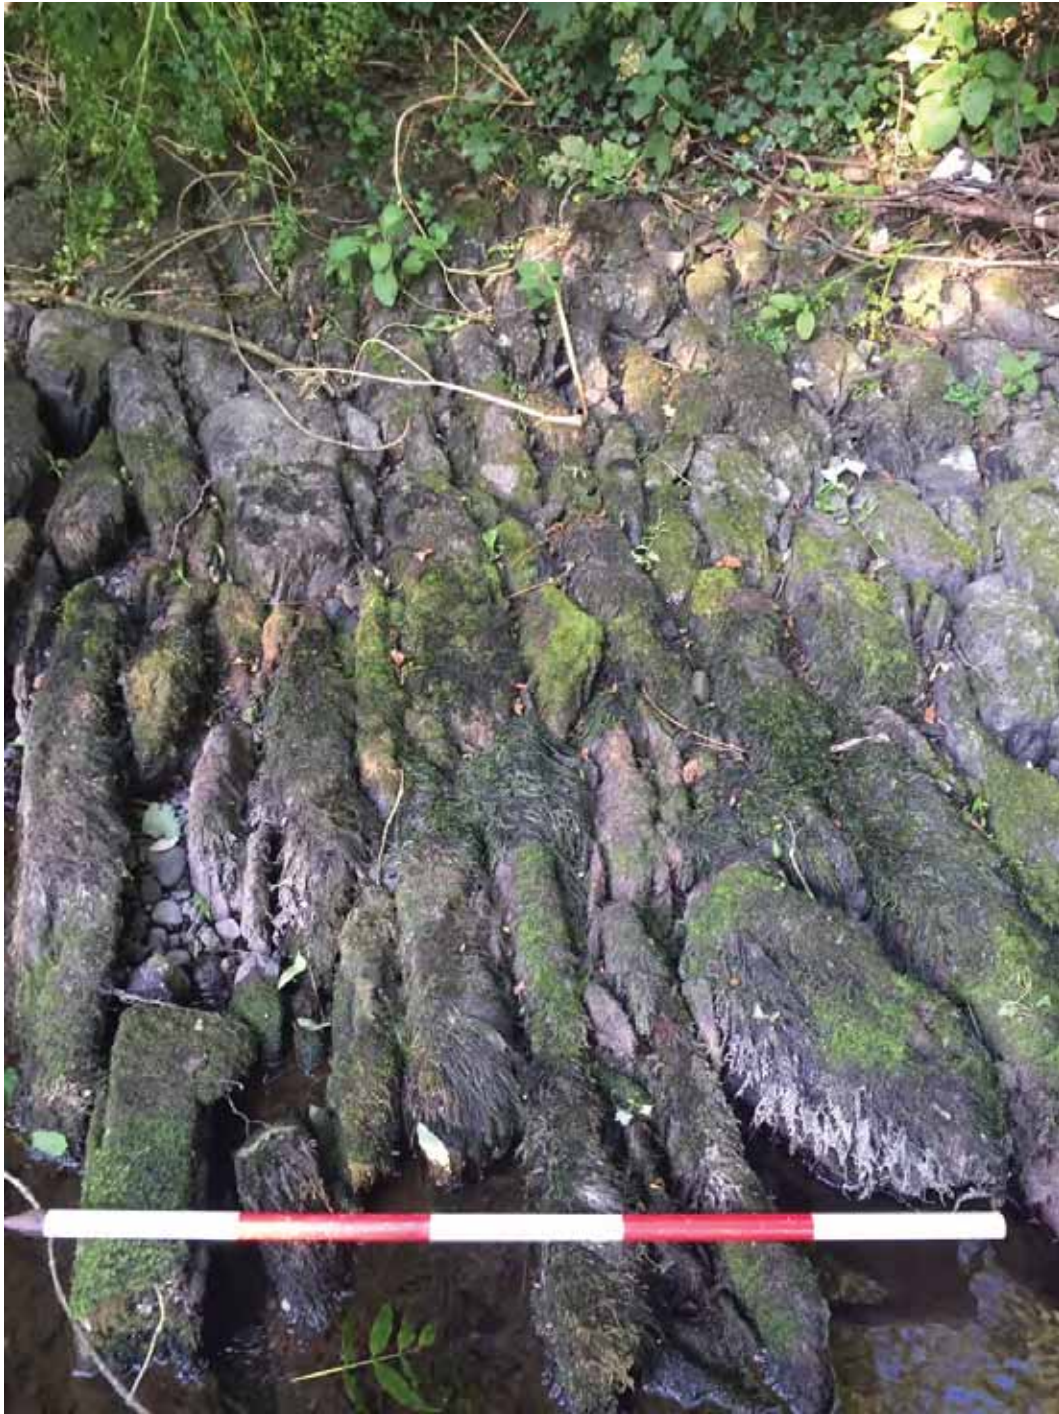
A coherent section of intra-riverine feature comprising well set and matched stones set on edge was recorded immediately south of the Headrace (Fig. & Plates 31 & 32). The feature, possibly a river access slip or revetment, projects from the eastern bank into the river in a WSW- ENE direction and slopes from a maximum height of 1.0 m beside the race down to the level of the riverbed. The Weir is not denoted on the 2<sup>nd</sup> Edition OS map and it is likely that this feature is possibly the remains of the weir indicated on the 1<sup>st</sup> edition OS map.

**Plate 32:** View of stone feature, possible remains of weir, taken from west

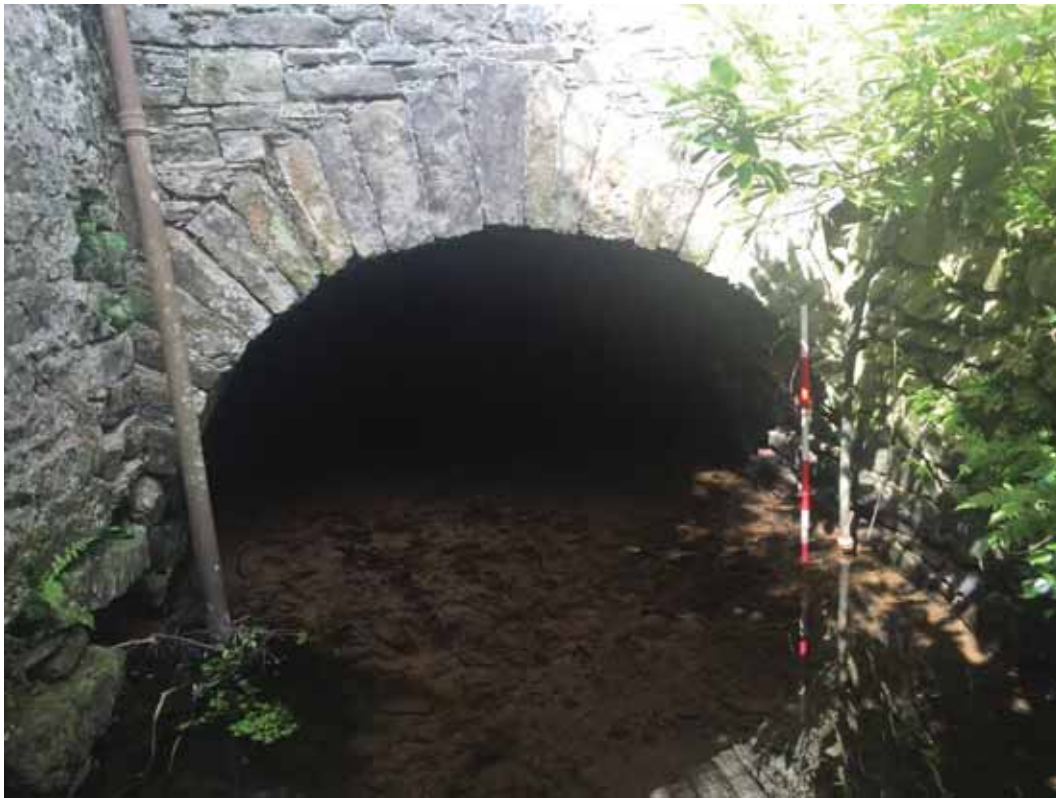
arch of twenty-six voussoirs (Plate 40). To the west of this is a crudely constructed wooden bridge spanning the second race (Plate 41). This is a twin culvert constructed of random rubble stone capped with large stone lintels (plates 42 & 43). Modern repairs comprising concrete support propping have been inserted at the exit, and the eastern channel of the twin culvert has collapsed.

**Plate 40:** View of CHS 13, from south.

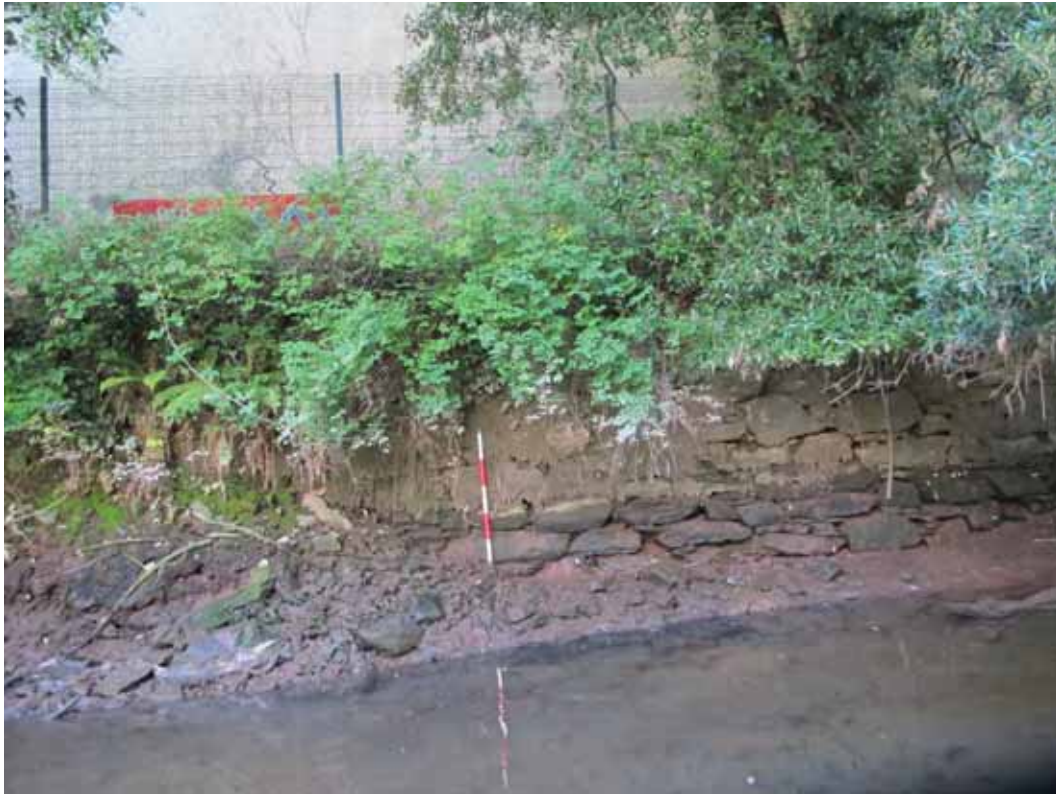
A revetment wall extends along the western bank for the majority of Survey Area 6 (Fig. 18, Plate 45). It is a roughly coursed sandstone wall, measuring up to 2.0m in height (Plate 45). The wall is constructed of large stones, the basal courses of which measure on average 0.5m x 0.3m. The mortar has been largely washed out.

**Plate 45:** View of CHS 16, revetment wall, taken from east.

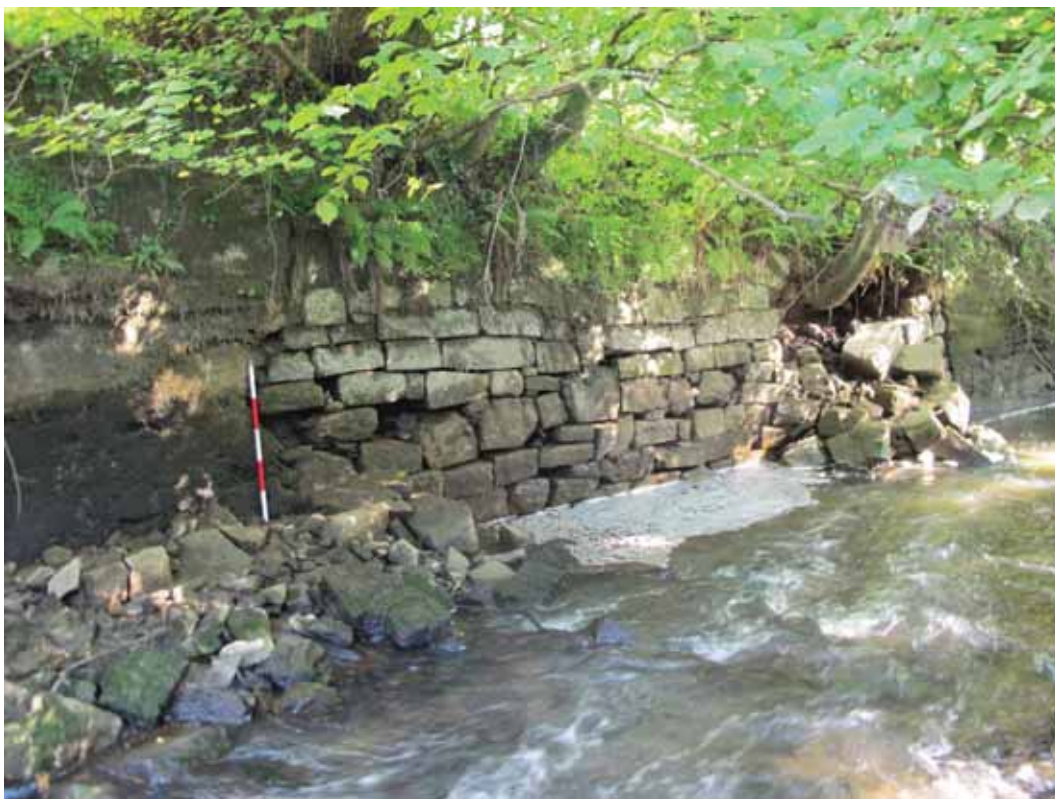
A revetment wall is visible on the east bank between the mill building and the tail race (Fig. 18, Plate 46). Due to an accumulation of sediment and dense vegetation it was not possible to examine the northern limits of this wall. It is possible that the wall continues further upstream concealed behind collapsed bank material. The wall is a substantial structure measuring up to 3.0m in height. It is constructed of dressed limestone blocks measuring from 0.30m x 0.30m up to 1m x 0.6m. Mortar bonding is visible in places. Tree root damage is particularly noticeable resulting in portions of the wall having completely collapsed as a result (plate 47 & 48). Three sections of the wall, measuring between 3.8 and 4.5m in width have been repaired with concrete.

**Plate 47:** View of CHS 17, revetment wall, taken from northwest.

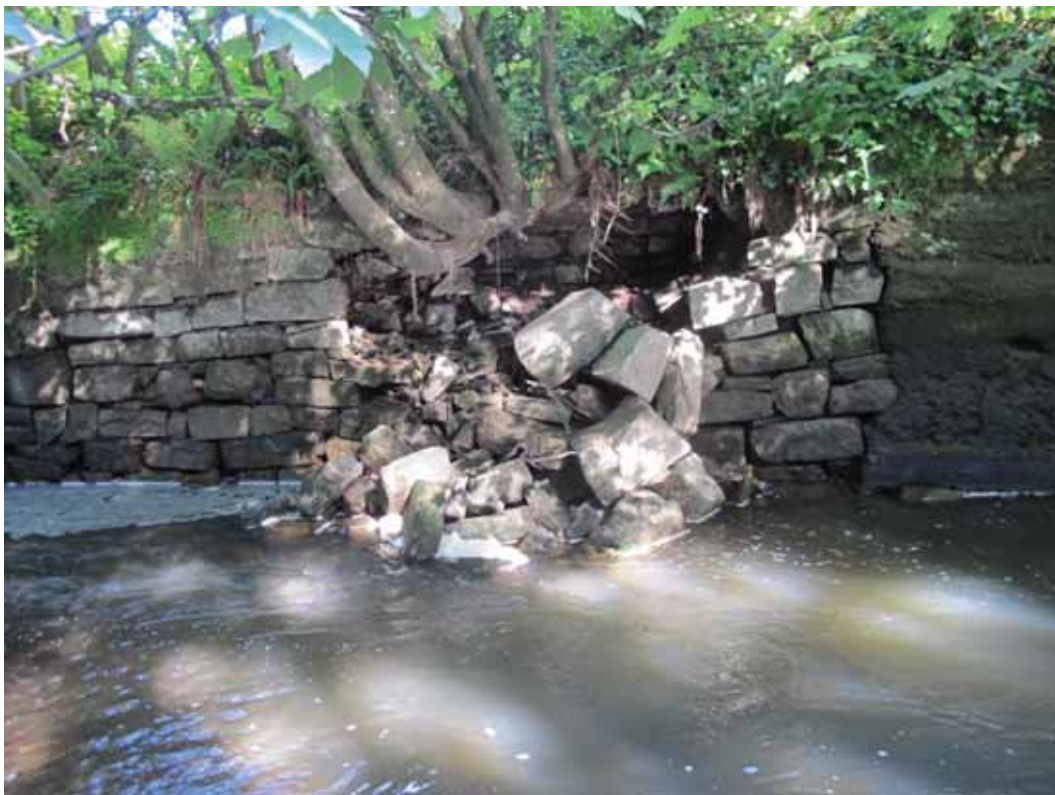
**Plate 48:** View of CHS 17, revetment wall, taken from west.

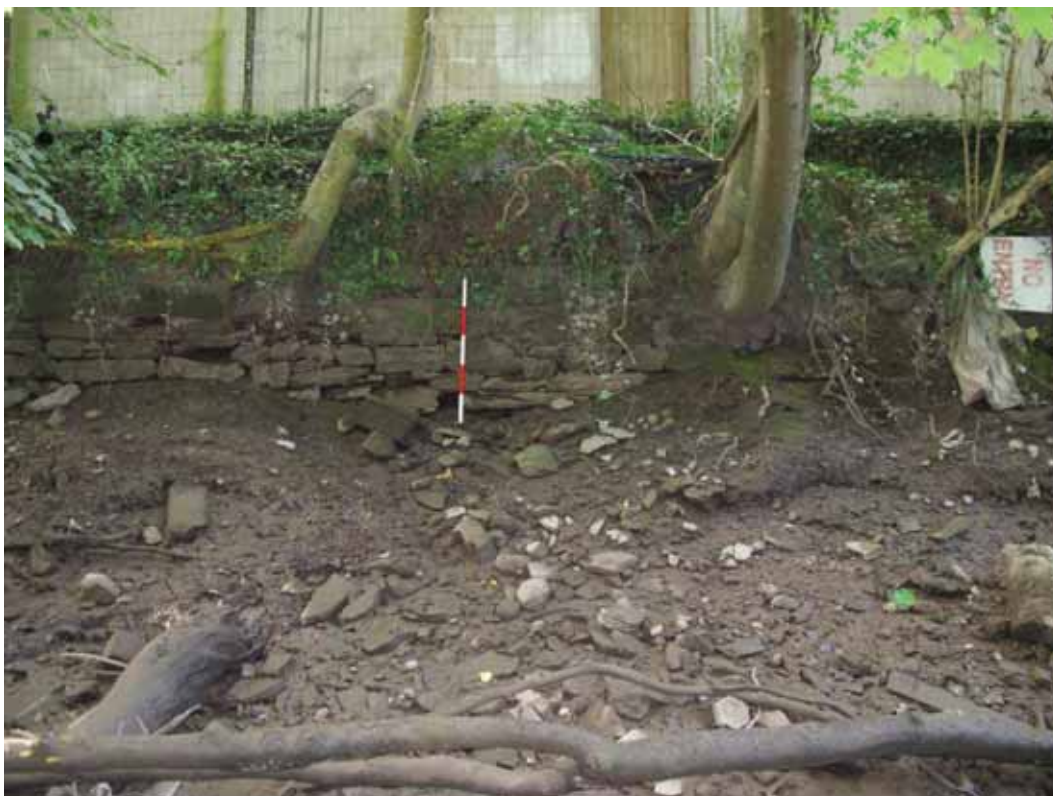
**Plate 51:** View of CHS 20, revetment wall, taken from south.

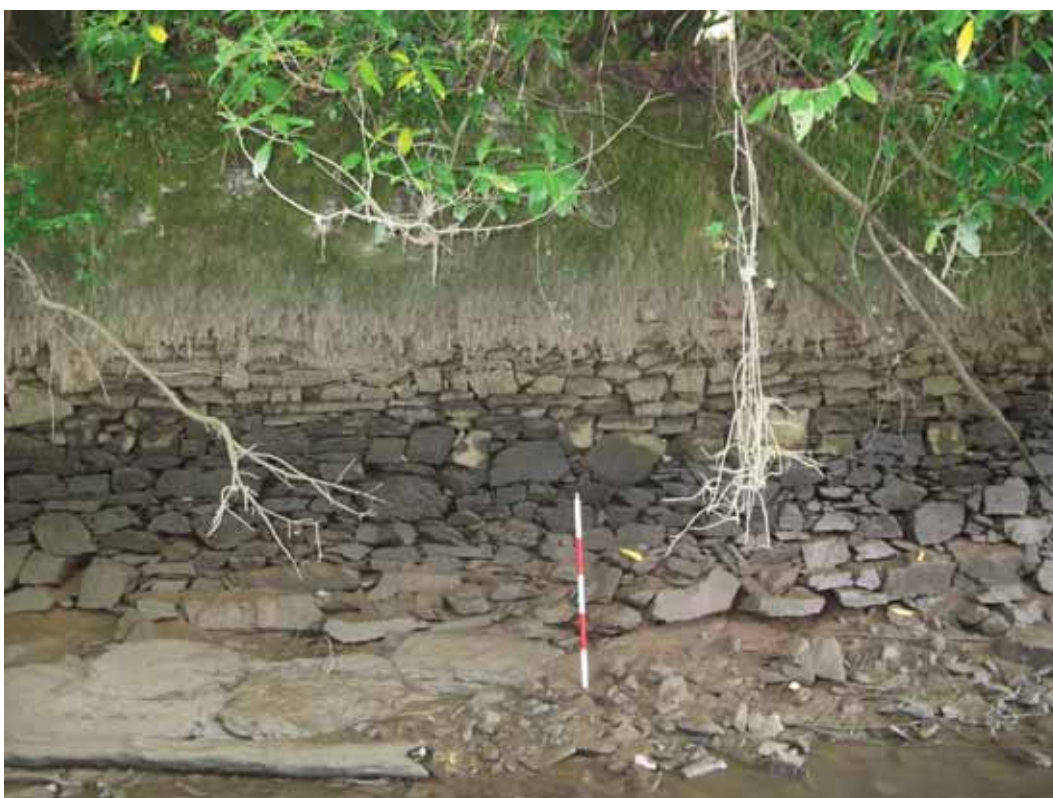
CHS 19 comprises a revetment wall extending along the east bank (Figure 21, Plate 52). The wall is constructed of roughly coursed stone with the larger stones (0.5m x 0.30m) at the base and smaller stones forming the upper courses. The revetment wall survives to a reduced height of 1.3m at the northern end and up to 4.0m in height in the southern end. Mature woodland extends along the eastern bank.

**Plate 52:** View of CHS 19, revetment wall, taken from north.
