Blackpool Culvert- Data Analyses and Rainfall Events Nov Dec Jan

Blackpool Flow Survey:

Blackpool Flow Survey: November 2014 Report

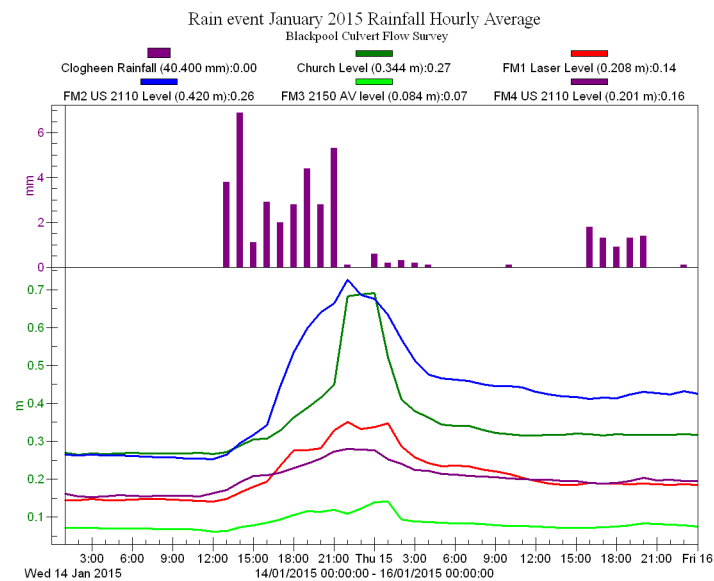
Figure 4 : Rainfall and levels during 14th January Rain event- (hourly average)

FM1: Rain Event 14th January Bride River - Laser and 2150 AV Loggers

Both Laser and 2150 AV show a peak level of 0.34 meters approx. The 2150 velocity data locked out during the increase but kicked in at the peak level for a period. However the Laser worked better and this is used as the benchmark for calculating an accurate flow at FM1 , (Bride River). The max flow recorded by the Laser logger was 6 m³/Sec approx.

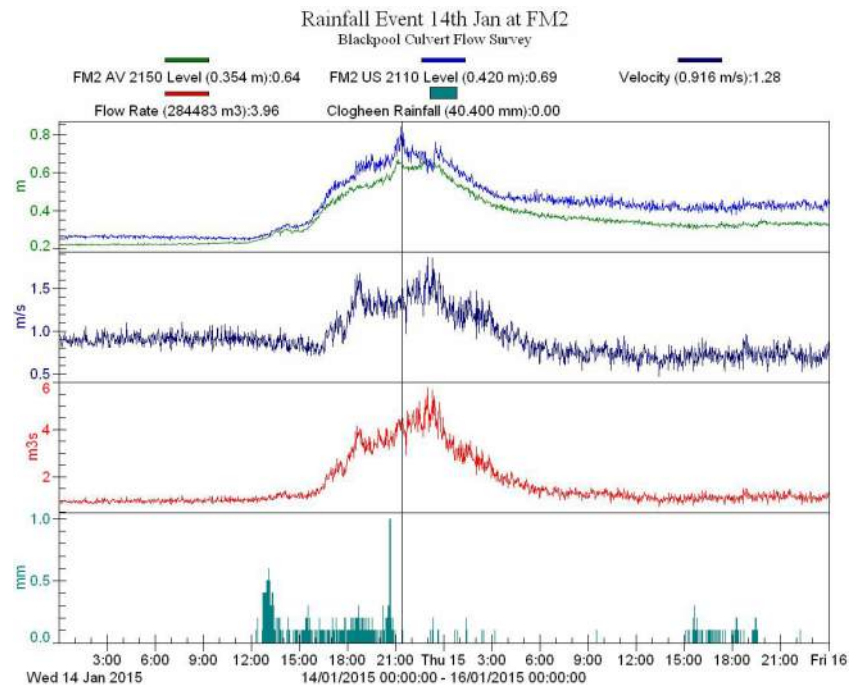
Fig 6: Rain Event 14th January at FM2- Level, Velocity and Flows

FM2: Rain Event 14th January Old Brewery Line – Ultrasonic 2110 Logger (US) and 2150 AV

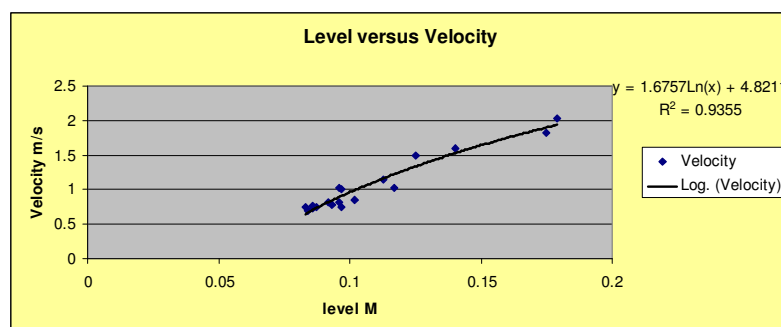
Fig 9: Level to velocity Algorithm used for FM4:

At FM4 we recorded levels with the newly fitted Ultrasonic Flow logger which is placed 3 meters upstream of the old 2150 AV position. We used an equation derived from previous level ,velocity data to convert levels to velocities and subsequently to flows in order to provide an estimate of the flow rates at FM4. This is used for flow balancing calculations.

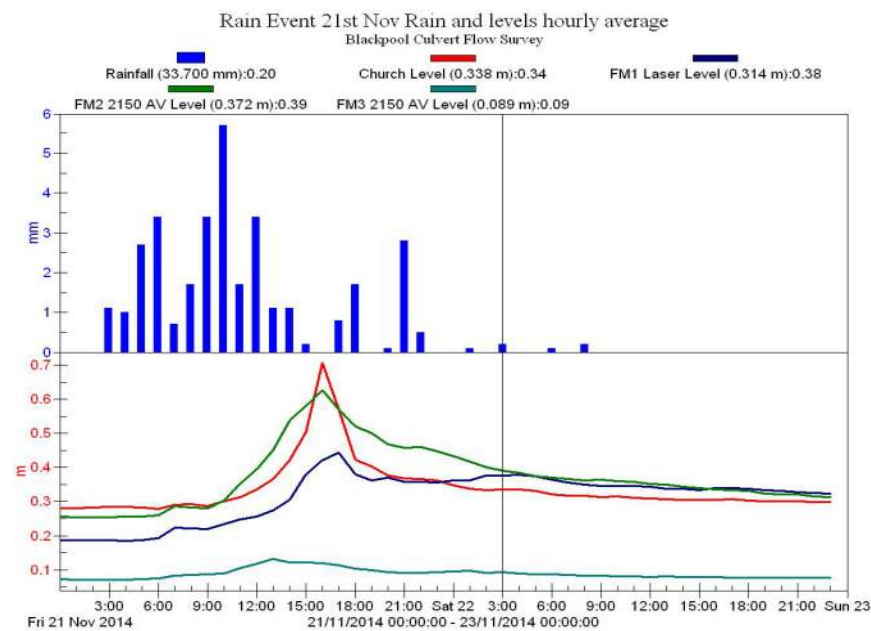
Fig 13: Rain Event 21st November 2014 Rainfall and Levels- hourly averaged

A significant rain event occurred on the 21st November. This was a week after the 13/14th rain events and a wet month overall and levels were still elevated prior to the event. Unfortunately on analyses it turns out there was issues with clogging on both rain gauges at White Church and Clogheen during the event. Hourly rainfall data acquired from Met Eireann for Cork Airport is used for analyzing the event. Also entry into the culvert at this time was not possible. The FM4 flow logger 2150 AV flow logger was not producing good data so flows are studied for FM1, FM2 and FM3 only and flows are derived for FM4 by subtraction.

33.7mm of rainfall was recorded at Cork Airport during the event. The peak church level was 0.7 meters approx. The peak level at FM2 old brewery line was 0.6 meters.

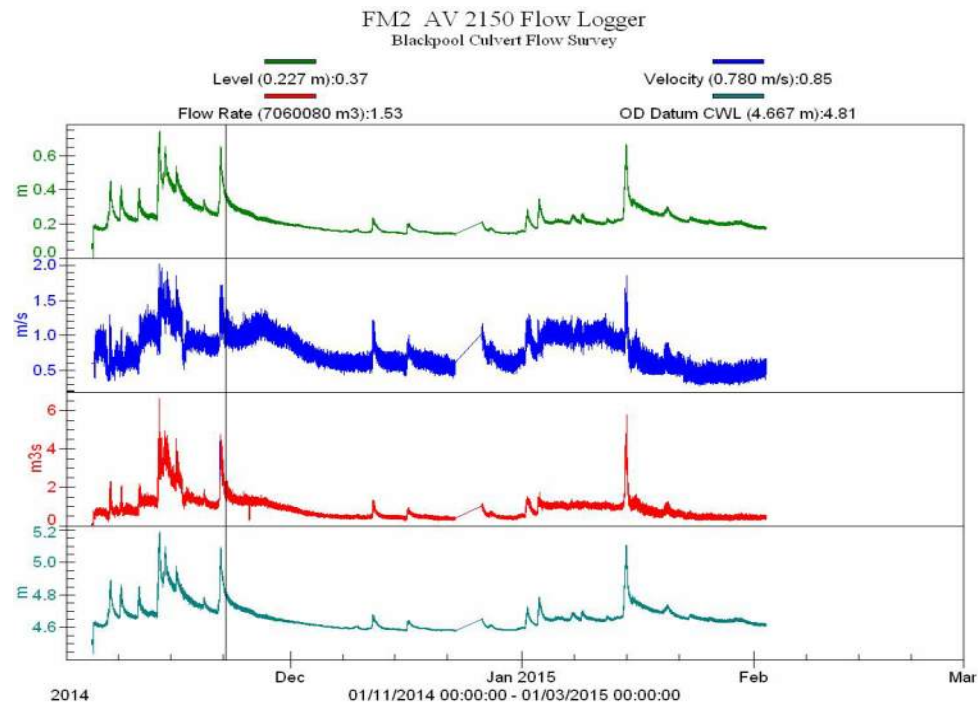
Fig 20 FM2 2150 AV Flow Logger complete recorded data Nov Dec Jan

Despite the uneven floored channel and varied and sometimes turbulent conditions in the FM 2 brewery line, the 2150 AV logger generally has worked well as can be seen in Figure 20. All main rain events were recorded. Flows are estimations based on a standard 4 meter rectangular culvert.

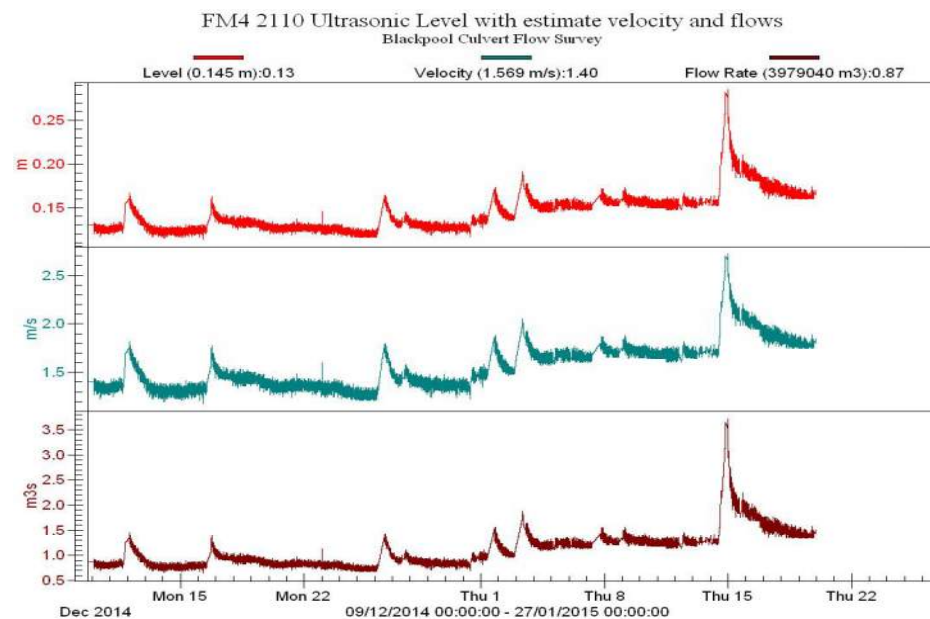
Fig 24: FM4 new ultrasonic 2110 level logger Level data and derived velocity and flow

Figure 24 shows the new 2110 ultrasonic level logger data installed in December. It also includes the estimated velocity and flows based on previous algorithms calculated.

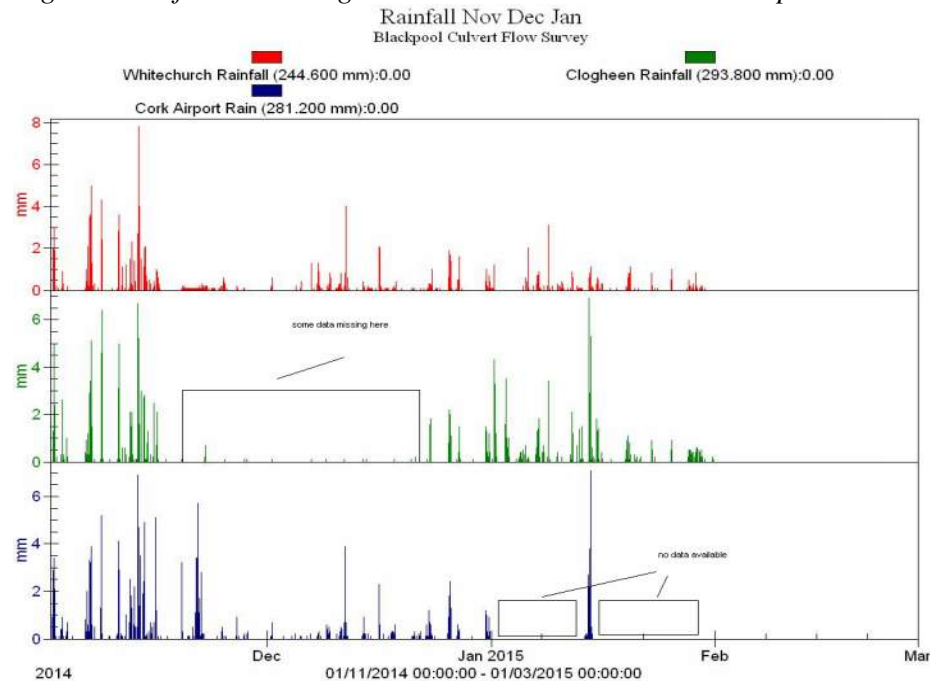
Fig: 25 Rainfall data Clogheen White Church and Cork Airport Nov Dec Jan

Generally the rain gauges worked well but in the autumn and winter months we encountered regular issues of clogging of the funnel which resulted in some missing data. This issue could occur very quickly so it was difficult to maintain. Unfortunately we missed the event on the 21st November and we rely on Cork Airport hourly data for this event. In the 14th January event the Clogheen Rainfall data was good. At the start of the event it was noted that White church was clogged and this was rectified after but data was not used because the first few hours were missing. Going forward we are considering installing a third rain gauge to provide more data security.

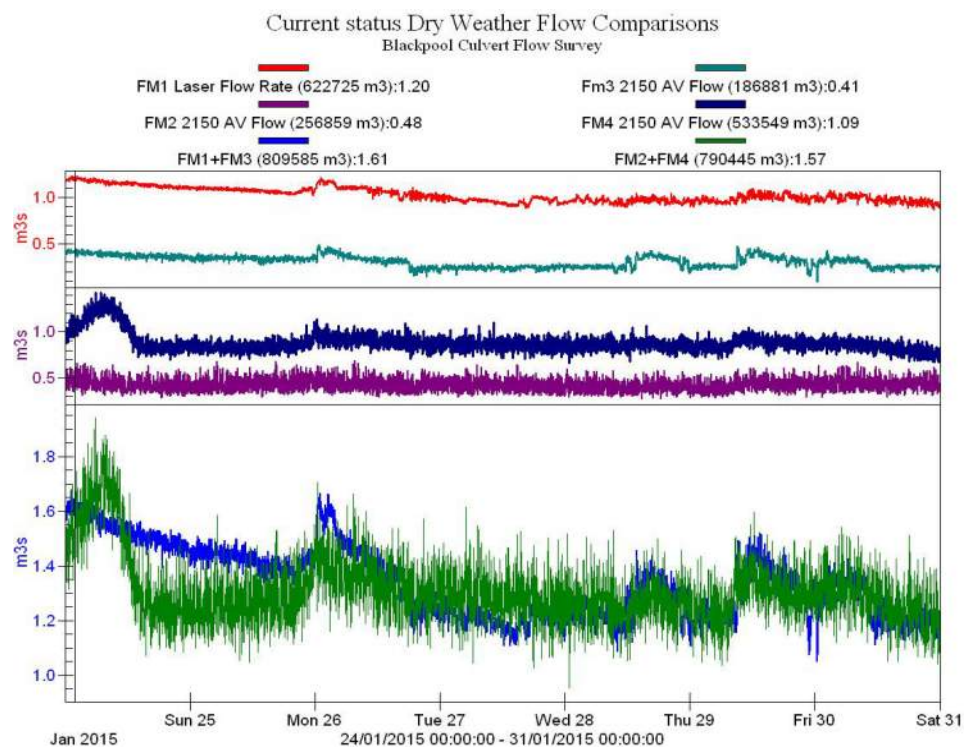
Fig26: Recent Dry weather flows in culvert with flow balancing

At present we have dry conditions in the culvert, Flow calculations of our most recent data at the end of January confirms good flow balancing providing some confidence in previous calculations.

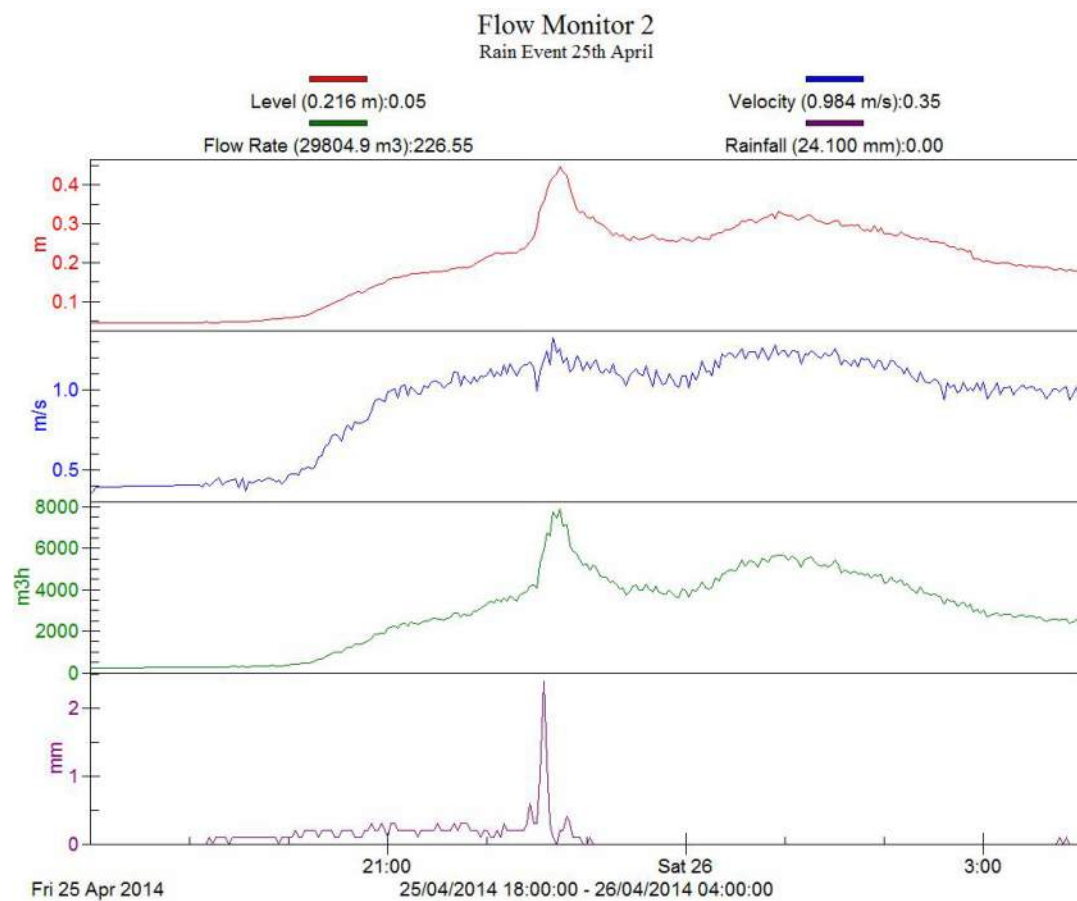
Event was picked up well at FM2 Brewery Channel:

Max level 0.447 metres at 10:40 pm

max velocity 1.32 m/s at 10:40 pm

Derived flow data may be unreliable due to uneven channel floor at measuring point.

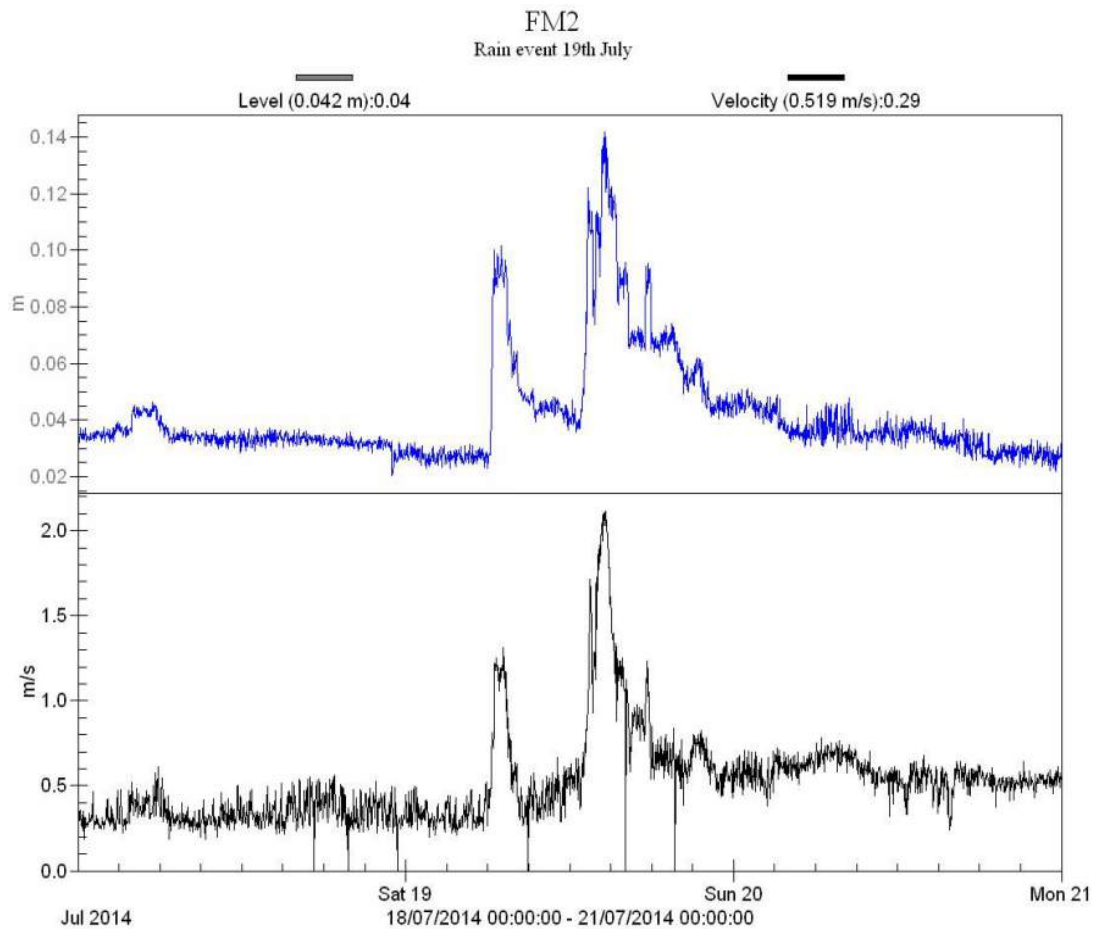
Level and velocity data recorded at FM 2 can be seen in graph below.

In general we are recommending that it is best to estimate the flow rates at FM2 by subtraction of FM1+ FM3-FM4 as the flows in the brewery channel are irregular due to the uneven floor surface.

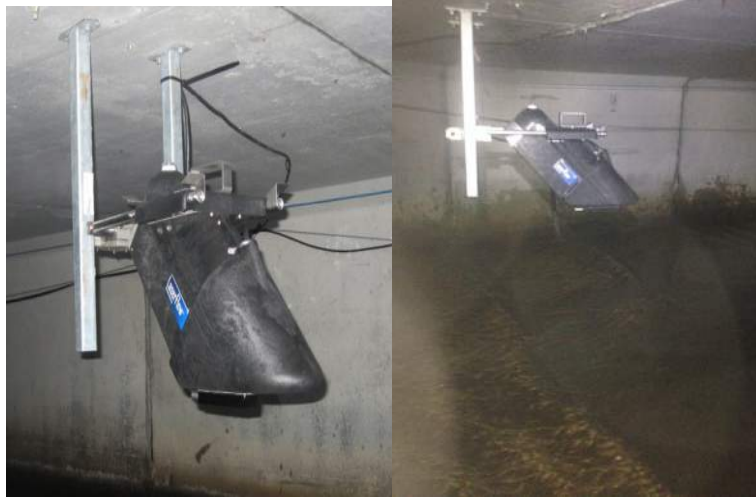
Fig 6: laser Flow Logger at FM1

A peak level of 0.7 Metres was recorded at the FM1 location on the 2150 AV flow logger. However the laser flow meter which is located within a few meters of the 2150 probe recorded a peak of 0.4 metres approx. The laser is mounted directly above the centre of the culvert while the 2150 is more to the side. The data would seem to indicate that there are higher levels at this side of the channel where the 2150 probe is located, although some of this may be due to localised ragging issues or possibly a slight localised standing wave caused by the probe itself during high velocities. The pink, (2150) and blue, (laser) trend above in Fig 5 shows a slightly higher level before the events on the 2150 but a significantly higher level during the event and after. Both the 2150 AV and Laser had good level to velocity profiles with similar flow rate trends. The Laser flow meter has a particularly good level to velocity correlation and in general we have used this data as our benchmark as we can be generally confident that there are no localised debris issues at this measuring location since it is non-contact sensor.

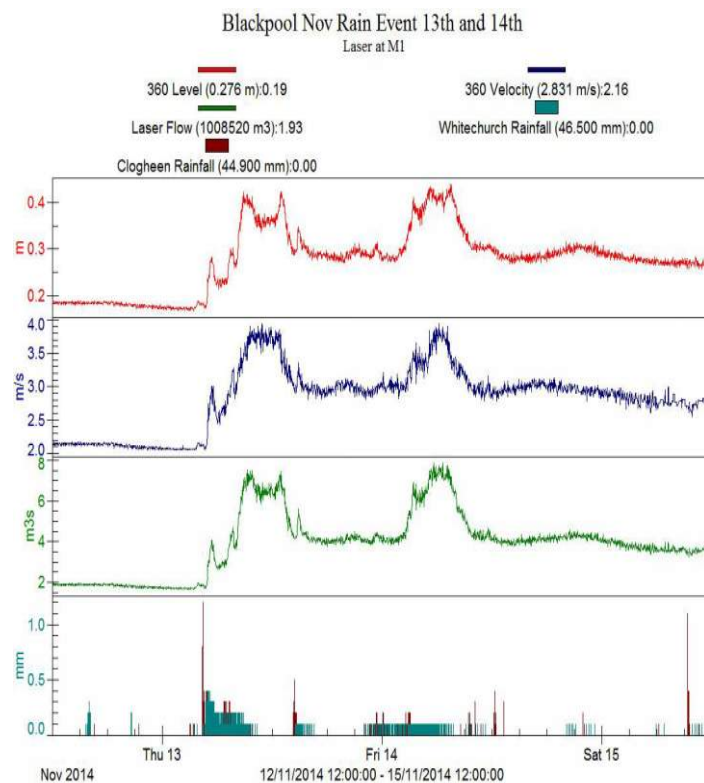
Fig 7: Laser Flow Logger Level velocity and flows at FM1 during Rain Events

The laser flow logger recorded a peak flow of 7 M3/sec with peak velocity at 3.8 m/s during the first rain event on the 13th Nov. There is a dip in the level in the middle of the peak which may indicate channelling of higher flows to the side of the channel.

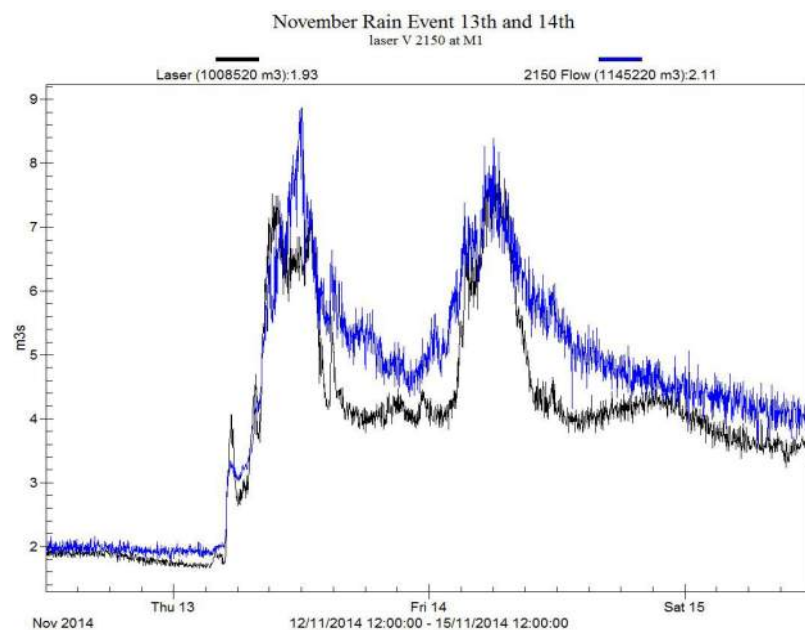
Fig 9 Comparison of flow rates between Laser and 2150AV Logger at FM1 during the two rain events

A comparison of flows between the Laser and 2150 at FM1 are seen in Fig 6 below which show a reasonable correlation at the peak flows.

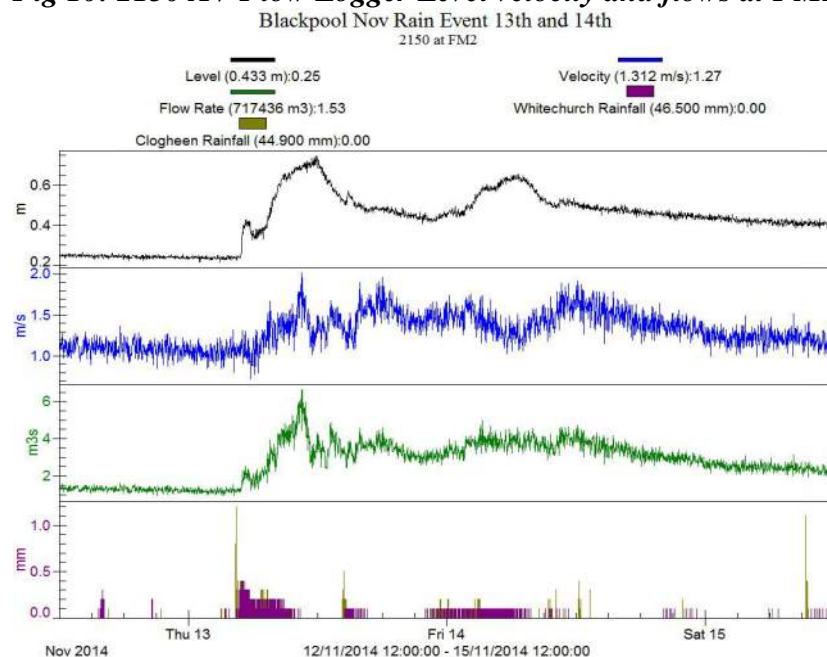
Fig 10: 2150 AV Flow Logger Level velocity and flows at FM2 during Rain Events

Good quality level and velocity data was logged at FM2 with a peak level of 0.7 metres during the rain event on the 13th corresponded with a velocity of 1.9 m/s. The Brewery channel is partly natural with an uneven gravel floor which makes it difficult to estimate flows accurately. However if we assume it to be a standard rectangular channel for estimation it would calculate at a peak flow of 6 m³/sec approx.

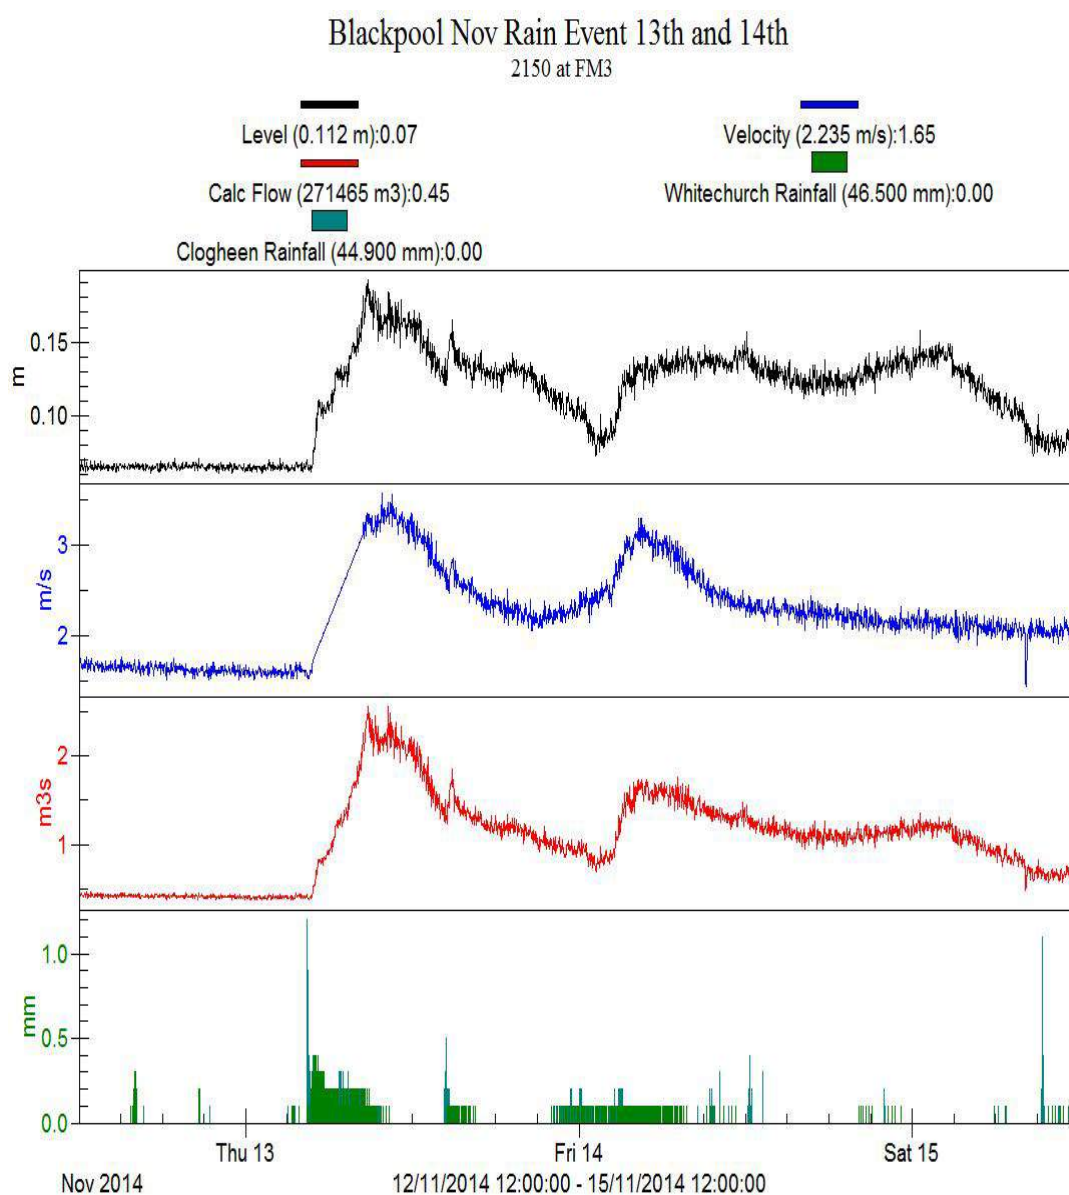
Fig 11: 2150 Flow logger Level, Velocity and Flow data during rain events at FM3

Fig 11 shows the level velocity and data logged during the rain events measured at FM3. Data at FM3 required a small amount of correction of velocity, which appeared to not read for a few hours during the first event, most likely due to ragging. The probe had some rags on the probe when we entered the culvert later on the 16th which may have affected the quality of both level and velocity; in particular the level data was a bit erratic after the events. However, for the most part, the data looked good during the peaks themselves. A peak flow rate of 2.4 M3/Sec was recorded coinciding with a logged velocity of 3.32 M/Sec.

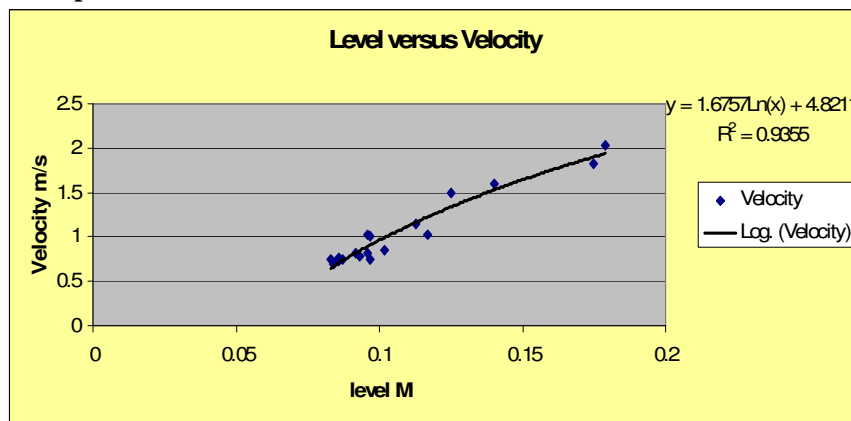
Fig 12: Virtual Velocity curve derived from manual selected points during ‘good data’ previous events.

Velocity data was not useable at FM4 due to ragging shortly into the start of the first rain event, however level data was intact. Due to the fact that all data to date would seem to indicate that flows were free flow without evidence of surcharging we concluded that we could apply a curve fit based on data analysed at FM4 during other events, to produce a reasonable virtual velocity trend. While we did not have points at the high end of the curve, in general the resultant velocity at the high levels seemed to be in line with velocities recorded in FM1 which is a similar channel. We further derived flows based on this velocity result. The resultant peak data during the first event was level 0.34 Metres, derived velocity 3 M/Sec , derived flow rate 4.84 M3/Sec

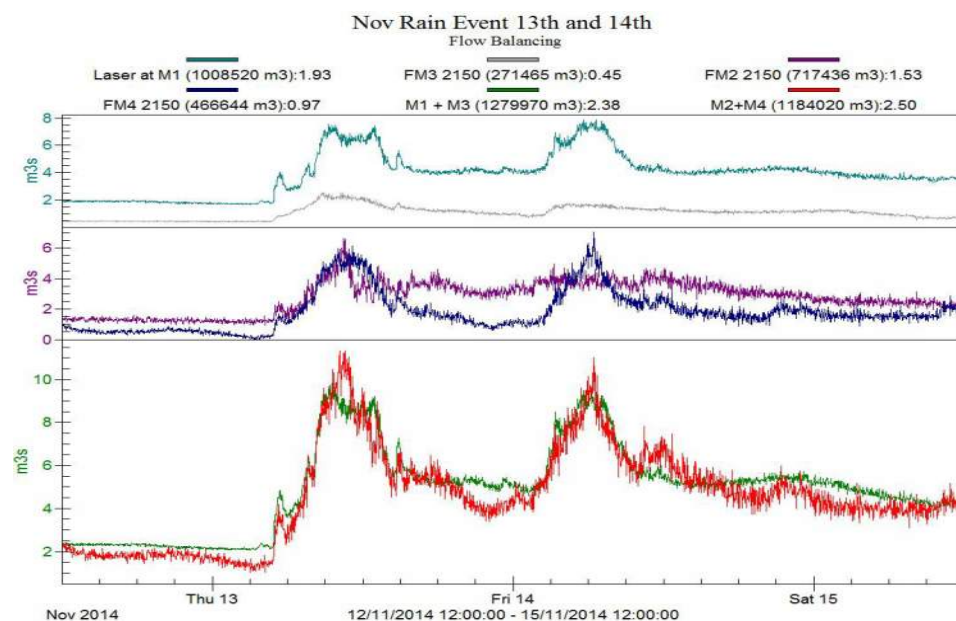
Fig 15: Flow Balancing Estimates by adding Flows

If we assume accuracy with FM1 and FM3, our derived flows at FM2 and FM4 would indicate an 8% underestimation. If we consider the total volumes the flow balancing percentages would calculate as seen in Fig 16 below.
