Appendix 6.2

Geomorphology Report

Hydromorphic audit of the River Glashaboy

November 2016

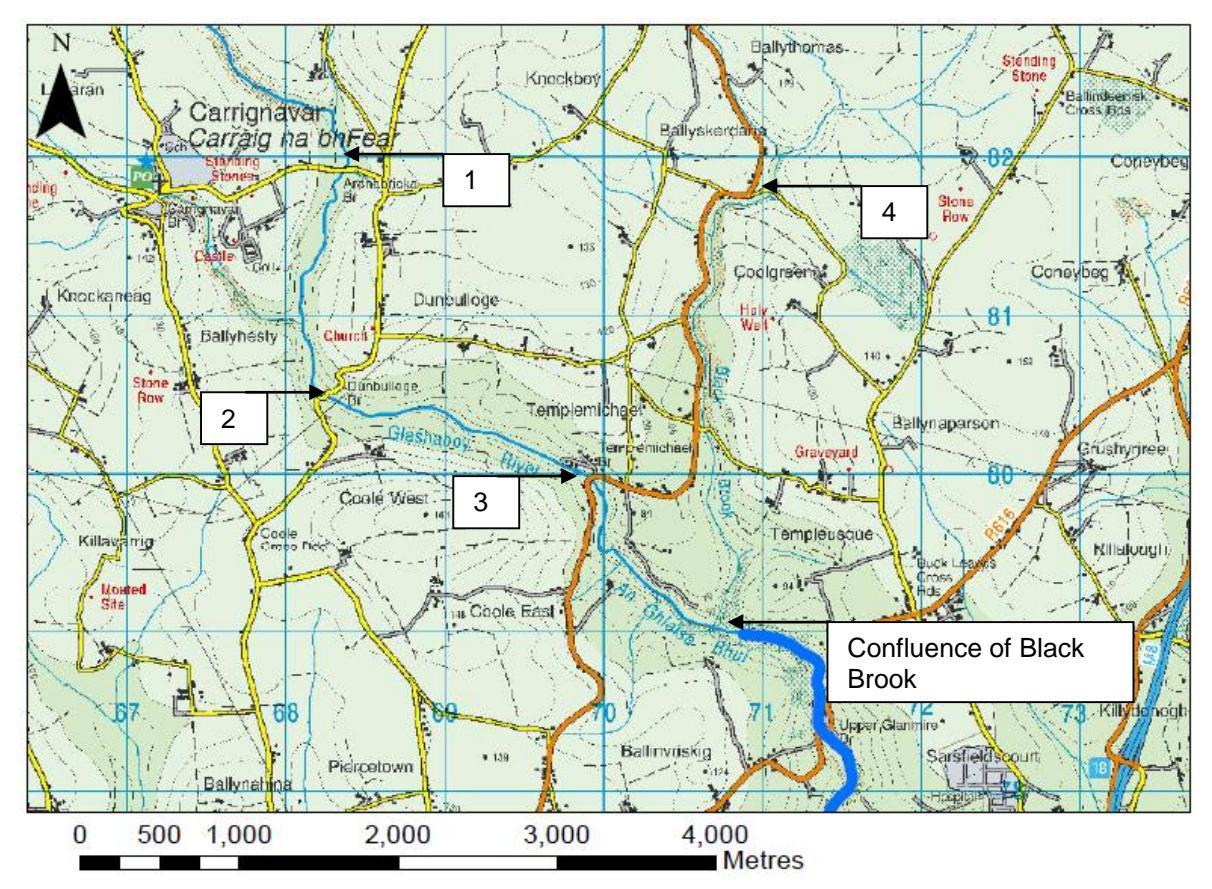
Figure 3-1 Survey Reach Overview

The upper sections of the Glashaboy between Carringnavar to Upper Glanmire Bridge (1 to 2 on Figure 3-1) are predominantly rural. The floodplain in most locations is narrow and dominated by farmland and woodland. The channel exhibits a pool-riffle morphology which is dominated by a cobble and gravel bed, with little evidence of significant transport of cobble and gravel sized material given the amount of bed algae present across this sediment (Figure 3-2). Limited large accumulations of gravel as bar features were noted even in areas where the gradient was reduced. This suggests a limited upstream supply of gravels and/or the ability of the channel to flush sediment downstream during higher flow events.

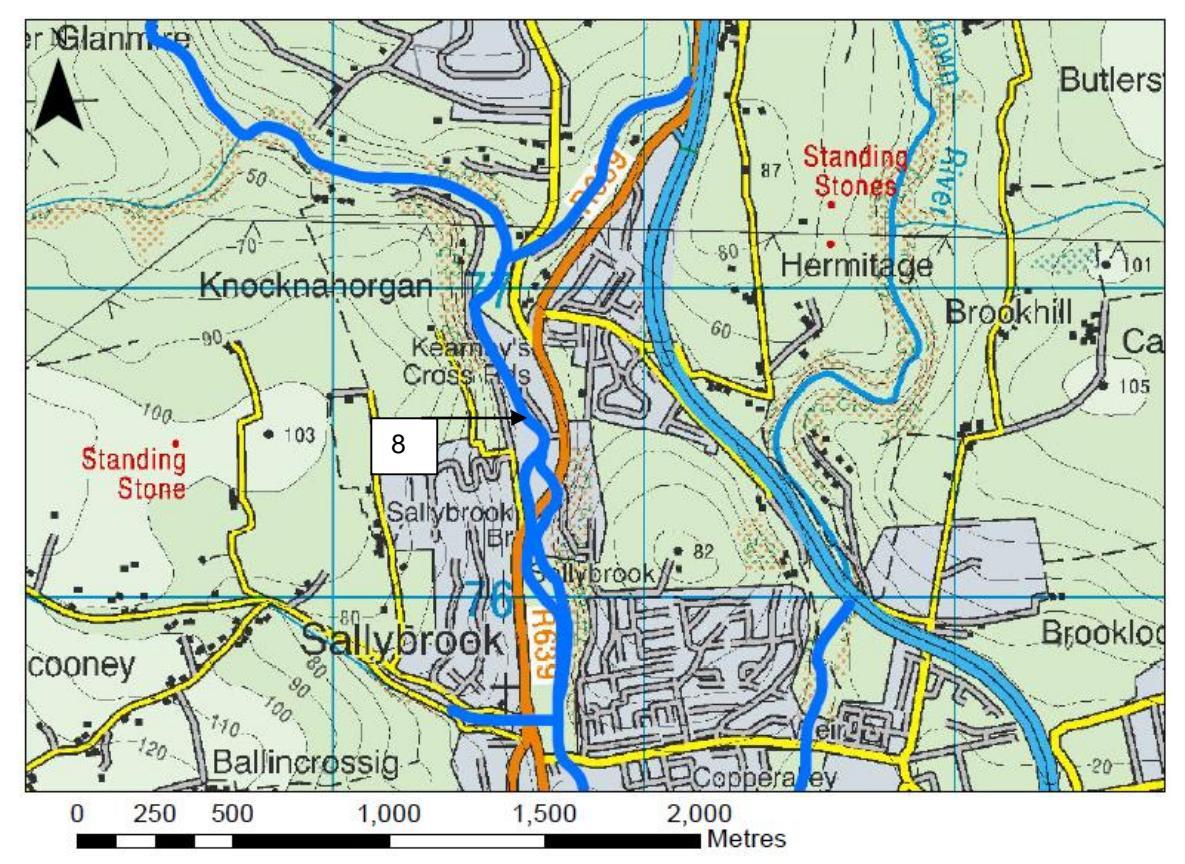
Figure 3-9 Reach overview

As the river approaches Sallybrook the channel and its floodplain become subject to greater urban influences including embankments, weirs and limited floodplain connectivity due to the presence of flood embankments.

As the channel approaches Sallybrook the valley widens and becomes less confined. The wider floodplain along this reach has been developed / built upon which acts to constrict the channel. In some areas informal flood embankments have been constructed. In other areas active bank erosion is occurring as the channel attempts to naturally adjust within is confined channel. This is exacerbated by the higher energies during flood conditions as a result of the channel constriction. Hard measures, such as walls have been constructed to reduce the erosional impact of the river (particularly on the outside of bends) and some of these are now failing (such as adjacent to the petrol station). The erosion of banks acts as a strong sediment supply of gravels and fine materials. Deposition is also common through this reach, with several gravel bars (which are unvegetated, signalling frequent movement) being present. However, in the lower portions of the reach the channel becomes incised as a result of these structures the channel is disconnected by over 1m from the floodplain (due to the channel eroding downwards in an attempt to adjust its bed gradient) and deposition is minimal, due to floodplain disconnection and high in channel energy levels. The channel in this lower section is dominated by coarser cobbles.

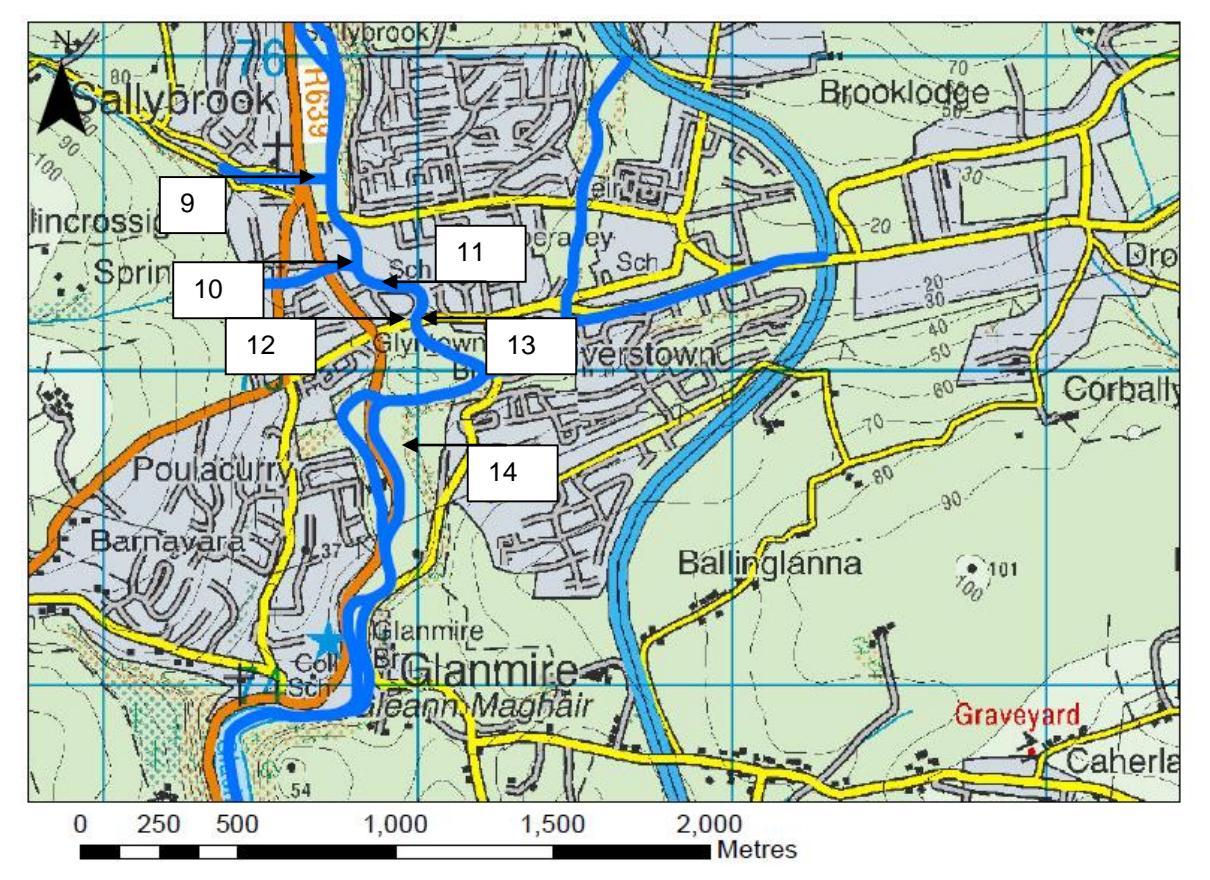
Figure 3-11 Reach overview

Downstream of Sallybrook the channel flows through a narrow urban corridor. The channel remains slightly incised, possibly due to historic straightening due to protected river banks. Sediment is delivered to this reach via several steep tributaries.

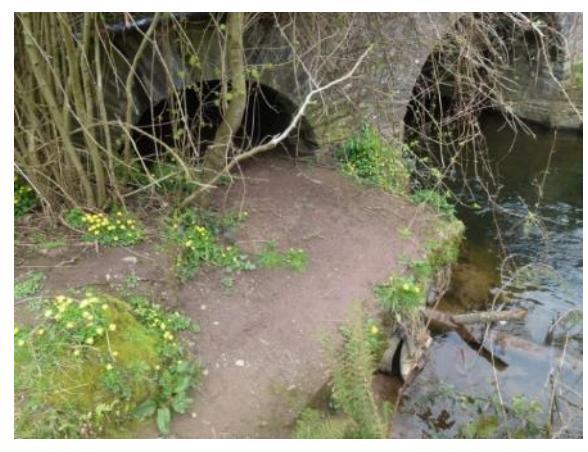
Figure 3-16 Upstream of the park (Point 12)

Downstream of the housing estate the channel enters a parkland area and connection to the floodplain is improved. In areas of the channel where flows are reduced fine sediment deposition is occurring (Figure 3-16) and in some areas small pockets of gravels (Figure 3-17) have been deposited, however, gravel deposition is not widespread. If sediment is removed as part of any future maintenance works, it should be expected that sedimentation will re-establish itself naturally.

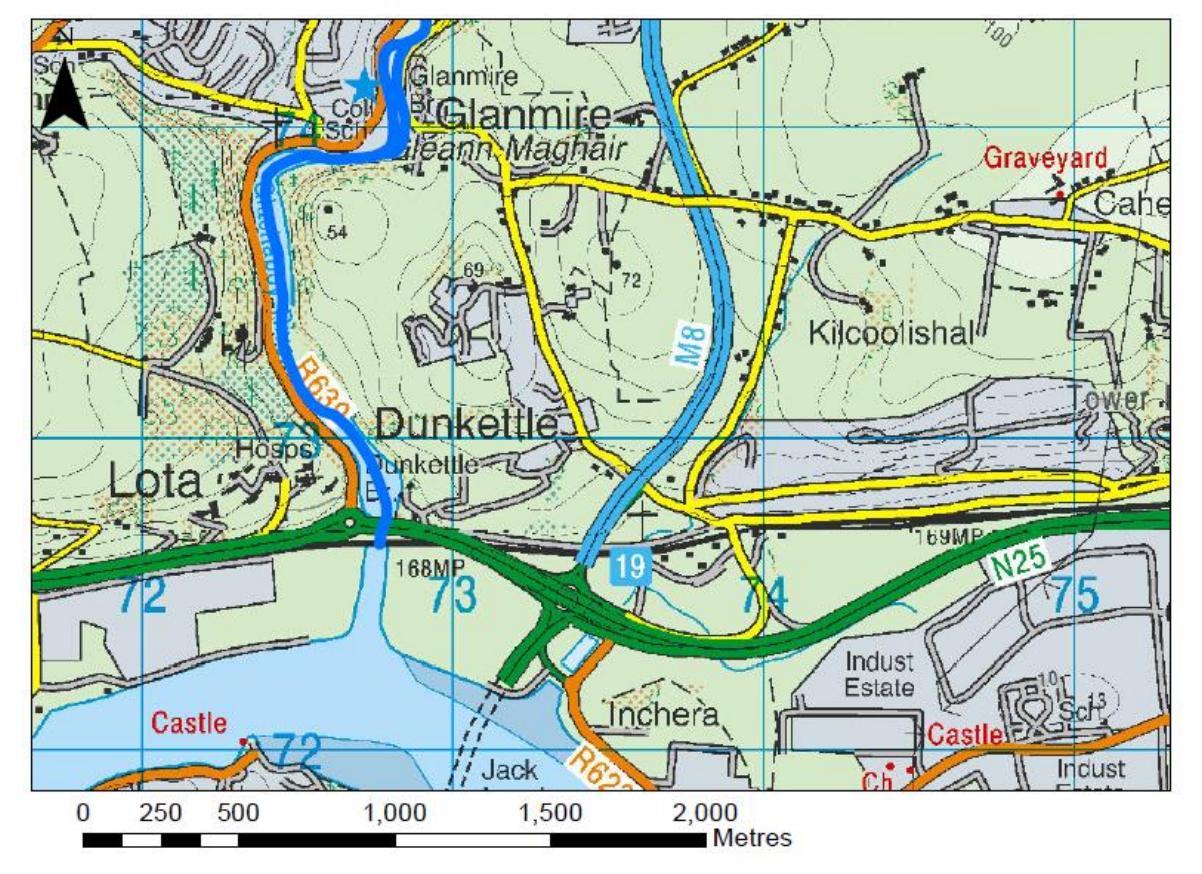
Figure 3-19 Reach overview

At Glanmire bridge, deposition of gravels is occurring on the left bank (Figure 3-20). Downstream of the bridge the river gradually becomes wider and eventually is influenced by the tidal regime. This influences water levels and flow conditions downstream of Glanmire, resulting in some deposition of tidally derived muds and silts. The deposition of this sediment appears low therefore there is little risk of increased sedimentation in this section.
