Environmental Report January 2025

Glashaboy Flood Relief Scheme

Document code: FFEC-GFRS-2025-001

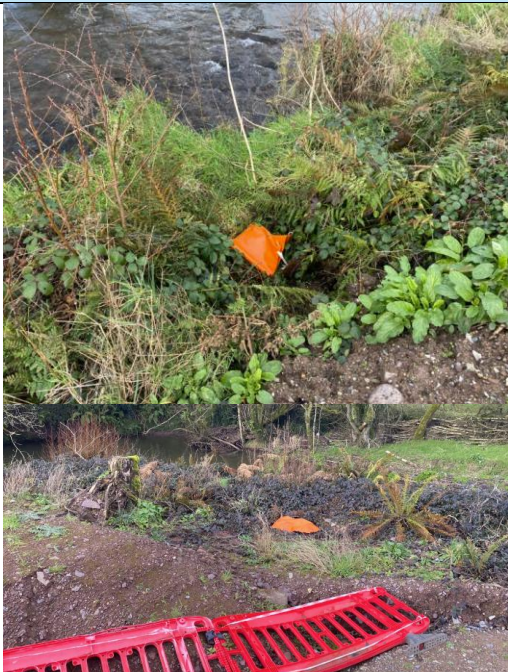
1.13	29/01/2025	In response to GFRS-RFI-344 Springmount Stream Wall C06_L04 Tree Removal, the tree in question and the ground surrounding the tree was inspected. It was noted that there may be the possibility that Spanish Bluebell (<i>Hyacinthoides hispanica</i>) is growing at this
