Project Number:	6075	Document Number:	Appendix 7.1	Revision:	09
Project Name:	GLASHABOY FRS	Document Title:	PHOTOMONTAGES	Date:	07 March 2018

Appendix 7.2

Summary of relevant
observations and Planning
Objectives from Cork
Development Plan (2014) and
Cobh Municipal District Local
Area Plan (2017)

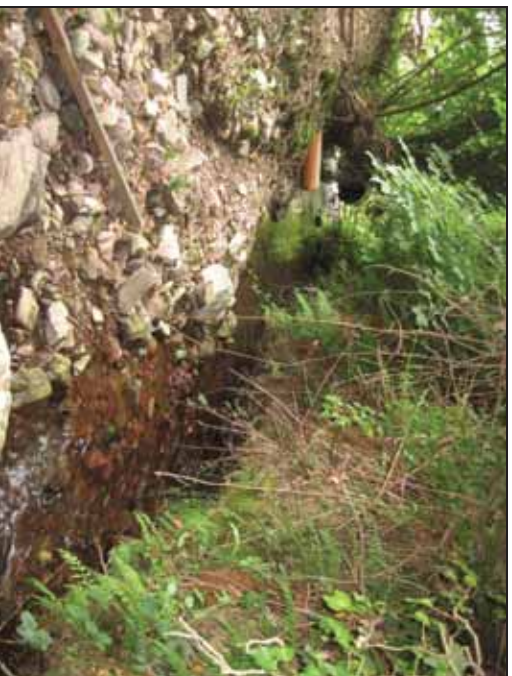
The stream runs southwest within a natural earthen channel divided into two sections by a culverted portion which runs under the access road to Cúil Chluthair. The bed of the stream is very stoney as are the sides. The western bank is defined by a near vertical slope while the eastern bank slopes steeply. Material has been dumped on the high ground at the top of the eastern bank.

The stream was generally quite clean although some metal pipes and debris were identified during the metal detector survey, all were modern in nature. There is a large concrete man-hole on the eastern bank of the stream on the southern downstream section. Otherwise this section was more overgrown than the upstream northern section. No features or finds of archaeological potential were identified.

Plate 1: Bleach Hill Stream, looking southwest

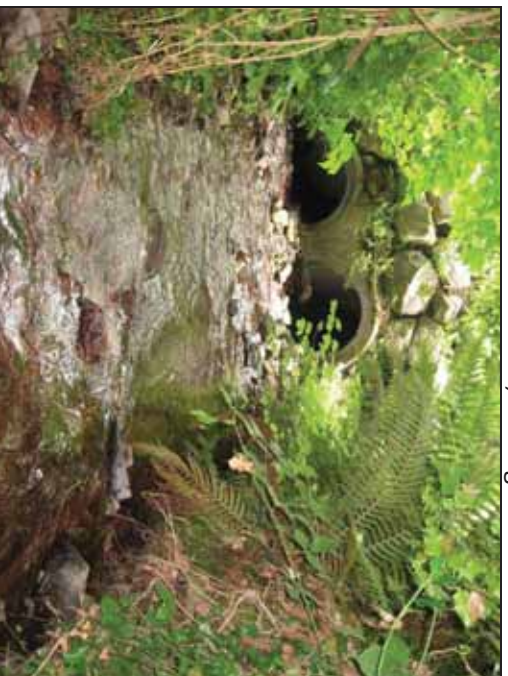
Plate 2: Bleach Hill Stream, opening of culvert under road, looking southwest

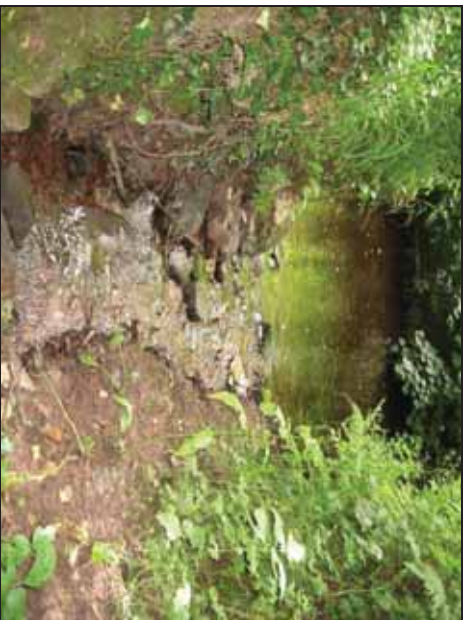
The channel bed is mostly stoney with some silty patches particularly where rubbish has built up. The rubbish is generally plastic and occasional modern metal objects were detected in the course of metal detecting. The sides are evenly cut and slope quite steeply and its appearance is consistent with a fairly recently constructed channel from the mid/late 20th century. Semi-mature trees have grown up around the channel. No features or finds of archaeological potential were identified.

Plate 3: Unnamed channel discharging into the Glashaboy River, looking west

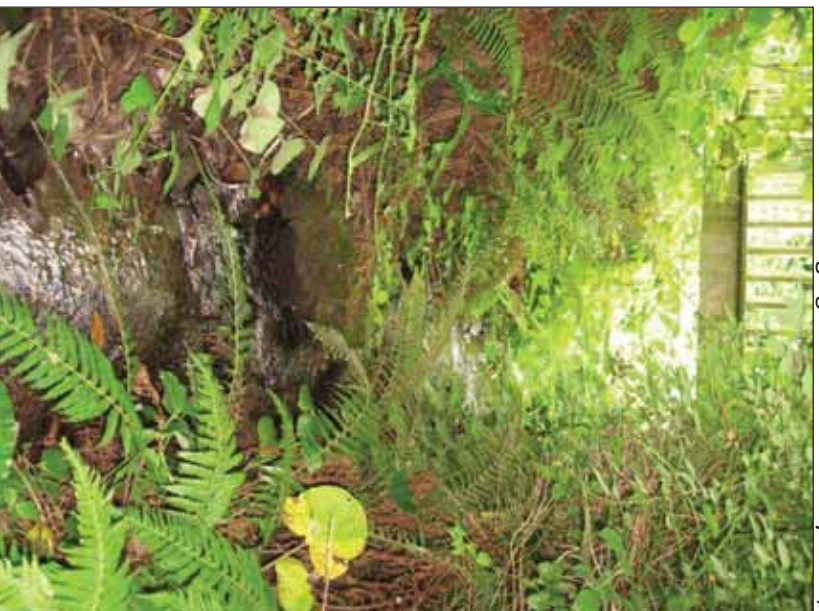
The watercourse runs in an earth-cut, L-shaped channel around the southern and eastern sides of Sallybrook House and drains into the eastern side of the Glashaboy River approximately 20m southwest of the house. It is crossed by a modern timber foot-bridge which provides access to the house. The channel begins to the northeast of Sallybrook House where it emerges from a culvert running through the Pat O'Donnell & Co. property. It is culverted through all of this property except for a small open section of approximately 5m at the northeast where it emerges from under the R639 road into the Pat O'Donnell & Co property.

Plate 4: Unnamed channel showing bridge to Sallybrook House, looking northeast

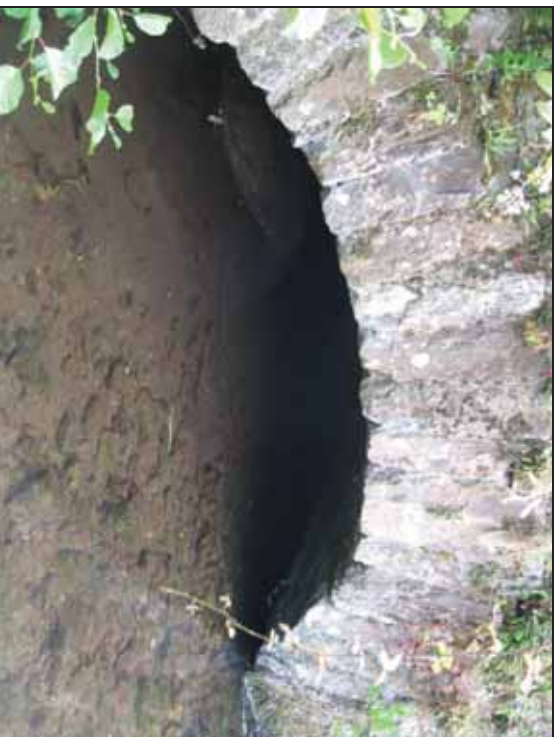
Plate 6: Eastern culvert opening, north-facing elevation

- 5.4 Works to the Glenmore Stream will comprise the replacement of the three existing culverts (two of concrete and one of random rubble) and construction of a single new larger one. Work will comprise excavation, temporary diversion of the stream and road re-grading to tie the new road over the new culvert back into the existing road levels. These works will impact the weir which is located between the culverts. The weir and the random rubble culvert date, probably, to the construction of the adjoining Brooklodge Grove Road at the turn of the 20th century. It is recommended that the weir and random rubble culvert will be recorded prior to works commencing at this location.

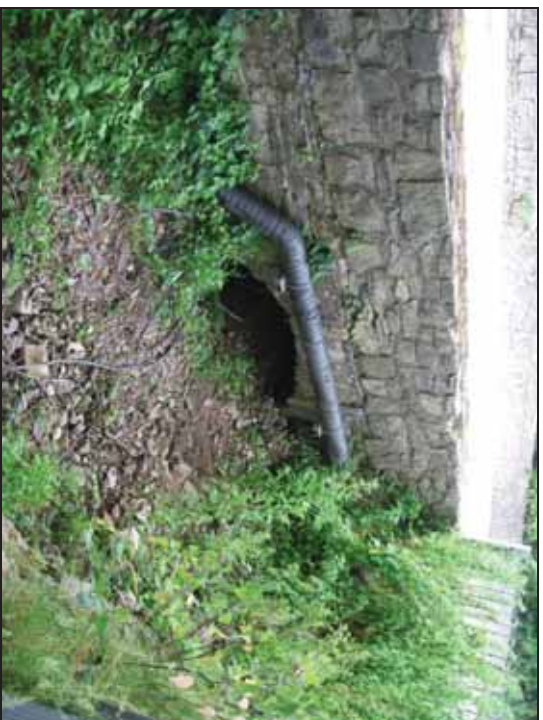
Plate 7: Eastern culvert opening, showing dry south-facing elevation

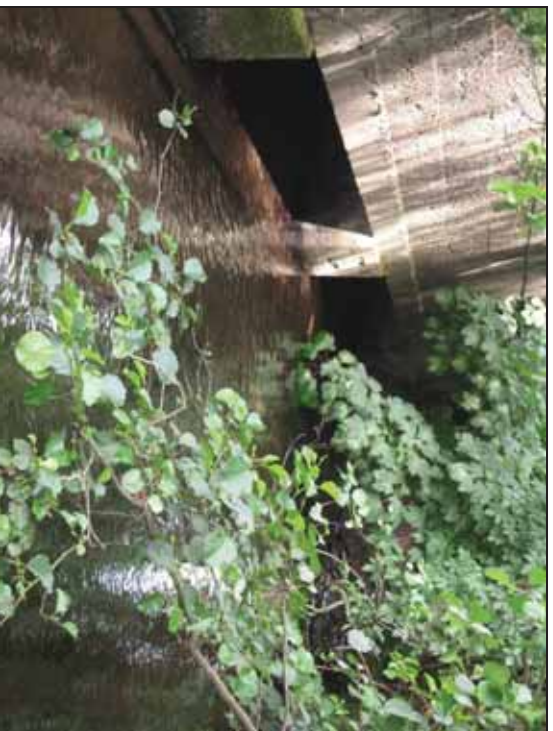
Plate 8: Western culvert opening, south-facing elevation

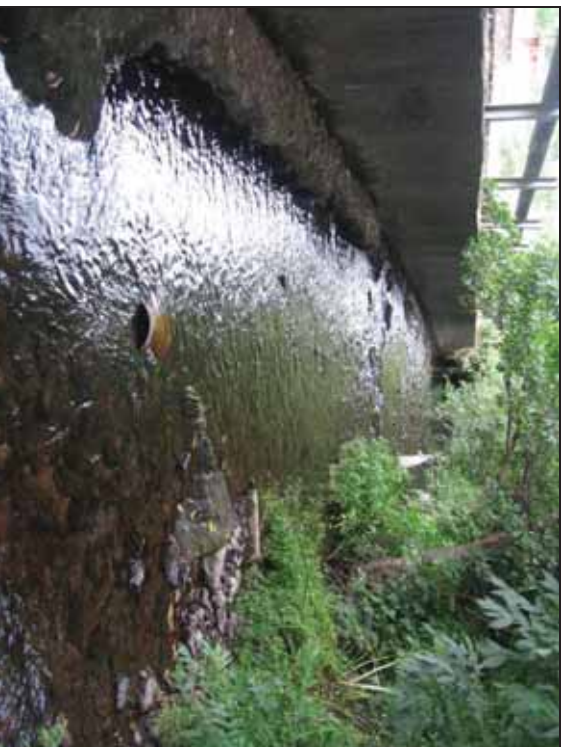
The eastern section of the stream was very clean with some modern pipes along the northern bank. The western section contained some modern rubbish including metal pipes and plastic rubbish. No archaeological features or finds were noted.

Plate 9: Glenmore Stream western section, looking east

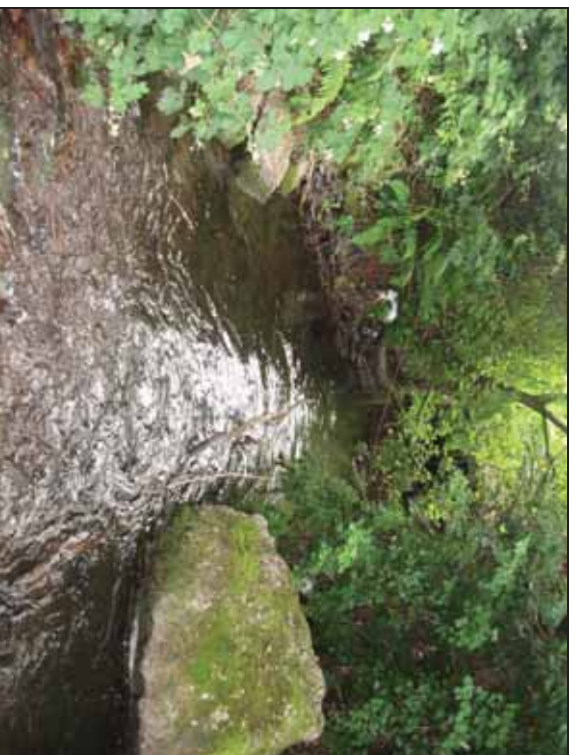
Plate 10: Glenmore Stream western section, looking west

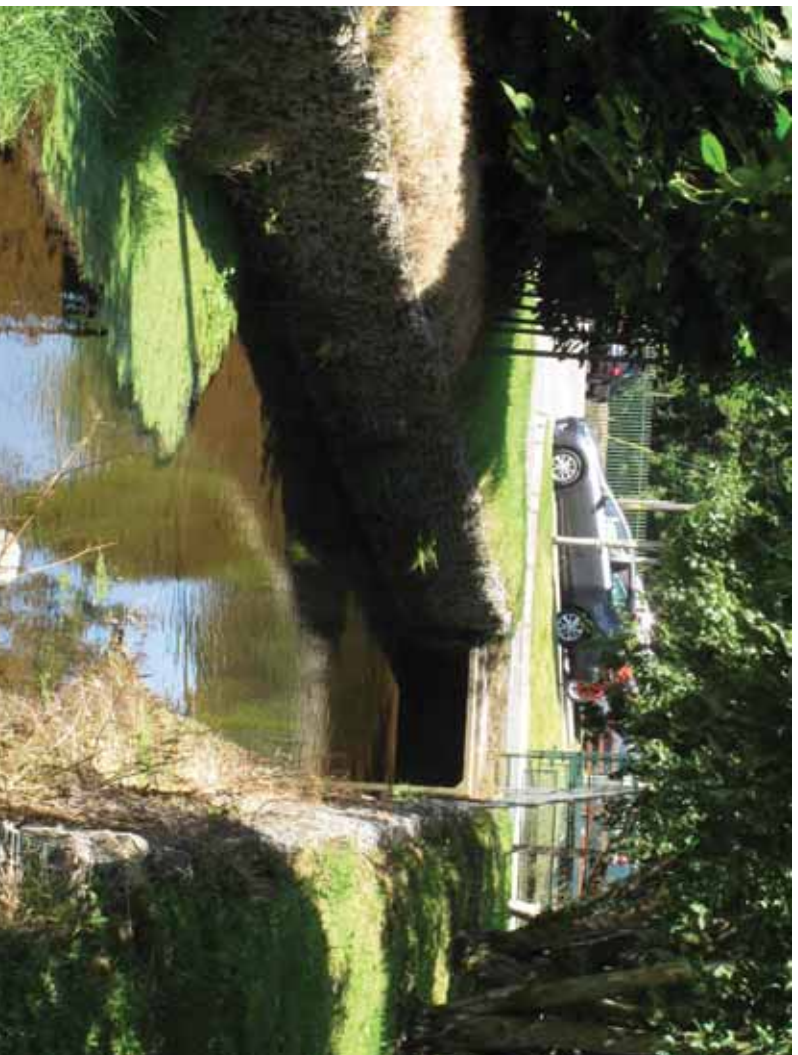
The banks/ side walls of the mill race have been significantly modified (Fig. 4,7 & 8; Plate 23). It now consists of gabion walls with boulders at the SE end. The original banks appear to have been removed or may be concealed behind the gabion walls.

Plate 23: View of CHS 07 head race Pike Mill, taken from northwest.

No mitigation required.

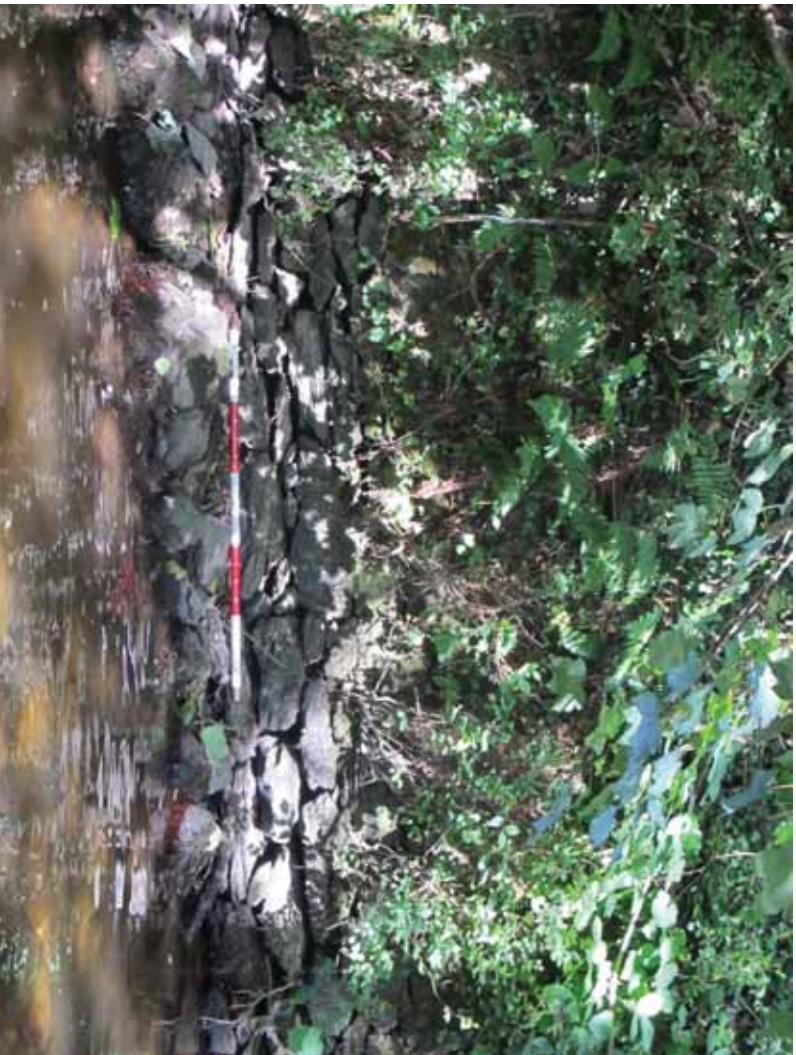
A riverbank revetment wall extends along most of Survey Area 3 (Fig. 9) albeit with sections missing in places exposing an earthen bank. In other sections it is replaced in an *ad hoc* fashion with various modern wall types including gabion walls, concrete walls or simply revetted with railway sleepers. It is of random rubble construction. An average height of 1.7m was recorded. At the northern limits of the survey a section of stone paving measuring 7.4m x 1.0m is present at the base of the wall (Plate 24 & 25).

Plate 25: View of CHS 08, revetment wall taken from west.

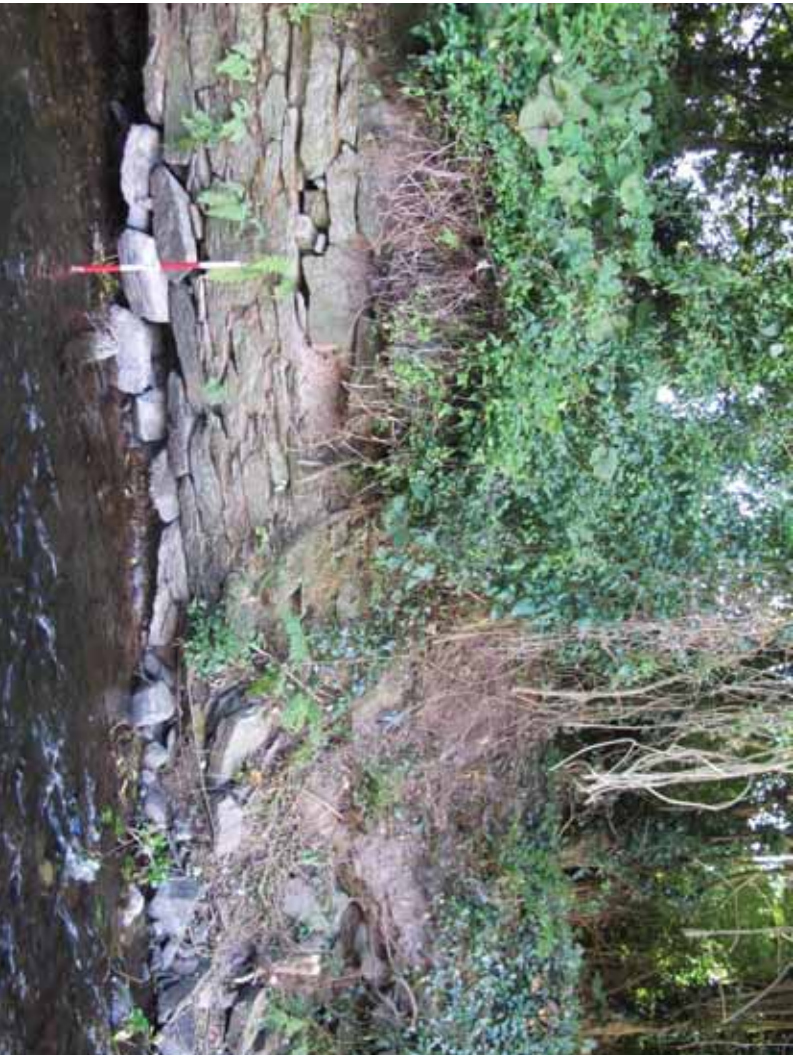
Three sections of the revetment wall on the western bank survive within the study area. The wall is constructed of uncoursed rubble sandstone (Plate 29). It has a max. height of 1.5m. It is in a poor state of preservation with outward bulging and a scour of up to 0.4m noted beneath the wall.

Plate 29: View of CHS 09, taken from north.

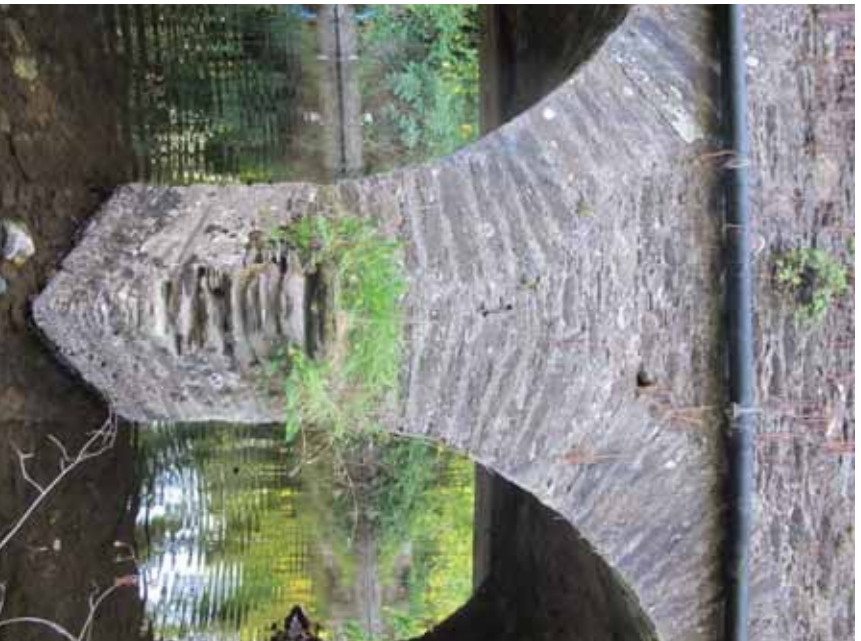
No foundations were visible at the base of the piers. The piers are protected on both elevations by rubble-stone pointed cutwaters projecting outwards by 0.9m, and 1.15m in height. The cutwaters are damaged as a result of erosion and vegetation. The modern concrete extension to facilitate a footpath has damaged the bridge and conceals much of the northern elevation. The parapet has vertically set coping.

Plate 38: View of CHS 12, bridge, cutwater on downstream elevation.

- Licensed archaeological monitoring should be undertaken by an experienced underwater archaeologist with regard to the proposed construction works C01-L05 & C01_L06.
- Mitigation by licensed archaeological testing in advance of construction should be undertaken with regard to all proposed works within the ZON associated with Riverstown Bridge a recorded monument and a recorded protected structure, including: - C0_L06; C01-L07; C01_P01; C01_R02; C01_C03 & C01_C04.
- The recorded protected structure Riverstown Bridge should be fully surveyed archaeologically in advance of construction works.

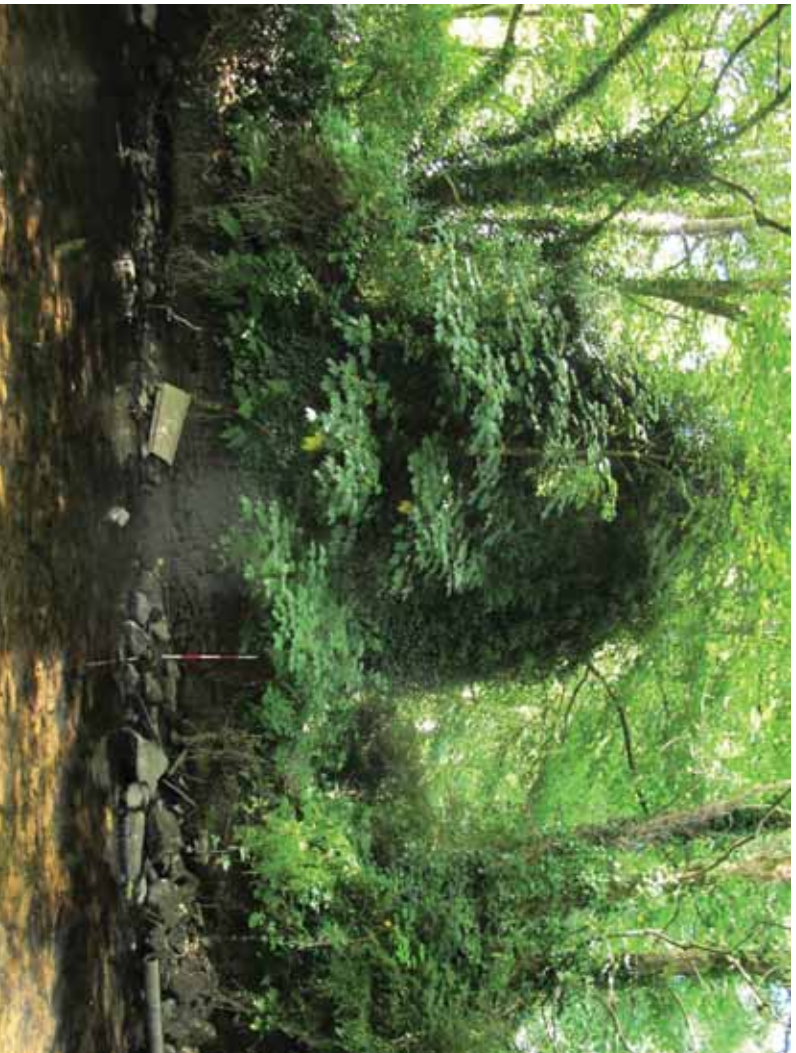
A second 2.5m high random rubble stone revetment wall with mortar bonding extends beyond the limit of Survey Area 5 in each direction. The wall is collapsed in sections and damaged by tree root action and erosion. The gable end of a relict extant structure abuts the western riverbank (Fig. 15, Plate 44). It is denoted on all editions of the OS maps. Concrete repairs and underpinning works are visible along this section of the revetment wall which is adjacent to the R639 roadway.

Plate 44: View of CHS 15, revetment wall, taken from southeast.

Licensed archaeological monitoring should be undertaken by an experienced underwater archaeologist with regard to the proposed construction works C01_L08 & C01-P02.

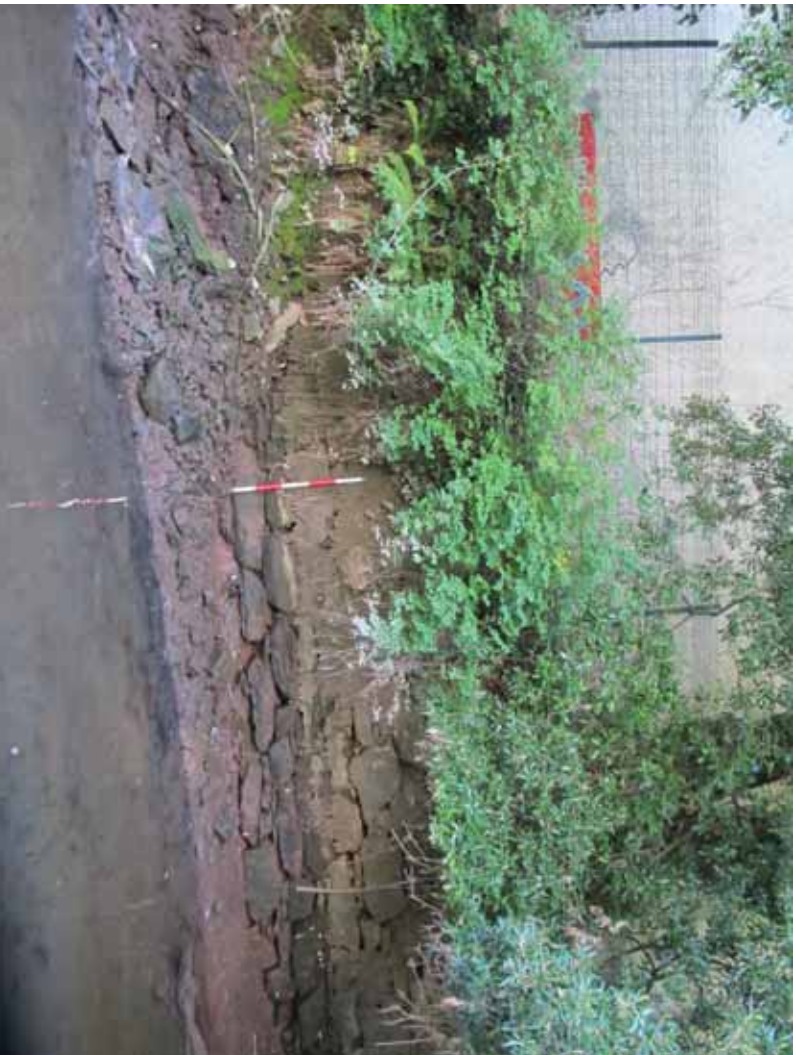
A revetment wall extends along the western bank for the majority of Survey Area 6 (Fig. 18, Plate 45). It is a roughly coursed sandstone wall, measuring up to 2.0m in height (Plate 45). The wall is constructed of large stones, the basal courses of which measure on average 0.5m x 0.3m. The mortar has been largely washed out.

Plate 45: View of CHS 16, revetment wall, taken from east.

No mitigation required.

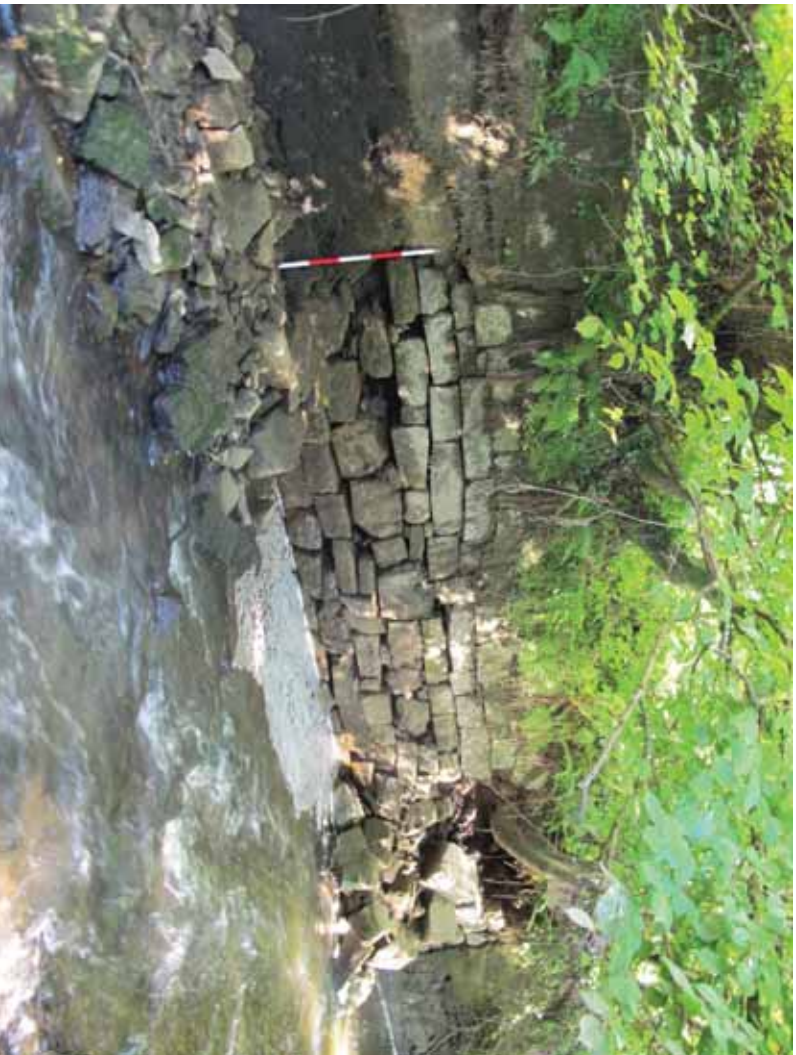
A revetment wall is visible on the east bank between the mill building and the tail race (Fig. 18, Plate 46). Due to an accumulation of sediment and dense vegetation it was not possible to examine the northern limits of this wall. It is possible that the wall continues further upstream concealed behind collapsed bank material. The wall is a substantial structure measuring up to 3.0m in height. It is constructed of dressed limestone blocks measuring from 0.30m x 0.30m up to 1m x 0.6m. Mortar bonding is visible in places. Tree root damage is particularly noticeable resulting in portions of the wall having completely collapsed as a result (plate 47 & 48). Three sections of the wall, measuring between 3.8 and 4.5m in width have been repaired with concrete.

Plate 47: View of CHS 17, revetment wall, taken from northwest.

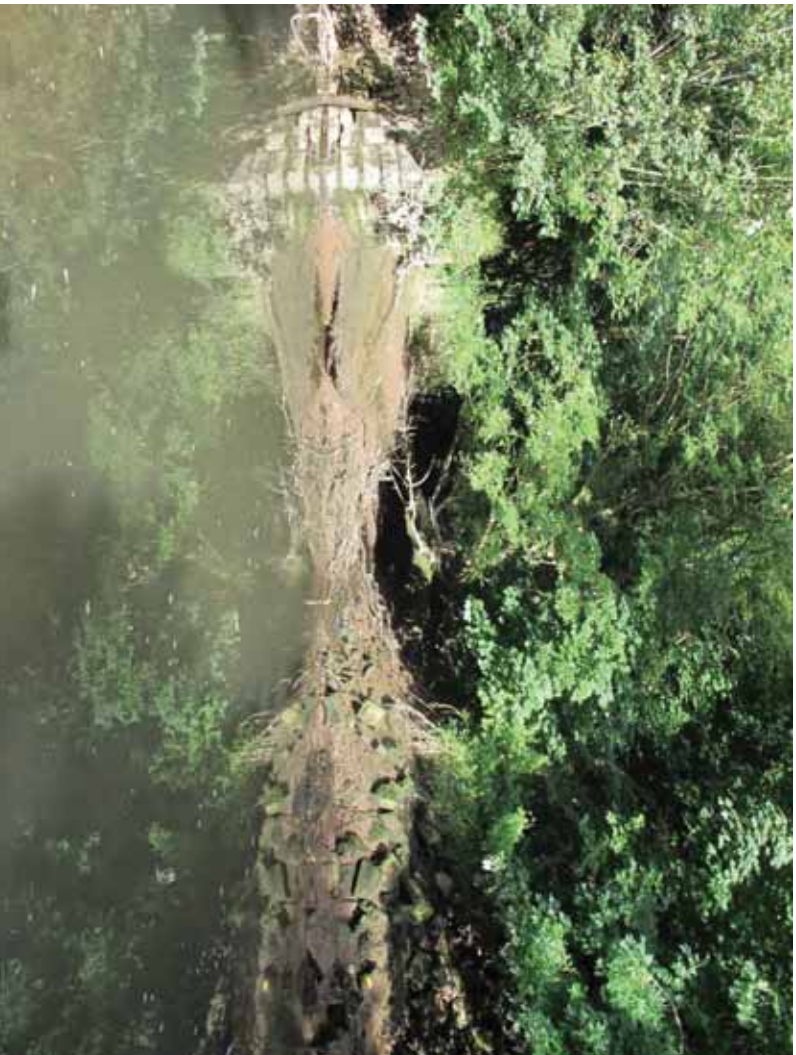
The tailrace for the Fountains Mill discharges into the river on a bend at the end of revetment wall CHS 17 (plate 49). The original exit point for the tailrace has been modified. A concrete slip supports /abouts the end of the revetment wall. The current concrete slip structure is most likely a replacement of an earlier 19th century slip. A Boat House shown on the 2nd Edition OS map, may have served the mill and indeed a nearby recorded Limekiln, CO075-002002. The south-eastern bank of the race has collapsed and now consists of mud with a large quantity of tumbled stone of which some are dressed limestone (Plate 50).

Plate 49: View of CHS 18, tailrace, taken from west.
