Monthly Environmental Audit – Sept 2025

Glanmire Flood Relief Scheme

01/09/25 to 30/09/25

ENVIRONMENTAL AUDIT

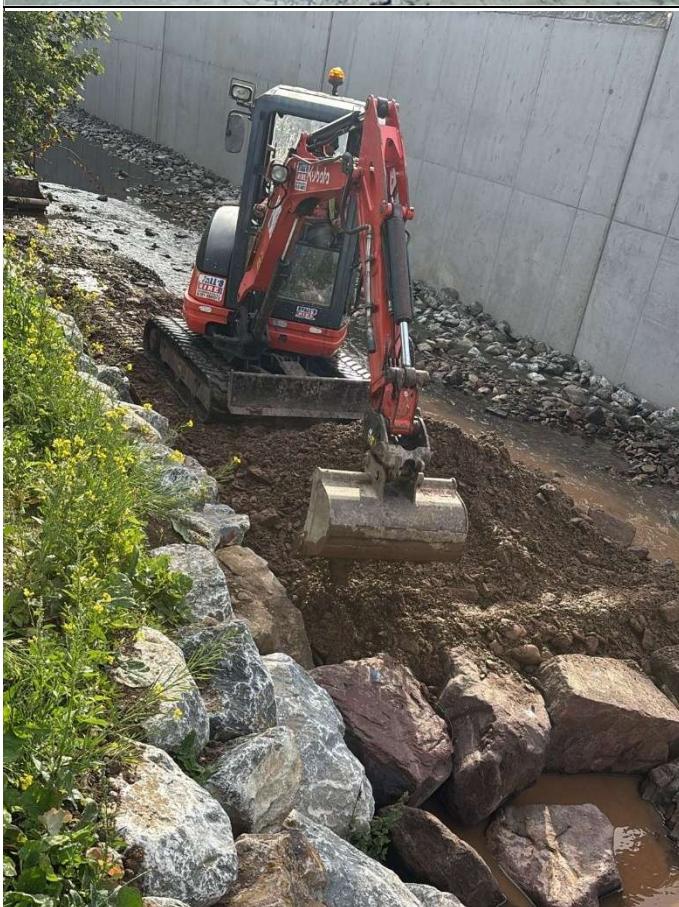
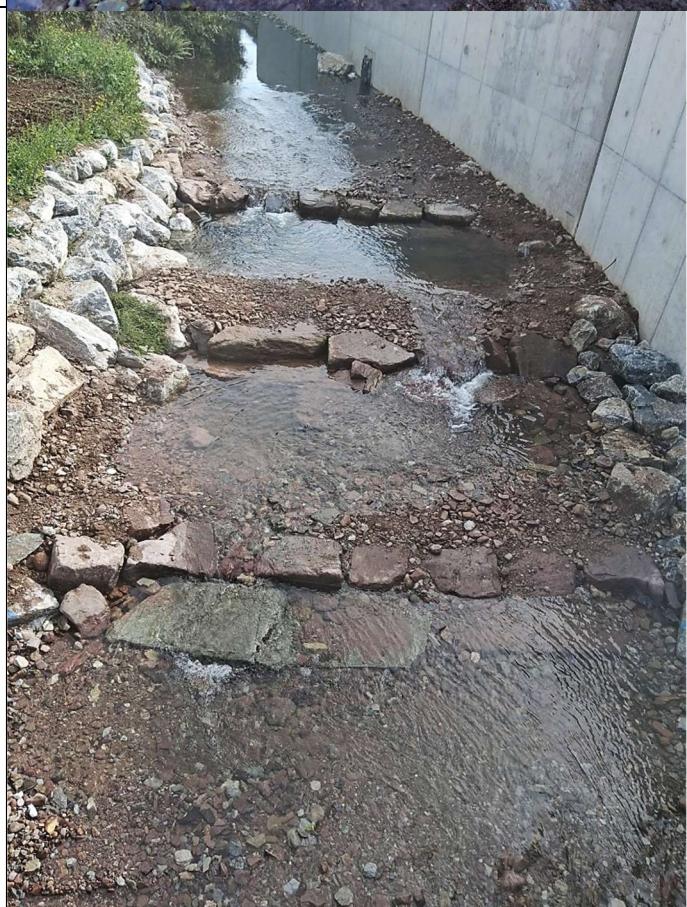
**Caption 3 New Line**

Additional river gravels, removed from the cofferdam of the eastern abutment of Hazelwood Shopping Centre Bridge, were added to the Step Pool Arrangement at New Line

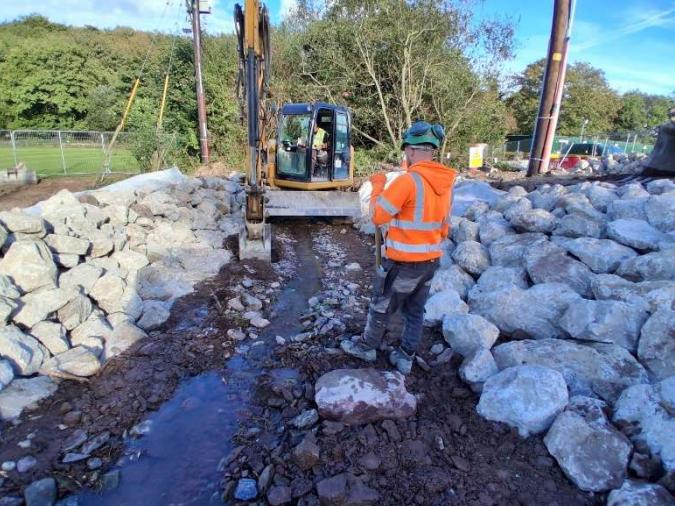
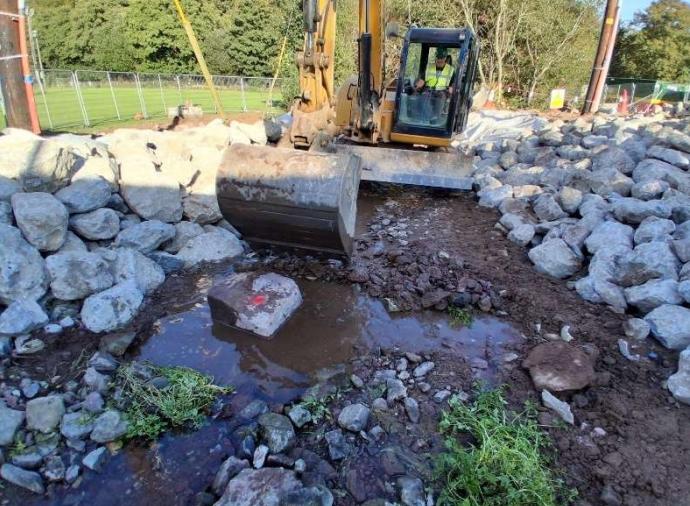
Caption 15 Cois na Gleann	Caption 16 Cois na Gleann

Installation of rock armouring at Cois na Gleann Stream. 4 no. Old Red Sandstone flagstones were also installed to improve the habitat for Dippers

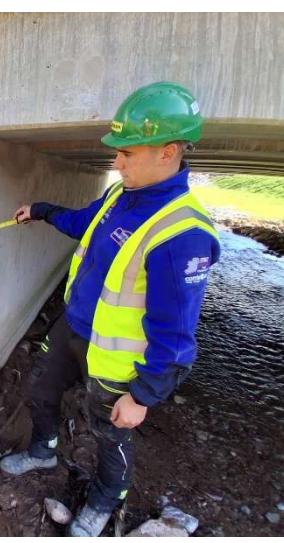
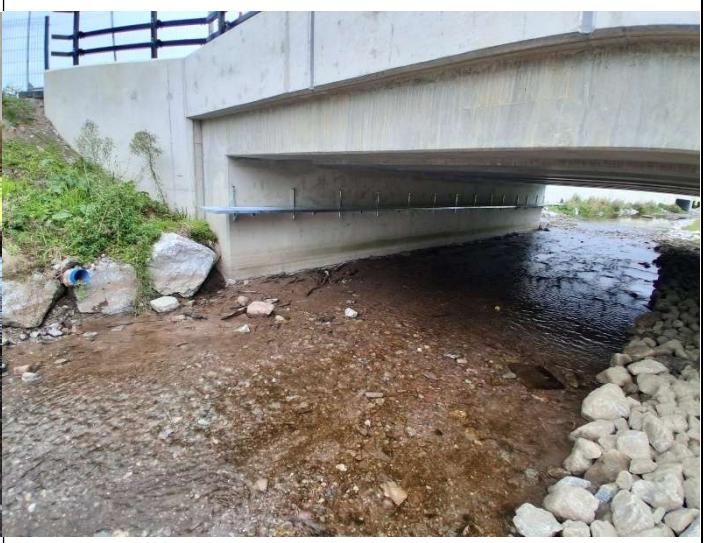
Caption 22

Advanced survey to design localised tie-ins for Otter ledges. Otter prints observed beneath Copper Valley Vue Culvert during the survey
