Cavan Town Flood Relief Scheme

Flood Report - October 2022

Cavan County Council

Report No. W3673-BLP-R-W-003 15 August 2023 Revision 02

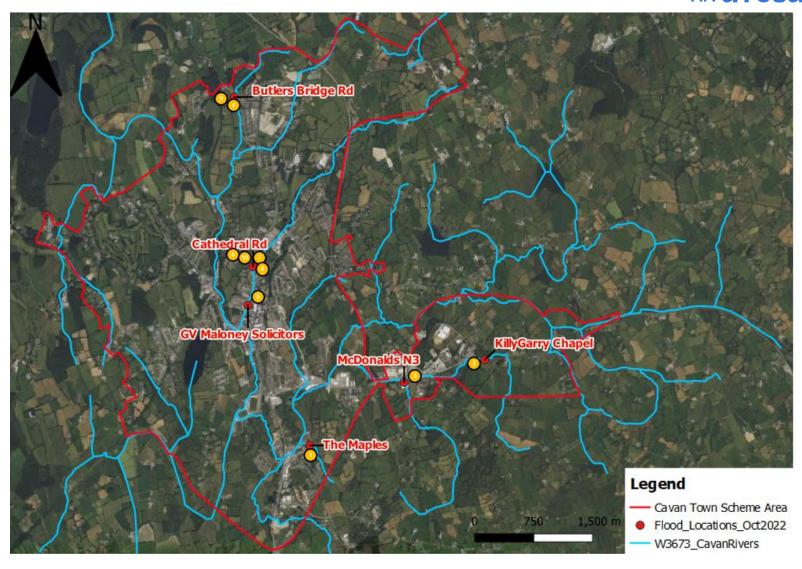
Figure 1-1 - Reported Flood Locations

This report provides commentary on the significant flood events that were recorded and whilst there has been no media capture of flooding at a minor number of sites (Reference Numbers 6 and 7); the report provides a complete compilation of locations in which significant flooding occurred.

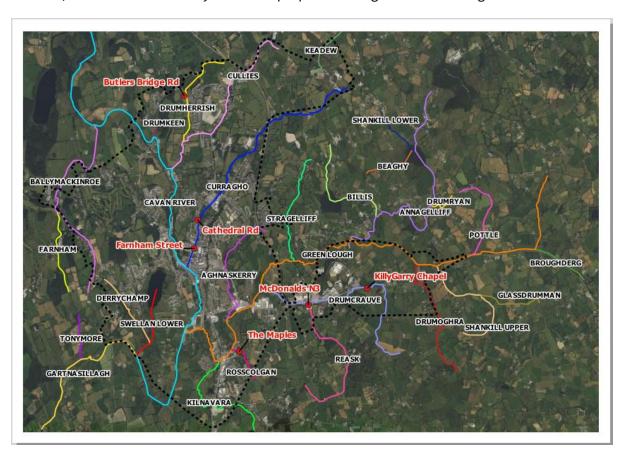
Figure 1-2 - Cavan River Tributaries

Cavan Town has numerous tributaries which amalgamate to form the Cavan River which eventually flows North as shown in Figure 1-2. During a flood event, the tributaries of the Cavan River overflow their banks after heavy rain due to narrow underground and surface channels within the river network, which results in nearby roads and properties being liable to flooding.

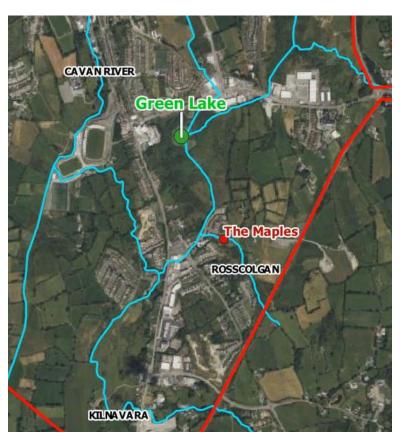
Figure 2-1 - Location of The Maples Housing Estate

The Maples housing estate in Cavan Town is situated above the River Rosscolgan and downstream of Green Lake, within the Cavan Town FRS Scheme Area, see Figure 2-1. Heavy rain causes Green Lake water levels to rise significantly. The Maples housing estate is directly affected by the annual flooding of Rosscolgan River. The homes lie below road level and after heavy downpours excessive water accumulated in driveways and conveyed into the houses of The Maples.

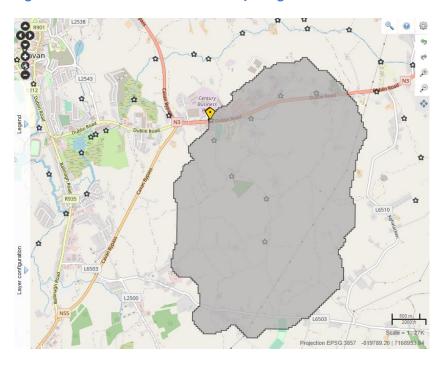
Figure 2-15 - Catchment Profile at McDonalds/Service Station

The service station and McDonalds are situated where the Reask River is culverted to join the Drumcrauve River (Figure 2-14). The associated catchment for the Reask (Figure 2-15), may be capturing extra surface water drainage from the N55 and commercial development, exceeding the culverts capacity capability, possibly causing the overspill at the entrance to the culvert. Assessing capacity, drainage profile and behaviour in due course could verify that the culvert is undersized. In order to expand the culverts diameter to increase flow of water, evaluations are to be conducted to mitigate flooding occurring on the forecourt without resulting in flooding at the confluence of the Reask and Drumcrauve River.

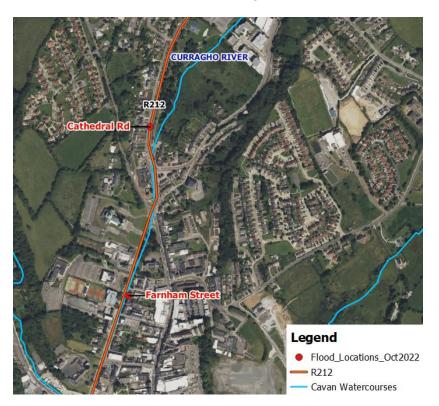
Figure 2-17 - R212 Flooding Locations

The R212 in Cavan Town flooded in two locations on October 28th, 2022. The regional road is directly affected by the Curragho River that runs parallel to this road. The watercourse is culverted under Cathedral Road and Farnham Street (Figure 2-17).

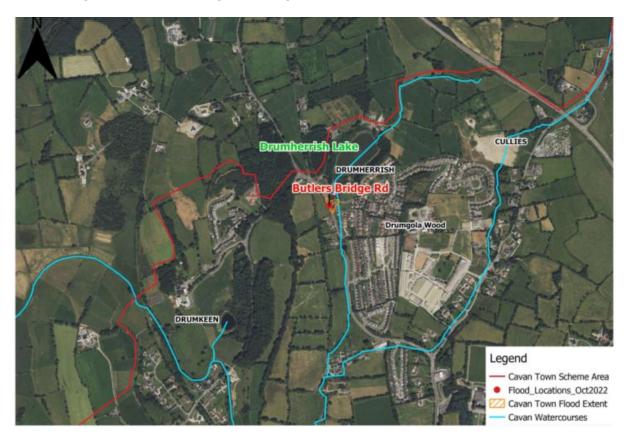
Figure 2-20 - Butlersbridge Road - Road Location

Butlersbridge Road is a road located in the Northern region of the Cavan Town scheme area, Figure 2-20. The Drumherrish River is the main nearby watercourse that has been susceptible to overtopping of its banks, resulting in flooding.

It was noted that the flooding occurred from heavy rain during the storm event that took place on 28th October 2022. This storm event resulted in the nearby roads and the entrance to the Drumgola Wood housing estate being restricted with water because of the flooding. A flood depth of 300mm was estimated from data supplied by Cavan County Council and Drumgola Wood housing estate was temporarily cut off from access due to this flood event. There was a restriction in access to the Drumgola Road as a result of this flood event.

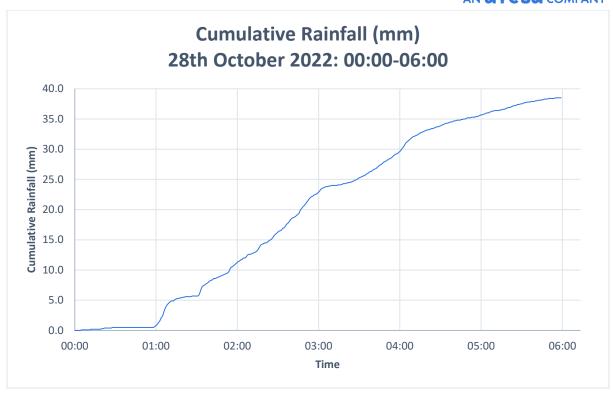
Figure 3-1 - Graph illustrating cumulative rainfall during storm event.

The cumulative rainfall that was recorded within the 6-hour storm period was 38.5mm. Figure 3-1 illustrates the build-up of cumulative rainfall over this 6-hour period.

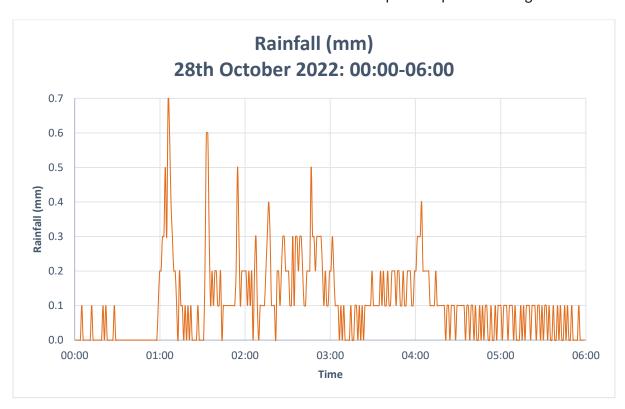
Figure 3-2 - Graph illustrating rainfall during storm event.

A breakdown of the rainfall measurements across the 6-hour period is provided in Figure 3-2.

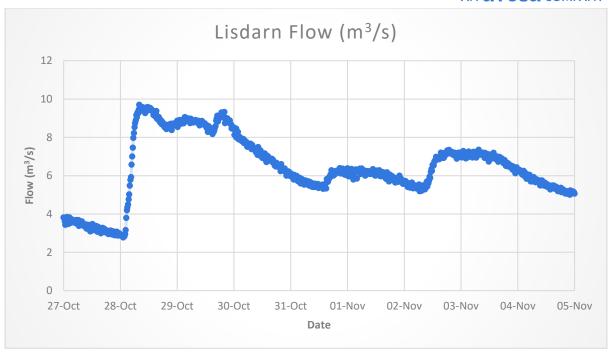
Figure 4-1 - Flow Values at Lisdarn during 9-day period

Flow recordings were extracted from a 9-day period from 27th October 00:00 until 5th November 00:00 and evaluated. The flow values for the entire 9-day period are represented in Figure 4-1 below.

The lead time from the rainfall event on the 28^{th} of October 00:00 - 06:00 to the time of the peak flow recording lasted several hours, which demonstrated a significant influence from rainfall to the flow recordings. The flow recordings start to significantly increase from 02:00 on 28/10/2022 from a flow value of 2.96 m³/s to the peak flow of 9.70 m³/s at 08:00 on 28/10/2022; a six-hour period.

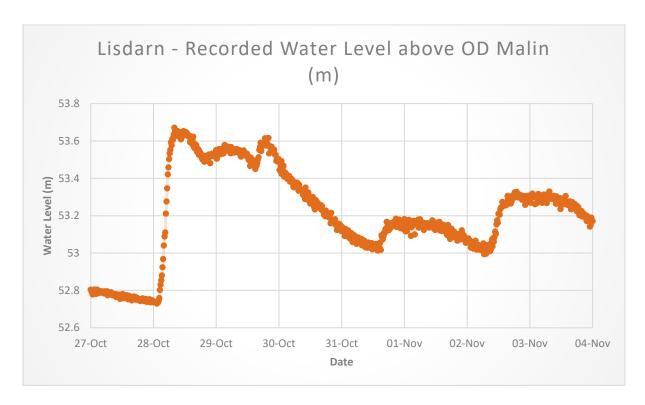
Figure 4-2 - Water Level Values at Lisdarn during 9-day period

The water level recordings were extracted from a nine-day period from 27th October 00:00 until 5th November 00:00. The highest water level recorded was 53.671mOD Malin. The water level values for the entire 9-day period are shown in Figure 4-2 below.

Upon comparison of the recorded peak water level value with the design water levels in Table 4-3, the peak water level is in between the 20% and 10% AEP event. The equivalent return period corresponds to a 1 in 5-year and 1 in 10-year period.

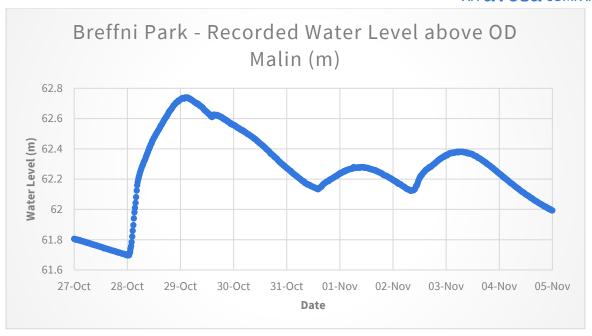
Figure 4-3 - Water Level Values at Breffni Park during 9-day period

The gauge at Breffni Park provides water level readings. The water level recordings were extracted from a 9-day period from 27th October 00:00 until 5th November 00:00. The highest water level recorded was 62.739mOD Malin on 29/10/2022 at 02:15, as shown in Figure 4-3. The time taken to increase to the peak water level was of a much longer duration at Breffni Park; rising from 61.697mOD Malin on 27th October at 23:45 to the peak water level of 62.739mOD Malin on 29th October at 02:15; an increase of 1.042m in water levels over a period of 26.5 hours.

The results illustrate a much greater lead time from the rainfall event on the 28th of October 00:00 – 06:00 until the peak flow which is approximately 24 hours after the rainfall event. The time taken to increase from its base water level to the respective peak water level is relatively long; approximately a 24-hour period. This may indicate that areas downstream of Breffni Park are a major contributing source to peak flows at Lisdarn gauging station, or that significant storage is occurring upstream of Breffni Park. This will become apparent during the hydraulics modelling and calibration.
