Environmental Report October 2025

Glashaboy Flood Relief Scheme

Document code: FFEC-GFRS-2025-010

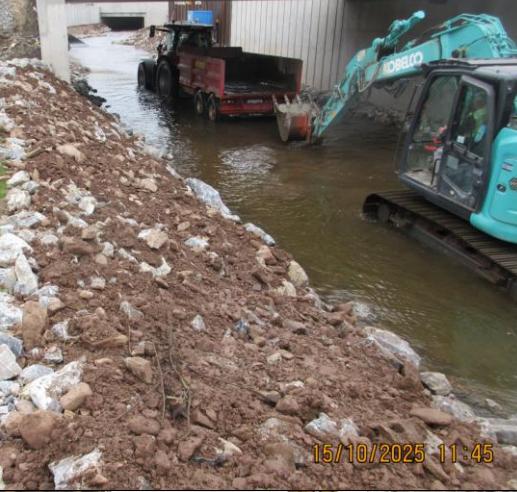
10.13	15/10/2025	<p>Additional coir mesh was installed downstream of the Hazelwood Road bridge overflow culvert to act as a matting layer over the soil while vegetation becomes established.</p>

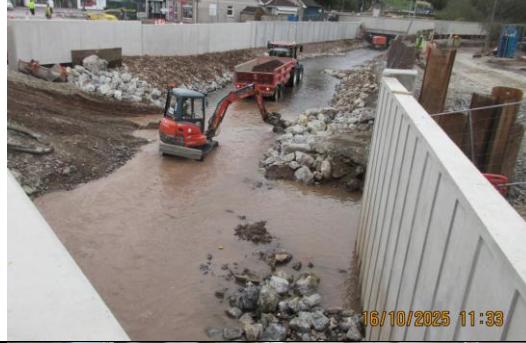
10.17	16/10/2025	Sheetpiles around the remaining cofferdam at Hazelwood Shopping Centre Bridge were removed which required an excavator with the movax attachment to work from within the river.

A photograph showing a blue generator unit with a black hose connected to it, situated on a rocky riverbank. Behind the generator is a vertical sheetpile wall. The timestamp '15/10/2025 11:42' is in the bottom right corner of the image.	Works were partially supervised and river parameters monitored throughout the works.	Sheet pile removal was carried out successfully with minimum disturbance to the river and minor siltation.

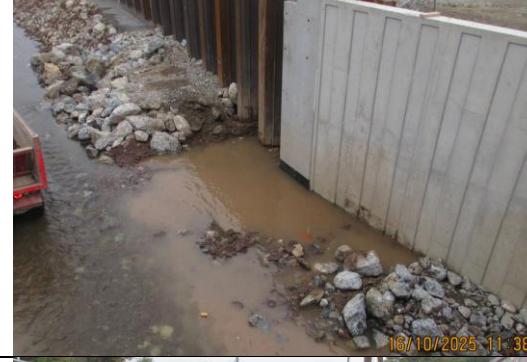
10.18	16/10/2025	It was noted during a site inspection that rock around at Cois na Gleann (CNG) has not received river gravels.
