E Flow Monitoring Survey Report

Blackpool Culvert Flow Survey 2014/2015

Blackpool Culvert Flow and Level Survey 2014 / 2015 – General Report

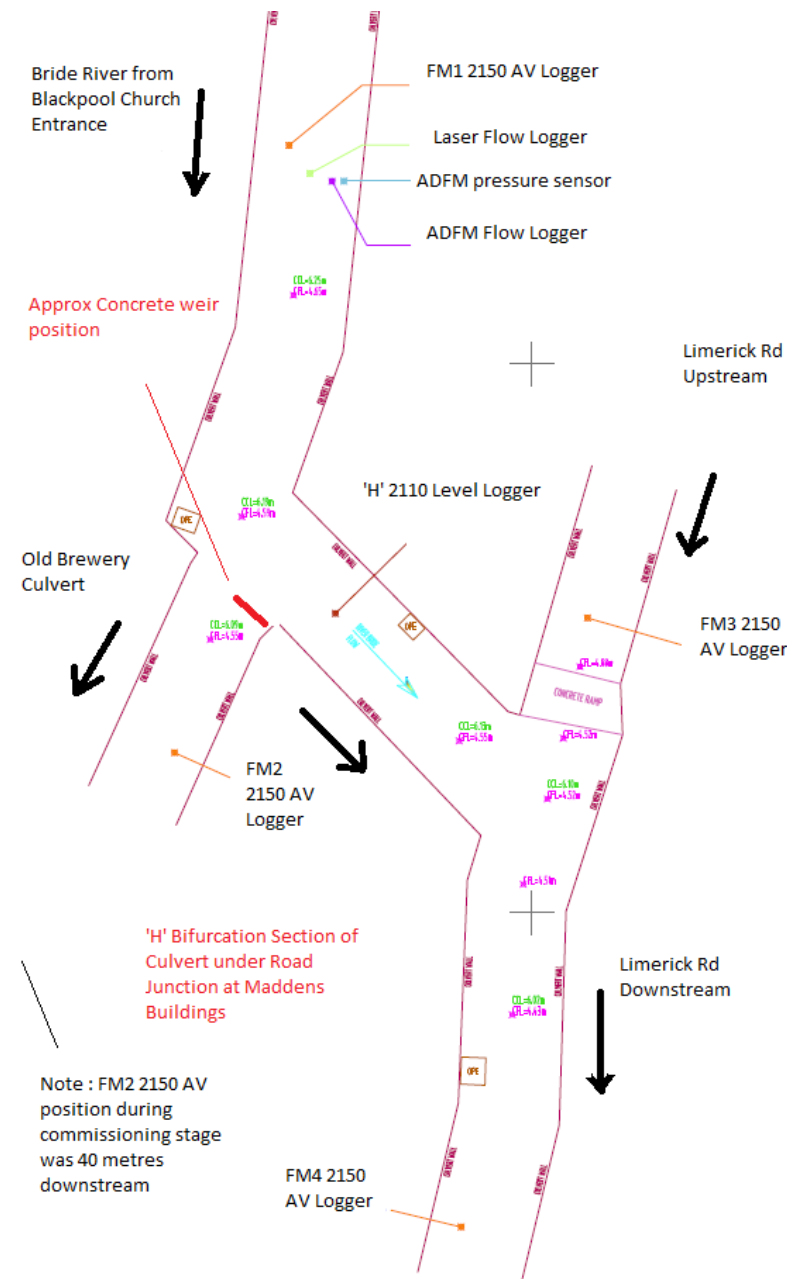
Fig 2: Location of all loggers in 4 culvert channels at Bifurcation.

Fig 2 shows both the type and location of each logger at the bifurcation. Some equipment such as the ADFM flow profiler and pressure sensor were installed temporarily while the 2150 loggers were installed for the duration of the survey.

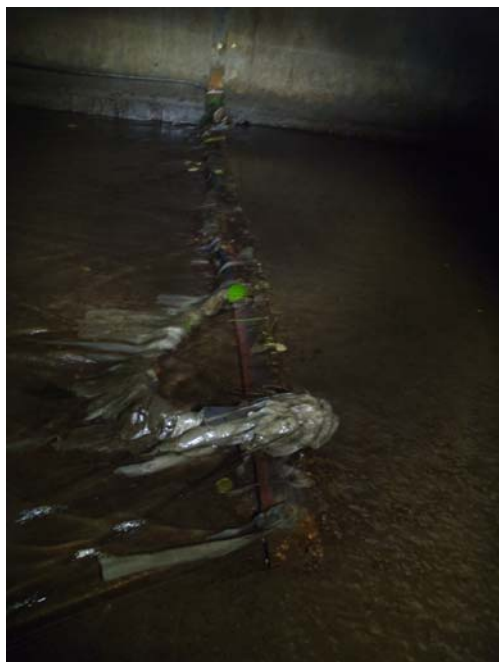
Fig 23: Ragging of AV probes was a common problem.

Fig 23 above taken at FM1 in low level shows how this ragging could completely block any meaningful velocity data. The ragging and debris was also creating errors with level measurement by creating localised small standing waves at the locations of the probes. This issue was most problematic at probe locations FM1 and FM4. This issue could have potentially stopped the survey proceeding beyond the initial test period. It was decided however that with more frequent entries to clean the probes, and with proper data management that the survey should proceed. The introduction of the Laser Flow Logger in August and additional ultrasonic level monitor at FM4 and FM2 in October did provide good data. In general the ragging issue became more manageable from November 2014 to February 2015, when the flows were higher.

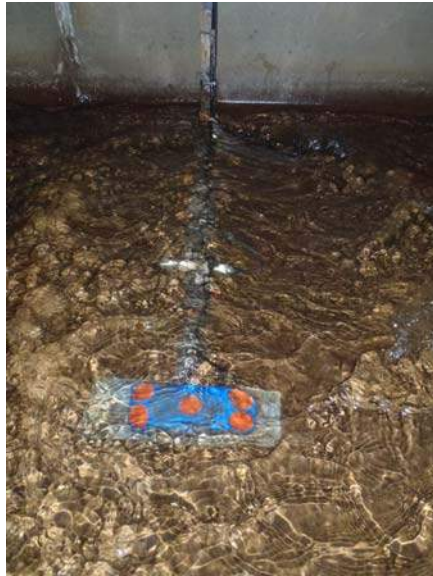
Fig 25: Isco Pro 20 ADFM probes at FM1.

1 X Isco Pro 20 ADFM Velocity Profiler was included as part of the kit to provide data which could validate the 2150 AV loggers during rain events. The ADFM profiler has a general overall accuracy specification of 2% of measurement. However ADFM measurements only start above water levels of 0.2m, (4.88 M OD), thus, very little data was collected. The ADFM profiler was initially only to be made available for a month, but it subsequently was left in place between the middle of April and end of September 2014. The ADFM was installed at FM1 site adjacent to the 2150 logger

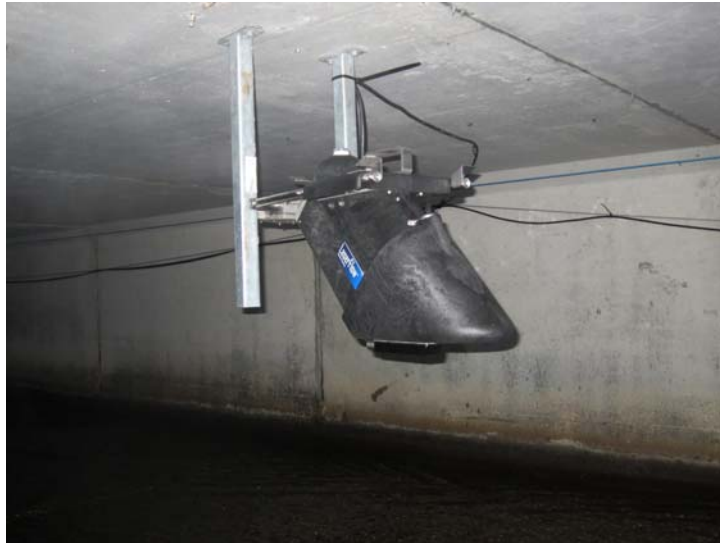
Fig 27: Isco 2160 Laser Flow Logger at FM1 .

The laser logger is a new ISCO product and became available in mid July. Due to the fact that the Laser measures velocity in a non- contact manner, thus eliminating the issue of ragging, we were anxious to acquire and deploy this device at the first possible opportunity. One Laser logger was installed on the 27th July at the same location as the FM1 2150 AV logger, and remained in place until the completion of all logging in the culvert.

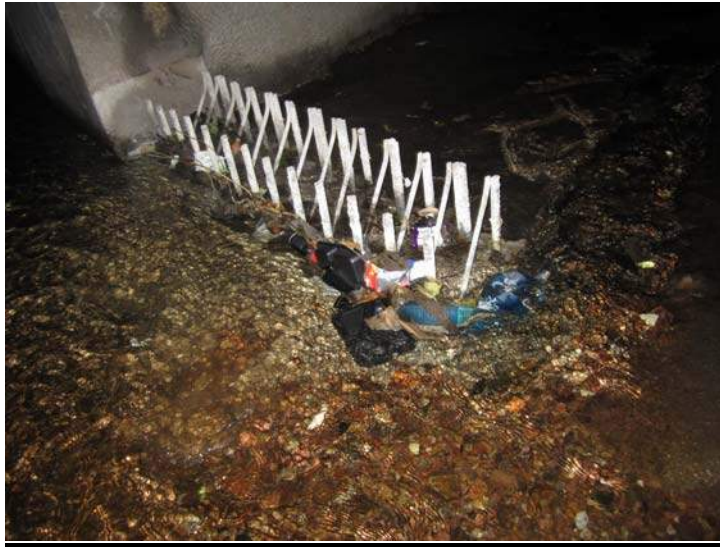
The metal reinforcement structure of the wall was not removed. Debris started catching and building up on this as seen in Fig 44.

Fig 44: Reinforcement structure left after wall was removed at entrance to Brewery Channel.

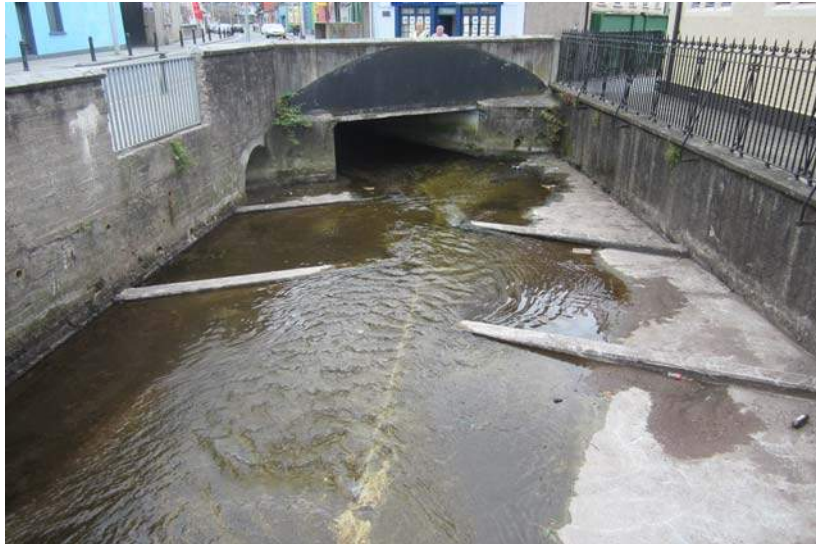
After cleaning was complete, water flowed only in the centre and road side under the bridge, as seen in the photo graph below. The water level was generally lower than before cleaning but at a higher velocity. We repositioned our level monitor under the centre of the bridge at M OD floor level 6.19 m. Only levels after cleaning relate to this M OD as the original level probe position and associated water levels may have an offset.

Fig 57: bridge at Blackpool Church after cleaning:

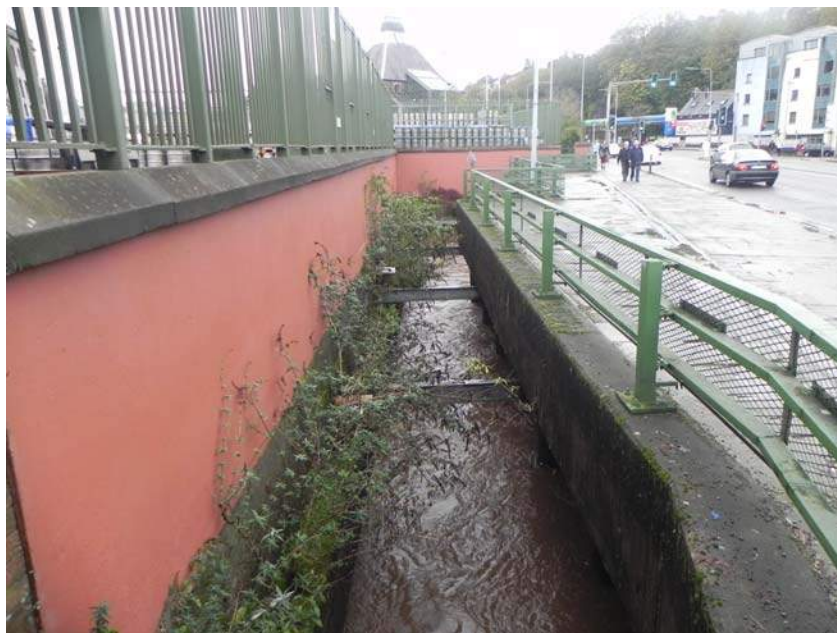
Fig 62: Flow witnessed Heineken Brewery after rain event on 14th November

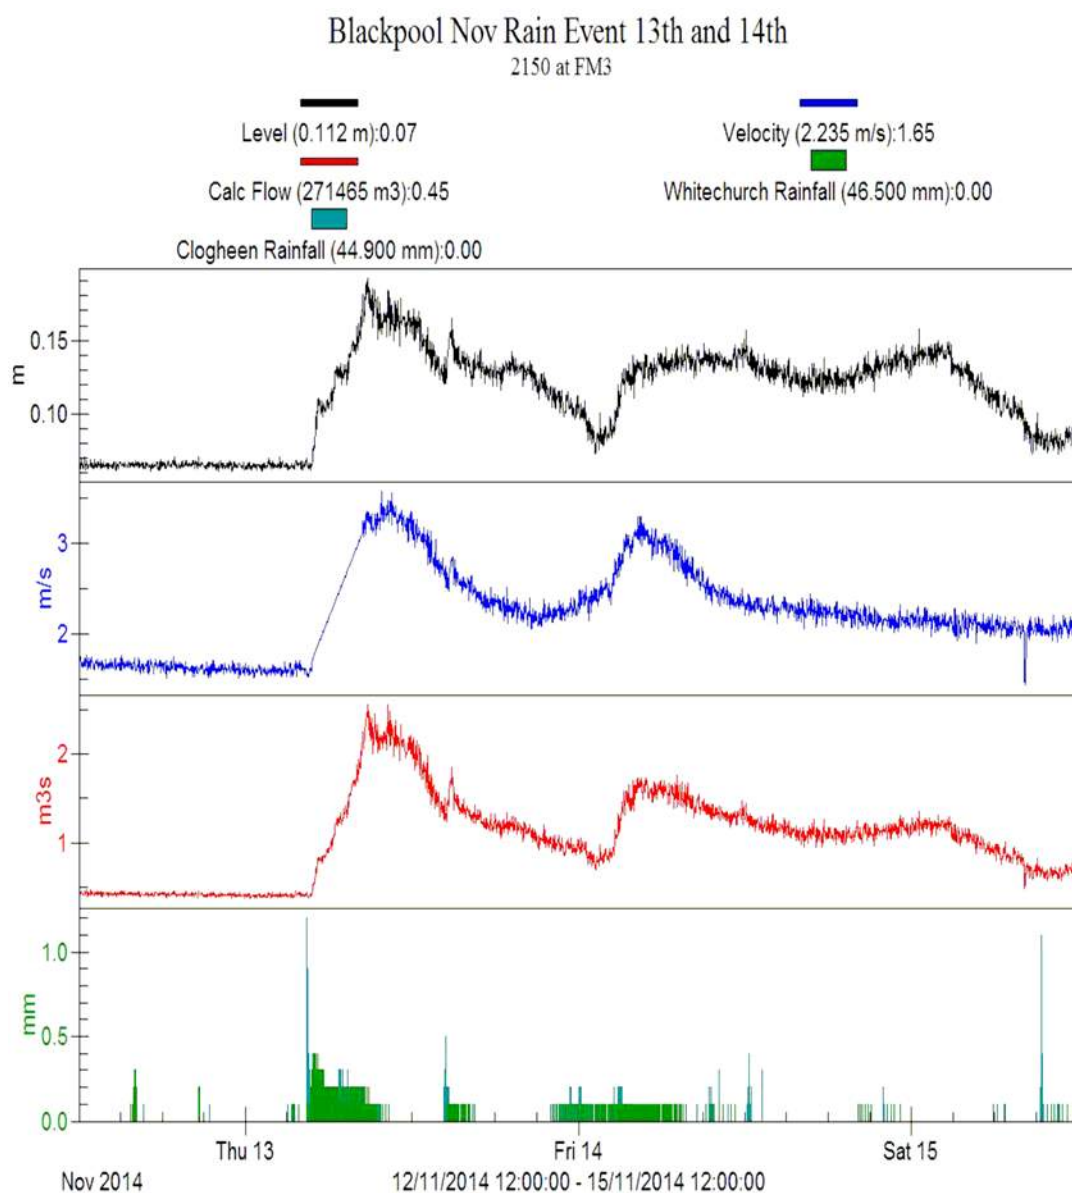
Fig 81 shows the level velocity and data logged during the rain events measured at FM3. Data at FM3 required a small amount of correction of velocity, which stopped logging for several hours due to ragging. The probe had some rags on the probe when we entered the culvert later on the 16th November which may have affected the quality of both level and velocity; in particular the level data was a bit erratic after the events. However, for the most part, the data looked good during the peaks themselves. A peak flow rate of 2.4 m³/s was recorded coinciding with a logged velocity of 3.32 m/s.

Fig 81: 2150 Flow logger Level, Velocity and Flow data during rain events at FM3

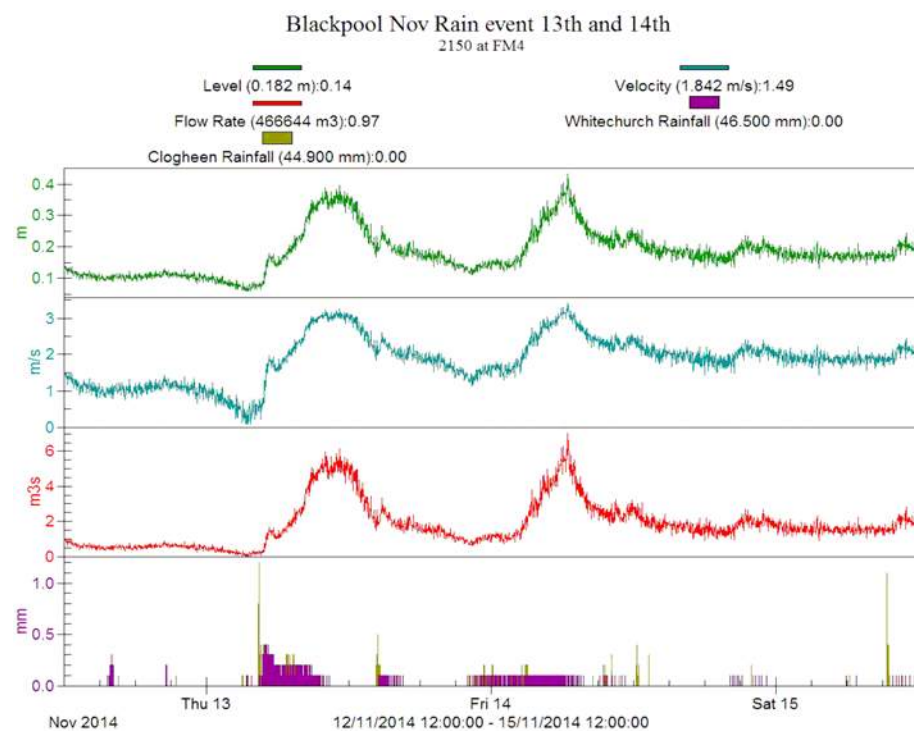
Velocity data was not usable at FM4 due to ragging shortly into the start of the first rain event, however level data was intact. Velocity data was derived as described in section 9.2. We further derived flows based on this velocity result. The resultant peak data during the first event was level 0.34 m, (4.72 M OD), derived velocity 3 m/s , derived flow rate 4.84 m³/s

Fig 82: 2150 Flow Logger at FM4 with Level and derived Velocity and Flow data

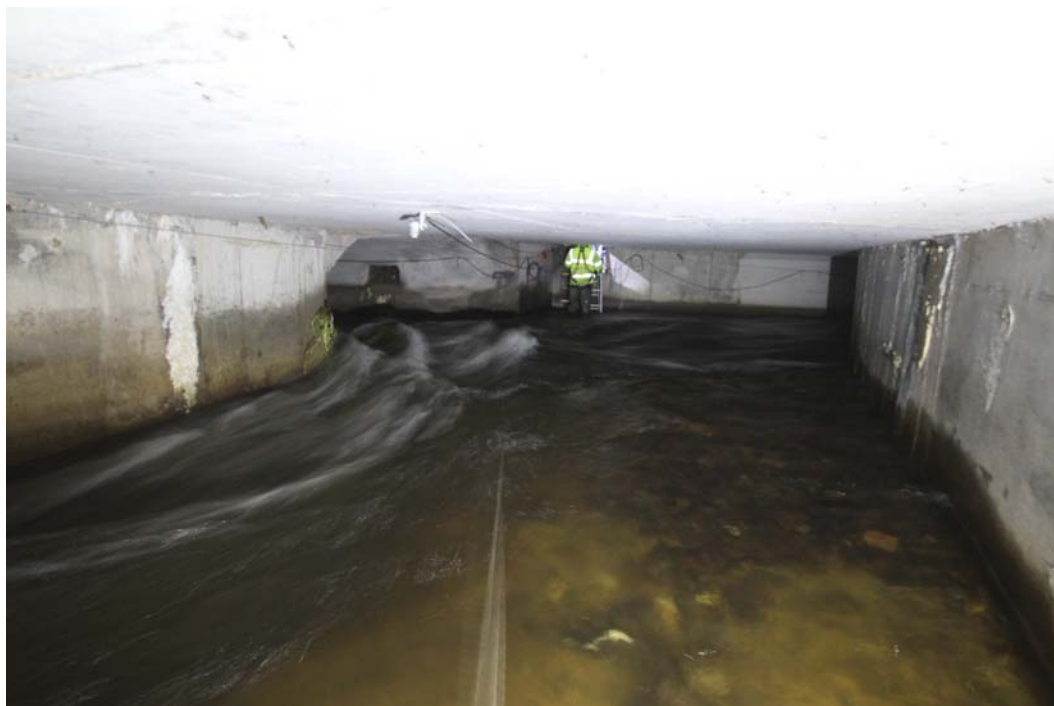
Fig 85 below shows a picture of the bifurcation looking back towards the flow going right to left from FM1 (church culvert), to FM2 , (Brewery). This picture was taken during the entry on Sunday afternoon the 16th November at 16:00 approx. At this time levels were still relatively high, with Church bridge level at 0.3 m, (6.49 M OD), with Laser level at 0.25 m, (4.93 M OD), with velocity of 2.46 m/s. The photograph would support the conclusion that the majority of the flow could have carried straight down the brewery culvert during the rain event.

Fig 85 : Photograph in Bifurcation looking at FM1 to FM2 at 16:00 on Sunday 16th November

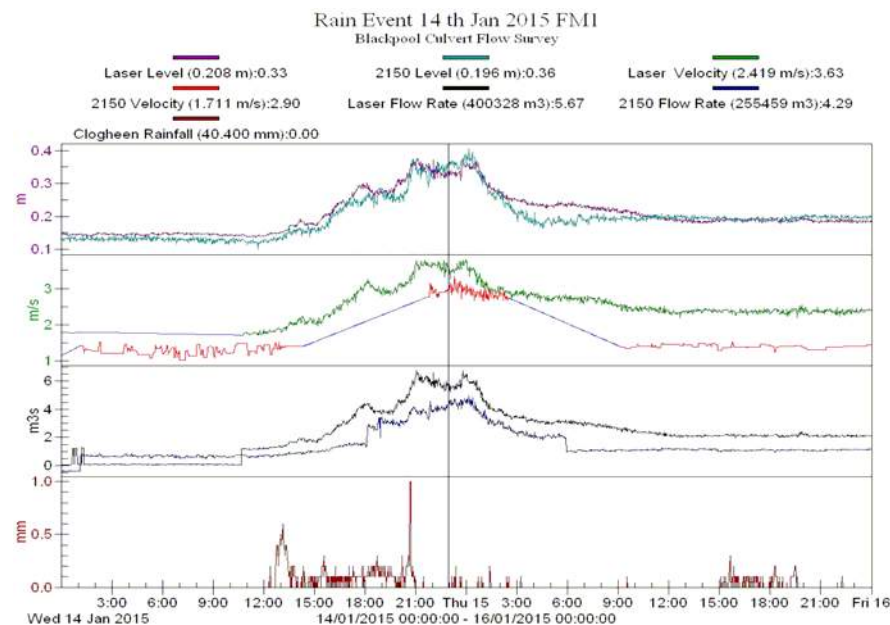
Fig 88: Rain Event 14th January at FM1- Level Velocity and Flows

Both Laser and 2150 AV show a peak level of 0.34 m approx, (5.04 M OD fpr 2150 and 5.02 M OD for Laser. The 2150 velocity data locked out during the increase but did record at the peak level for a period. However the Laser worked better and this is used as the benchmark for calculating an accurate flow at FM1. The max flow recorded by the Laser logger was 6 m³/s approx.

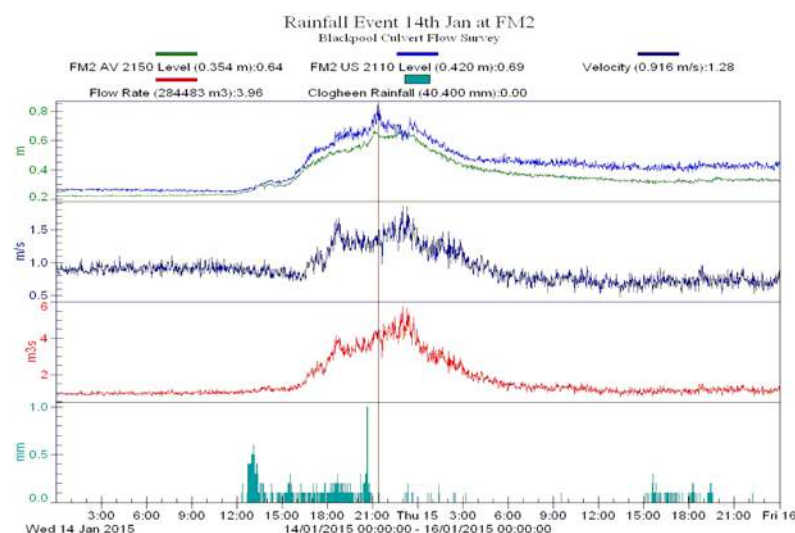
Fig 89: Rain Event 14th January at FM2- Level, Velocity and Flows

Ultrasonic 2110 Logger (US) and 2150 AV

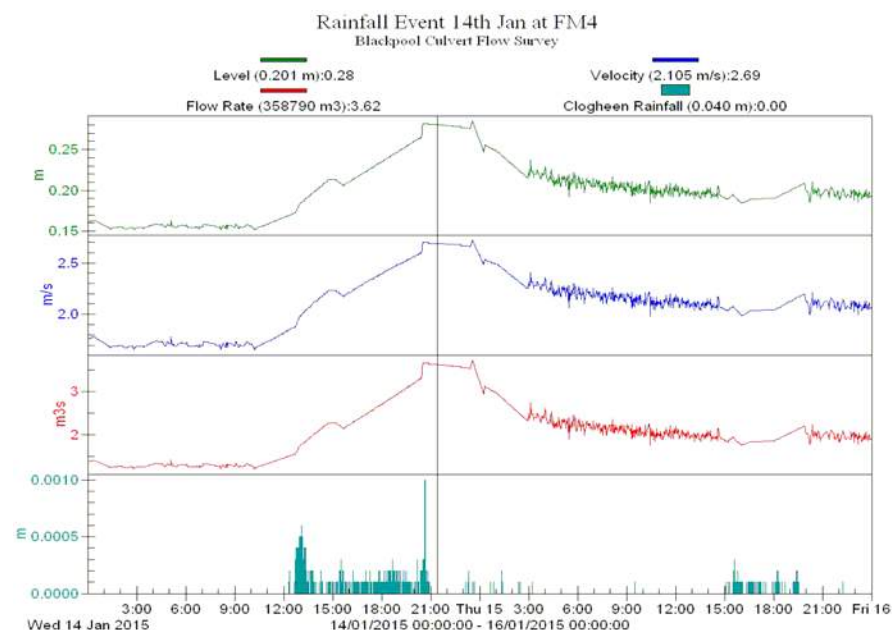
Fig 91: Rain Event 14th January at FM4- Level calculated Velocity and calculated Flows

At FM4 we recorded levels with the newly fitted Ultrasonic Flow logger which is placed 3 m upstream of the old 2150 AV position. We used an equation derived from previous level ,velocity data to convert levels to velocities and subsequently to flows in order to provide an estimate of the flow rates at FM4. This is used for flow balancing calculations.

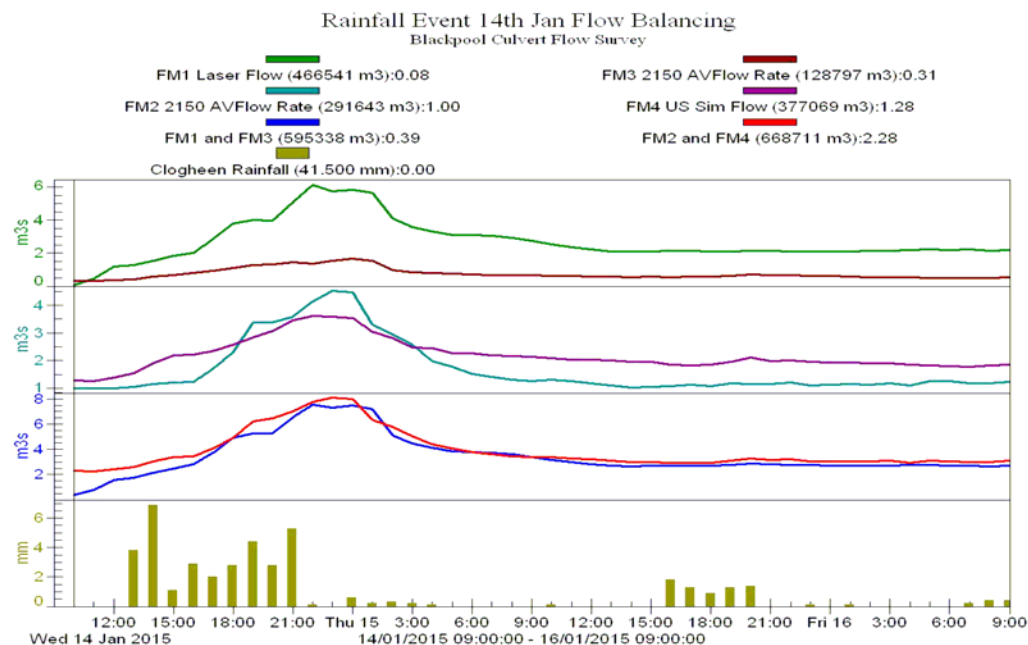
Fig 92: Rain Event 14th January Flow Calculation Summary Graph

Flows at FM4 are derived from the ultrasonic level logger using an algorithm created from previous level velocity data. FM2 is a natural channel but for flow calculating purposes we assume a rectangular channel with an even floor level.
